Report on Geotechnical Investigation

Affordable Housing

211A-215 Harbour Drive, Coffs Harbour NSW

Project 89890.01

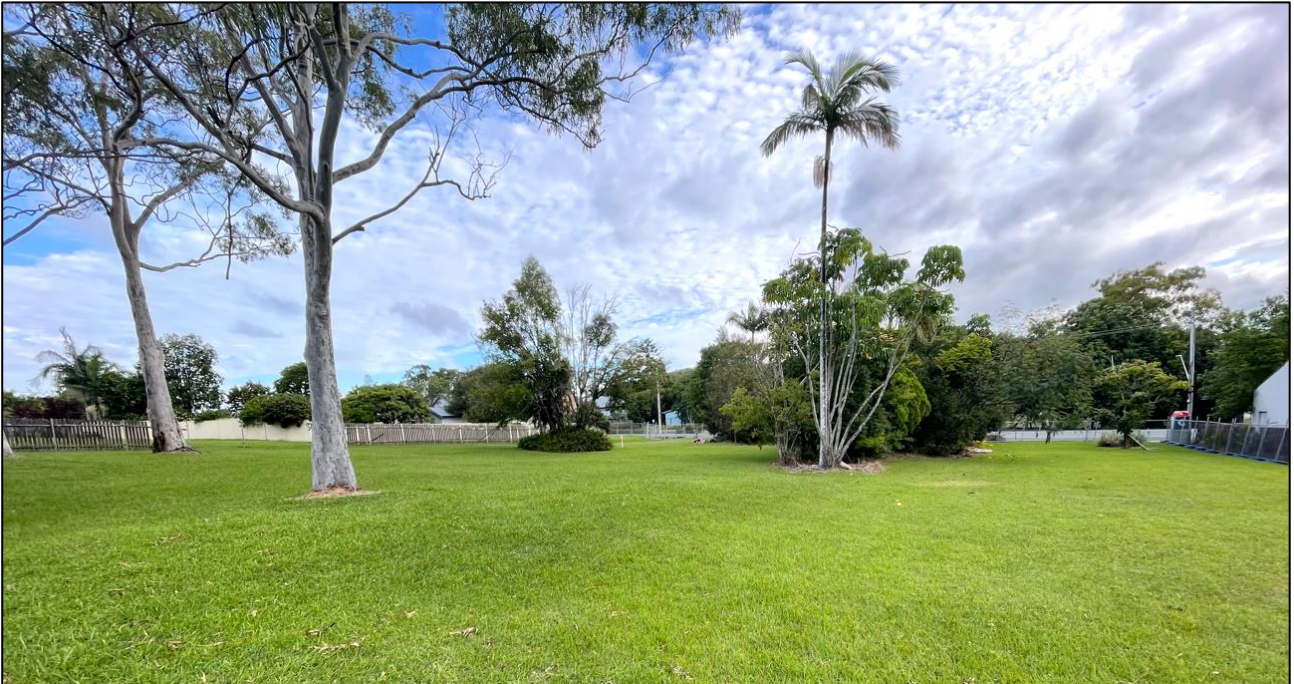
At the time of the investigation, the site was vacant and grassed, with some trees in parts (refer Figure 3 and Figure 4). An existing sewer main crossed the north-eastern part of the property. Low-rise, commercial buildings were present to the east and west, and residential buildings to the north and east of the site.

Figure 3: View south across the site

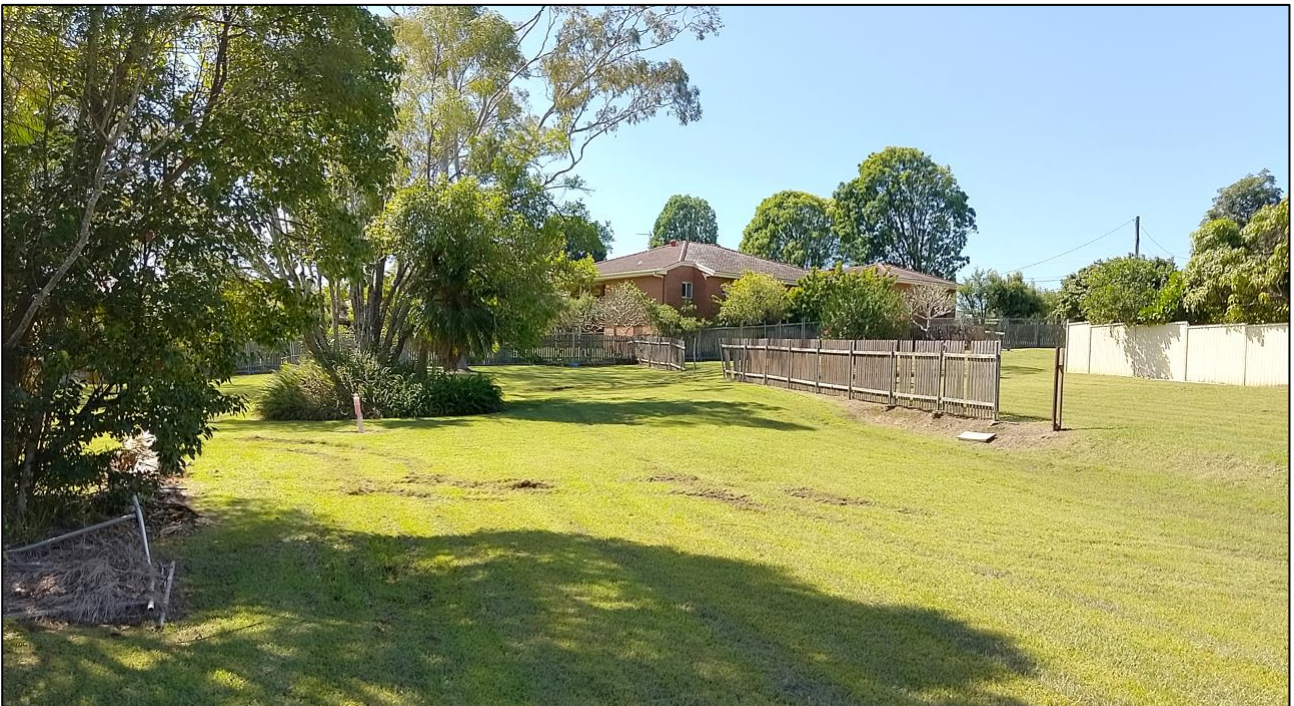
Figure 4: View north across the site

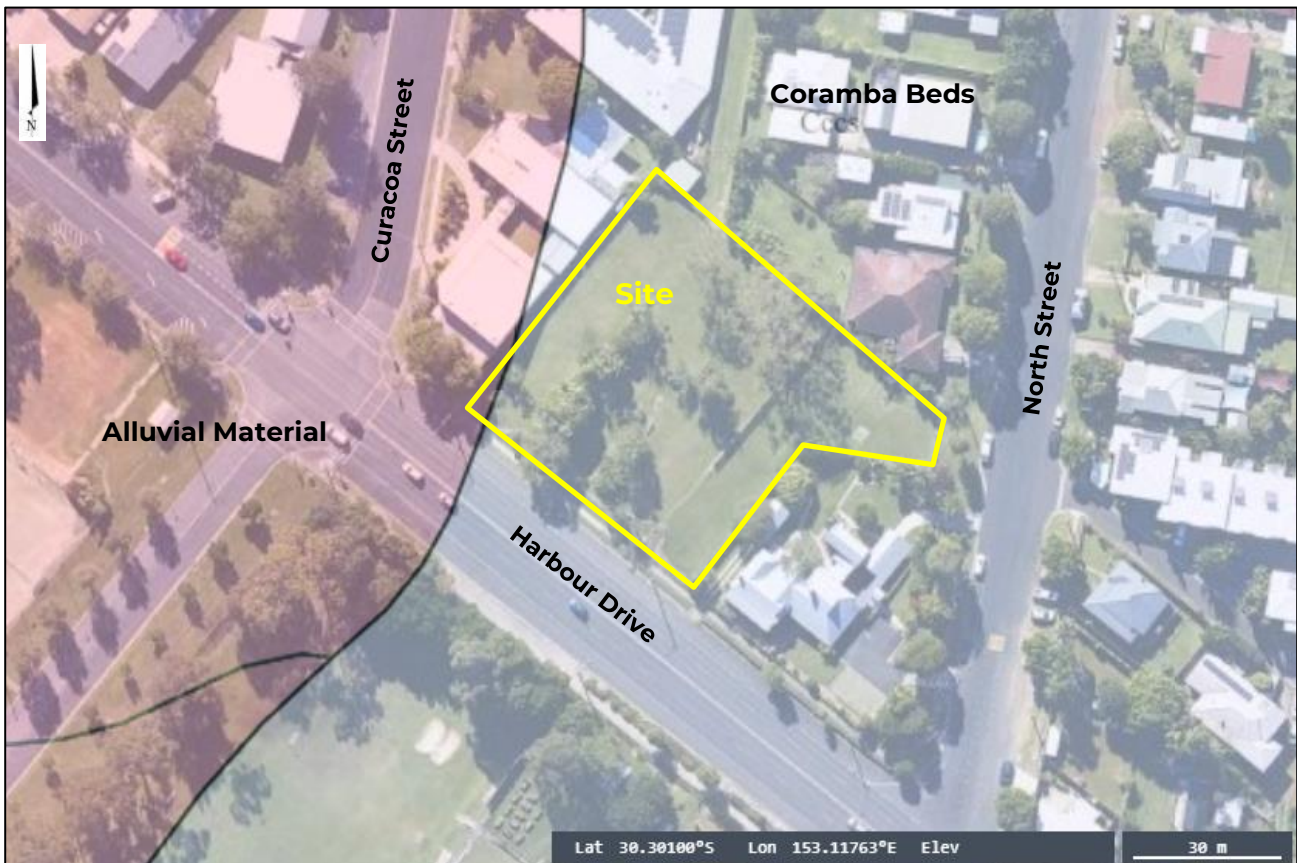
The NCCA Quaternary mapping indicates that the far western corner of the site is underlain by quaternary aged alluvial plain / terrace material which typically comprises silt, clay, fluvial sand and gravel.

Figure 5: Extract of NCCA geology mapping with approximate property / site location

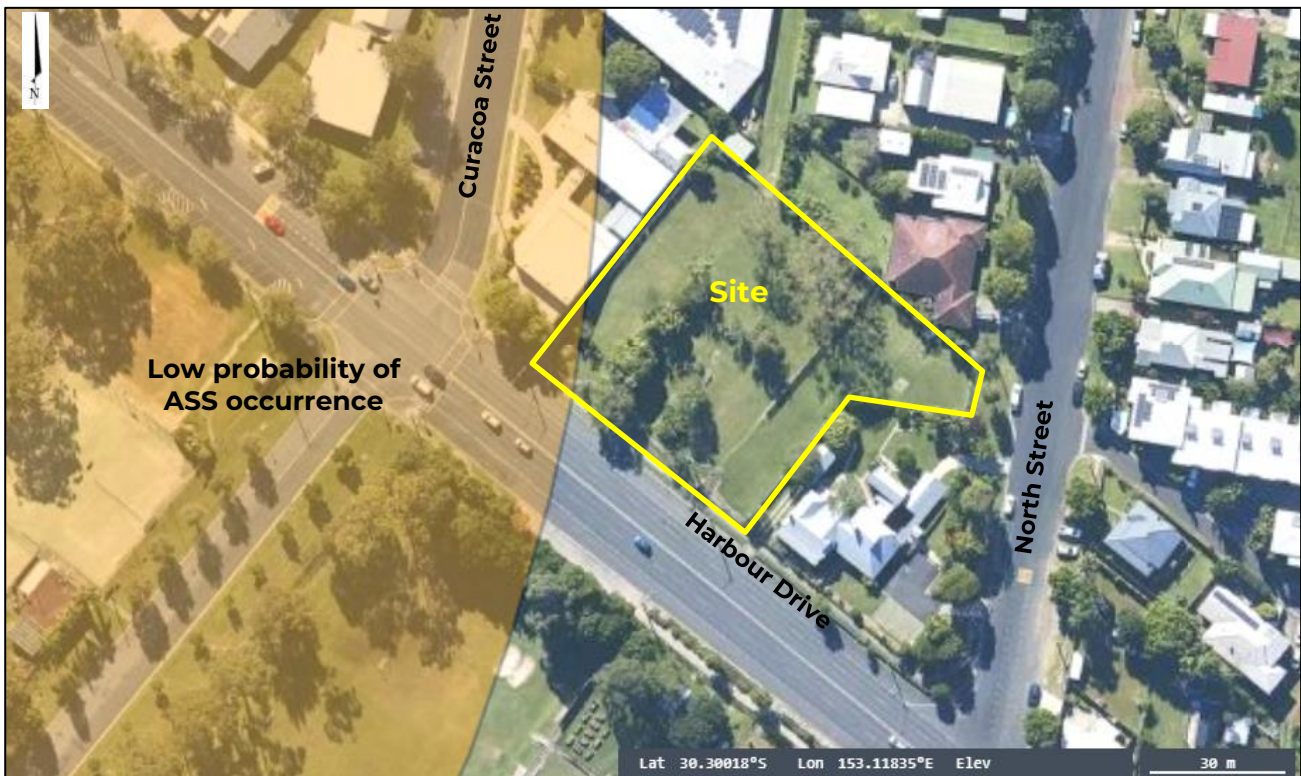
Reference to the NSW 1:25,000 Acid Sulfate Soil Risk Mapping indicates there is a low probability of occurrence of acid sulfate soil (ASS) in the far western corner of the site and is generally not expected to contain ASS materials in this area. The mapping also indicates that the majority of the site is located outside of areas of known acid sulfate soil risk mapping. ASS risk mapping is shown in Figure 6.

Figure 6: Extract of acid sulfate soil mapping

With reference to the Environmental Planning Instruments (EPI) maps for Acid Sulfate Soils (Coffs Harbour LEP, 2013), these risk zones correspond to Class 4 in the areas of low probability of ASS occurrence, with the majority of the site mapped as Class 5, reflecting the 500m “buffer zone”.

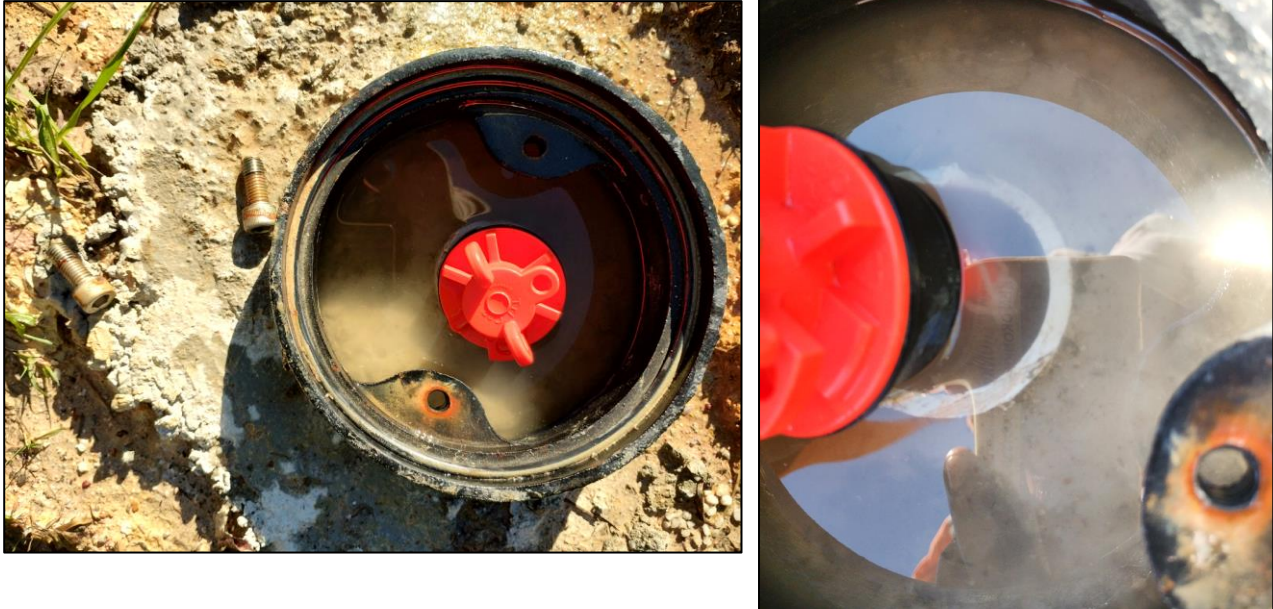
It is noted that groundwater levels rose to near ground level of Bore 109 within approximately 16 hours of drilling (refer Figure 7), following installation of a standpipe.

Figure 7: Groundwater at surface of monitoring well at Bore 109A (7 May 2025)

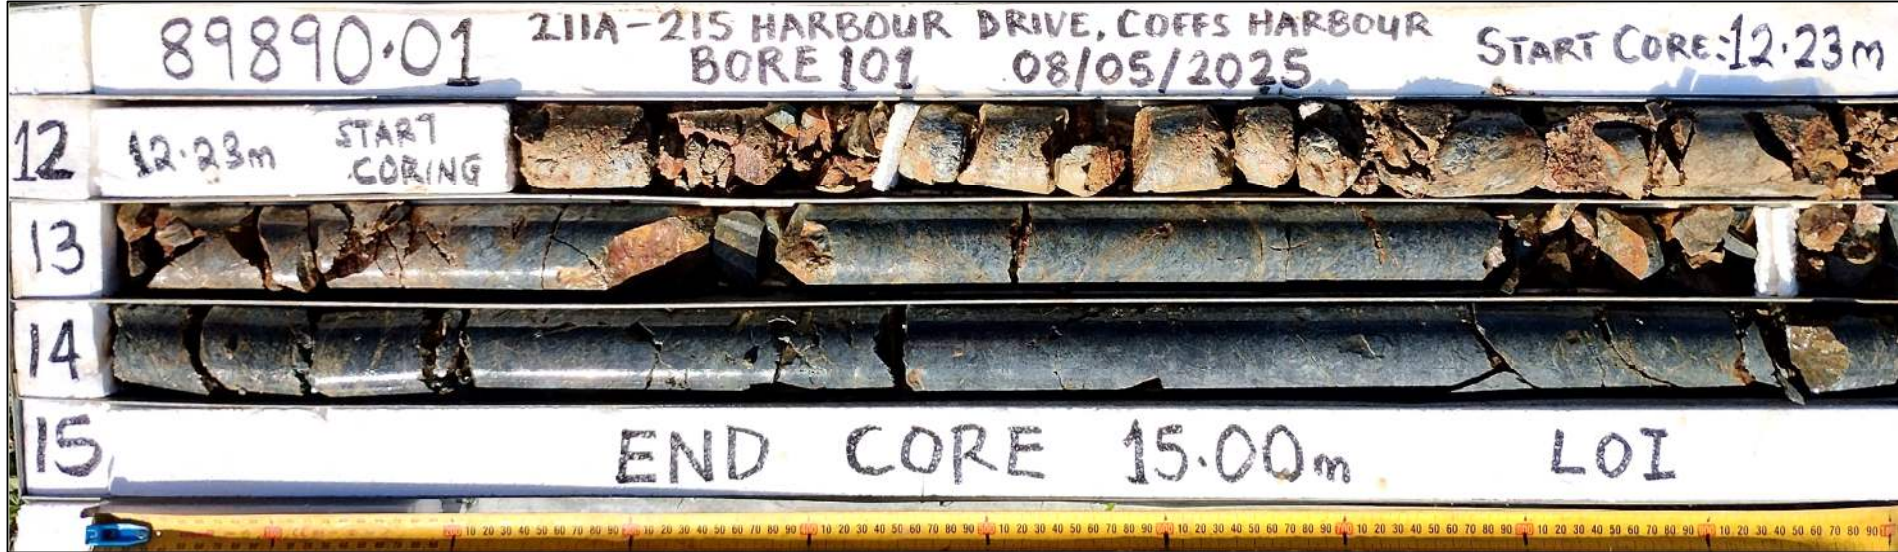
Photo 1: Bore 101 core 12.23 m to 15.00 m

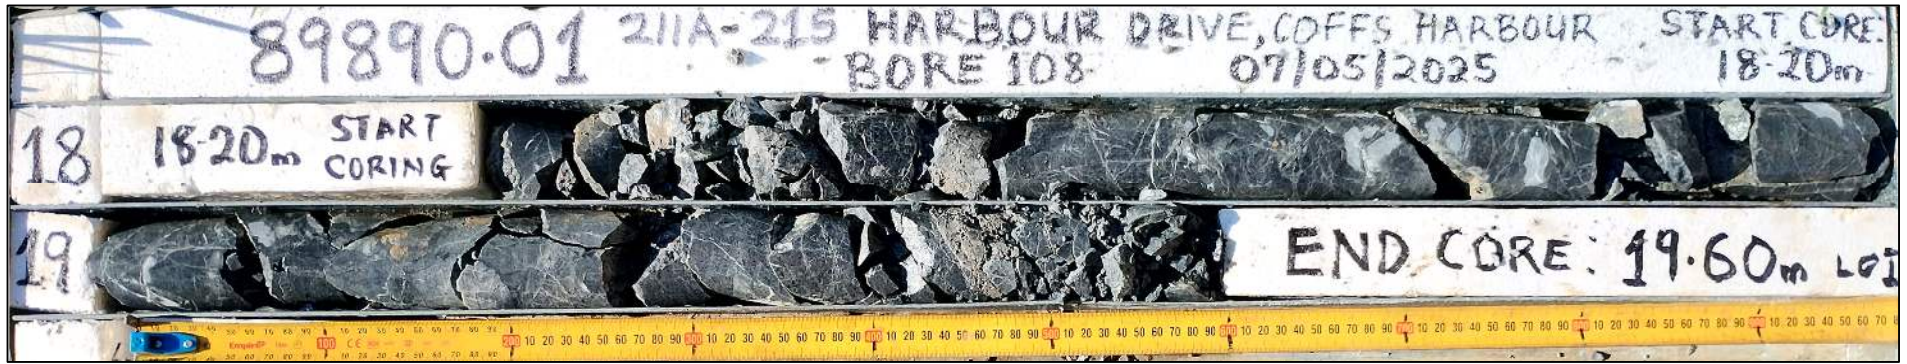
Photo 2: Bore 108 core 18.20 m to 19.60 m

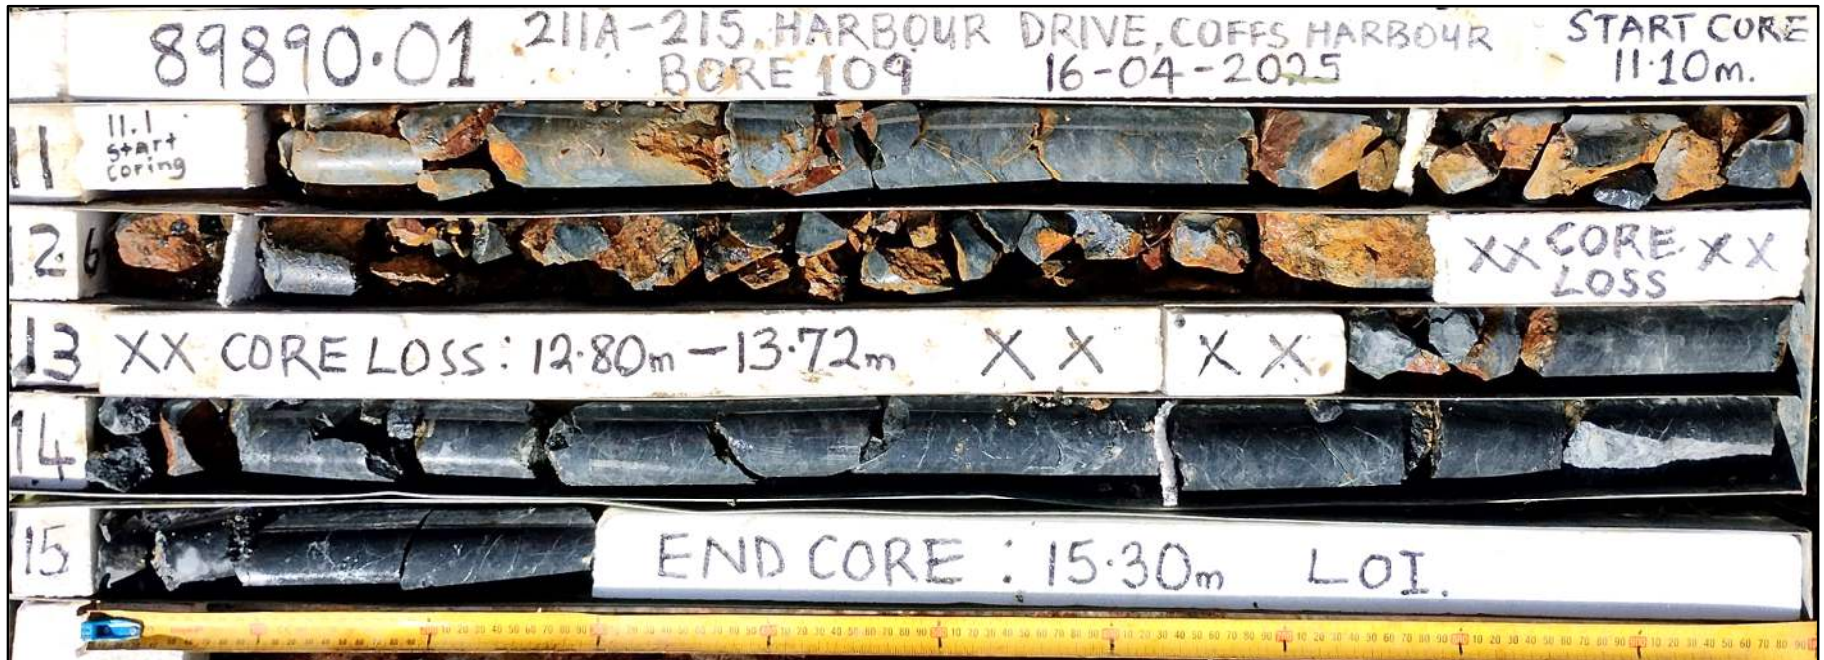
Photo 3: Bore 109 core 11.1m to 15.30
