Project 227295.00  
20 September 2024  
R.003.Rev0  
JCL:co

## **Report on Infiltration Testing Proposed Residential Development 5-7 Church & 42 Donald Street, Nelson Bay NSW**

This report prepared by Douglas Partners Pty Ltd (Douglas) presents the results of infiltration testing undertaken for a proposed residential development at 5-7 Church & 42 Donald Street, Nelson Bay NSW (the site). The investigation was commissioned by email instructing to proceed dated 10 September 2024 from Roberto Giammaria of Fortezza Group Pty Ltd and was undertaken in line with Douglas' proposal 227295.00.P.002.Rev1 dated 10 September 2024.

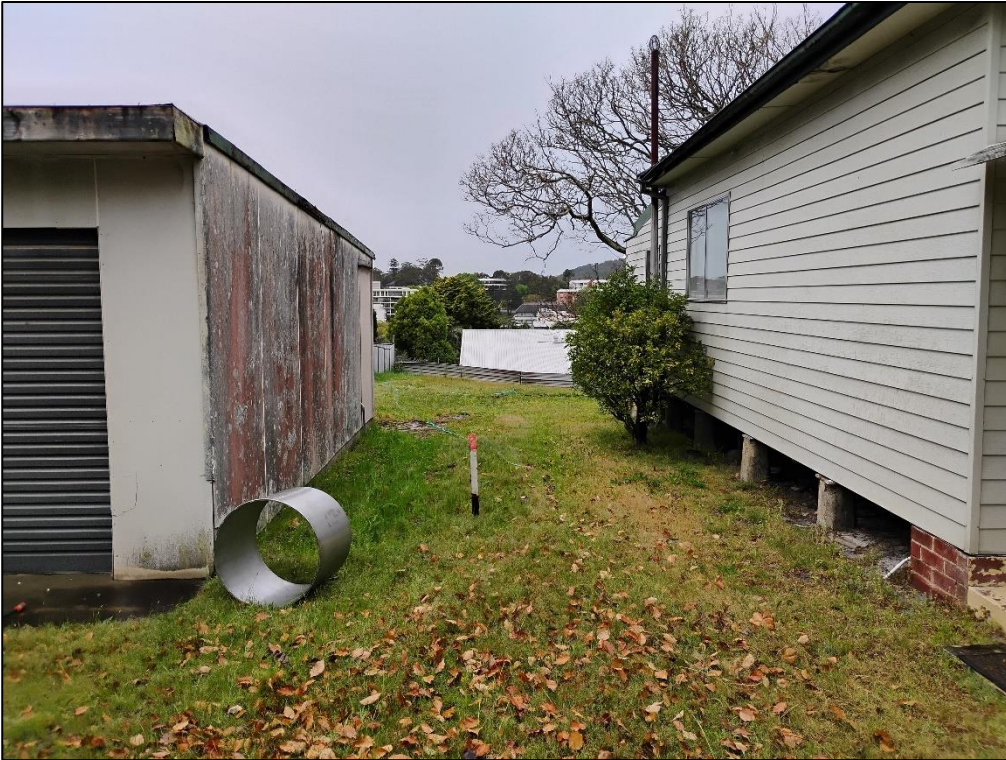
**Figure 1: DRI 101 location, looking east.**

| Location | Description | Soil Description | Depth (m) | Estimated steady state infiltration rate | |
|---|---|---|---|---|---|
| 101 | Between garage and residential dwelling at 5 Church Street | Silty sand (grassed) | 0.0 | 86 | 860 |

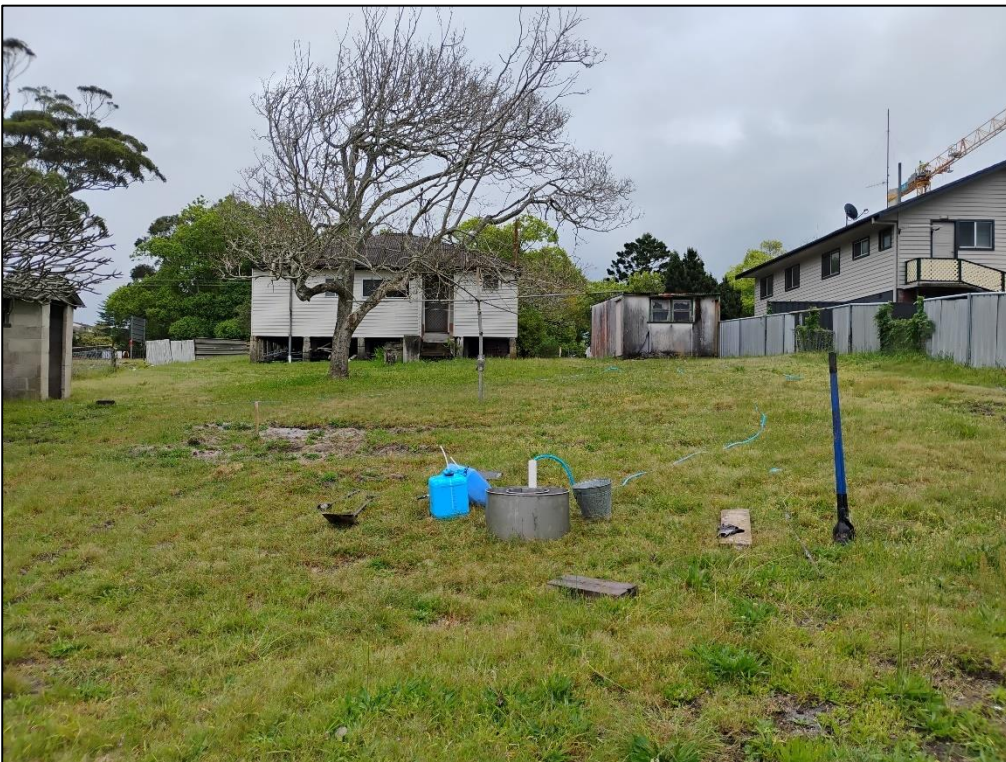
**Figure 2: DRI 102 location, looking west.**

| Location | Description | Soil Description | Depth (m) | Estimated steady state infiltration rate | |
|---|---|---|---|---|---|
| 102 | Backyard at 5 Church Street | Silty sand (grassed) | 0.0 | 128 | 1280 |
| 102 | | Sand | 0.5 | 151 | 1510 |

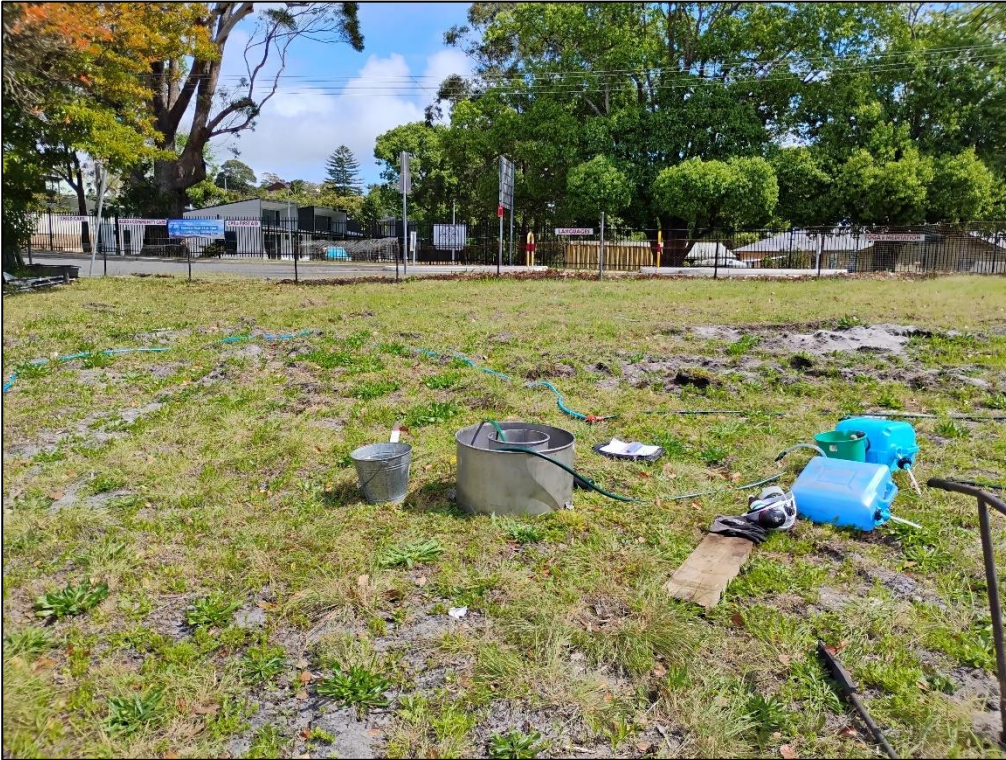
**Figure 3: DRI 103 location, looking west.**

| Location | Description | Soil Description | Depth (m) | Estimated steady state infiltration rate | |
|---|---|---|---|---|---|
| 103 | Centre of 7 Church Street | Silty sand (grassed) | 0.0 | 95 | 950 |

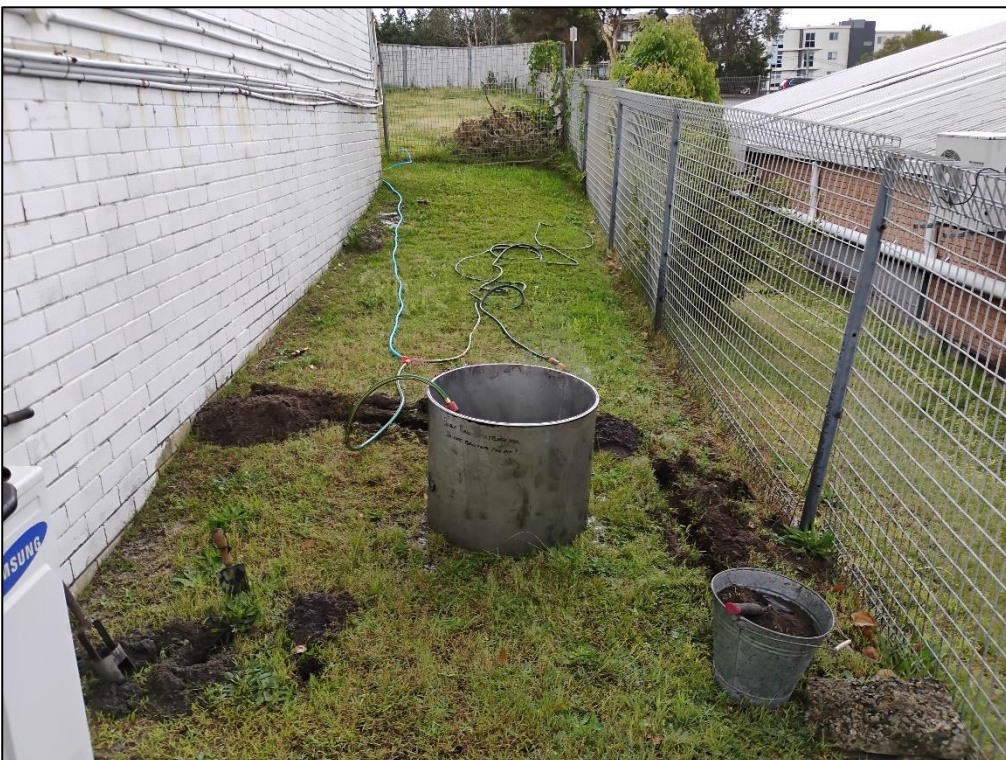
**Figure 4: DRI 104 location, looking north.**

| Location | Description | Soil Description | Depth (m) | Estimated steady state infiltration rate | |
|---|---|---|---|---|---|
| 104 | Eastern side of building at 42 Donald Street | Sandy gravel (grassed) | 0.0 | 106 | 1060 |
