### **Report on Additional Geotechnical Investigation**

### **Proposed Residential Development**

**5-7 Church & 42 Donald St, Nelson Bay  
NSW**

**Project 227295.02**

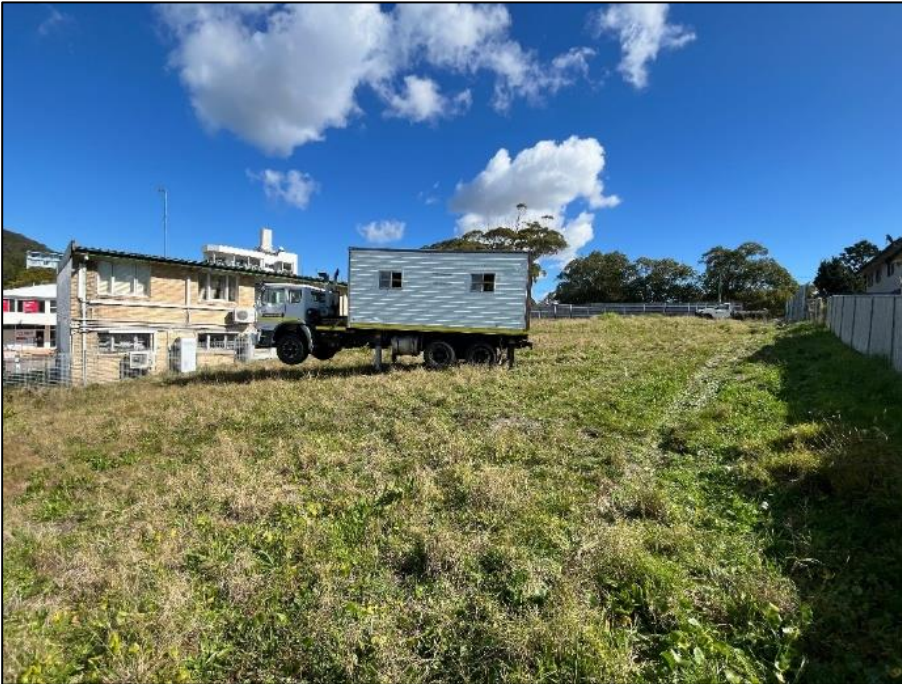
**Figure 2: North-east corner of Lot 15 looking south-west**

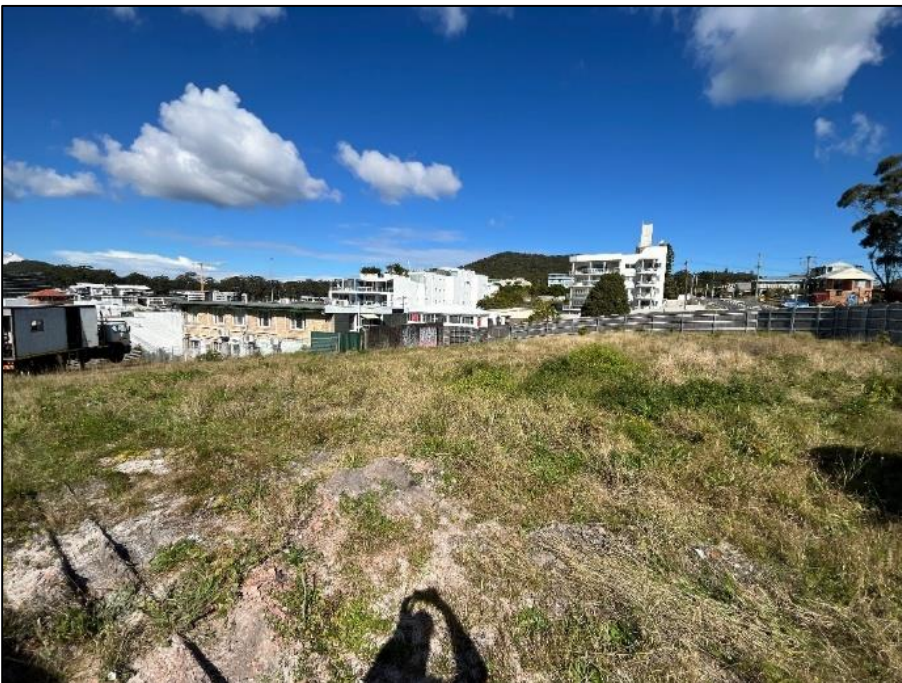
**Figure 3: North-west corner of Lot 15 looking south-east**

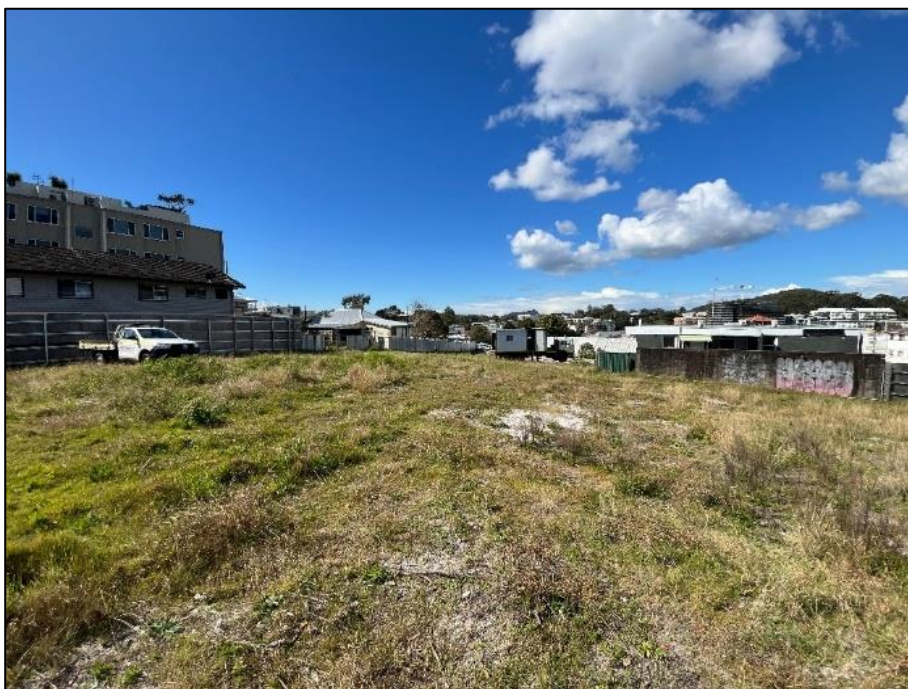
**Figure 4: South-west corner of Lot A looking north-east**

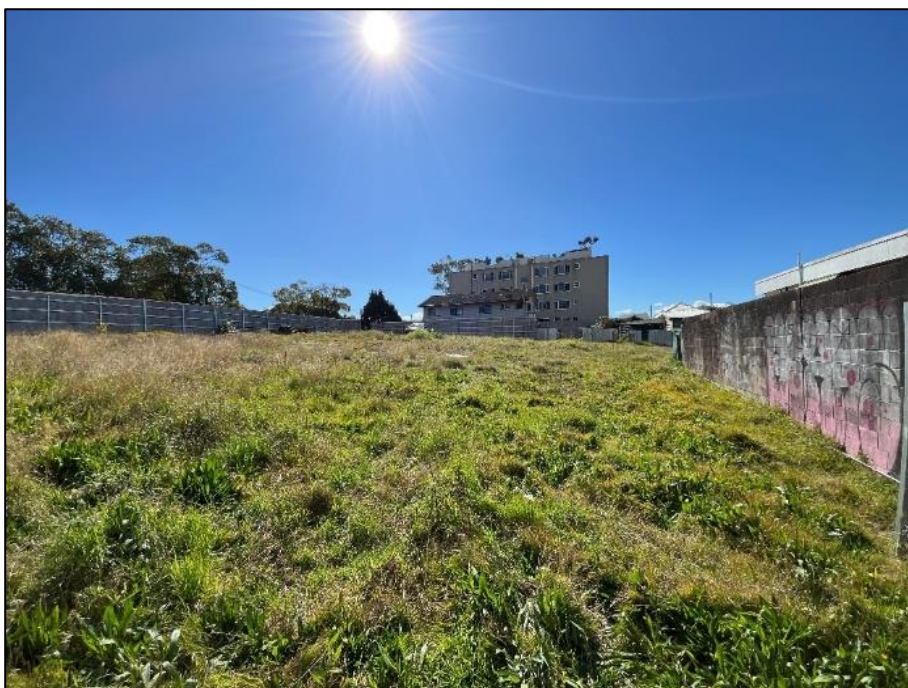
**Figure 5: South-east corner of Lot A looking north-west**

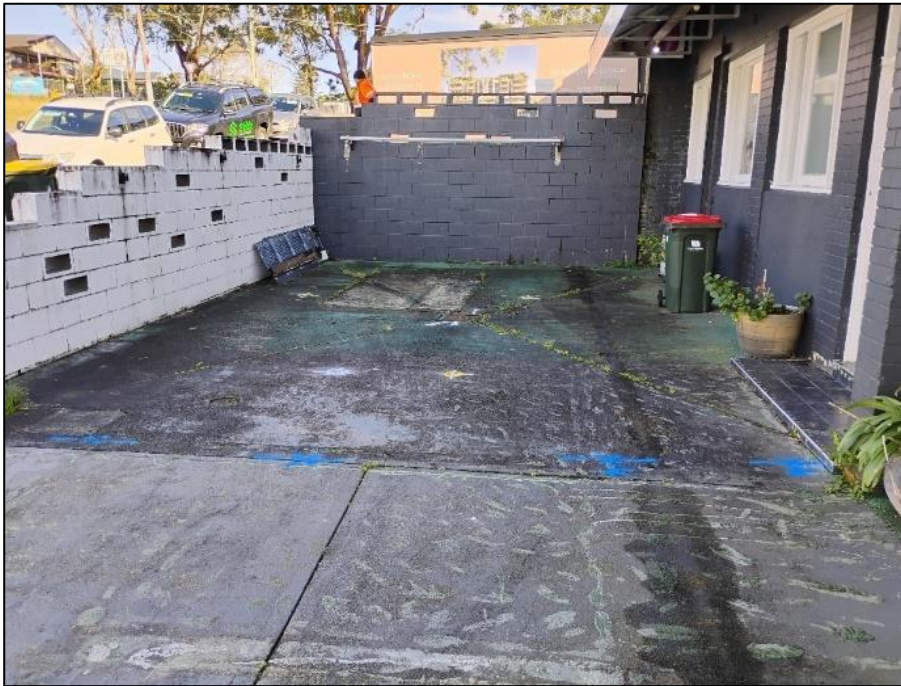
**Figure 6: South-east corner of Lot B looking west**

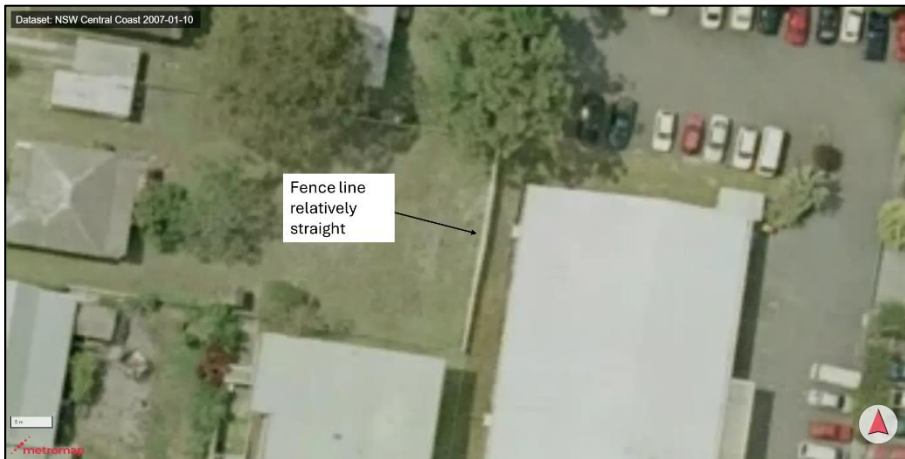
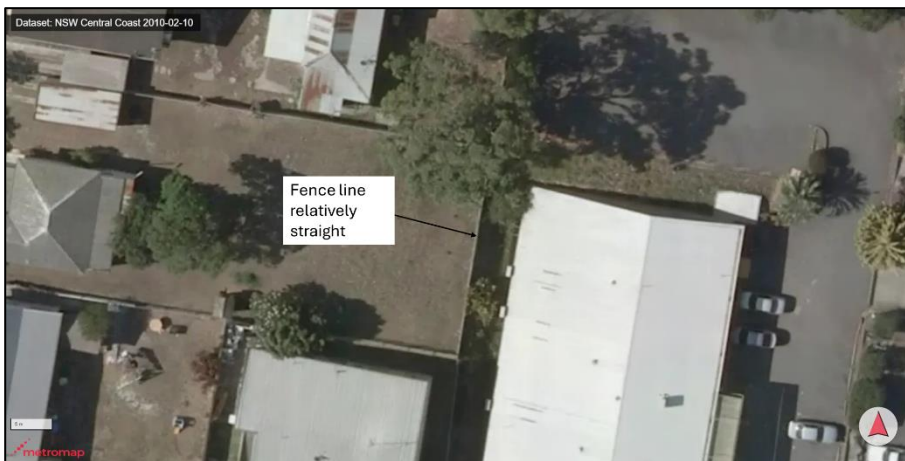
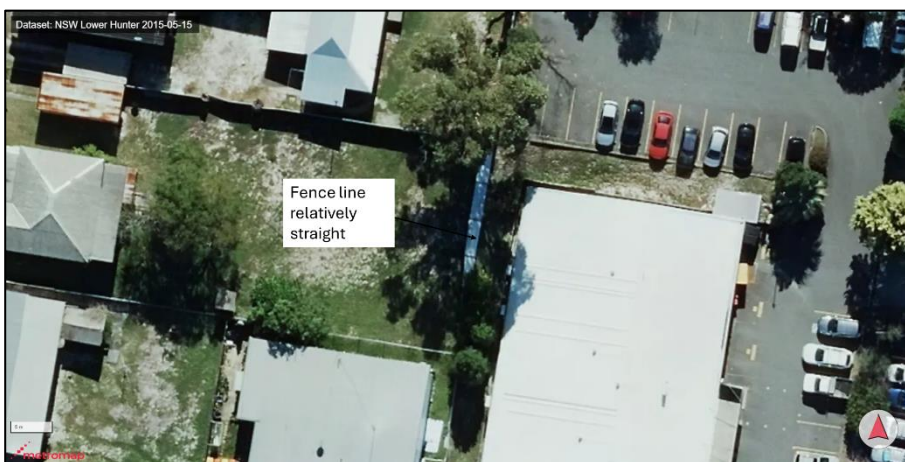
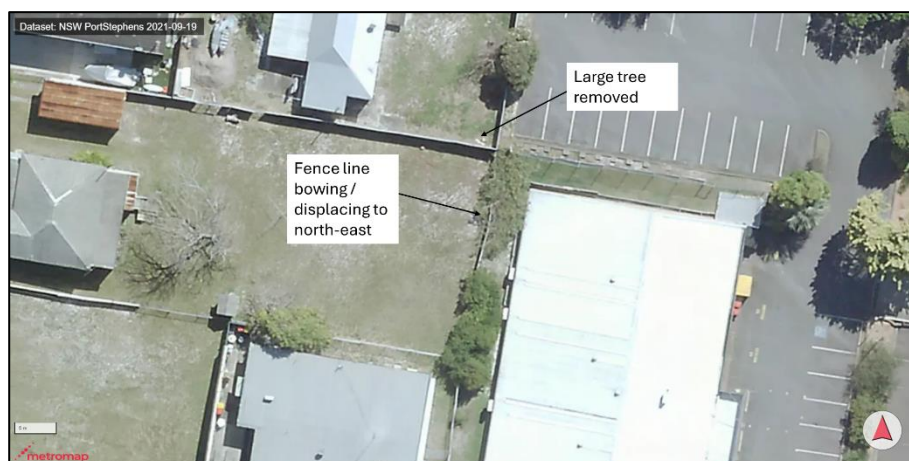
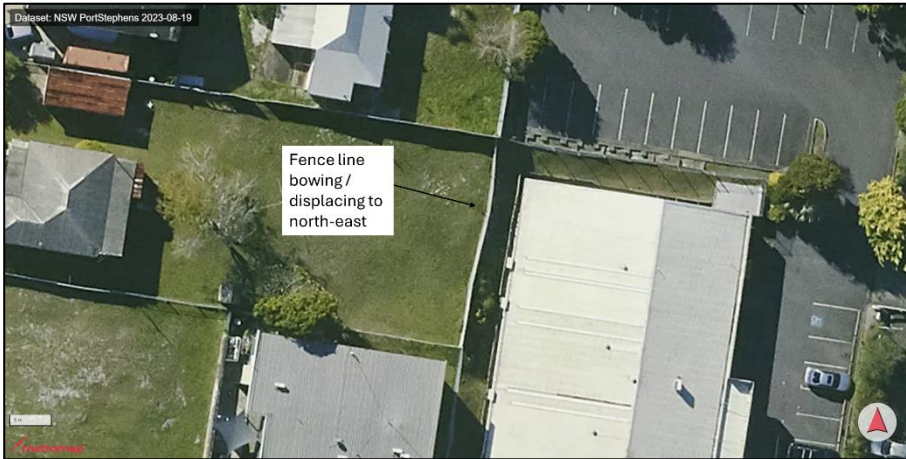
A review of historical aerial imagery (Figure 8 to Figure 15 ) and local site features (Figure 16 and Figure 17) suggests that slope creep or a historical localised instability may have occurred in the north-east part of the site. The available aerial imagery indicates the following:

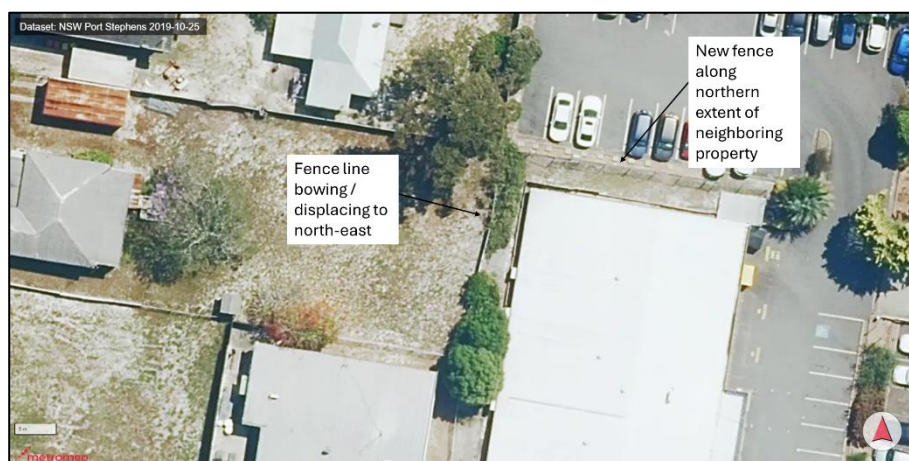
- **2019:** The feature along the fence observed in 2015 had been removed, with bowing and displacement of the fence along the north-east boundary. A new fence had also been constructed along the northern boundary of the neighbouring property to the east;

**Figure 11: MetroMap aerial image 2019**

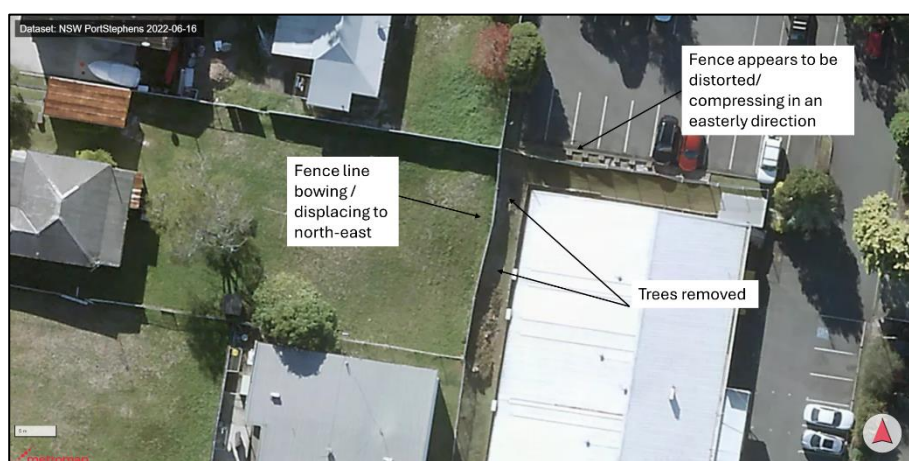
- **2022:** Trees were removed from along the north-east boundary and from the neighbouring property to the north;
- **2023:** No obvious changes were noted;

**Figure 13: MetroMap aerial image 2022**

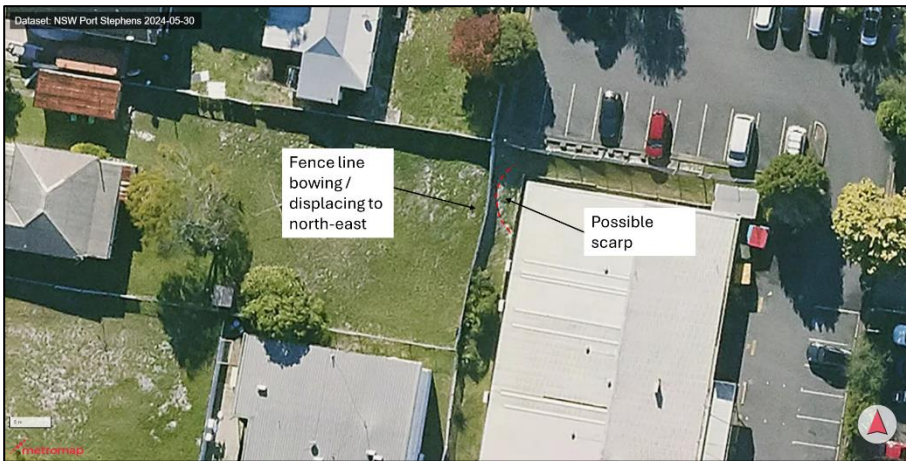
- **2024:** Imagery suggests the development of a possible scarp behind the retaining wall on the neighbouring property;
- **2025:** No obvious changes were observed.

**Figure 15: MetroMap aerial image 2024**

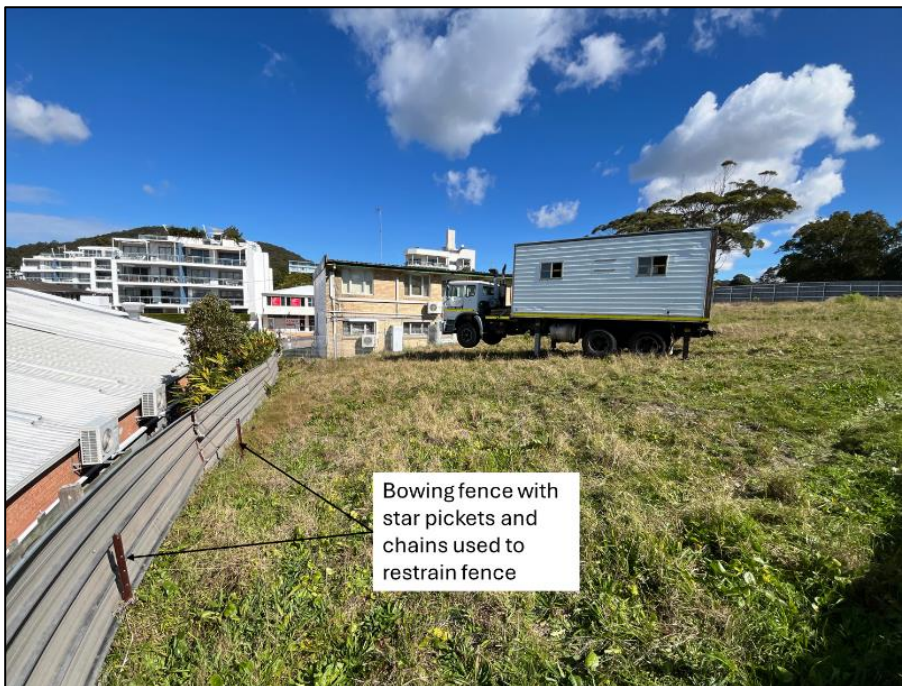
**Figure 17: Looking south along fence line current investigation**

The combination of reduced strength indicated by the CPTs, likely attributable to a loss of confinement, together with observations from site inspections and aerial imagery, suggests that creep of the sand mass downslope and/or a localised historical slip failure may have occurred. While this appears to be a localised issue, it nevertheless presents implications for the performance of the foundation system and basement shoring in this part of the site, as well as a potential hazards to construction plant operating in the vicinity. In particular, heavy equipment such as piling rigs or cranes working upslope could remobilise the failure or accelerate creep movements, leading to instability of the plant and/or damage to the neighbouring property and the existing retaining wall to east of the site boundary. It is also possible that such creep or localised instability has already contributed to damage of the existing timber retaining wall located downslope on the adjoining eastern property.

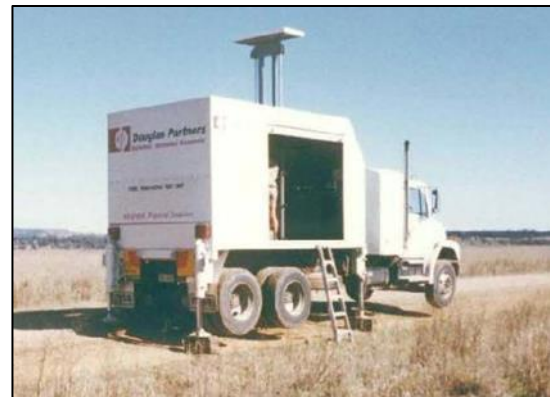
The cone is thrust into the ground at a steady rate of about 20 mm/sec, usually using the hydraulic rams of a purpose built CPT rig, or a drilling rig. The testing is carried out in accordance with the Australian Standard AS1289 Test 6.5.1.

Figure 2: Purpose built CPT rig
