GEOTECHNICAL INVESTIGATION AND ACID SULFATE SOILS (ASS) ASSESSMENT

16-20 Middle Harbour Road, Lindfield

Report No: 25/1383

May 2025

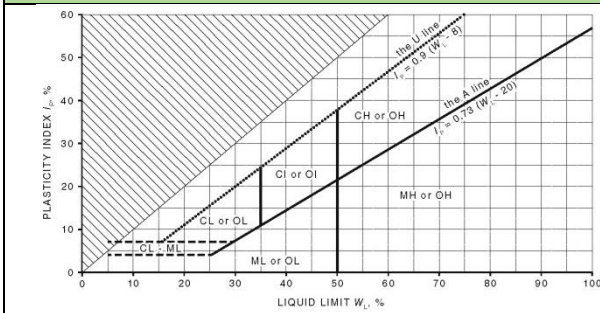
PLASTICITY PROPERTIES

CL, CI	Inorganic clays of low to medium plasticity, gravelly clays, sandy clays, silty clays, medium to high dry strength.
Liquid Limit > than 50%	OL		Organic silts and organic silty clays of low plasticity, low to medium dry strength.		
	MH	Inorganic silts of high plasticity, high to very high dry strength.			
	CH	Inorganic clays of high plasticity, high to very high dry strength.			
Highly Organic soil	PT	OH	Organic clays of medium to high plasticity, medium to high dry strength.		
		PT	Peat muck and other highly organic soils.
