# Appendix 11.1

## Appendix B: Asbestos Removal Control Plan

# **Asbestos Removal Control Plan**

**Penshurst Public School**

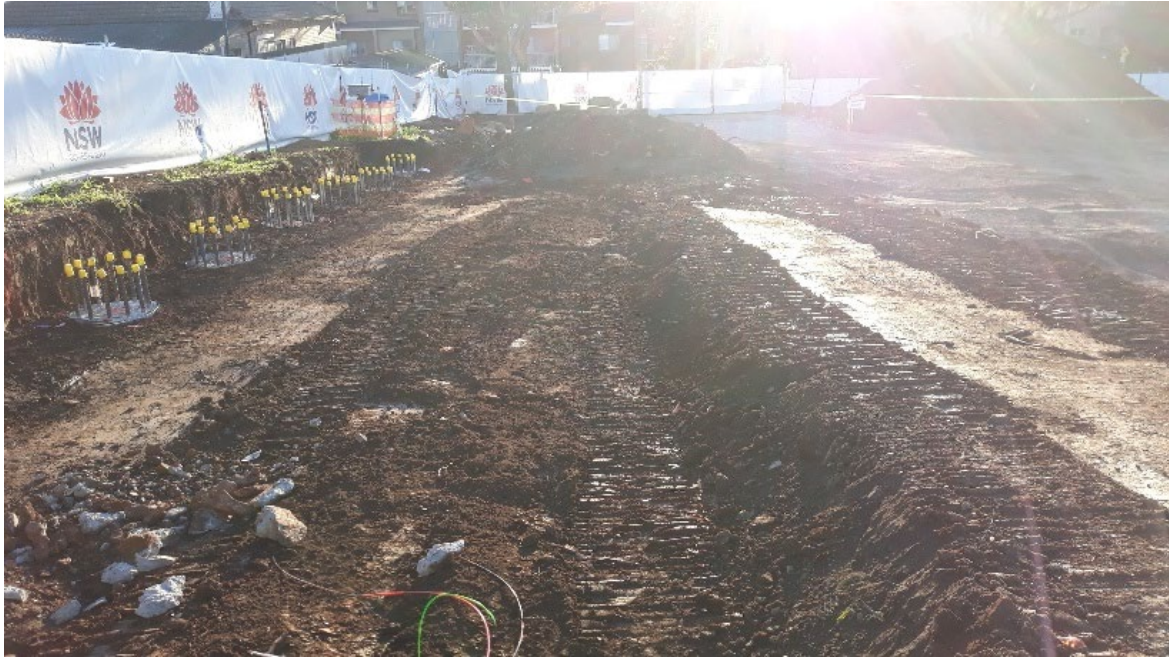
The visual inspection undertaken on 8 August 2019 was carried out by completing a systematic walkover of the exposed soil in the Grid 4 and 6 areas at the site. The visual inspection found the exposed surface of the fill soil in the Grid 4 and 6 areas to be free of visible asbestos containing material such as fragments of asbestos cement.

Based on the findings of the visual inspection of the exposed surface of the fill soil within the Grid 4 and 6 areas at the site on 8 August 2019 which found there to be no visible asbestos containing material to be present (on the ground surface), we confirm that the Grid 4 and 6 areas within the Grindley construction area at the Penshurst Public School construction site in Forest Road, Penshurst NSW, corner Arcadia Street may be accessed without the use of asbestos personal protective equipment (PPE) for construction work to be undertaken.

**Looking across the Grid 4 and 6 areas at the Penshurst Public School  
at completion of visual walkover inspection on 8 August 2019**

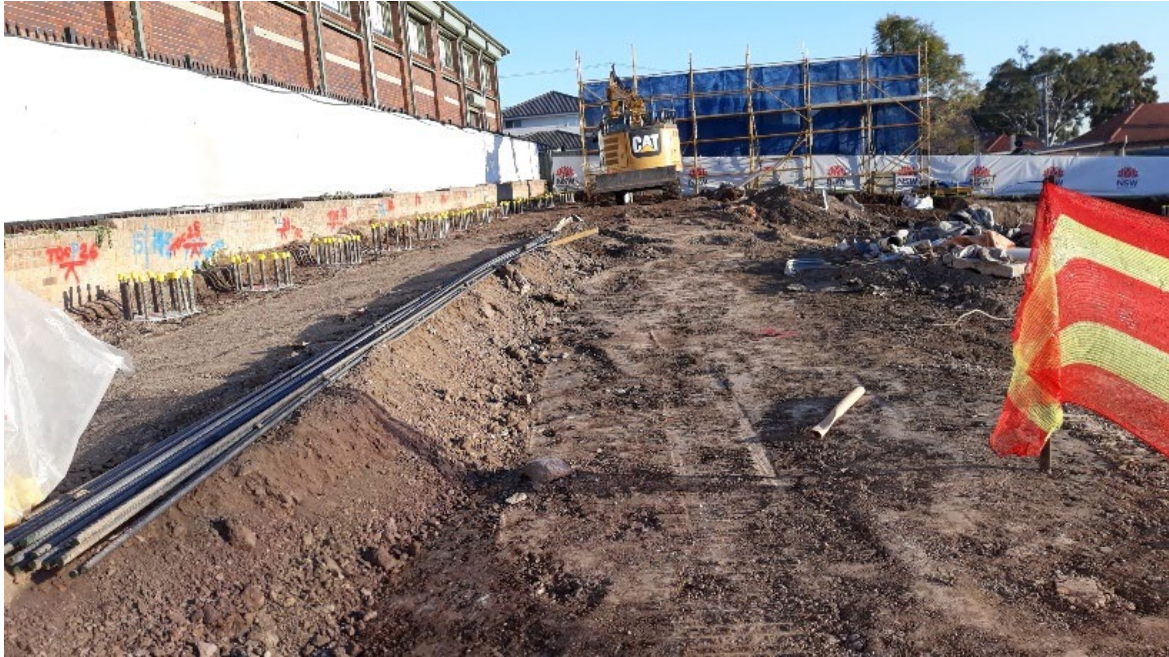
The visual inspection undertaken prior to the commencement of work on 8 August 2019 was carried out by completing a systematic walkover of the exposed soil in the Grid 8 and 12 areas at the site. The visual inspection found the exposed surface of the fill soil in the Grid 8 and 12 areas to be free of visible asbestos containing material such as fragments of asbestos cement.

**Looking across the Grid 8 area at the Penshurst Public School  
at completion of visual walkover inspection on 8 August 2019**

Based on the findings of the visual inspection of the exposed surface of the fill soil within the Grid 8 and 12 areas at the site on 8 August 2019 which found there to be no visible asbestos containing material to be present (on the ground surface), we confirm that the Grid 8 and 12 areas within the Grindley construction area at the Penshurst Public School construction site in Forest Road, Penshurst NSW, corner Arcadia Street may be accessed without the use of asbestos personal protective equipment (PPE) for construction work to be undertaken.

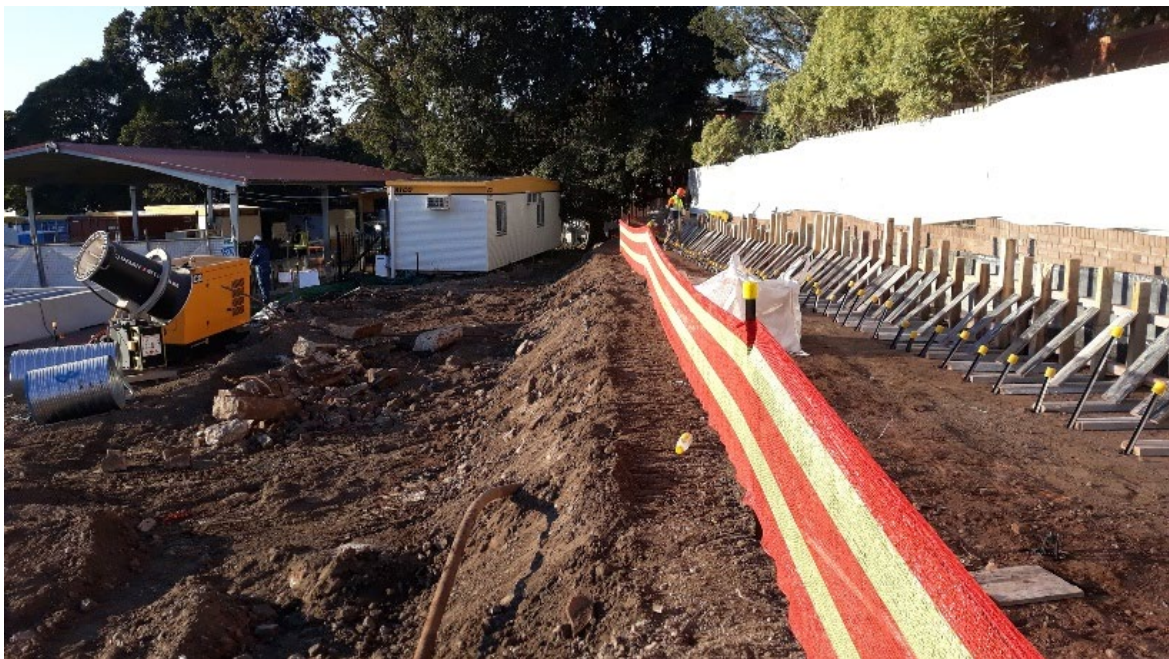
**Looking across the Grid 12 area at the Penshurst Public School  
at completion of visual walkover inspection on 8 August 2019**

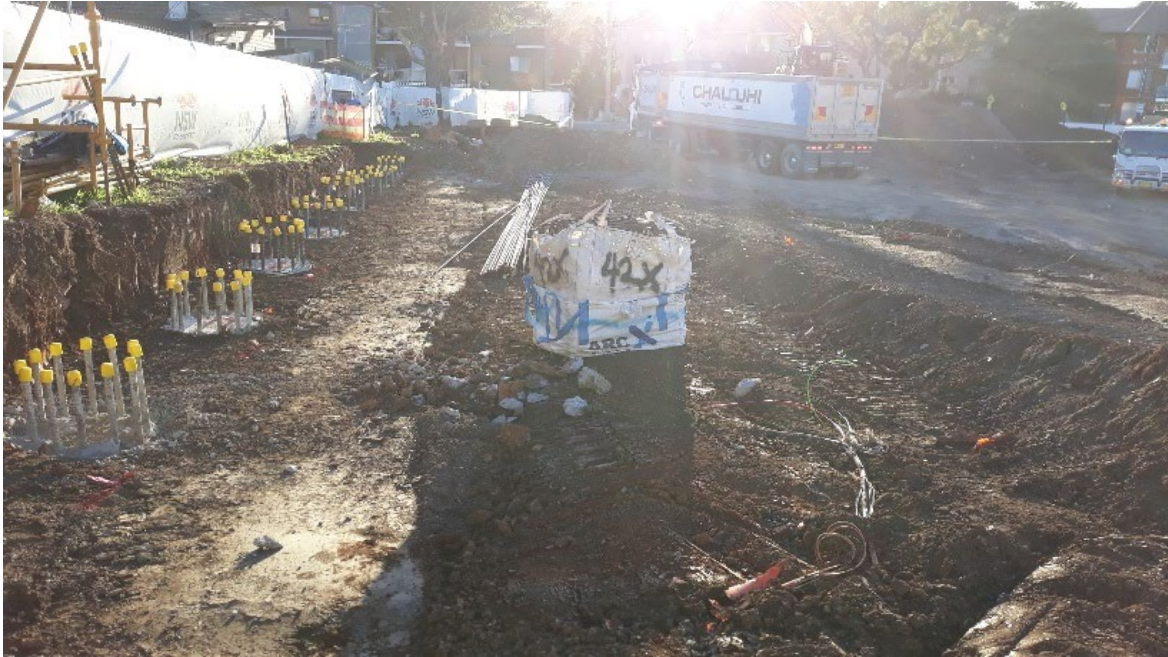
The visual inspection undertaken on 9 August 2019 was carried out by completing a systematic walkover of the exposed soil in the Grid 4 and 6 areas at the site. The visual inspection found the exposed surface of the fill soil in the Grid 4 and 6 areas to be free of visible asbestos containing material such as fragments of asbestos cement.

**Looking across the Grid 4 and 6 areas at the Penshurst Public School  
at completion of visual walkover inspection on 9 August 2019**

Based on the findings of the visual inspection of the exposed surface of the fill soil within the Grid 4 and 6 areas at the site on 9 August 2019 which found there to be no visible asbestos containing material to be present (on the ground surface), we confirm that the Grid 4 and 6 areas within the Grindley construction area at the Peshurst Public School construction site in Forest Road, Peshurst NSW, corner Arcadia Street may be accessed without the use of asbestos personal protective equipment (PPE) for construction work to be undertaken.

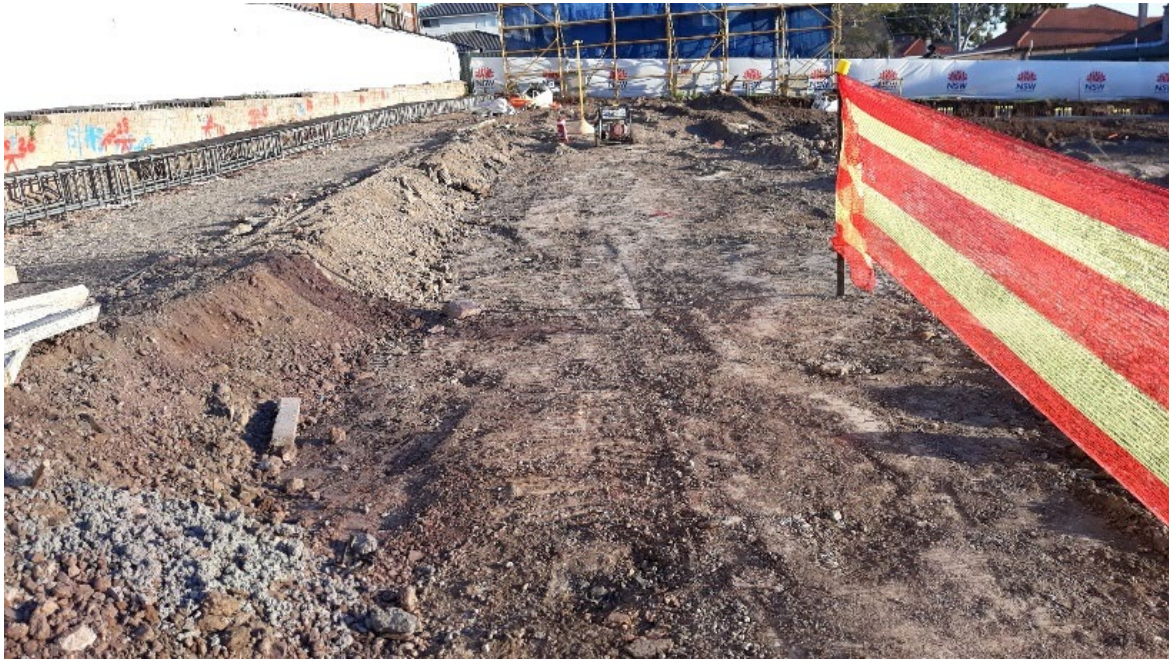
The visual inspection undertaken prior to the commencement of work on 9 August 2019 was carried out by completing a systematic walkover of the exposed soil in the Grid 8 and 12 areas at the site. The visual inspection found the exposed surface of the fill soil in the Grid 8 and 12 areas to be free of visible asbestos containing material such as fragments of asbestos cement.

**Looking across the Grid 8 area at the Penshurst Public School  
at completion of visual walkover inspection on 9 August 2019**

Based on the findings of the visual inspection of the exposed surface of the fill soil within the Grid 8 and 12 areas at the site on 9 August 2019 which found there to be no visible asbestos containing material to be present (on the ground surface), we confirm that the Grid 8 and 12 areas within the Grindley construction area at the Penshurst Public School construction site in Forest Road, Penshurst NSW, corner Arcadia Street may be accessed without the use of asbestos personal protective equipment (PPE) for construction work to be undertaken.

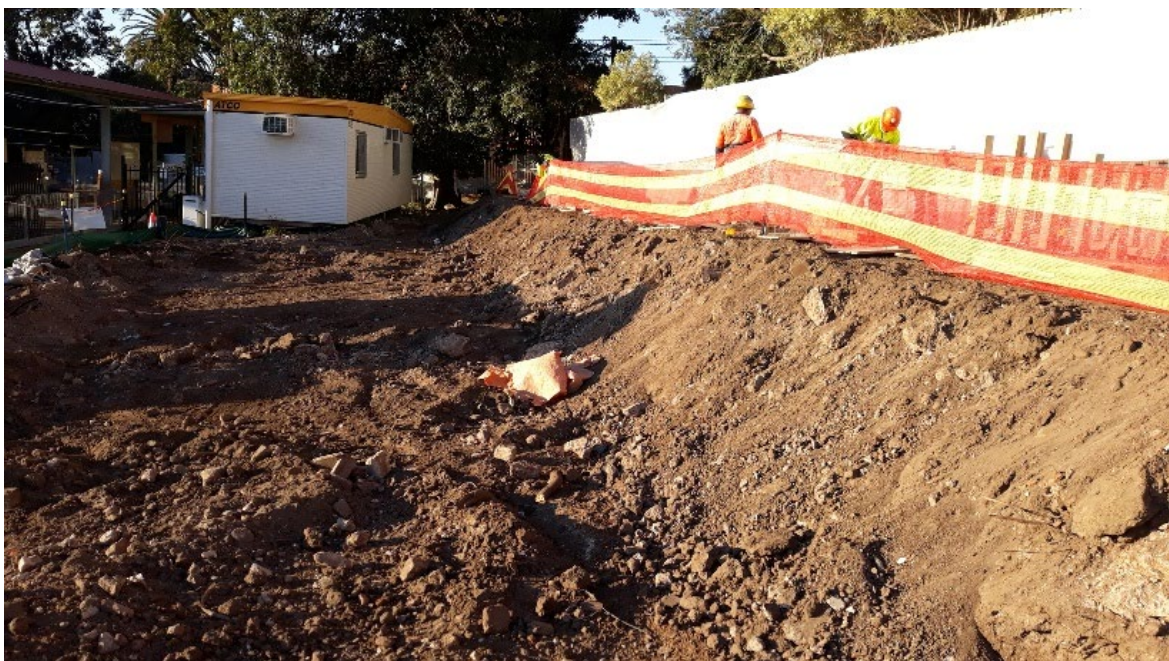
**Looking across the Grid 12 area at the Penshurst Public School  
at completion of visual walkover inspection on 9 August 2019**

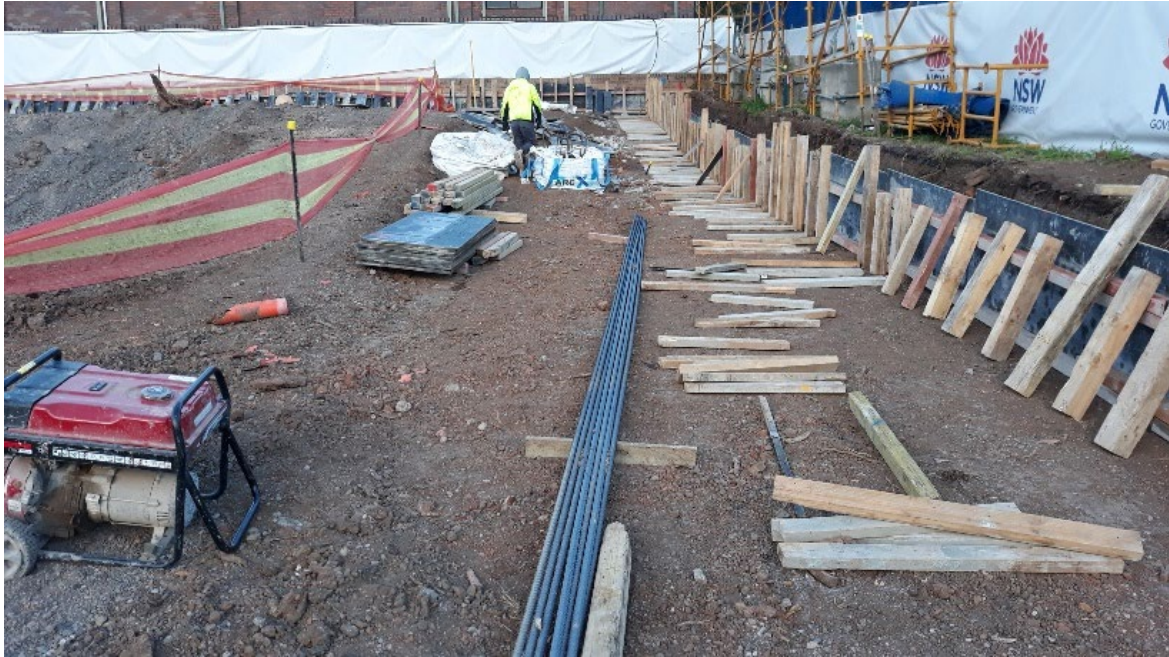
The visual inspection undertaken on 12 August 2019 was carried out by completing a systematic walkover of the exposed soil in the Grid 4 and 6 areas at the site. The visual inspection found the exposed surface of the fill soil in the Grid 4 and 6 areas to be free of visible asbestos containing material such as fragments of asbestos cement.

**Looking across the Grid 4 and 6 areas at the Penshurst Public School  
at completion of visual walkover inspection on 12 August 2019**

Based on the findings of the visual inspection of the exposed surface of the fill soil within the Grid 4 and 6 areas at the site on 12 August 2019 which found there to be no visible asbestos containing material to be present (on the ground surface), we confirm that the Grid 4 and 6 areas within the Grindley construction area at the Peshurst Public School construction site in Forest Road, Peshurst NSW, corner Arcadia Street may be accessed without the use of asbestos personal protective equipment (PPE) for construction work to be undertaken.

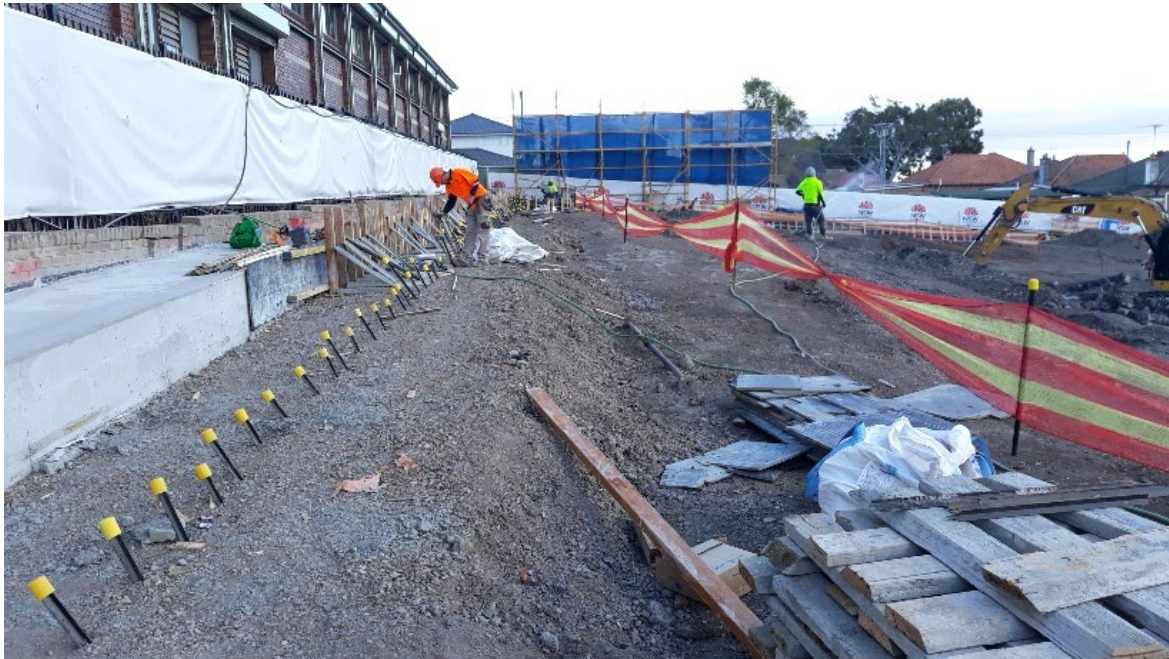
The visual inspection undertaken prior to the commencement of work on 12 August 2019 was carried out by completing a systematic walkover of the exposed soil in the Grid 8 and 12 areas at the site. The visual inspection found the exposed surface of the fill soil in the Grid 8 and 12 areas to be free of visible asbestos containing material such as fragments of asbestos cement.

**Looking across the Grid 8 area at the Penshurst Public School  
at completion of visual walkover inspection on 12 August 2019**

Based on the findings of the visual inspection of the exposed surface of the fill soil within the Grid 8 and 12 areas at the site on 12 August 2019 which found there to be no visible asbestos containing material to be present (on the ground surface), we confirm that the Grid 8 and 12 areas within the Grindley construction area at the Penshurst Public School construction site in Forest Road, Penshurst NSW, corner Arcadia Street may be accessed without the use of asbestos personal protective equipment (PPE) for construction work to be undertaken.

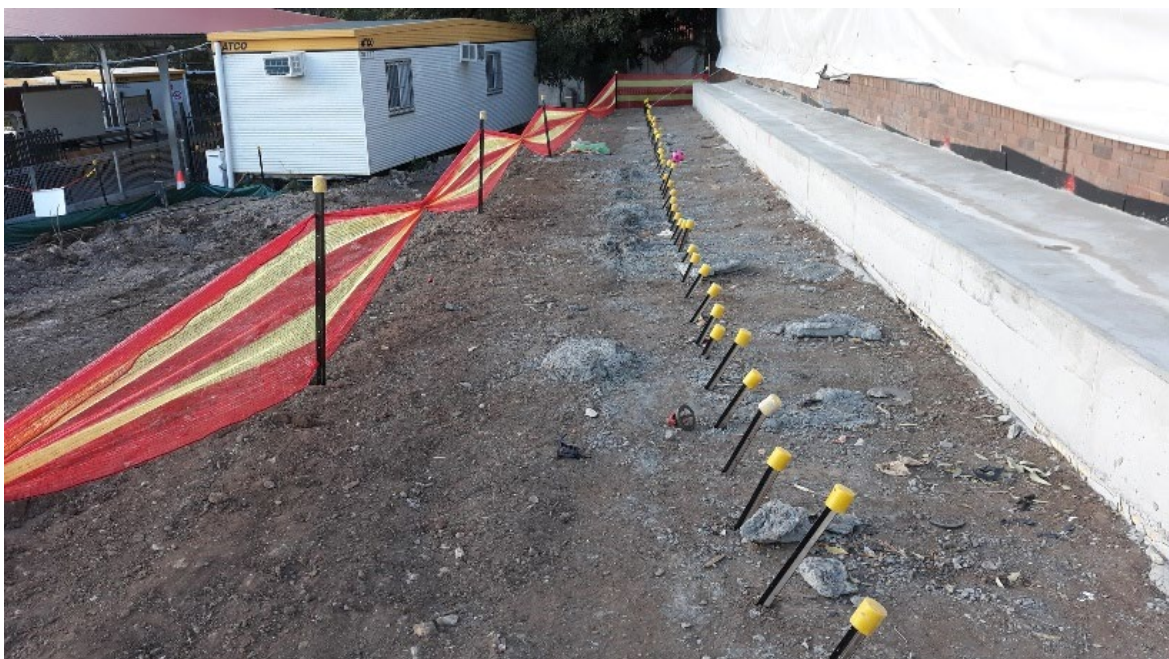
**Looking across the Grid 12 area at the Penshurst Public School  
at completion of visual walkover inspection on 12 August 2019**

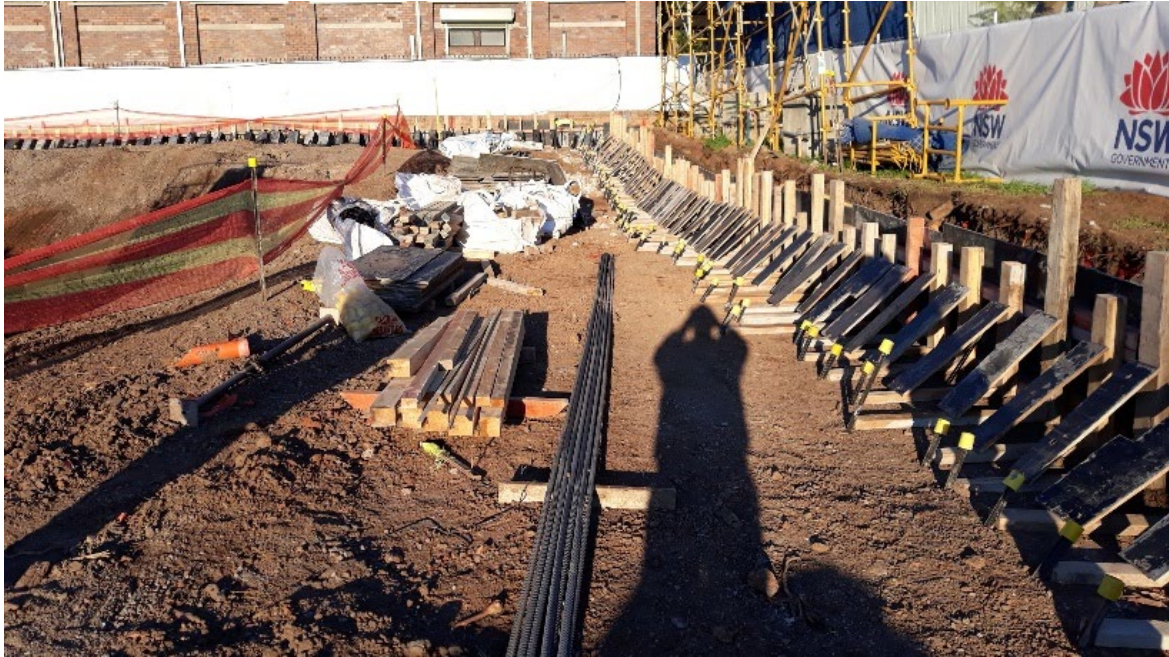
The visual inspection undertaken on 13 August 2019 was carried out by completing a systematic walkover of the exposed soil in the Grid 4 and 6 areas at the site. The visual inspection found the exposed surface of the fill soil in the Grid 4 and 6 areas to be free of visible asbestos containing material such as fragments of asbestos cement.

**Looking across the Grid 4 and 6 areas at the Penshurst Public School  
at completion of visual walkover inspection on 13 August 2019**

Based on the findings of the visual inspection of the exposed surface of the fill soil within the Grid 4 and 6 areas at the site on 13 August 2019 which found there to be no visible asbestos containing material to be present (on the ground surface), we confirm that the Grid 4 and 6 areas within the Grindley construction area at the Peshurst Public School construction site in Forest Road, Peshurst NSW, corner Arcadia Street may be accessed without the use of asbestos personal protective equipment (PPE) for construction work to be undertaken.

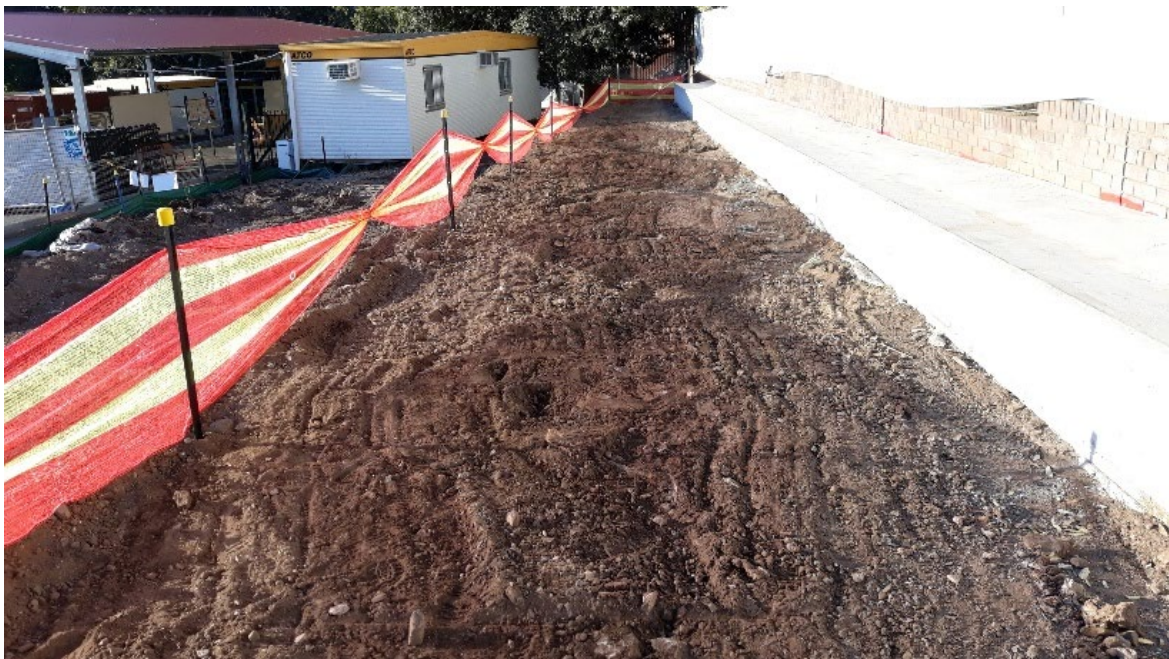
The visual inspection undertaken prior to the commencement of work on 13 August 2019 was carried out by completing a systematic walkover of the exposed soil in the Grid 8 and 12 areas at the site. The visual inspection found the exposed surface of the fill soil in the Grid 8 and 12 areas to be free of visible asbestos containing material such as fragments of asbestos cement.

**Looking across the Grid 12 area at the Penshurst Public School  
at completion of visual walkover inspection on 13 August 2019**

Based on the findings of the visual inspection of the exposed surface of the fill soil within the Grid 8 and 12 areas at the site on 13 August 2019 which found there to be no visible asbestos containing material to be present (on the ground surface), we confirm that the Grid 8 and 12 areas within the Grindley construction area at the Penshurst Public School construction site in Forest Road, Penshurst NSW, corner Arcadia Street may be accessed without the use of asbestos personal protective equipment (PPE) for construction work to be undertaken.

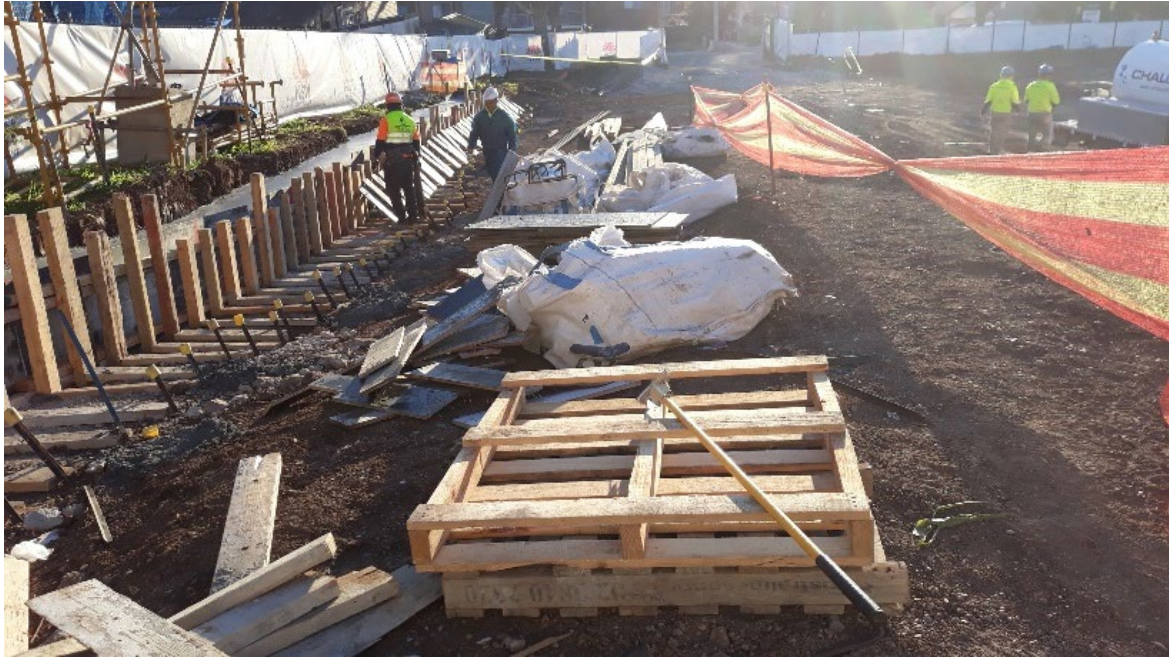
The visual inspection undertaken on 14 August 2019 was carried out by completing a systematic walkover of the exposed soil in the Grid 4 and 6 areas at the site. The visual inspection found the exposed surface of the fill soil in the Grid 4 and 6 areas to be free of visible asbestos containing material such as fragments of asbestos cement.

**Looking across the Grid 4 and 6 areas at the Penshurst Public School  
at completion of visual walkover inspection on 14 August 2019**

Based on the findings of the visual inspection of the exposed surface of the fill soil within the Grid 4 and 6 areas at the site on 14 August 2019 which found there to be no visible asbestos containing material to be present (on the ground surface), we confirm that the Grid 4 and 6 areas within the Grindley construction area at the Penshurst Public School construction site in Forest Road, Penshurst NSW, corner Arcadia Street may be accessed without the use of asbestos personal protective equipment (PPE) for construction work to be undertaken.

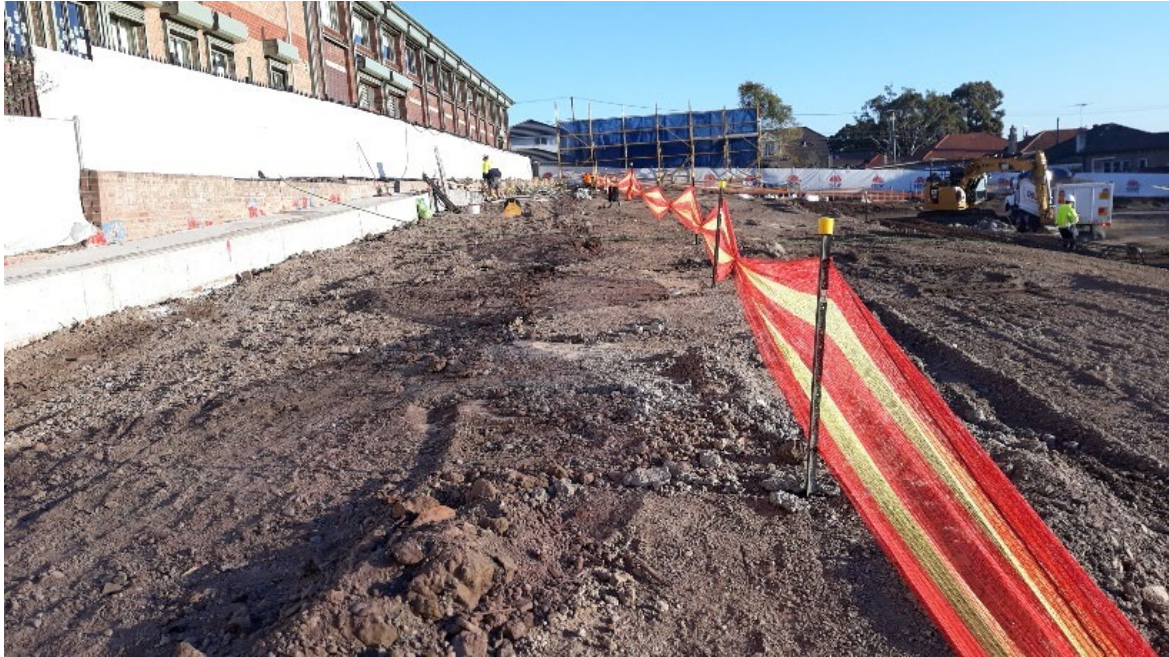
The visual inspection undertaken prior to the commencement of work on 14 August 2019 was carried out by completing a systematic walkover of the exposed soil in the Grid 8 and 12 areas at the site. The visual inspection found the exposed surface of the fill soil in the Grid 8 and 12 areas to be free of visible asbestos containing material such as fragments of asbestos cement.

**Looking across the Grid 8 area at the Penshurst Public School  
at completion of visual walkover inspection on 14 August 2019**

Based on the findings of the visual inspection of the exposed surface of the fill soil within the Grid 8 and 12 areas at the site on 14 August 2019 which found there to be no visible asbestos containing material to be present (on the ground surface), we confirm that the Grid 8 and 12 areas within the Grindley construction area at the Penshurst Public School construction site in Forest Road, Penshurst NSW, corner Arcadia Street may be accessed without the use of asbestos personal protective equipment (PPE) for construction work to be undertaken.

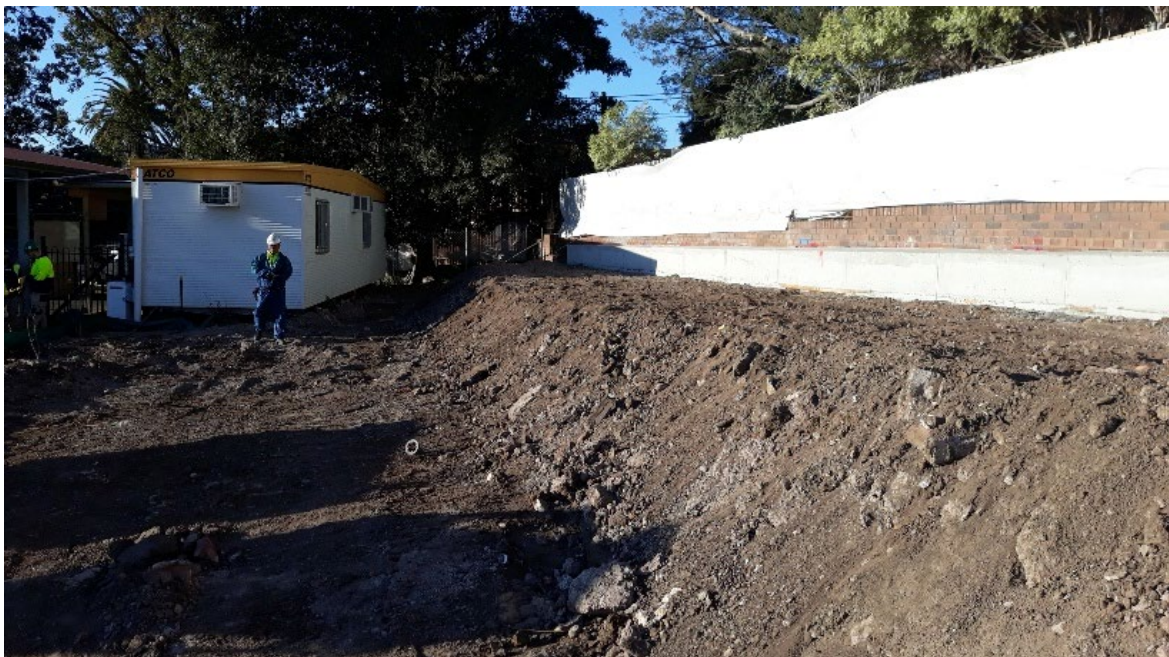
**Looking across the Grid 12 area at the Penshurst Public School  
at completion of visual walkover inspection on 14 August 2019**

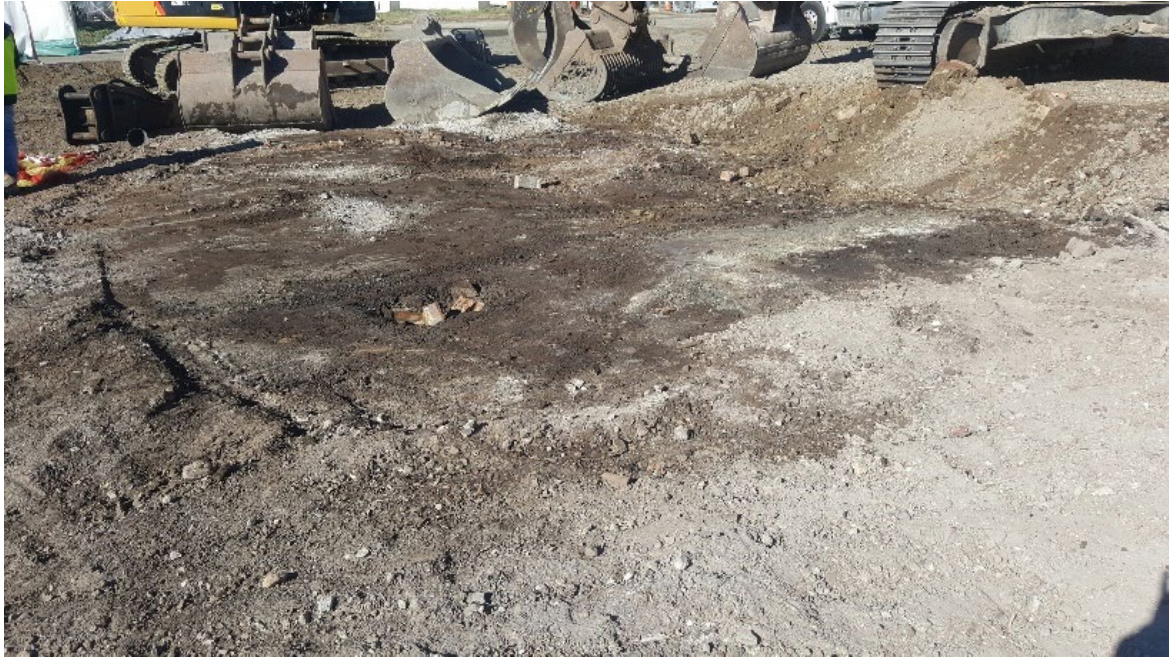
31 May 2019

**Ground area on which soil was located in the Block A area at the Penshurst Public School  
at completion of the visual clearance inspection on 30 May 2019**

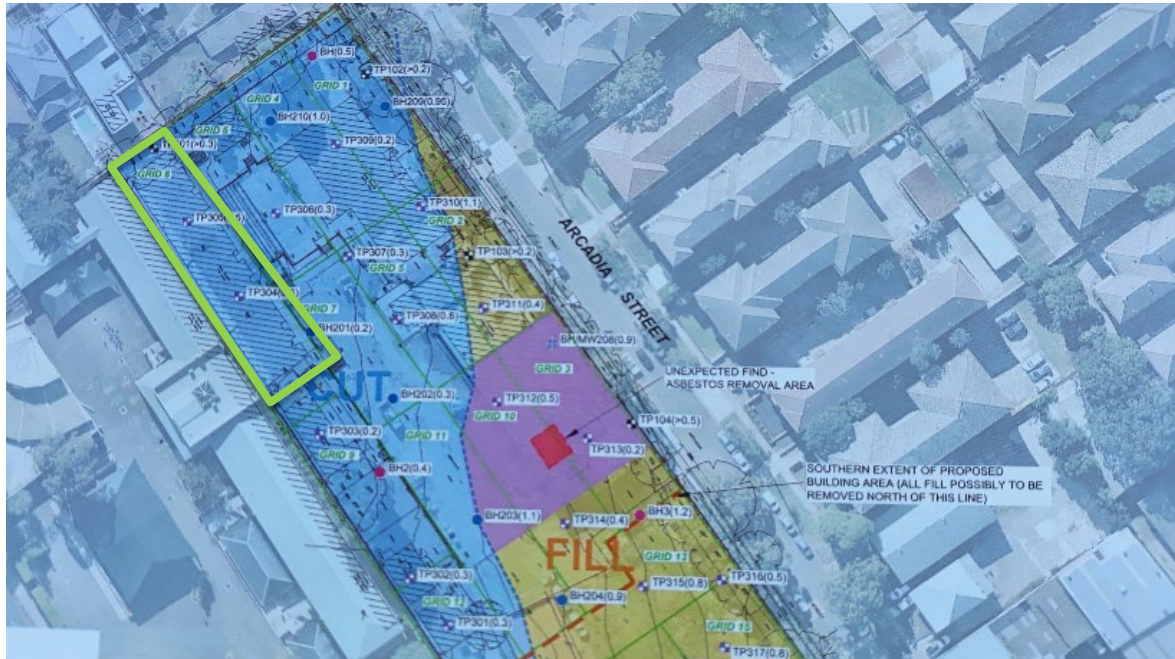
23 July 2019

**Location of Grid 8 area within green outline at the Penshurst Public School, corner of Forest Road and Acacia Street, Penshurst NSW which was inspected on 22 July 2019**

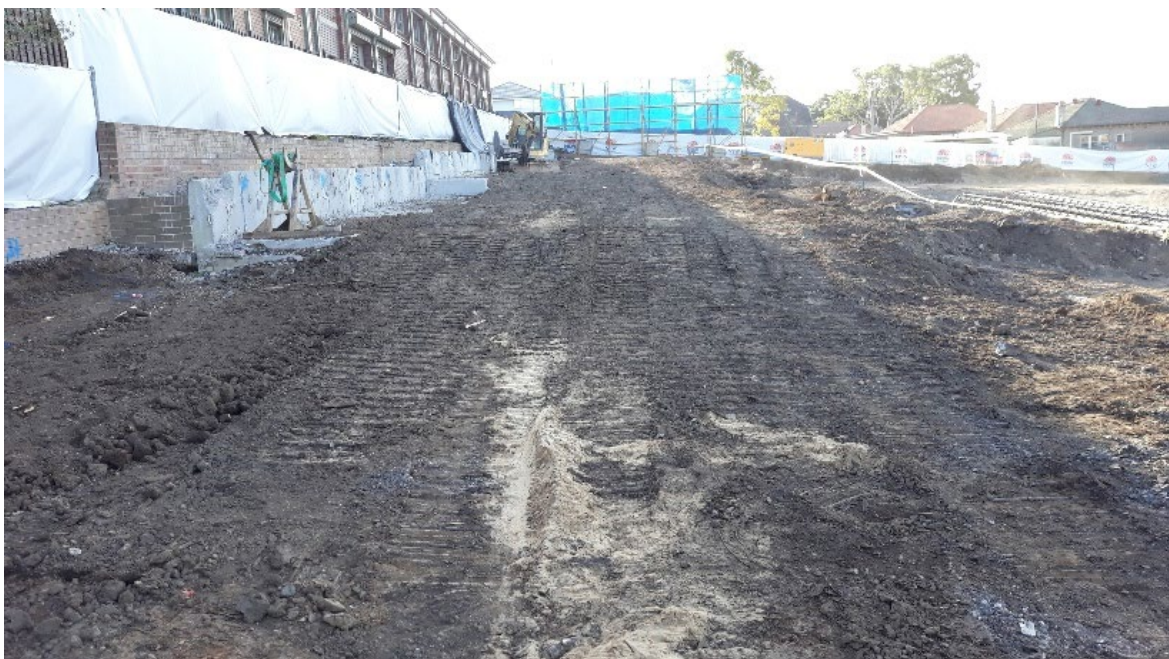
**Looking across the Grid 8 area at the Penshurst Public School at completion of visual walkover inspection on 22 July 2019**

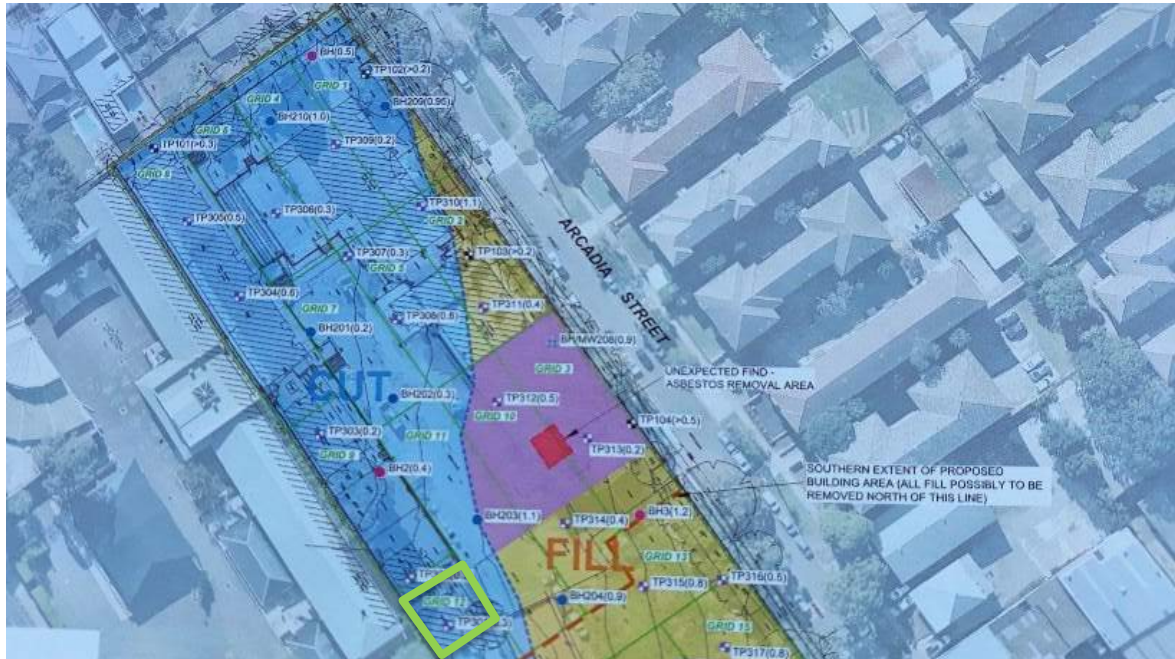
25 July 2019

**Location of Grid 12 area within green outline at the Penshurst Public School, corner of Forest Road and Acacia Street, Penshurst NSW which was inspected on 24 July 2019**

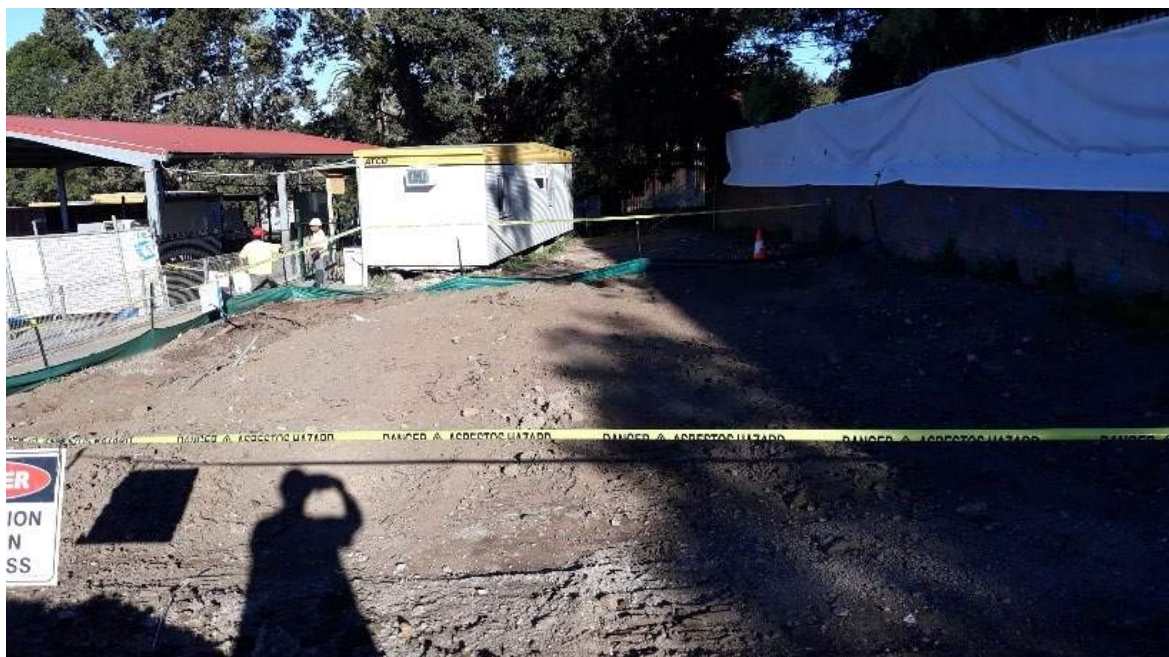
**Looking across the Grid 12 area at the Penshurst Public School at completion of visual walkover inspection on 24 July 2019**

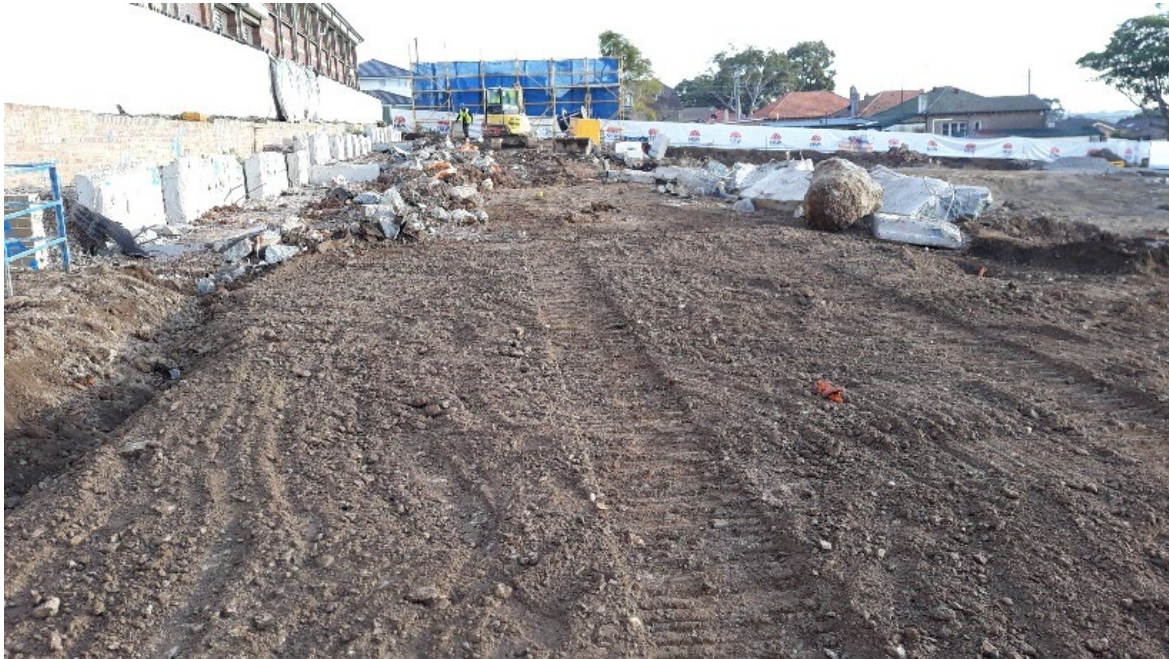
**Looking across the Grid 8 area at the Penshurst Public School  
at completion of visual walkover inspection on 26 July 2019**

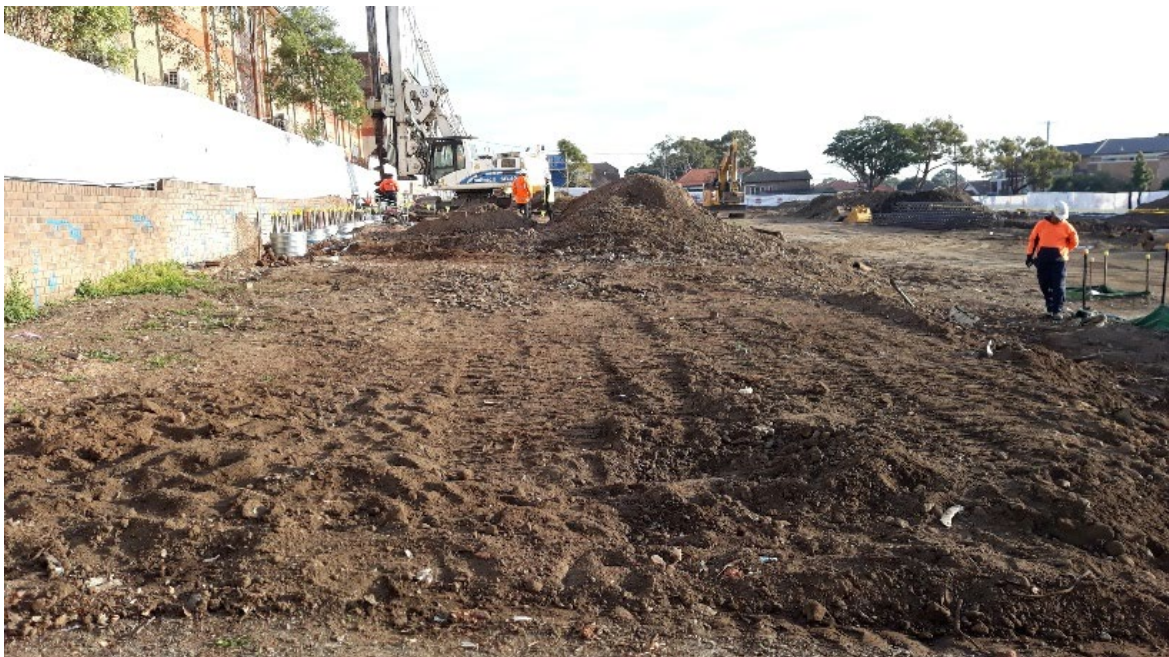
**Looking across the Grid 12 area at the Penshurst Public School  
at completion of visual walkover inspection on 26 July 2019**

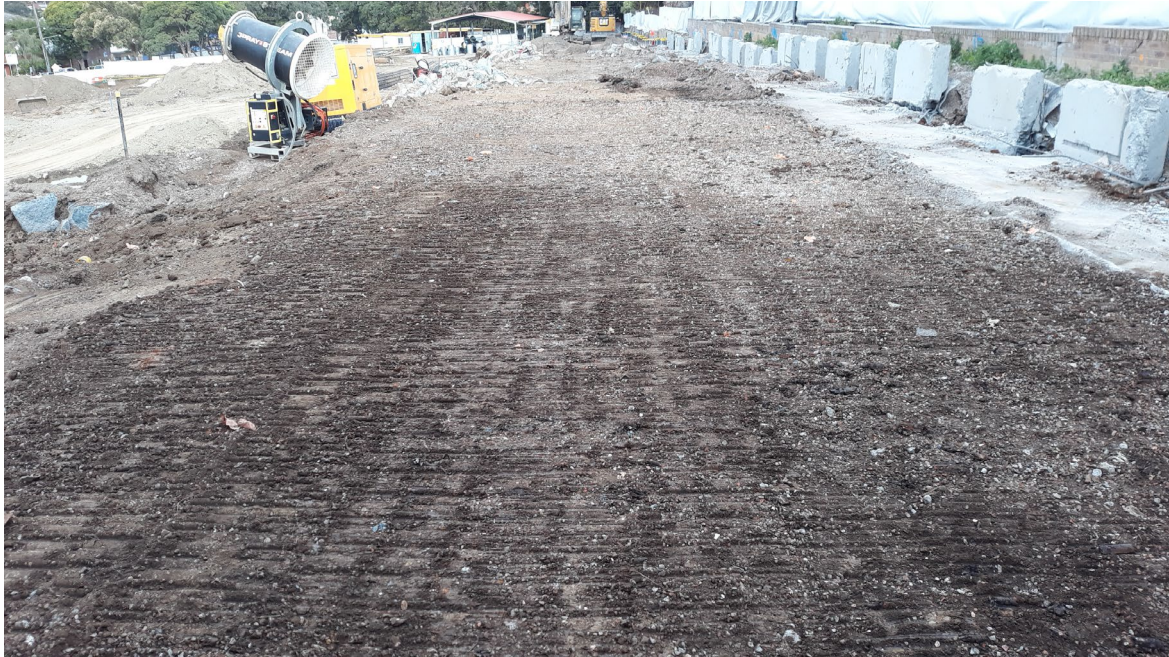
27 July 2019

**Looking across the Grid 8 area at the Penshurst Public School  
at completion of visual walkover inspection on 26 July 2019 (afternoon)**

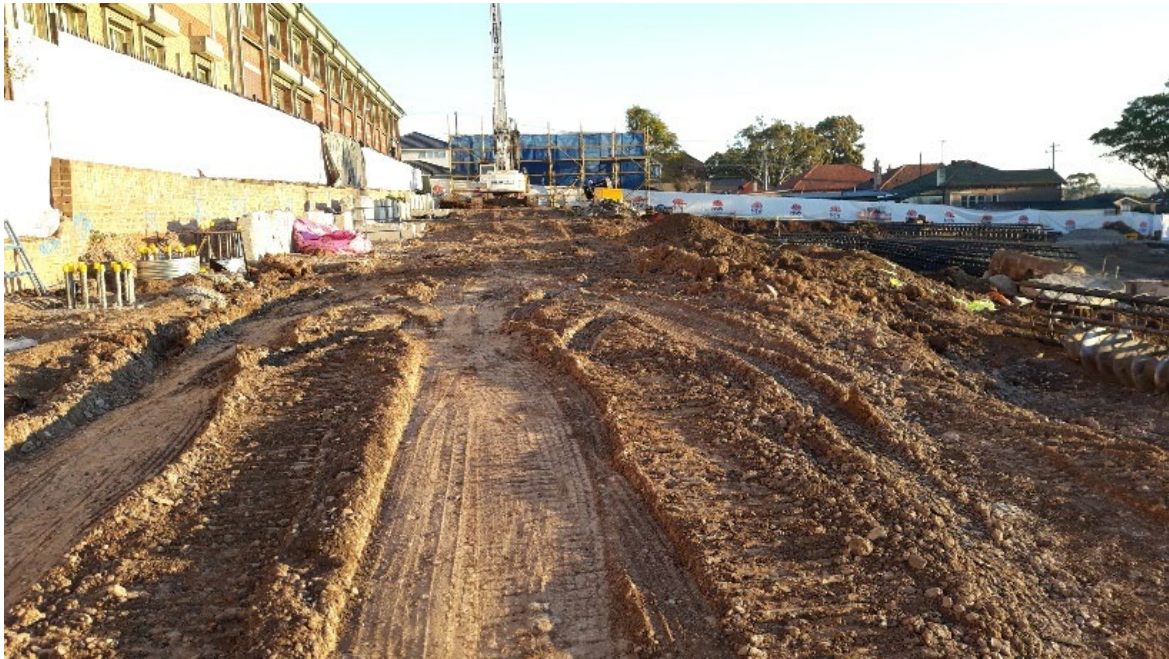
**Looking across the Grid 8 area at the Penshurst Public School  
at completion of visual walkover inspection on 29 July 2019**

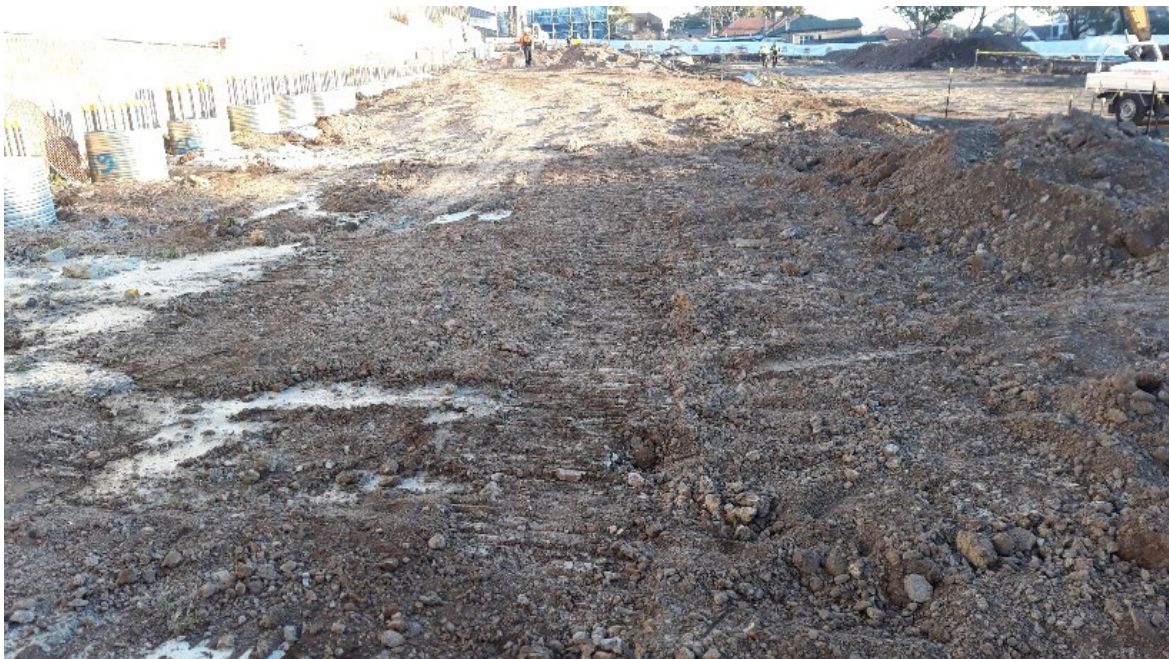
**Looking across the Grid 12 area at the Penshurst Public School  
at completion of visual walkover inspection on 29 July 2019**

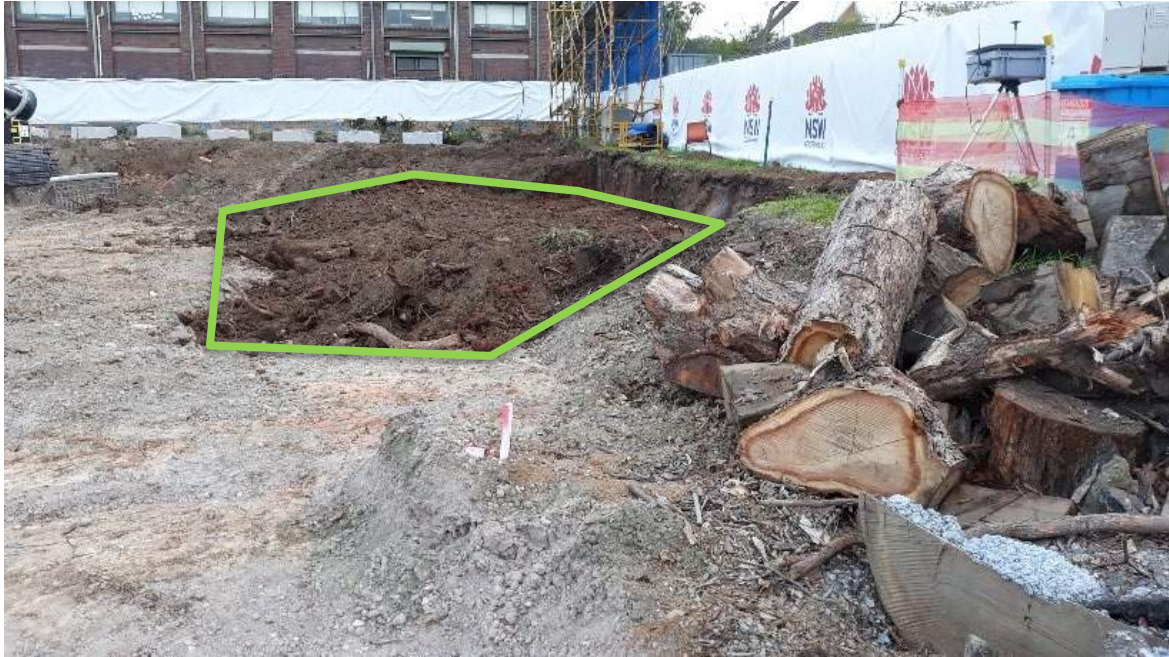
**Looking across the Grid 4 and 6 areas at the Penshurst Public School  
at completion of visual walkover inspection on 29 July 2019 (within green outline)**
