# Appendix 11.1

## Appendix B: Asbestos Removal Control Plan

# **Asbestos Removal Control Plan**

**Penshurst Public School**

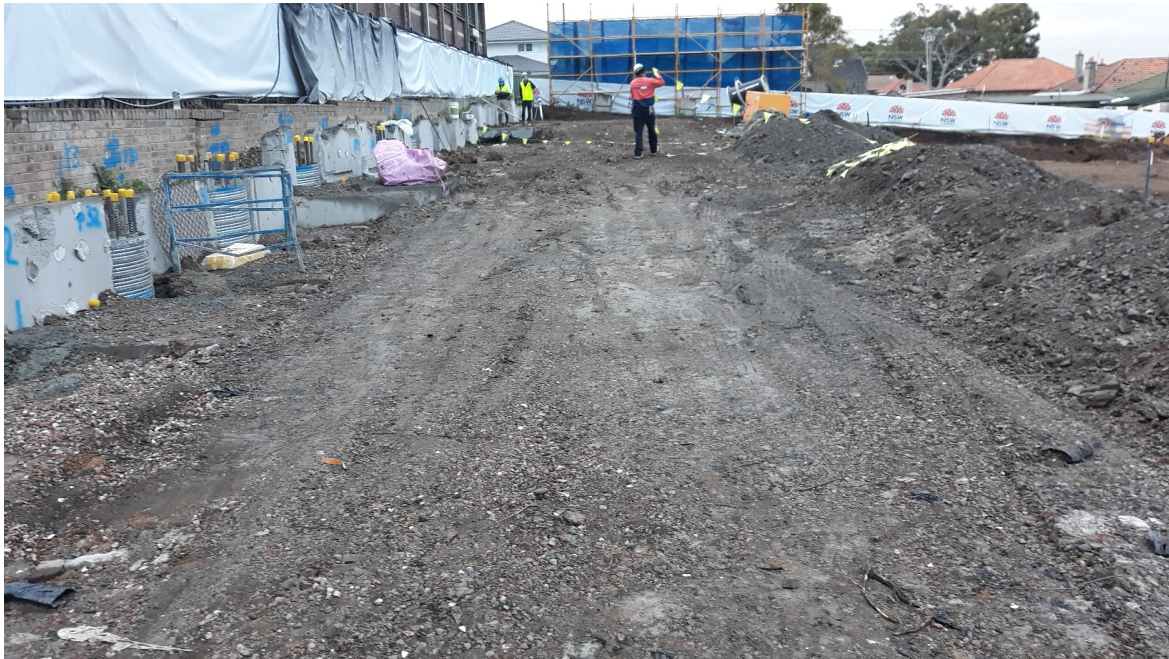
**Looking across the Grid 8 area at the Penshurst Public School  
at completion of visual walkover inspection on 30 July 2019**

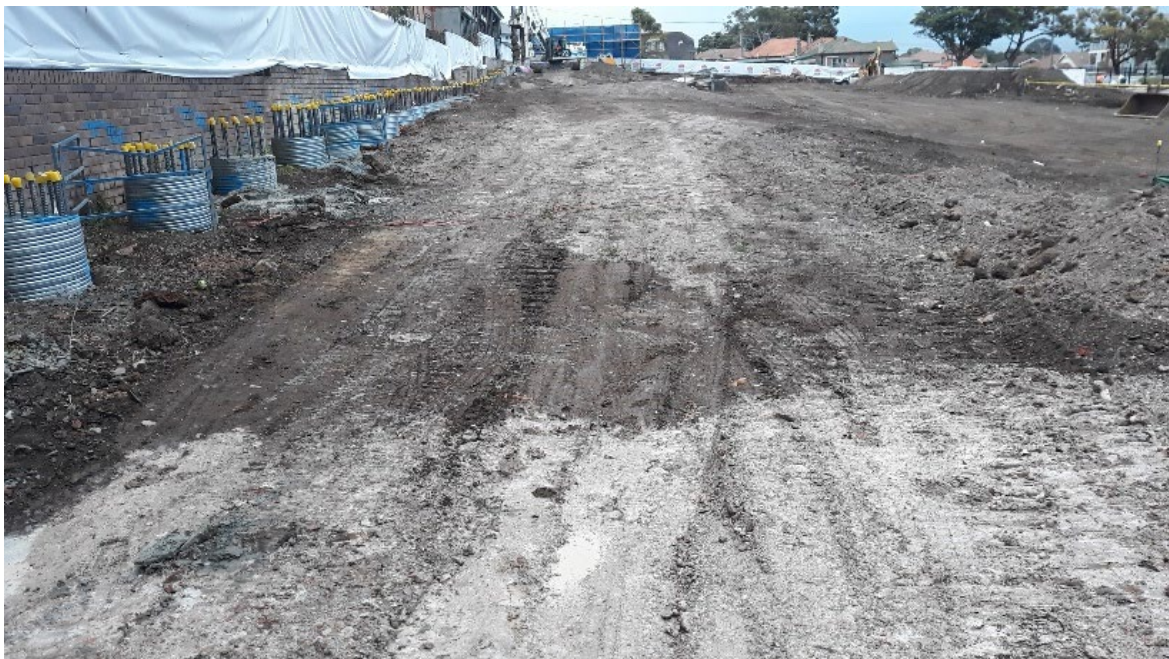
**Looking across the Grid 12 area at the Penshurst Public School  
at completion of visual walkover inspection on 30 July 2019**

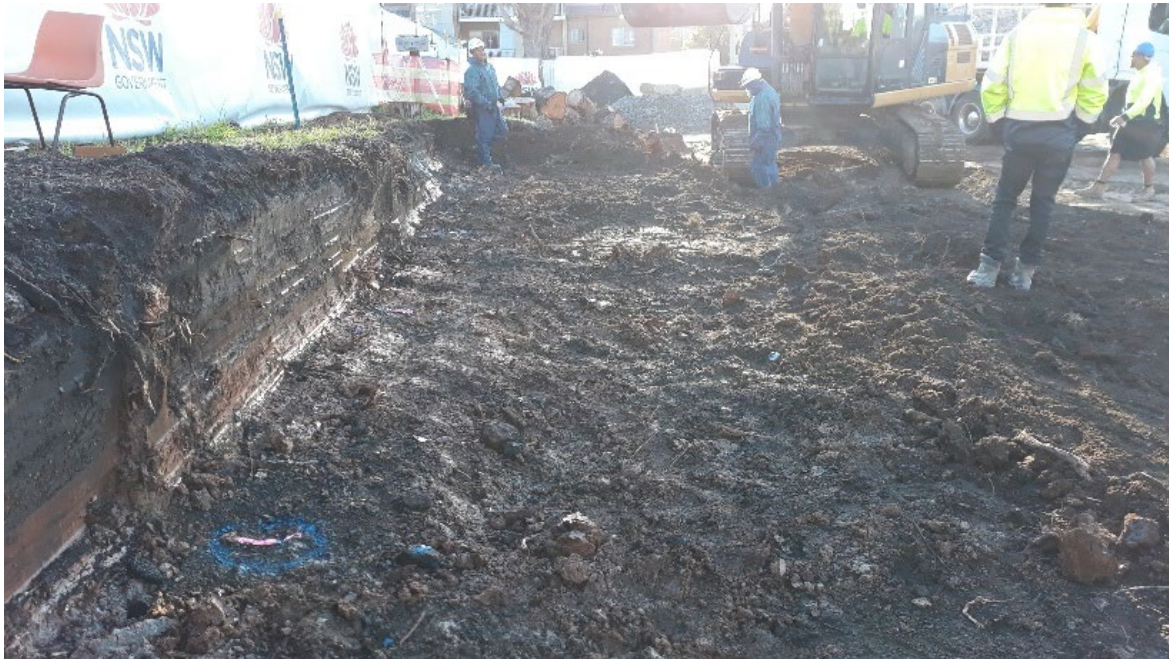
31 July 2019

**Looking across the Grid 4 and 6 areas at the Penshurst Public School  
at completion of visual walkover inspection on 31 July 2019**

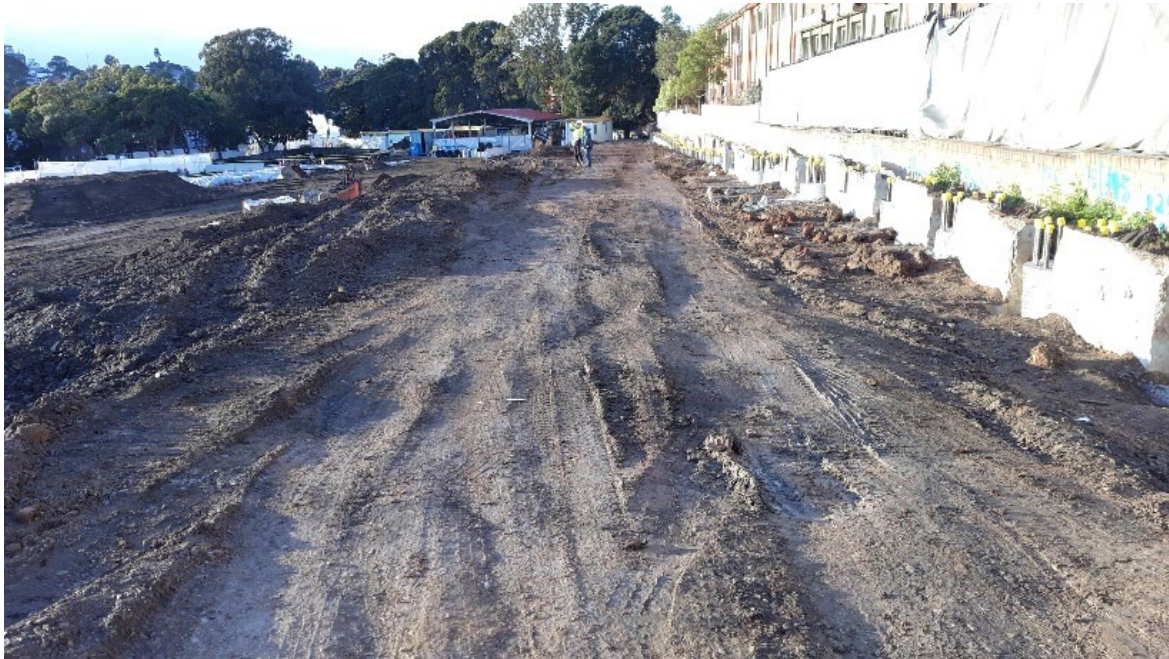
**Looking across the Grid 8 area at the Penshurst Public School  
at completion of visual walkover inspection on 31 July 2019**

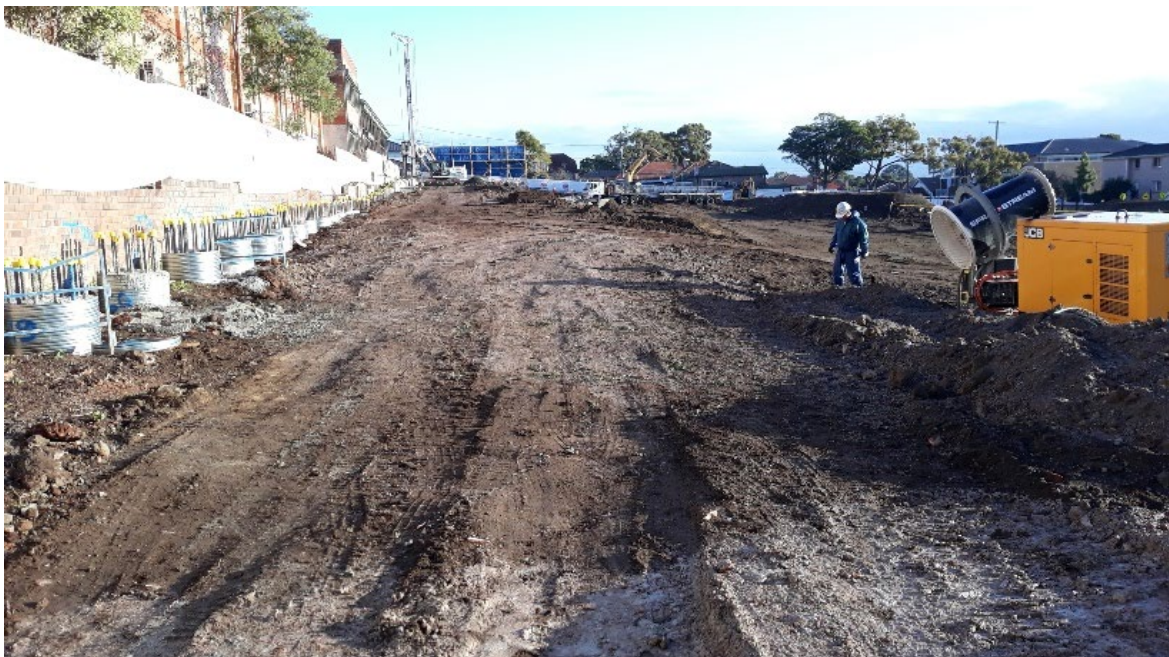
**Looking across the Grid 12 area at the Penshurst Public School  
at completion of visual walkover inspection on 31 July 2019**

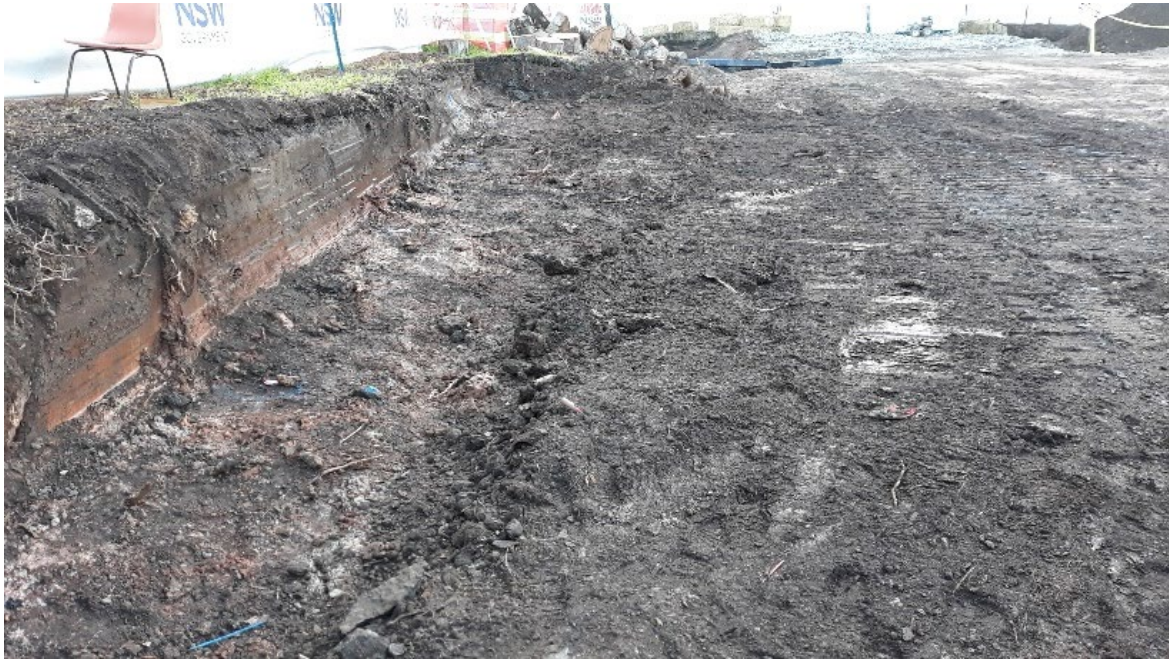
1 August 2019

**Looking across the Grid 4 and 6 areas at the Penshurst Public School  
at completion of visual walkover inspection on 1 August 2019**

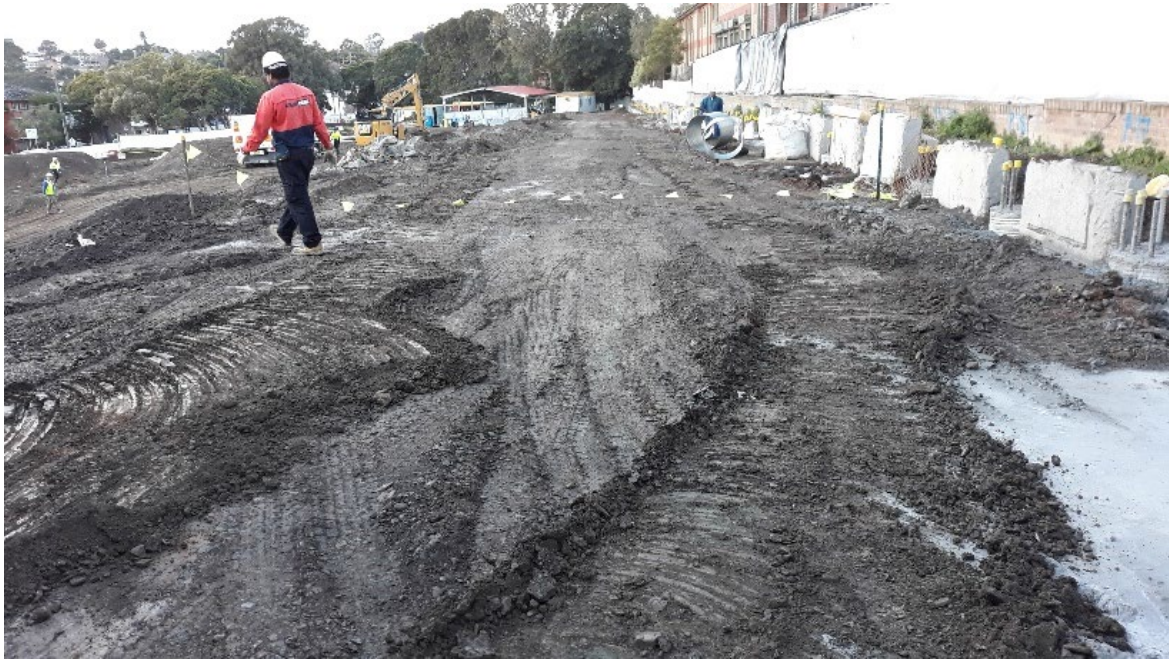
**Looking across the Grid 8 area at the Penshurst Public School  
at completion of visual walkover inspection on 1 August 2019**

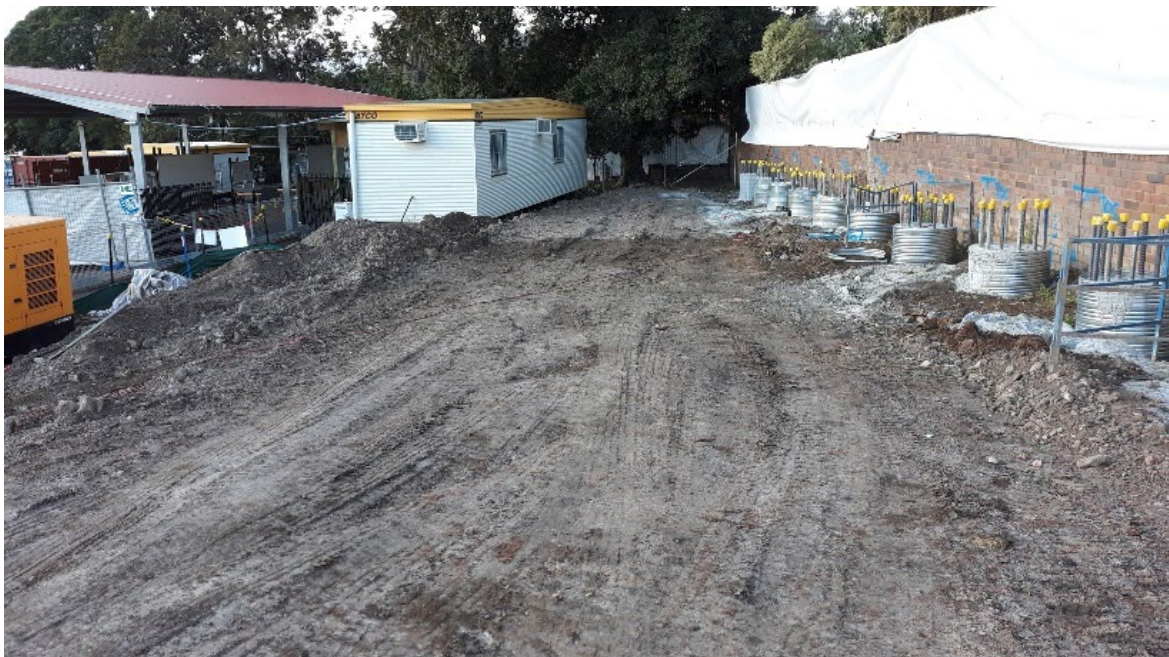
**Looking across the Grid 12 area at the Penshurst Public School  
at completion of visual walkover inspection on 1 August 2019**

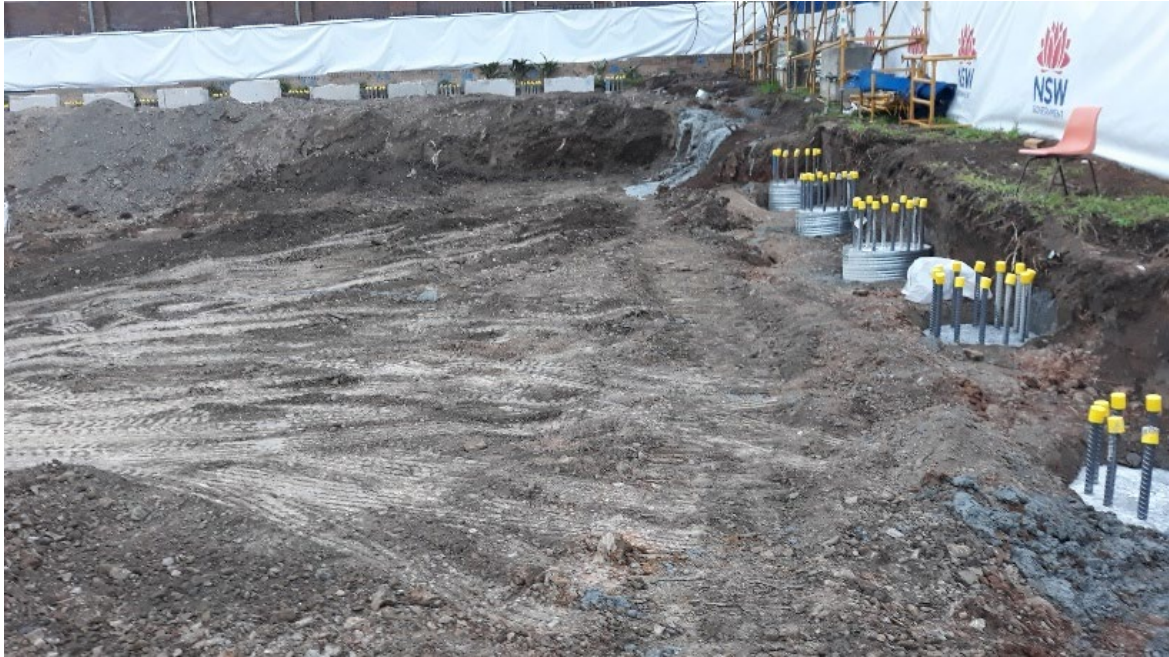
1 August 2019

**Looking across the Grid 4 and 6 areas at the Penshurst Public School  
at completion of visual walkover inspection on 2 August 2019**

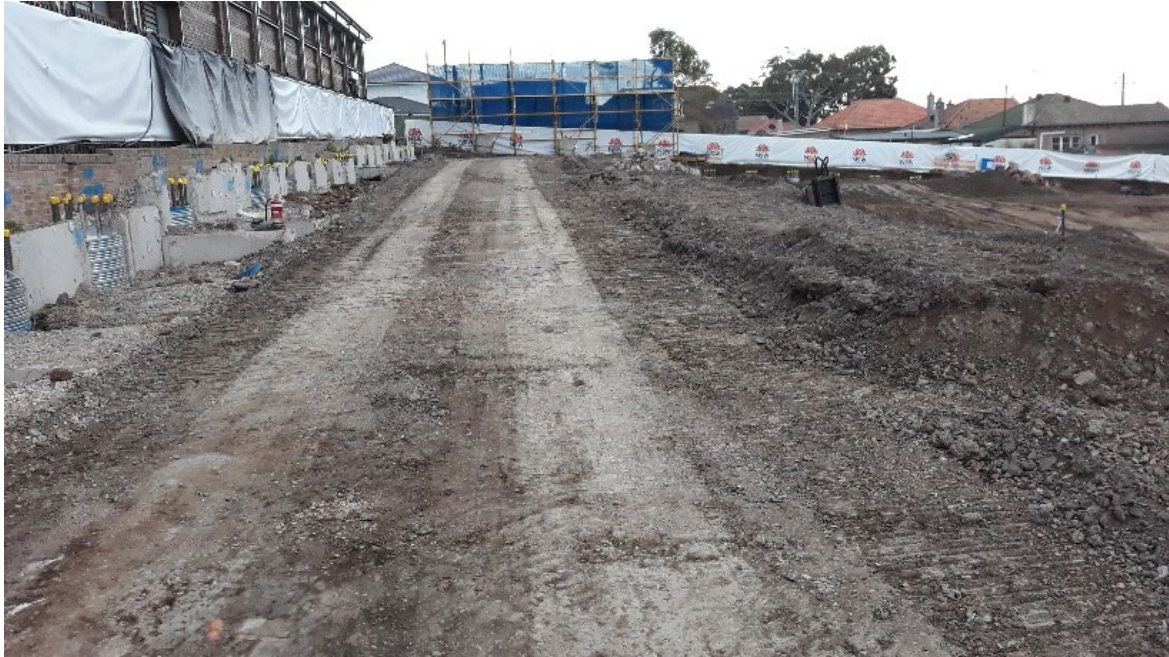
**Looking across the Grid 8 area at the Penshurst Public School  
at completion of visual walkover inspection on 2 August 2019**

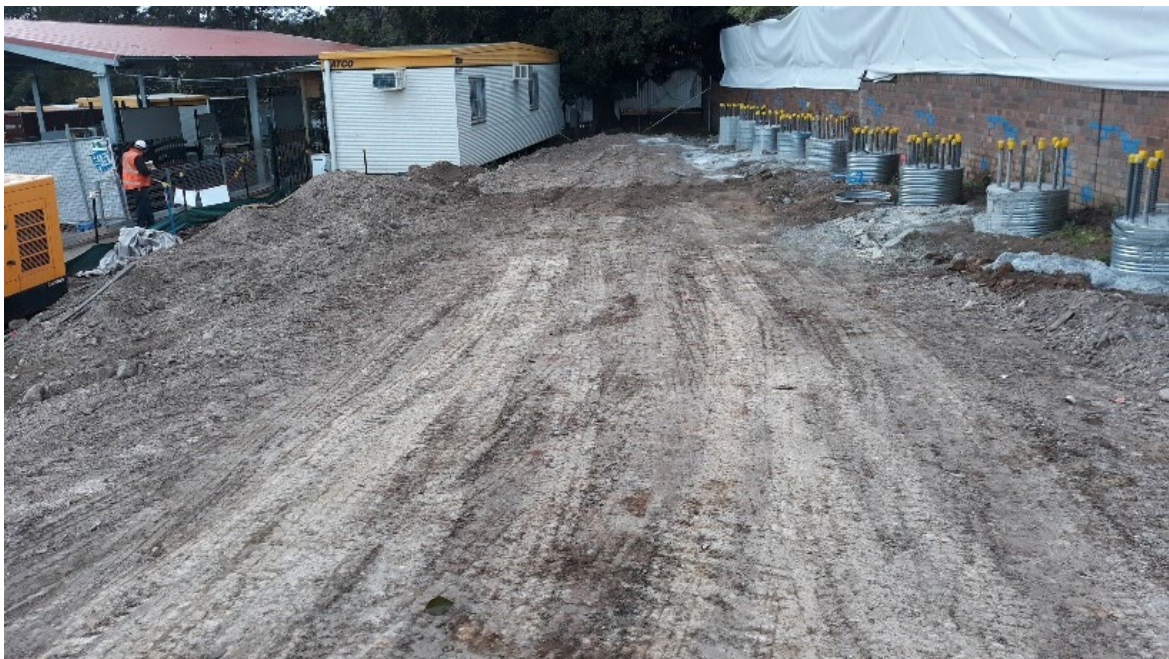
**Looking across the Grid 12 area at the Penshurst Public School  
at completion of visual walkover inspection on 2 August 2019**

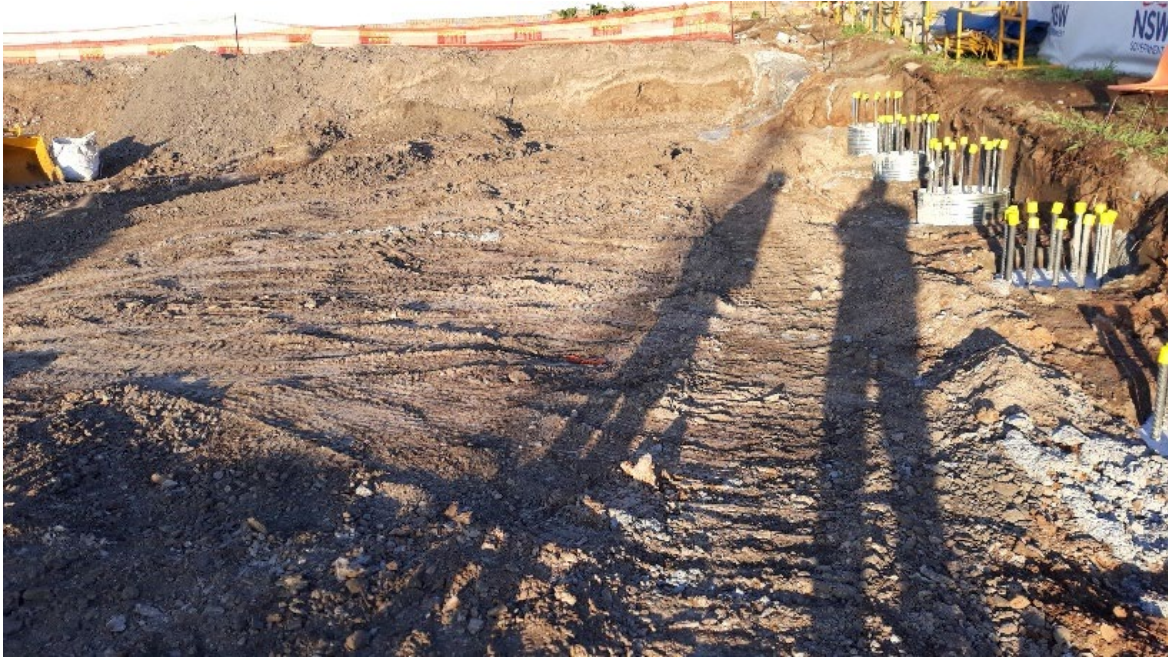
5 August 2019

**Looking across the Grid 4 and 6 areas at the Penshurst Public School  
at completion of visual walkover inspection on 5 August 2019**

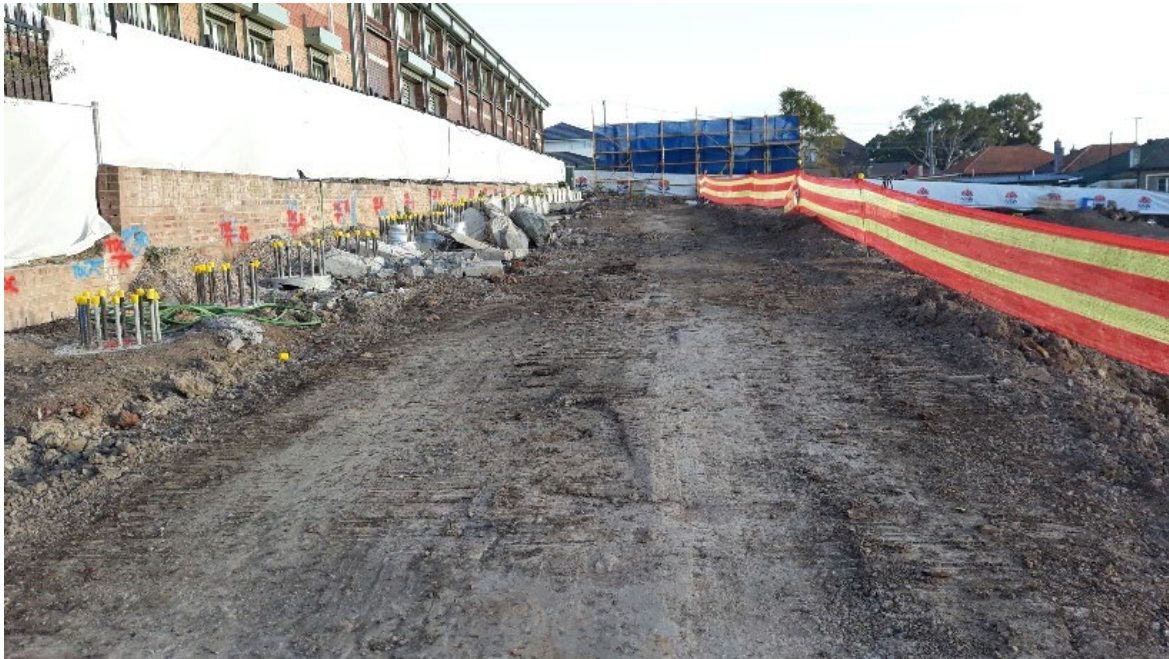
**Looking across the Grid 8 area at the Penshurst Public School  
at completion of visual walkover inspection on 5 August 2019**

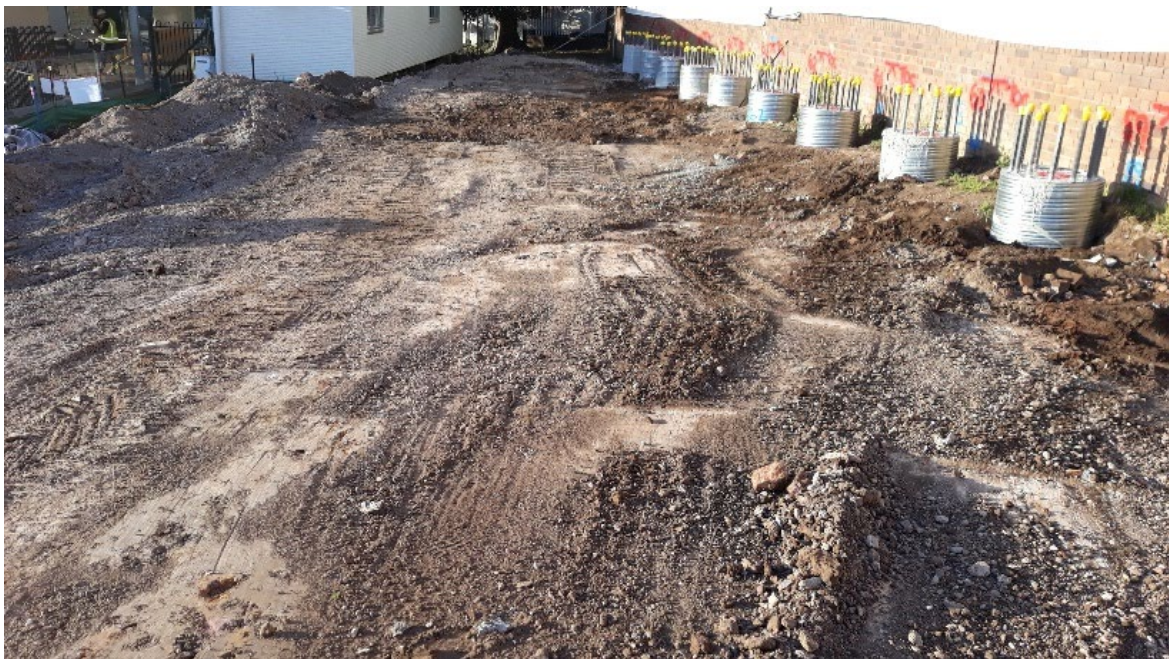
**Looking across the Grid 12 area at the Penshurst Public School  
at completion of visual walkover inspection on 5 August 2019**

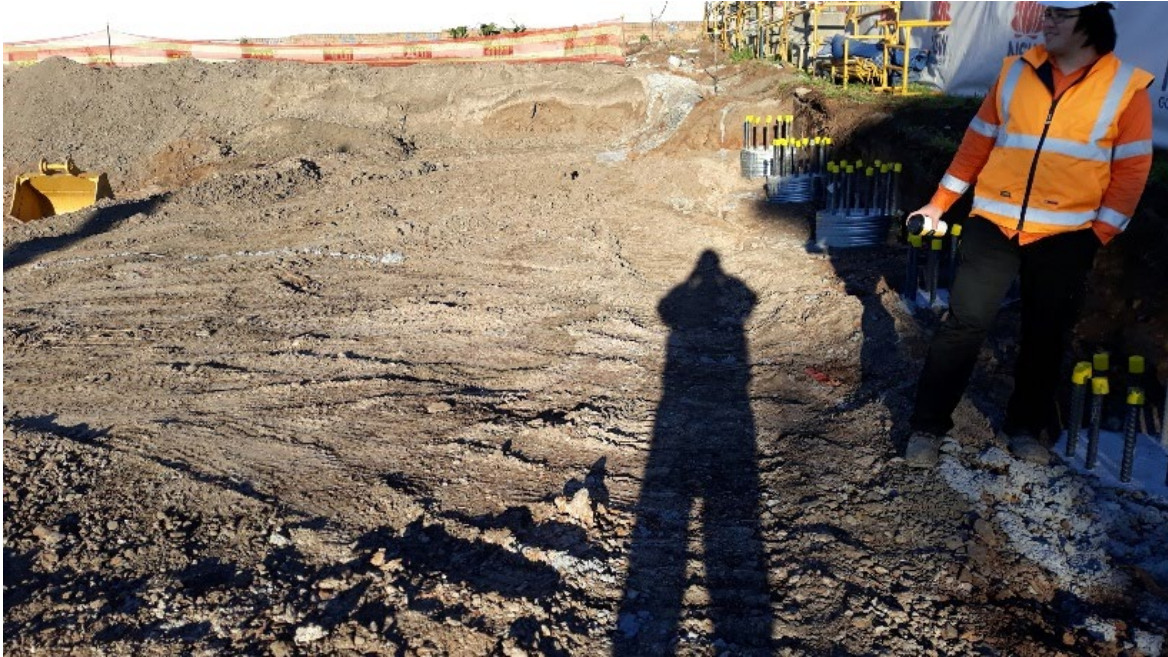
6 August 2019

**Looking across the Grid 4 and 6 areas at the Penshurst Public School  
at completion of visual walkover inspection on 6 August 2019**

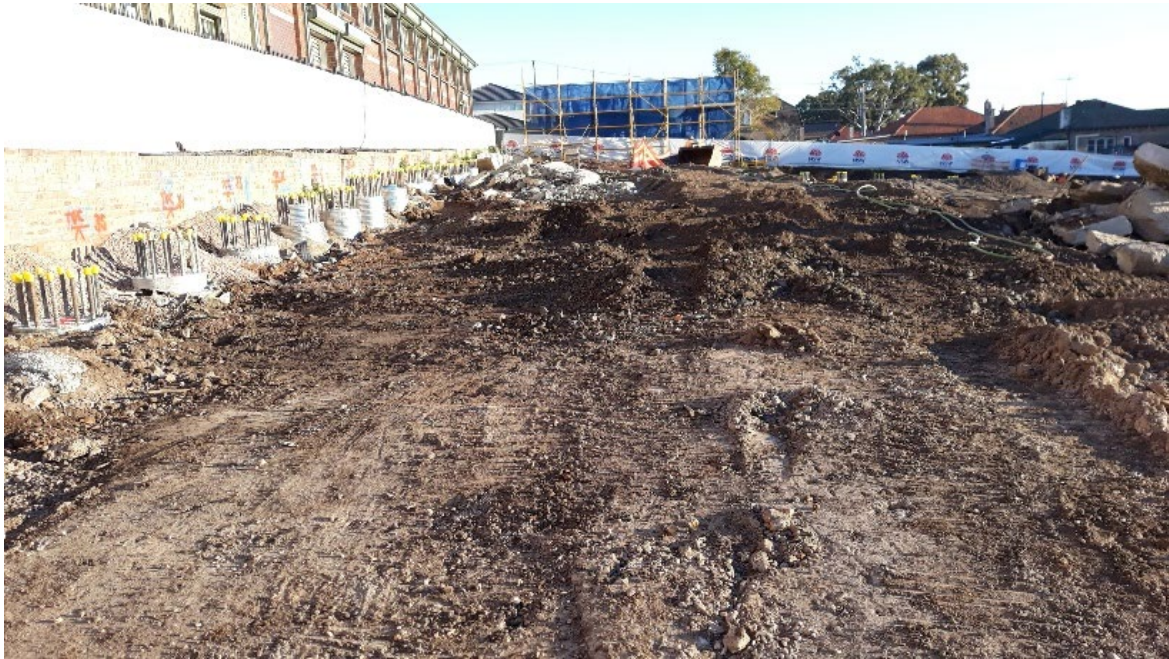
**Looking across the Grid 8 area at the Penshurst Public School  
at completion of visual walkover inspection on 6 August 2019**

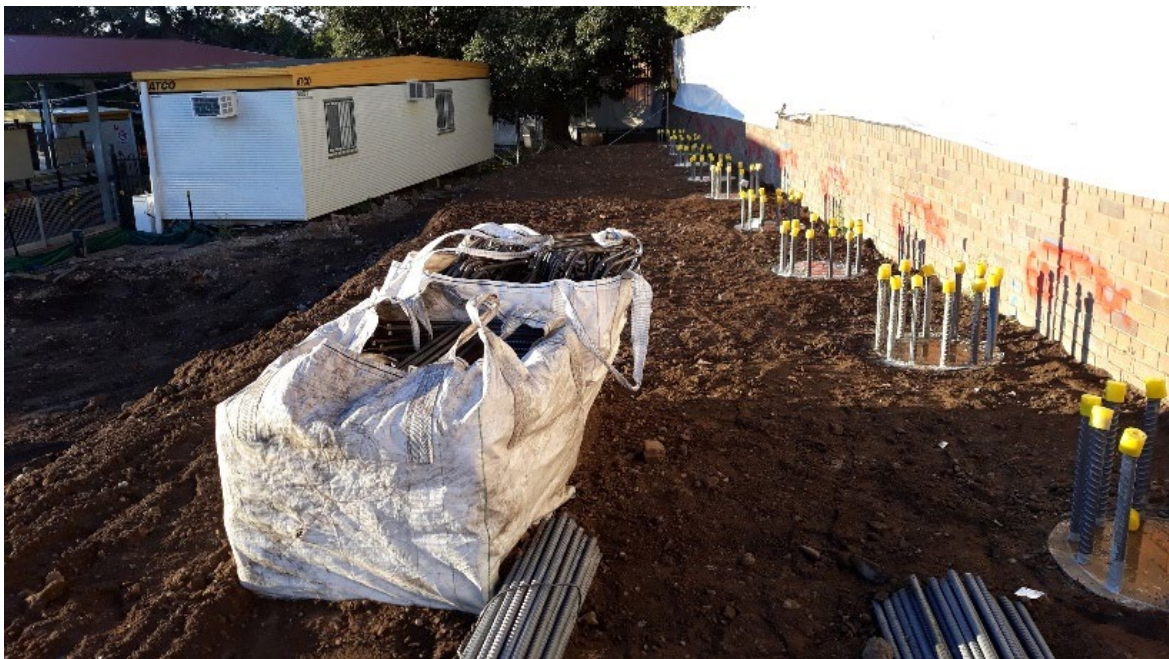
**Looking across the Grid 12 area at the Penshurst Public School  
at completion of visual walkover inspection on 6 August 2019**

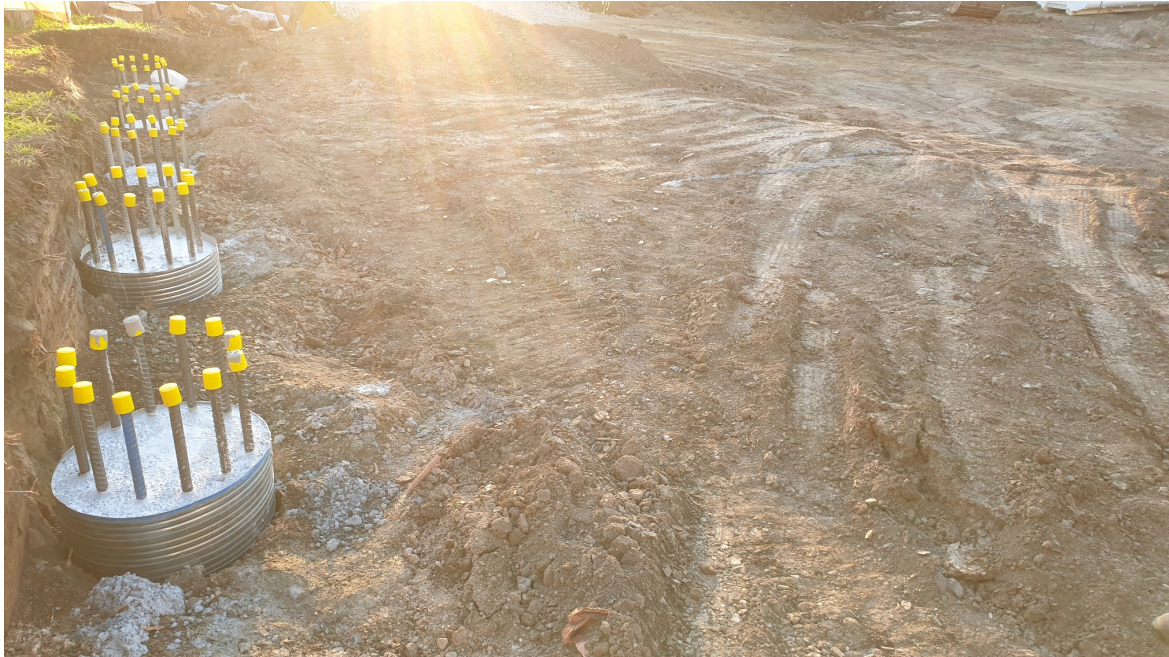
7 August 2019

**Looking across the Grid 4 and 6 areas at the Penshurst Public School  
at completion of visual walkover inspection on 7 August 2019**

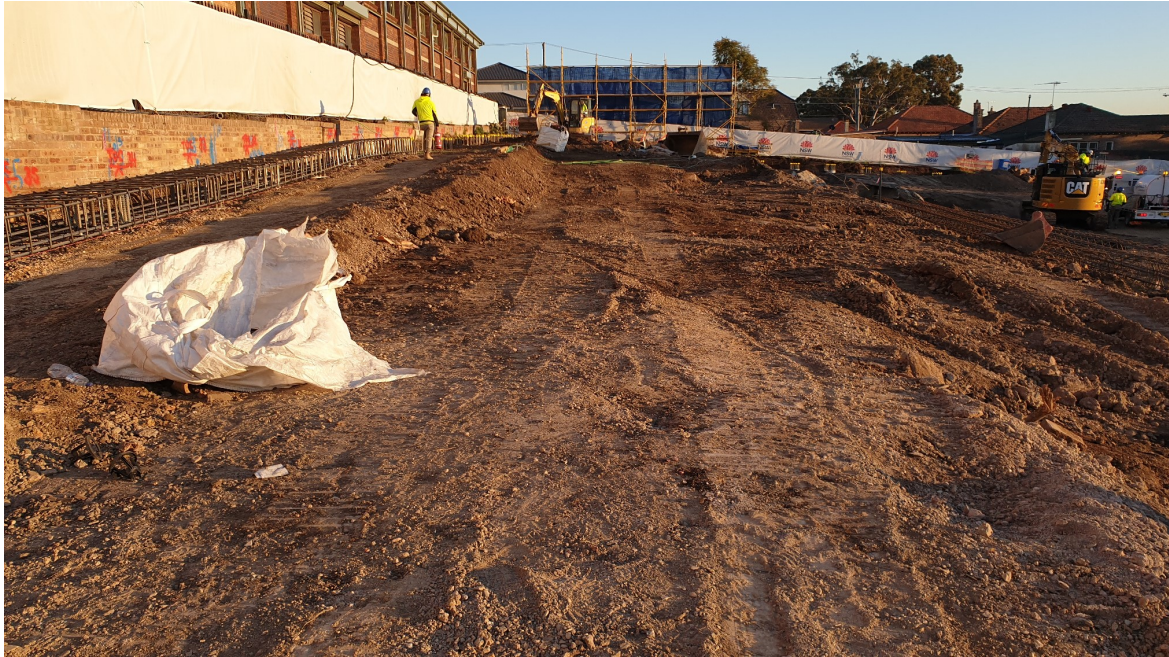
**Looking across the Grid 8 area at the Penshurst Public School  
at completion of visual walkover inspection on 7 August 2019**

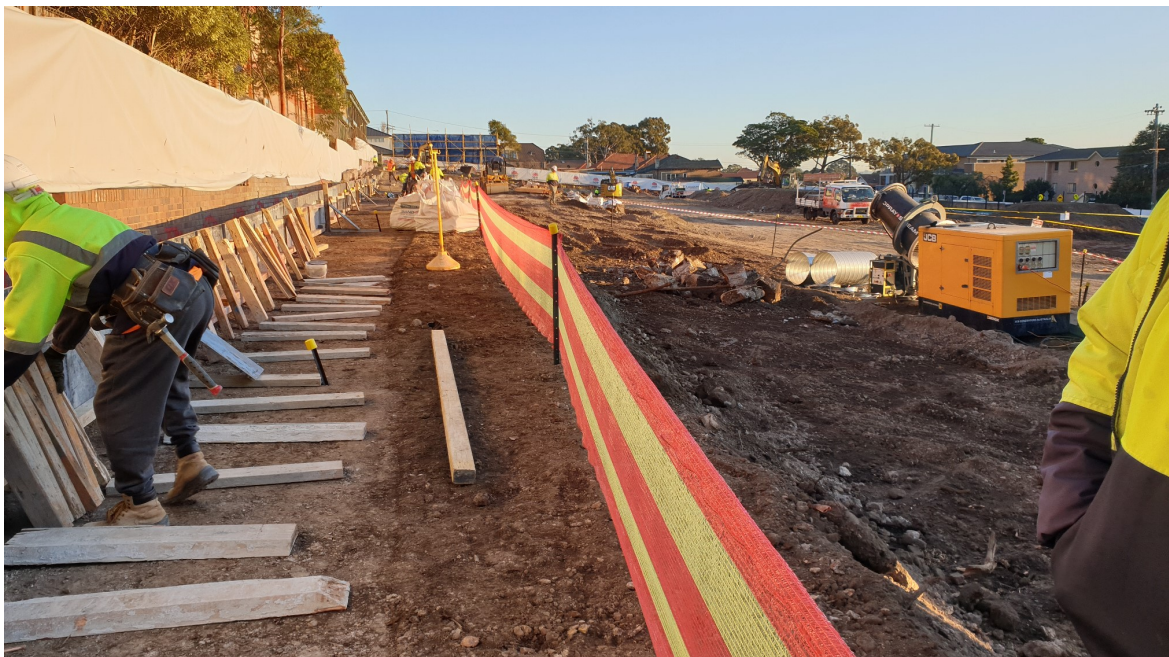
**Looking across the Grid 12 area at the Penshurst Public School  
at completion of visual walkover inspection on 7 August 2019**

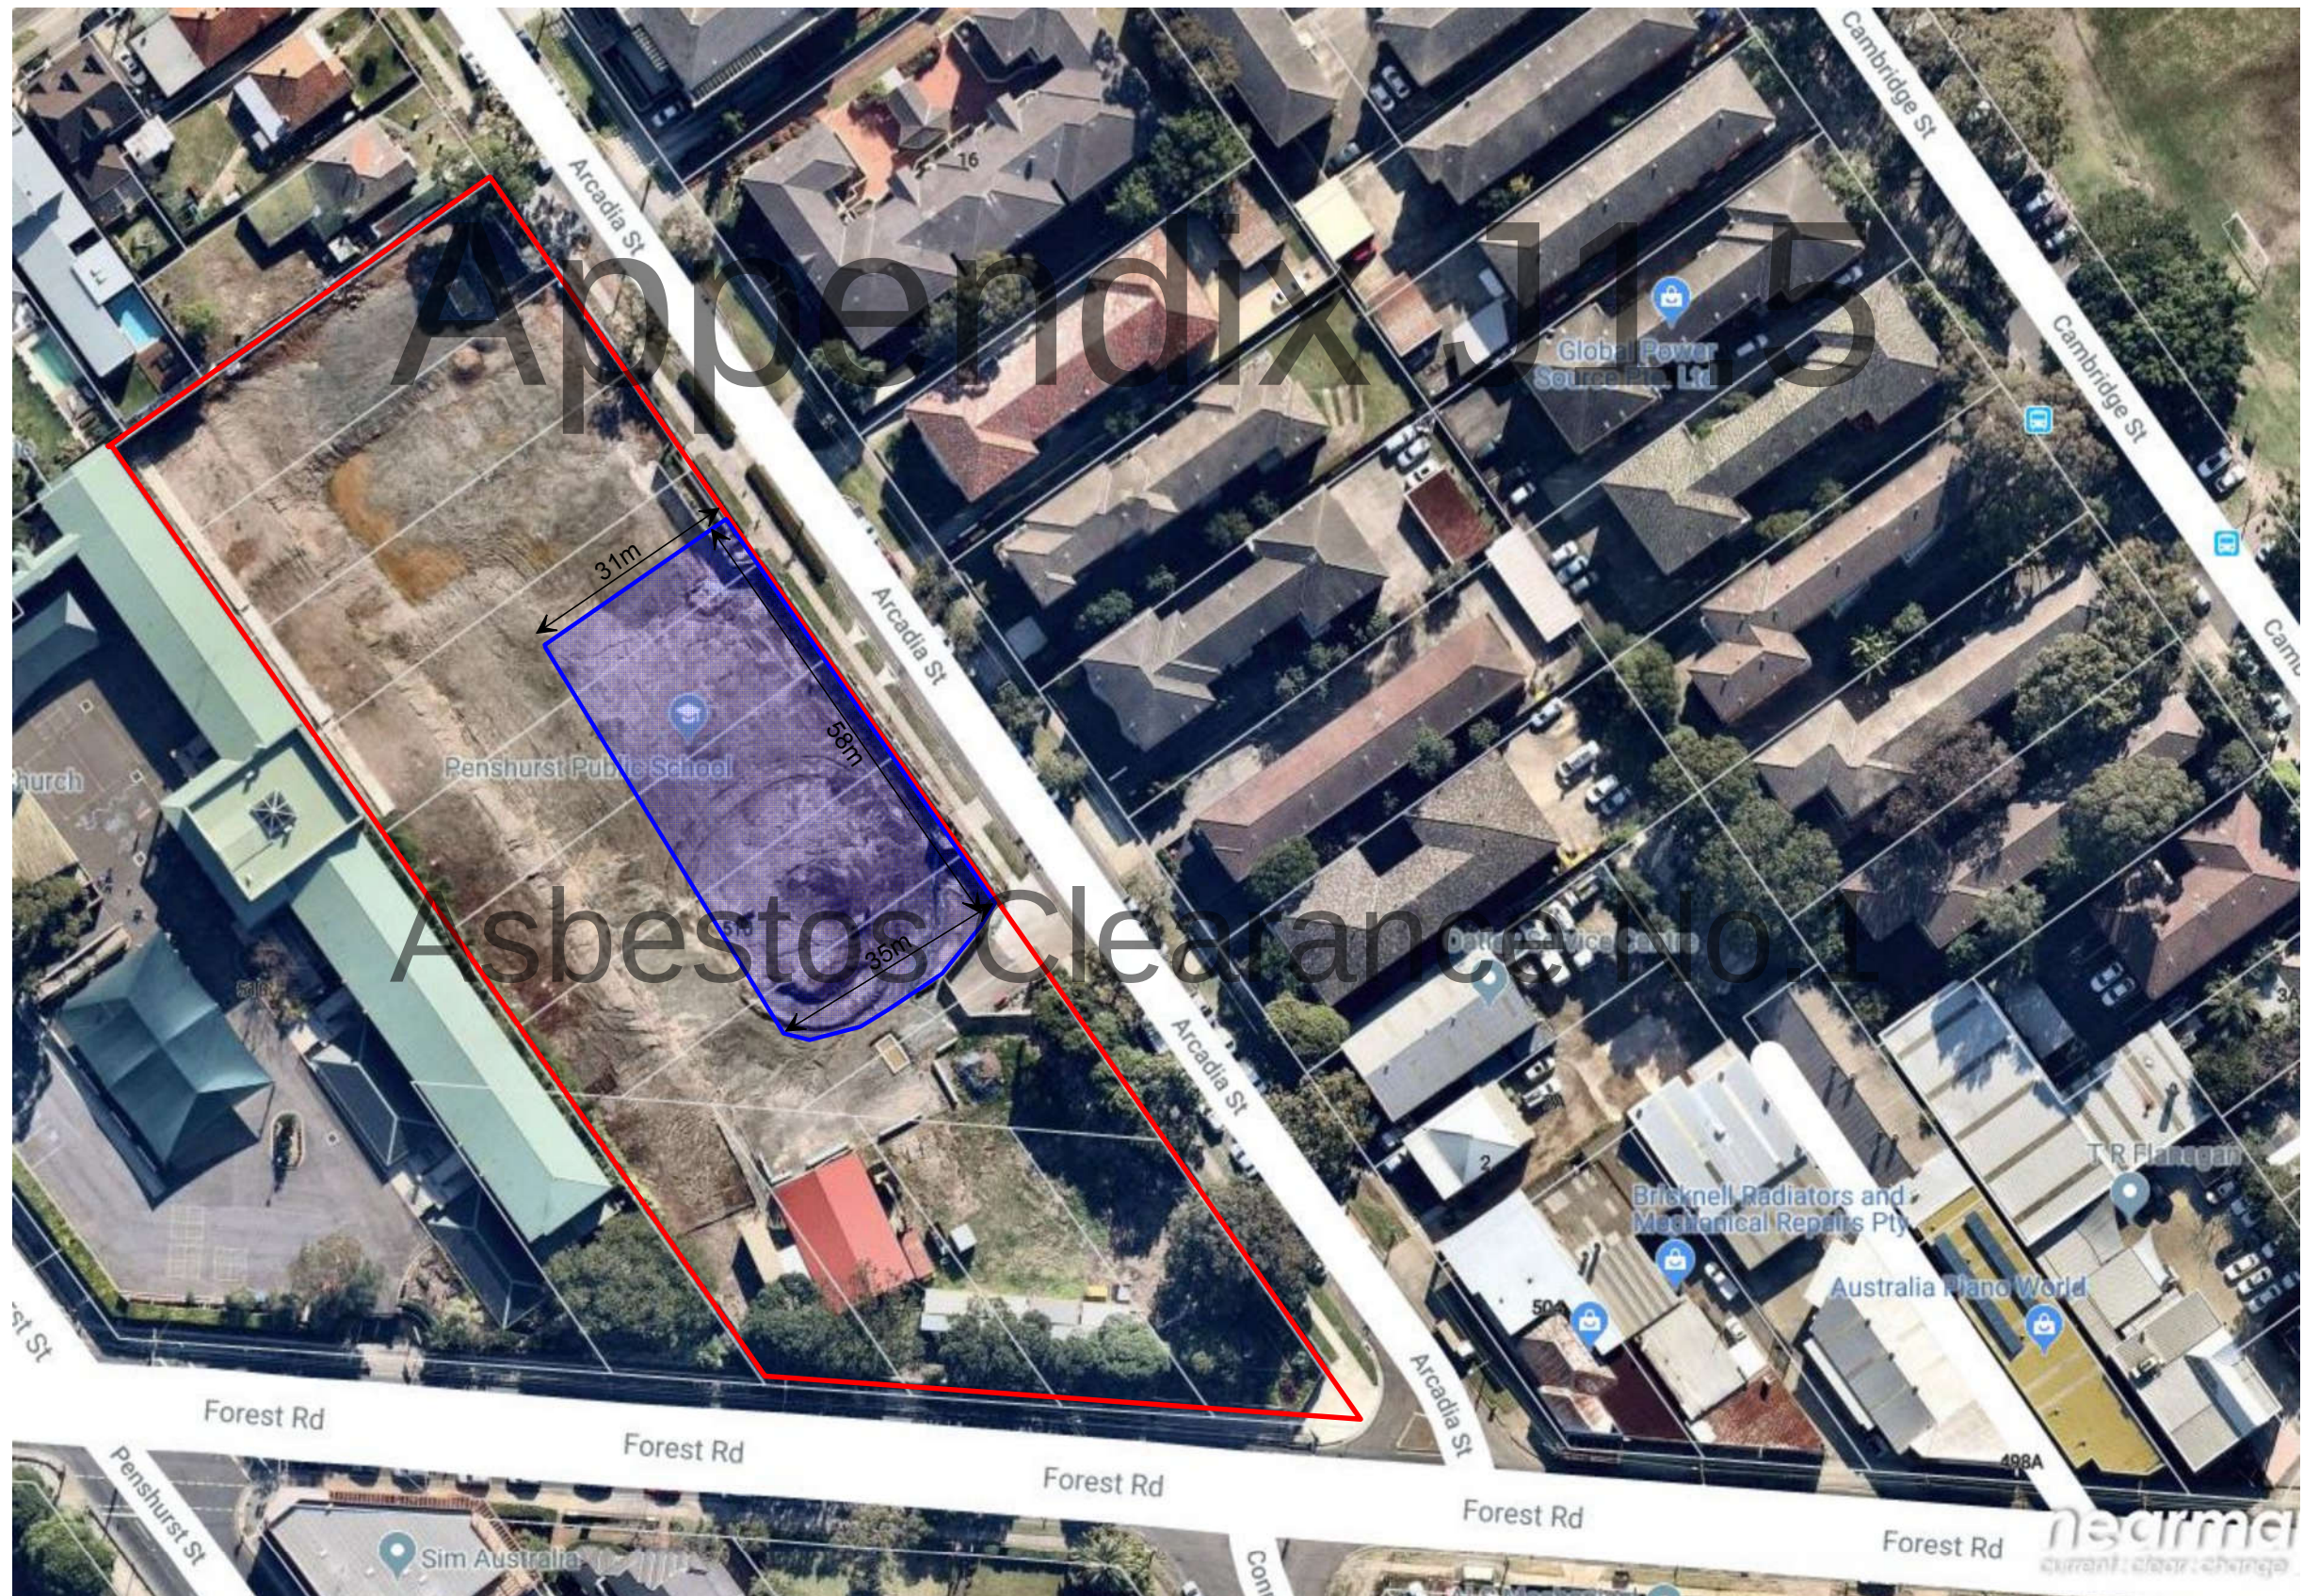
- APPROXIMATE SITE BOUNDARY
- AREA INSPECTED (APPROXIMATE BOUNDARY)

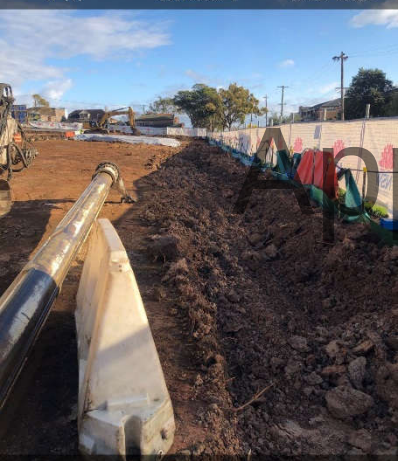
| <p>DIRECTION<br/>N (T)      33.96268°S      ACCURACY 5 m<br/>151.08804°E      DATUM WGS84</p> <p>East boundary      Arcadia St      2019-08-27<br/>08:01:57+10:00</p> | <p>Area inspected – eastern (Arcadia Street) boundary</p> |

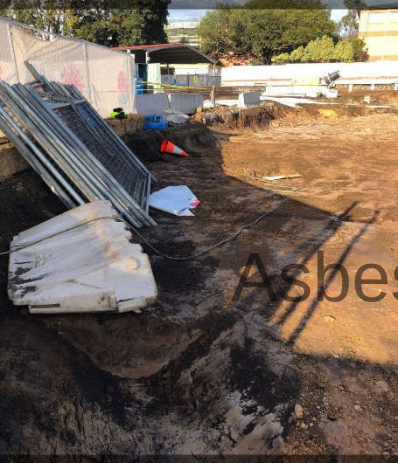
| <p>DIRECTION<br/>SW (T)      33.96274°S      ACCURACY 5 m<br/>151.08803°E      DATUM WGS84</p> <p>South boundary      And wall      2019-08-27<br/>08:02:10+10:00</p> | <p>Area inspected – southern boundary, including cut wall</p> |

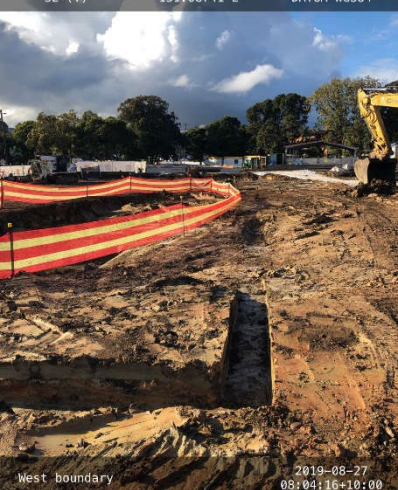
| <p>DIRECTION<br/>SE (T)      33.96249°S      ACCURACY 5 m<br/>151.08741°E      DATUM WGS84</p> <p>West boundary           2019-08-27<br/>08:04:16+10:00</p> | <p>Area inspected – western boundary</p> |

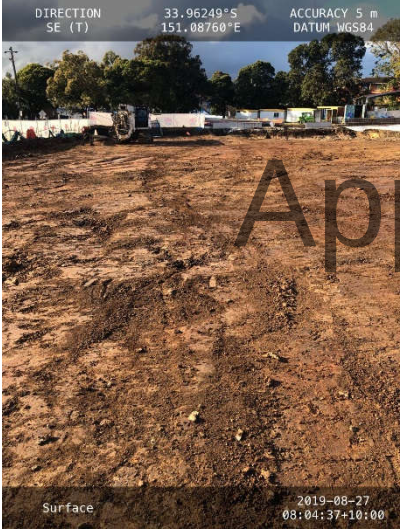
| | <p>Area inspected – general surface, facing southwards</p> |
