# Appendix 11.1

## Appendix B: Asbestos Removal Control Plan

# **Asbestos Removal Control Plan**

**Penshurst Public School**

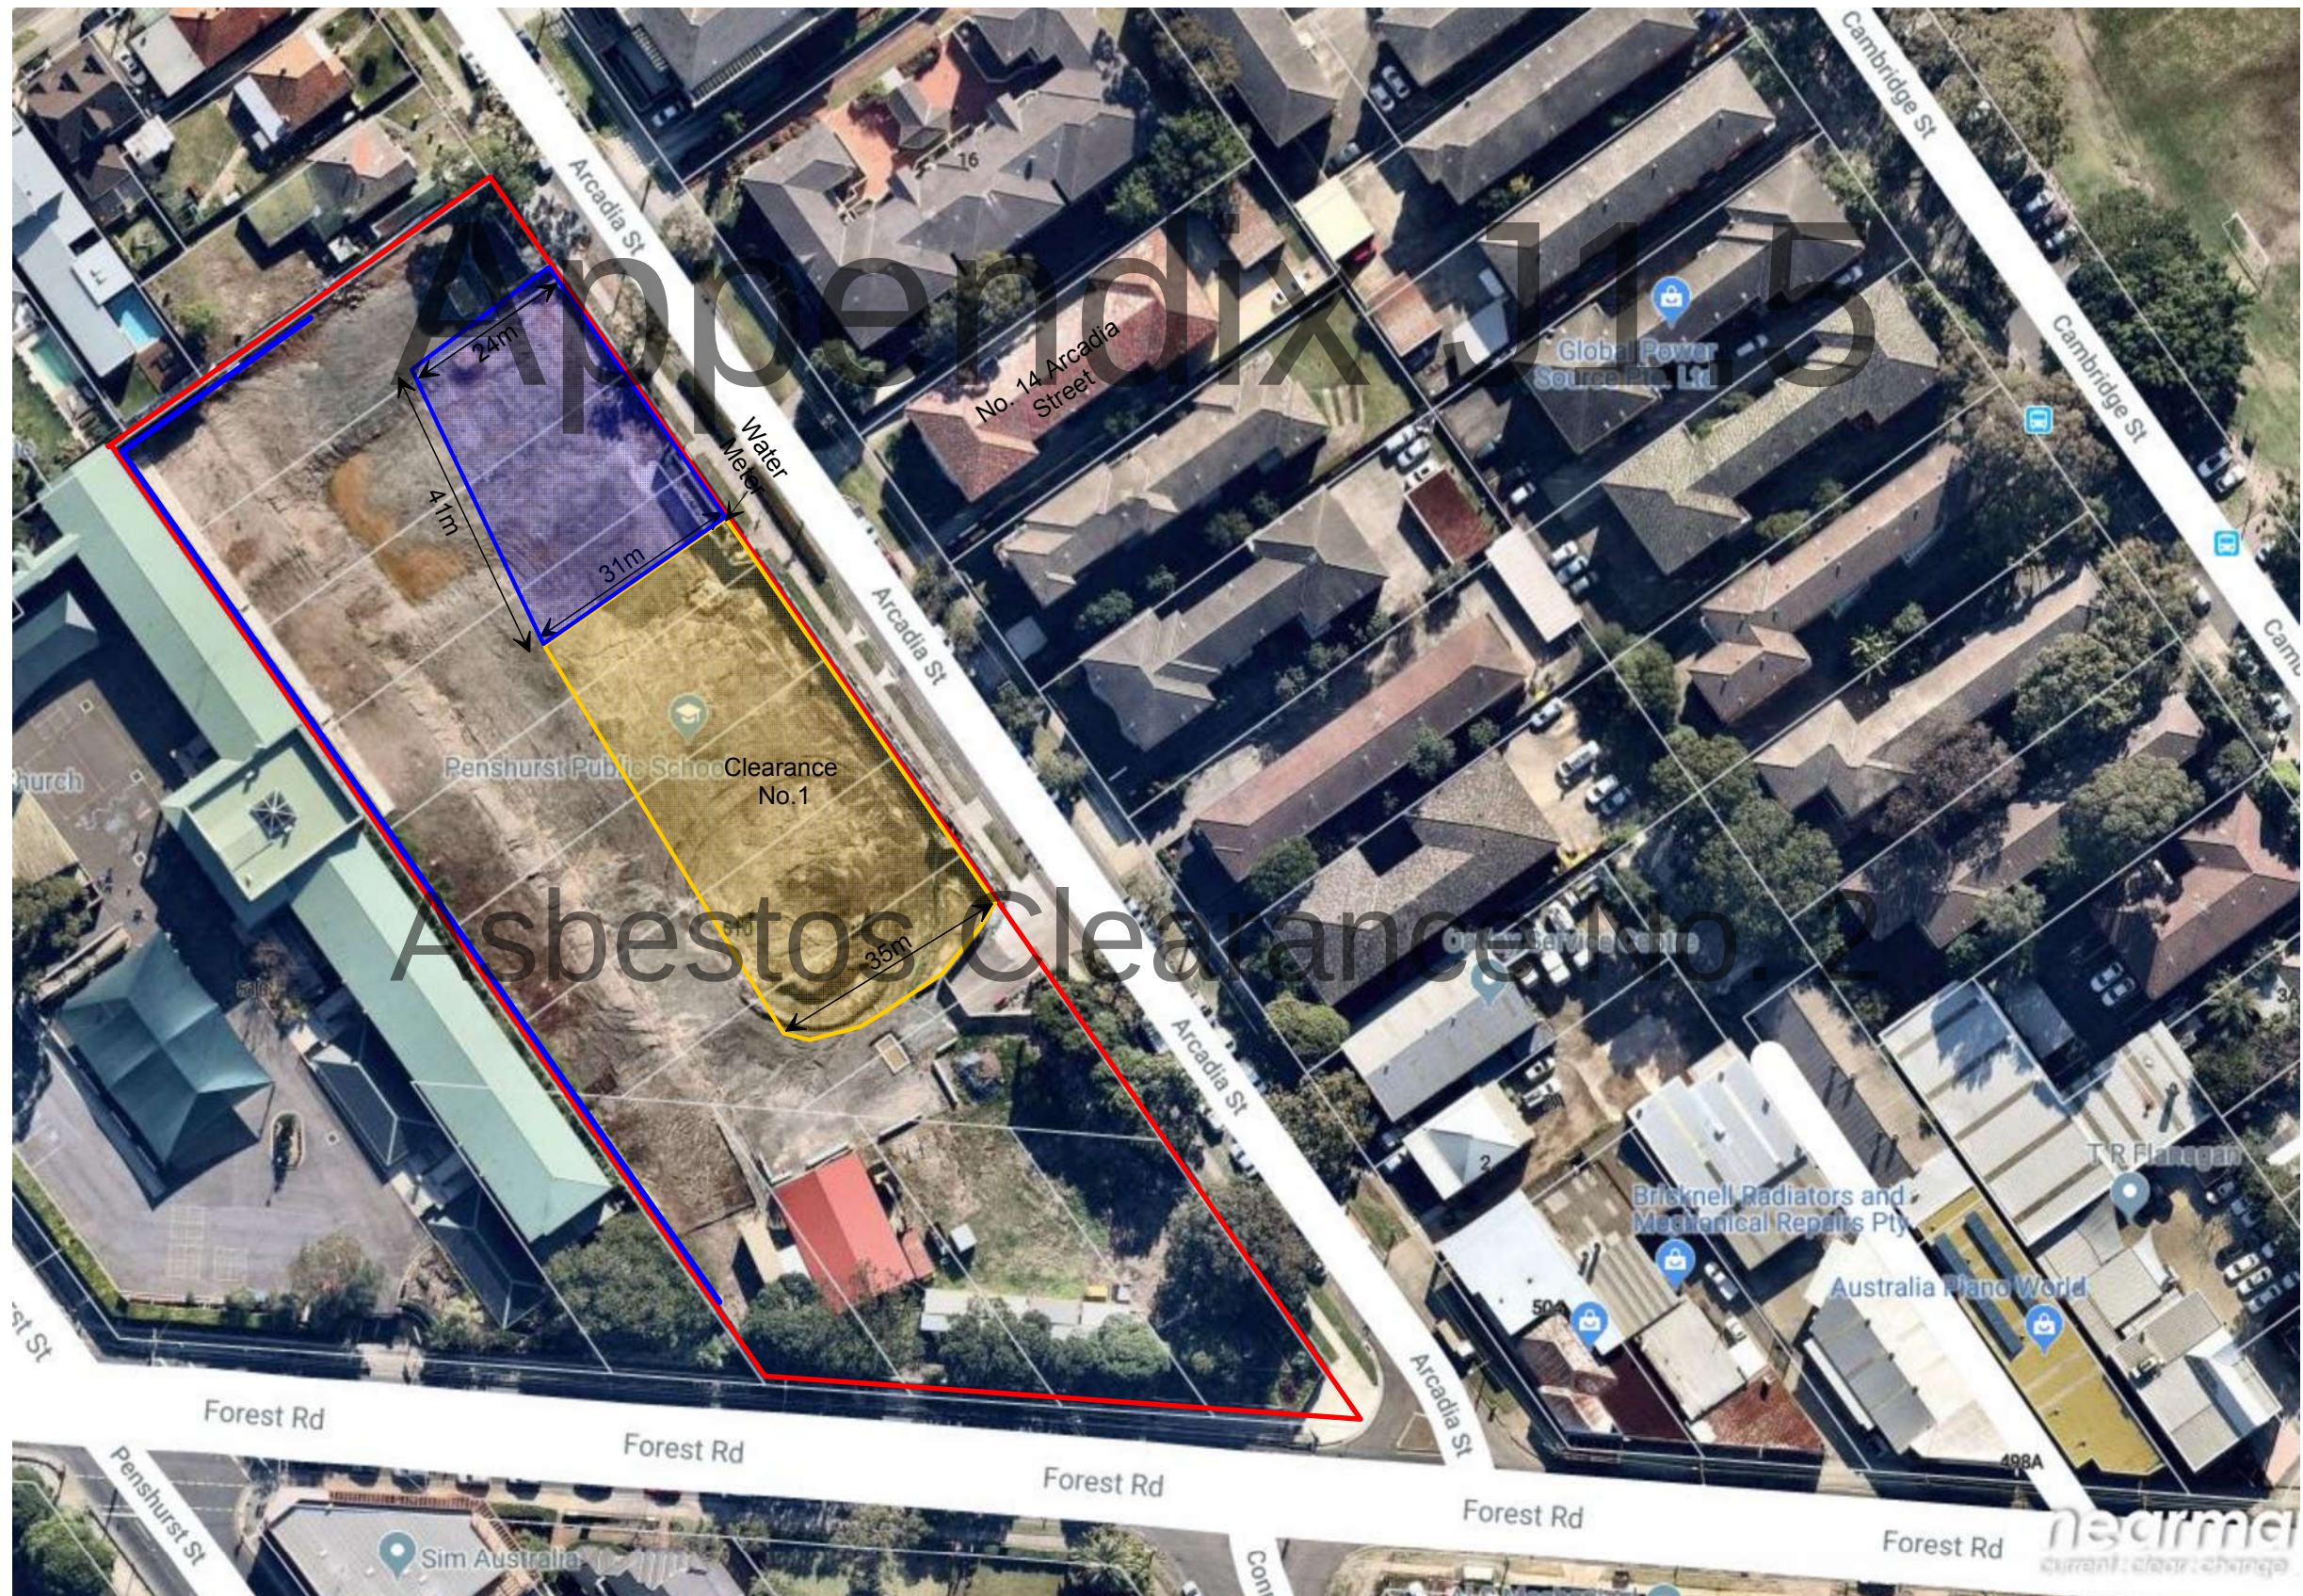
- APPROXIMATE SITE BOUNDARY
- AREA INSPECTED (APPROXIMATE BOUNDARY)
- AREA(S) SUBJECT TO PREVIOUS CLEARANCE(S)

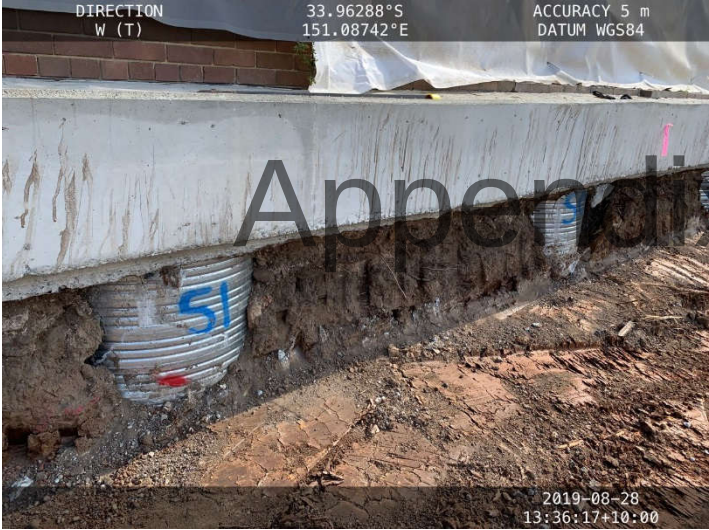
| <p>DIRECTION<br/>W (T)      33.96288°S<br/>151.08742°E      ACCURACY 5 m<br/>DATUM WGS84</p> <p>2019-08-28<br/>13:36:17+10:00</p> | <p>Area inspected – vertical wall beneath capping beam, western boundary</p> |

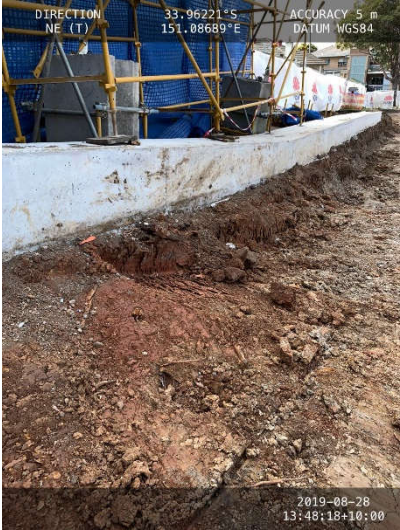
| <p>DIRECTION<br/>NE (T)      33.96221°S<br/>151.08689°E      ACCURACY 5 m<br/>DATUM WGS84</p> <p>2019-08-28<br/>13:48:18+10:00</p> | <p>Area inspected – vertical wall beneath capping beam, northern boundary</p> |

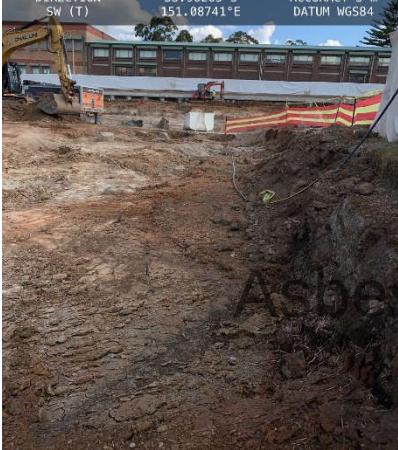
| <p>DIRECTION<br/>SW (T)      33.96205°S<br/>151.08741°E      ACCURACY 5 m<br/>DATUM WGS84</p> <p>2019-08-28<br/>14:11:21+10:00</p> | <p>Area inspected – northern boundary adjacent to entry driveway, facing west</p> |

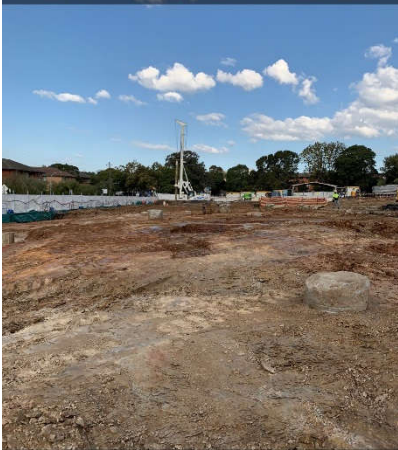
| <p>DIRECTION<br/>SE (T)      33.96211°S<br/>151.08733°E      ACCURACY 4 m<br/>DATUM WGS84</p> <p>2019-08-28<br/>14:11:56+10:00</p> | <p>Area inspected – western boundary of area adjoining Arcadia Street, facing south</p> |

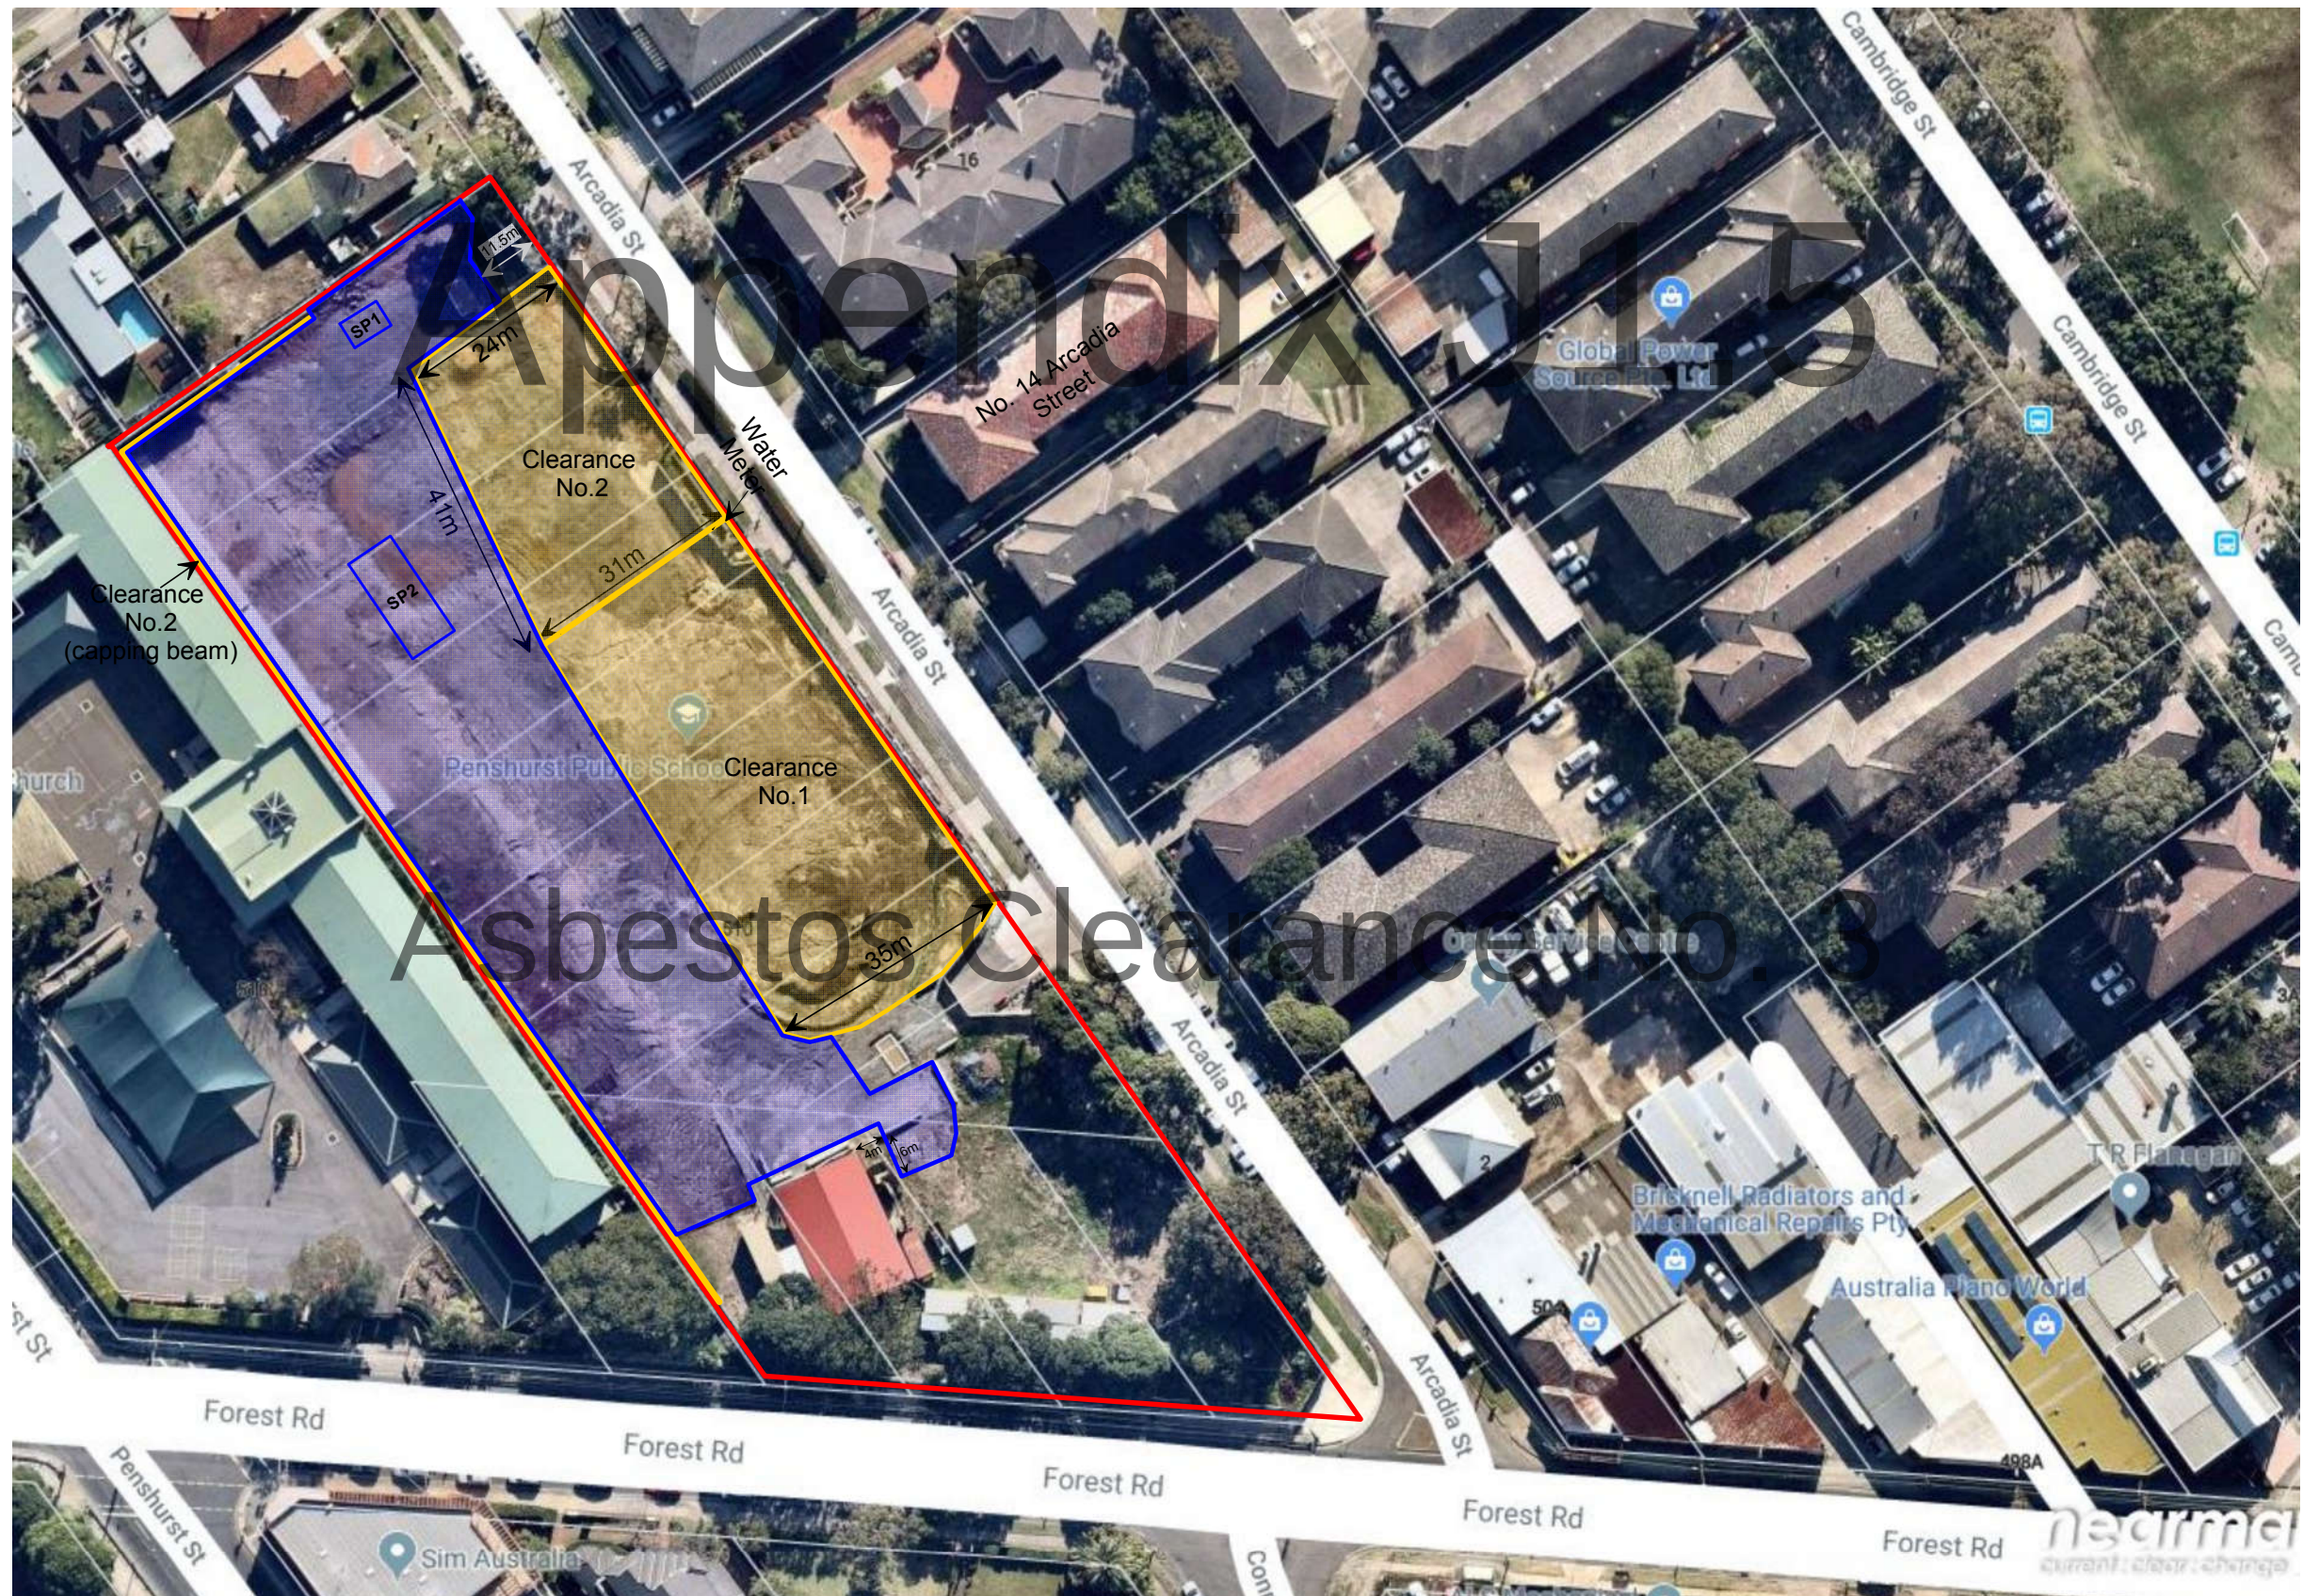
- APPROXIMATE SITE BOUNDARY
- AREA INSPECTED (APPROXIMATE BOUNDARY)
- AREA(S) SUBJECT TO PREVIOUS CLEARANCE(S)

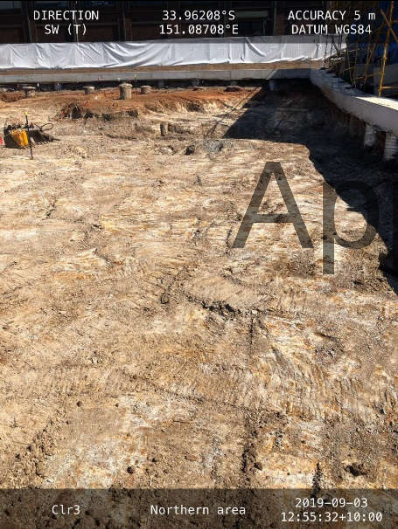
| | Area inspected – northern portion, facing south-west |

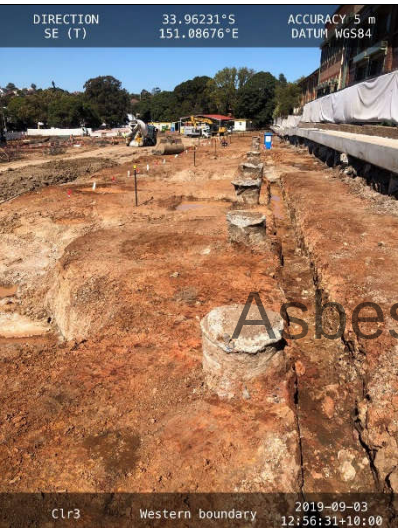
| | Area inspected – western boundary, facing south-east |

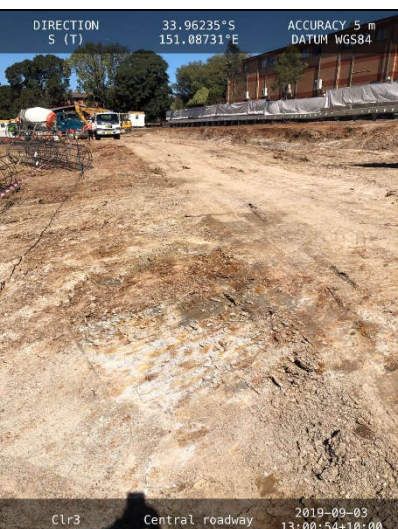
| | Area inspected – central haul road, facing south |

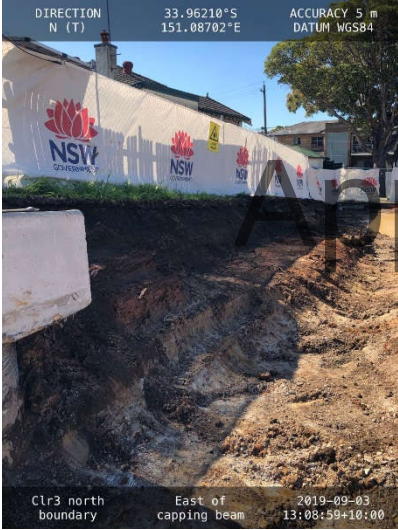
| | <p>Area inspected – vertical cut wall, northern end of the area inspected</p> |

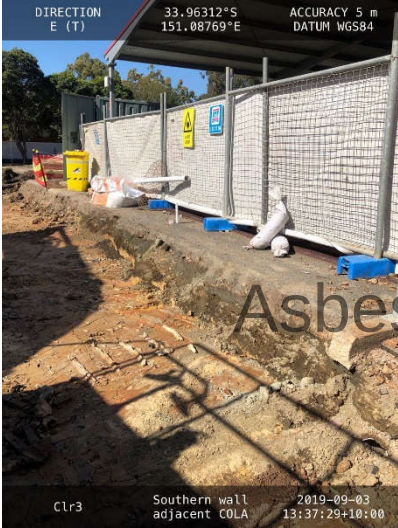
| | <p>Area inspected – vertical cut wall, southern end of area inspected</p> |
