**REPORT TO**  
**GRINDLEY CONSTRUCTION PTY LTD**

**ON**  
**VALIDATION ASSESSMENT**

**FOR**  
**PROPOSED SCHOOL REDEVELOPMENT**

**AT**  
**PENSHURST PUBLIC SCHOOL,**  
**510 FOREST ROAD, PENSHURST, NSW**

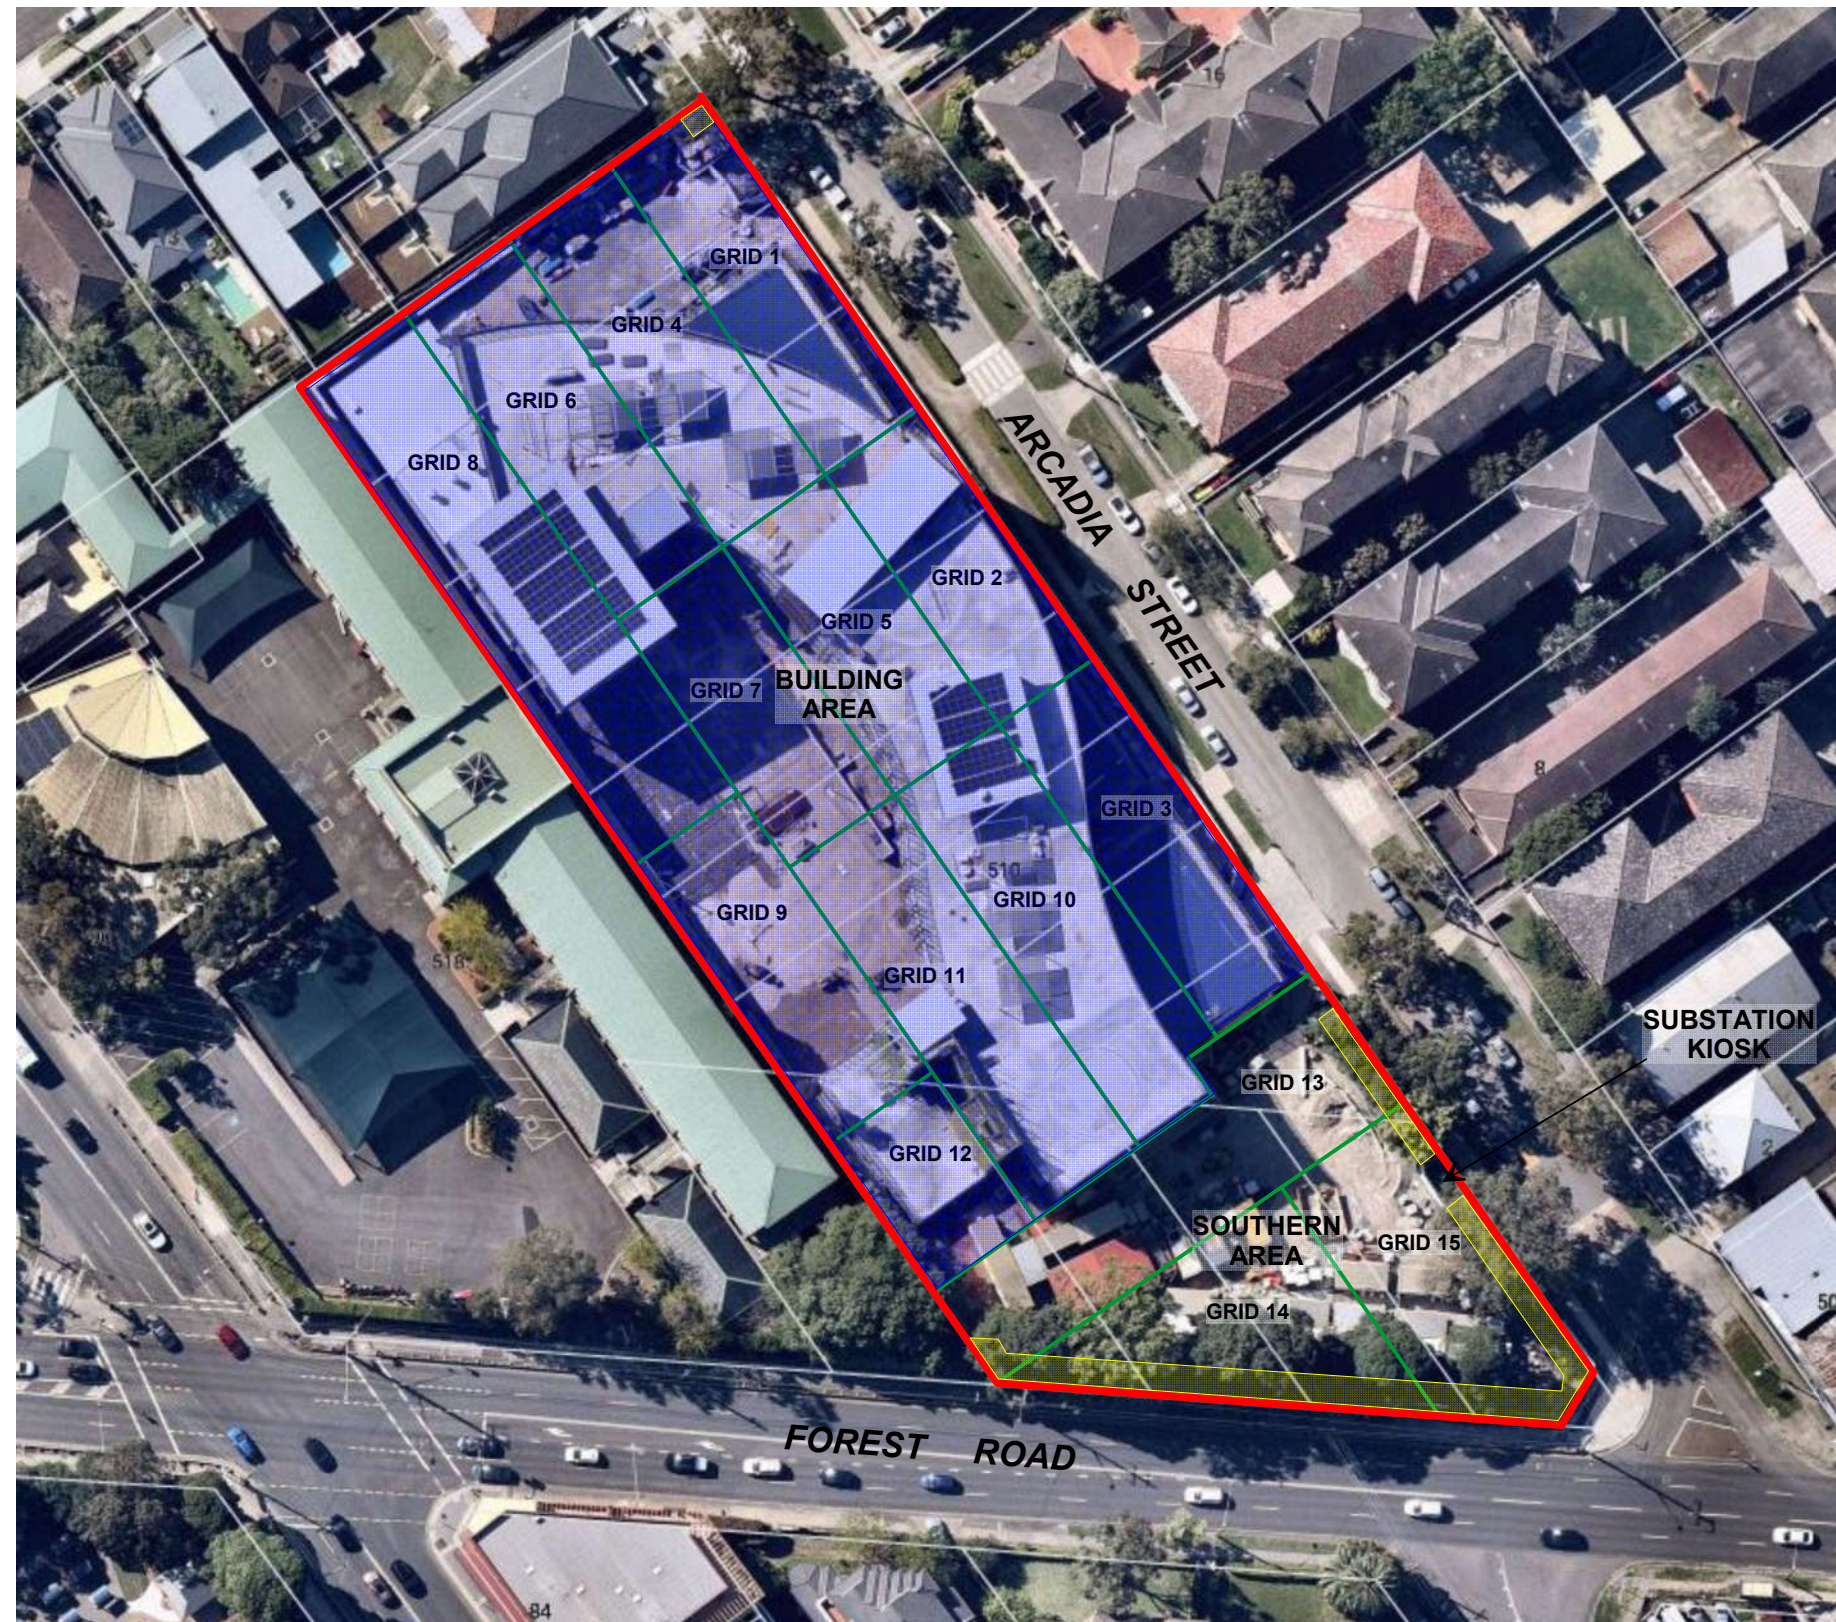
Minor amounts of fill also remained in the north-eastern driveway area and in a TPZ in the north-eastern corner of the site adjacent to Arcadia Street (see Figure 2 in Appendix A). Exposed fill/ground surfaces in these areas were inspected as documented in Asbestos Clearance No. 13 and Asbestos Clearance No. 14. There was no visible asbestos observed during these clearances.

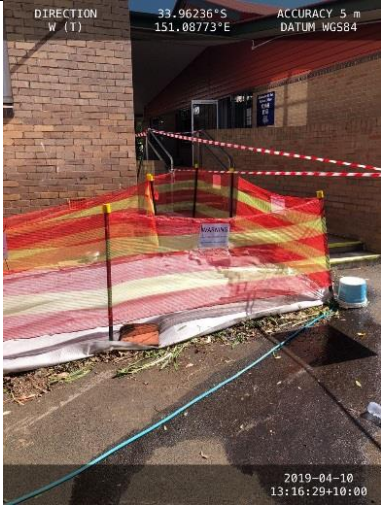
| Date | Notes | Photos |
|---|---|---|
| 10 April 2019<br>(BP) | <ul style="list-style-type: none"> <li>• Pre-commencement meeting with Root Partnerships, Grindley, Senversa, Chalouhi and EIS/JKE.</li> <li>• Discussed DGI requirements, requirements for asbestos remediation (particularly regarding the TPZs), and for classifying and monitoring waste disposal.</li> <li>• Briefly inspected TP103 on completion of meeting. The area had been cleared of vegetation, isolated and overlain with geofabric to minimise the potential for disturbance and cross contamination.</li> <li>• Demolition to continue for next seven weeks.</li> </ul> | <p>Photo 1: TP103 area separation</p> |

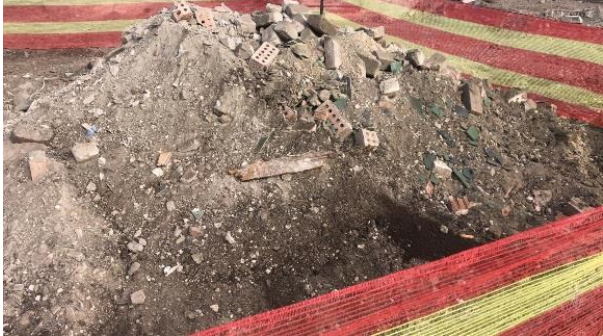
| Date | Notes | Photos |
|---|---|---|
| 20 May 2019 | <ul style="list-style-type: none"> <li>• Advised by Chalouhi that there was an unexpected asbestos find that included ACM in buried fill under the 1 of 2 staircase structures in Building A.</li> <li>• Phil Clifton was booked by Chalouhi to visit the site the following day.</li> <li>• Chalouhi supplied photographs.</li> </ul> | <p>Photo 2: Unexpected find No. 1, bonded ACM under Building A stairs</p> |

There was one unexpected find during project which included a 'cluster' of FCF/ACM found at the surface beneath the stairwell of the former Building A during demolition. This occurred in May 2019. A summary of the remedial actions and validation documentation is provided below. The documentation associated with the unexpected find is presented in Appendix H.

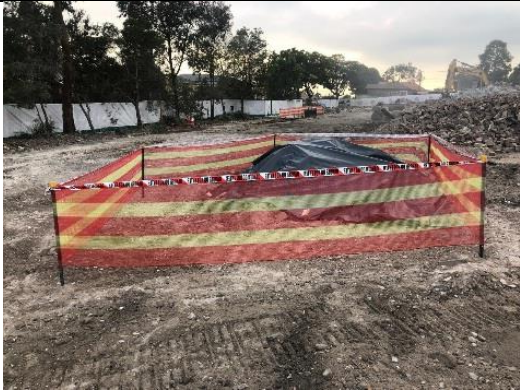
| Date | Notes | Photos |
|---|---|---|
| 20 May 2019<br>continued | | <p data-bbox="1182 611 1525 639">Photo 3: Unexpected find No. 1</p> |

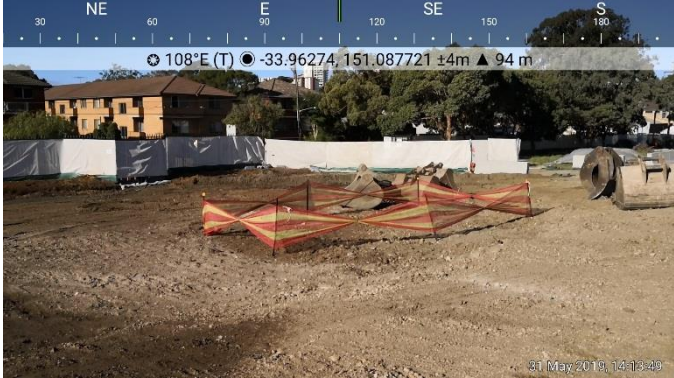
| Date | Notes | Photos |
|---|---|---|
| 30-31 May 2019<br>(HW) | <ul style="list-style-type: none"> <li>• Data gap Investigation completed.</li> <li>• Observed adequate isolation of AEC/unexpected finds.</li> <li>• ACM not observed across the site surface.</li> <li>• Inspection beneath former demountables and around covered outdoor learning area occurred as required under the RAP.</li> </ul> | <p data-bbox="1182 1078 1675 1107">Photo 4: Unexpected find area, after removal</p> |

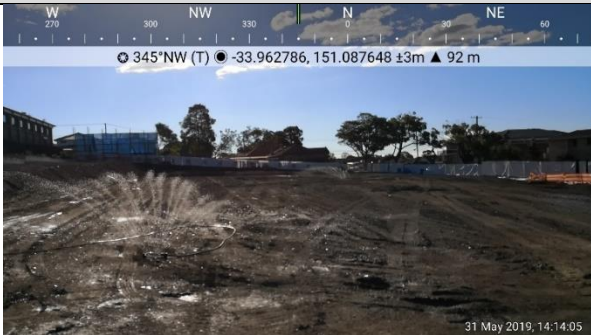
| Date | Notes | Photos |
|---|---|---|
| 30-31 May 2019<br>continued | | <p>Photo 5: Site facing north, post-demolition</p> <p>Photo 6: Site facing south, post-demolition</p> <p>Photo 7: Typical sieved bulk sample</p> |

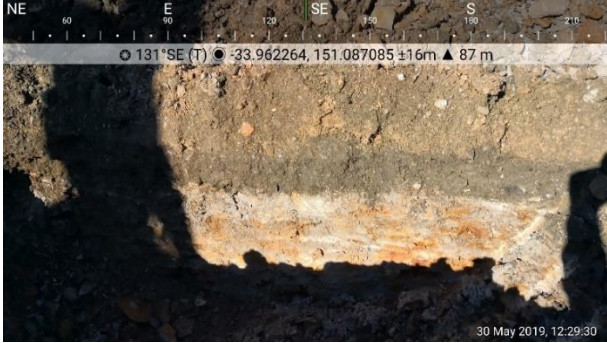
| Date | Notes | Photos |
|---|---|---|
| 30-31 May 2019<br>continued | | <p>Photo 8: Test pit, obvious differentiation between fill and natural soil</p> |

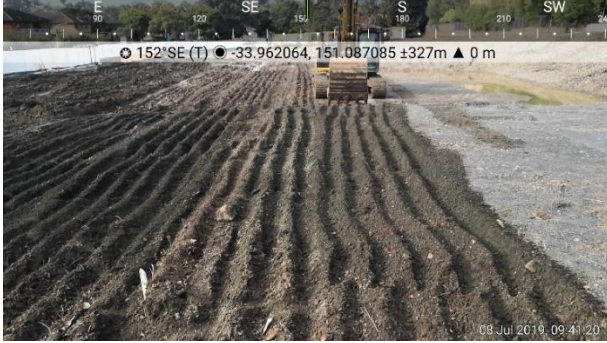
| Date | Notes | Photos |
|---|---|---|
| 8 July 2019 (HW) | <ul style="list-style-type: none"> <li>• Exploration of Grids 1, 4, 6 and 8 in the cut zone to establish whether visible ACM was present (to inform waste classification).</li> <li>• Surface (0.1m deep) disturbed using teeth of excavator bucket.</li> <li>• Trenches excavated to facilitate inspection of full depth of fill plus trench spoil.</li> </ul> | <p>Photo 9: Scraping top 0.1m of soil with teeth of excavator bucket prior to inspection</p> |

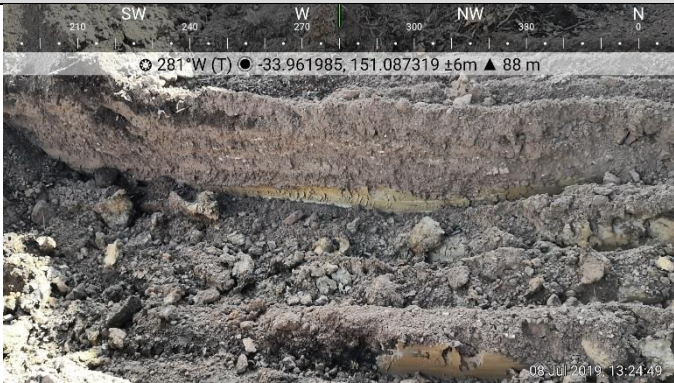
| Date | Notes | Photos |
|---|---|---|
| 8 July 2019<br>continued | | <p>Photo 10: Trench through fill, prior to inspection of walls and trench spoil</p> |

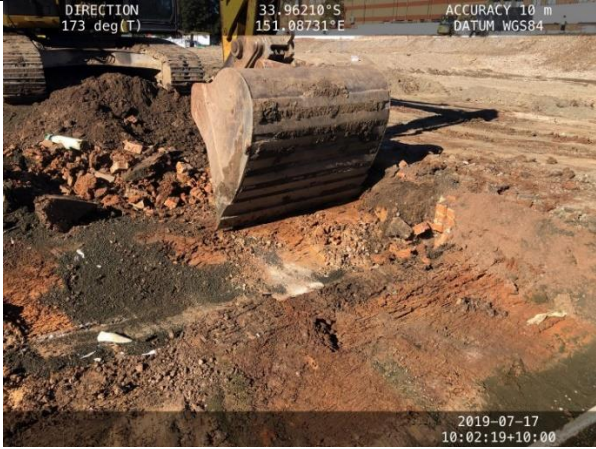
| Date | Notes | Photos |
|---|---|---|
| 17-19 July 2019<br>(MMP) | <ul style="list-style-type: none"> <li>• Initial scrape up and consolidation of fill in Grids 1, 2, 4 and 5.</li> <li>• Minor occurrence of fibre cement identified, process discussed with client.</li> <li>• Letter subsequently produced outlining additional visual assessment procedures (E30104Plet-WC2rev1).</li> <li>• Grid 8 piling platform left in-situ. Area checked and cleared by Chalouhi's asbestos supervisor 19 July 2019.</li> <li>• No waste left site.</li> </ul> | <p>Photo 11. Initial scrape up and consolidation of fill in Grids 1, 2, 4 and 5.</p> |

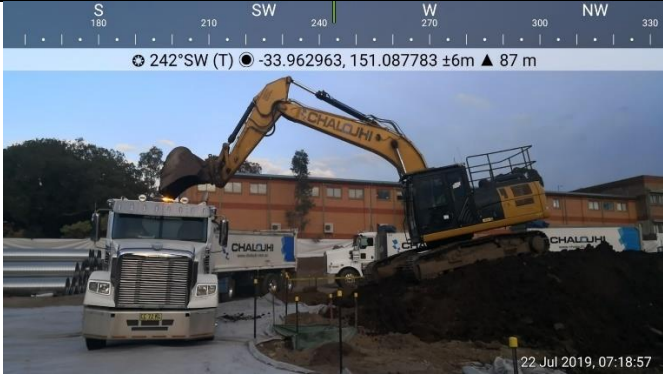
| Date | Notes | Photos |
|---|---|---|
| 22-24 July 2019<br>(HW) | <ul style="list-style-type: none"> <li>Commenced excavation and disposed GSW asbestos off-site from Grids 3 and 10. Waste disposal of GSW asbestos on 22 and 23 July only.</li> </ul> | <p>Photo 14. Excavation and load out of GSW asbestos from Grids 3 and 10. Note asbestos controls and use of geofabric on haul road to minimise cross contamination.</p> |

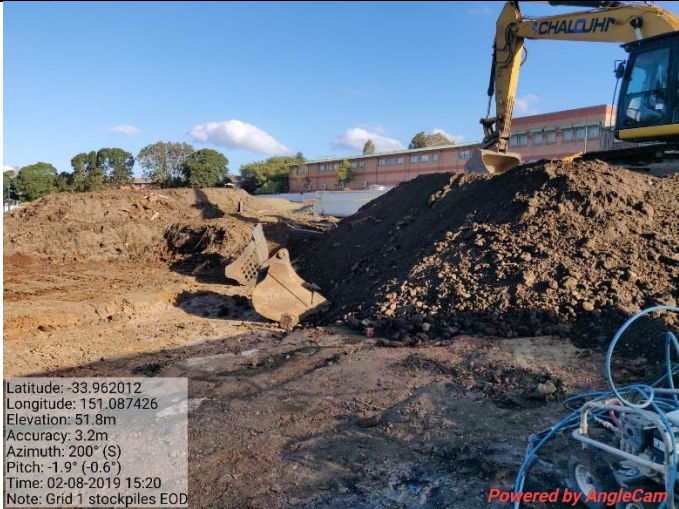
| Date | Notes | Photos |
|---|---|---|
| 1 - 2 August 2019<br>(SW) | <ul style="list-style-type: none"> <li>Continued treatment trial in Grid 1.</li> </ul> | <p>Photo 15: Treated (right) and non-treated (left) stockpiles in Grid 1 at end of 2 August 2019</p> |

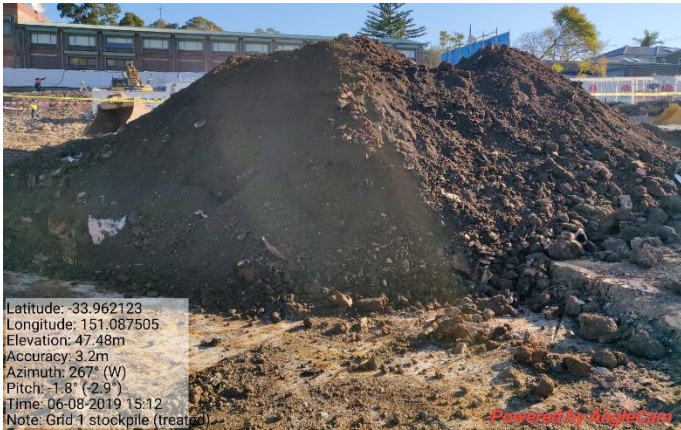
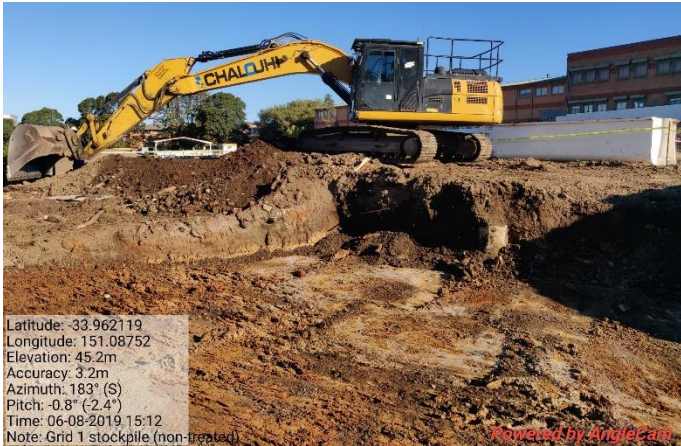
| Date | Notes | Photos |
|---|---|---|
| 6 August 2019 | <ul style="list-style-type: none"> <li>• Load out of GSW Asbestos stockpiled in Grids 3 and 10</li> <li>• Continued treatment trial in Grid 1.</li> </ul> | <p>Photo 16: Photo of treated stockpile end of day</p> <p>Photo 17: Photo of non-treated stockpile end of day</p> |

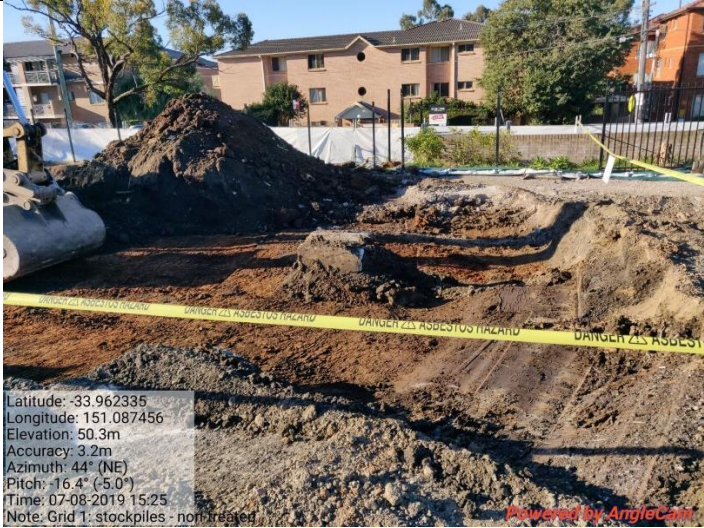
| Date | Notes | Photos |
|---|---|---|
| 7 – 8 August 2019 (SW) | <ul style="list-style-type: none"> <li>Continued treatment trial in Grid 1.</li> </ul> | <p>Latitude: -33.962335<br/>Longitude: 151.087456<br/>Elevation: 50.3m<br/>Accuracy: 3.2m<br/>Azimuth: 44° (NE)<br/>Pitch: -16.4° (-5.0°)<br/>Time: 07-08-2019 15:25<br/>Note: Grid 1: stockpiles - non-treated</p> <p>Photo 18: Grid 1 treatment</p> |

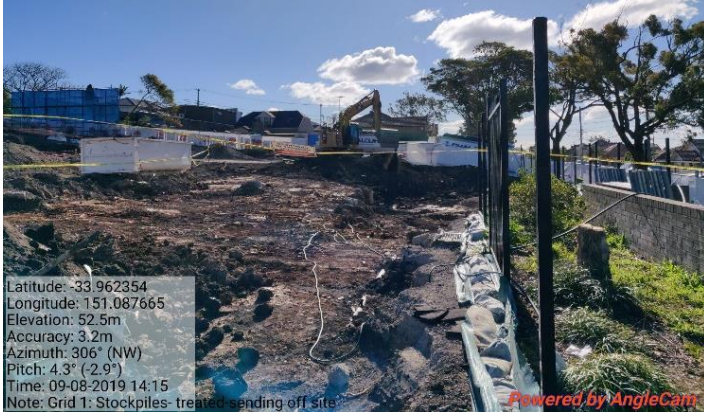
| Date | Notes | Photos |
|---|---|---|
| 9 - 12 August 2019 (SW) | <ul style="list-style-type: none"> <li>Continued treatment trial in Grid 1.</li> <li>Ceased treatment of Grid 1 and moved onto Grid 2</li> <li>Loadout of treated soil from Grid 1 on 9 August 2019.</li> <li>Treatment trial discontinued after 12 August 2019.</li> </ul> | <p>Latitude: -33.962354<br/>Longitude: 151.087665<br/>Elevation: 52.5m<br/>Accuracy: 3.2m<br/>Azimuth: 306° (NW)<br/>Pitch: 4.3° (-2.9°)<br/>Time: 09-08-2019 14:15<br/>Note: Grid 1: Stockpiles - treated sending off site</p> <p>Photo 19: Grid 1 treated stockpile loaded to be sent off site</p> |

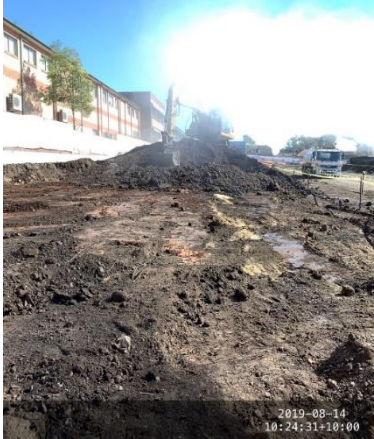
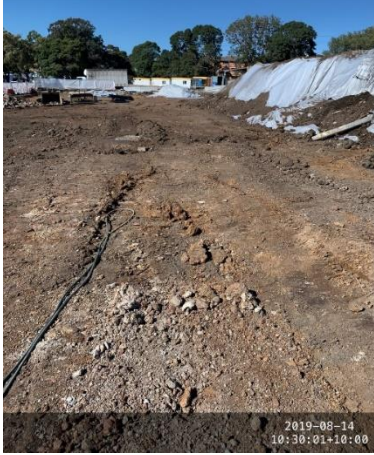
| Date | Notes | Photos |
|---|---|---|
| 14 August 2019<br>(HL) | <ul style="list-style-type: none"> <li>• Inspection of Grid 12. Fill material still visible at the surface across the grid, but no fibre cement observed. JKE advised additional scraping to be completed.</li> <li>• Inspection of Grid 2 and Grid 5. Fill material identified at various locations, but no fibre cement observed. JKE advised general clean-up of both grids required.</li> <li>• Stockpile of material identified along south-west boundary of Grids 2 and 5.</li> </ul> | <div data-bbox="1182 213 1554 708"> <p>DIRECTION 33.96388°S ACCURACY 6 m<br/>NW (T) 151.08762°E DATUM WGS84</p> <p>2019-08-14<br/>10:24:31+10:00</p> </div> <p>Photo 20: View of Grid 12 facing north-west. Note the fill material at the surface and the stockpile of material at the northern end.</p> <div data-bbox="1182 833 1554 1343"> <p>DIRECTION 33.96238°S ACCURACY 5 m<br/>SE (T) 151.08754°E DATUM WGS84</p> <p>2019-08-14<br/>10:30:01+10:00</p> </div> <p>Phot 21: View of Grids 2 and 5 facing south-east. Note the covered stockpile.</p> |

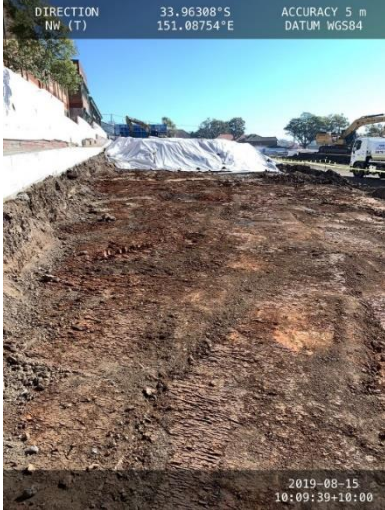
| Date | Notes | Photos |
|---|---|---|
| 15 August 2019<br>(HL) | <p><u>Grid 12</u></p> <ul style="list-style-type: none"> <li>• Natural clay material visible at the surface of the grid.</li> <li>• Some areas of deeper fill observed along the north-east boundary.</li> <li>• No ACM identified.</li> <li>• Stockpile of material at the north-west boundary covered with geo-fabric.</li> </ul> <p><u>Grid 6 &amp; 8</u></p> <ul style="list-style-type: none"> <li>• Large areas of fill and road base still in situ.</li> <li>• JKE advised to continue scraping until the natural is visible.</li> </ul> <p><u>Grid 4</u></p> <ul style="list-style-type: none"> <li>• Mostly completed, with exception of small trench along the northern boundary.</li> <li>• Chalouhi advised that the trench will be excavated.</li> </ul> | <p>Photo 22: View of Grid 12 facing north. Note the natural clay at the surface and the stockpile of fill covered with geo-fabric.</p> |

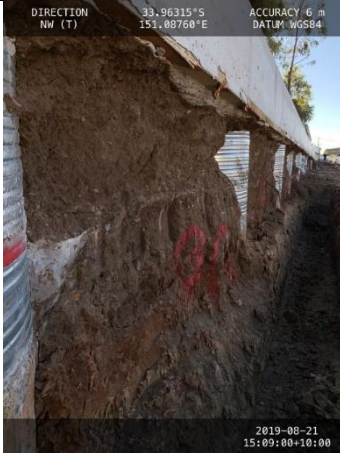
| Date | Notes | Photos |
|---|---|---|
| | | <p data-bbox="1182 678 1933 707">Photo 30: View of the western piling wall. No fibre cement identified.</p> |

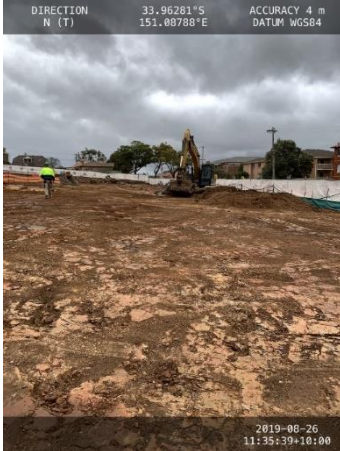
| Date | Notes | Photos |
|---|---|---|
| 26 August 2019<br>(HL) | <p data-bbox="353 767 501 796"><u>Grids 3 &amp; 10</u></p> <ul data-bbox="353 810 1151 1145" style="list-style-type: none"> <li>• Chalouhi scraped and removed excess fill spoil from along the Arcadia street boundary.</li> <li>• The southern boundary with the southern driveway was cleaned up and excess fill was removed and stockpiled.</li> <li>• Surfaces of the grids were scraped to tidy up any small patches of fill.</li> <li>• JKE advised that Grids 3 and 10 were successfully cleared of fill. Grindley advised a piling rig was to be parked on this area.</li> </ul> | <p data-bbox="1182 1225 2112 1289">Photo 31: View of Grids 3 and 10 facing north. Note the surface of the grids cleared of fill material and natural visible at the surface.</p> |

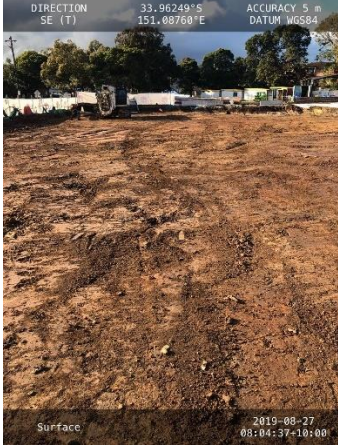
| Date | Notes | Photos |
|---|---|---|
| 27 August 2019<br>(BP) | <ul style="list-style-type: none"> <li>• Eastern site area inspected. All fill had been removed and natural soil was exposed at ground surface.</li> <li>• Asbestos clearance certificate was issued for these areas, Ref: E30104Plet-Clr1, dated 27 August 2019.</li> </ul> | <p>Photo 32: View of Grids 3 and 10 facing south. Surface successfully cleared.</p> |

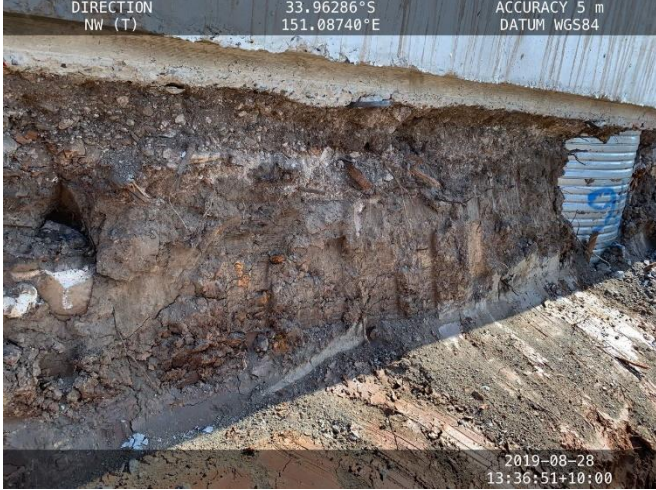
| Date | Notes | Photos |
|---|---|---|
| 28 August 2019<br>(HL) | <p>Western Piling Wall</p> <ul style="list-style-type: none"> <li>• Piling was face was inspected, where visible until the northern end where it was below the ground surface.</li> <li>• No fibre cement fragments identified.</li> </ul> <p>North-East Clearance Inspection</p> <ul style="list-style-type: none"> <li>• Northern wall of excavation (southern boundary of driveway) was inspected exposed some fill at the top of the wall and natural clay beneath</li> <li>• The base and walls of the excavation was inspected. Approximately 28 footings were still in-situ.</li> <li>• No fibre cement fragments identified.</li> <li>• Natural clay soils and siltstone/shale visible across the base of the excavation.</li> </ul> | <p>Photo 33: View of the western piling wall facing north-west.</p> |

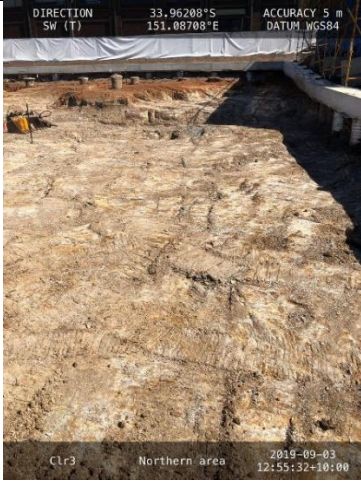
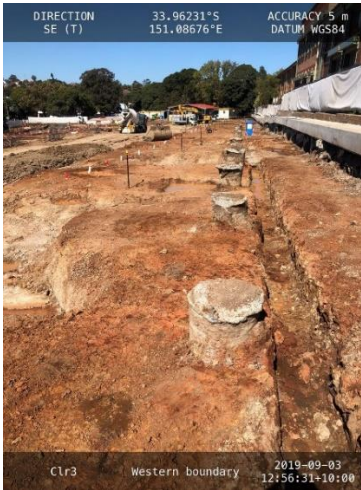
| Date | Notes | Photos |
|---|---|---|
| 3 September 2020 (BP) | <ul style="list-style-type: none"> <li>The building area had largely been scraped back to remove fill.</li> <li>Asbestos clearance certificate was issued for these areas, Ref: E30104Plet-Clr3, dated 4 September 2019.</li> <li>Piling was underway in areas covered by Asbestos Clearance No.1 and Asbestos Clearance No. 2 (generating VENM).</li> <li>Small stockpiles on site had been generated by scraping back haul road after heavy rain (haul road was constructed on natural ground). The stockpiles did not contain anthropogenic material or fibre cement fragments.</li> </ul> | <p>Photo 36: Fill removed, natural soil at surface in northern area</p> <p>Photo 37: Fill removed, natural soil at surface along western boundary.</p> |

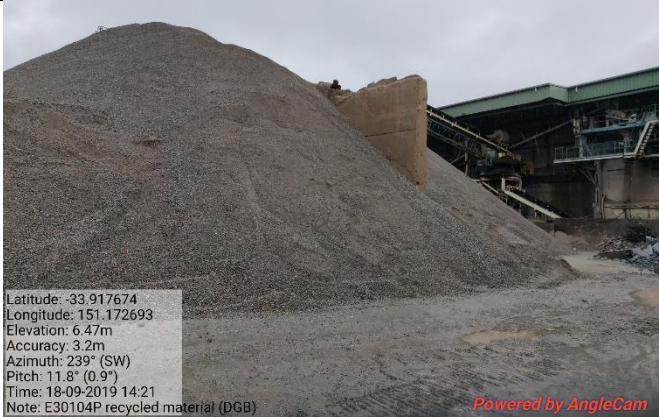
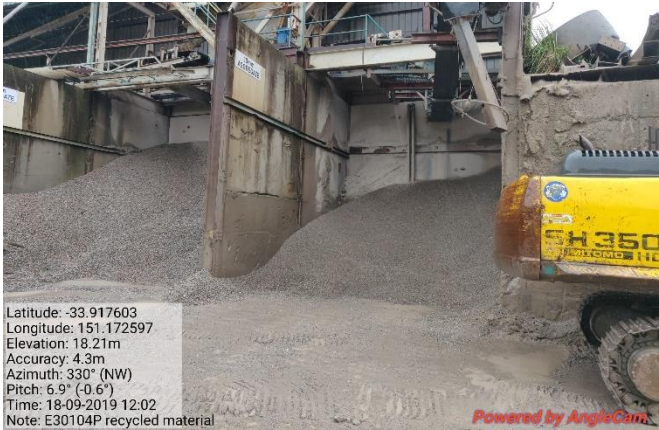
| Date | Notes | Photos |
|---|---|---|
| 18 September 2019 (SW) | <ul style="list-style-type: none"> <li>• Sampling of 10mm and DGB20 recycled products from St Peters.</li> <li>• No indicators of contamination, staining, odours or fibre cement.</li> </ul> | <p>Photo 38: Stockpile of DGB20 material from St Peters</p> <p>Photo 39: Stockpile of 10mm Aggregate from St Peters</p> |

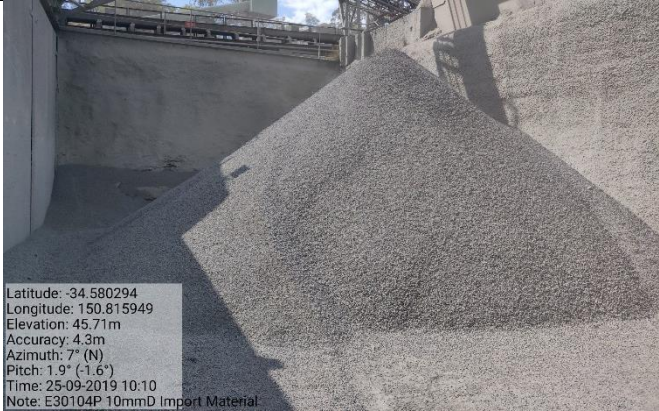
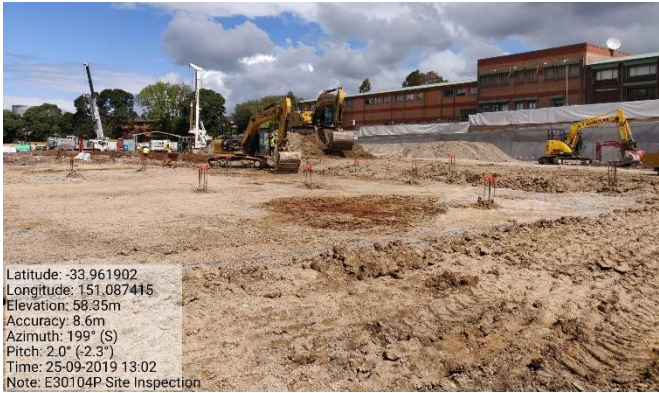
| Date | Notes | Photos |
|---|---|---|
| 25 September 2019 (SW) | <ul style="list-style-type: none"> <li>• Sampling of 10mm quarry product from Albion Park Quarry. No indicators of contamination, staining, odours or fibre cement.</li> <li>• General site inspection at Penshurst. Cut earthworks and piling underway. All within zone where fill removal had occurred previously (i.e. only moving natural clay/shale).</li> </ul> | <p>Latitude: -34.580294<br/>Longitude: 150.815949<br/>Elevation: 45.711m<br/>Accuracy: 4.3m<br/>Azimuth: 7° (N)<br/>Pitch: 1.9° (-1.6°)<br/>Time: 25-09-2019 10:10<br/>Note: E30104P 10mmD Import Material</p> <p>Photo 40: 10mm Quarry Product from Albion Park Quarry</p> <p>Latitude: -33.961902<br/>Longitude: 151.087415<br/>Elevation: 58.35m<br/>Accuracy: 8.6m<br/>Azimuth: 199° (S)<br/>Pitch: 2.0° (-2.3°)<br/>Time: 25-09-2019 13:02<br/>Note: E30104P Site Inspection</p> <p>Photo 41: Overview of the site during inspection</p> |

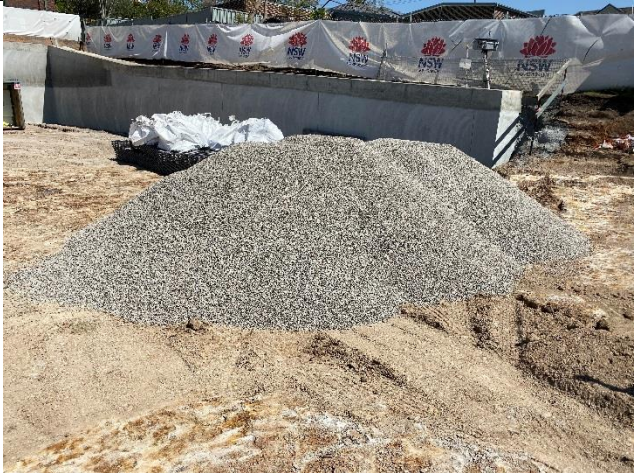
| Date | Notes | Photos |
|---|---|---|
| 4 October 2019<br>(MMP) | <ul style="list-style-type: none"> <li>• Inspection of imported materials including 10mm recycled and DGB20 recycled, 10mm quarry product and Blue Quarry Sand.</li> <li>• No indicators of contamination, staining, odours or fibre cement.</li> </ul> | <p data-bbox="1182 699 2069 767">Photo 42: Inspection of imported materials including 10mm recycled and DGBB20 recycled, 10mm quarry product and Blue Quarry Sand.</p> |

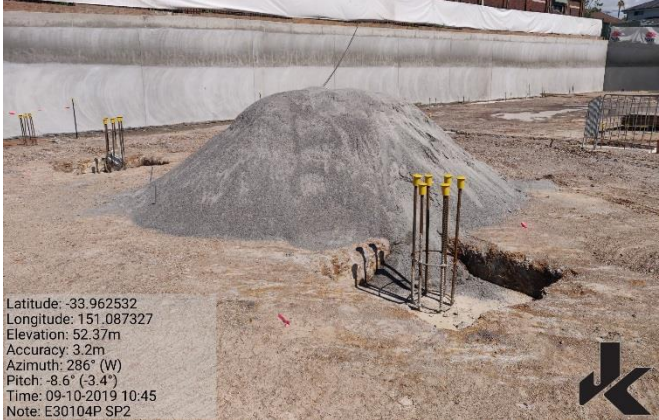
| Date | Notes | Photos |
|---|---|---|
| 9 October 2019<br>(SW) | <ul style="list-style-type: none"> <li>• Inspection and sampling of imported Blue Quarry Sand.</li> <li>• No indicators of contamination, staining, odours or fibre cement.</li> </ul> | <p data-bbox="1182 1114 1339 1241"> Latitude: -33.962532<br/> Longitude: 151.087327<br/> Elevation: 52.37m<br/> Accuracy: 3.2m<br/> Azimuth: 286° (W)<br/> Pitch: -8.6° (-3.4°)<br/> Time: 09-10-2019 10:45<br/> Note: E30104P SP2 </p> <p data-bbox="1182 1252 1749 1278">Photo 43: One of the Stockpiles of Blue Quarry Sand</p> |

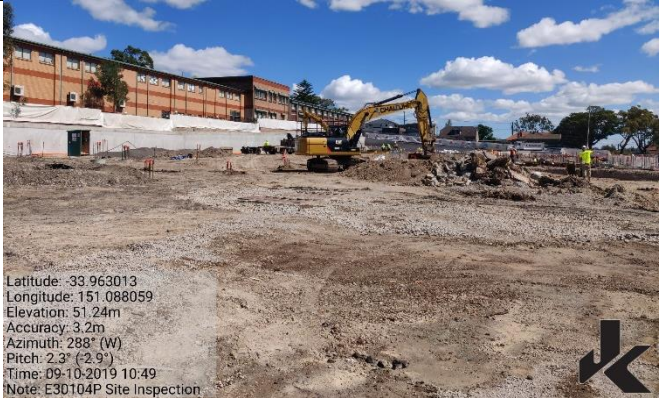
| Date | Notes | Photos |
|---|---|---|
| | | <p>Latitude: 33.963013<br/>Longitude: 151.088059<br/>Elevation: 51.24m<br/>Accuracy: 3.2m<br/>Azimuth: 288° (W)<br/>Pitch: 2.3° (-2.9°)<br/>Time: 09-10-2019 10:49<br/>Note: E30104P Site Inspection</p> <p>Photo 44: Overview of site during inspection</p> |

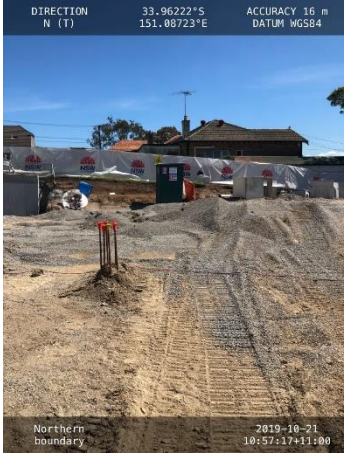
| Date | Notes | Photos |
|---|---|---|
| 21 October 2019<br>(BP) | <ul style="list-style-type: none"> <li>• Called out for surface clearance of south-eastern driveway which was being relocated slightly to the south of the original driveway. Area was not ready to be inspected.</li> <li>• Cattle grid moving to an area where fill remained in-situ. Area to be excavated and cleared at a later date. Clearance required following fill removal from driveway area.</li> <li>• Imported materials inspected including 10mm recycled and DGB20 recycled, 10mm quarry product and Blue Quarry Sand. No indicators of contamination, staining, odours or fibre cement.</li> </ul> | <p>DIRECTION 33.96222°S ACCURACY 16 m<br/>N (T) 151.08723°E DATUM WGS84</p> <p>Northern boundary 2019-10-21 10:57:17+11:00</p> <p>Photo 45: Imported materials, example of 10mm recovered aggregate</p> |

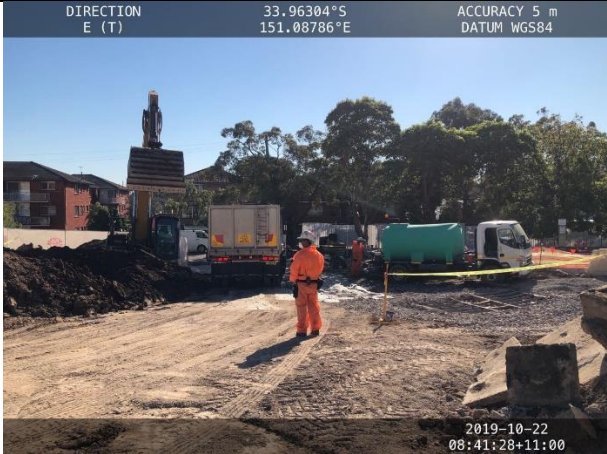
| Date | Notes | Photos |
|---|---|---|
| 22 October 2019<br>(BP) | <ul style="list-style-type: none"> <li>General inspection, footing and pre-slab pour preparations underway. Recovered aggregates extensively used beneath proposed building slabs.</li> <li>Imported materials inspected. No indicators of contamination, staining, odours or fibre cement.</li> <li>Loading out GSW Asbestos soils from the south-eastern driveway for the temporary entry realignment. Adequate controls in place (however we did not observe/check air monitors).</li> <li>Site walkover with auditor.</li> </ul> | <p>Photo 46: Excavation for south-eastern driveway/entry realignment</p> |

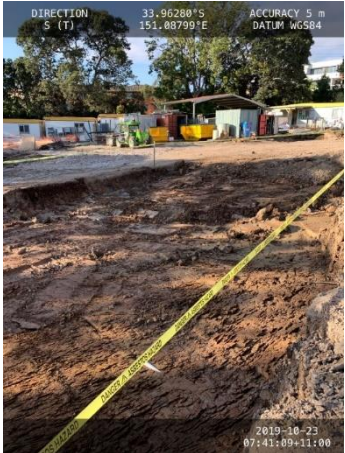
| Date | Notes | Photos |
|---|---|---|
| 23 October 2019<br>(HL) | <ul style="list-style-type: none"> <li>Clearance required following fill removal from driveway area</li> <li>Natural soil visible across the surface of the excavation</li> <li>Natural soil visible along the northern excavation wall</li> <li>Fill visible along the southern and eastern walls</li> <li>No fibre cement fragments identified and the area was successfully cleared.</li> <li>Asbestos clearance certificate issued Ref: E30104Plet-Clr4, dated 24 October 2019.</li> </ul> | <p>Photo 47: Areas inspected for Asbestos Clearance No. 4</p> |

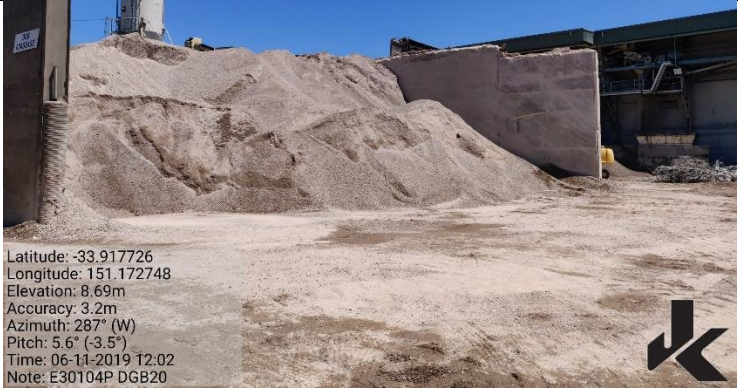
| Date | Notes | Photos |
|---|---|---|
| 6 November 2019 (SW) | <ul style="list-style-type: none"> <li>• DBG20 Sampling at Metropolitan Demolition and Recycling Facility, St Peters (Round 2).</li> <li>• No indicators of contamination, staining, odours or fibre cement.</li> </ul> | <p>Latitude: -33.917726<br/>Longitude: 151.172748<br/>Elevation: 8.69m<br/>Accuracy: 3.2m<br/>Azimuth: 287° (W)<br/>Pitch: 5.6° (-3.5°)<br/>Time: 06-11-2019 12:02<br/>Note: E30104P DGB20</p> <p>Photo 48: Stockpile of DBG20 Material</p> |

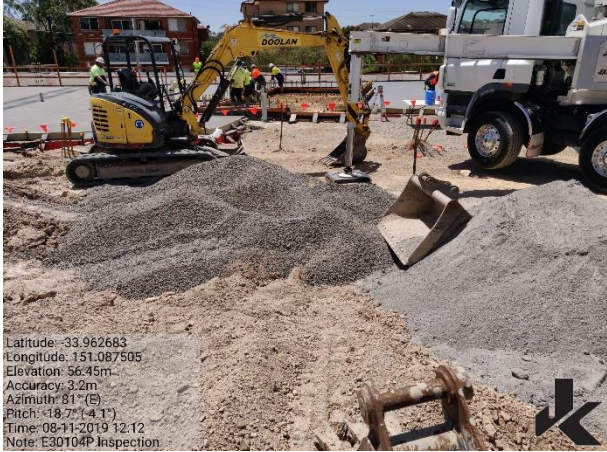
| Date | Notes | Photos |
|---|---|---|
| 8 November 2019 (SW) | <ul style="list-style-type: none"> <li>• Inspection of imported materials, including quarry metals and recycled materials.</li> <li>• No indicators of contamination, staining, odours or fibre cement.</li> </ul> | <p>Latitude: -33.962683<br/>Longitude: 151.087505<br/>Elevation: 56.45m<br/>Accuracy: 3.2m<br/>Azimuth: 81° (E)<br/>Pitch: 18.7° (4.1°)<br/>Time: 08-11-2019 12:12<br/>Note: E30104P Inspection</p> <p>Photo 49: Stockpile of 10mm and Blue Quarry Sand (quarry materials)</p> |

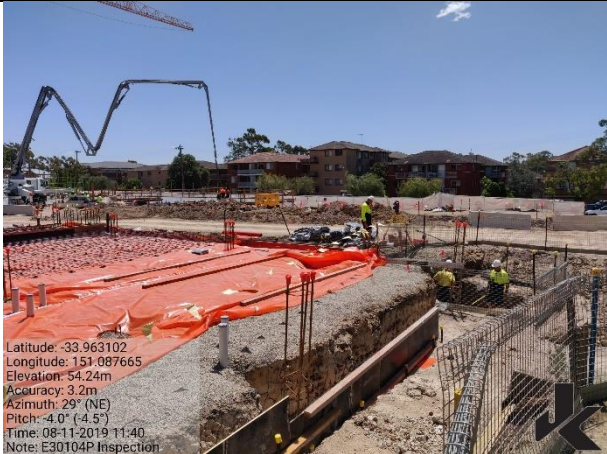
| Date | Notes | Photos |
|---|---|---|
| | | <p>Latitude: -33.963102<br/>Longitude: 151.087665<br/>Elevation: 54.24m<br/>Accuracy: 3.2m<br/>Azimuth: 29° (NE)<br/>Pitch: -4.0° (-4.5°)<br/>Time: 08-11-2019 11:40<br/>Note: E30104P Inspection</p> <p>Photo 50: Recycled DGB20 beneath proposed building slabs</p> |

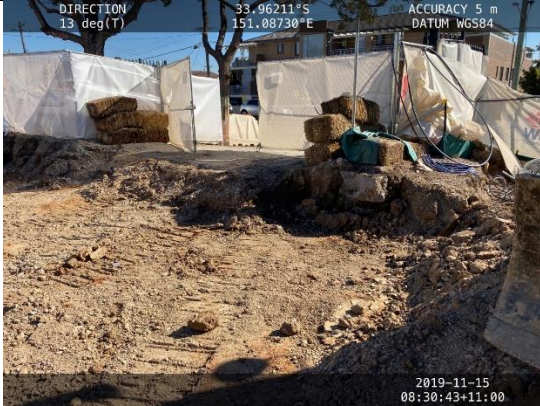
| Date | Notes | Photos |
|---|---|---|
| 15 November 2019 (MMP) | <ul style="list-style-type: none"> <li>• Clearance required following excavation of part of north-eastern driveway.</li> <li>• No fibre cement fragments identified and the area was successfully cleared.</li> <li>• Asbestos clearance certificate issued, Ref: E30104Plet-Clr5, dated 15 November 2019.</li> </ul> | <p>DIRECTION 13 deg (T)      33.96211°S      ACCURACY 5 m<br/>151.08730°E      DATUM WGS84</p> <p>2019-11-15<br/>08:30:43+11:00</p> <p>Photo 51: Area inspected subject to Asbestos Clearance No. 5</p> |

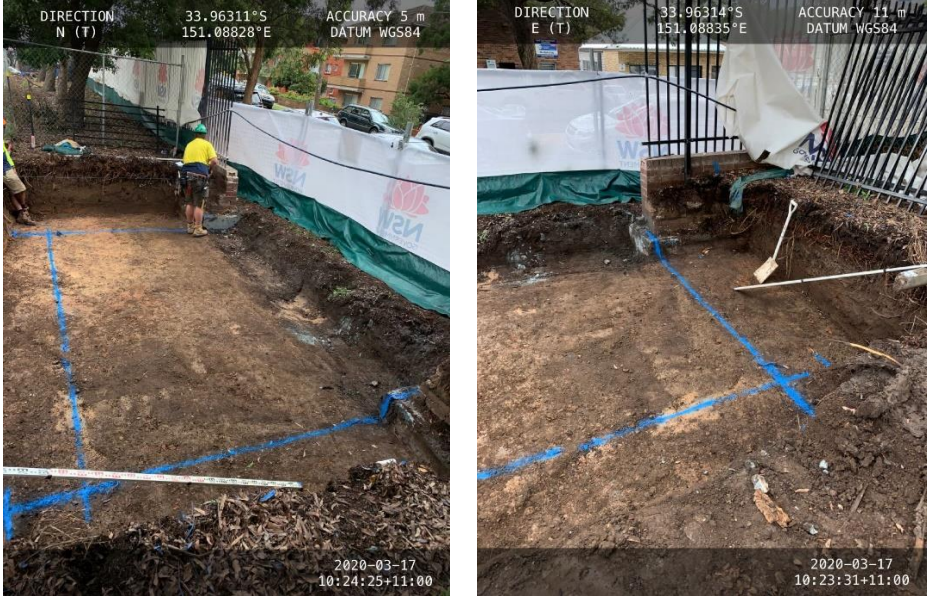
| Date | Notes | Photos |
|---|---|---|
| 17 March 2020<br>(HL) | <ul style="list-style-type: none"> <li>• Clearance required following fill removal from proposed substation kiosk in south-east corner of site.</li> <li>• Natural soil visible across the surface of the excavation.</li> <li>• Fill visible along all excavation walls to depths of 0.1-0.3m</li> <li>• Natural soil visible beneath fill along all excavation walls and beneath brick wall in the south-east and north-east corners (where brick wall still in-situ).</li> <li>• No fibre cement fragments identified and the area was successfully cleared.</li> <li>• Asbestos clearance certificate issued, Ref: E30104Plet-Clr6, dated 17 March 2020.</li> </ul> | <p data-bbox="1182 826 1630 855">Photos 52-53: View of the area inspected</p> |

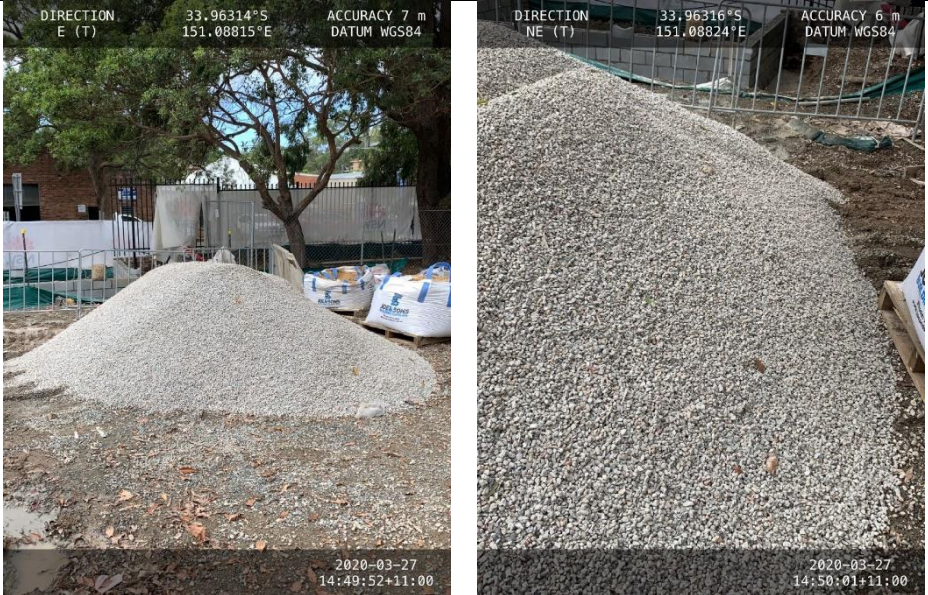
| Date | Notes | Photos |
|---|---|---|
| 27 March 2020<br>(HL) | <ul style="list-style-type: none"> <li>Inspected 10mm aggregate imported to substation kiosk area</li> <li>No indicators of contamination, staining, odours or fibre cement.</li> <li>Material consistent with description and previously imported aggregate.</li> </ul> | <p>Photos 54-55: View of imported 10mm aggregate stockpile</p> |

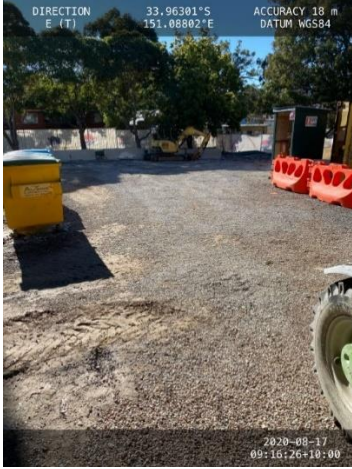
| Date | Notes | Photos |
|---|---|---|
| 18 August 2020<br>(BP) | <ul style="list-style-type: none"> <li>Meeting on site to discuss southern area and remaining validation with Grindley.</li> <li>Southern area full of site sheds, containers and amenities.</li> <li>Driveway area had 10mm quarry gravel and DGB spread over it. No visible asbestos or contamination indicators.</li> <li>Structure was up and well progressed. Landscaping not yet commenced.</li> </ul> | <p>Photo 56: View of southern area and imported gravels/DGB over surface</p> |

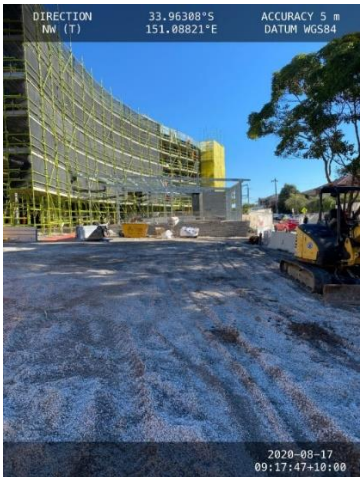
| Date | Notes | Photos |
|---|---|---|
| | | <p>Photos 57: Main building structure</p> |

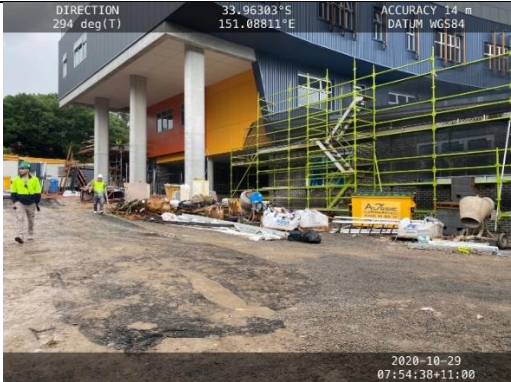
| Date | Notes | Photos |
|---|---|---|
| 29 October 2020 (MMP) | <ul style="list-style-type: none"> <li>Attended site to conducted validation test pitting to the southern area of site and tree protection zones.</li> </ul> | <p>Photo 58: Southern aspect of site.</p> |

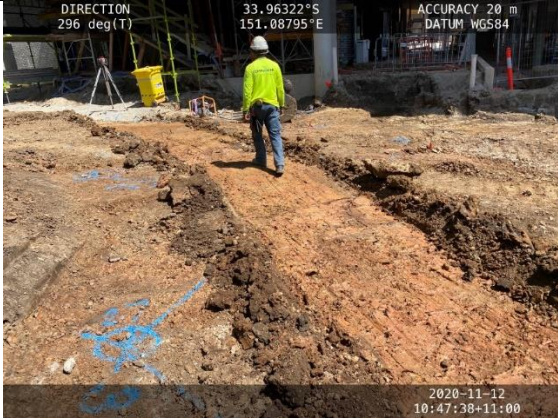
| Date | Notes | Photos |
|---|---|---|
| 12 November 2020 (MMP) | <ul style="list-style-type: none"> <li>Overview and guidance whilst stripping and cutting of fill over swale area is conducted.</li> </ul> | <p>Photo 62: Foot print of swale cut to depth of VENM pre inspection.</p> |

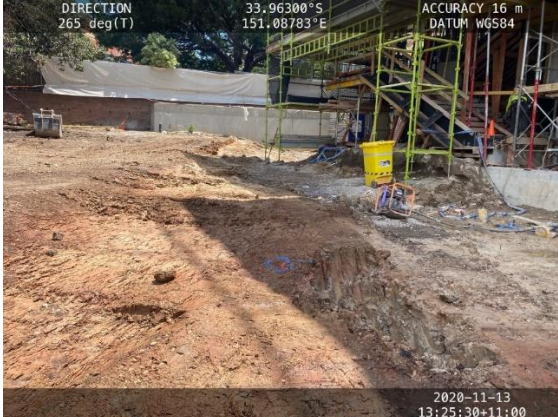
| Date | Notes | Photos |
|---|---|---|
| 13 November 2020 (MMP) | <ul style="list-style-type: none"> <li>Final inspection of swale area following removal of fill material.</li> <li>All fill removed to ground surface of area inspected, ground surface was observed to be natural soil.</li> <li>Asbestos clearance certificate issued, Ref: E30104Plet-Clr9, dated 18 November 2020.</li> </ul> | <p>Photo 63: Foot print of western portion of swale area inspected and cleared.</p> |

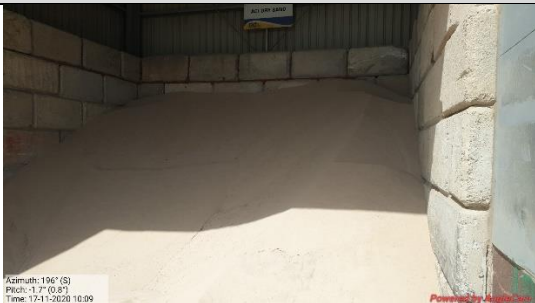
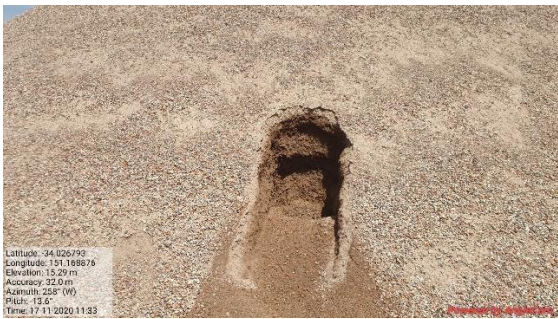
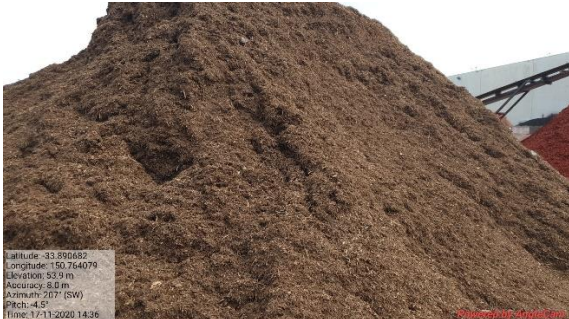
| Date | Notes | Photos |
|---|---|---|
| 17 November 2020 (CR) | <ul style="list-style-type: none"> <li>• Sampling of imported landscaping materials at source facilities.</li> <li>• No indicators of contamination, staining, odours or fibre cement.</li> <li>•</li> </ul> | <p>Photo 64: ACI Dry Sand Kiln Dried – BC Sands Taren Point</p> <p>Photo 65: Enviro Sand – Concrete Recyclers Kurnell</p> <p>Photo 66: Forest Fines – ANL Badgerys Creek</p> |

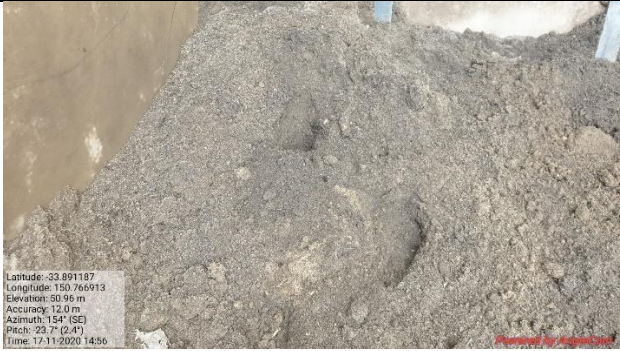
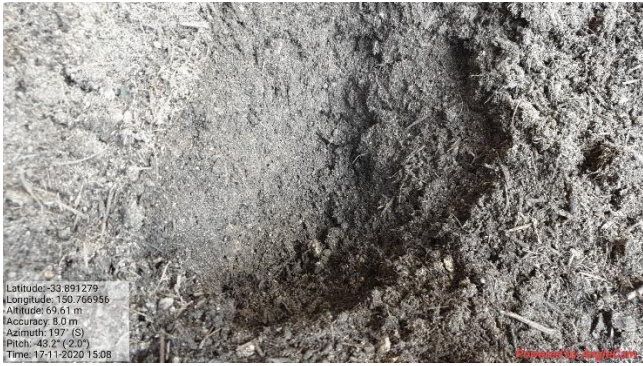
| Date | Notes | Photos |
|---|---|---|
| | | <p>Photo 67: Turf Underlay – ANL Badgerys Creek</p> <p>Photo 68: Organic Garden Mix – ANL Badgerys Creek</p> |

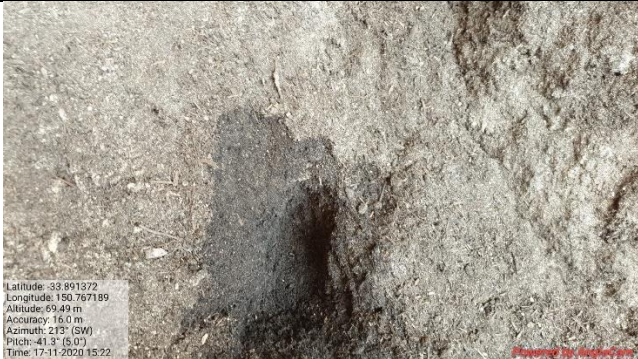
| Date | Notes | Photos |
|---|---|---|
| | | <p>Photo 69: Planter Box Mix – ANL Badgerys Creek</p> |

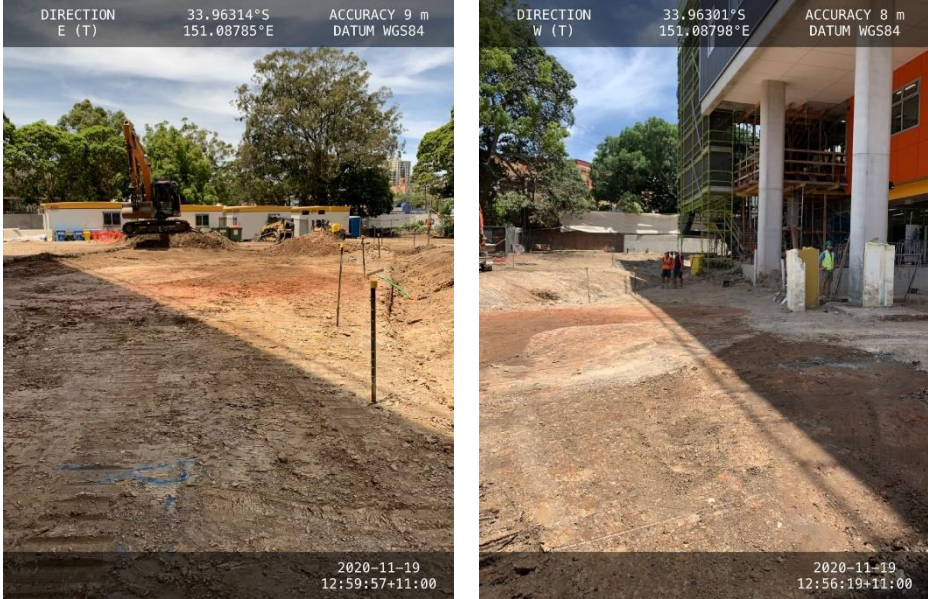
| Date | Notes | Photos |
|---|---|---|
| 19 November 2020 (HL) | <ul style="list-style-type: none"> <li>• Clearance required following minor excavation for area south of the main building and west of the southern driveway;</li> <li>• Fill visible across the base in the northern portion of the area inspected;</li> <li>• Natural soil visible across the southern portion of the area inspected, north of the swale; and</li> <li>• No fibre cement fragments identified and the area was successfully cleared.</li> <li>• Asbestos clearance certificate issued, Ref: E30104Plet-Clr10, dated 20 November 2020.</li> <li>• Visual inspection of a small stockpile of imported topsoil (organic garden mix). Material was consistent with expectations.</li> <li>• No indicators of contamination, staining, odours or fibre cement.</li> </ul> | <p>Photos 70-71: View of the area inspected</p> |
