**REPORT TO**  
**GRINDLEY CONSTRUCTION PTY LTD**

**ON**  
**VALIDATION ASSESSMENT**

**FOR**  
**PROPOSED SCHOOL REDEVELOPMENT**

**AT**  
**PENSHURST PUBLIC SCHOOL,**  
**510 FOREST ROAD, PENSHURST, NSW**

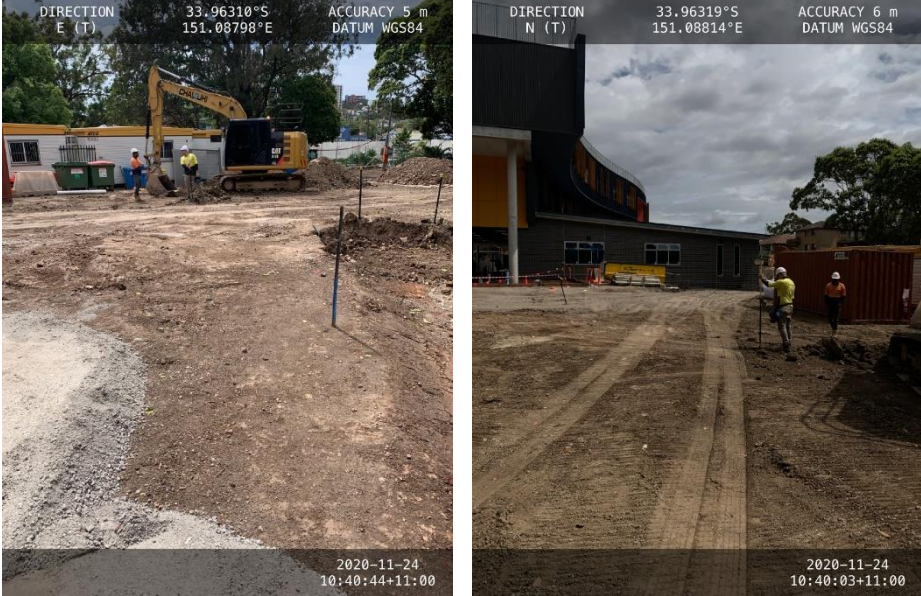
| Date | Notes | Photos |
|---|---|---|
| 24 November 2020 (HL) | <ul style="list-style-type: none"> <li>• Clearance required following minor excavation for area immediately north-east of the swale and small area beneath stair 4.</li> <li>• Natural soil visible across both areas inspected.</li> <li>• No fibre cement fragments identified and the area was successfully cleared.</li> <li>• Asbestos clearance certificate issued, Ref: E30104Plet-Clr11, dated 24 November 2020.</li> <li>• Visual inspection of a small stockpile of imported DGB located adjacent the Northern gate driveway.</li> <li>• Material consisted of igneous gravels, consisted with DGB. No indicators of contamination, staining, odours or fibre cement.</li> </ul> | <p>Photos 74-75: View of the area inspected</p> |

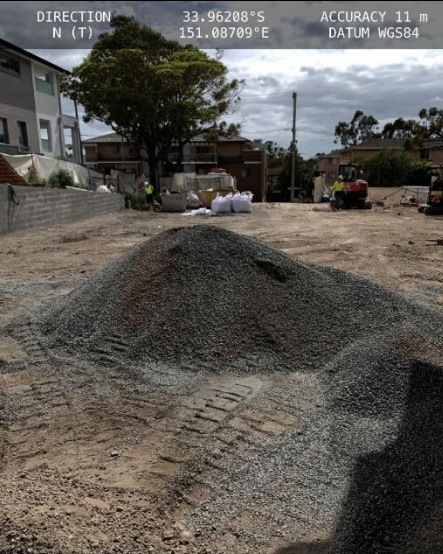
| Date | Notes | Photos |
|---|---|---|
| | | <div data-bbox="1182 212 1637 815"> <p>DIRECTION 33.96205°S ACCURACY 34 m<br/>NW (T) 151.08720°E DATUM WGS84</p> <p>2020-11-24<br/>10:27:41+11:00</p> </div> <div data-bbox="1648 212 2103 815"> <p>DIRECTION 33.96208°S ACCURACY 11 m<br/>N (T) 151.08709°E DATUM WGS84</p> <p>2020-11-24<br/>10:28:01+11:00</p> </div> <p>Photos 76-77: View of the imported DGB</p> |

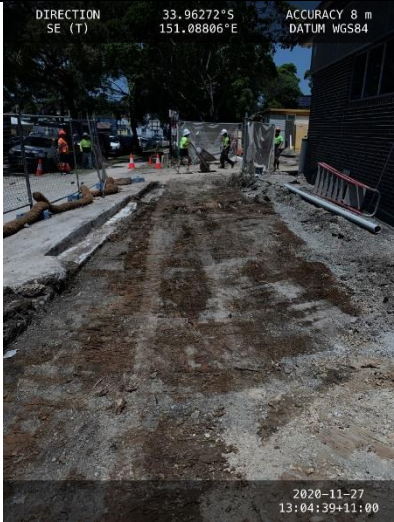
| Date | Notes | Photos |
|---|---|---|
| 27 November 2020 (HL) | <ul style="list-style-type: none"> <li>• Clearance required following minor excavation for area immediately east of the main building. This area had previously been cleared, however an additional clearance was requested due to it's proximity with the entry driveway and overlap with previous clearances.</li> <li>• Natural soil visible across both areas inspected. Some 'fill' also observed, but this was consistent with site-won material.</li> <li>• No fibre cement fragments identified and the area was successfully cleared.</li> <li>• Asbestos clearance certificate issued, Ref: E30104Plet-Clr12, dated 30 November 2020.</li> </ul> | <p>Photo 78: Area inspected, facing south</p> |

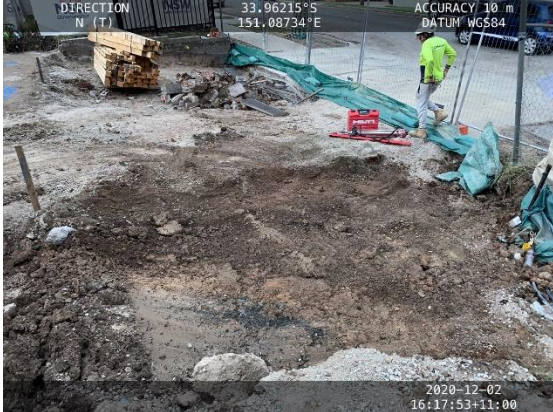
| Date | Notes | Photos |
|---|---|---|
| 2 December 2020 (HL) | <ul style="list-style-type: none"> <li>• Clearance required following minor excavation for the north-east driveway area.</li> <li>• Natural soil visible across the area inspected. Minor amounts of 'fill' also observed.</li> <li>• No fibre cement fragments identified and the area was successfully cleared.</li> <li>• Also completed in-situ asbestos quantification validation location AQAV2 in the driveway.</li> <li>• Asbestos clearance certificate issued, Ref: E30104Plet-Clr13, dated 3 December 2020.</li> </ul> | <p>Photo 79: Area inspected, facing north</p> |

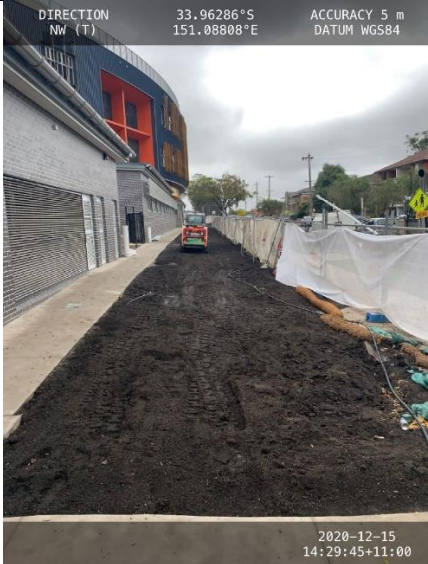
| Date | Notes | Photos |
|---|---|---|
| | | <div data-bbox="1182 213 1608 778"><div>DIRECTION<br/>NW (T)</div><div>33.96286°S<br/>151.08808°E</div><div>ACCURACY 5 m<br/>DATUM WGS84</div><div>2020-12-15<br/>14:29:45+11:00</div></div> <p data-bbox="1182 794 1904 821">Photo 81: Organic garden mix adjacent to Arcadia Street boundary</p> |

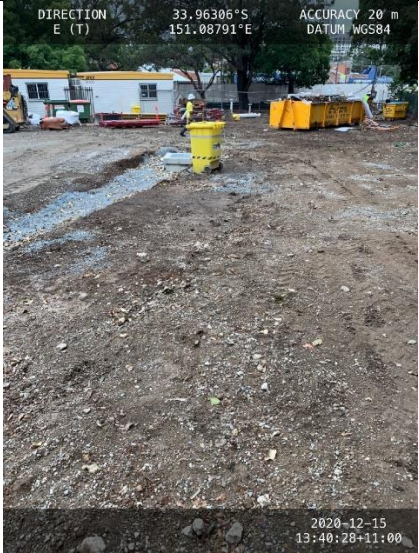
| Date | Notes | Photos |
|---|---|---|
| | | <p>Photo 82: Southern area inspected</p> |

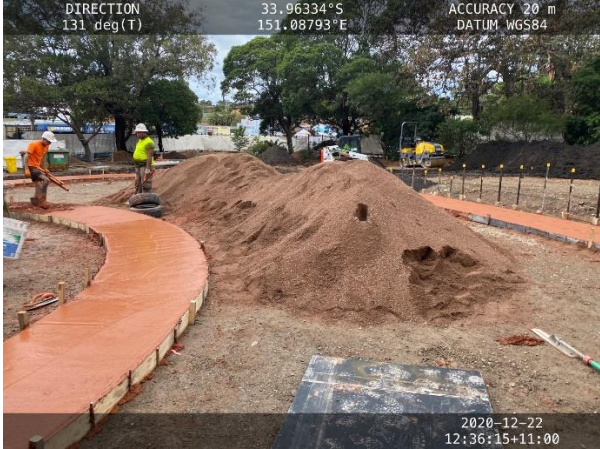
| Date | Notes | Photos |
|---|---|---|
| 22 December 2020 (MMP) | <ul style="list-style-type: none"> <li>• Inspection of Enviro Sand in southern area.</li> <li>• The materials were consistent with expectations and there were no indicators of contamination, staining, odours or fibre cement.</li> </ul> | <p>Photo 83: Enviro sand placed in southern area</p> |

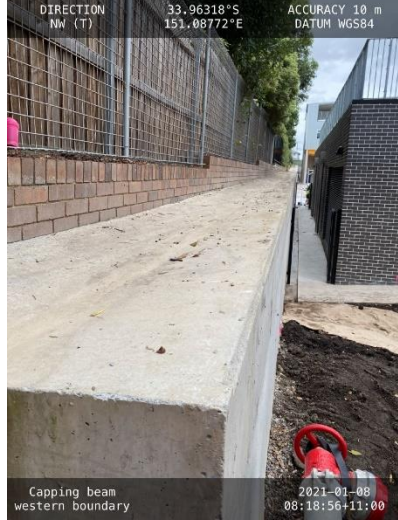
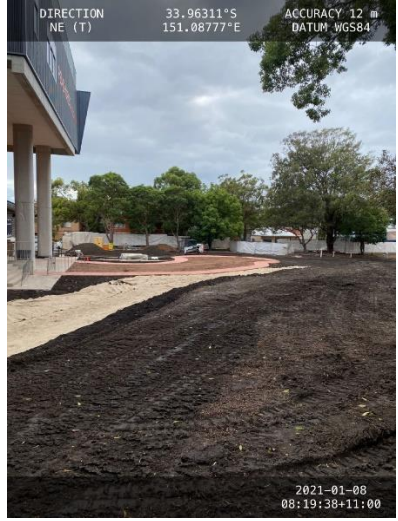
| Date | Notes | Photos |
|---|---|---|
| 8 January 2021<br>(BP) | <ul style="list-style-type: none"> <li>• Final inspection of site prior to issue of site validation report.</li> <li>• Inspected imported materials as listed in the photographs. The materials were consistent with expectations and there were no indicators of contamination, staining, odours or fibre cement.</li> <li>• Check of imported materials thicknesses in southern area/TPZs to confirm placement of &gt;0.1m.</li> </ul> | <p>Photo 84: Capping beam, western boundary</p> <p>Photo 85: Southern area, including turf underlay</p> |

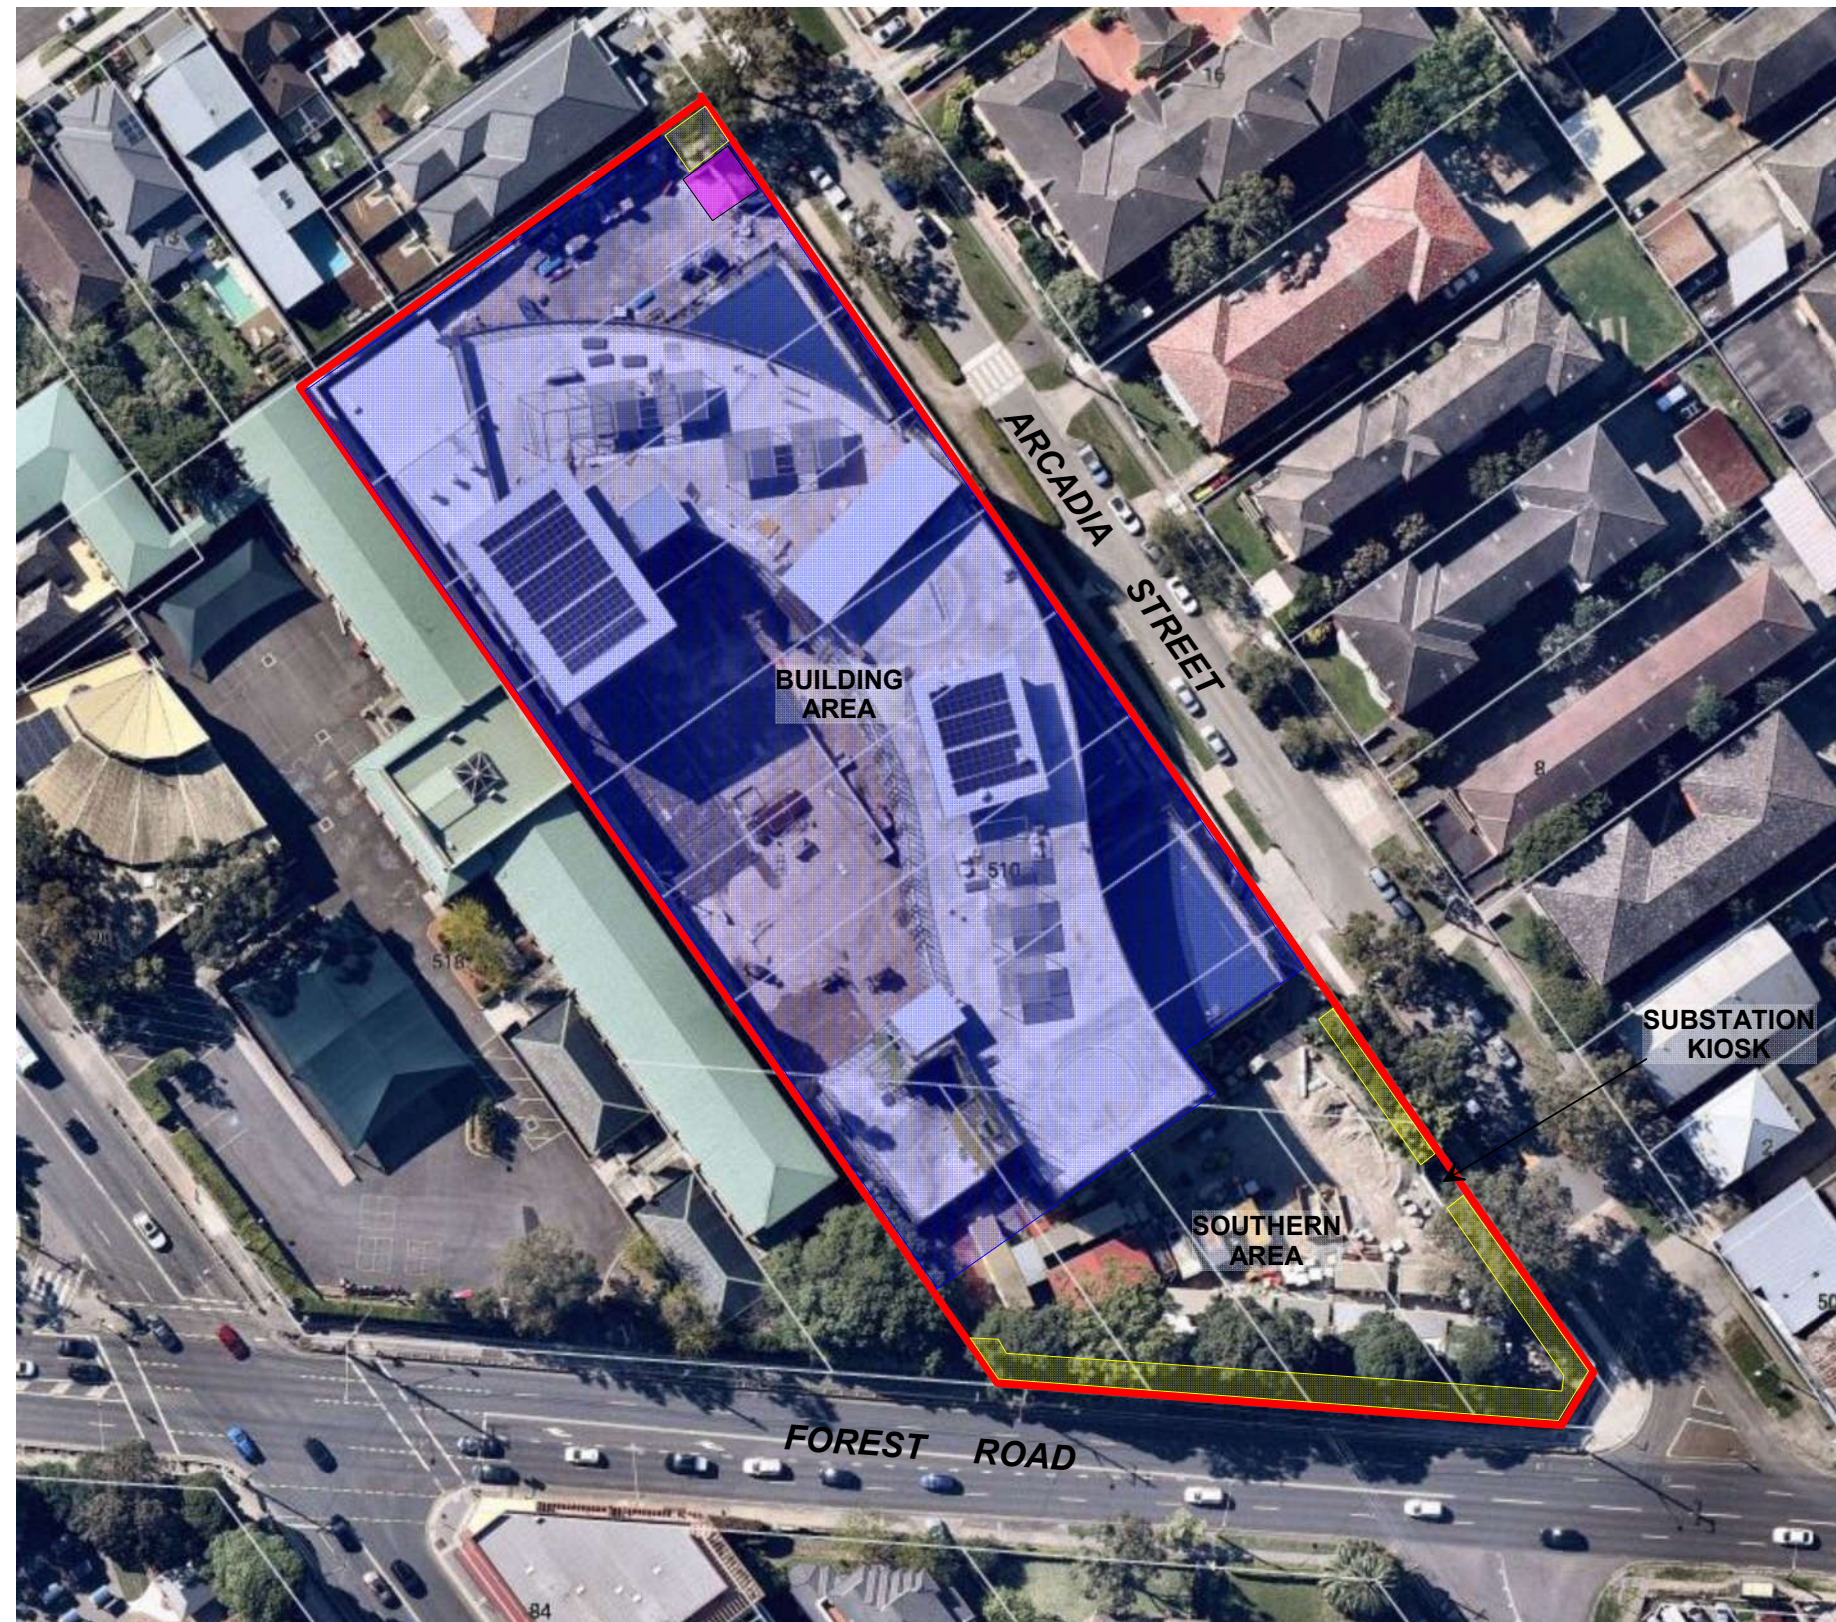
Figure E1

## **Appendix E: Fill Removal from Building Area**

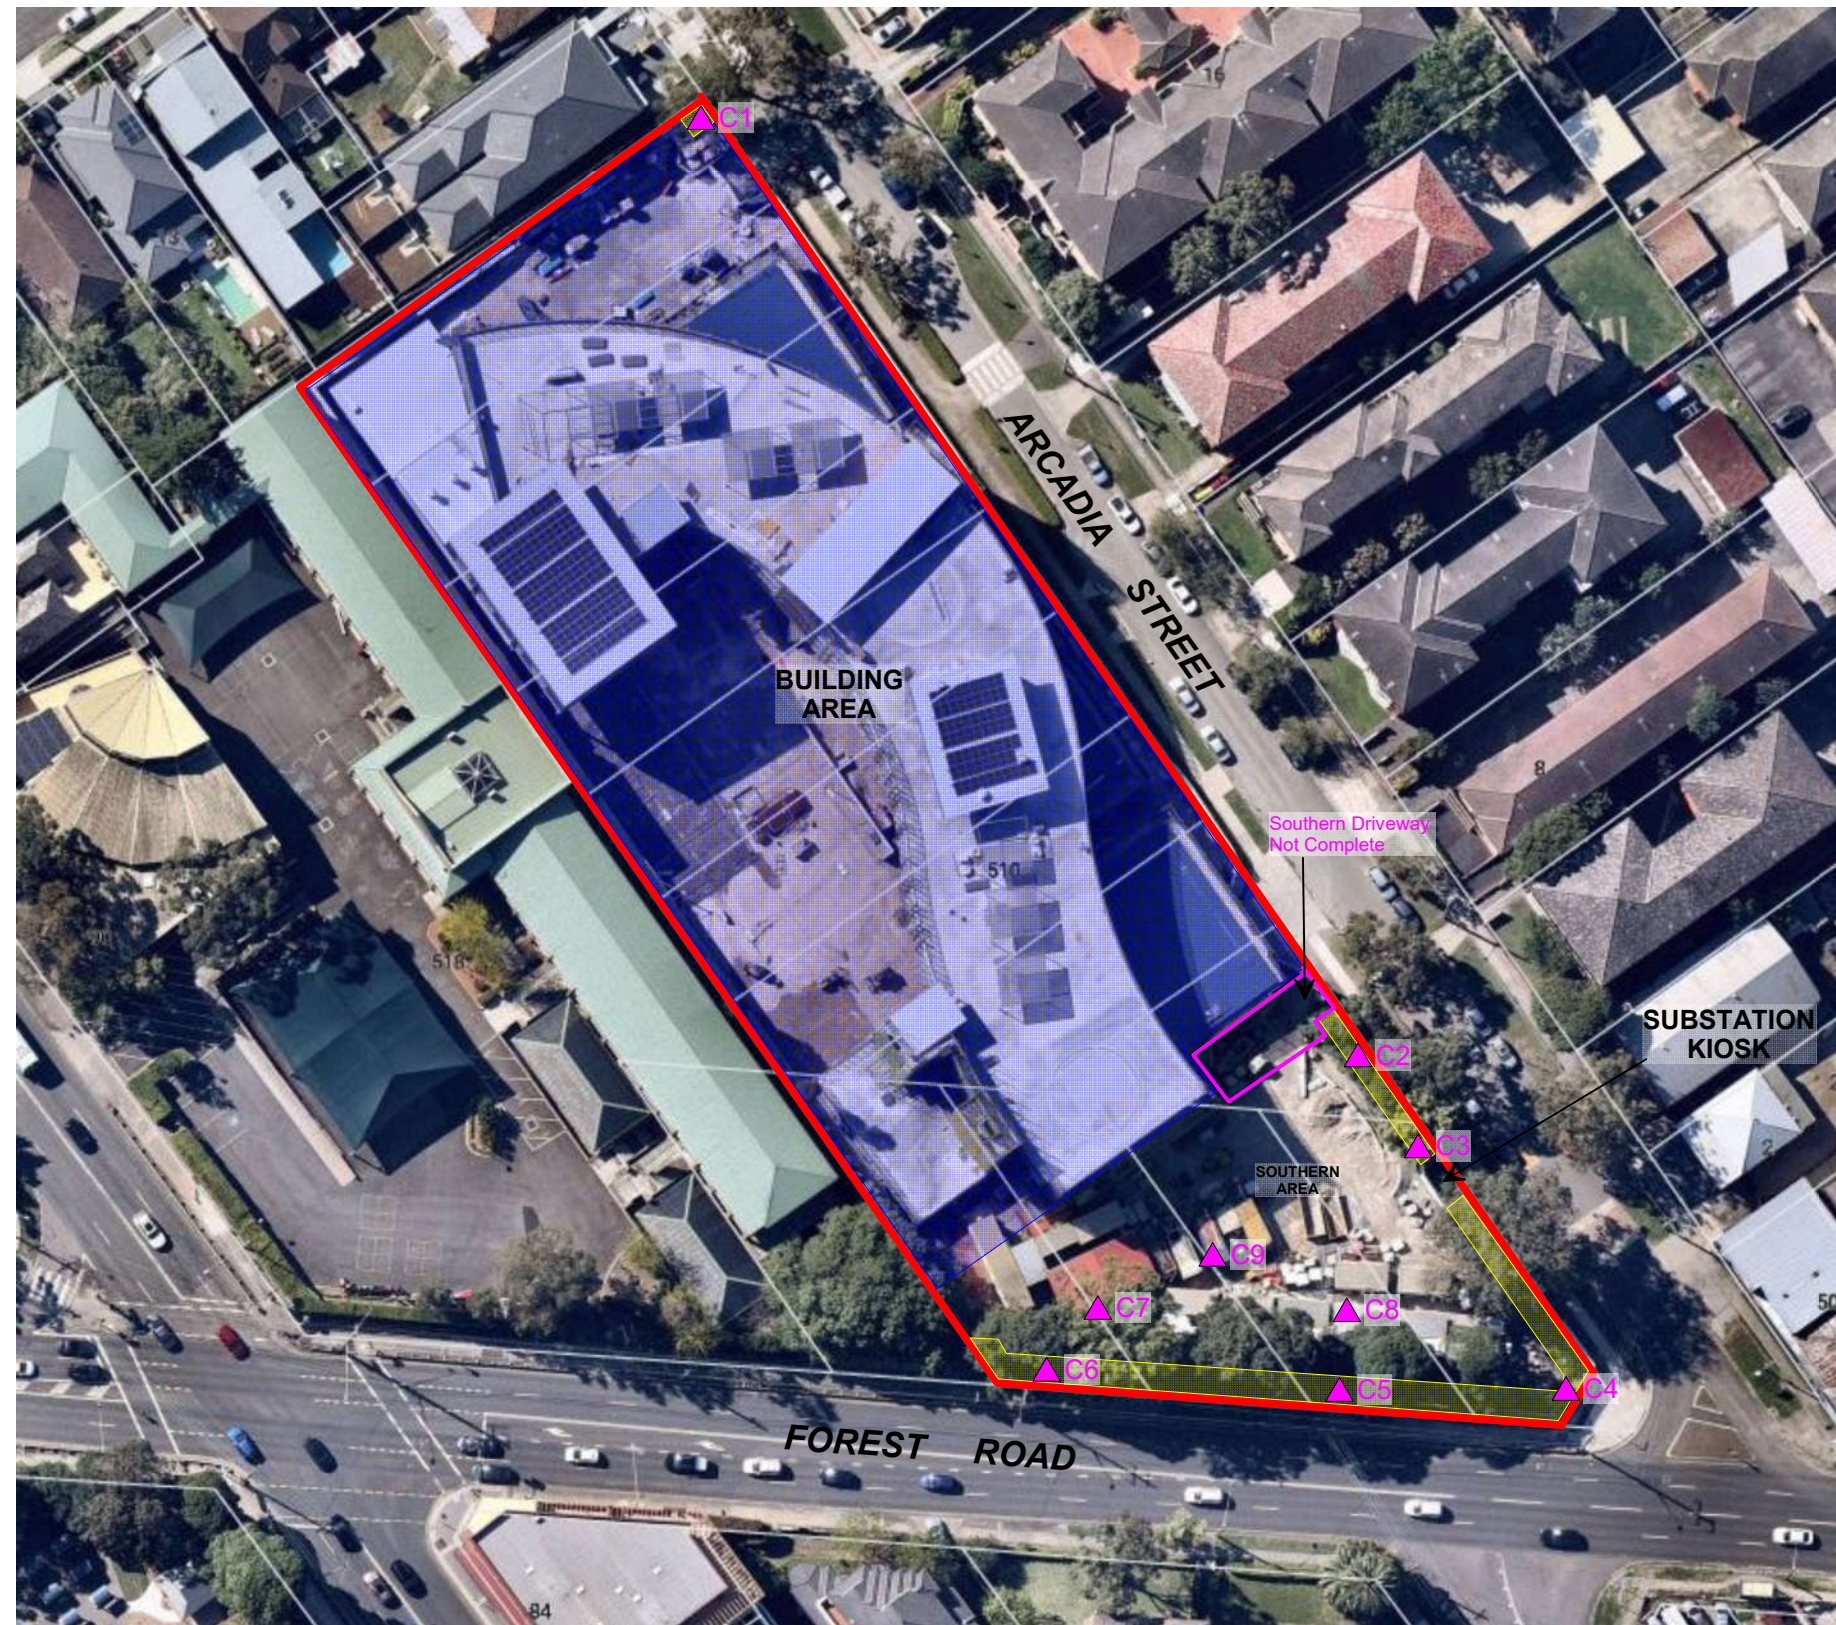
## G1 – Verification Location Plan

- APPROXIMATE SITE BOUNDARY
- APPROXIMATE 'BUILDING AREA'
- APPROXIMATE 'TPZ'
- ▲ C1 VERIFICATION LOCATION FOR MINIMUM 100mm COVER

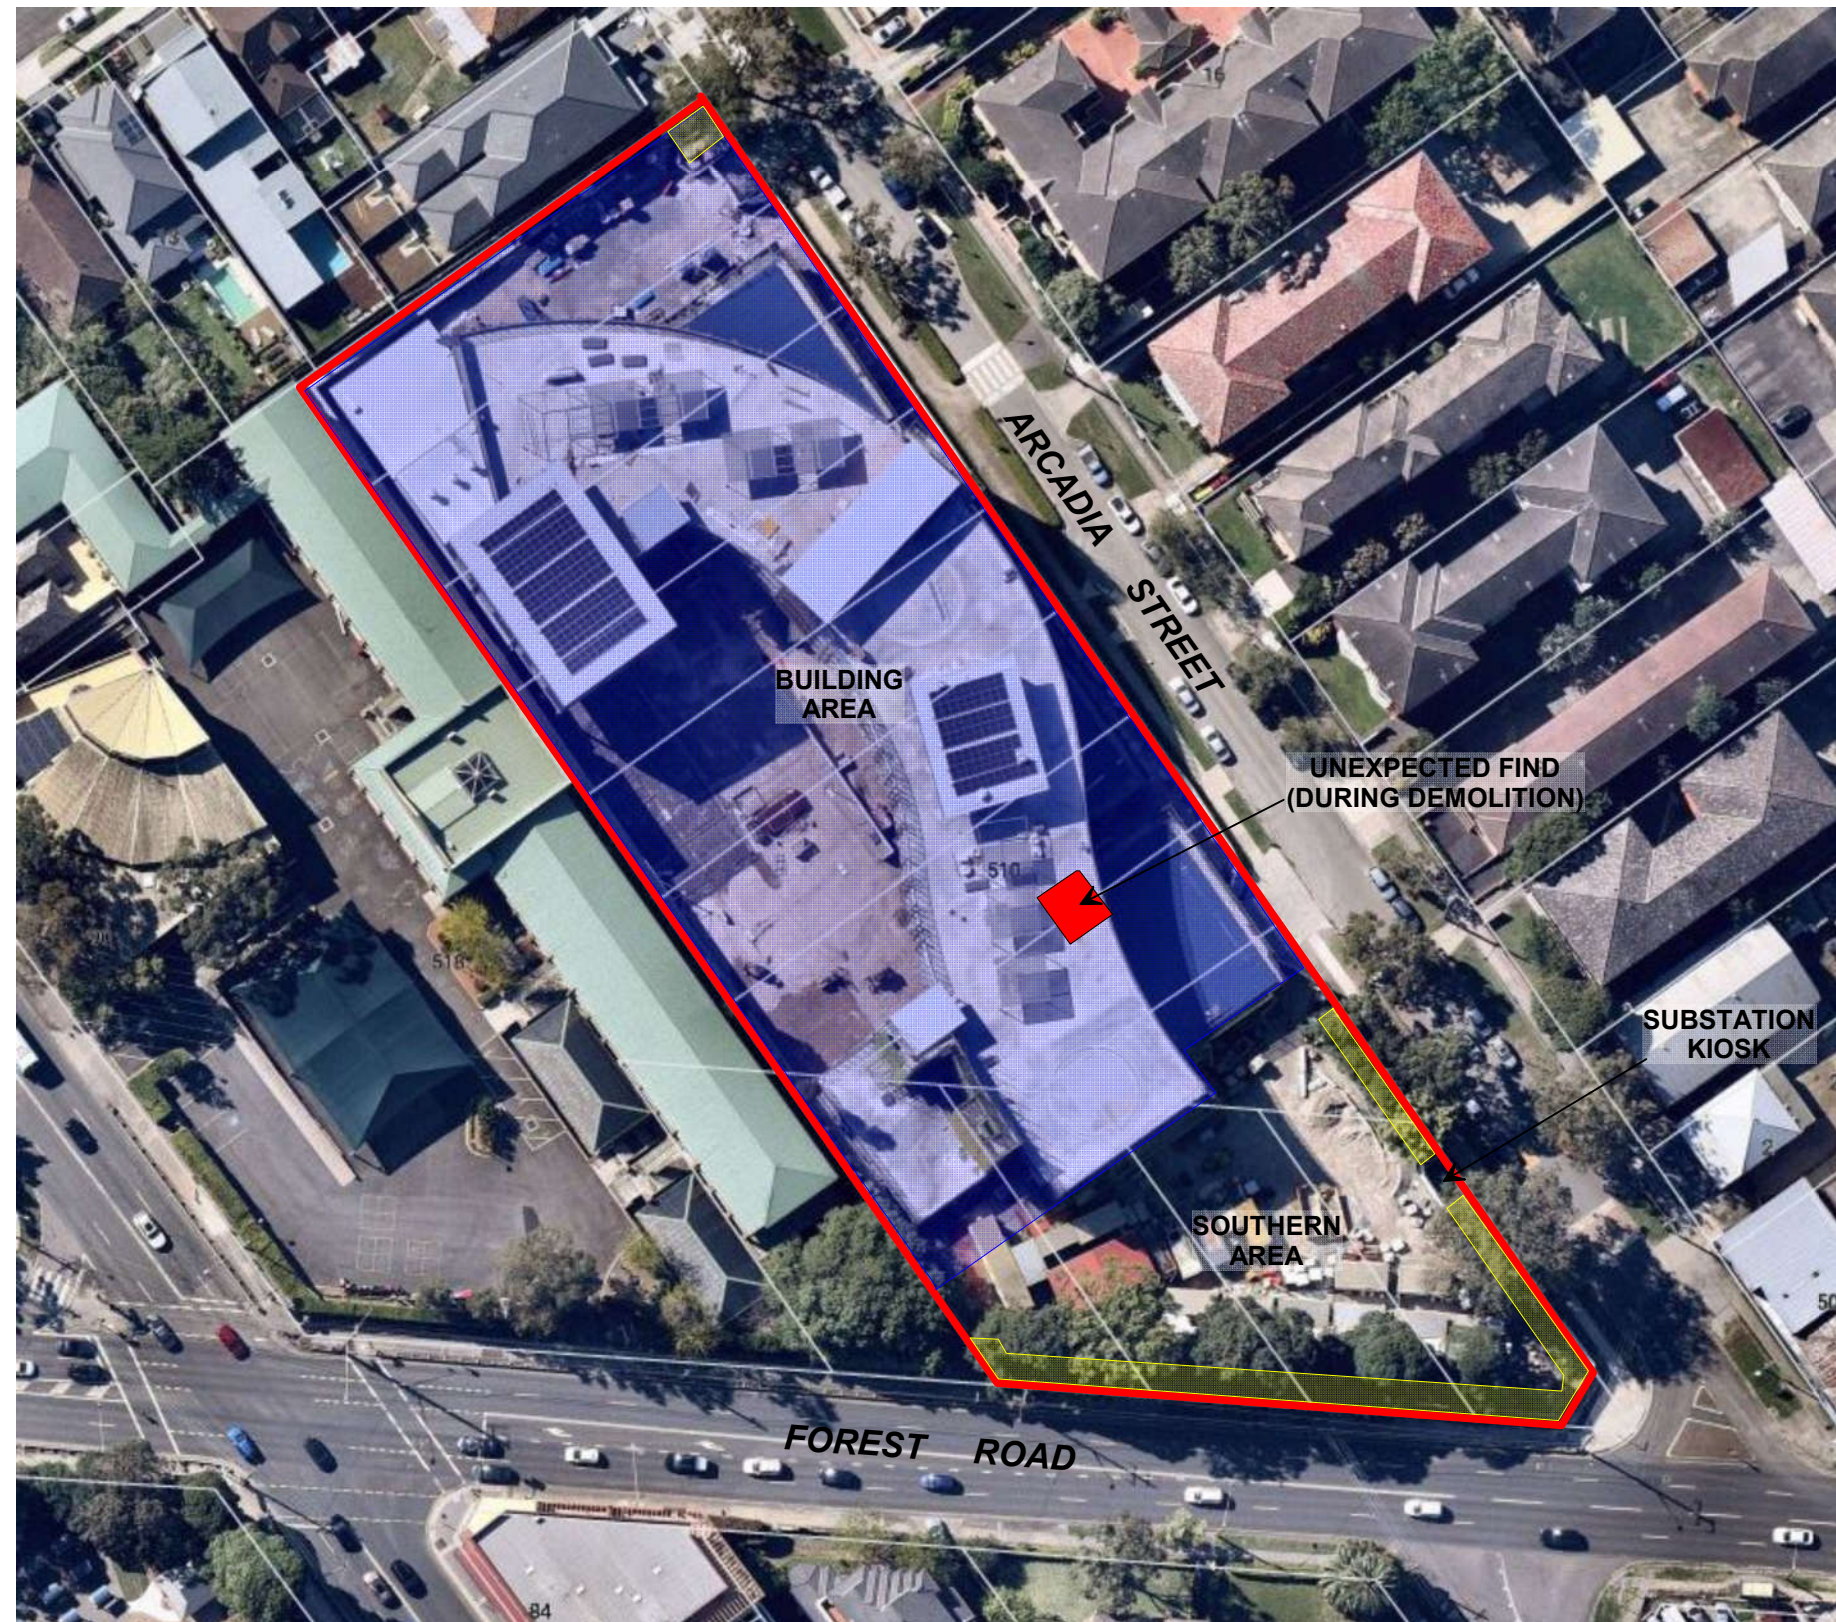
H1 – Figure H1 – Unexpected Find

## **Appendix H: Unexpected Find**

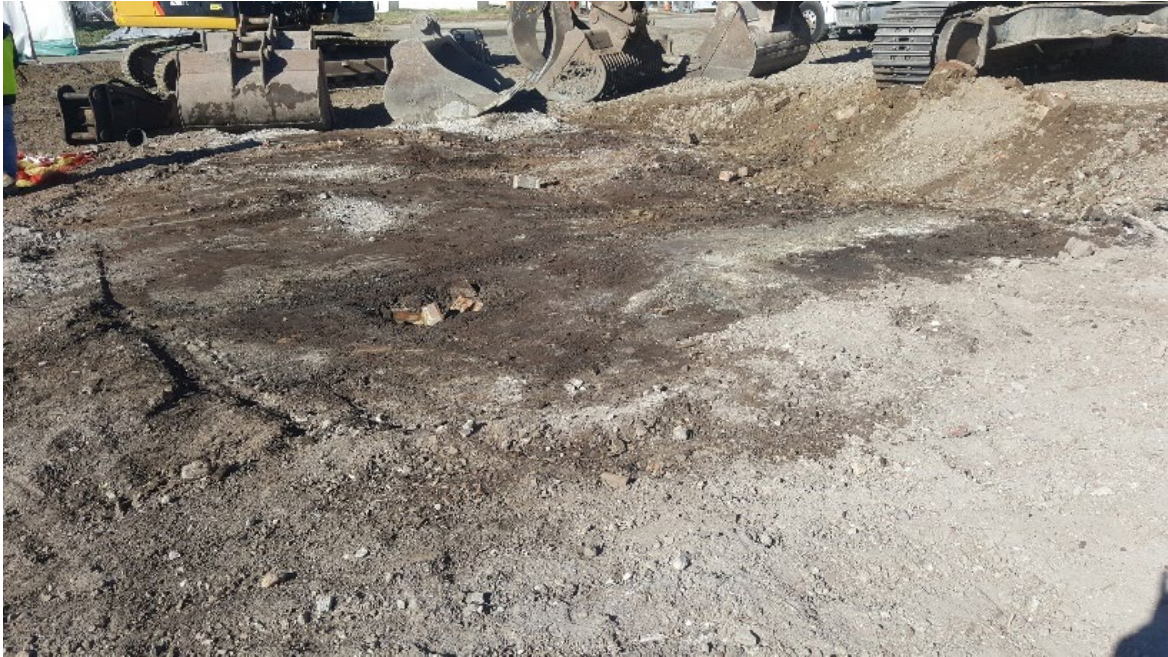
31 May 2019

**Ground area on which soil was located in the Block A area at the Penshurst Public School  
at completion of the visual clearance inspection on 30 May 2019**

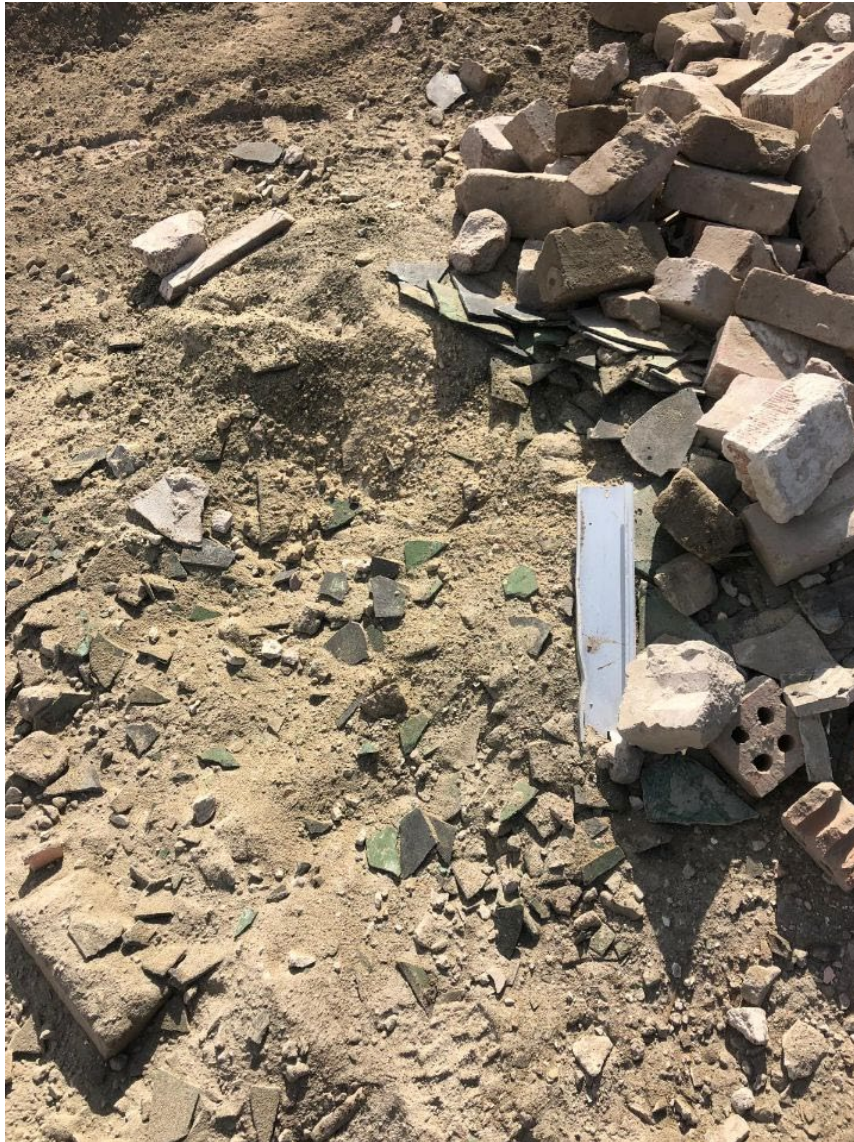
29 May 2019

**Stockpiled fill soil containing asbestos cement sheet debris in the Block A area at the Penshurst Public School, Forest Road, Penshurst NSW on 21 May 2019**
