Report on  
Salinity Investigation and Management Plan

Stage 25, Stage 18B, Entertainment Precinct and the  
Proposed School Site  
The Hermitage Estate, Gledswood Hills

Project 34295.75  
June 2016

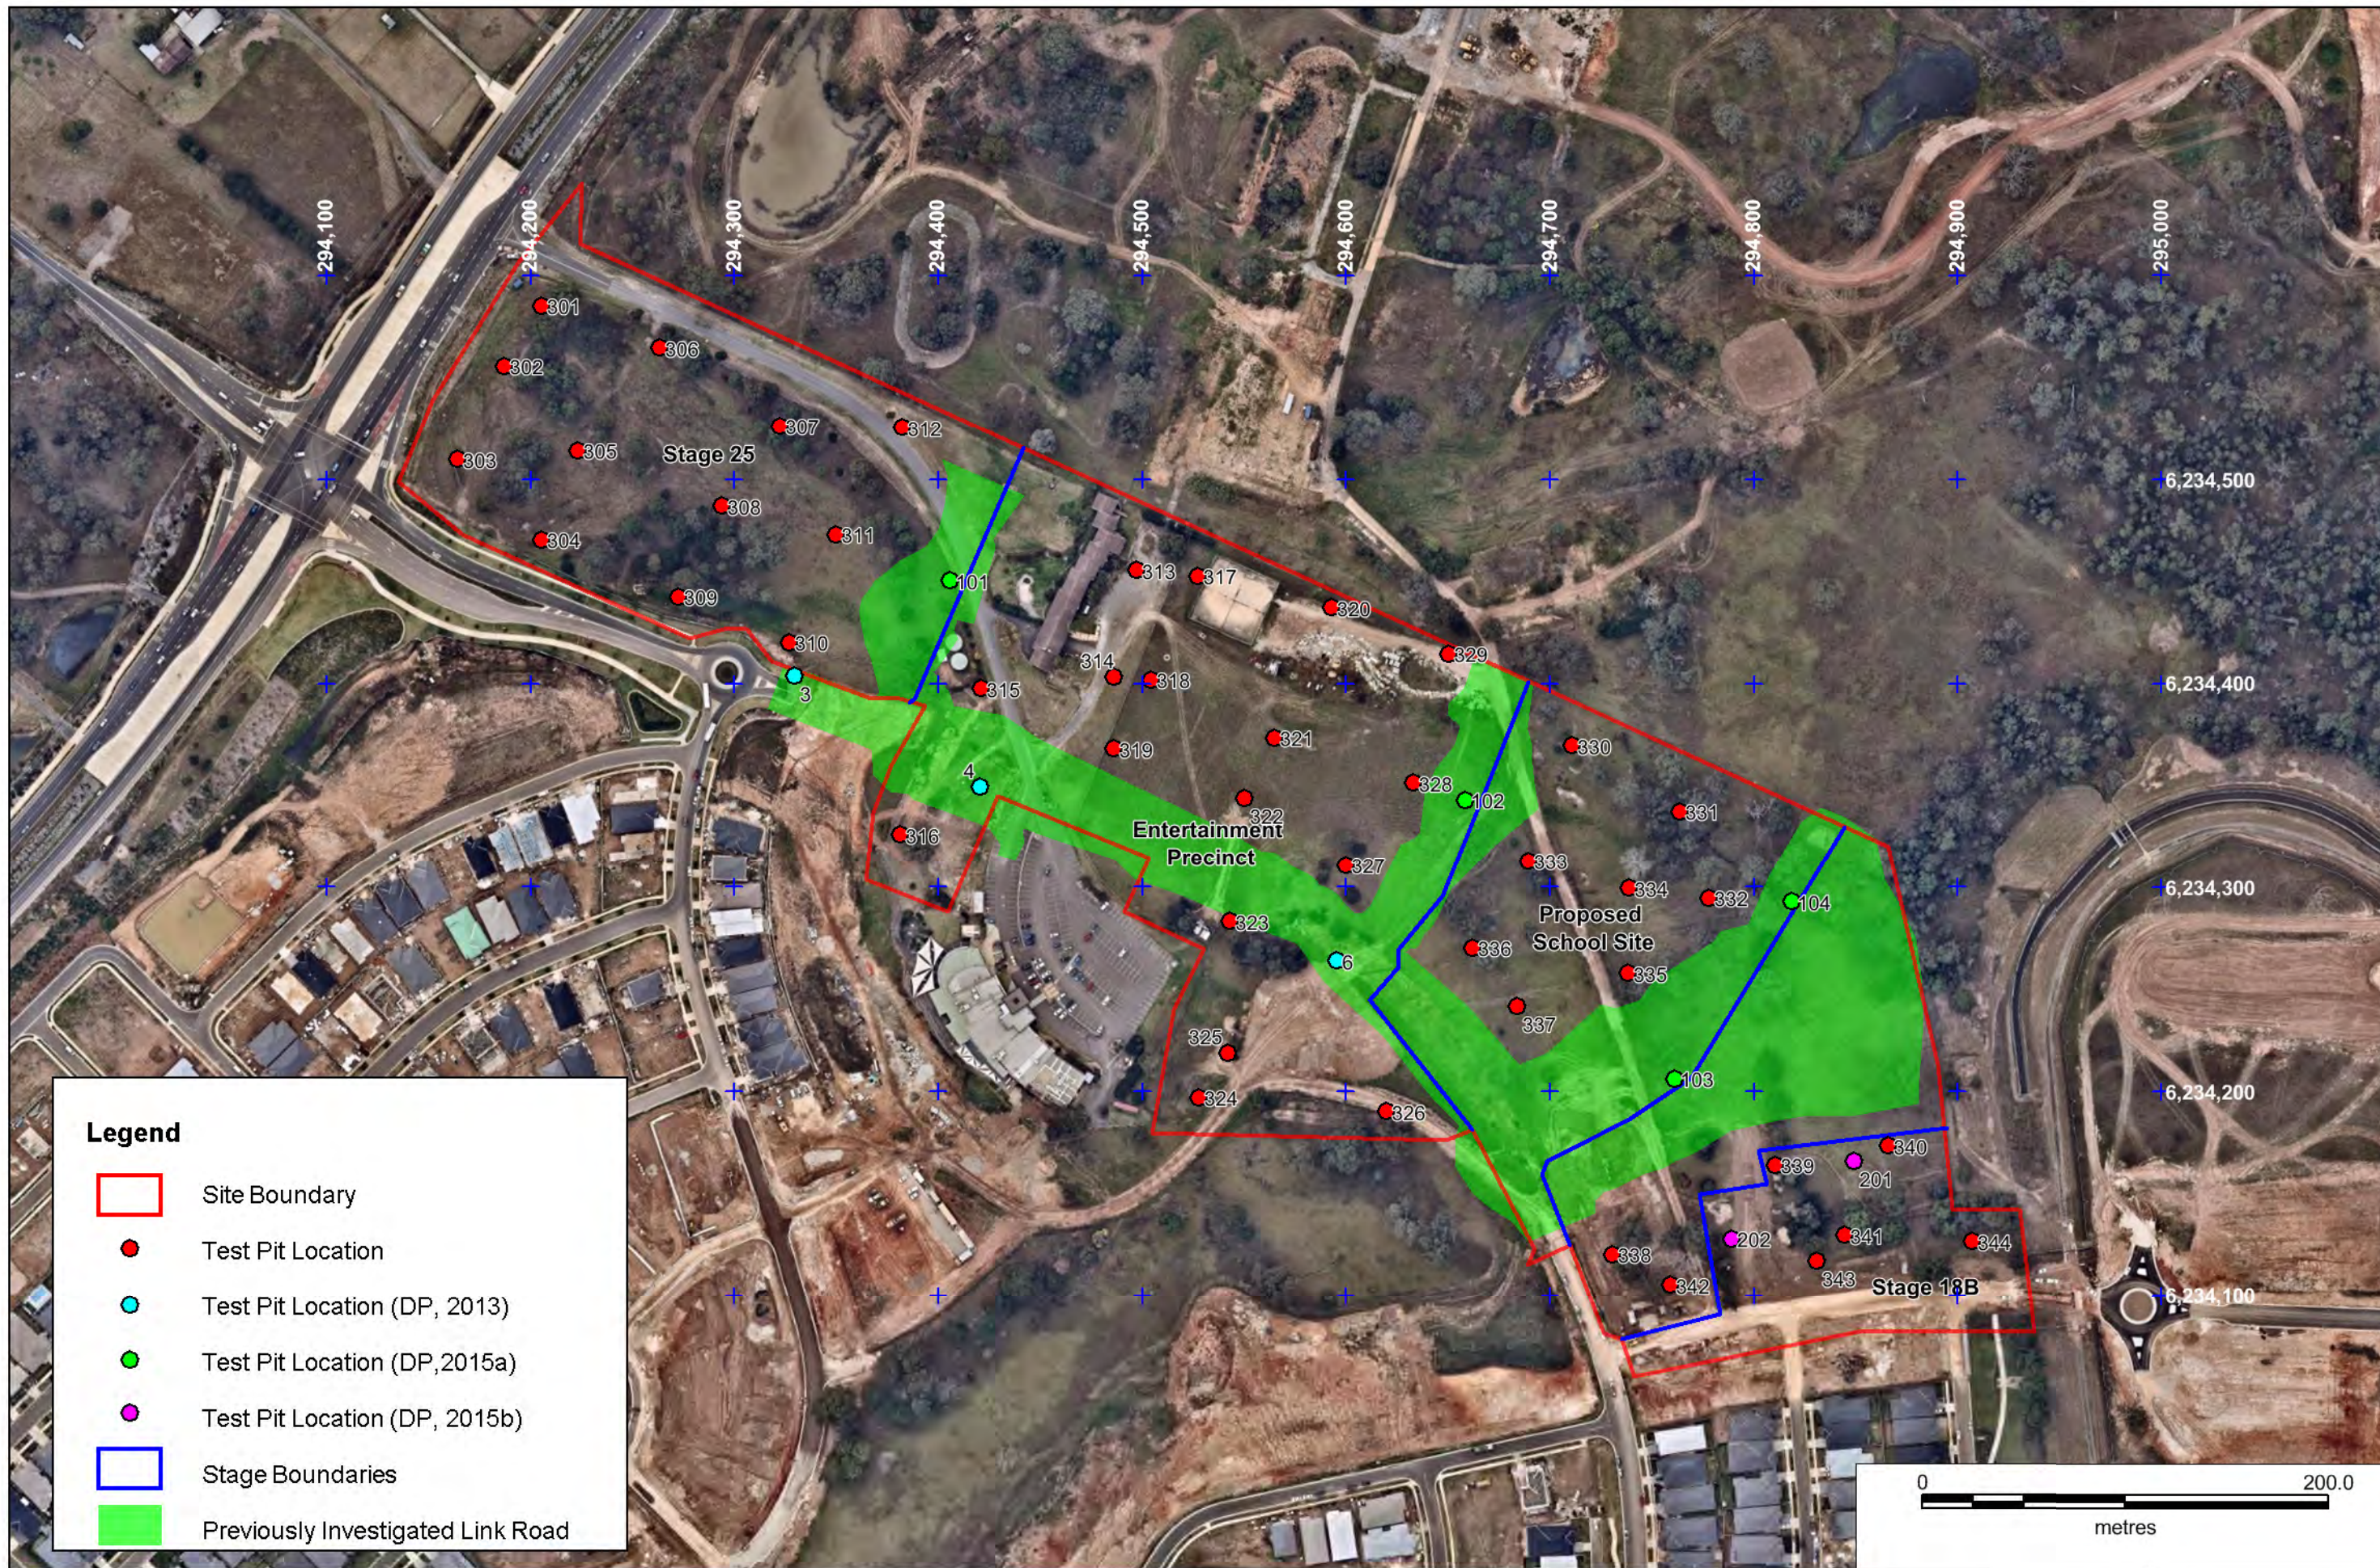
Drawings 1 to 4

The worst case results for each test pit were used to define approximate areas of mild (pH 4.5 – 5.5) aggressivity to concrete foundations and piles, represented by colour zones on Drawing 2 (Appendix B).
