Acid Sulfate Soil Management Plan

Stage 2-4 Bulk Earth Works Development
Application

Former Corrimal Coke Works
27 Railway Street, Corrimal NSW 2518

Project No. 22158
Version 2

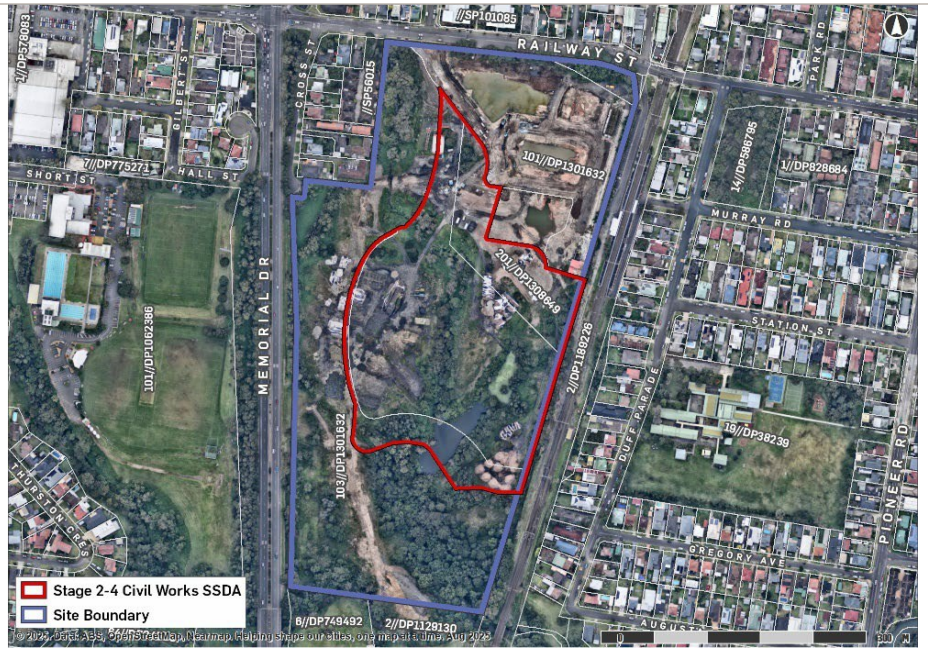
Existing Legal Description	<p>The existing legal property description of the former Corrimal Coke Works site is Lot 101 DP1301632, Lot 201 DP1308649, Lot 202 DP1308649, and Lot 103 DP1301632 (registered titles). The former Corrimal Coke Works site boundary extent is identified in blue below.</p> <p>The proposed works associated with the civil works SSDA extend across Lot 201 DP1308649 (part), Lot 202 DP1308649, and Lot 103 DP1301632 (part).</p> <p>The land to which the civil works SSDA relates is identified in red below.</p>

The area of the land to which the Stage 2-4 Civil Works SSDA relates is 66,226 sqm. This land is identified in the image above in **red**.

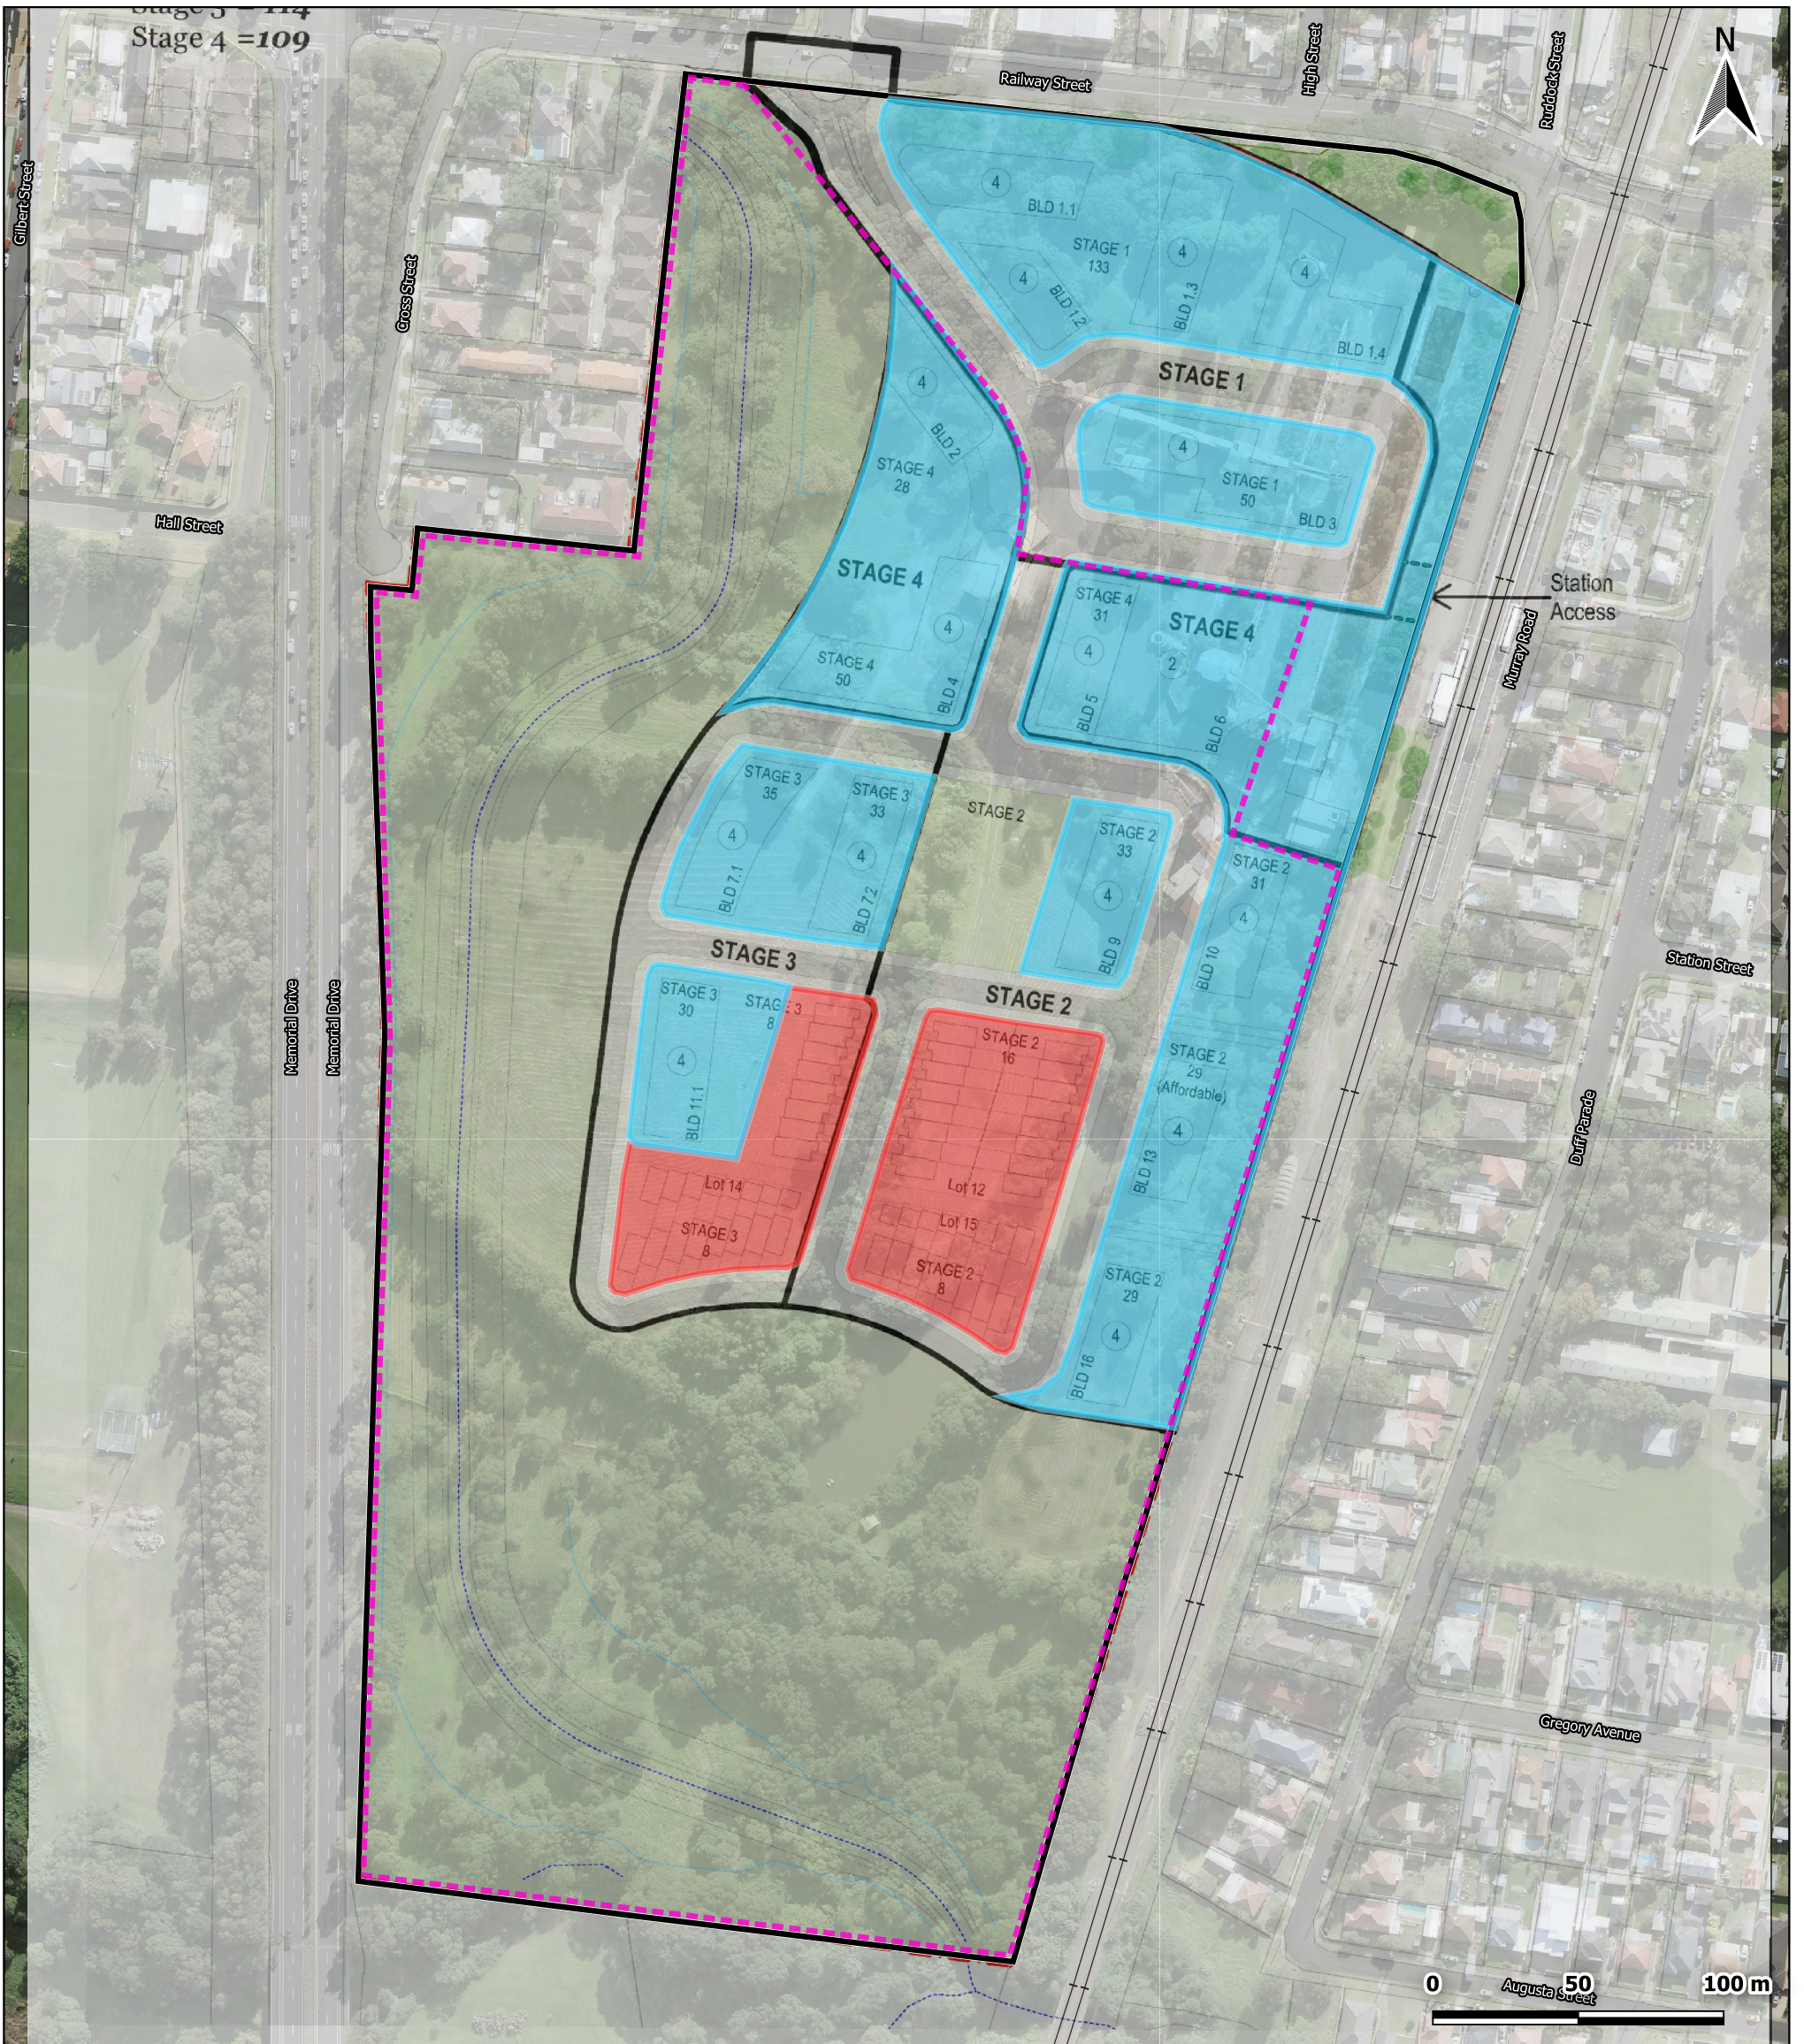
Figure 3 - Land Uses & Redevelopment Staging
 Former Corrimal Coke Works, Railway Street, Corrimal, NSW
 22158 - Acid Sulfate Soil Management Plan
 LegPro 70 Pty Ltd ATF LegPro 70 Unit Trust c/- Legacy Property Pty Ltd

Legend	
	Site Boundary
	Stage 2 Boundary
	High-Density Residential Land Use Area
	Low-Density Residential Land Use Area
*Unshaded areas outside low- and high-density residential land use classified as "Recreational and Public Open Space" land
