## Additional Geotechnical Investigation

45-53 Macleay Street, Potts Point, NSW

Report No: E26863.G04\_Rev2

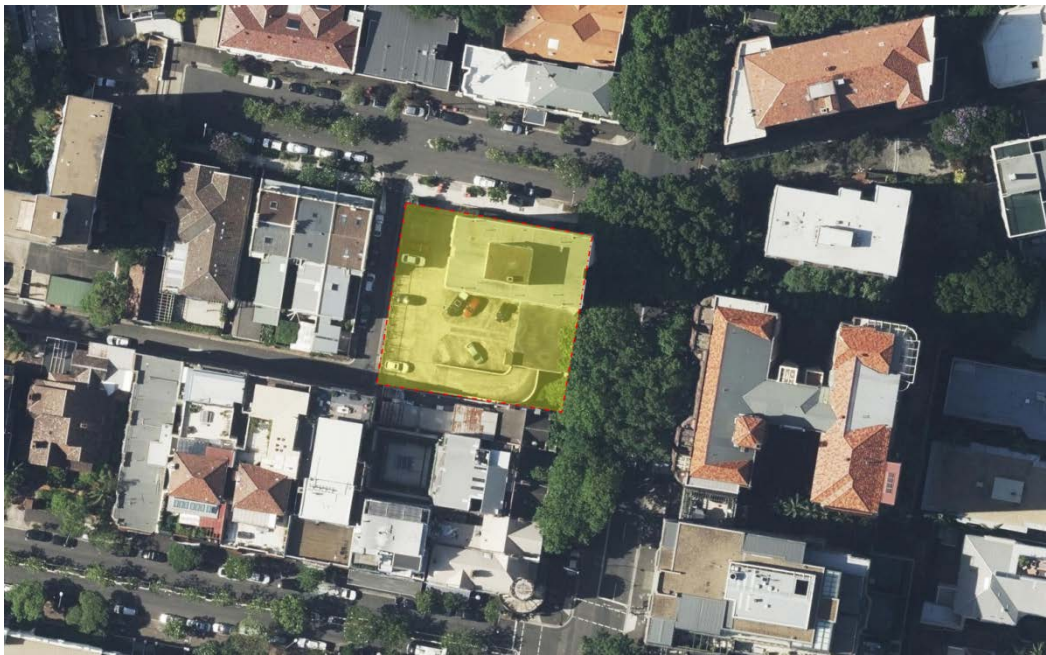
**Plate 1**      Aerial photograph of the site (source: Sixmap, accessed on 11 Sep. 2025)

A twelve-storey apartment building of brick and concrete construction occupied the north-eastern corner of the site. The remainder of the site comprised a concrete paved car park and the ground floor parking level extended under the apartment building. The first floor of the building also comprised a parking level and the upper parking level extended south from the south-eastern side of the apartment building. The upper parking level is accessible via a concrete ramp which lined the southern site boundary. Due to the gentle grade across the site, the at-ground level car park accessed off McDonald Street is elevated above the McDonald Street and the McDonald Lane level, retained by low brick retaining wall along the McDonald Lane frontage.

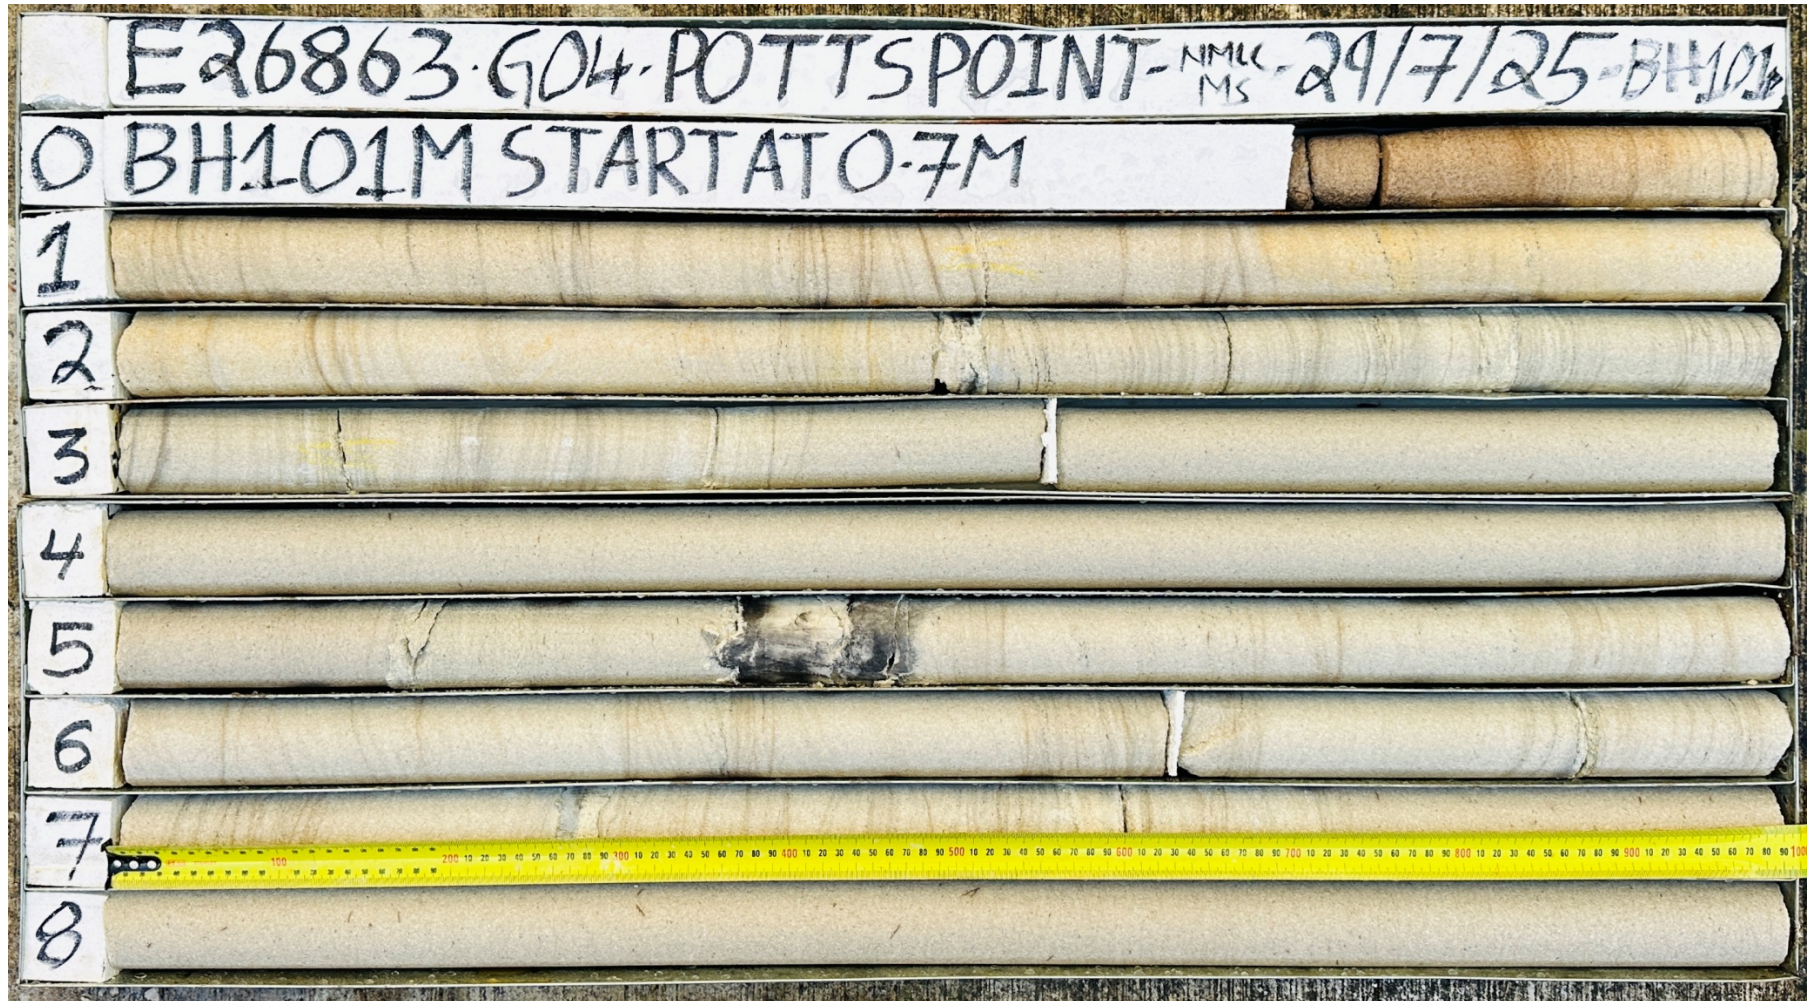
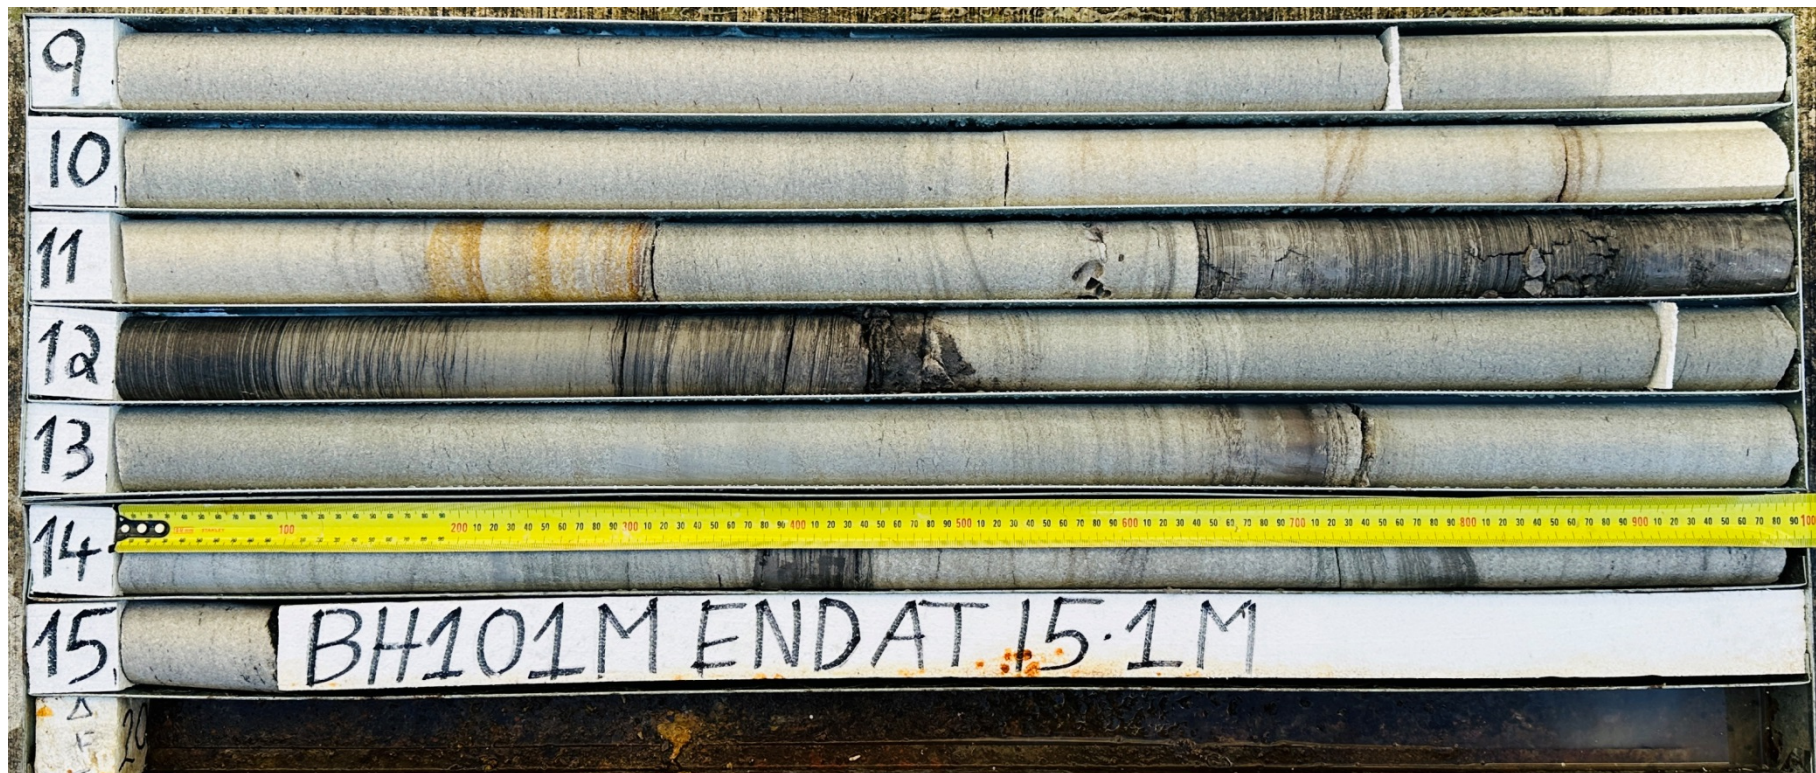
## CORE PHOTOGRAPH OF BOREHOLE: BH101M

| <b>Project</b> | Proposed Development | <b>East</b> | 335869.2 | <b>Depth Range</b> | 0.7m to 15.10m | | |

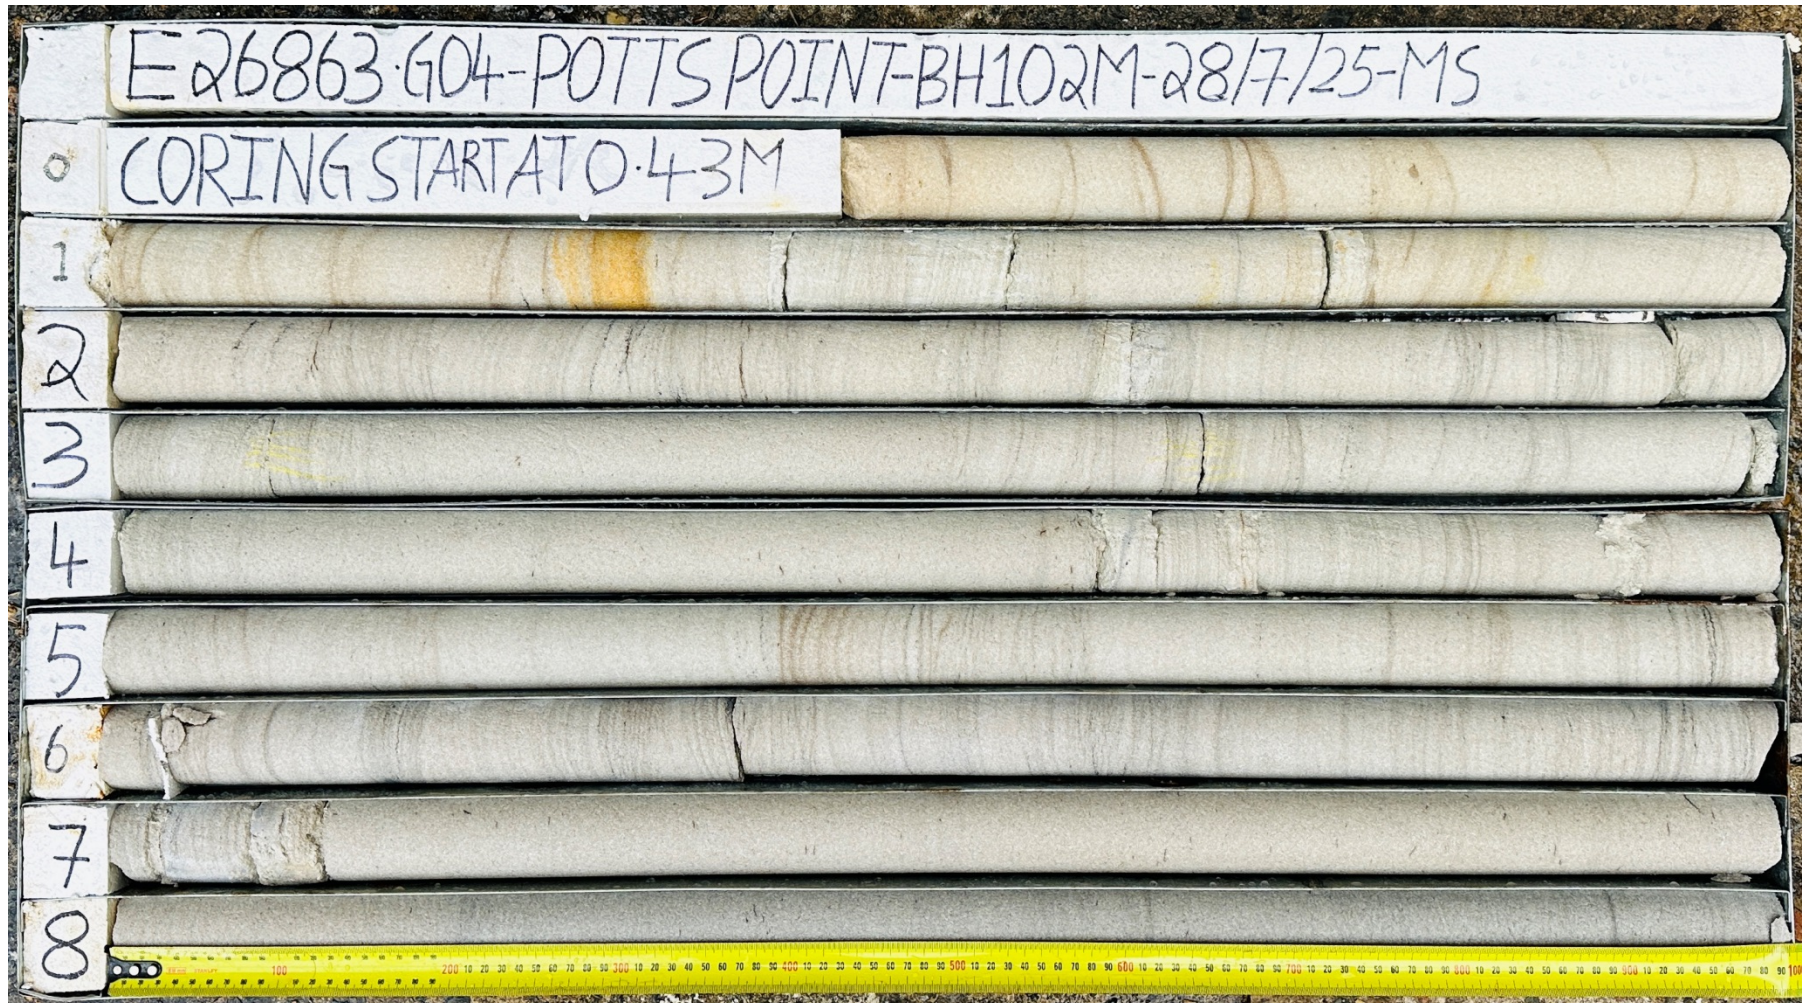
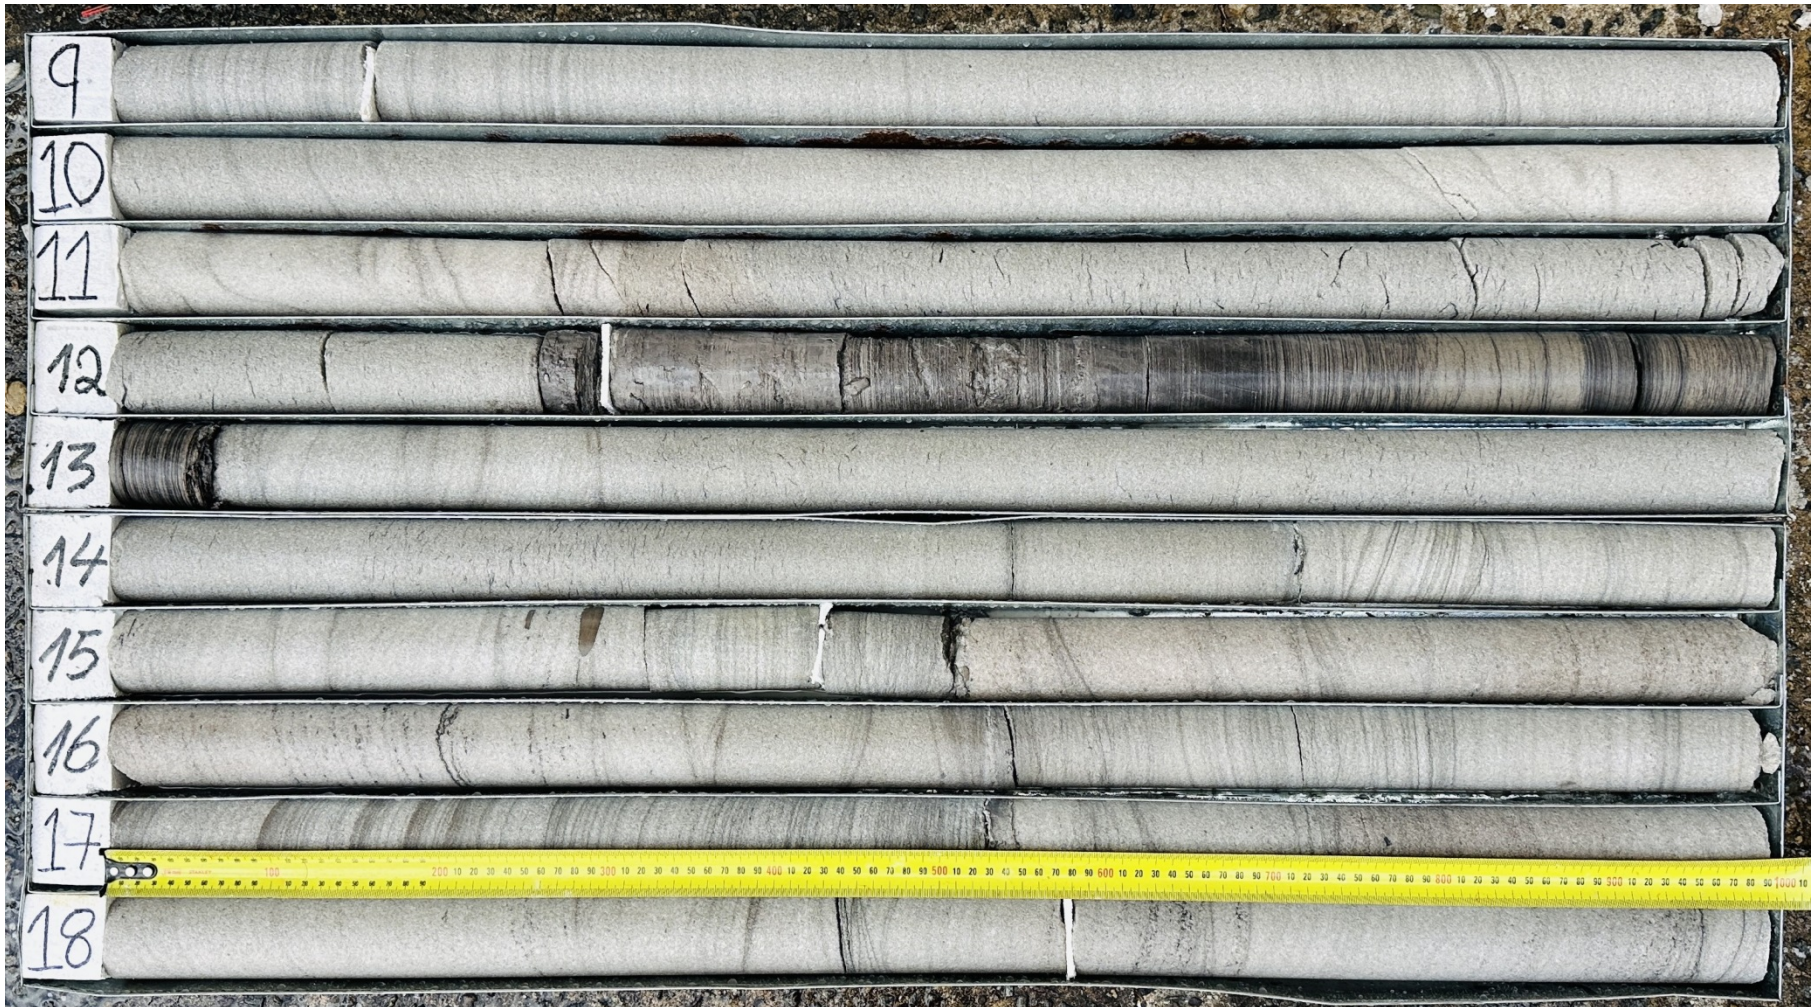
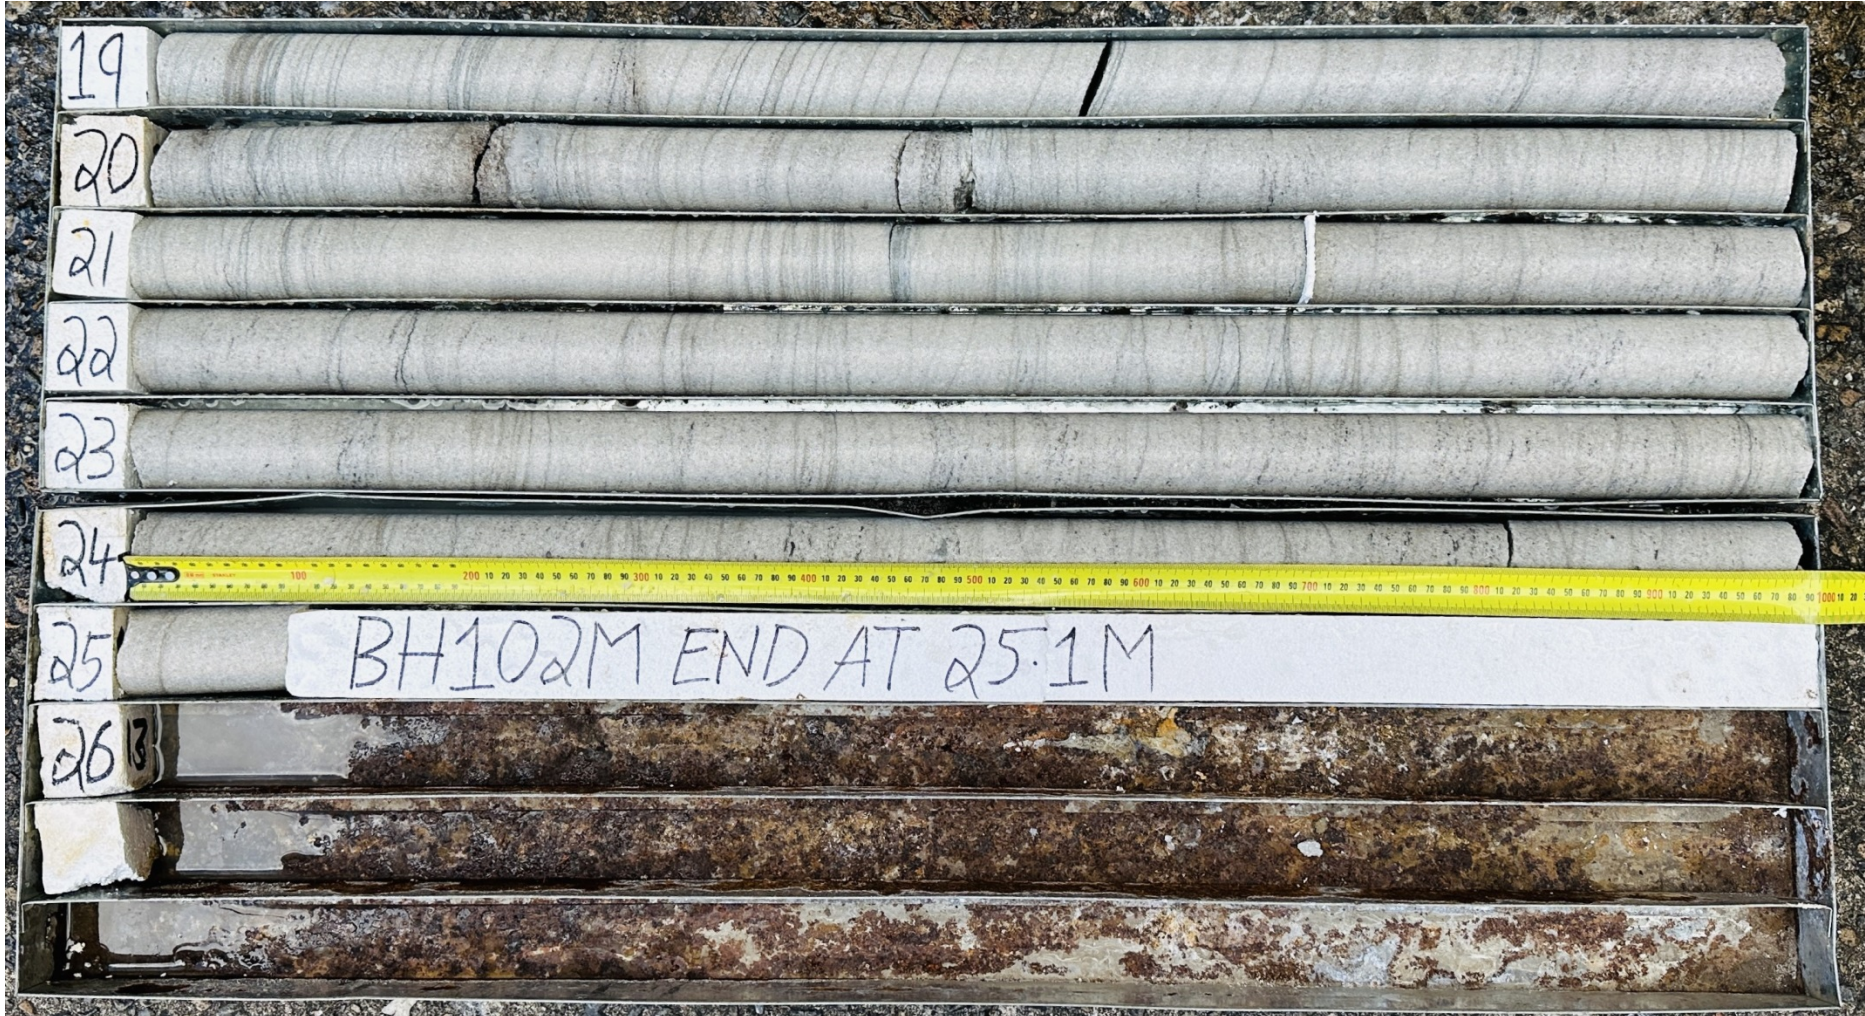
## CORE PHOTOGRAPH OF BOREHOLE: BH102M

| <b>Project</b> | Proposed Development | <b>East</b> | 335869.2 | <b>Depth Range</b> | 0.7m to 15.10m | |

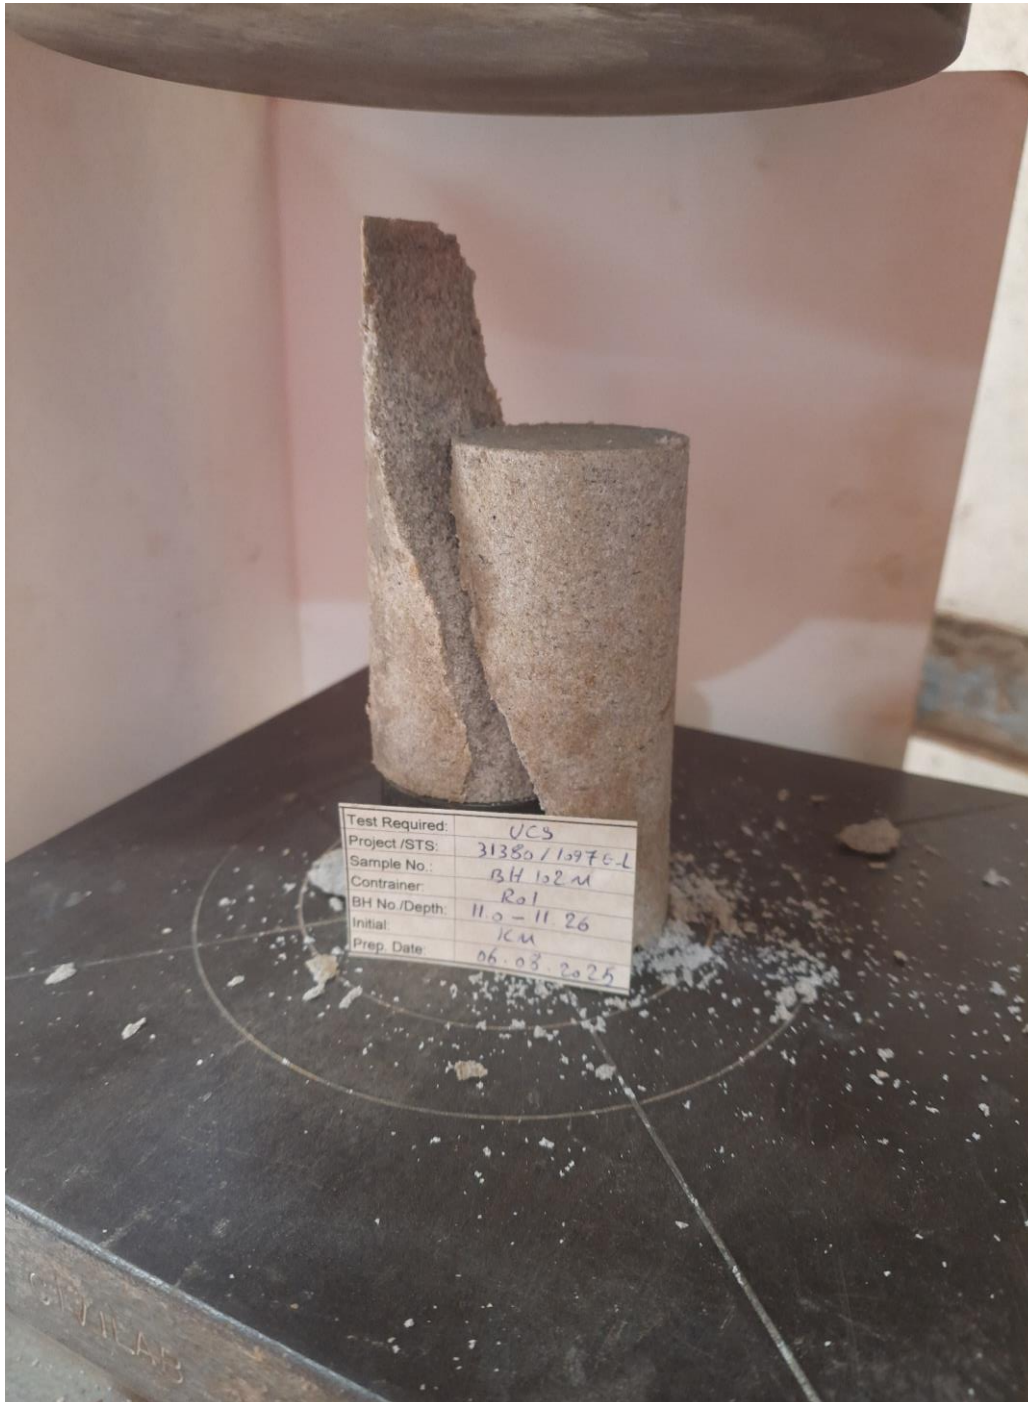
**BH102M (11.0- 11.26)m**

*Unconfined Compressive Strength of Rock Cores*
