# GEOTECHNICAL DESKTOP STUDY

Project Title – 15a, 15b Moseley Street & 25-31 Donald Street, Carlingford

Project Type – Proposed Multi-Use Development

Project No. – GR25162-1A

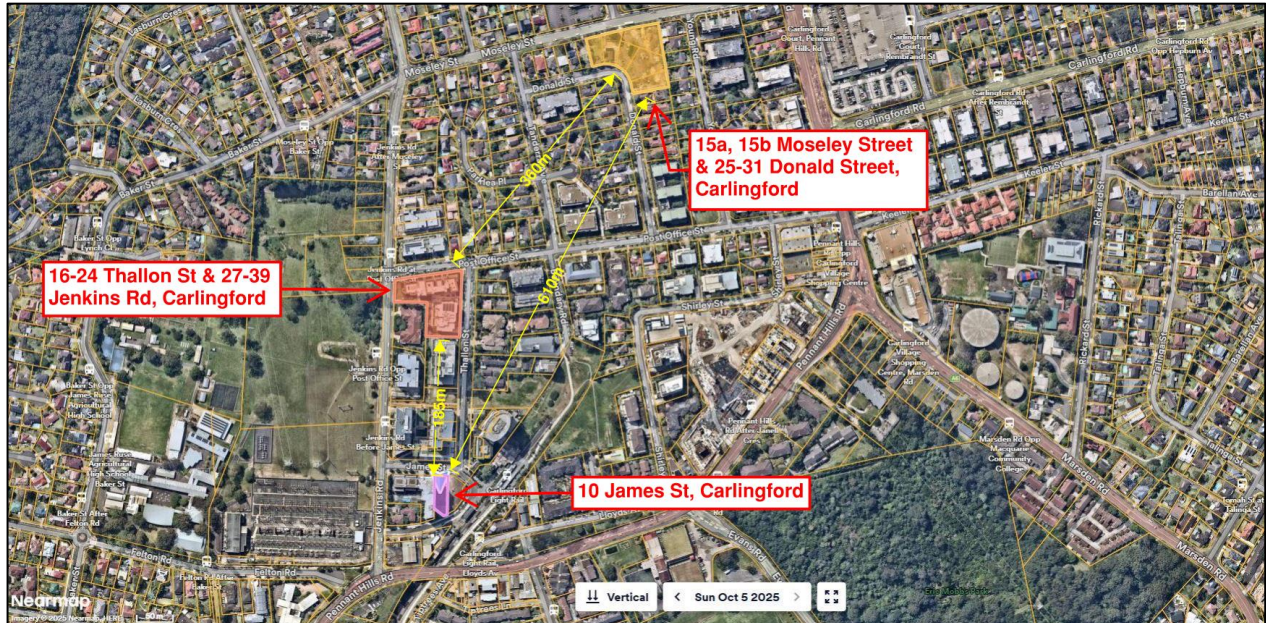
**Figure 3:** Aerial View of Site, Previous Geotechnical Investigations within its Vicinity

An additional Geotechnical Investigation Report prepared by JK Geotechnics, Project No. 33910SNrpt was previously conducted at 16-24 Thallon Street & 27-29 Jenkins Road, Carlingford, with an approximate thickness of the subsurface conditions as demonstrated in Table 2. The site is located approximately 360m, South West from 15a, 15b Moseley St & 25-31 Donald St, Carlingford (as shown in Figure 3). The 1:100,000 geological map of Sydney indicates that the site (16-24 Thallon Street & 27-29 Jenkins Road, Carlingford) is underlain by Ashfield Shale of the Wianamatta Group and is located near the boundary with the underlying Hawkesbury Sandstone. As the geological formation is in close proximity of Hawkesbury Sandstone, the findings presented in the report demonstrate that the site consists of Silty CLAY, underlain by SANDSTONE, as shown below. All boreholes remained dry during auger drilling and upon completion of the drilling works. Approximately three weeks after standpipe installation, standing water was observed within the bedrock profile at depths of approximately 5.9-6.7 m (RL 84.6-87.6) below the existing ground surface. However, given the low permeability of both the soil and bedrock materials, it is considered likely that these water levels reflect localised seepage rather than a true representation of a regional groundwater table. Long term groundwater inflows are expected to be minor and can be effectively managed by directing them to a sump for periodic pumping and disposal to the stormwater system.

A further Geotechnical Investigation Report prepared by JK Geotechnics, Project No. 37031YMrptRev2 was previously conducted at 10 James Street, Carlingford. The site is located approximately 610m, Southwest from 15a, 15b Moseley St & 25-31 Donald St, Carlingford (as shown in Figure 3). the findings presented in the report demonstrate that the site consists of Silty CLAY underlain by SHALE and SANDSTONE (as shown in Table 3).
