Report on Geotechnical Investigation

Green Square Stage 3

960A Bourke Street, Zetland

Project 72258.23

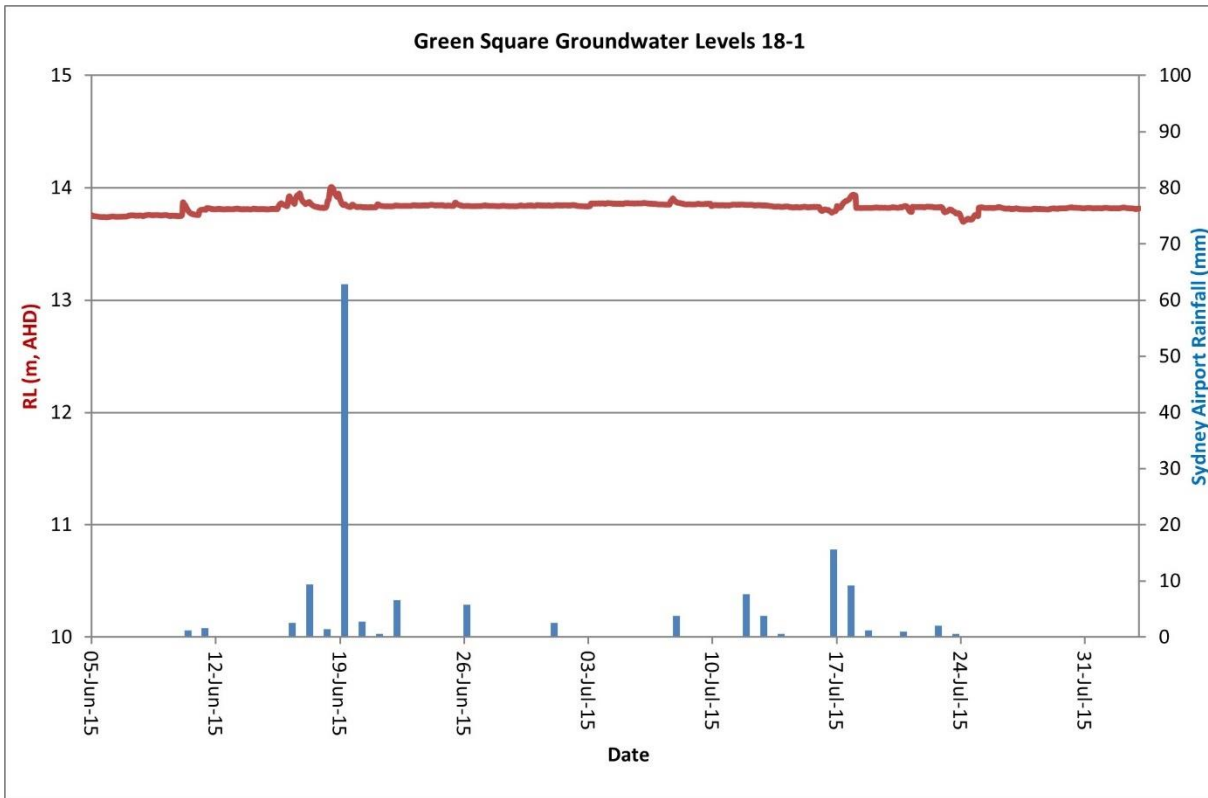
Figure 4: Results of Groundwater Monitoring in Monitoring Well 18-1

A graphical summary of the monitoring data is shown in Figures 2 to 4. Daily rainfall information recorded by the Bureau of Meteorology at Sydney Airport is also included on the graphs. It should be noted that the daily rainfall totals are reported as rainfall in the 24 hours to 9 am rather than from midnight to midnight.

The groundwater levels measured during the previous monitoring period vary between RL 11.6 m and RL 14.0 m AHD. It appears as though the groundwater in the south-eastern portion of the site (i.e. BH18-1) is on average at about RL 13.8 m AHD. The groundwater in the north-western portion of the site (i.e. BH7-2 and BH7-3) is on average at about RL 11.8 m AHD. A 2 m variation in levels has therefore been observed on the site.

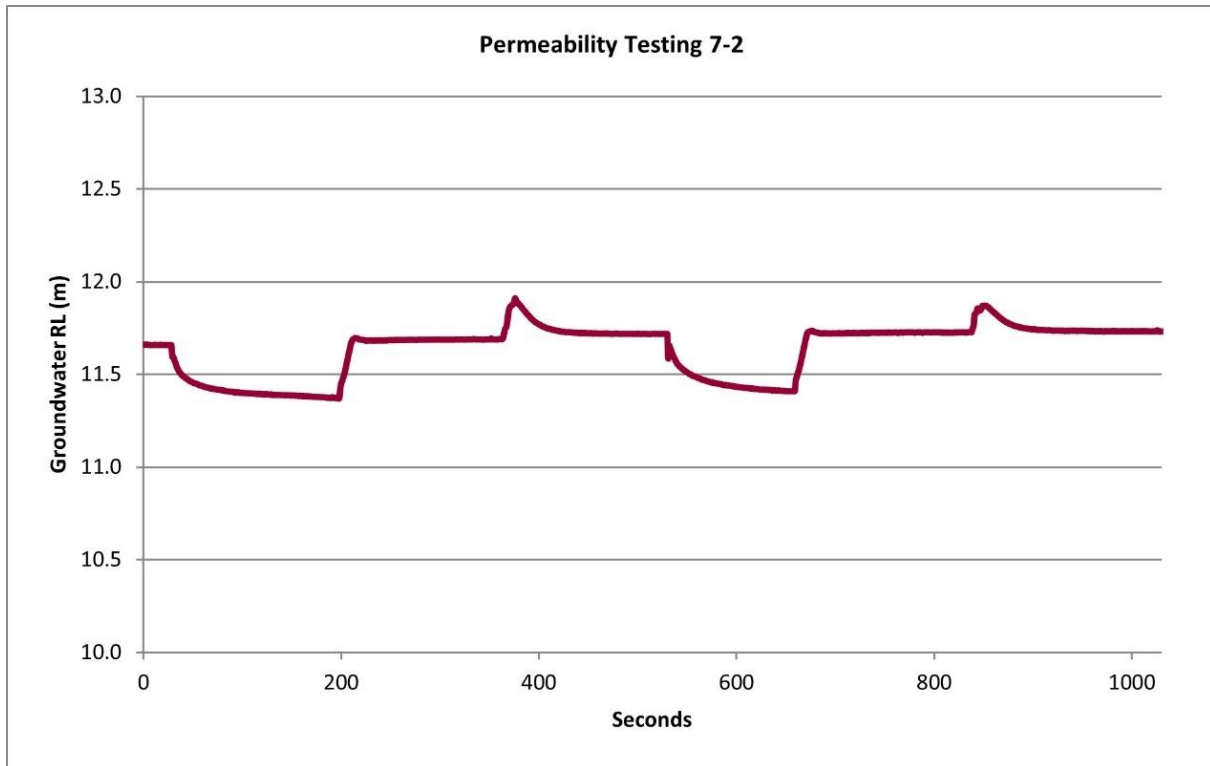
Figure 5: Results of Permeability Testing in Monitoring Well 7-2

The results of the drawdown and inflow slug testing are shown in Figures 5 to 7. In each case, the data from the LevelTROLL loggers is plotted as water level against time. The water levels have been converted from pressure readings and the elapsed time is shown in seconds.

It should be noted that the shape of the graphs appear irregular in some cases which is due to the process of installing the monitors and removing water from or adding water to the monitoring wells during testing.

The soil permeability adjacent to each monitoring well was assessed using the slug test results. The data plotted on Figures 2 to 4 was selectively analysed to determine representative values of soil permeability. The results of the analyses are shown in Tables 4 and 5.

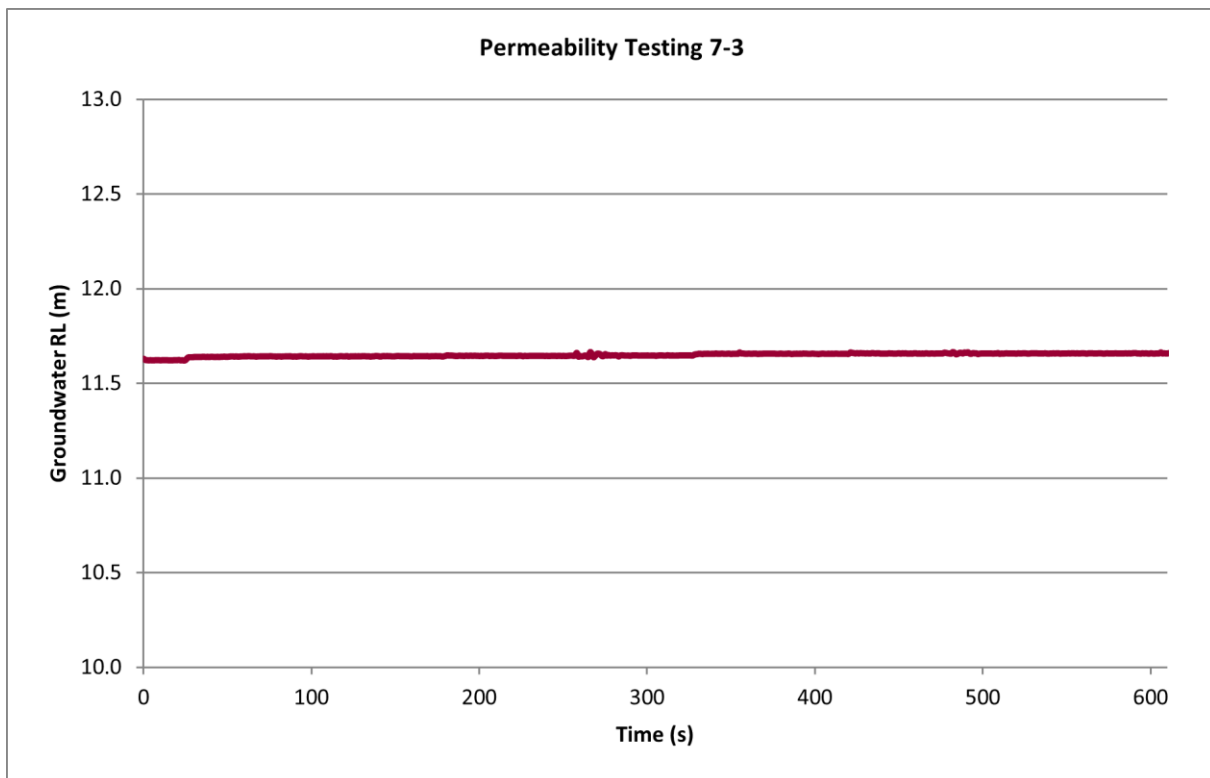
Figure 6: Results of Permeability Testing in Monitoring Well 7-3

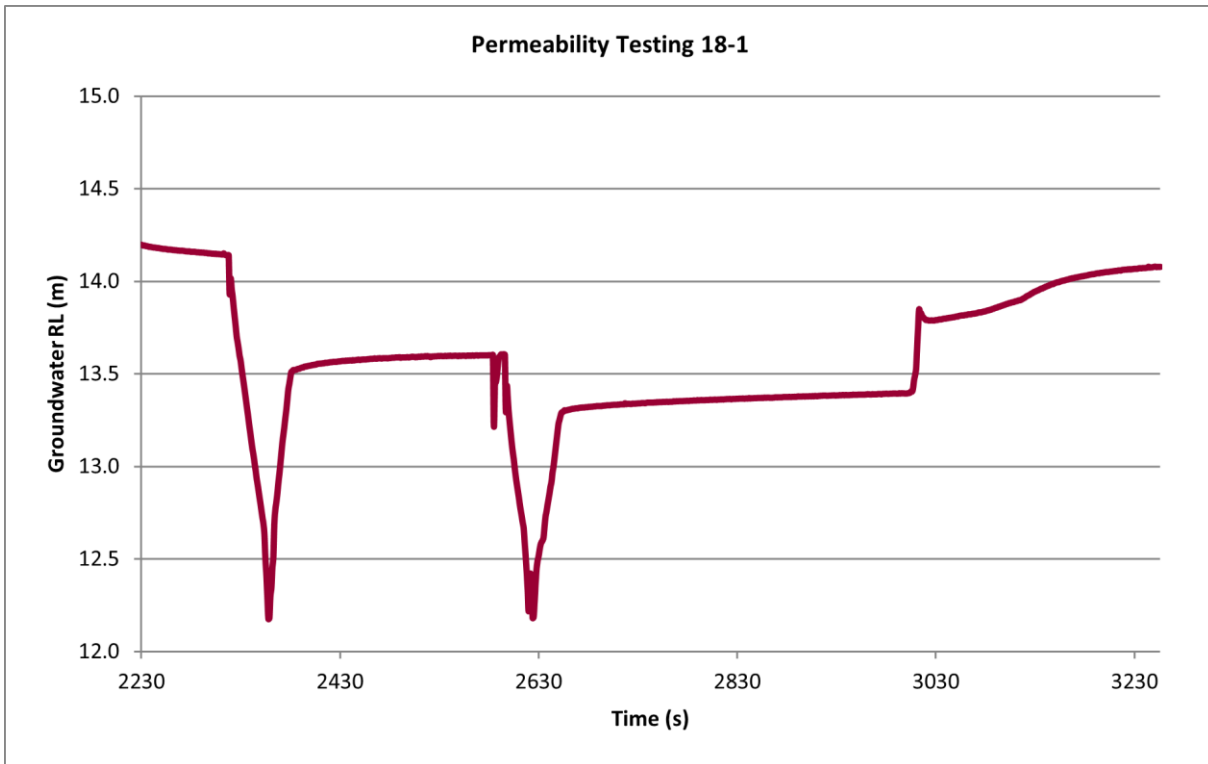
Figure 7: Results of Permeability Testing in Monitoring Well 18-1

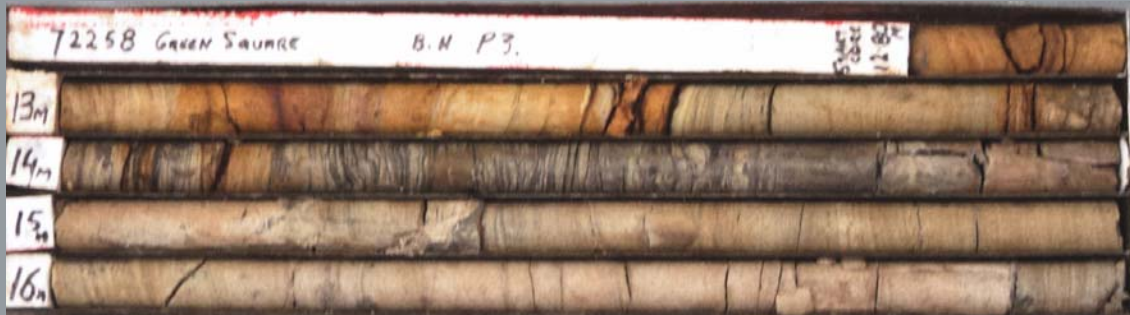
12.8 - 17.0m

DOUGLAS PARTNERS PTY
GREEN SQUARE TOWN CENTRE - ZETLAND
BORE P3 PROJECT 72258 FEB 2011

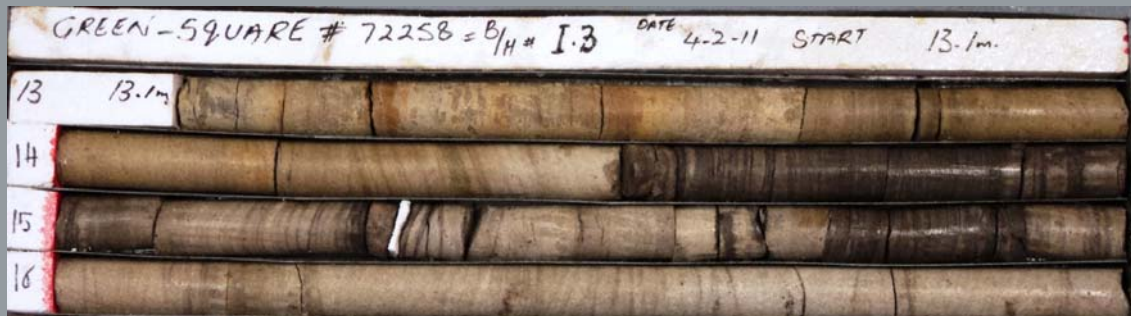
13.1 - 17.0m

DOUGLAS PARTNERS PTY
GREEN SQUARE TOWN CENTRE - ZETLAND
BORE 13 PROJECT 72258 FEB 2011

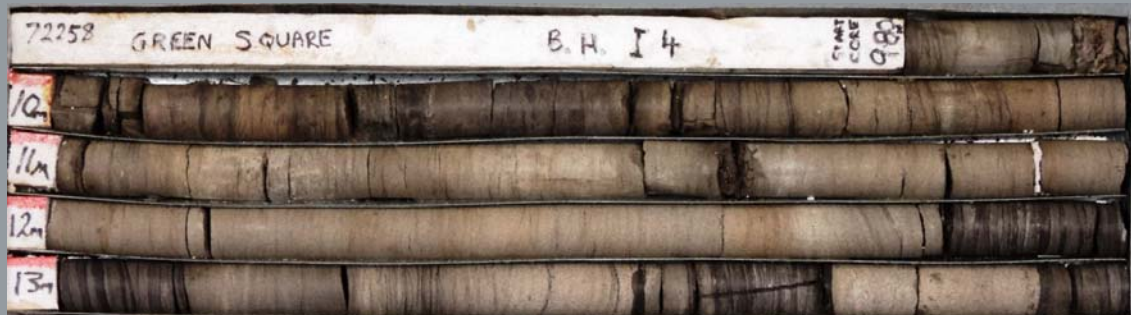
9.8 - 14.0m

DOUGLAS PARTNERS PTY
GREEN SQUARE TOWN CENTRE - ZETLAND
BORE 14 PROJECT 72258 FEB 2011
