L02 (Curtain Wall Investigations – 105 Miller St North Sydney) Rev 0

18 November 2024

## L02: Supplementary Curtain Wall Investigations - 105-153 Miller Street, North Sydney NSW

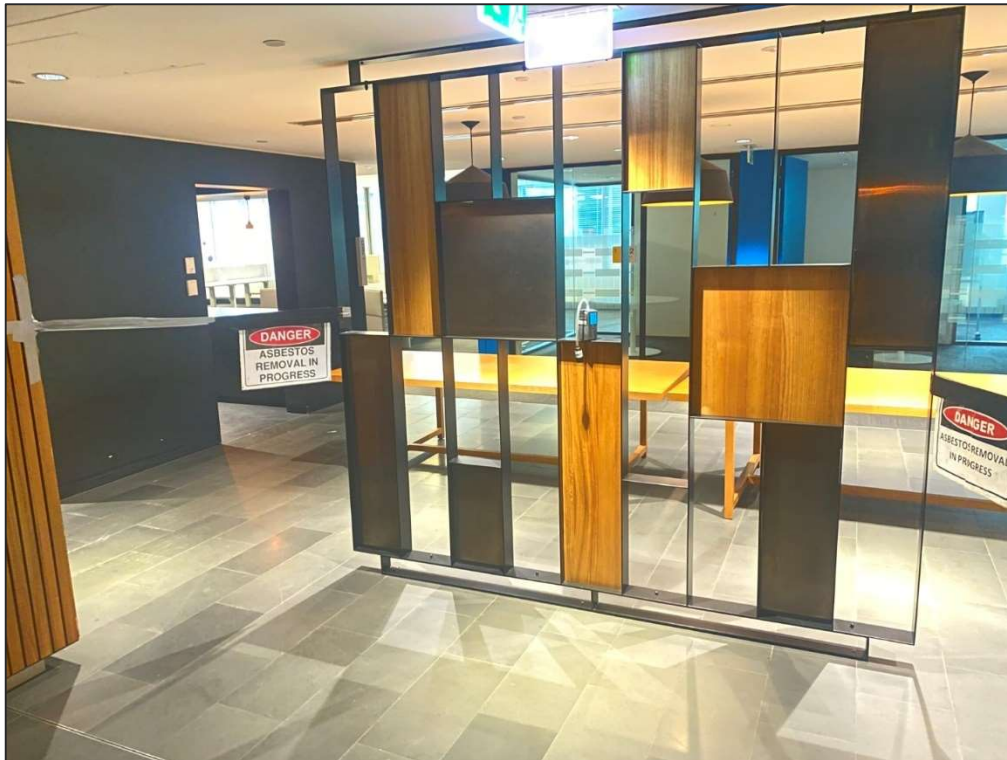
**Photograph 1:** An exclusion zone and asbestos air monitoring were established for the investigation works.

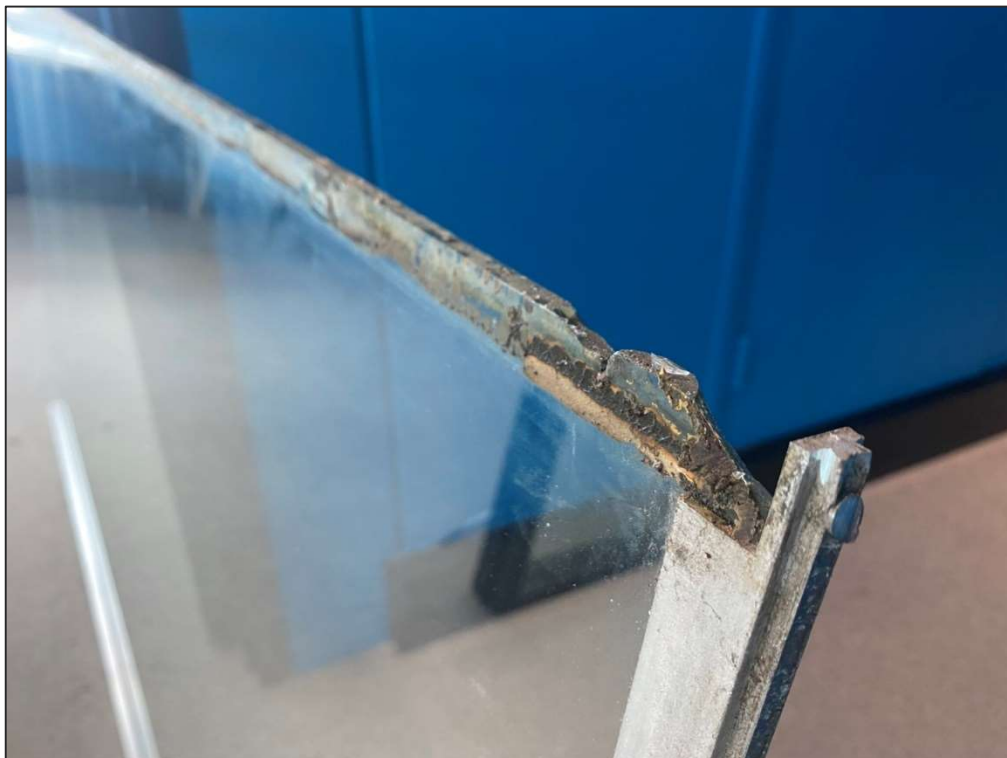
| Sample ID | Material Type | Sample Location | Specified Analysis | Laboratory Result |
|---|---|---|---|---|
| CW-A1 | Black, vitreous, hardened sealant material | Inner vision window (side glazing channel) | Asbestos | No asbestos detected |
| CW-A2 | Dark grey, hardened sealant material | Inner vision window (upper glazing channel) | Asbestos | No asbestos detected |

**Photograph 2:** Inner vision windows were removed, and sealant materials around glazing sampled. All collected samples were analysed for asbestos analysis by a NATA accredited laboratory.

- Whilst no asbestos was identified to glazing channels of the internal vision windows sampled, as per JBS&G 2024, asbestos mastic should be assumed to these windows unless further investigation is conducted to demonstrate otherwise;

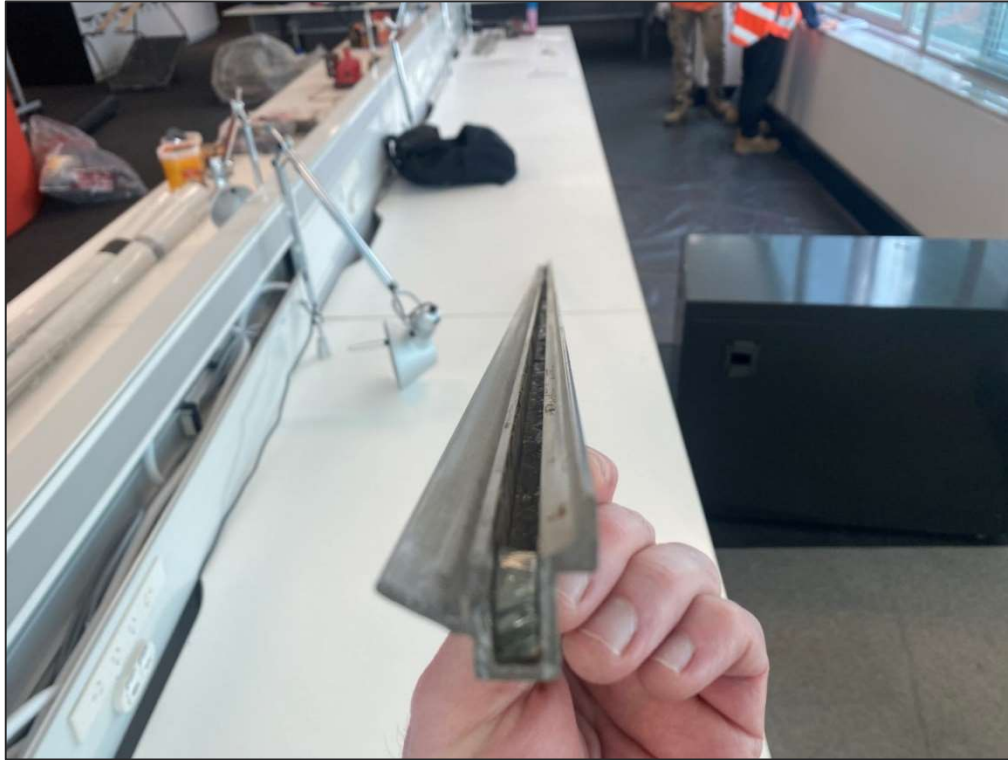
**Photograph 3:** Glazing channel of inner vision windows.

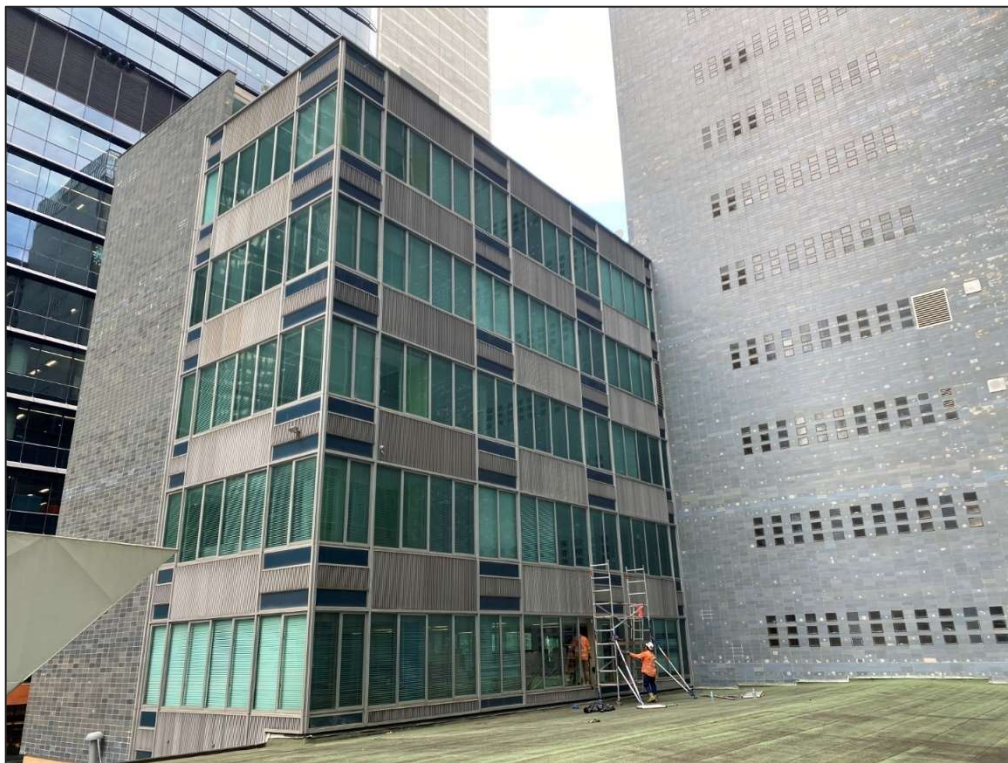
**Photograph 4:** Scaffolding was erected on the northern ground level rooftop to access the external façade.

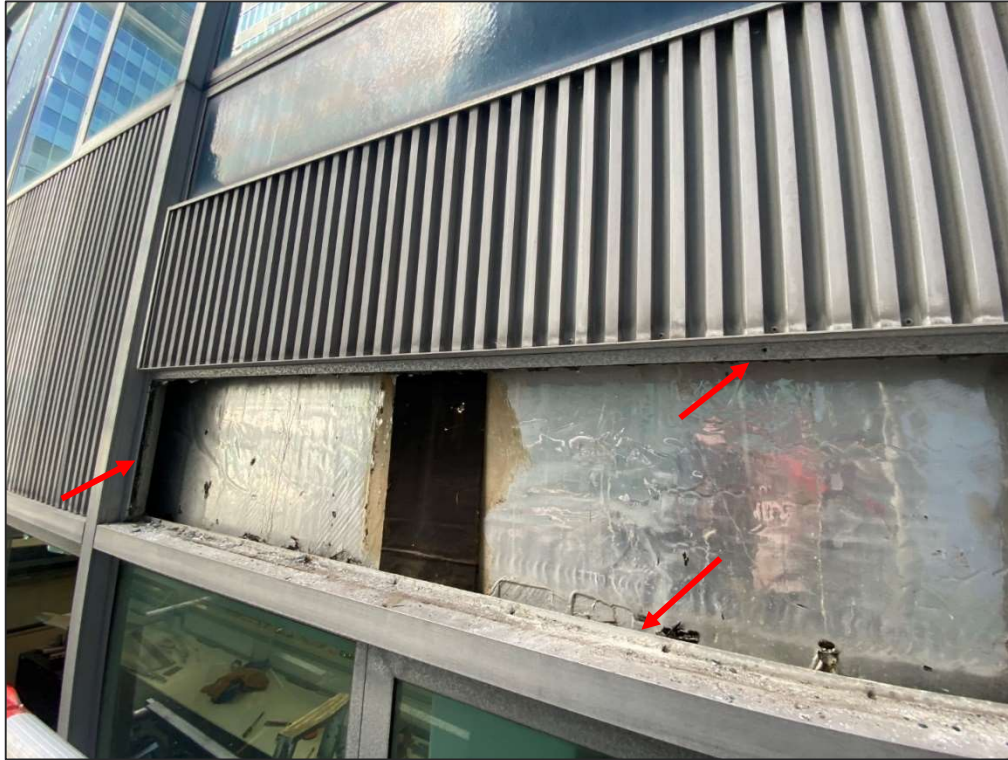
| Sample ID | Material Type | Sample Location | Specified Analysis | Laboratory Result |
|---|---|---|---|---|
| CW-A5 | Grey, soft mastic material | Colour-back glass panel (glazing channel) | Asbestos | <b>Chrysotile asbestos detected</b> |

- Asbestos mastic to the glazing channel of the outer vision windows and colour-back glass panels of the curtain wall that was previously identified in JBS&G 2024 was confirmed to be present;

**Photograph 7:** The grey mastic surrounding the colour-back glass panels contain asbestos.

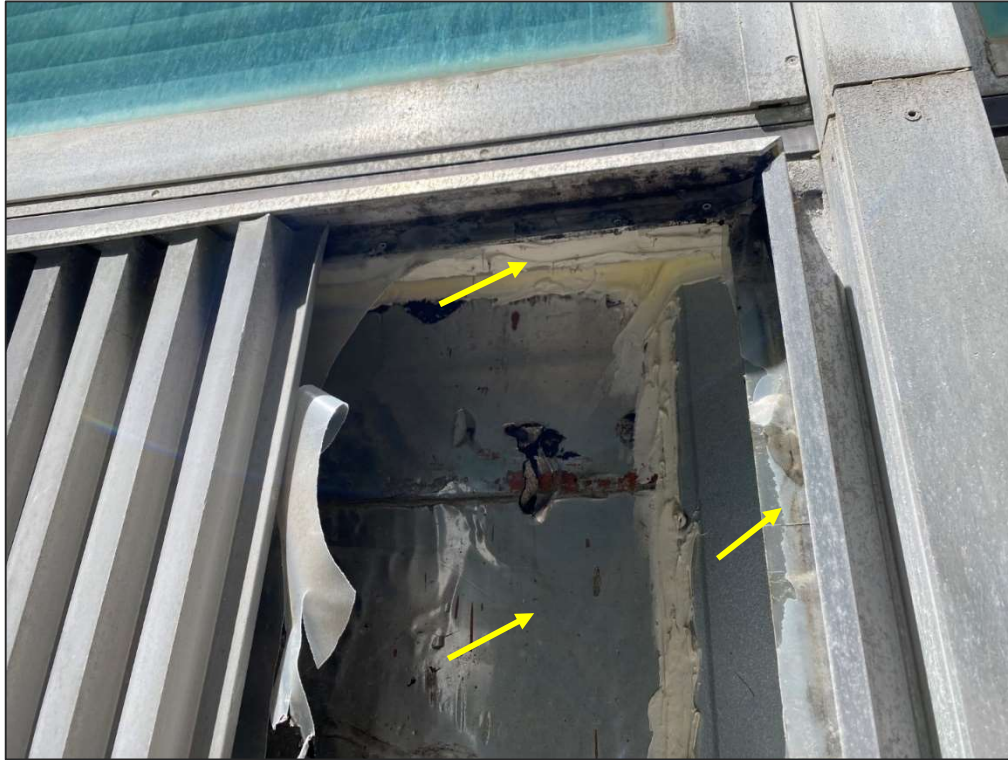
| Sample ID | Material Type | Sample Location | Specified Analysis | Laboratory Result |
|---|---|---|---|---|
| CW-A6 | Black bituminous coating to aluminium flashing strip | Cavity behind corrugated spandrel panel | Asbestos | No asbestos detected |

| CW-A8 | White silicon material | Corking to sheet metal flashing in spandrel cavity (assumed retrofit) | Asbestos | No asbestos detected |
| CW-A9 | Clear sticky tape (dark staining) | Adhesive tape fixing clear plastic sheet in spandrel cavity (assumed retrofit) | Asbestos | No asbestos detected |

**Photograph 8:** Samples collected of black aluminium flashing, white silicon and clear adhesive tape materials within the spandrel cavity did not identify asbestos.

**Photograph 9:** As per Photo 8

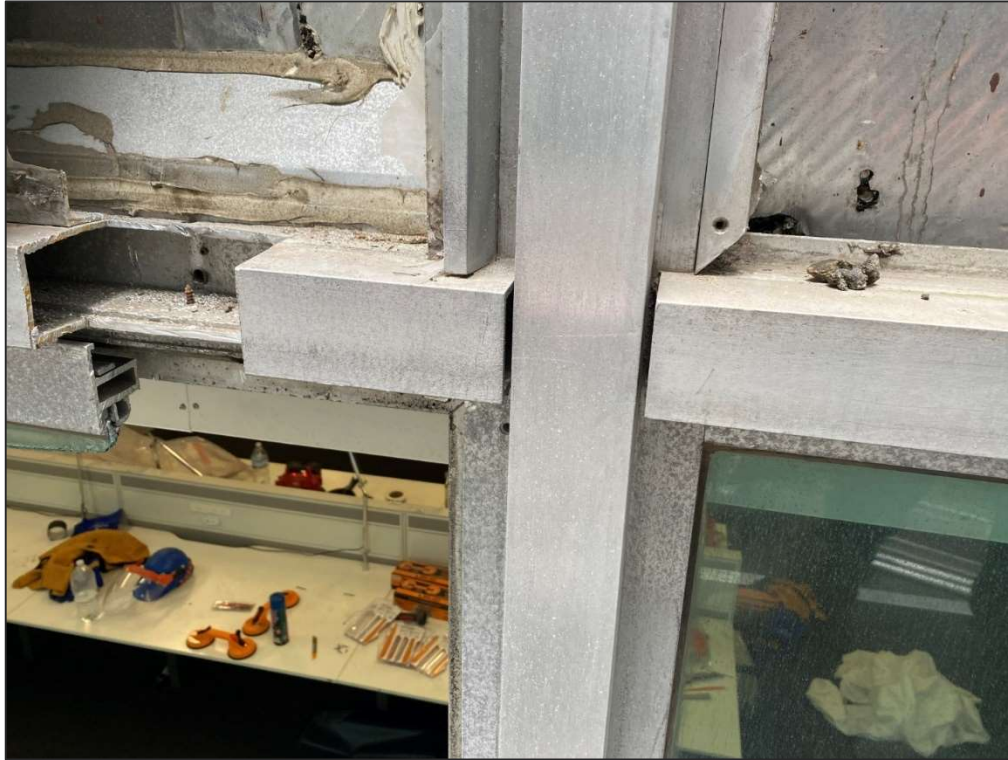
**Photograph 11:** Front view of mullion / head transom connection to the curtain wall.

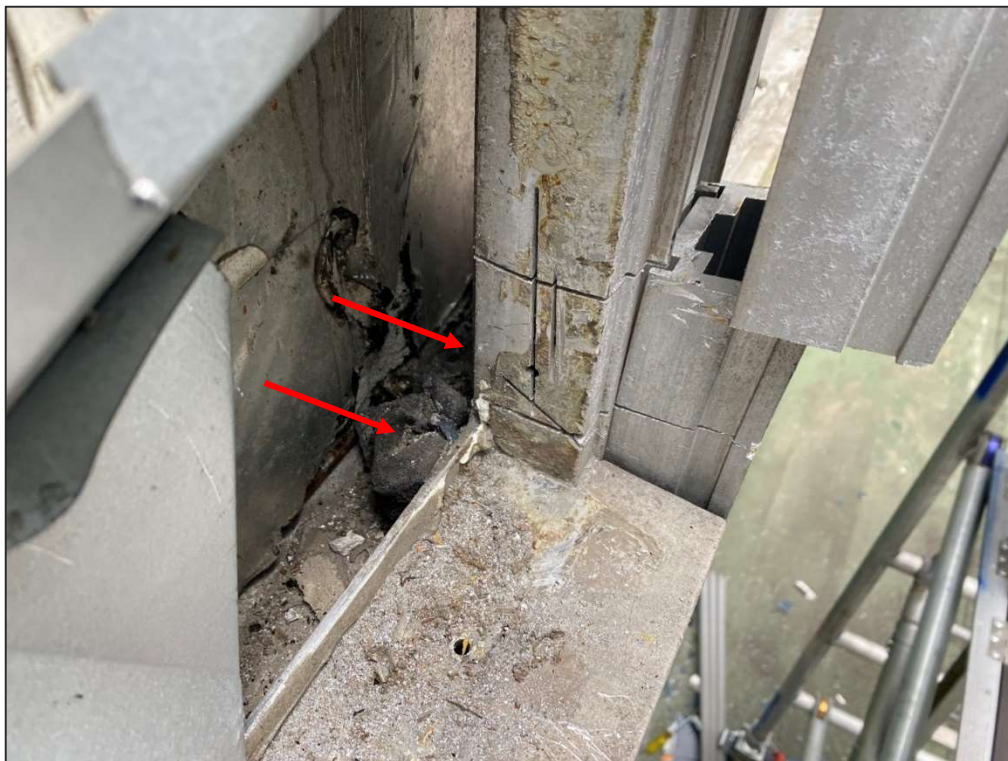
| Sample ID | Material Type | Sample Location | Specified Analysis | Laboratory Result |
|---|---|---|---|---|
| CW-A7 | Grey / brown, soft mastic material | Back of mullion / head transom connection in spandrel cavity | Asbestos | <b>Chrysotile asbestos detected</b> |

- Additional asbestos mastic that had not previously been identified in JBS&G 2024 was identified behind a representative mullion / 'head' transom connection and is assumed to be present to similar locations throughout the curtain wall system. Exterior corrugated aluminium panels to the spandrels would need to be removed to access these areas.

**Photograph 12:** The grey /brown mastic identified at the rear of the mullion / head transom connection contains asbestos.

- The HBMS and register (JBS&G 2024) must be updated at the completion of all supplementary investigations to provide accurate information for tendering and demolition purposes; and
