Remediation Action Plan

Proposed Redevelopment

105-153 Miller Street, North Sydney NSW

Project 86964.05

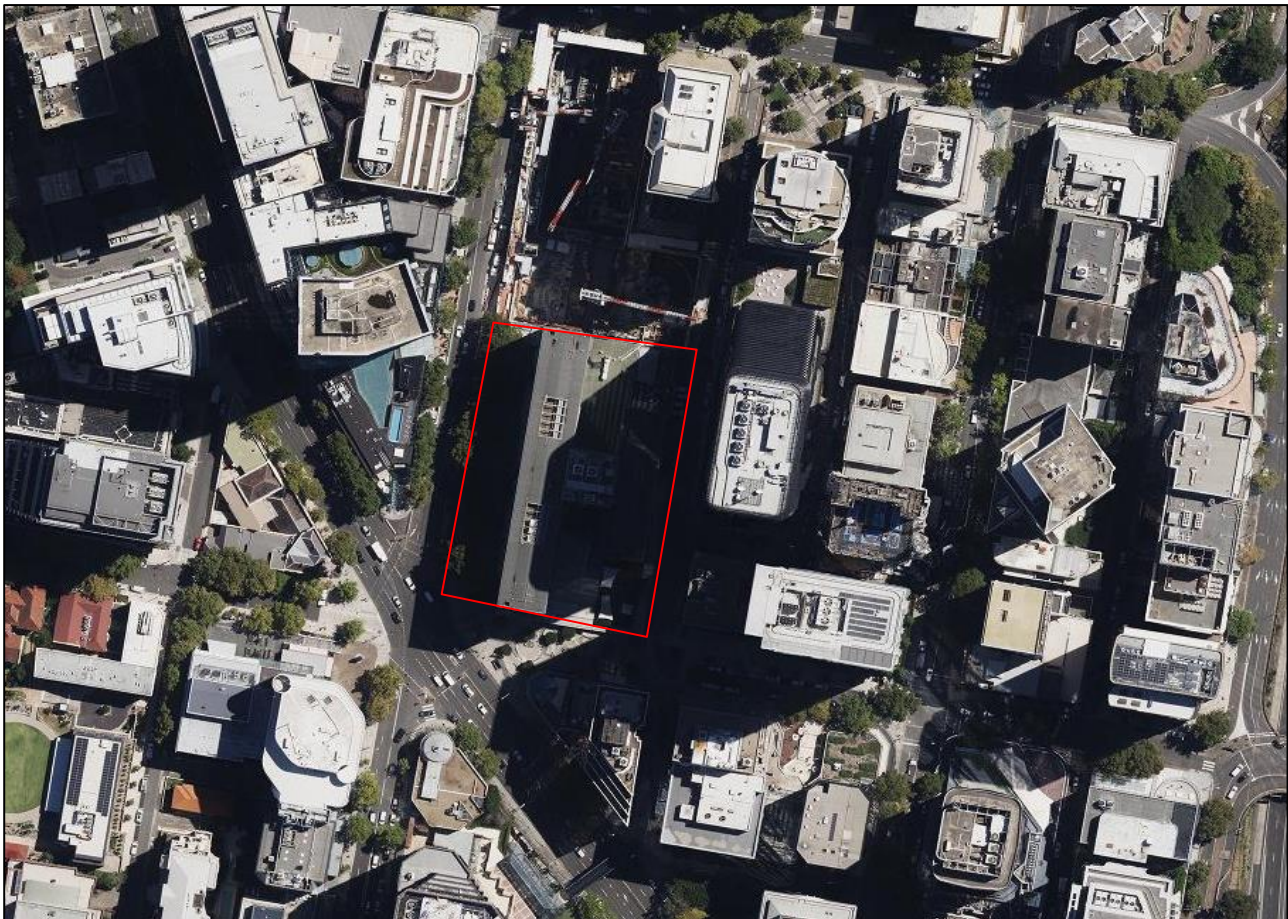
Figure 1: Site location and site boundary

The site boundary is shown on Drawing 1.

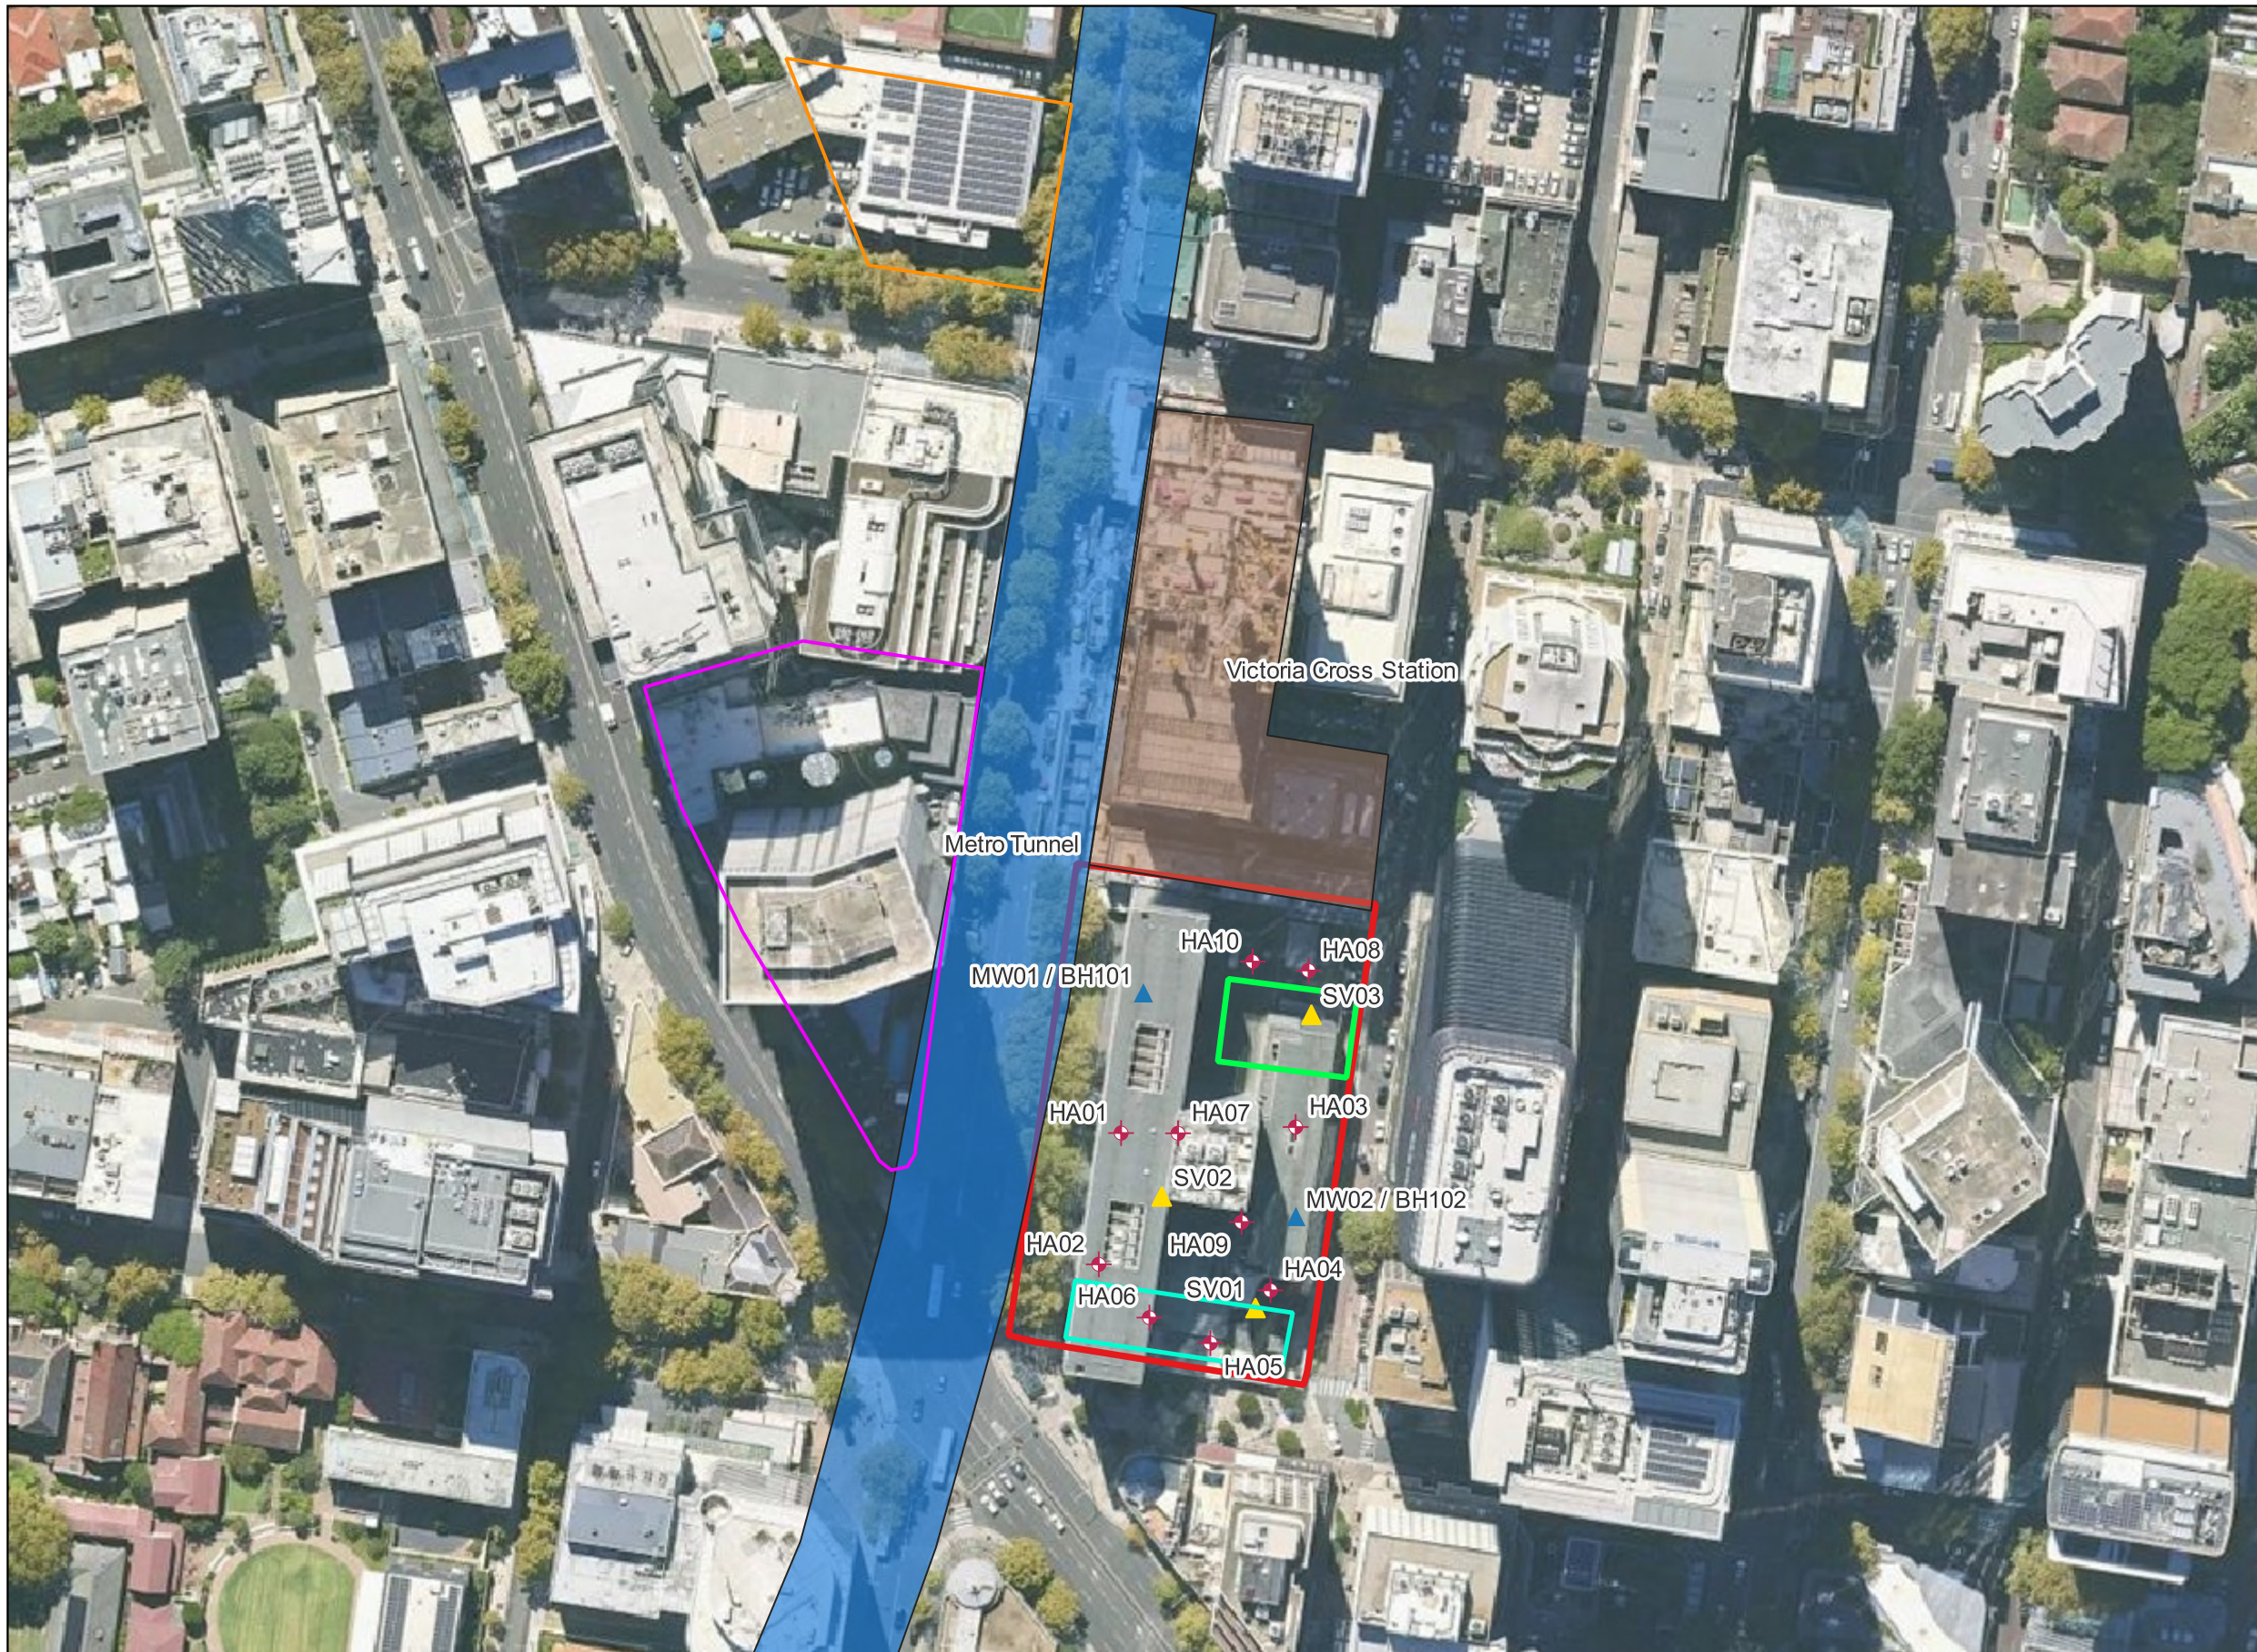
PROJECT: **86964.05**
 DRAWING No: 1
 REVISION: 0

SITE LOCATION

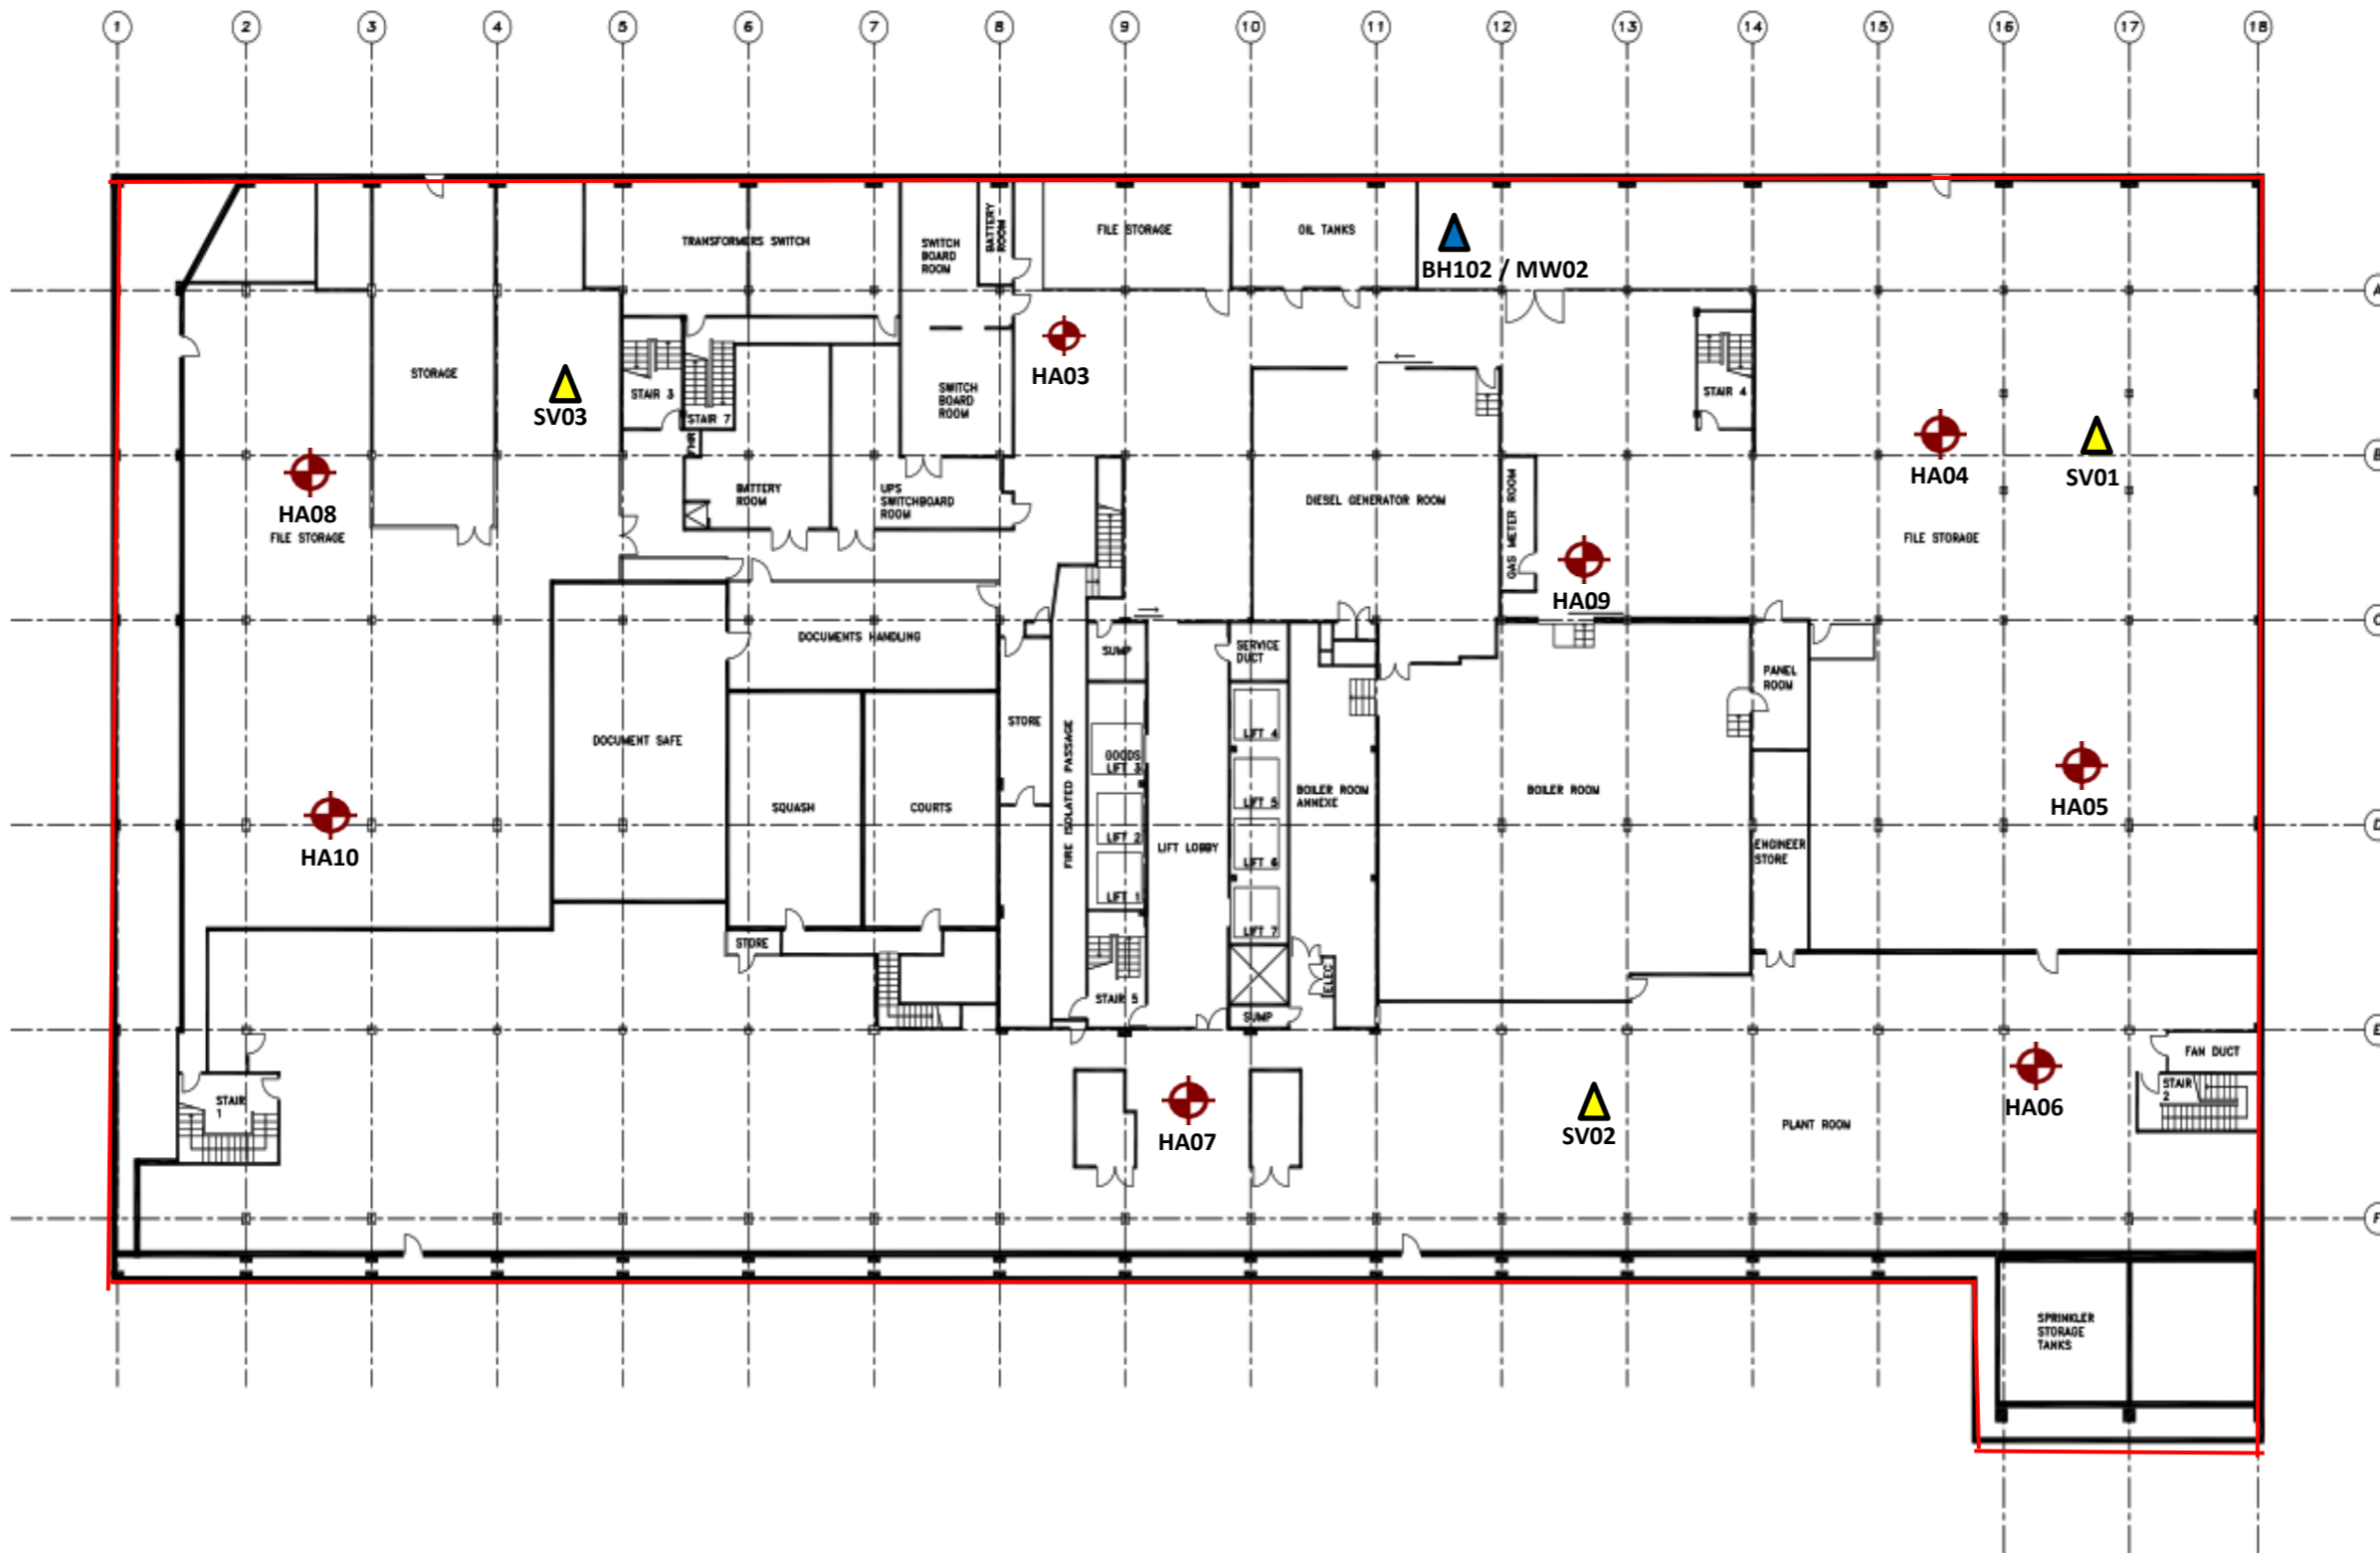
PROJECT No:	86964.05
DRAWING No:	D.002
REVISION:	0

- LEGEND**
- Site Boundary
 - ⊕ DSI Boreholes
 - ▲ DSI Soil Vapour Ports
 - ▲ DSI Groundwater Wells

TITLE: **Test Location Plan (Basement Level)**
Proposed Redevelopment
105 Miller Street, North Sydney, NSW

Test locations were selected based on targeting known or suspected contamination sources including the diesel tank, boiler / generator room, former dry cleaner, and printer shop and general fill / site condition. The soil vapour pins were targeted to areas considered most likely to be contaminated based on the results of the PSI.

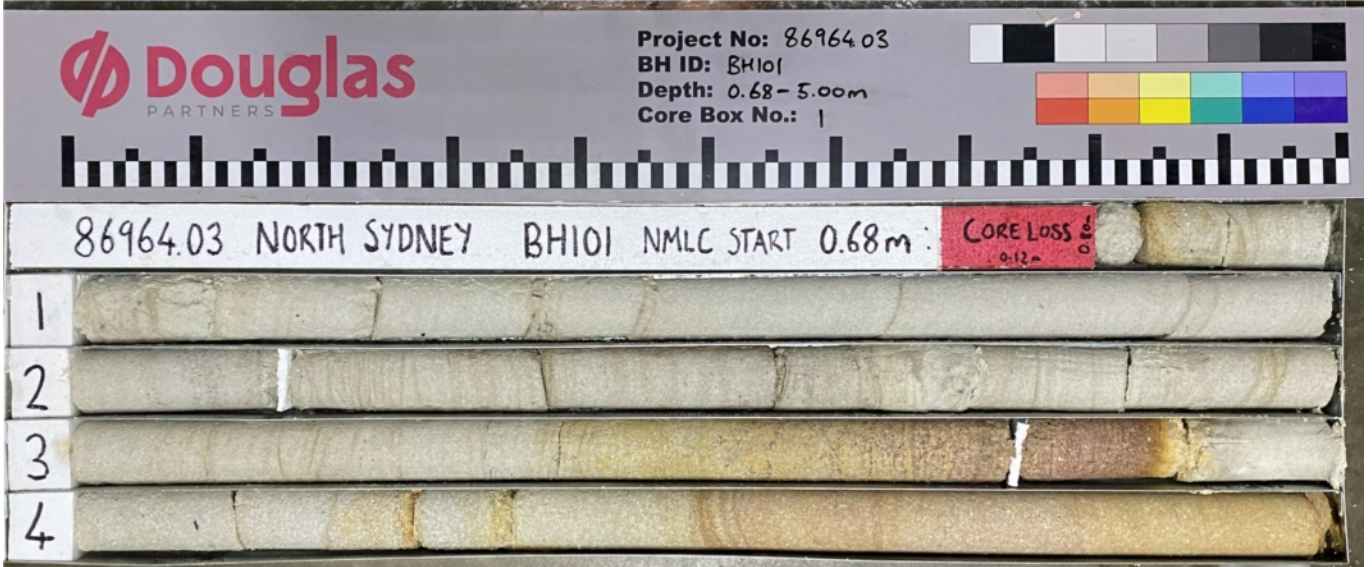
0.68-5.00 m depth

LOCATION ID: BH101/MW01
PROJECT No: 86964.03
DATE: 16/09/24
SHEET: 1 of 3

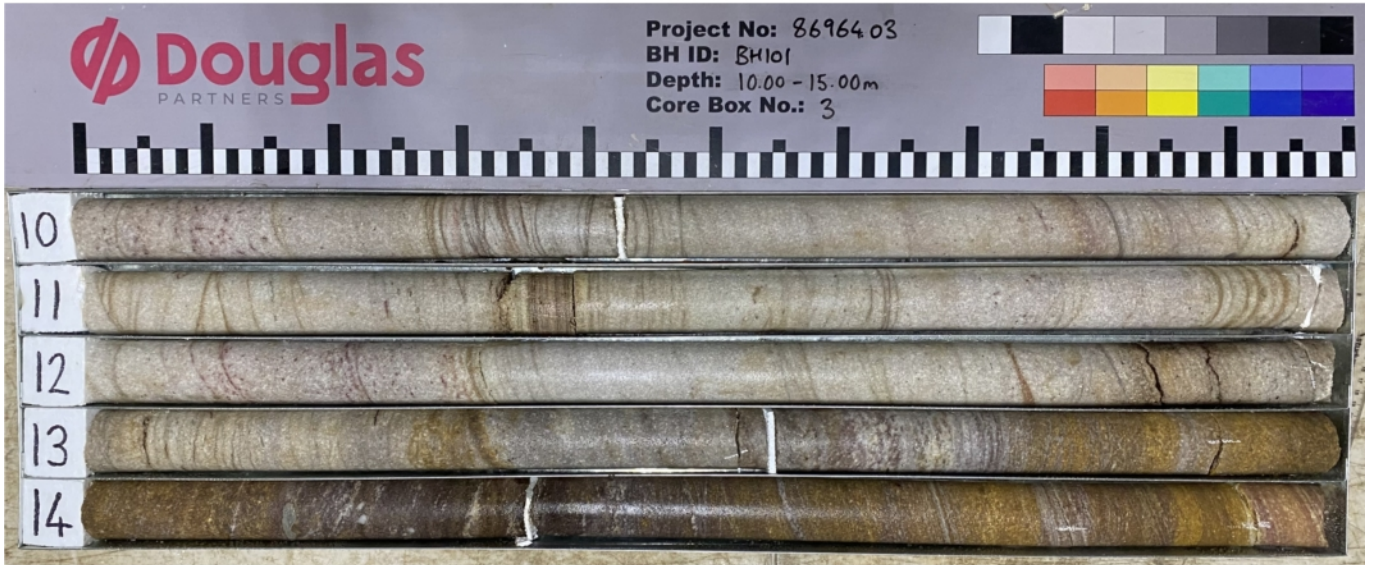
10.00-15.00 m depth

LOCATION ID: BH101/MW01
PROJECT No: 86964.03
DATE: 16/09/24
SHEET: 2 of 3

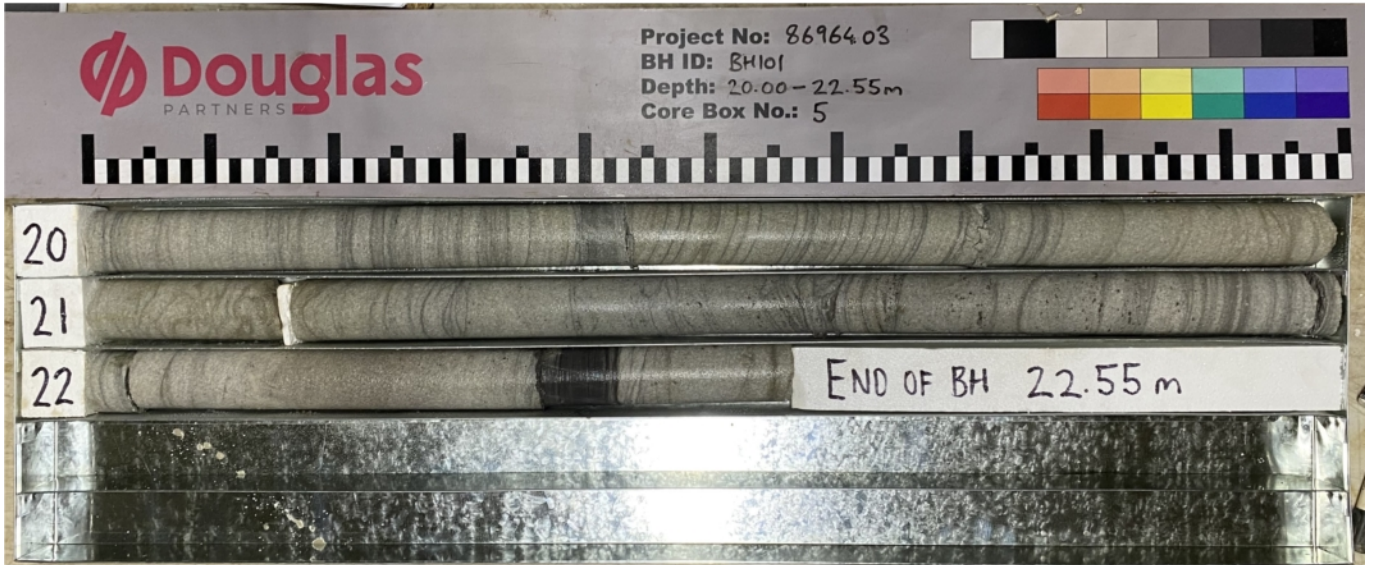
20.00-22.55 m depth

LOCATION ID: BH101/MW01
PROJECT No: 86964.03
DATE: 16/09/24
SHEET: 3 of 3
