## **Report on Geotechnical Assessment**

### **Proposed Wollongong Private Hospital Expansion**

**366 - 368 Crown Street & 15 - 23 Urunga  
Parade, Wollongong**

**Project 73522.14**

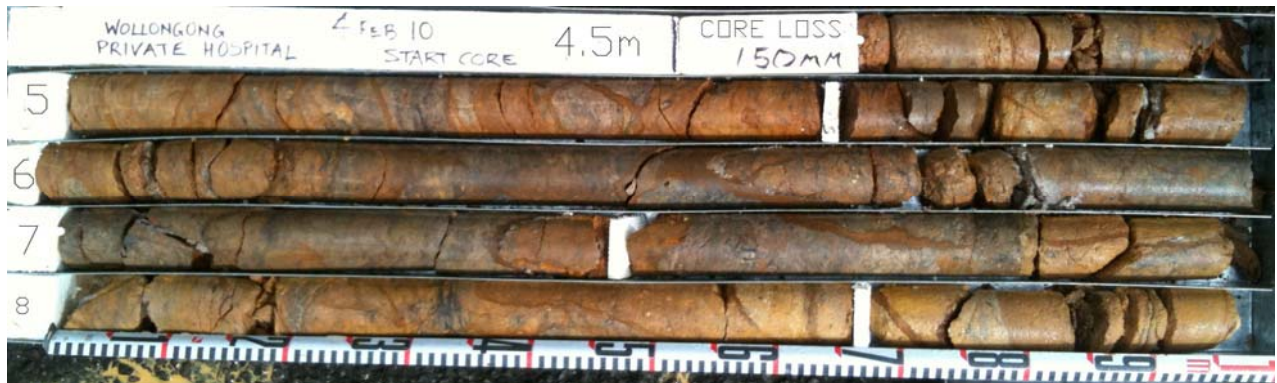
**Borehole BH2: Start of Core (4.5m) to 9.0m**

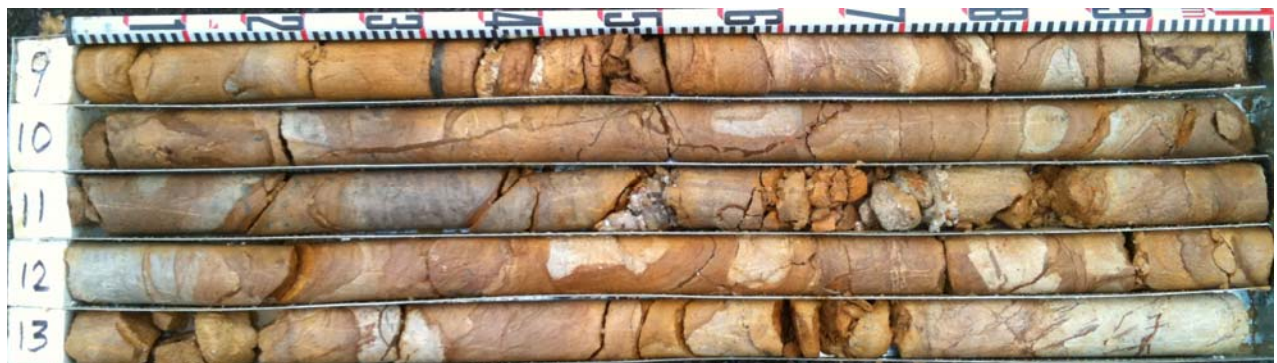
**Borehole BH2: 9.0m to 14.0m**

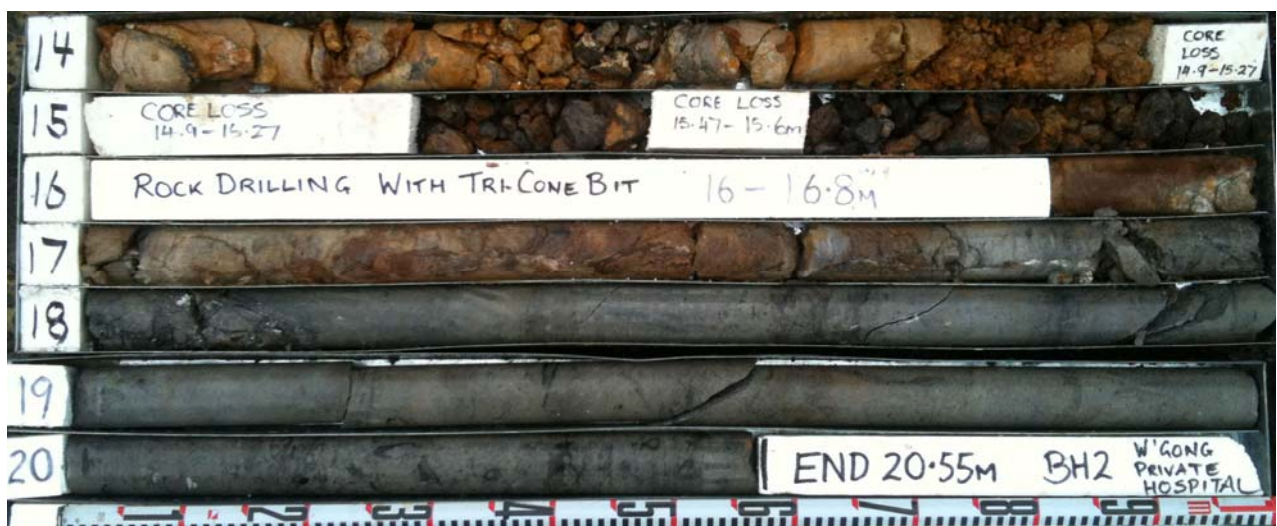
**Borehole BH2: 14.0m to 20.55m (End)**

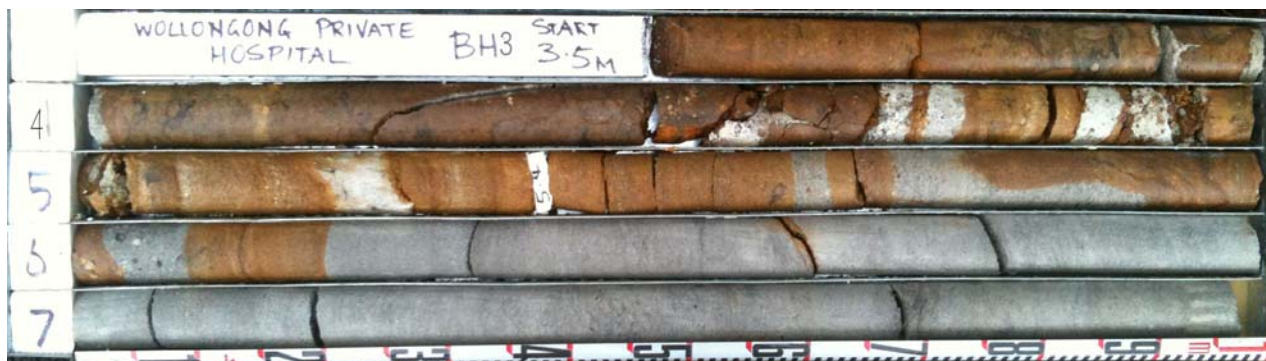
**Borehole BH3: Start of Core (3.5m) to 8.0m**

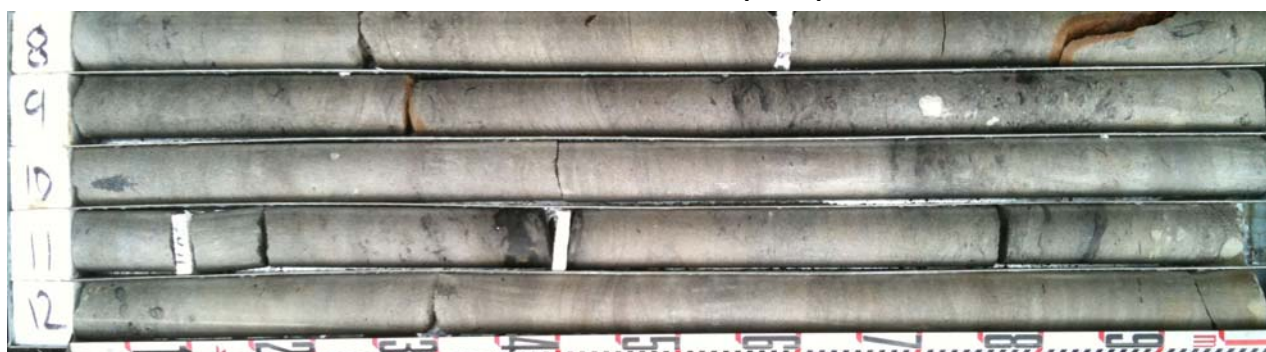
**Borehole BH3: 8.0m to 13.0m**

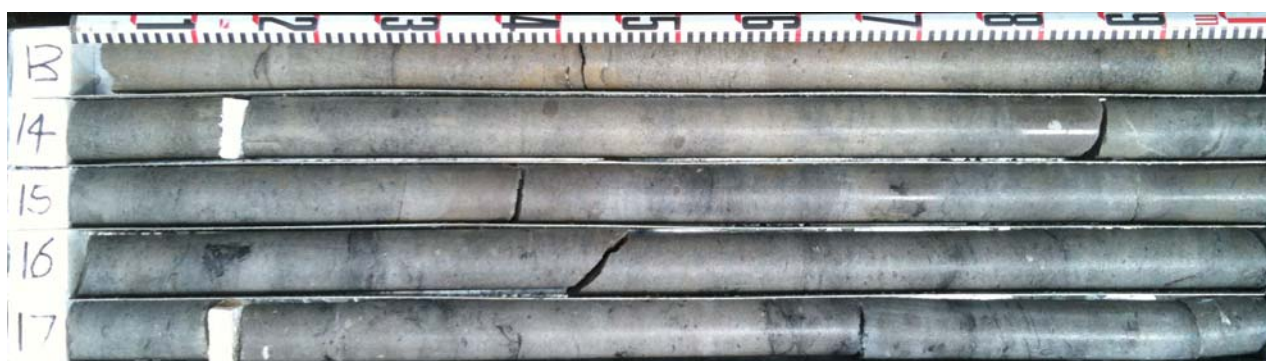
**Borehole BH3: 13.0m to 18.0m (End)**

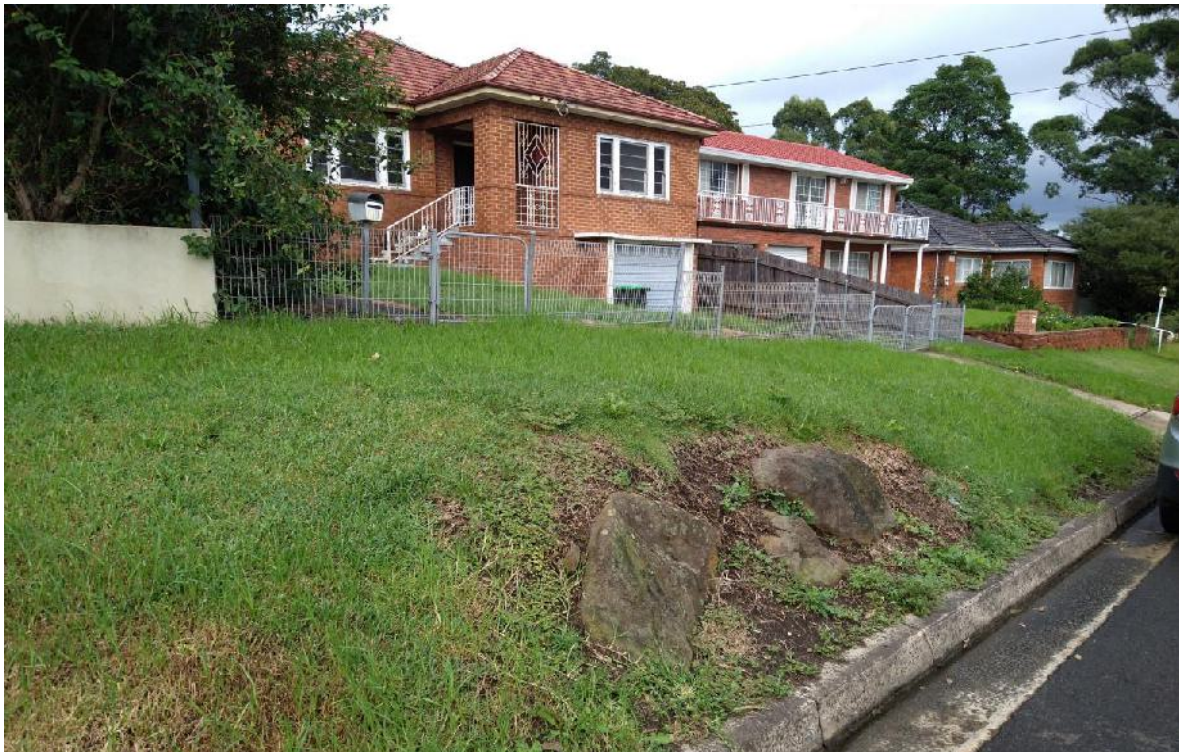
Photo 5: View looking at medium strength sandstone blocks exposed in the nature strip at the front of No. 17 Urunga Parade.

- Sandstone blocks are exposed in the nature strip at the front of No. 17 Urunga Parade (refer Photo 5), which is probably the 'cap-rock' previously identified at the Wollongong Private Hospital site and encountered in Bores 302 and 201.
- Sandstone blocks were also observed near the north-western corner of No. 23 Urunga Parade, which is probably the 'caprock' encountered in Bore 401.
- Seepage was previously observed along the driveway (refer Photo 6) at No. 17 Urunga Parade during the 2022 investigation. While there were wet surfaces on all of the lots during the inspection (ie following rainy weather), no other seepage points were identified.
- Seepage was previously observed from the nature strips on the northern side of No. 49 Urunga Parade and No. 59 Rosemont Street during the 2022 investigation.

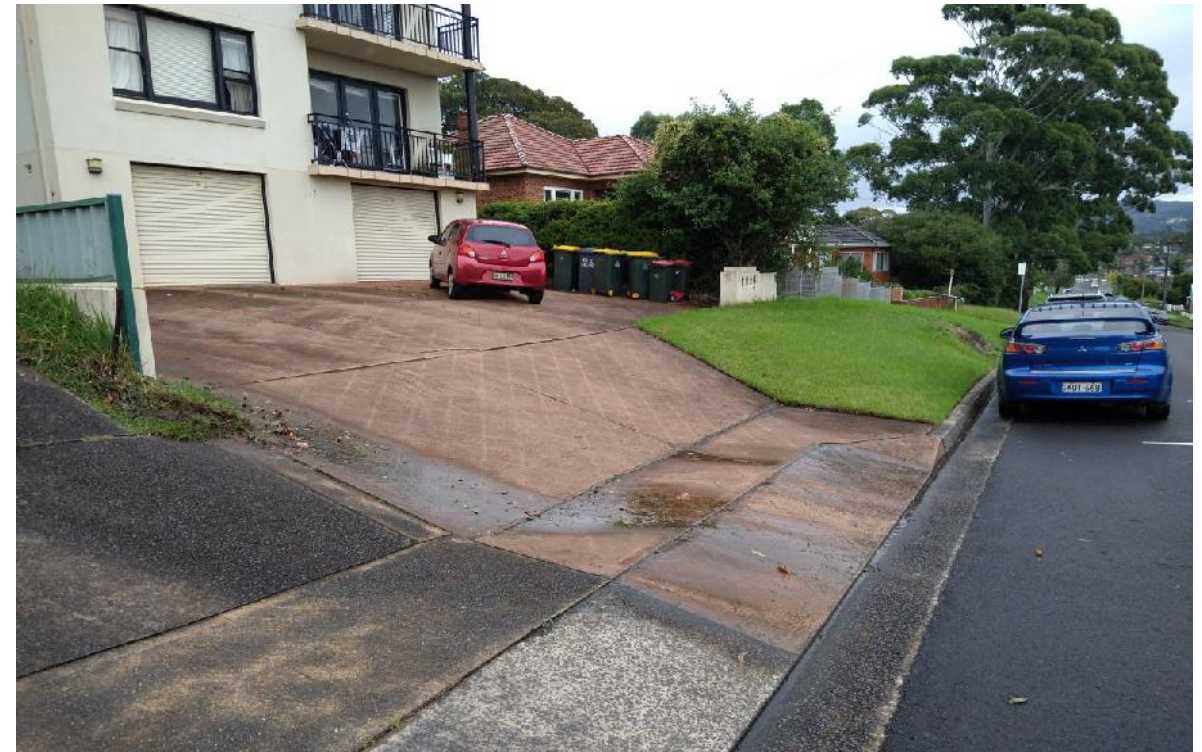
Photo 6: View looking at seepage from No. 17 Urunga Parade.

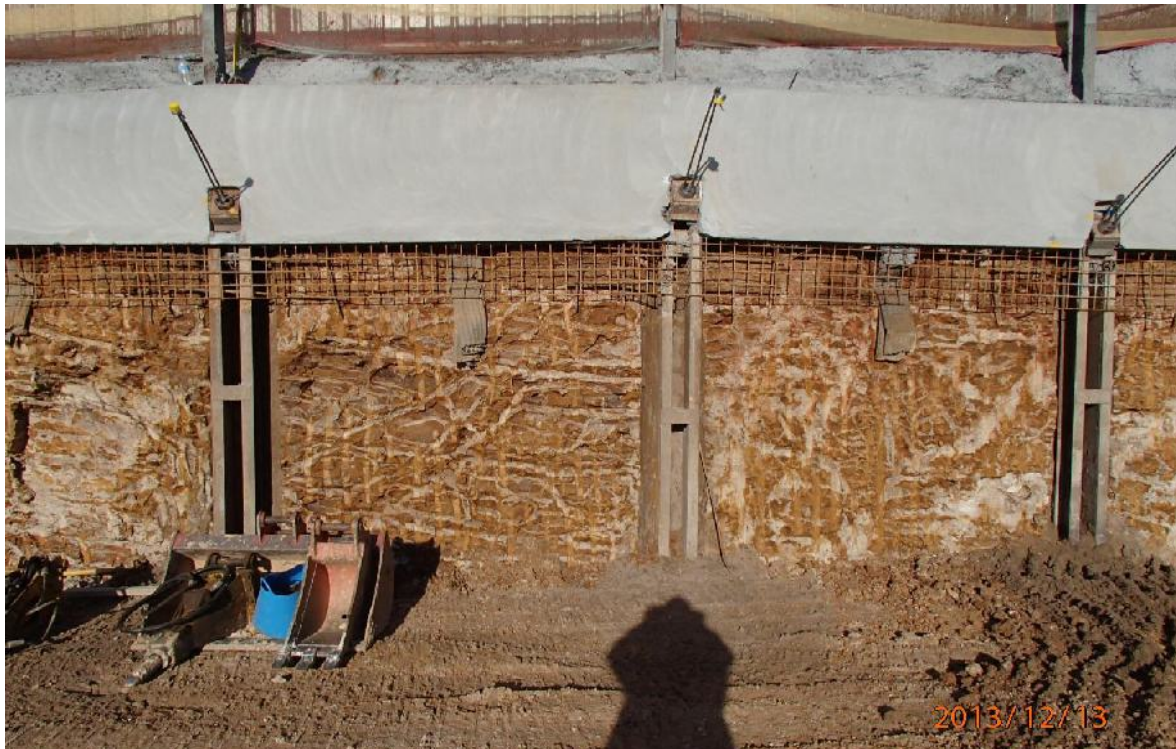
Photo 9: View looking at the weathered sandstone profile exposed in the second bench of the Wollongong Private Hospital excavation adjacent to Crown Street.

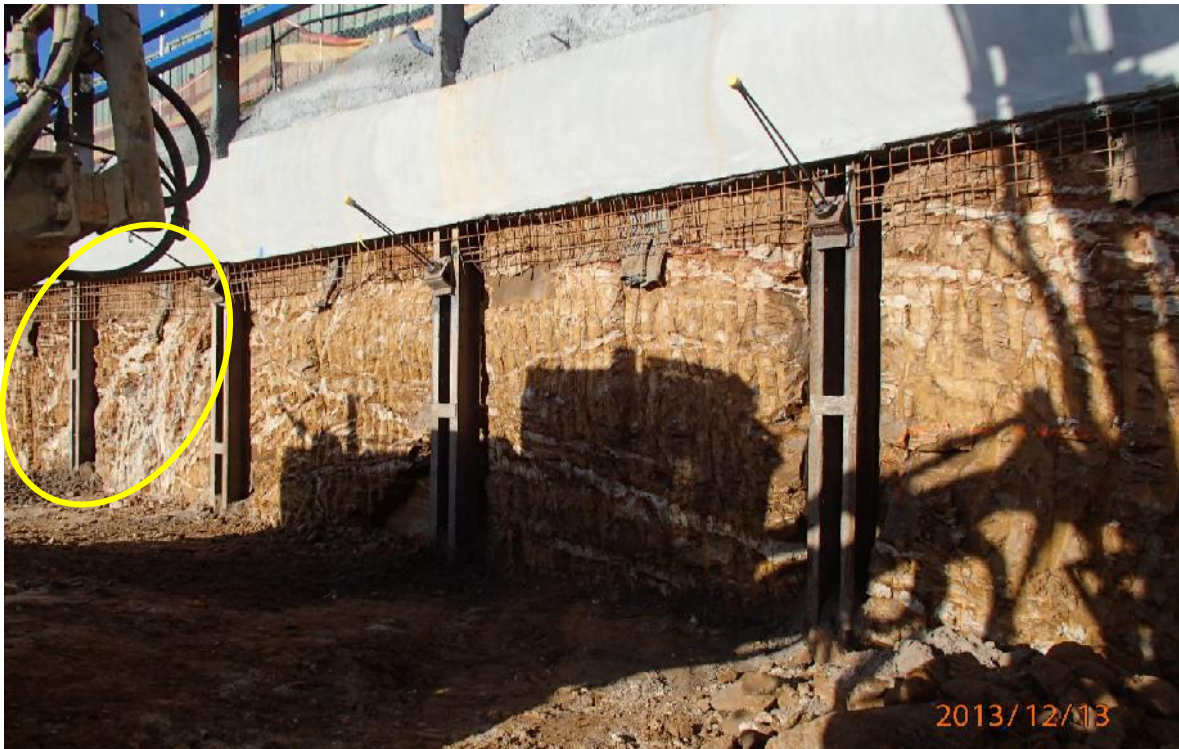
Photo 10: View looking south east at the weathered sandstone profile exposed in the second bench of the Wollongong Private Hospital excavation, adjacent to Crown Street.

- Faulting was observed to intersect the southern excavation face, adjacent to Crown Street (refer Photo 10). The strike and dip of the fault was 120°/40° to the south.

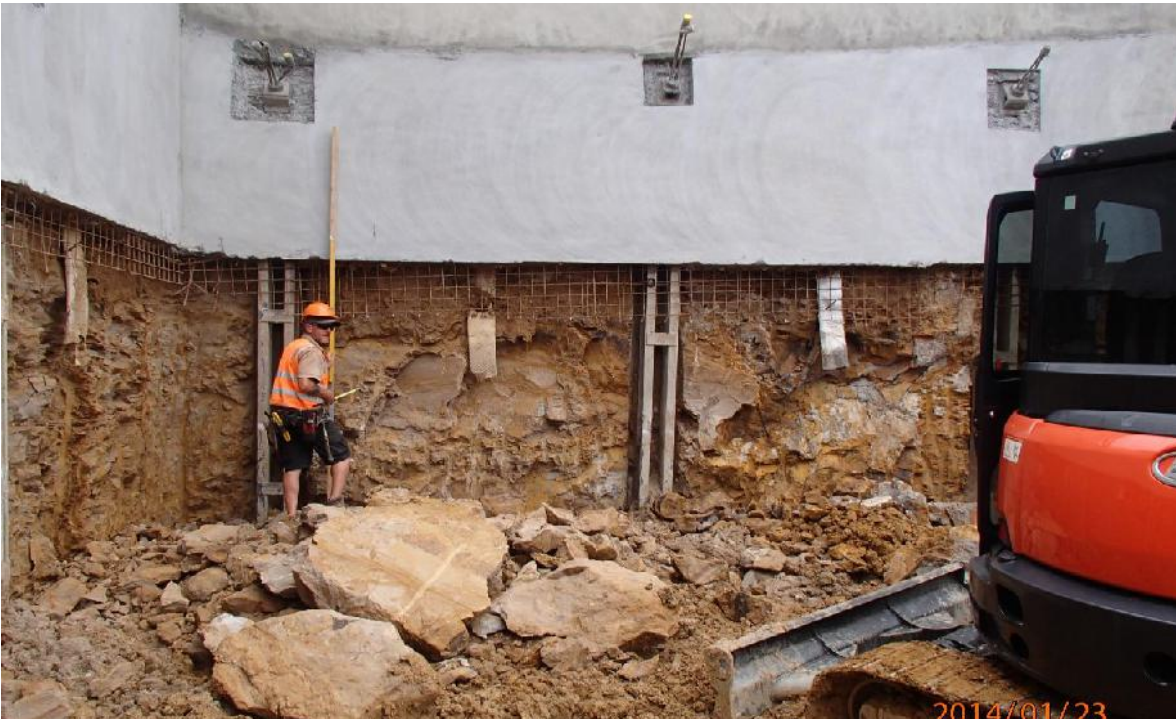
Photo 11: View looking west at a fault zone daylighting in the third bench of the Wollongong Private Hospital site adjacent to the western boundary with No. 366 Crown Street.

- Faulting was observed to intersect the western excavation face, adjacent to the boundary with No. 366 Crown Street (refer Photos 11 and 12). The strike and dip of the fault was 175°/70° east. The fault was adversely oriented (ie dipping into the excavation) and required the installation of additional temporary anchors to support the face during construction.

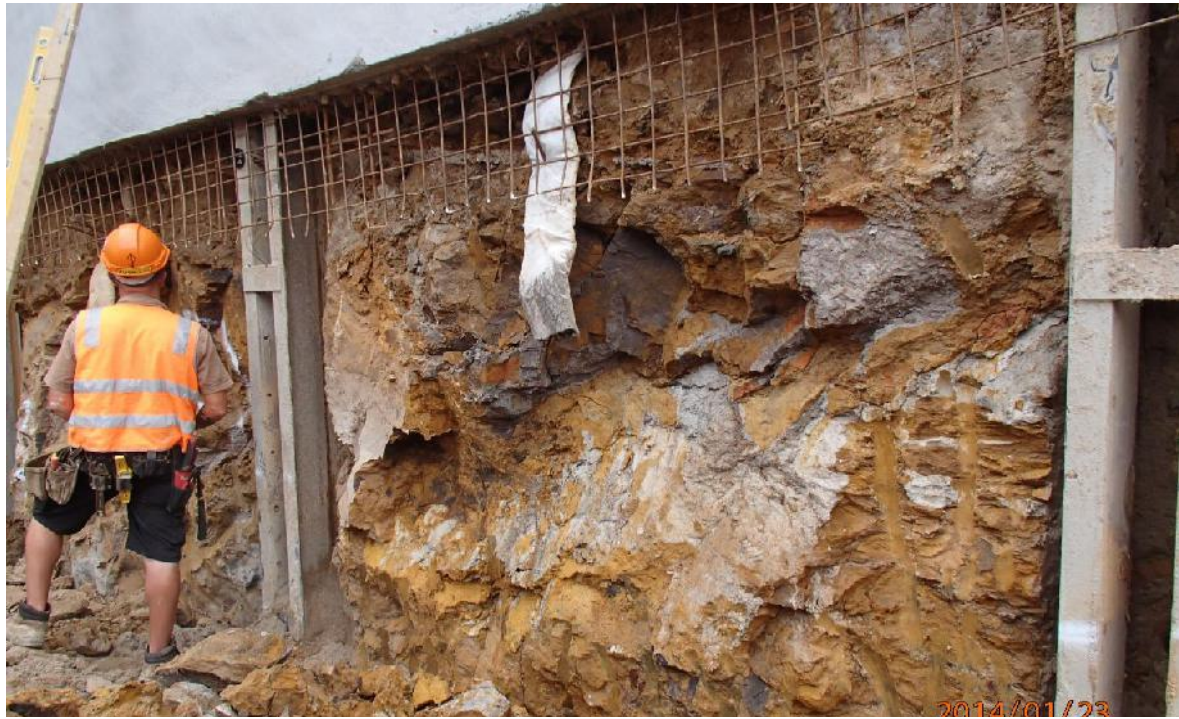
Photo 12: View looking south west at the shear surface exposed in a fault plane exposed in the third bench of the Wollongong Private Hospital adjacent to the western boundary with No. 366 Crown Street.

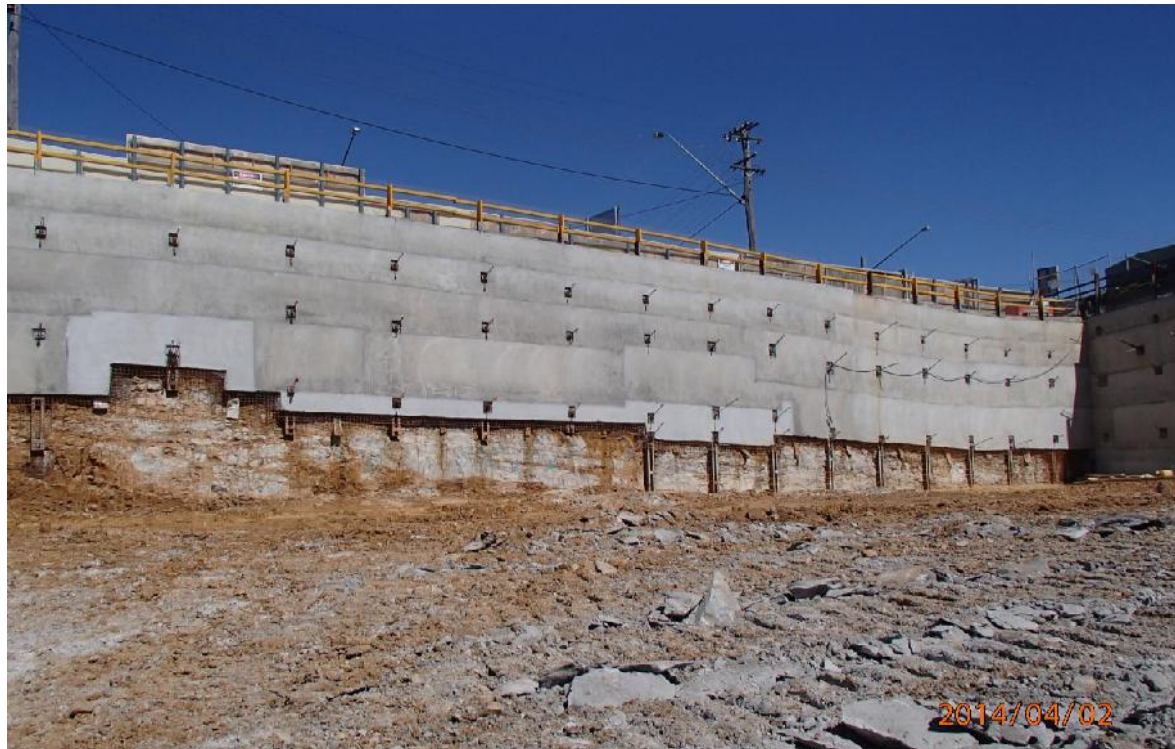
Photo 13: View looking south west toward the fifth bench of the Wollongong Private Hospital excavation adjacent to Crown Street. Note: this is the design (ie completed)

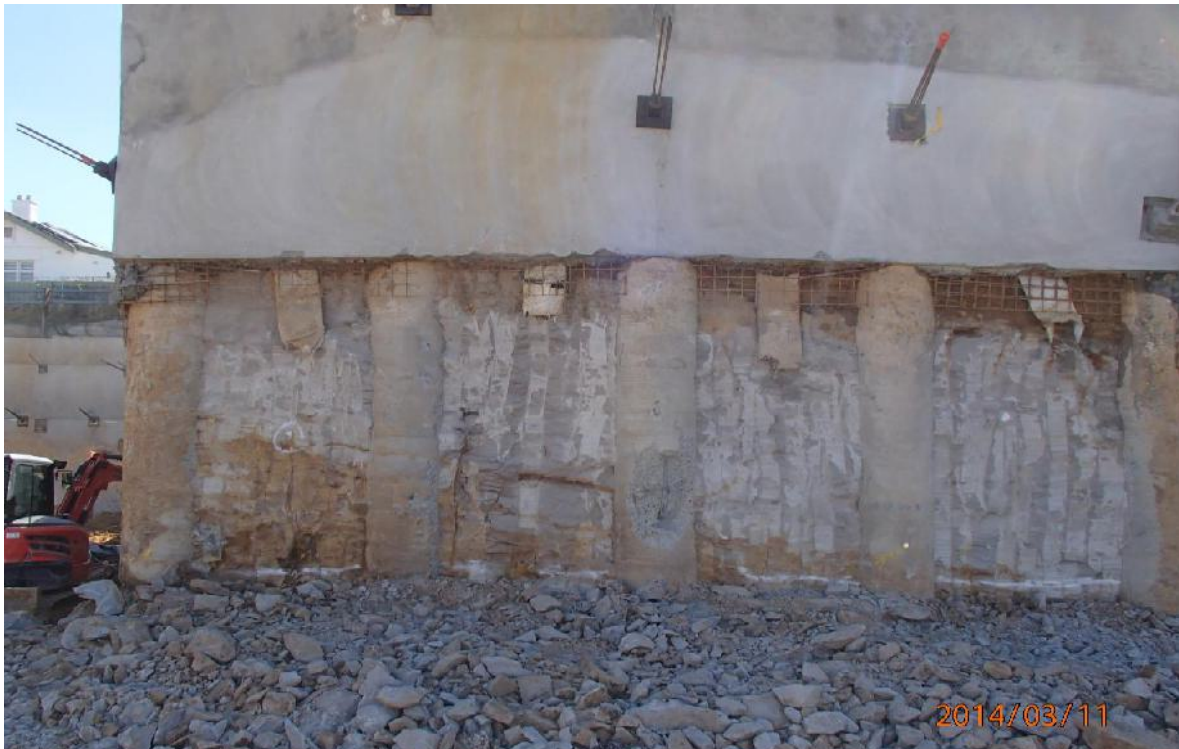
Photo 14: View looking west towards the fourth bench of the Wollongong Private Hospital excavation adjacent to the south eastern corner of No. 15 Urunga Parade.

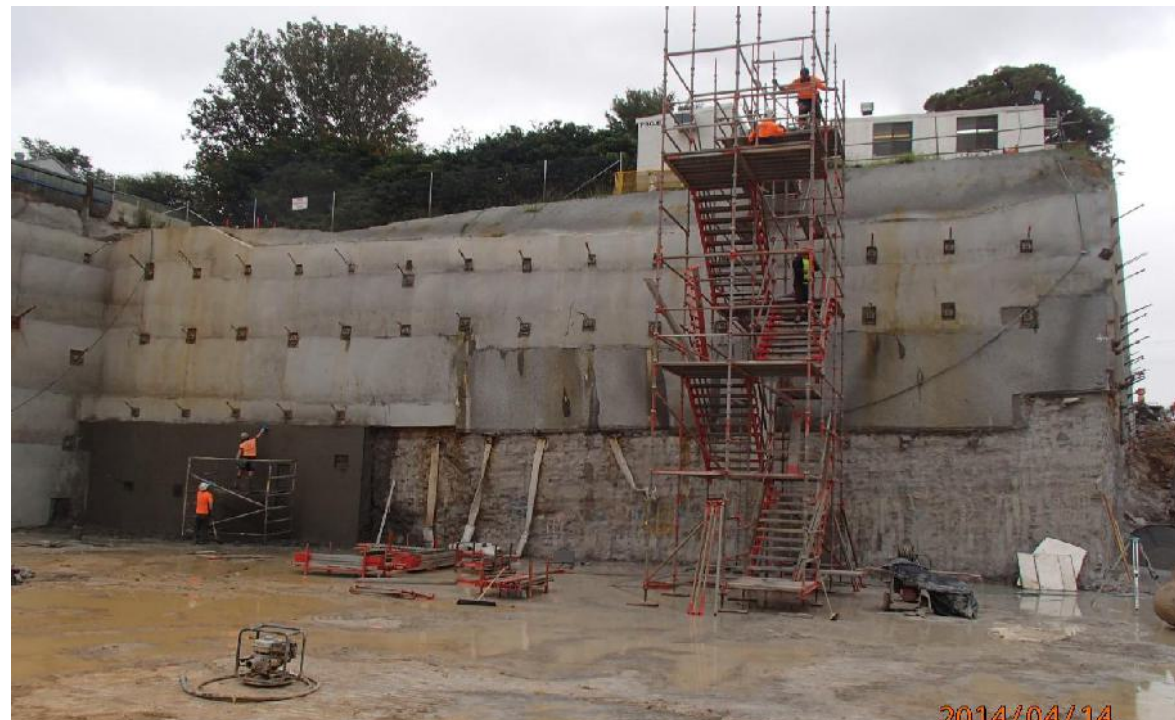
Photo 15: View looking north toward the fifth bench of the Wollongong Private Hospital excavation adjacent to the rear boundary of No. 15 and 17 Urunga Parade. Note: this is the design (ie completed) basement excavation level.

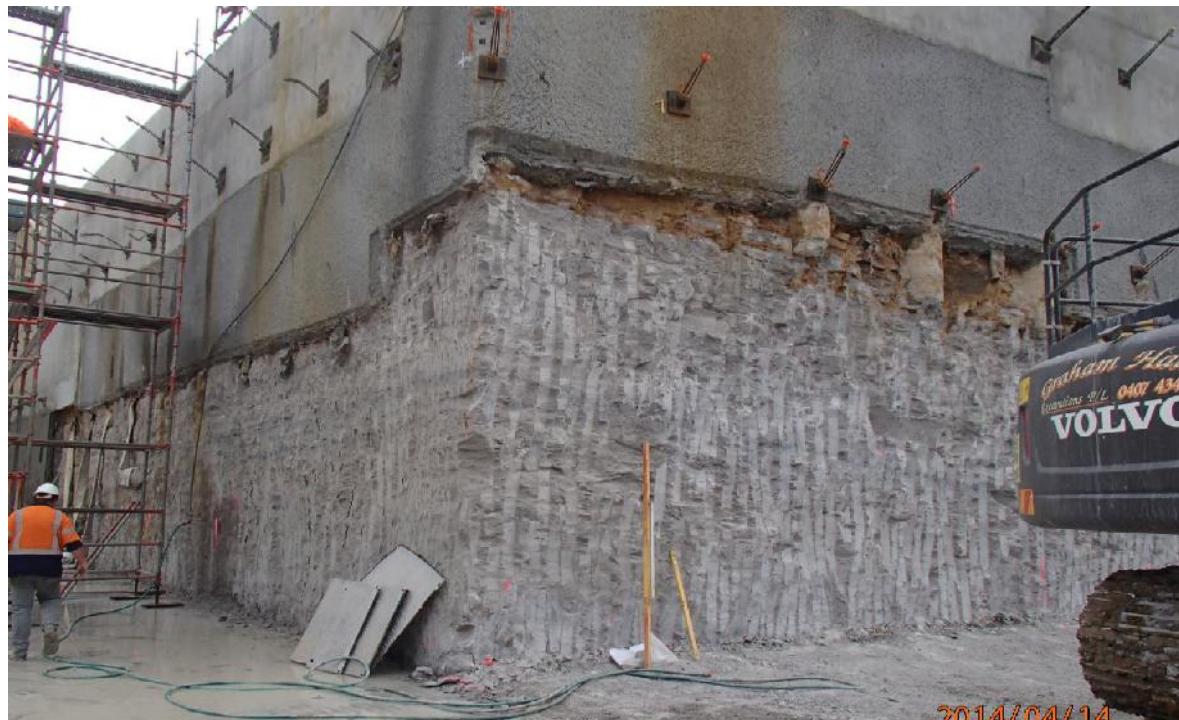
Photo 16: View looking north west toward the fifth bench of the Wollongong Private Hospital excavation adjacent to the south eastern corner of No. 15 Urunga Parade. Note: this is the design (ie completed) basement excavation level.
