**Preliminary Geotechnical Assessment**

**Proposed Multistorey Apartment Building Development**

**23-25 Ashton Avenue, The Entrance NSW**

Report No. RGS50080.2 - AC

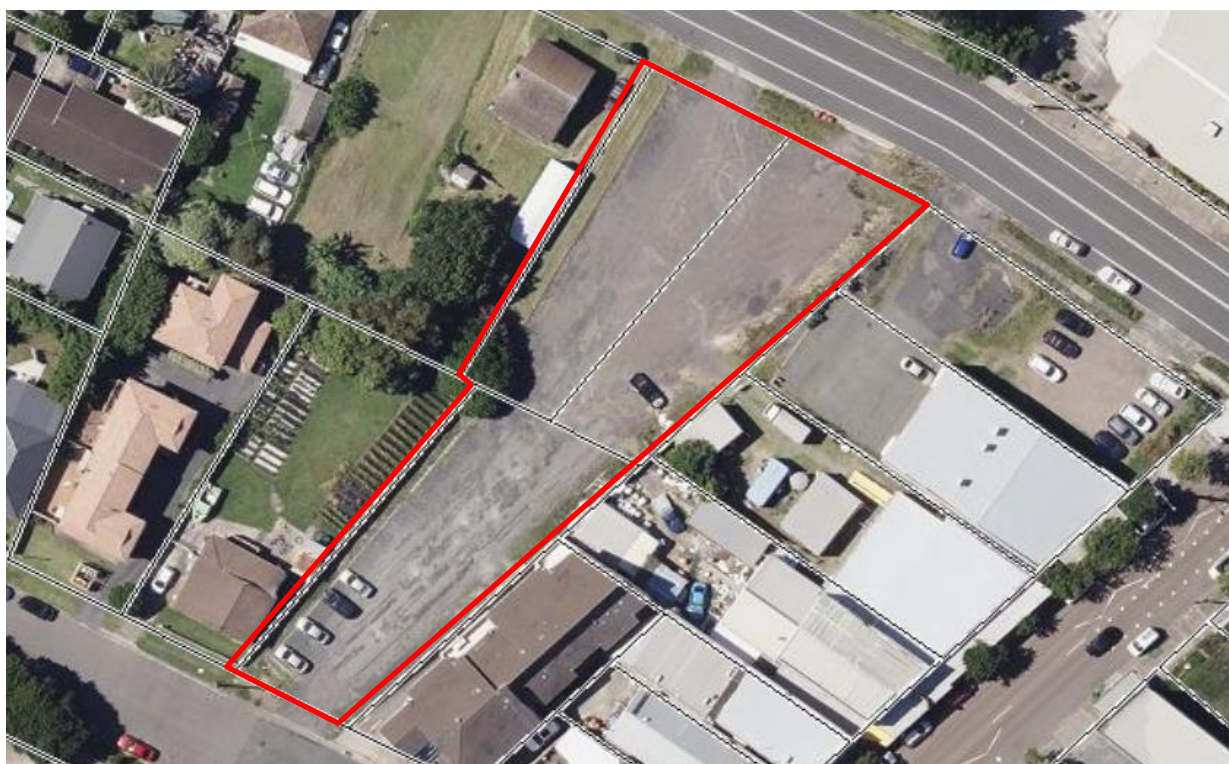
**Diagram 2:** Satellite photograph obtained from Google Earth that illustrates the site location and setting. The site boundaries are outline in red.

The site is situated within gently sloping terrain in a near coastal area between Tuggerah Lake and The Entrance Beach. A satellite photograph that shows the location of the site and the site setting is reproduced below.

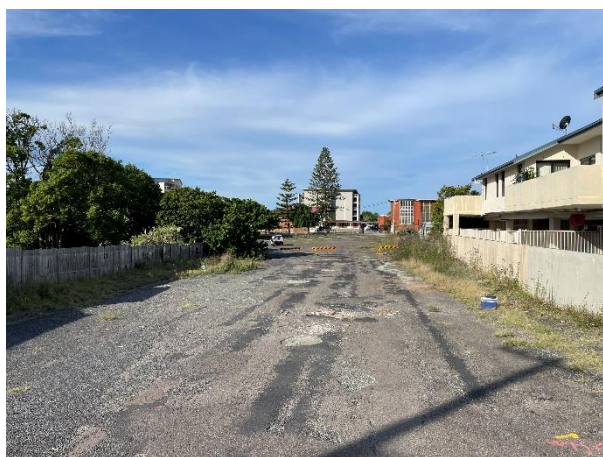
*Looking north over Lot 24. The majority of the lot is sealed with grass along the boundaries.*

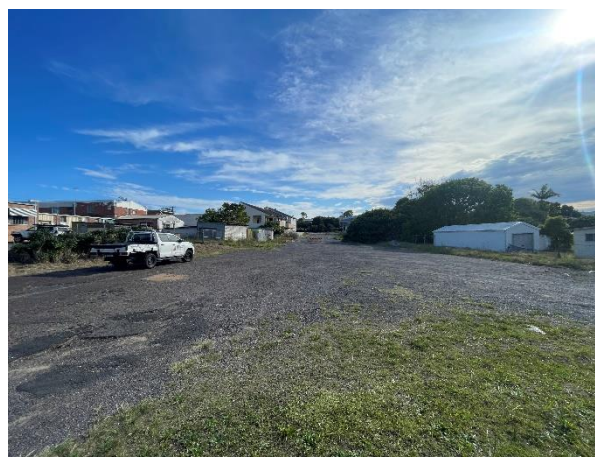
*Looking southeast over Lot 36 and 37. The majority of the lot is sealed with grass along the boundaries.*

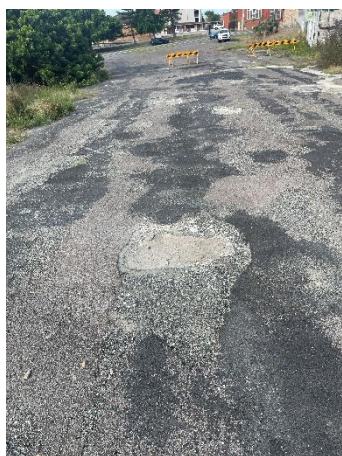
*Large pothole located in the existing seal on Lot 24.*

The site is currently vacant and sealed with a bitumen hardstand. The seal is in poor condition with various defects including large potholes.

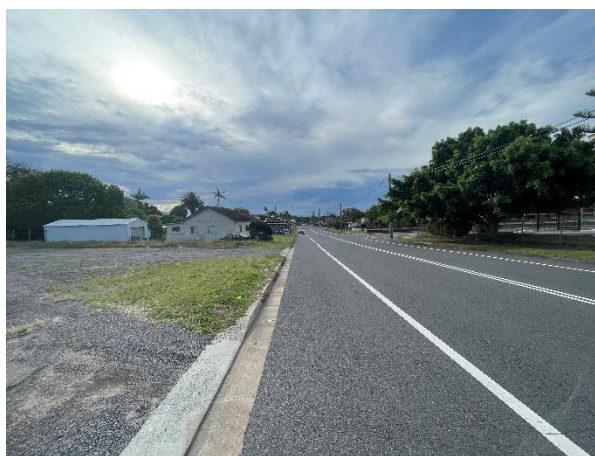
*Curb and gutter off the entrance to Lot 37.*

The northern lots are accessed via Ashton Avenue that comprises a sealed road with curb and gutter, and the southern lot is accessed via Campbell Avenue that also comprises a sealed road with curb and gutter.

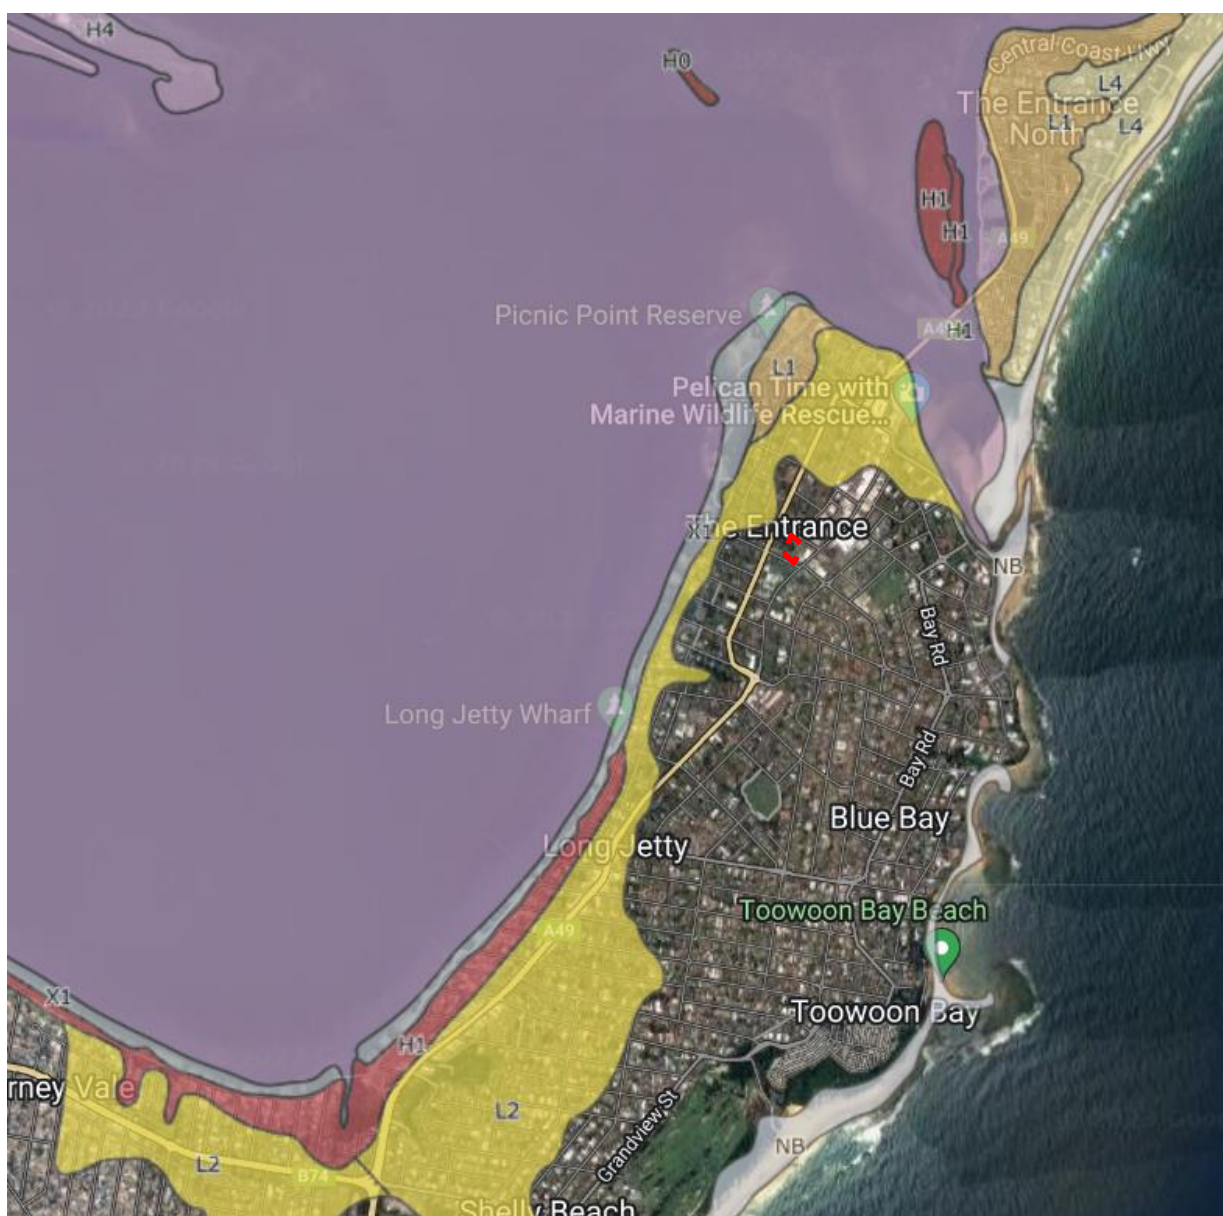
**Diagram 3:** Acid Sulfate Soils Risk map of The Entrance area is reproduced with NSW Government website "Espade v2.2" the lot boundaries are outlined red.

The Acid Sulfate Soil Risk Mapping of The Entrance area indicates the proposed development is situated approximately 200m west of an area mapped as having a low probability of ASS between a depth of 1m and 3m and within an area of marine and aeolian sand deposits. An extract of the map is reproduced below in Diagram 3.
