**Pacific Link Housing**

**Geotechnical Assessment**

**Proposed Multistorey Apartment Building Development**

**23-25 Ashton Avenue, The Entrance NSW**

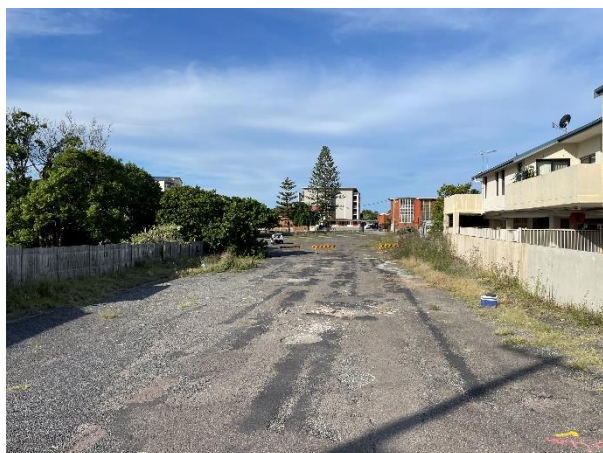
*Looking north over Lot 24. Most of the lot is sealed with grass along the boundaries.*

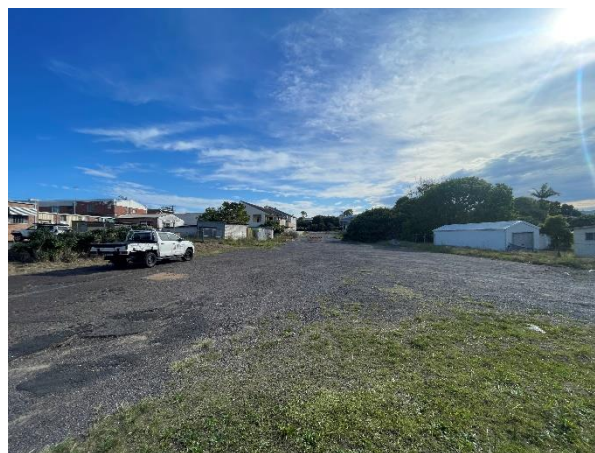
*Looking southeast over Lot 36 and 37. The majority of the lot is sealed with grass along the boundaries.*

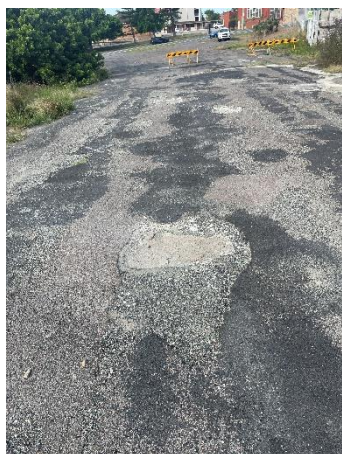
*Large pothole located in the existing seal on Lot 24.*

The site is currently vacant and sealed with a bitumen hardstand. The seal is in poor condition with various defects including large potholes.

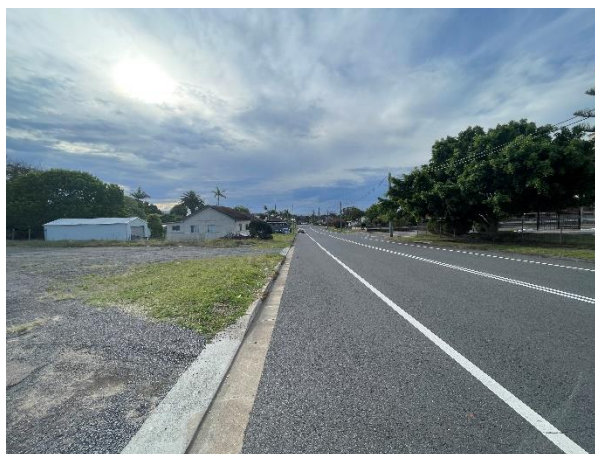
*Curb and gutter off the entrance to Lot 37.*

The northern lots are accessed via Ashton Avenue that comprises a sealed road with curb and gutter, and the southern lot is accessed via Campbell Avenue that also comprises a sealed road with curb and gutter.
