**Re: Aboriginal Heritage Due Diligence Report – Nos. 23-25 Ashton Avenue, The Entrance**

Artefact Heritage and Environment Pty Ltd (Artefact) have been engaged by WPP Planning and Property to prepare an Aboriginal Heritage Due Diligence Report for the proposed mixed use housing development at Nos. 23-25 Ashton Avenue, The Entrance.

## 1.1 Project information

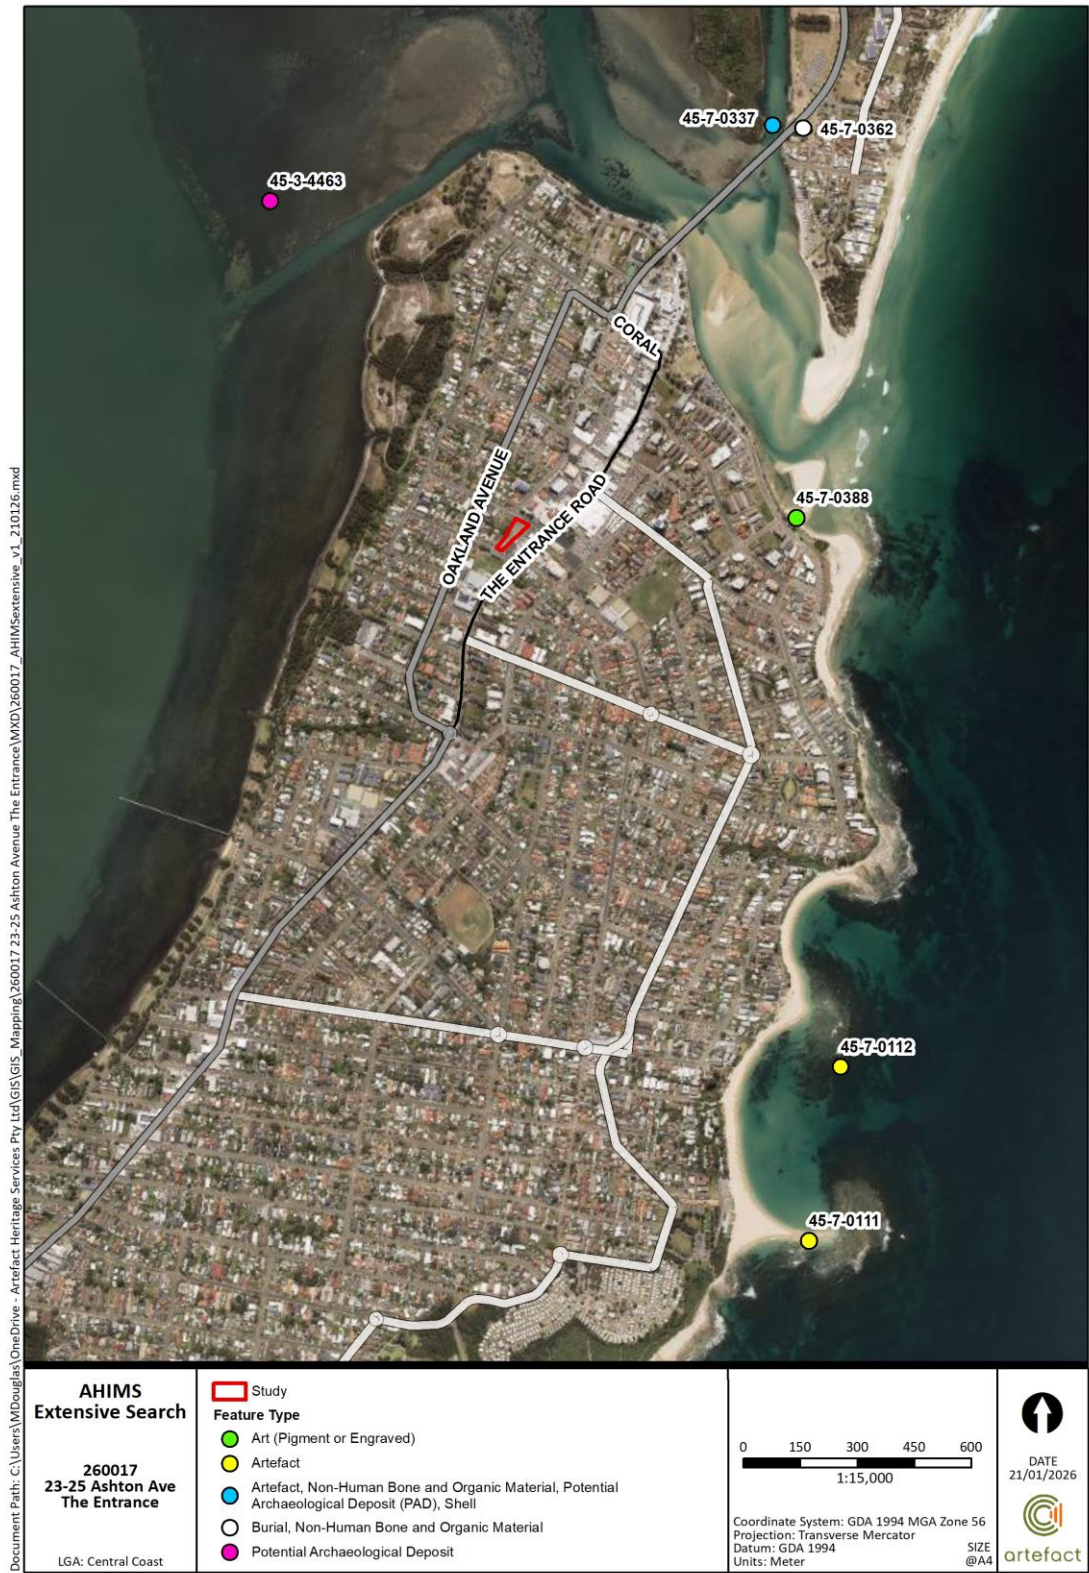
Figure 2: AHIMS site register search results

A search of the Aboriginal Heritage Information Management System (AHIMS) database (Client Service ID 1082823) was completed on 16 January 2026 for a search area measuring approximately 4 km x 4 km that encompasses the study area (Figure 2). The parameters of this search were:

A total of 6 registered Aboriginal sites were identified within the search area (Figure 2). There were 0 registered Aboriginal sites within the study area. The closest AHIMS site identified in the search is located approximately 704m east of the study area.

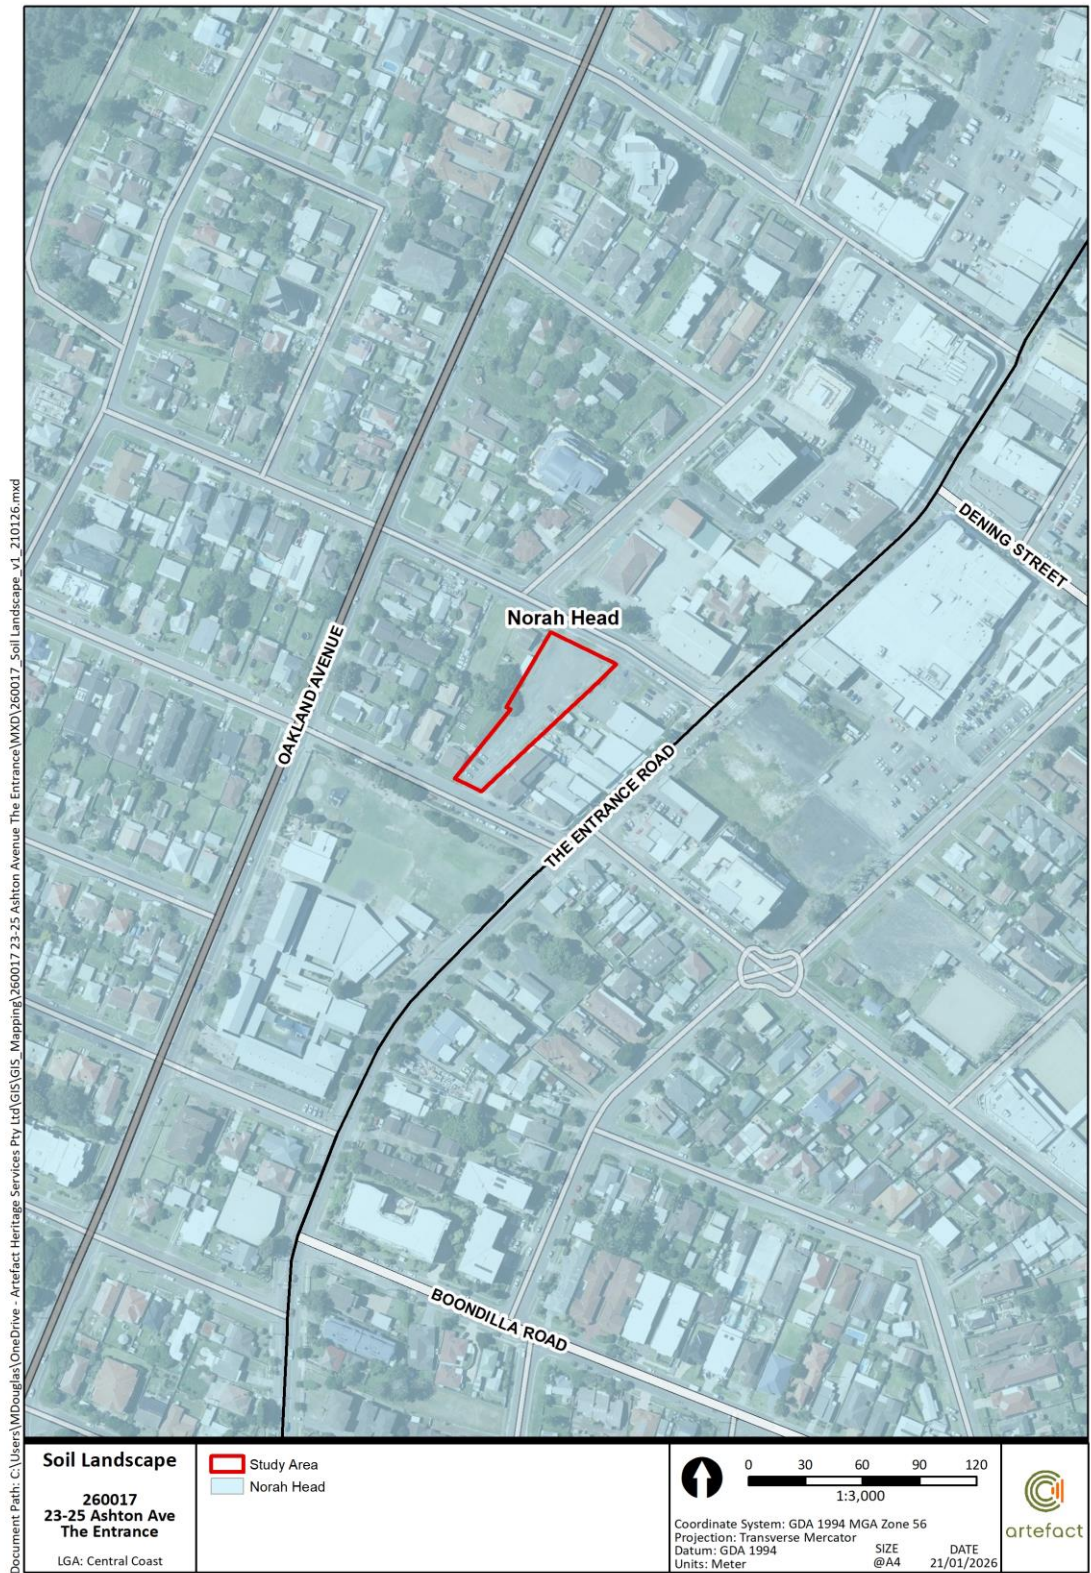
Figure 3: soil landscape of the study area

| Environmental Context | Description |
|---|---|
| Soil | The study area is located within the Norah Head soil landscape (Figure 3). Norah Head soils are located on elevated undulating sand sheet plains to rolling dune fields and sand sheets of windblown sand on coastal headlands. The soils are deep (c.200cm) with an extreme wind erosion hazard and high water erosion hazard. Erosion has likely been stabilised by the high levels of urban development in The Entrance. Vegetation would have also been cleared during development. The soils in this area have very low water-holding capacities (eSPADE, 2026), meaning that any potential surviving Aboriginal artefacts would likely be lithic remains which would survive water damage. |

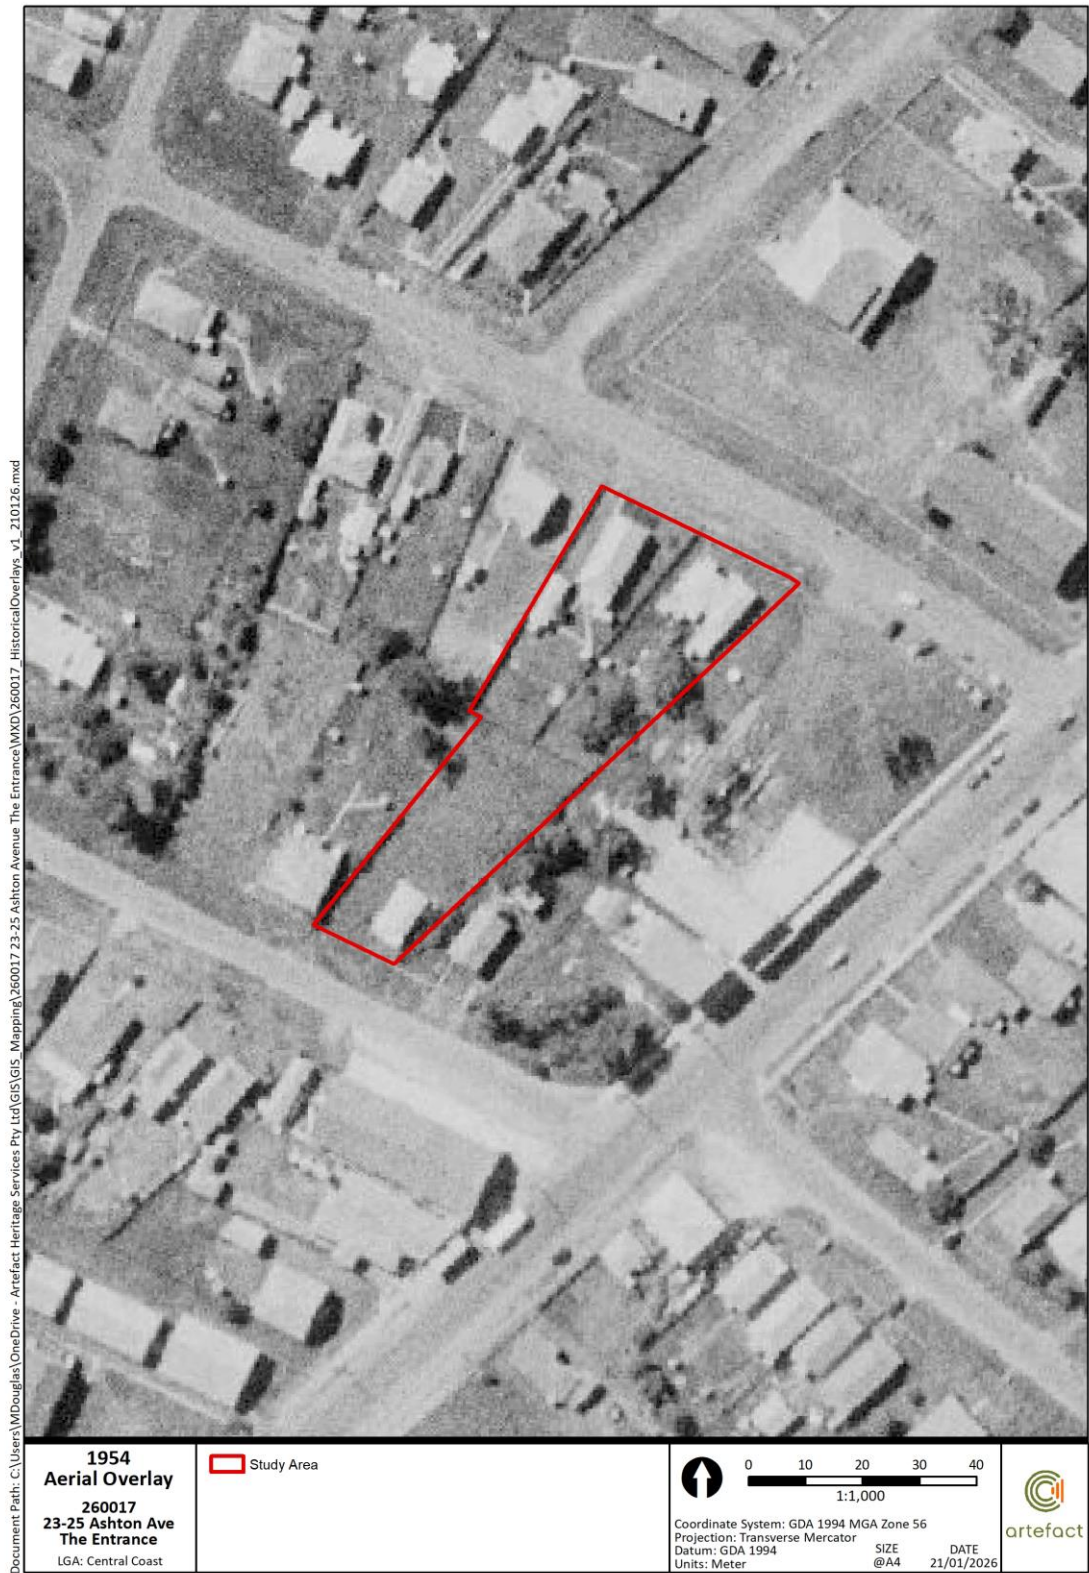
Figure 6: 1954 historic aerial imagery of the study area

1954 historic aerial imagery shows the study area as partially covered by three structures, appearing to be two residential structures in the north and an outbuilding or shed in the south. Foundation works for these structures during construction may have contributed to ground disturbance in the study area (Figure 6). By 1965, the shed or outbuilding structure in the south of the study area had been removed and the land appeared unoccupied to the south of the two residential structures which were still present. A fence line can be seen between the two properties, and the property in the west of the study area had added more outbuildings between 1954 and 1965, possibly contributing to ground disturbance (Figure 7).

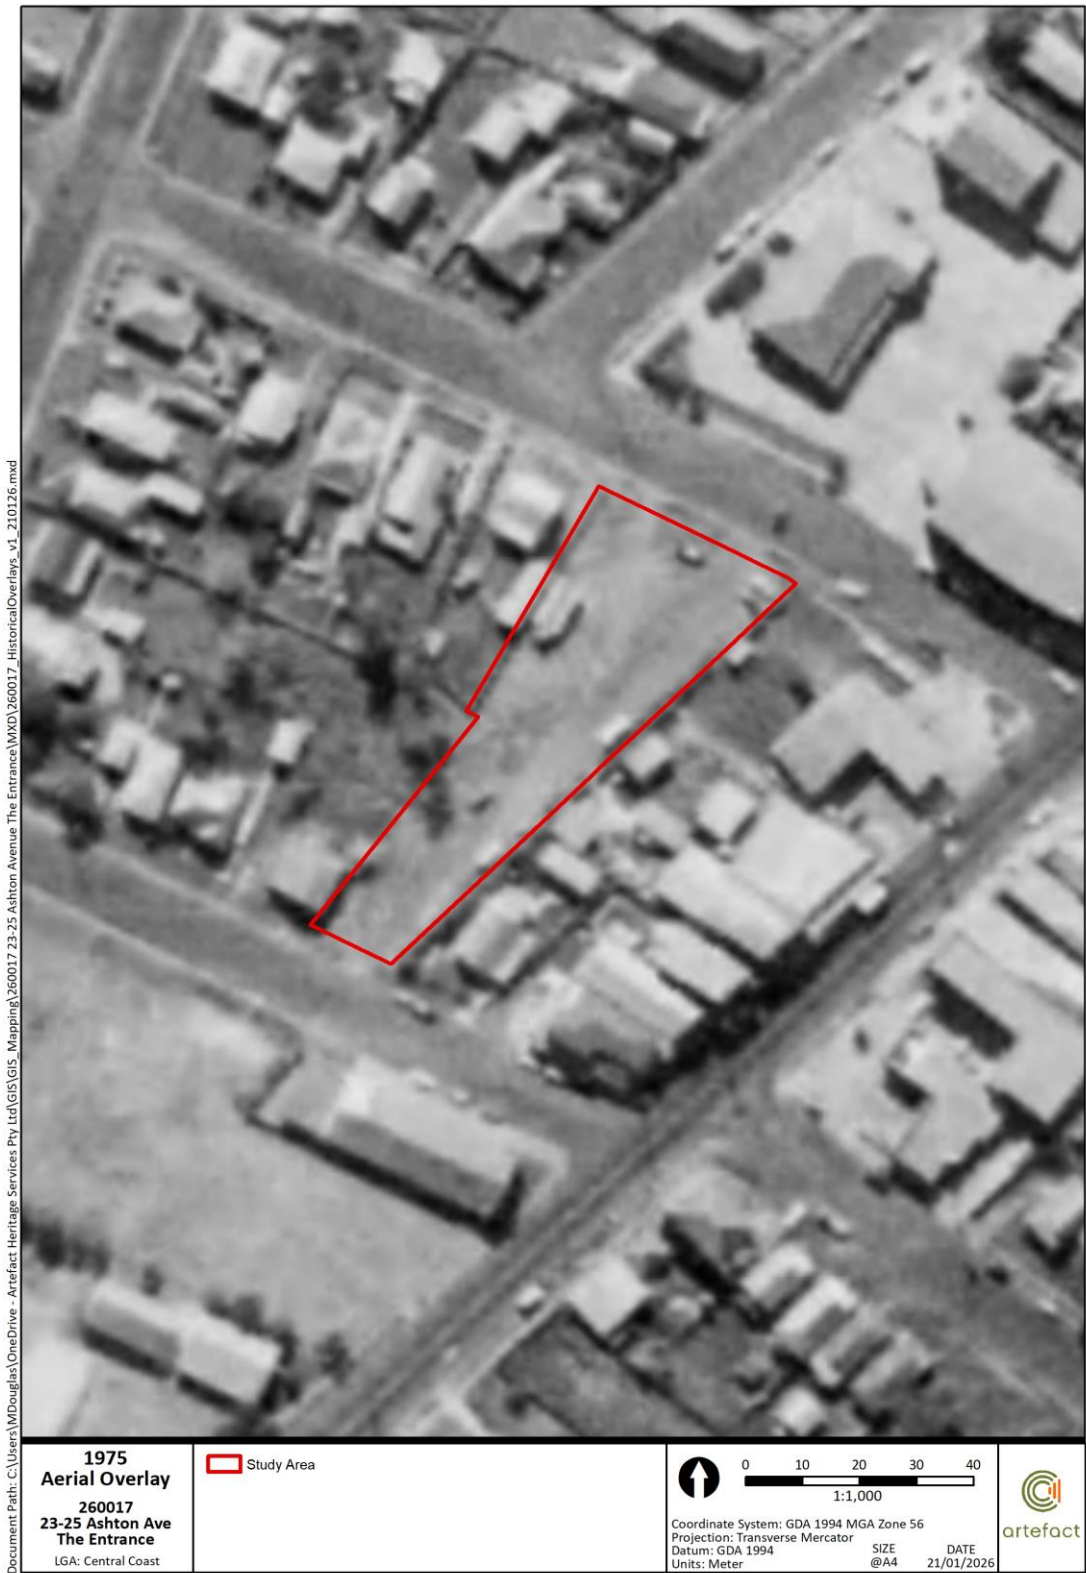
Figure 8: 1975 historic aerial imagery of the study area

Between 1965 and 1975 the two residential structures were demolished, leaving only minor outbuildings occupying the study area, which otherwise appears completely cleared. This included vegetation clearance as well as demolition of the structures, which would have contributed to ground disturbance (Figure 8). By 1990, the study area had been mostly tarmacked and was in use as a car park, which has been the case until the present day (Figure 9).

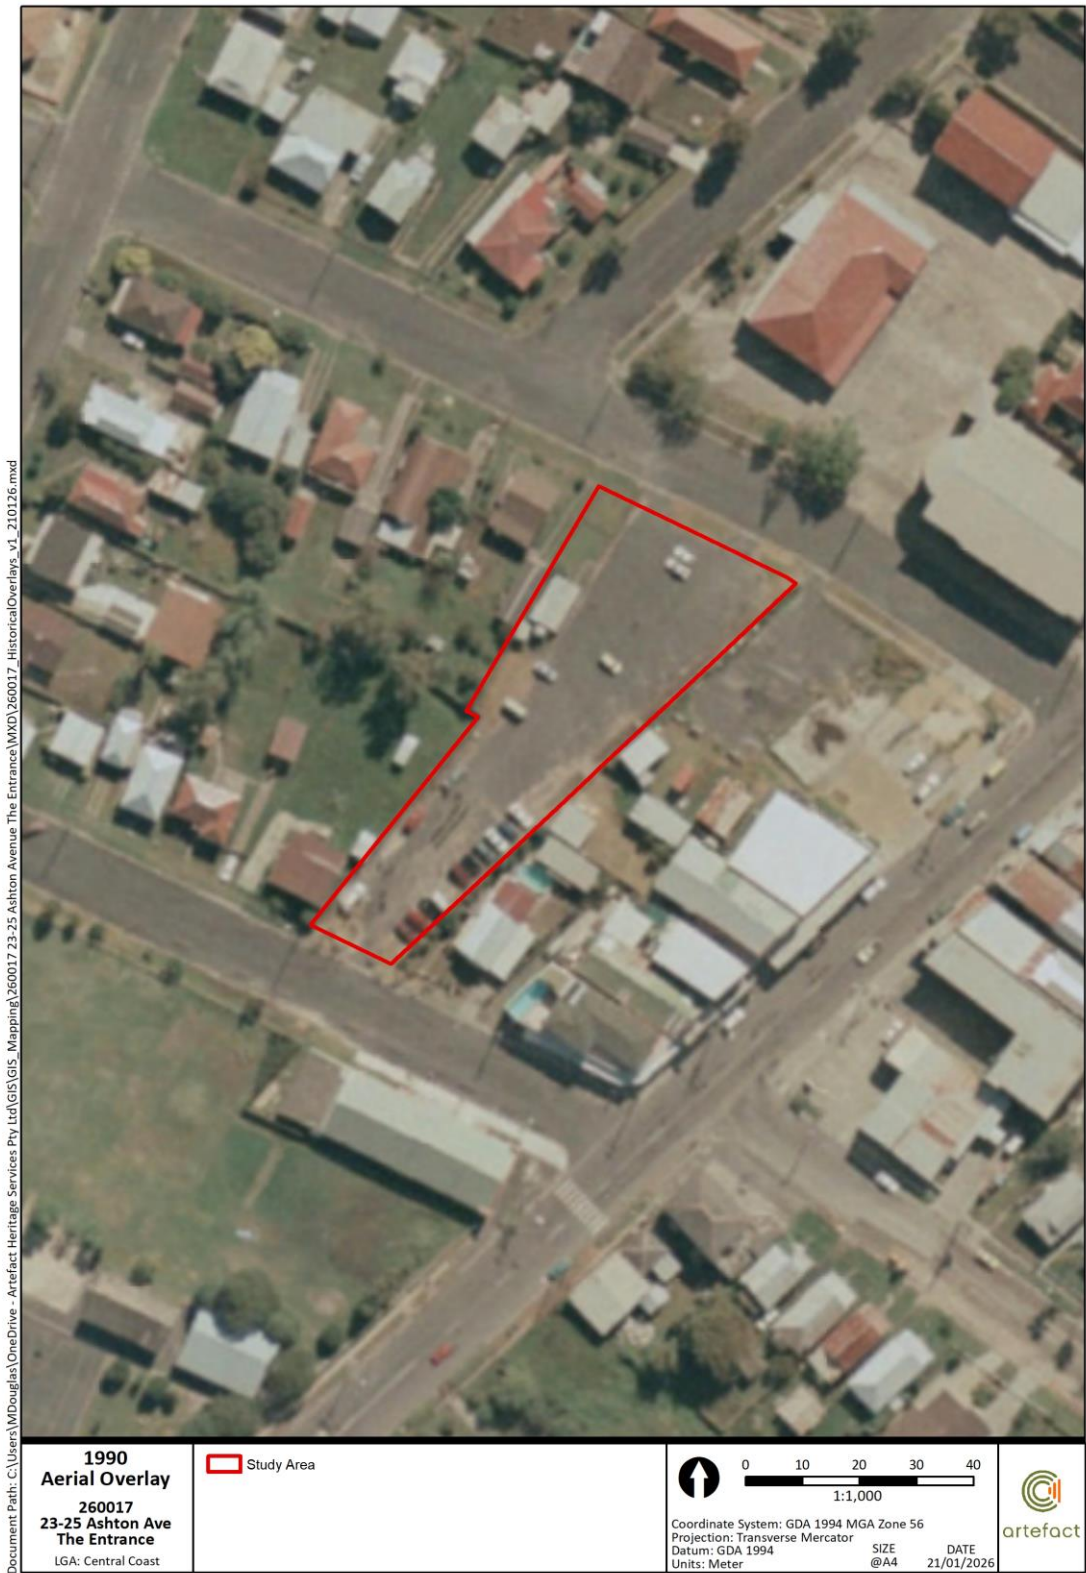
Figure 9: 1990 historic aerial imagery of the study area

The construction and removal of the residential structures in the area prior to 1975, as well as the removal of trees and vegetation in preparation for the study area being tarmacked for use as a car park would have disturbed the natural ground surface. This may have contributed to the disturbance or destruction of Aboriginal artefacts that may have been present in the study area. However, the residential structures did not cover the whole of the study area, and it is unlikely that tarmacking for conversion into a car park would have impacted the ground deep enough to affect the entirety of the Norah Head soils, which have a depth of c.200cm.

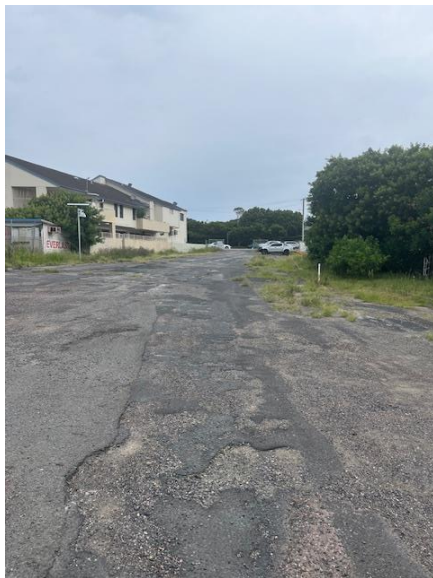
**Figure 11: View South from Ashton Avenue towards Campbell Avenue**

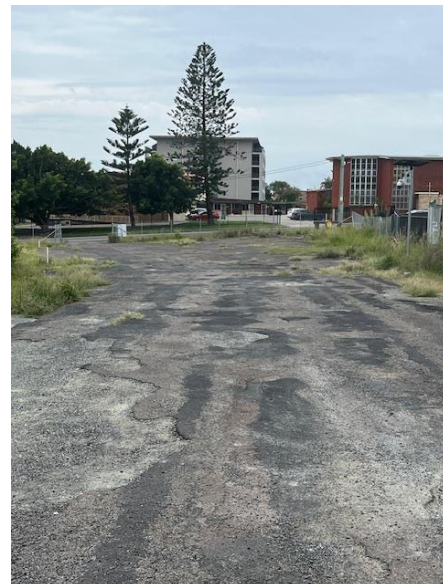
**Figure 12: View North from Campbell Avenue towards Ashton Avenue**

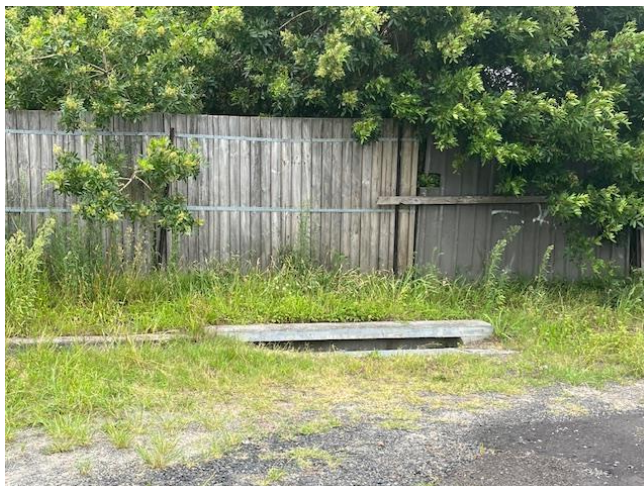
**Figure 13: Gutter and drain on eastern side**

No Aboriginal objects or areas of potential were identified during the site inspection. Ground surface visibility was very low however the presence of drainage works and previous paving of the area suggests disturbance to the top layers of sediment.

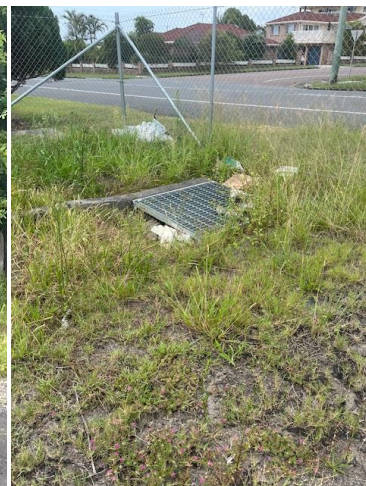
**Figure 14: example of drain found on eastern and western sides of study area**

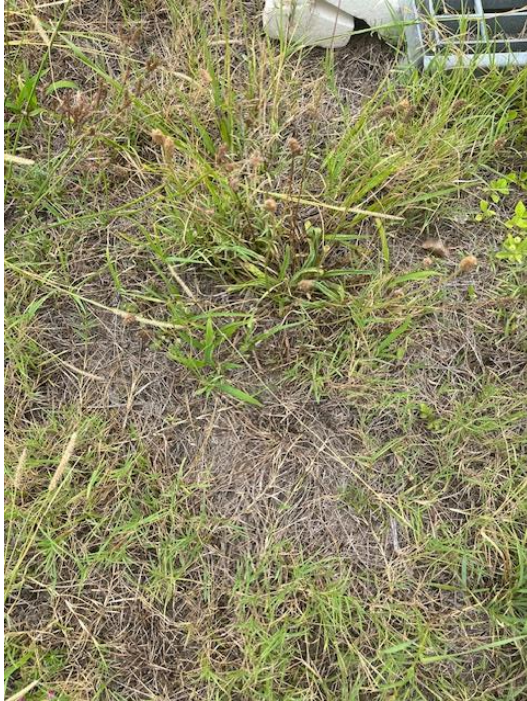
Figure 15: example of typical ground cover and soil exposure over bitumen on edges of study area

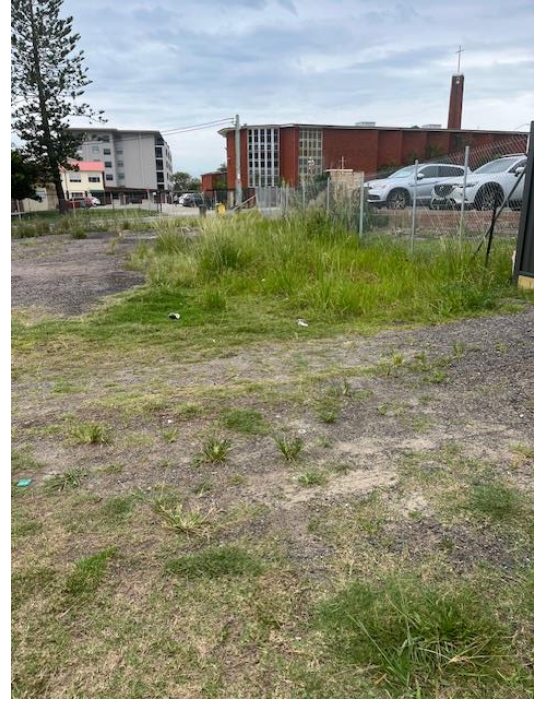
Figure 16: Vegetated area over drain line on eastern side of study area
