# ATTACHMENT A OEH REVIEW OF ISSUES FOR THE CURRAWARRA SOLAR PROJECT

## RESPONSE TO SUBMISSIONS (SSD 8437)

### Currawarra Solar Farm

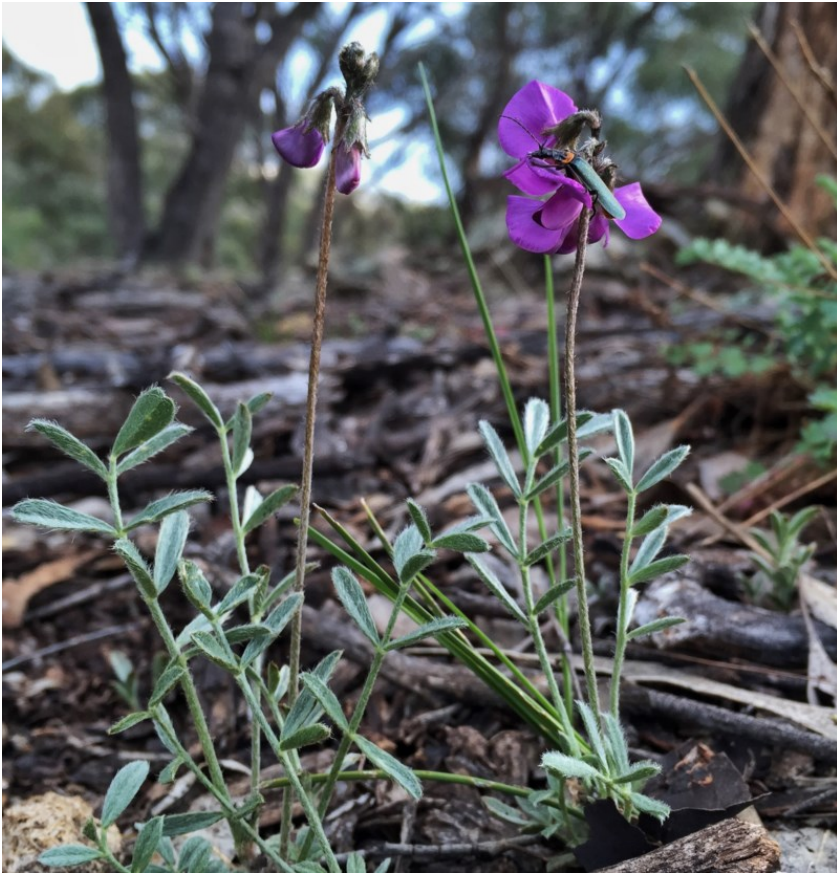
Photograph 1 – *Swainsona sericea* (<https://canberra.naturemapr.org/Community/Sighting/1948178>)

| Issue | OEH Issue (identified in EIS response) | RES response | OEH response to RTS | Timing |
|---|---|---|---|---|
| 4 | Spring survey is required for four plant species: a spear grass ( <i>Austrostipa wakoolica</i> ), Silky Swainson-pea ( <i>Swainsona sericea</i> ), Slender Darling Pea ( <i>Swainsona murrayana</i> ) and Winged Peppercress ( <i>Lepidium monoplocoides</i> ). The BAR needs to be revised once these results are known. | <p>Areas of native vegetation were surveyed for <i>Austrostipa wakoolica</i>, <i>Swainsona sericea</i>, <i>Swainsona murrayana</i> and <i>Lepidium monoplocoides</i> using parallel field transects within areas of suitable habitat as identified within the BAR (NGH, 2017). These included areas of PCTs 15, 16 and 80 containing native understorey.</p> <p>Three species of <i>Austrostipa</i> were identified during these surveys; <i>Austrostipa scabra</i>, <i>Austrostipa aristiglumis</i> and <i>Austrostipa blackii</i>. No <i>Austrostipa wakoolica</i> observed.</p> <p>No <i>Lepidium monoplocoides</i> were observed during surveys. One <i>Lepidium</i> species, (<i>Lepidium pseudohyssopifolium</i>) was identified during previous surveys of the development envelope.</p> <p>No <i>Swainsona murrayana</i> or <i>Swainsona sericea</i> were identified during surveys. One pea forb was identified during previous surveys, which was identified during this survey as the exotic <i>Astragalus hamosus</i>.</p> <p>Surveys were also undertaken to check for the presence of <i>Amphibromus fluitans</i>. Irrigation channels and dams were checked for the presence of the species; however, the majority of irrigation channels were dry and cleared, and the species was not detected.</p> <p><b>The BAR is not considered to require updating for these species.</b></p> | <p>We note that targeted fauna survey was undertaken in December 2017. The Threatened Species Profile Database lists September and October as the months when <i>Swainsona sericea</i> can be identified during field survey.</p> <p><i>Swainsona sericea</i> is a species credit species and must be assessed in accordance with Section 6.5 of the FSA</p> <p><b>Recommended further action:</b></p> <p>4.1. Confirm if surveys for <i>Swainsona sericea</i> were undertaken during September or October.</p> <p><b><u>It is acknowledged that the species was not surveyed during the period identified within the Threatened Species Profile Database. However a targeted survey was conducted in December 2017 and included walked parallel transects, and any plants within the <i>Swainsona</i> genus would likely have been present at that time in a vegetative state with leaves present. Were <i>Swainsona</i> present on site, any individuals would have flowered and fruited by the time of survey, thus would have been identifiable.</u></b></p> <p><b><u>The pea-like forb detected on site during initial surveys in May and August, and during targeted surveys in December was not able to be identified to species level as the sample of the plant wilted in the heat in December. However, the plant is considered likely to be the exotic species <i>Astragalus hamosus</i>. The NSW PlantNET description for <i>Swainsona sericea</i> states that the species has “stems densely pubescent with medifixed hairs, hairs appressed or with both ends raised”. An example of <i>Swainsona sericea</i> is provided in Photograph 1 below. The plants detected on site were not densely pubescent, as</u></b></p> | Pre-determination |

| Issue | OEH Issue (identified in EIS response) | RES response | OEH response to RTS | Timing |
|---|---|---|---|---|
| | | | <p><u>shown in Photograph 2. The plant shown in Photograph 2 is likely <i>Astragalus hamosus</i>, and we are able to confirm that is not <i>Swainsona sericea</i>.</u></p> <p><u>Furthermore, <i>Swainsona sericea</i> was assessed as having a low likelihood of occurrence within the vegetation due to the highly degraded nature of the roadside vegetation. This vegetation is subject to regular slashing, and has a disturbed soil profile. The surveys conducted within the site have identified all flora species present as above ground vegetation at time of survey, and were individuals of the <i>Swainsona</i> genus present, they would have been identified during surveys. As such, adequate survey is considered to have been conducted to assess the occurrence of the species on site.</u></p> <p><i>4.2. S. sericea must be included in the assessment unless adequate justification that it is not present on the proposal site is given in accordance with FBA Paragraph 6.5.1.3.</i></p> <p><u>As discussed above, surveys undertaken in August and December are considered adequate for the detection of the species, were the species present on site. The species was included as a species requiring survey as it could not be ruled out as a species requiring further assessment in accordance with FBA Paragraph 6.5.1.3</u></p> | |

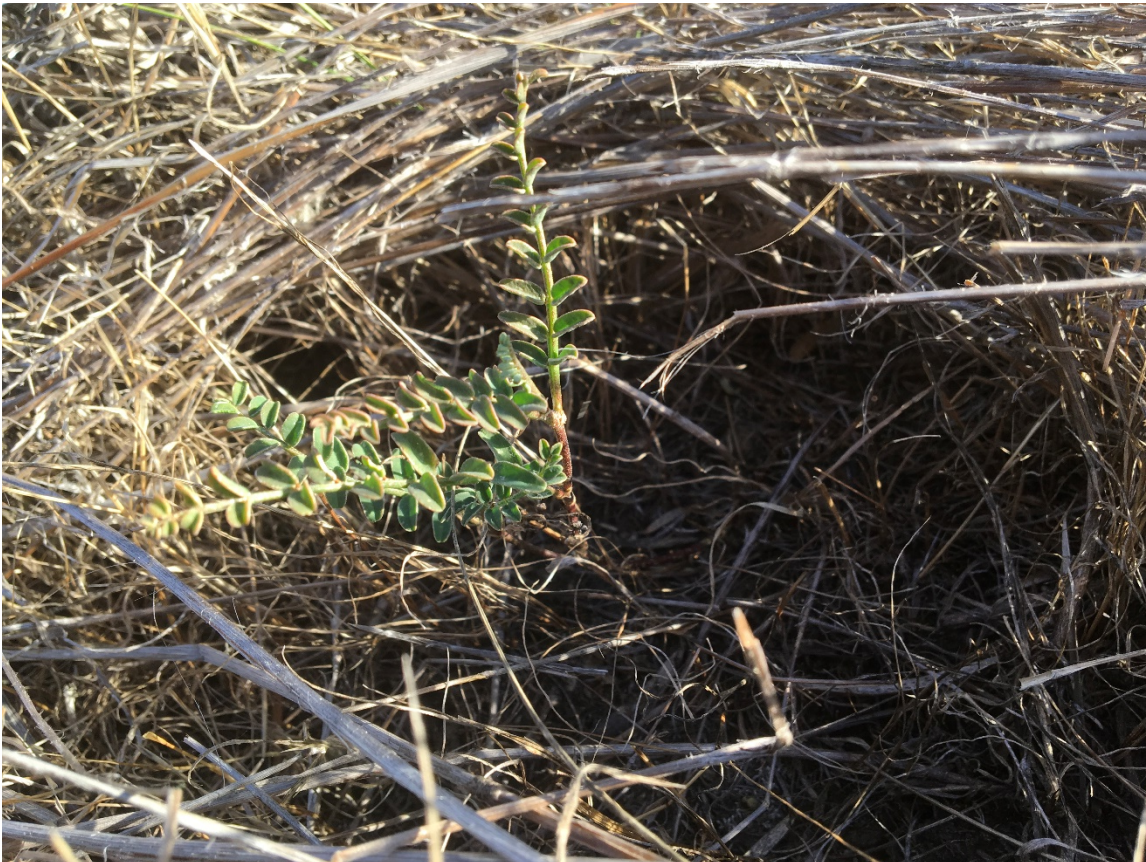
Photograph 2 – Fabaceae sp. within the north-eastern corner of Parfreys Road site

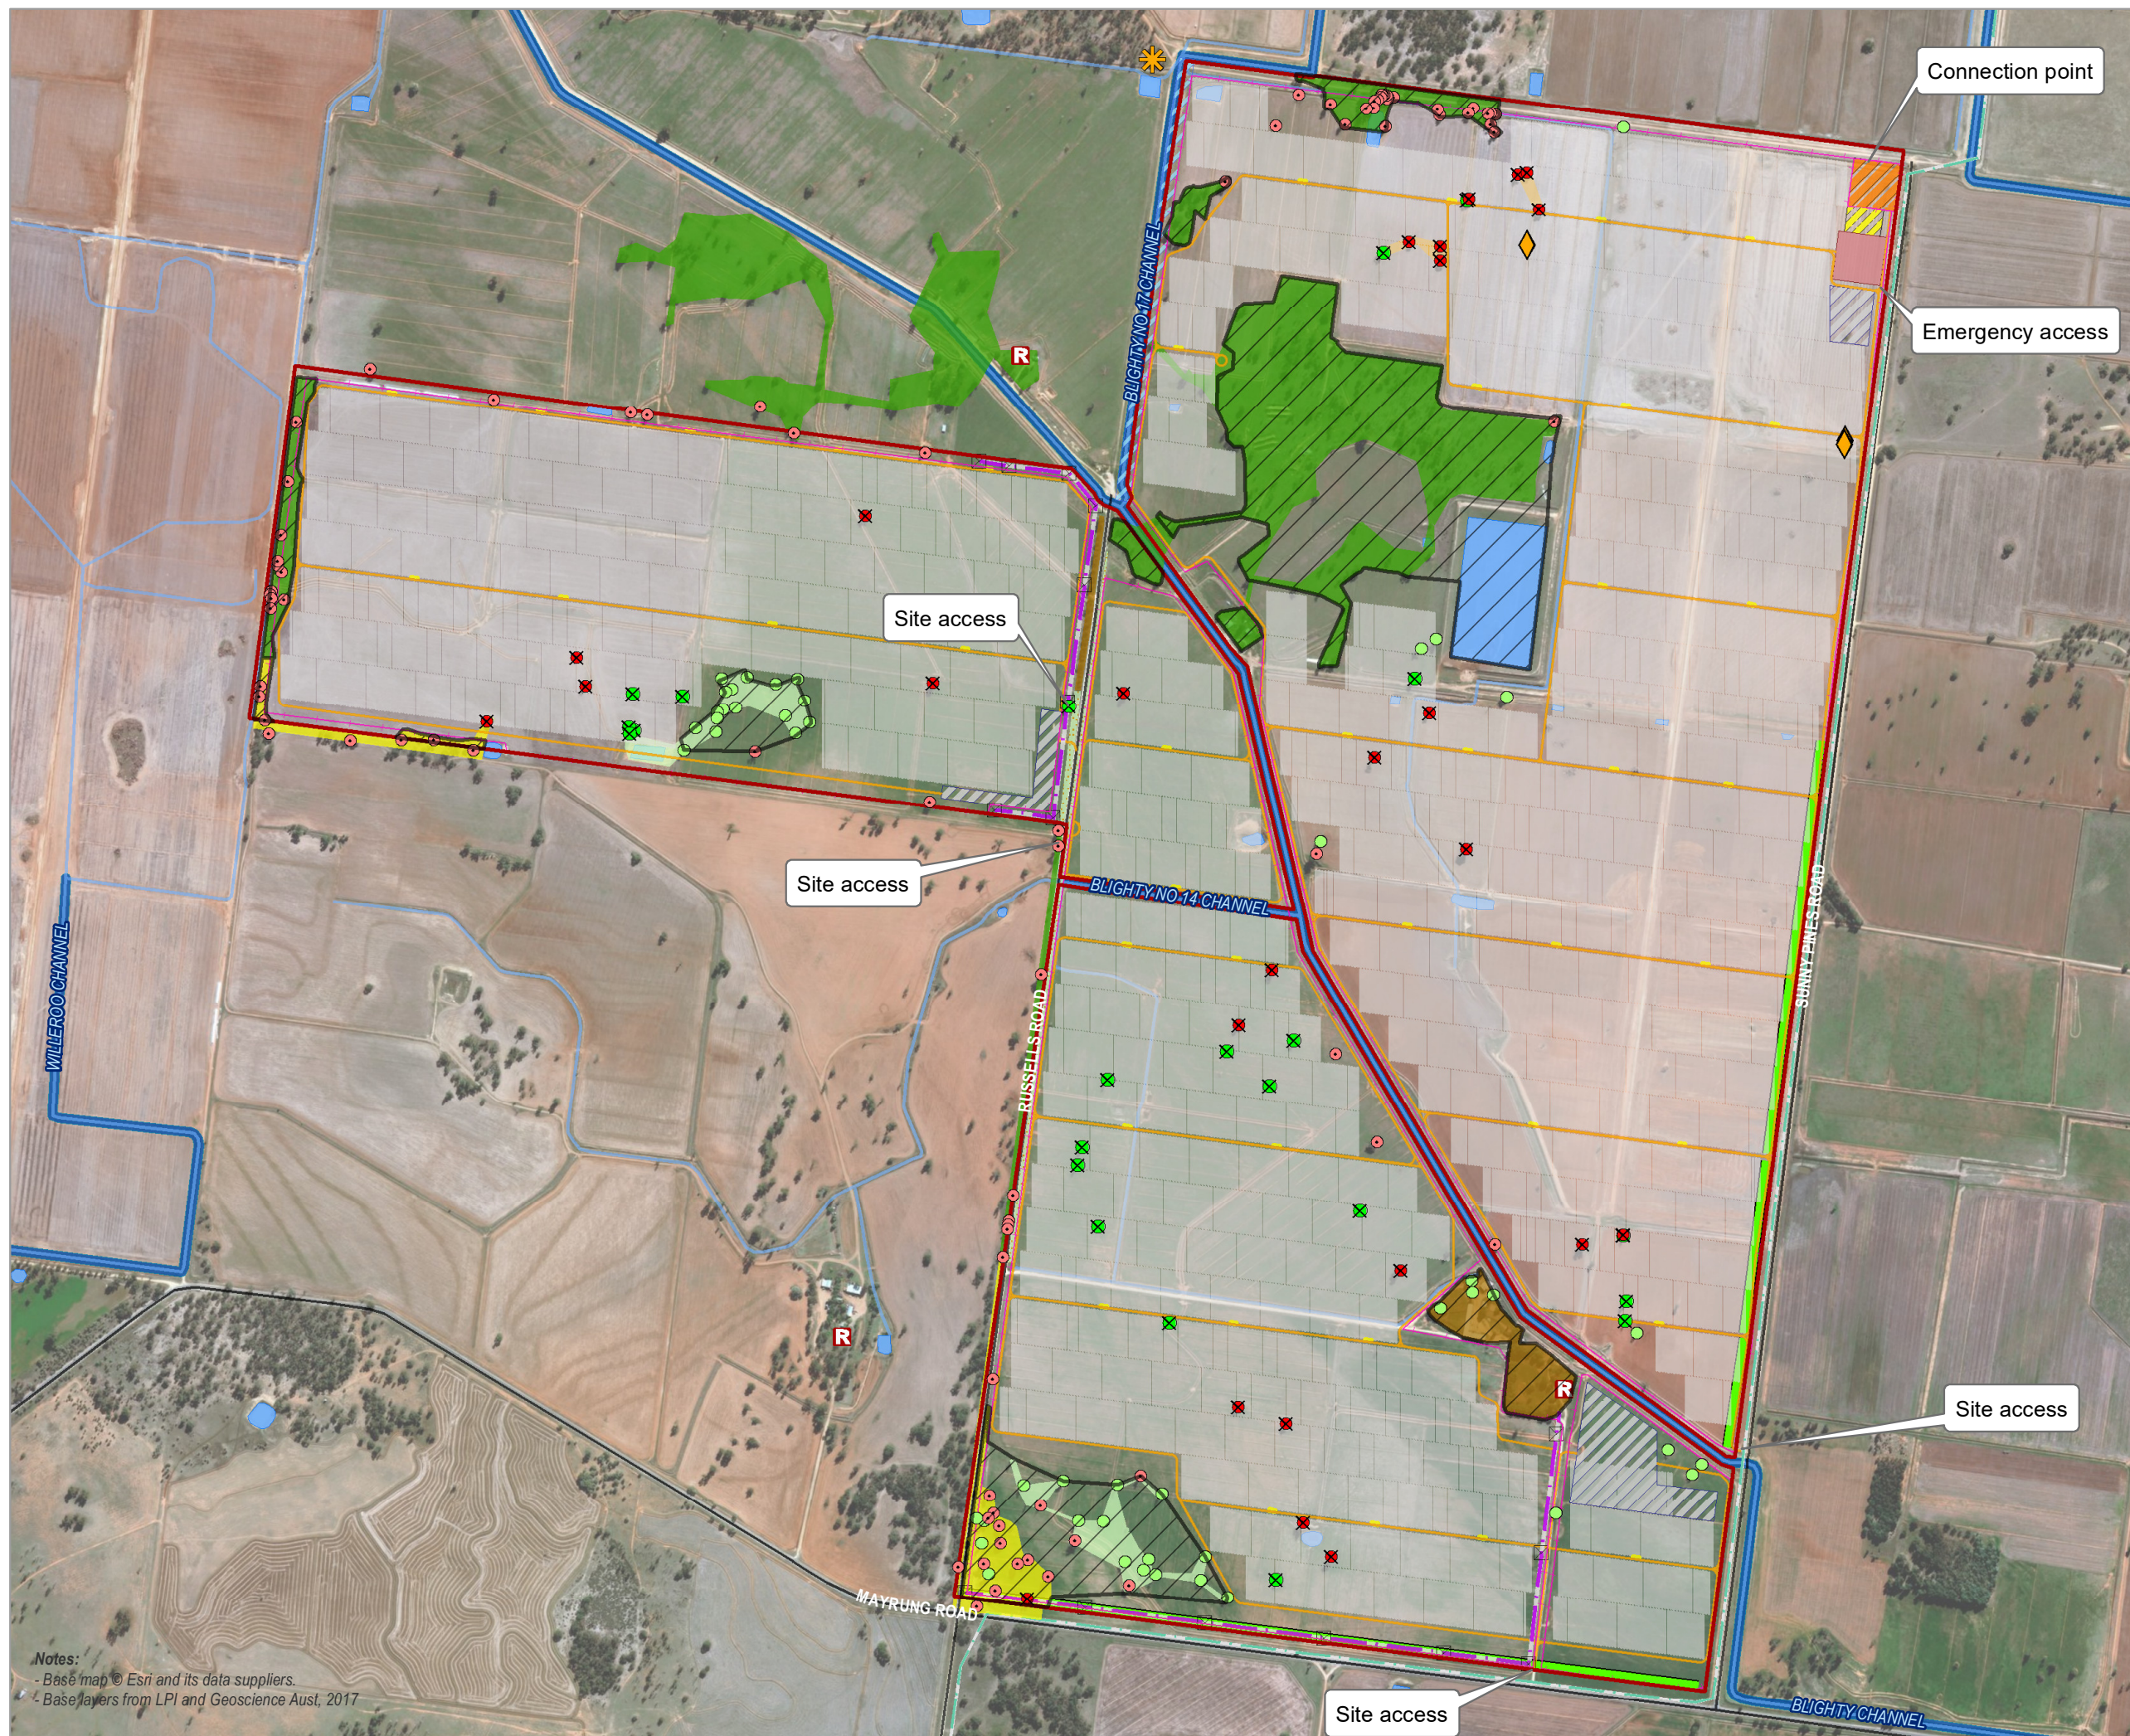
## PROPOSAL LAYOUT AND SITE CONSTRAINTS

- Revise the main project layout map (Appendix A – RTS) to include the development footprint boundary.  
 This plan will follow next week
