Remedial Action Plan, 253-265 Pacific Highway, North Sydney

Report

13 June 2025

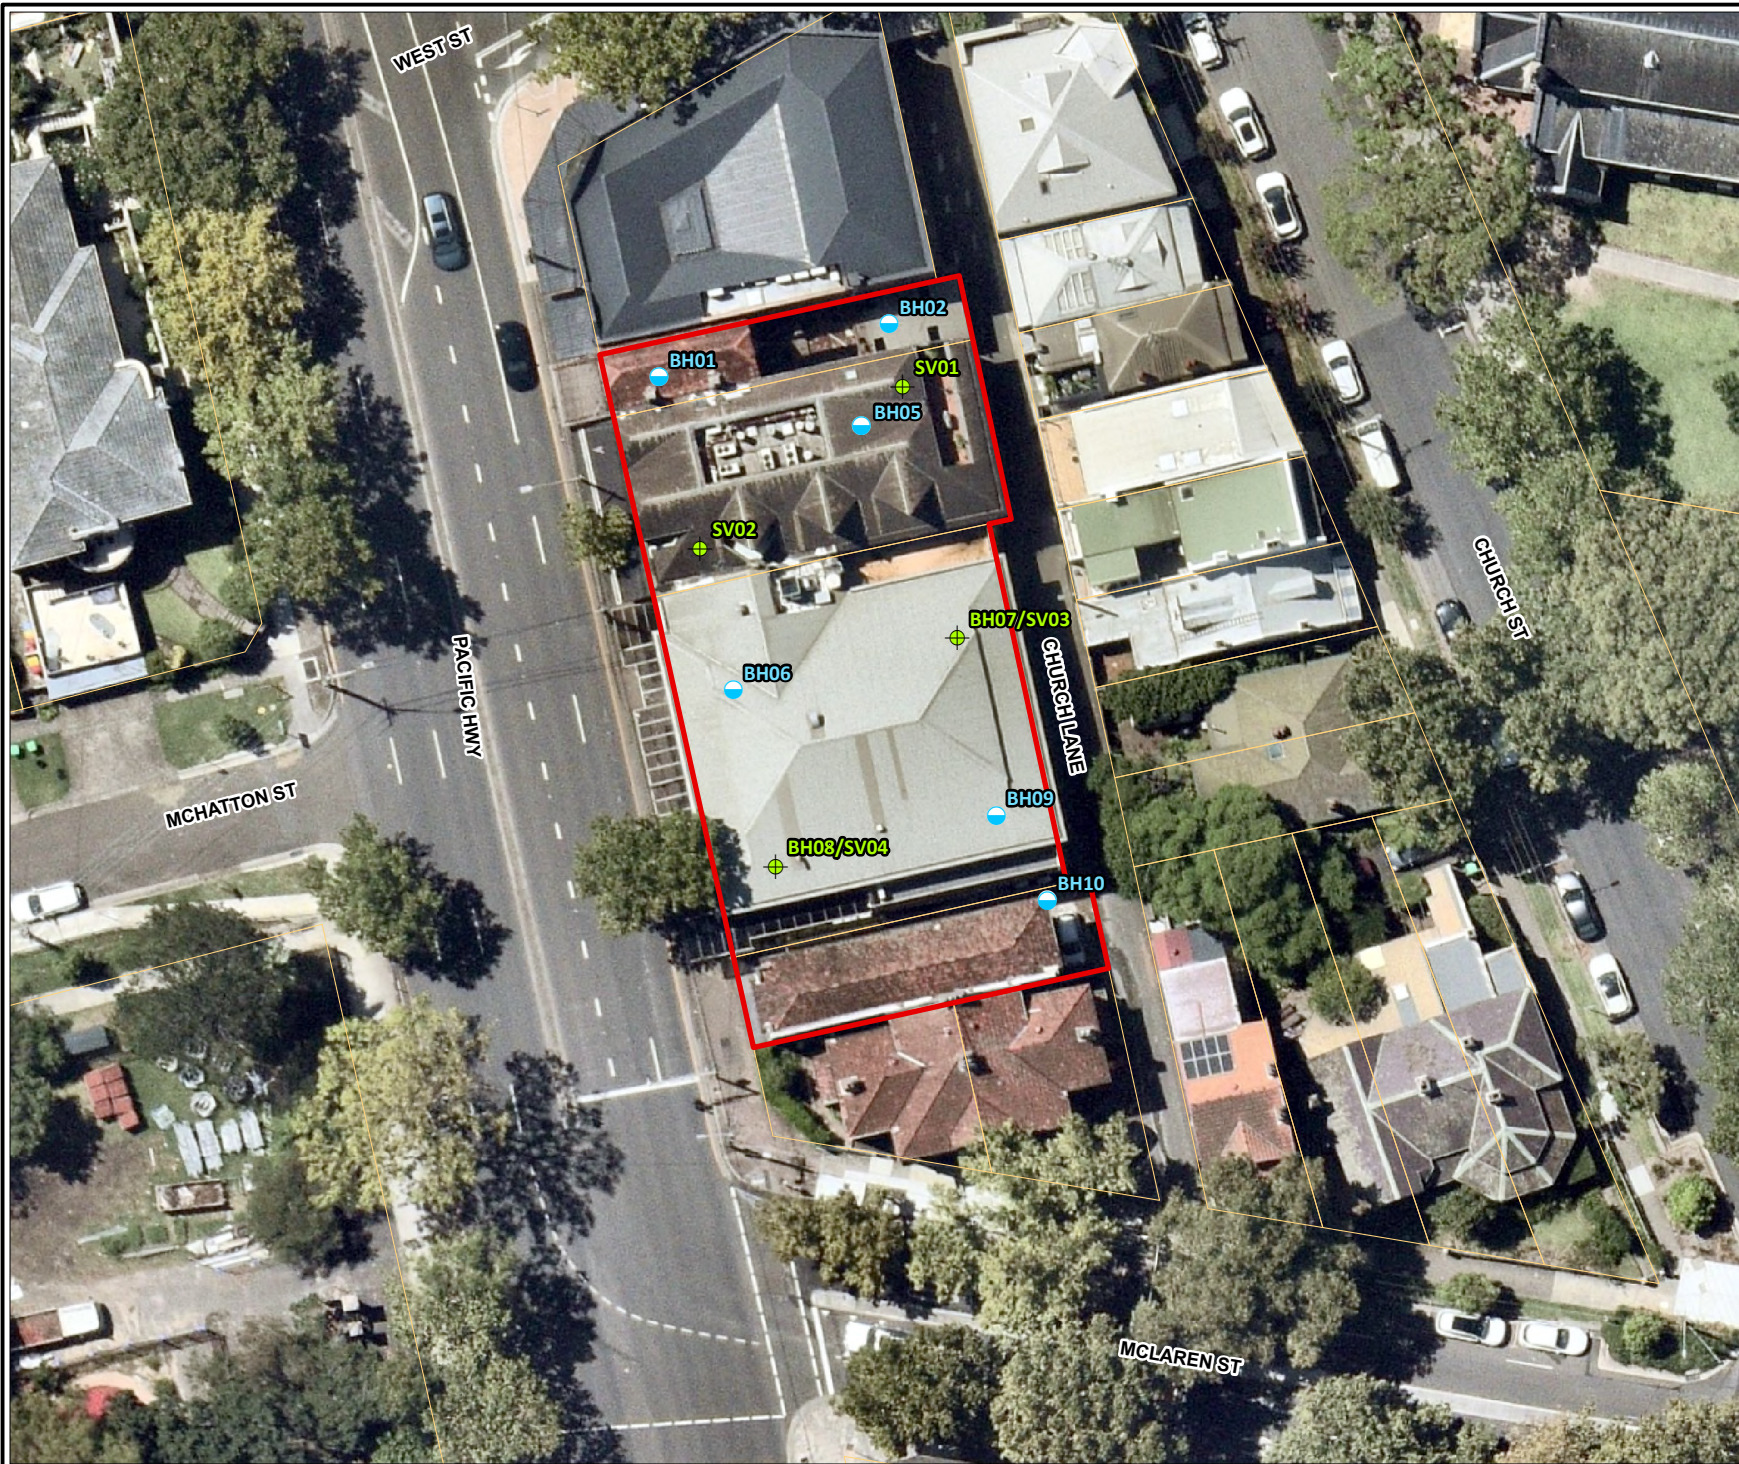
FIGURE 3

SAMPLE LOCATIONS

JBS&G undertook intrusive sampling of the soil at eight locations across the site and soil vapour sampling at two accessible locations at the site. It should be noted since the preparation of JBS&G 2018, 267 Pacific Highway has been removed from the proposed development plans and is considered outside of the site boundary.

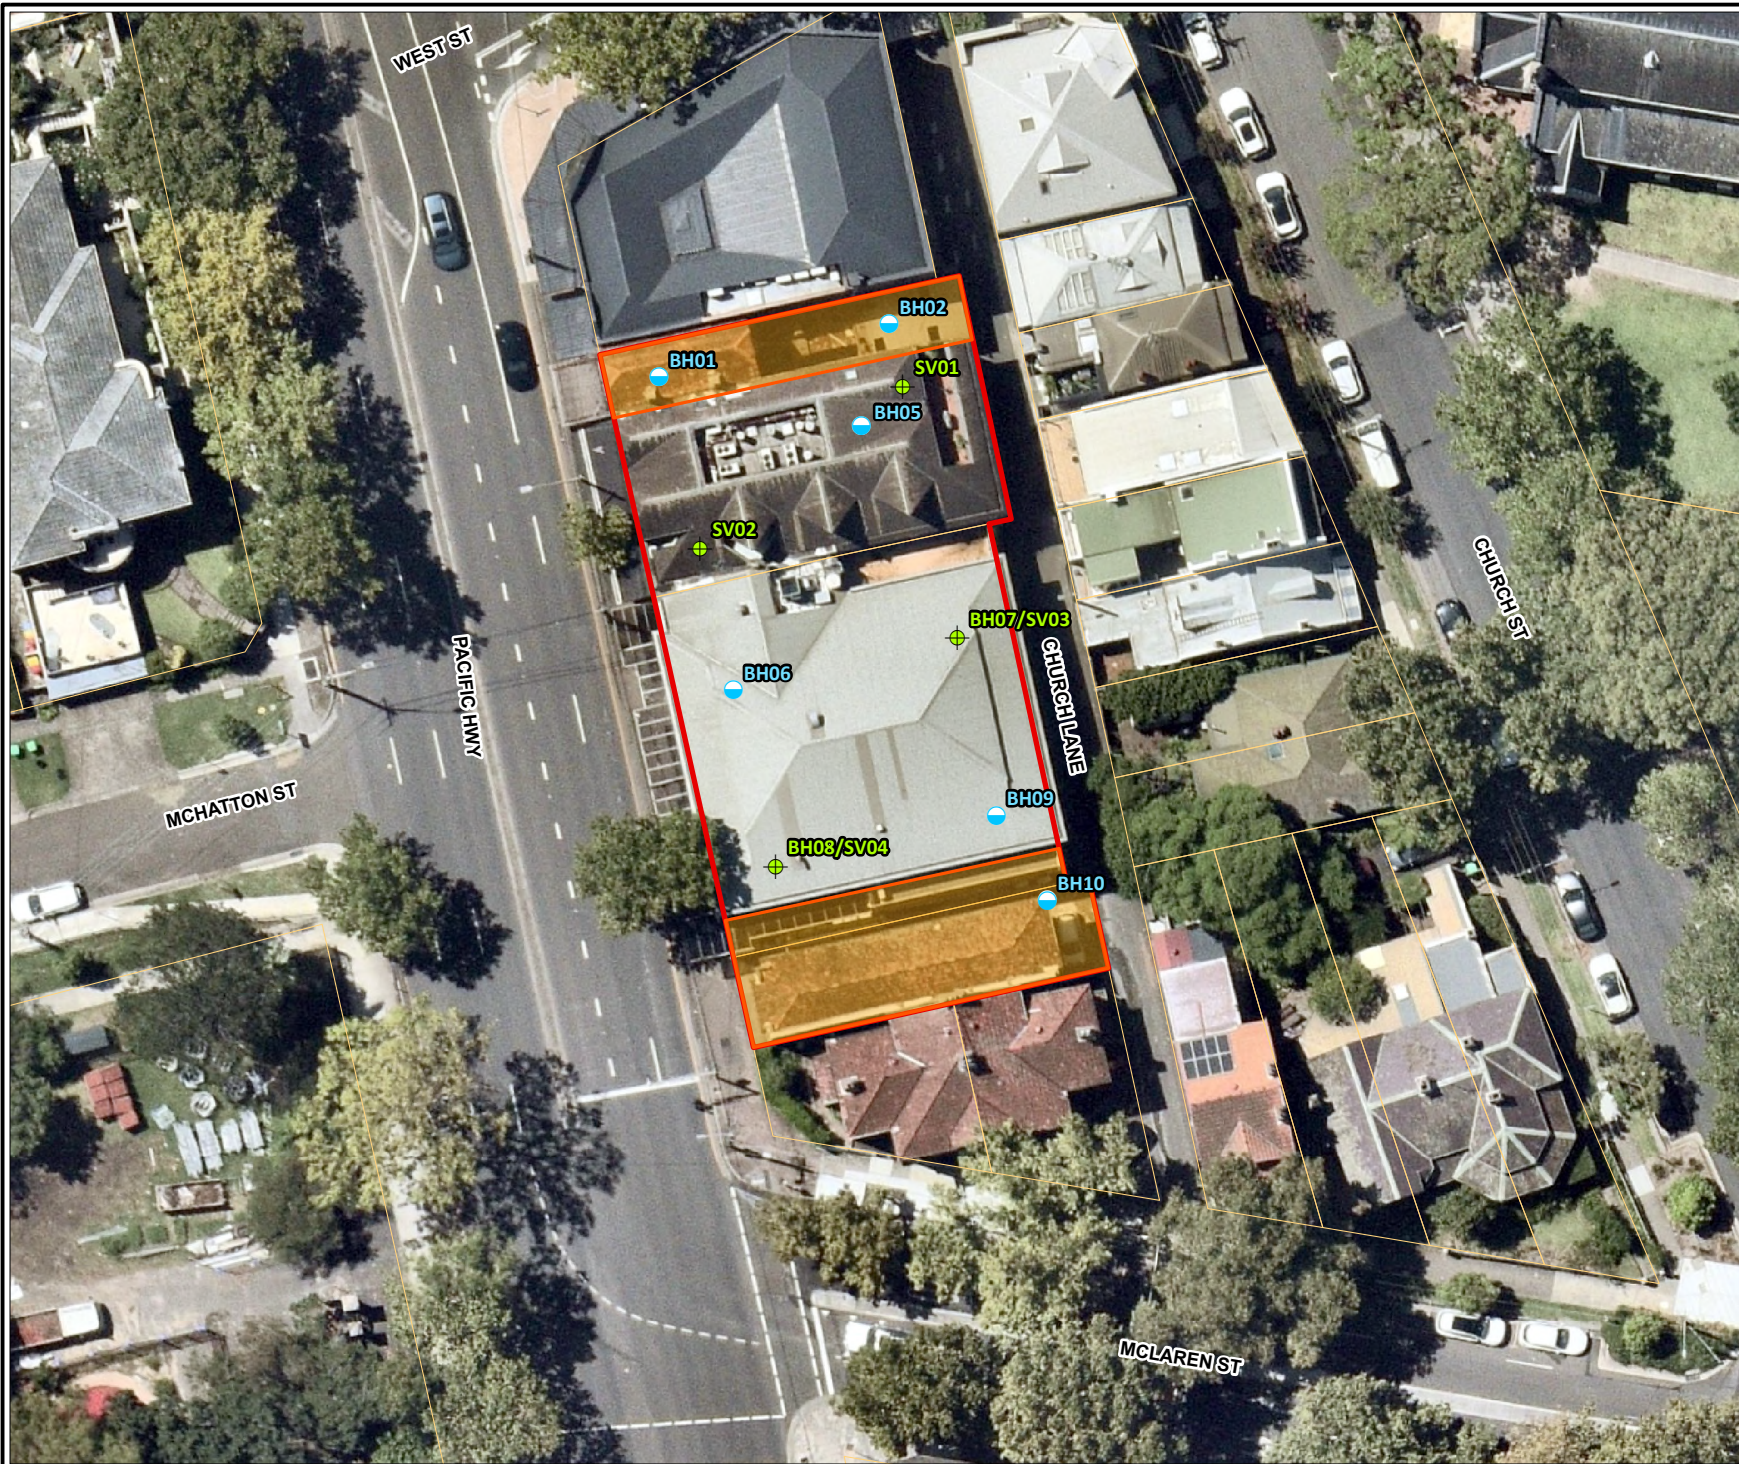
FIGURE 4

REMEDIAL EXTENTS

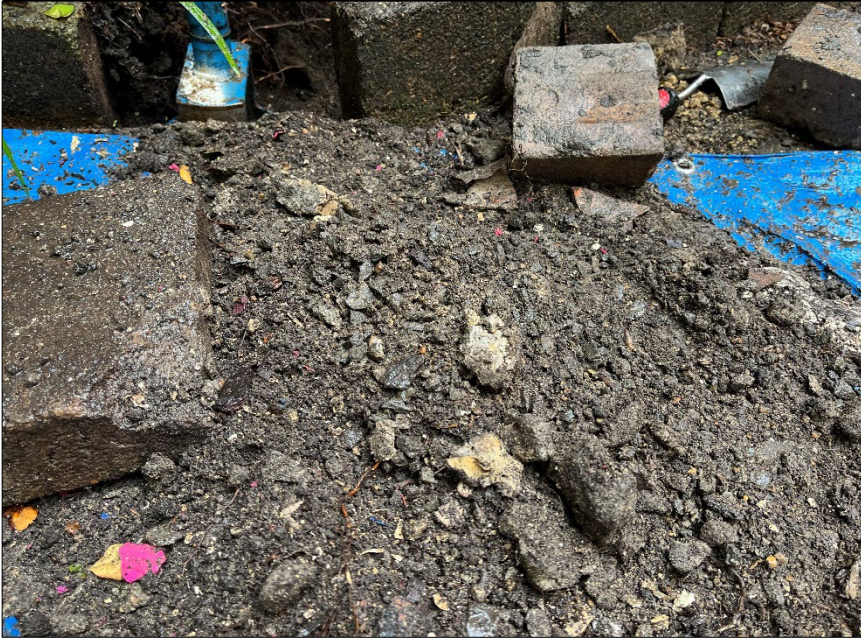
PHOTO 13: FILL AT BH12

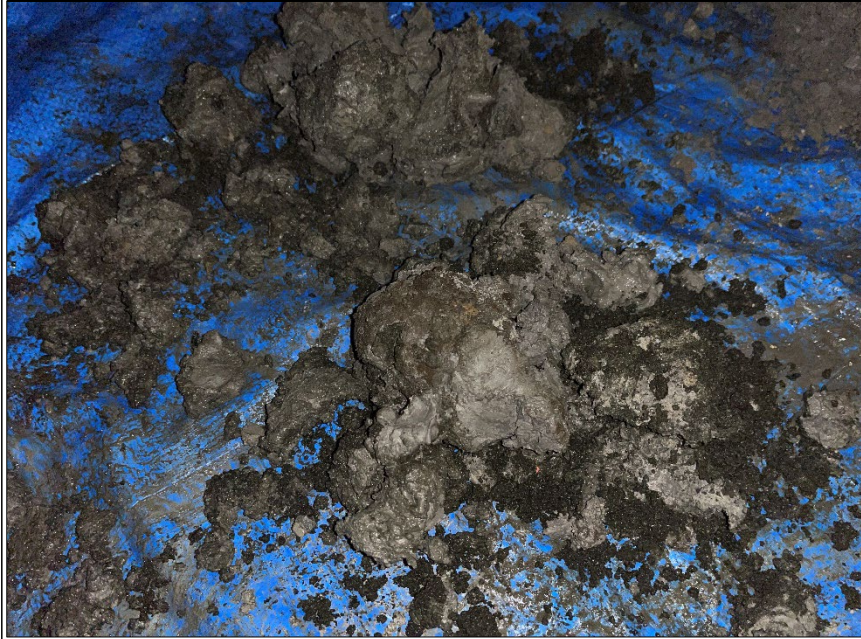
PHOTO 14: FILL AT BH06

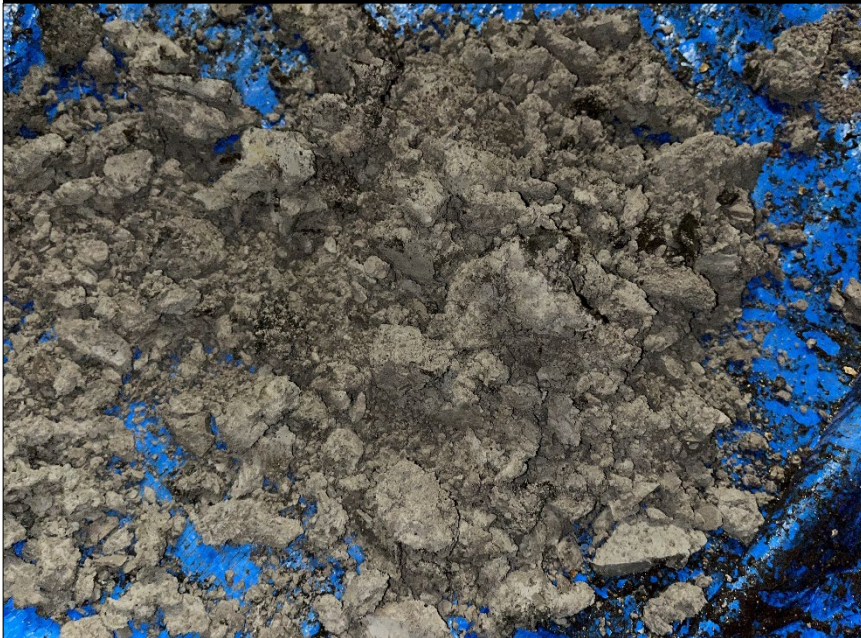
PHOTO 15: NATURAL CLAY AT BH09

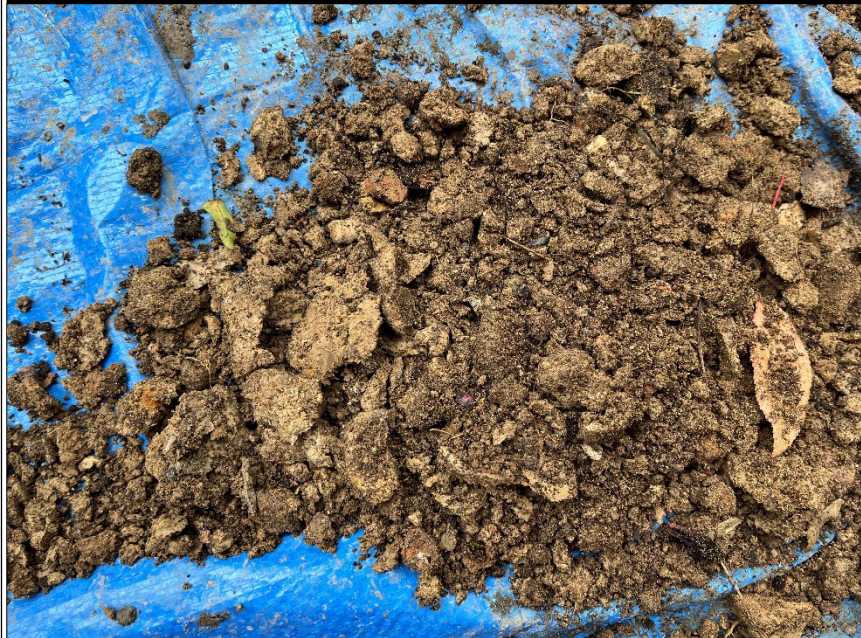
PHOTO 16: NATURAL CLAY AT BH11

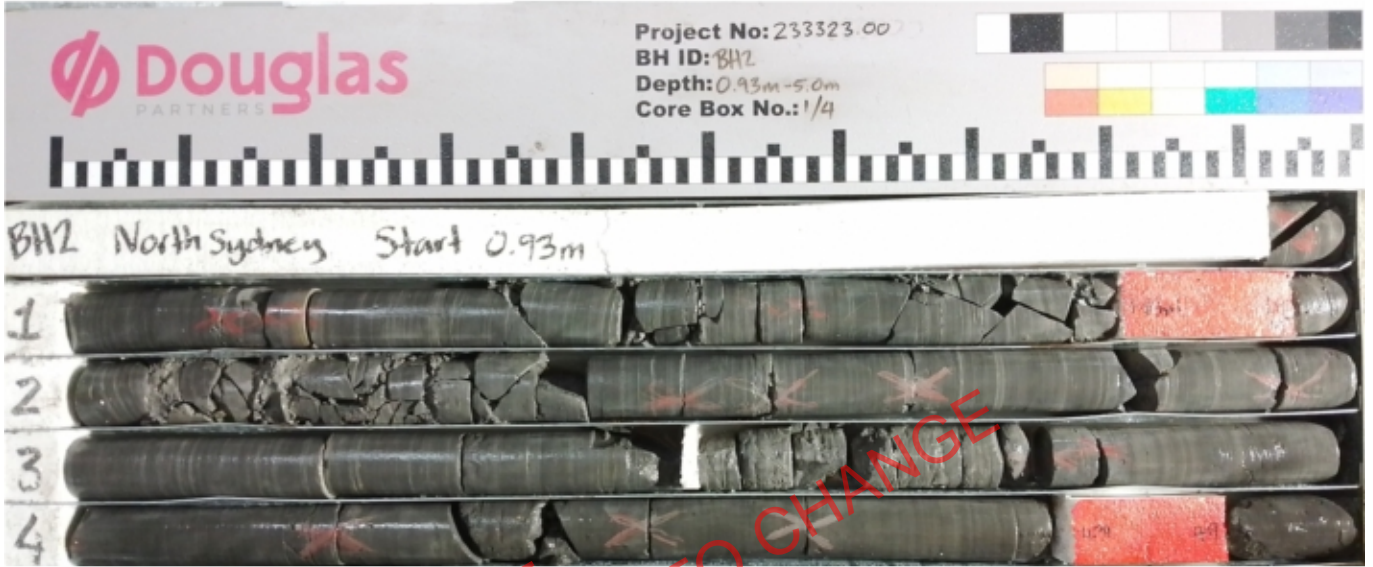
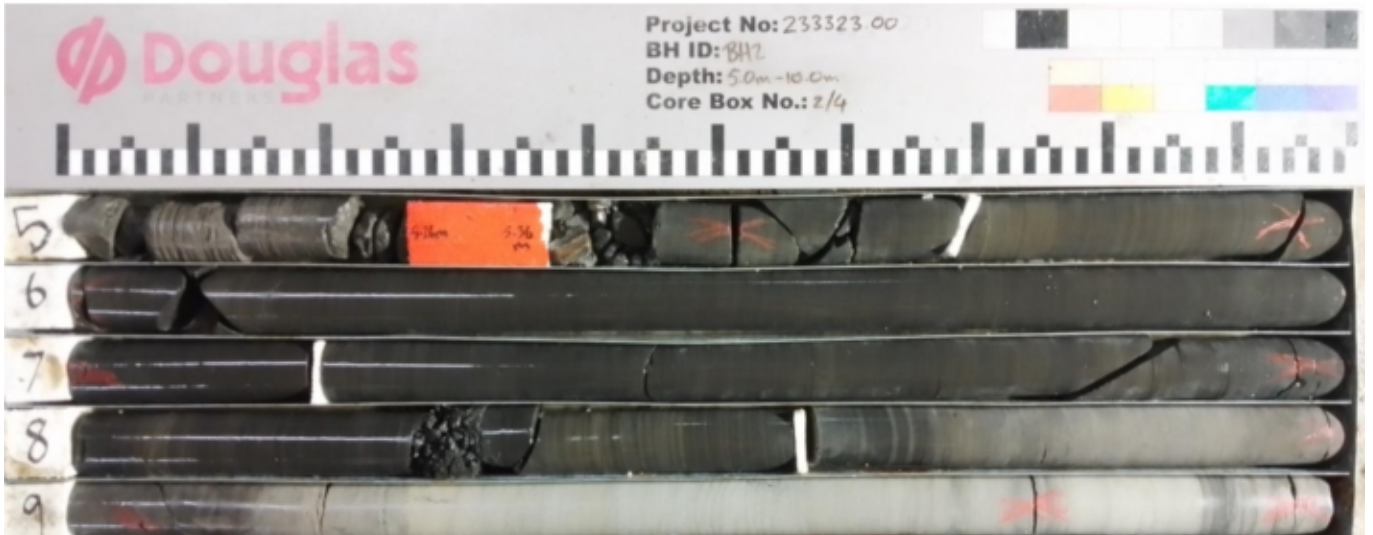
LOCATION ID: BH02
PROJECT No: 233323.00
DATE: 21/01/25
SHEET: 1 of 2

0.93-5.00 m depth

5.00-10.00 m depth

CORE PHOTO LOG

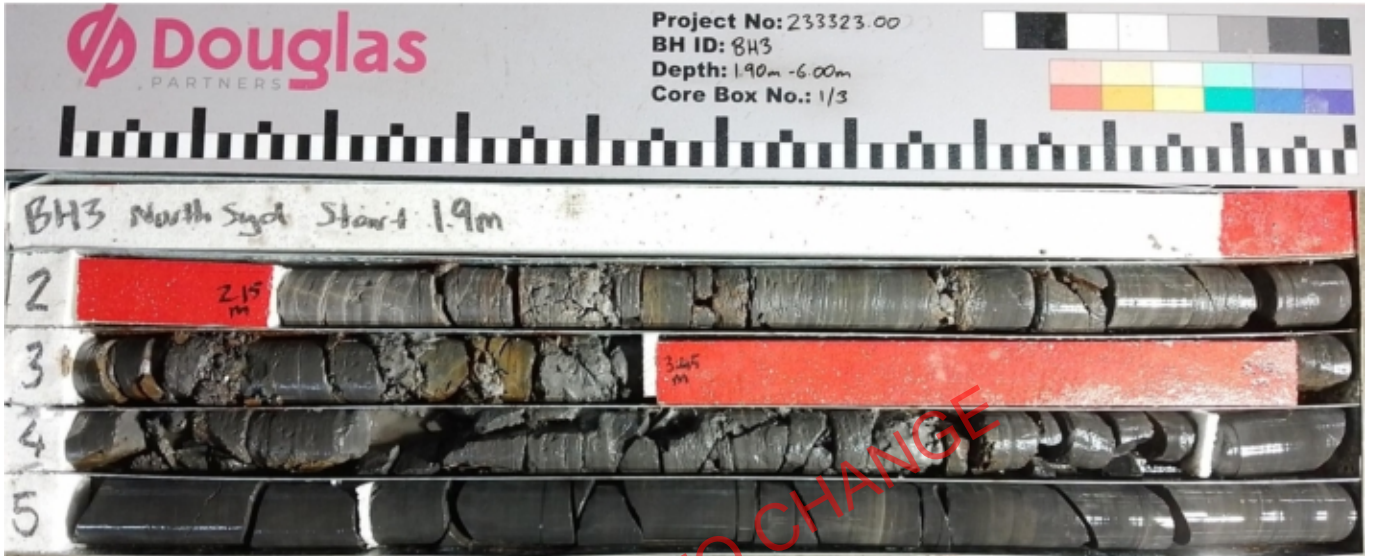
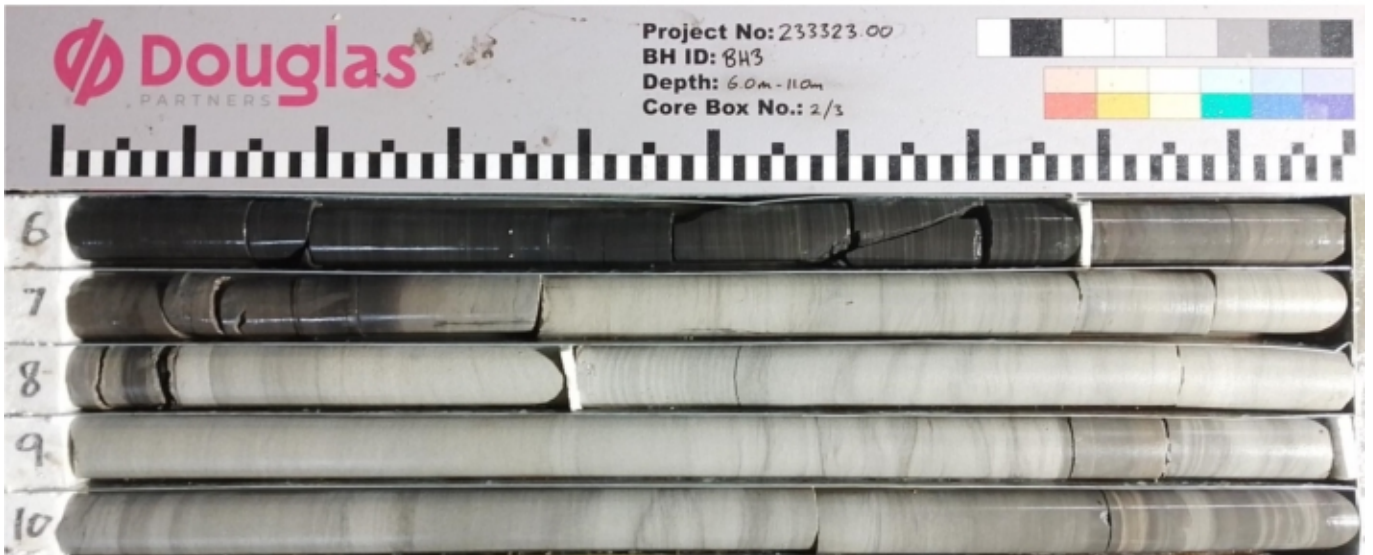
LOCATION ID: BH03
PROJECT No: 233323.00
DATE: 20/01/25
SHEET: 1 of 2

1.90-6.00 m depth

6.00-11.00 m depth

CORE PHOTO LOG

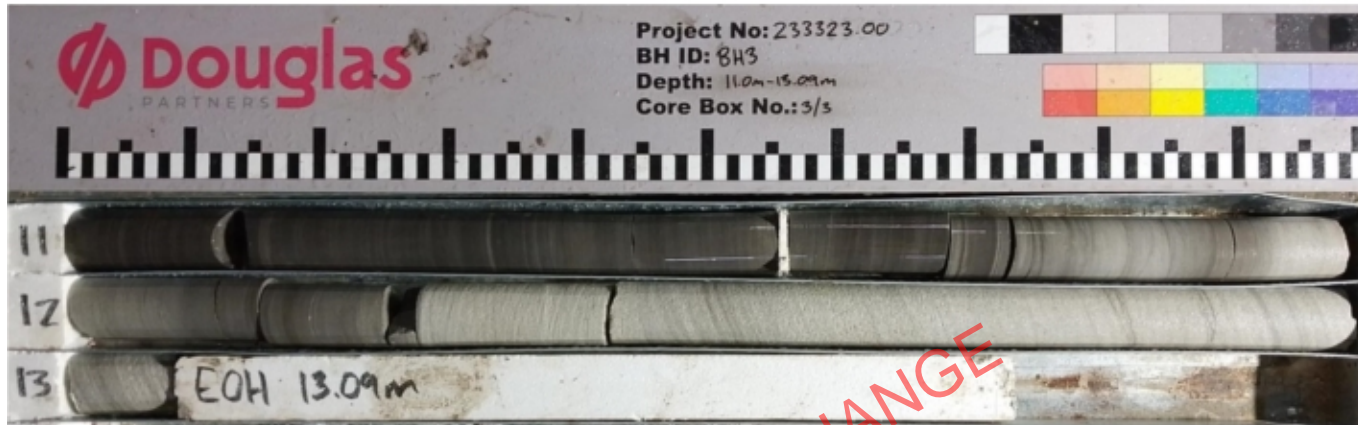
LOCATION ID: BH03
PROJECT No: 233323.00
DATE: 20/01/25
SHEET: 2 of 2

11.00-13.09 m depth

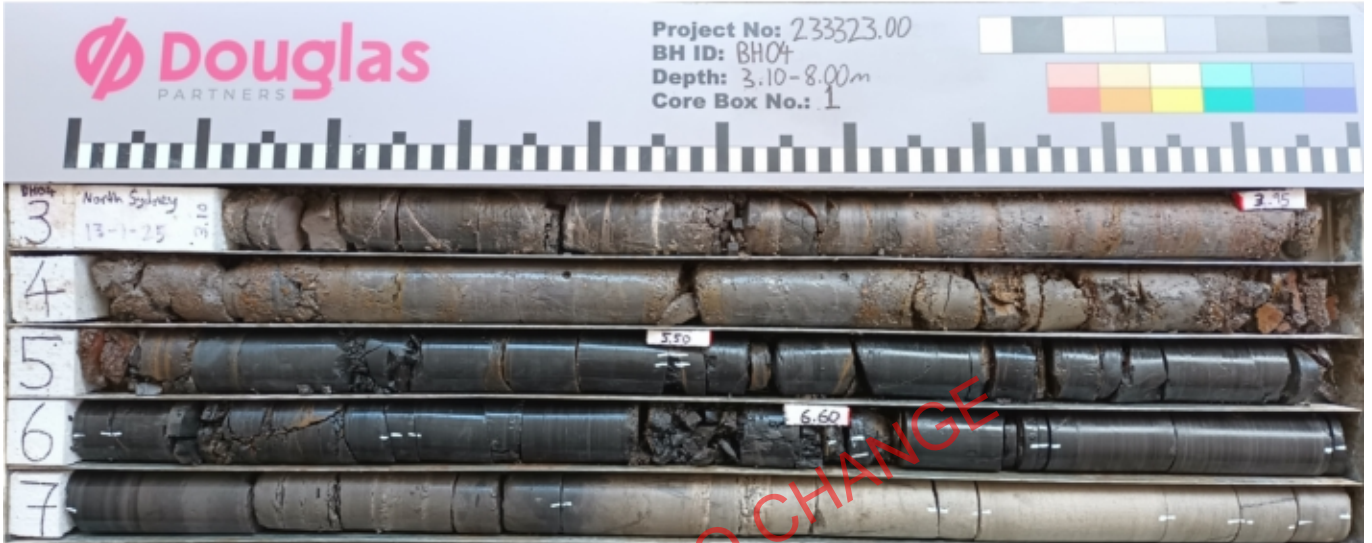
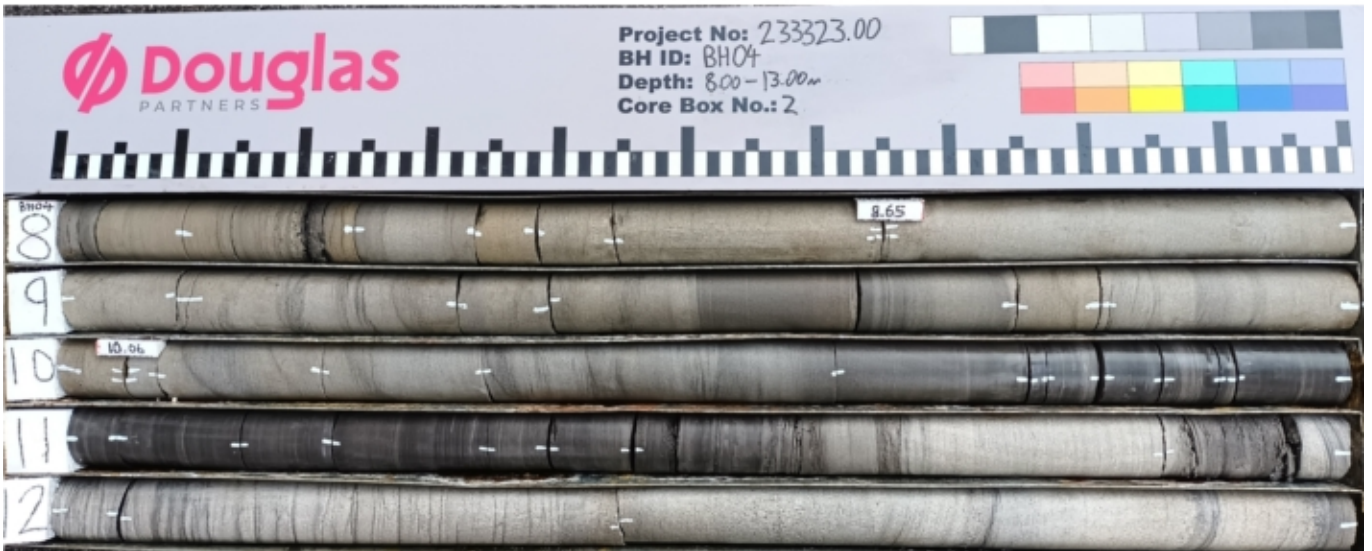
LOCATION ID: BH04
PROJECT No: 233323.00
DATE: 13/01/25 - 14/01/25
SHEET: 1 of 2

3.10-8.00 m depth

8.00-13.00 m depth

CORE PHOTO LOG
