**Report on Geotechnical Investigation**

**Proposed Mixed Use Development**

**253-265 Pacific Highway, North Sydney  
NSW**

**Project 233323.00**

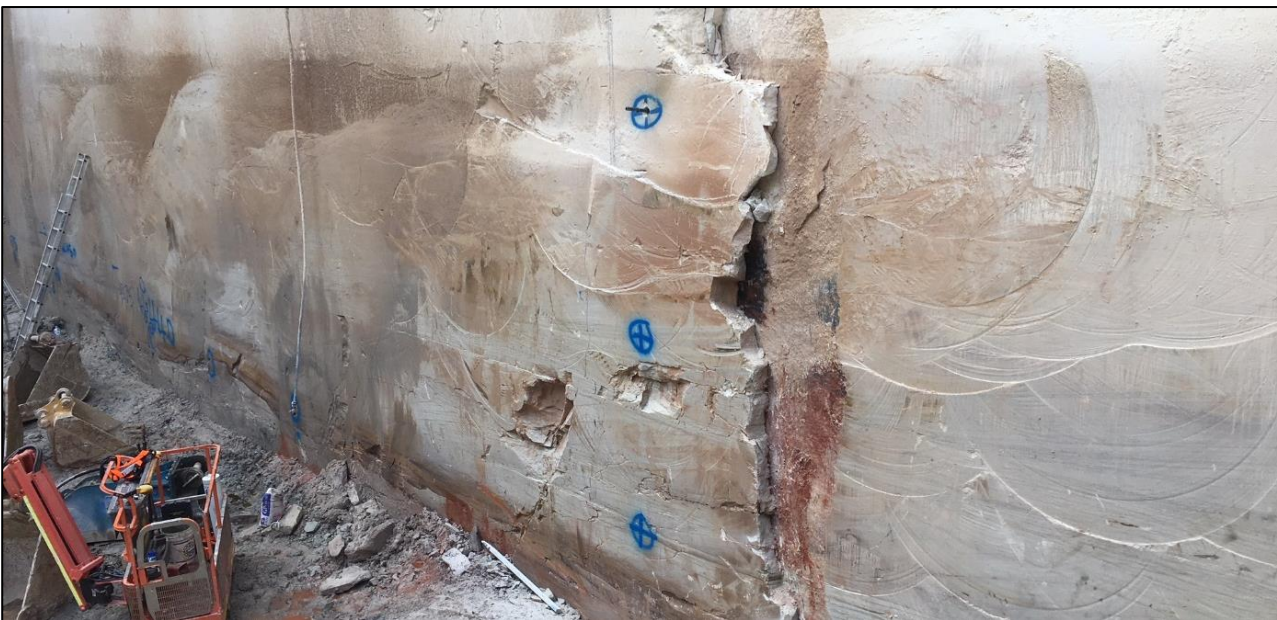
**Figure 1: Example 'feathered edge' in Sandstone excavation sidewall**

The eastern and western sides of the excavation are oriented just off parallel with the major joint sets in Sydney and steeply dipping joints should be conservatively expected in the sandstone. Although the northern and southern elevations do not coincide with the strikes of the major joint sets, adversely dipping joints should still be expected. Some allowance for stabilisation of large rock wedges should be made and this risk will be higher where shoring piles are founded at higher levels. These joints are typically about near vertical to 70° above horizontal and have been encountered on excavation projects in North Sydney.

Staged excavation and inspection by a suitably qualified geotechnical engineer or engineering geologist will be required to confirm that the rock in front of the wall is not adversely affected by discontinuities (example shown in Figure 1), especially where passive resistance is to be relied upon.

Where soldier piles do not extend to the base of the excavation, it is possible that localised siltstone beds within Unit 5 will need to be protected to limit the potential of fretting/unravelling and undermining of the rock mass above. Additionally, shotcrete or mesh may be required where beds/seams of extremely or very low strength rock are encountered within higher strength rock, secured with rock bolts, dowels and pins, as required.

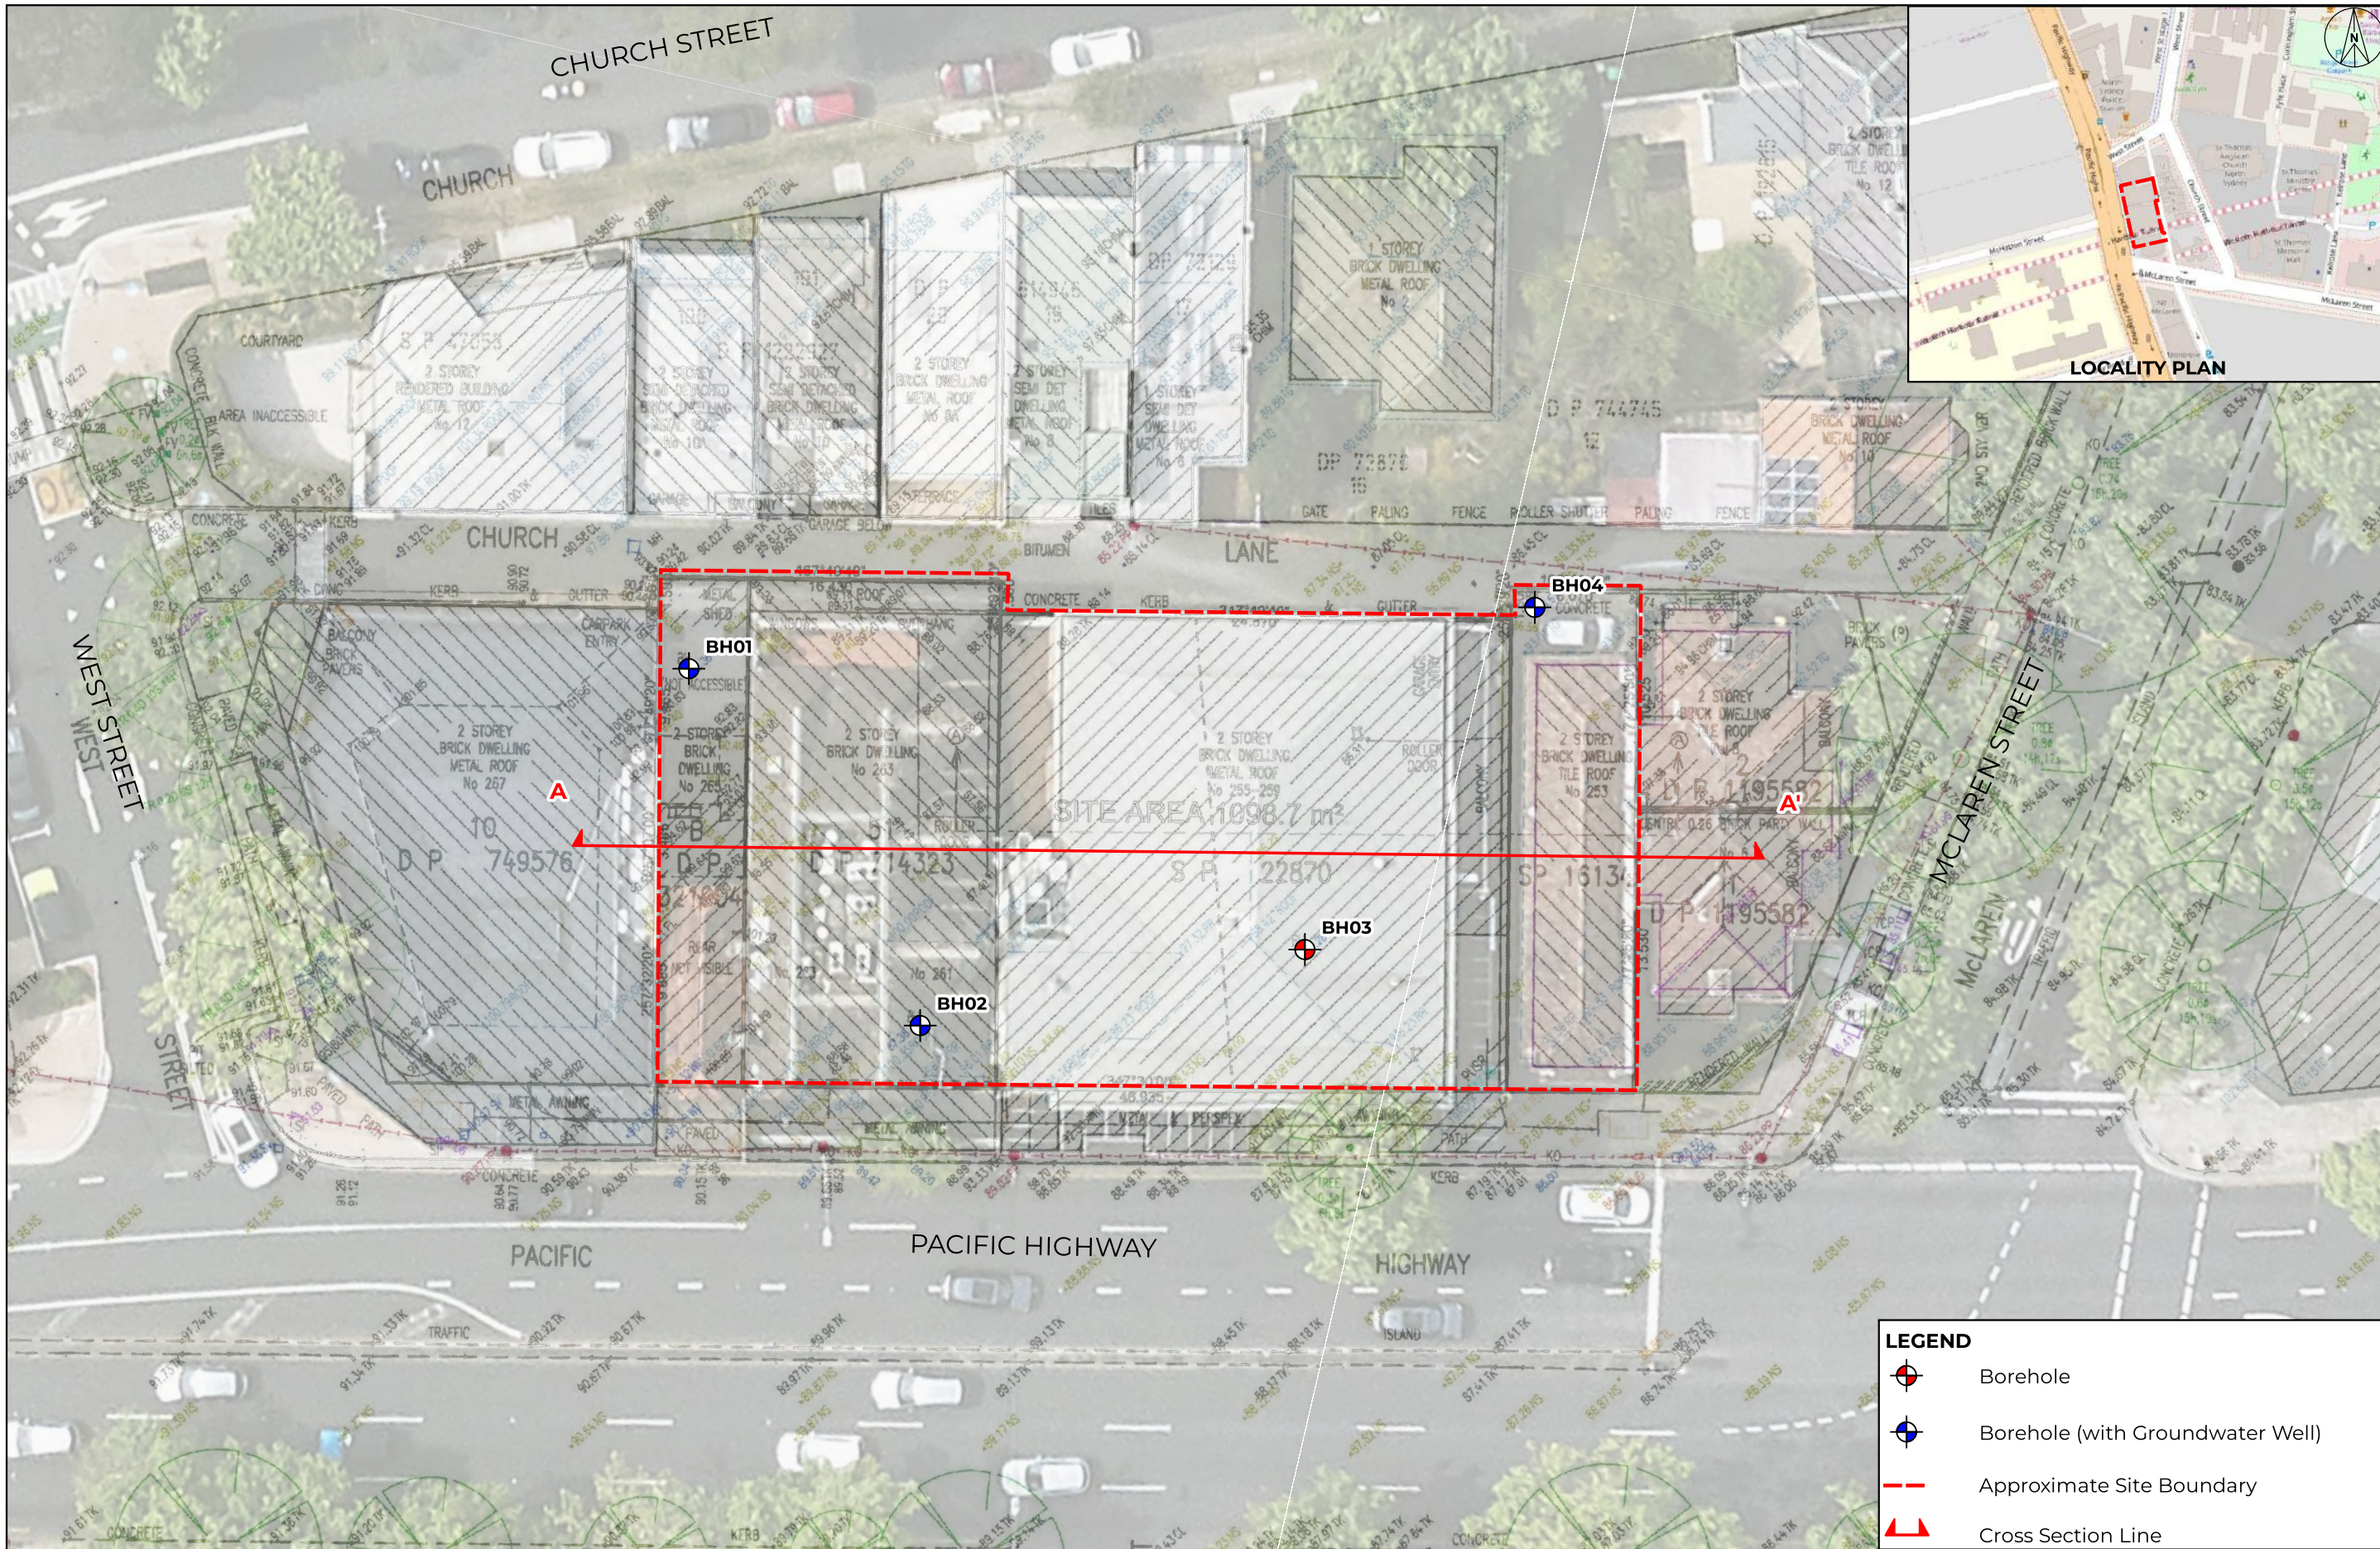
PROJECT NO:  
**233323.00**  
DRAWING NO:  
**1**  
REVISION:  
**0**

LEGEND	
	Borehole
	Borehole (with Groundwater Well)
	Approximate Site Boundary
	Cross Section Line

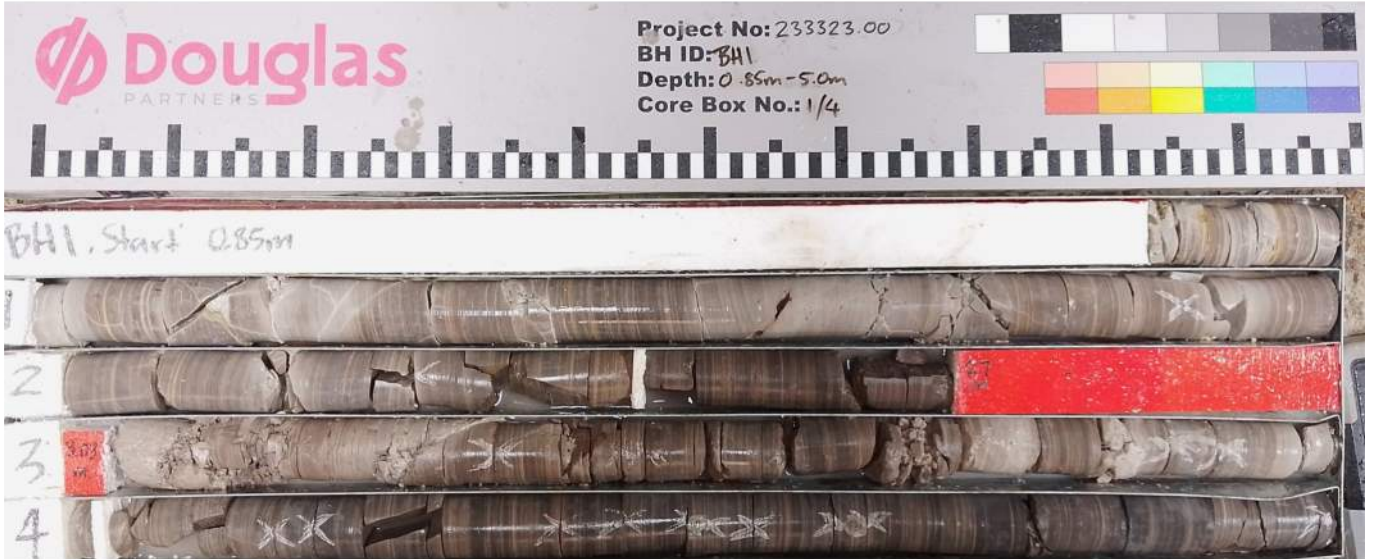
0.85-5.00 m depth

**LOCATION ID:** BH01  
**PROJECT No:** 233323.00  
**DATE:** 23/01/25  
**SHEET:** 1 of 2

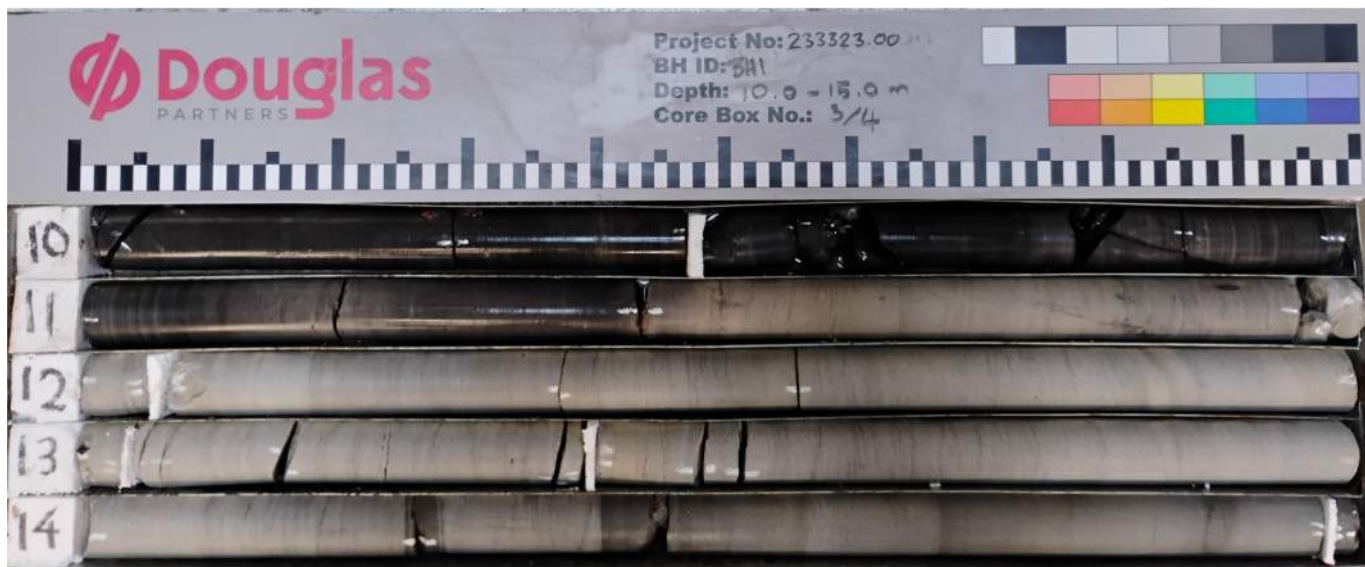
10.00-15.00 m depth

**LOCATION ID:** BH01  
**PROJECT No:** 233323.00  
**DATE:** 23/01/25  
**SHEET:** 2 of 2

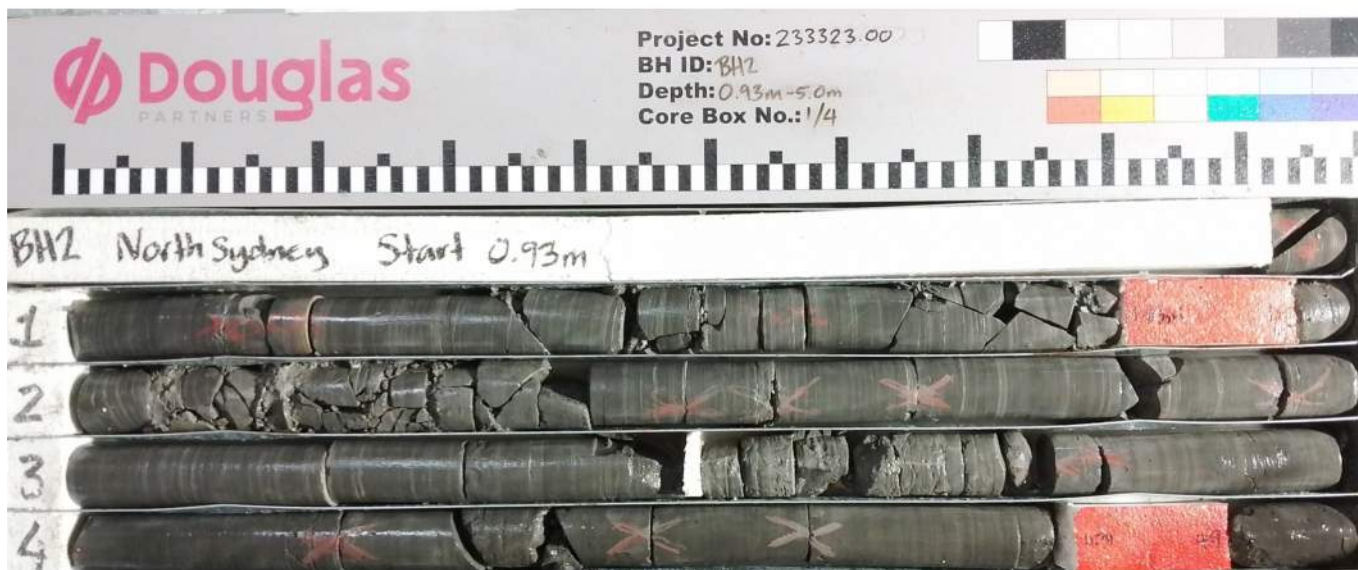
0.93-5.00 m depth

**LOCATION ID:** BH02  
**PROJECT No:** 233323.00  
**DATE:** 21/01/25  
**SHEET:** 1 of 2

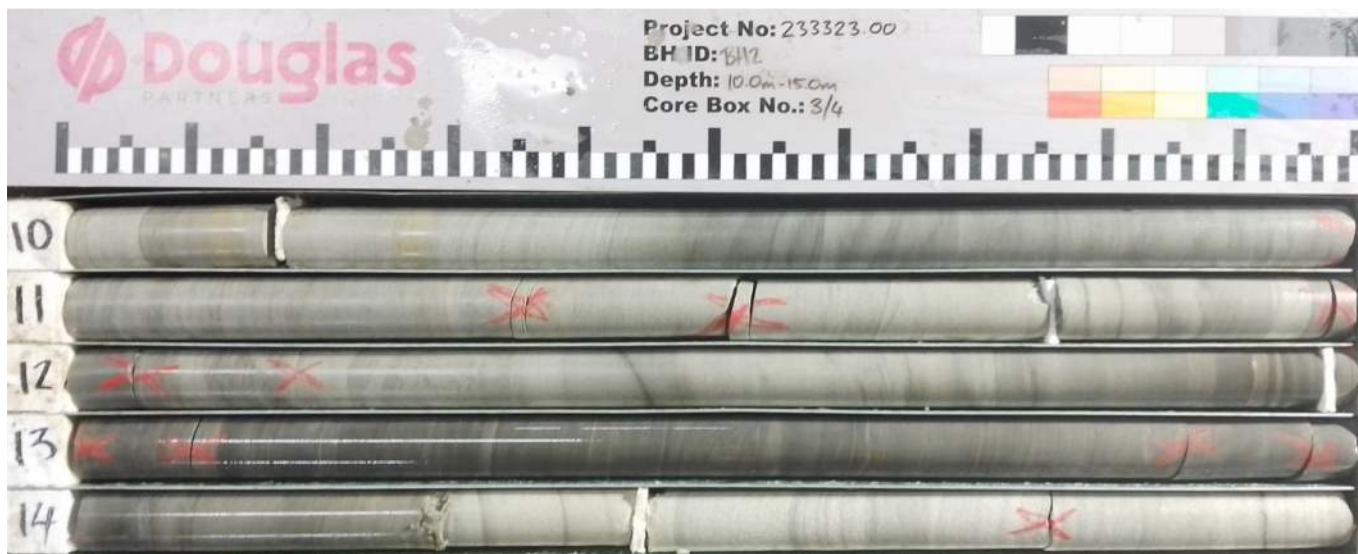
10.00-15.00 m depth

**LOCATION ID:** BH02  
**PROJECT No:** 233323.00  
**DATE:** 21/01/25  
**SHEET:** 2 of 2

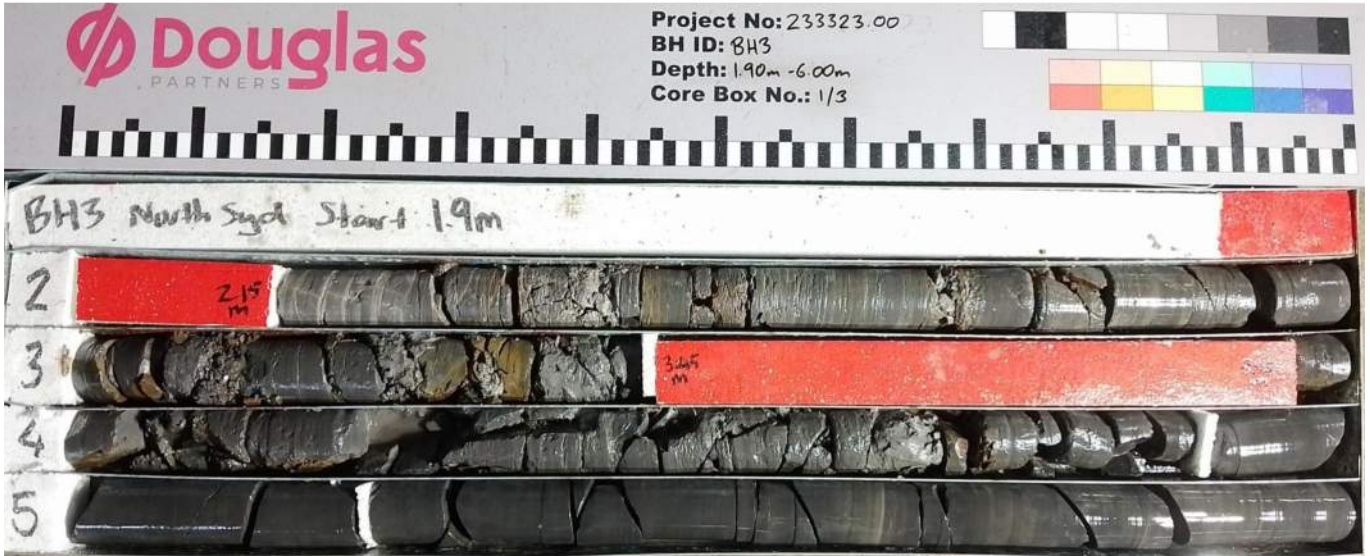
1.90-6.00 m depth

**LOCATION ID:** BH03  
**PROJECT No:** 233323.00  
**DATE:** 20/01/25  
**SHEET:** 1 of 2

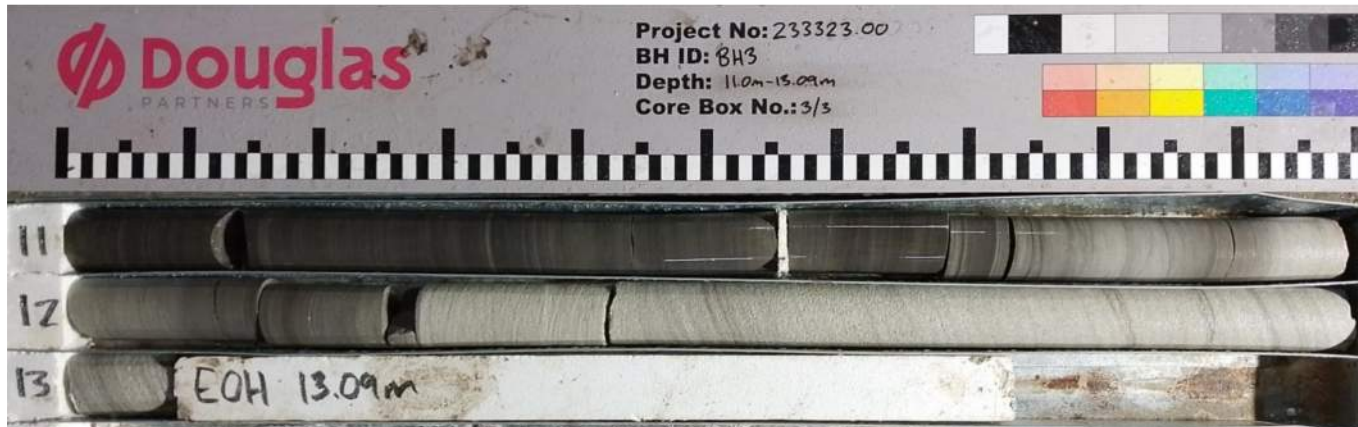
11.00-13.09 m depth

**LOCATION ID:** BH03  
**PROJECT No:** 233323.00  
**DATE:** 20/01/25  
**SHEET:** 2 of 2

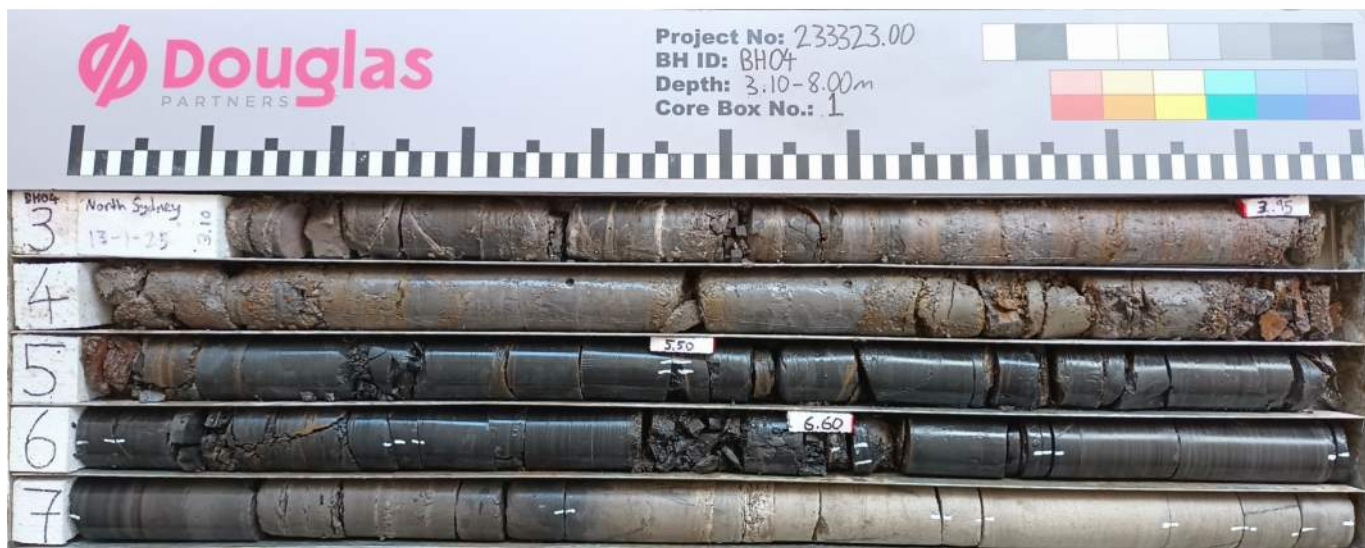
3.10-8.00 m depth

**LOCATION ID:** BH04  
**PROJECT No:** 233323.00  
**DATE:** 13/01/25 - 14/01/25  
**SHEET:** 1 of 2

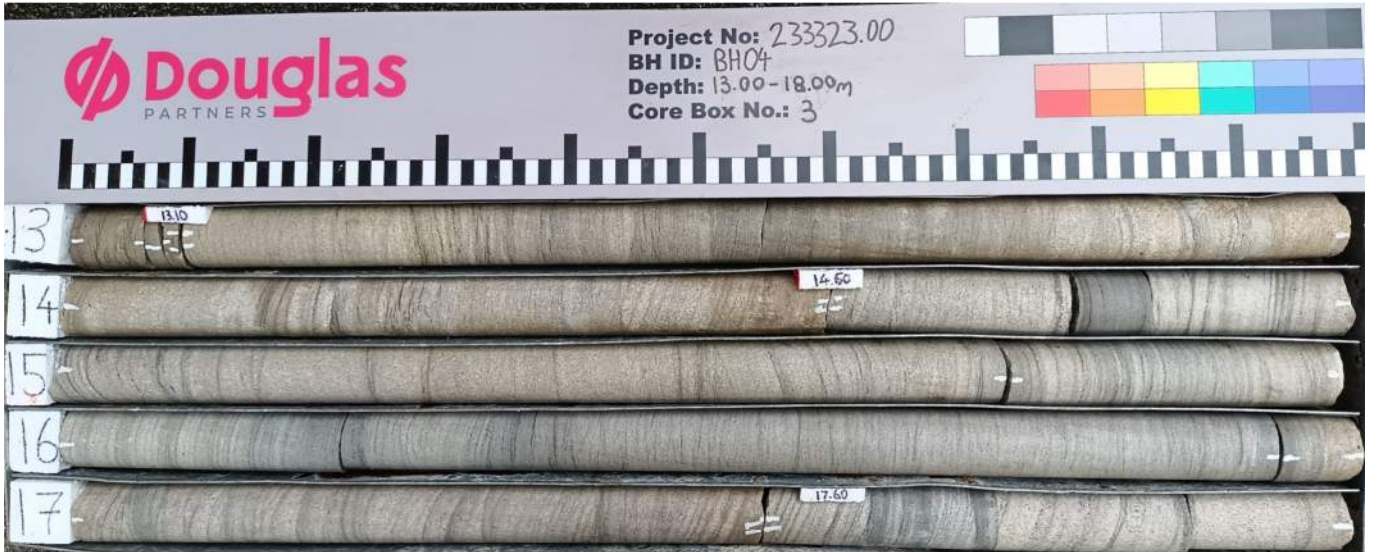
13.00-18.00 m depth

**LOCATION ID:** BH04  
**PROJECT No:** 233323.00  
**DATE:** 13/01/25 - 14/01/25  
**SHEET:** 2 of 2

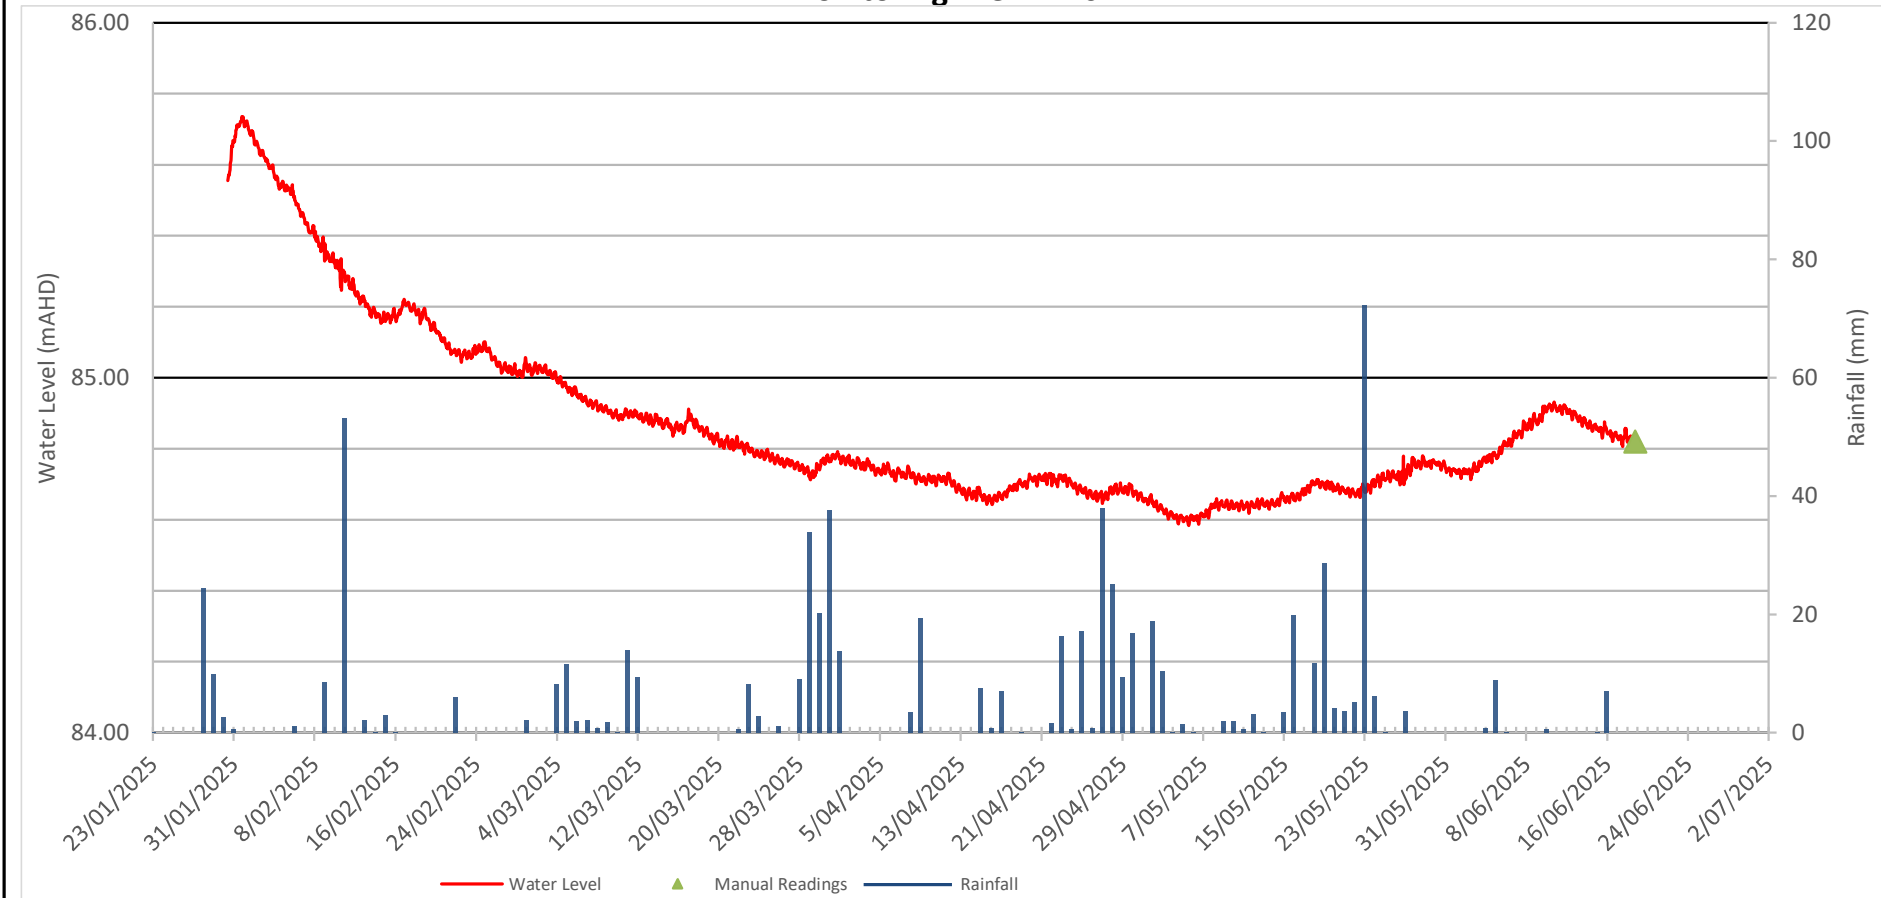
### Monitoring Well: BH01

Note: Reading Interval = 60 minutes

Groundwater was measured at around RL 83 to 86 m AHD within the monitoring wells and was within the Unit 4 rock, indicating a groundwater flow direction towards the south-south-east, generally falling with ground surface levels. It is likely that the measured groundwater is associated with perched water along the rock surface and within joints/fractures in the rock and not a regional groundwater table.

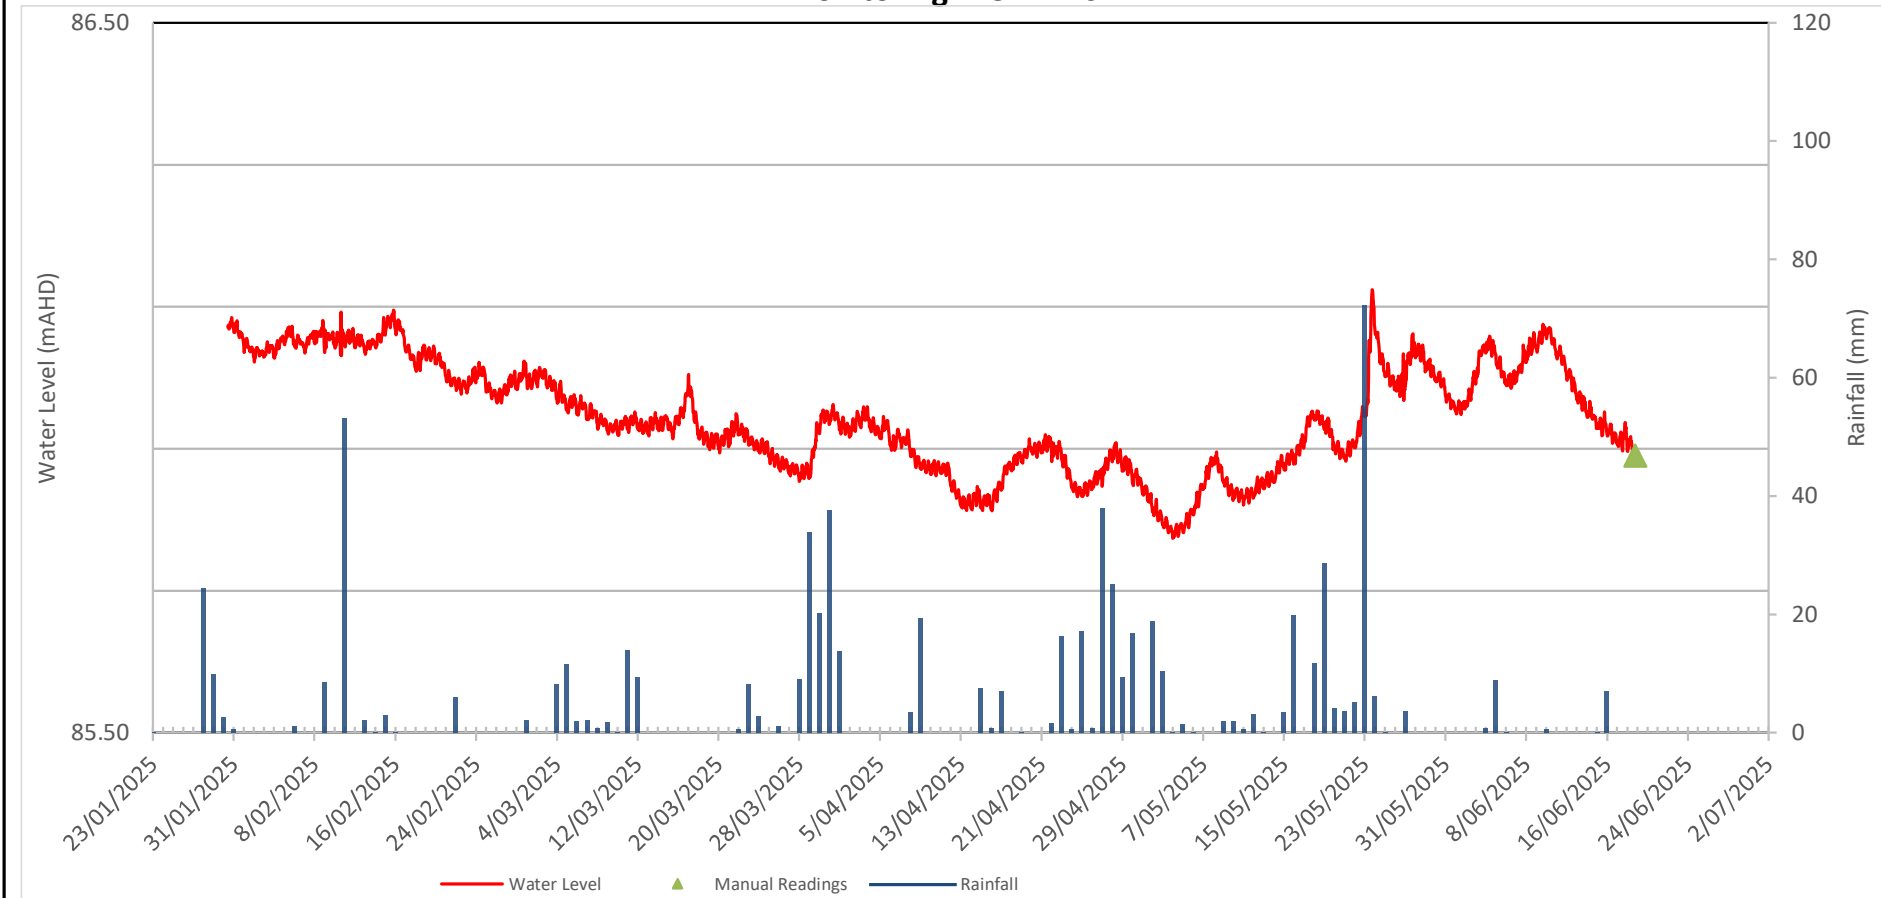
### Monitoring Well: BH02

Note: Reading Interval = 60 minutes

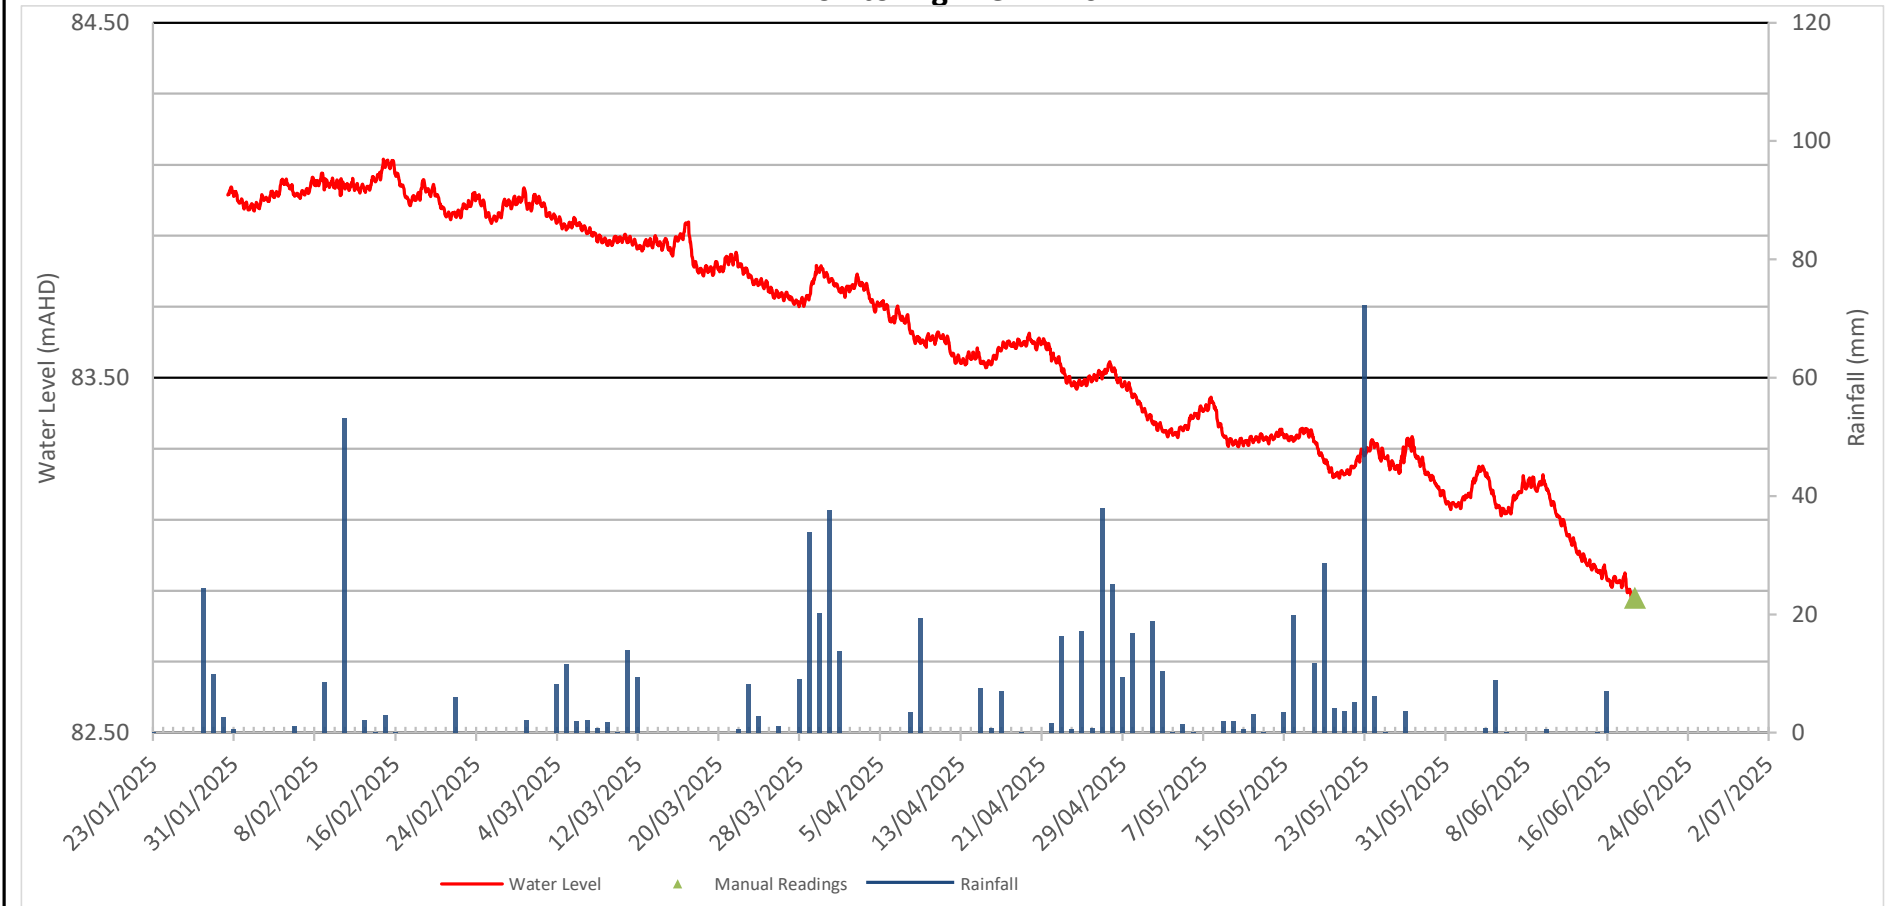
### Monitoring Well: BH04

Note: Reading Interval = 60 minutes

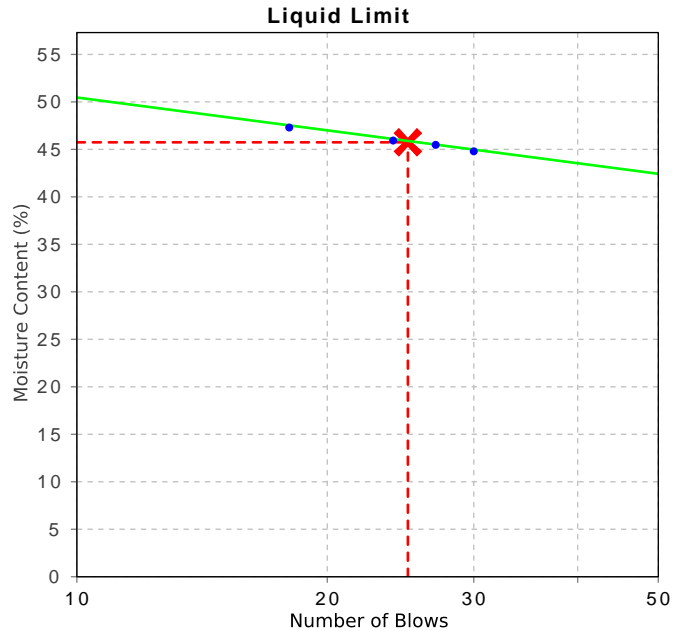
Atterberg Limit (AS1289 3.1.1 & 3.2.1 & 3.3.1)		Min	Max
Sample History	Oven Dried		
Preparation Method	Dry Sieve		
Liquid Limit (%)	46		
Plastic Limit (%)	25		
Plasticity Index (%)	21		
Linear Shrinkage (AS1289 3.4.1)		Min	Max
Moisture Condition Determined By	AS 1289.3.1.1		
Linear Shrinkage (%)	9.5		
Cracking Crumbling Curling	Curling		
Moisture Content (AS 1289 2.1.1)		Min	Max
Moisture Content (%)	19.3

Test Location	Material	Depth (m)	Liquid Limit (%)	Plastic Limit (%)	Plastic Index (%)	Linear Shrinkage (%)	Field Moisture Content (%)
BH03	FILL/CLAY	0.1-0.25	33	22	11	-	19.4
BH04	Residual CLAY	1.0-1.45	46	25	21	9.5	19.3
BH04	Residual CLAY	2.5-2.95	36	26	10	6.0	18.8

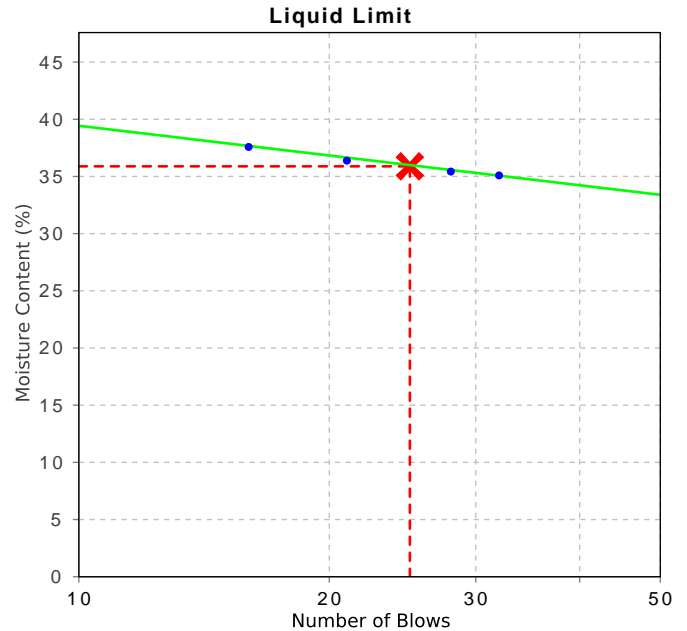
Atterberg Limit (AS1289 3.1.1 & 3.2.1 & 3.3.1)		Min	Max
Sample History	Oven Dried		
Preparation Method	Dry Sieve		
Liquid Limit (%)	36		
Plastic Limit (%)	26		
Plasticity Index (%)	10		
Linear Shrinkage (AS1289 3.4.1)		Min	Max
Moisture Condition Determined By	AS 1289.3.1.1		
Linear Shrinkage (%)	6.0		
Cracking Crumbling Curling	None		
Moisture Content (AS 1289 2.1.1)		Min	Max
Moisture Content (%)	18.8

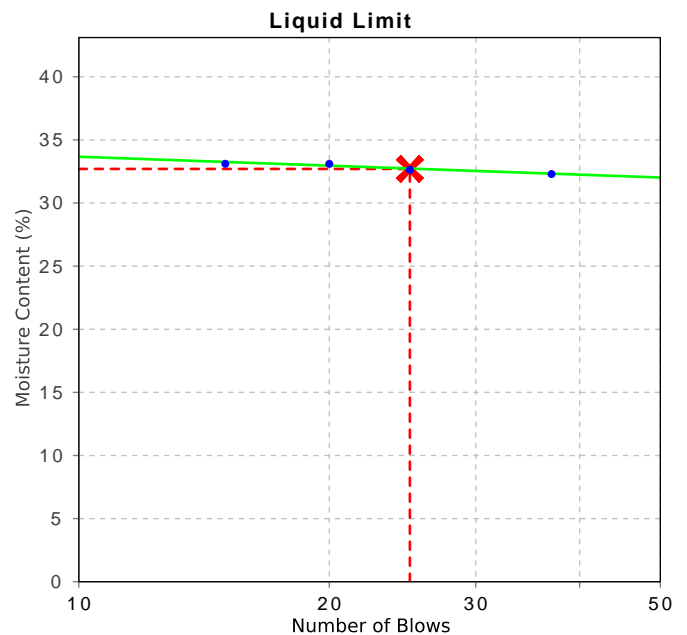
Atterberg Limit (AS1289 3.1.1 & 3.2.1 & 3.3.1)		Min	Max
Sample History	Oven Dried		
Preparation Method	Dry Sieve		
Liquid Limit (%)	33		
Plastic Limit (%)	22		
Plasticity Index (%)	11		
Linear Shrinkage (AS1289 3.4.1)		Min	Max
Moisture Condition Determined By	AS 1289.3.1.1		
Linear Shrinkage (%)	6.5		
Cracking Crumbling Curling	None		
Moisture Content (AS 1289 2.1.1)		Min	Max
Moisture Content (%)	19.4
