# 2024 Annual Rehabilitation Walkover

Refuse Emplacement Area

| Project Name | Tahmoor Coal Pty Ltd Rehabilitation Monitoring 2024 |

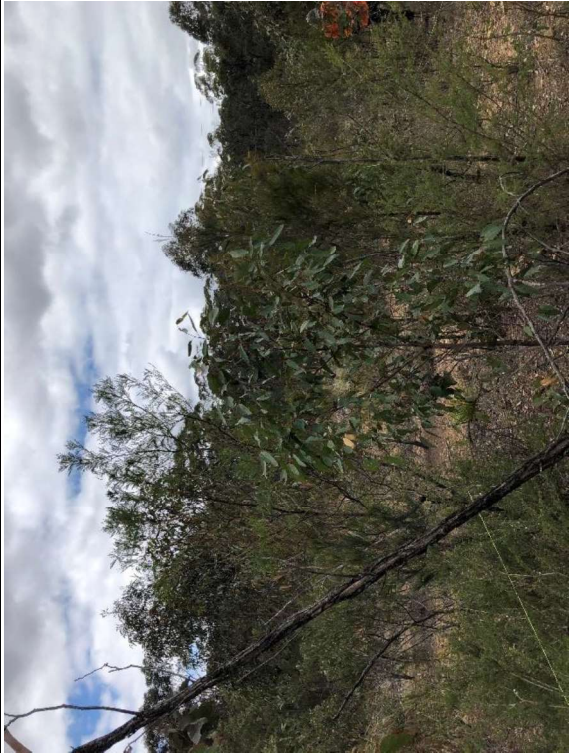
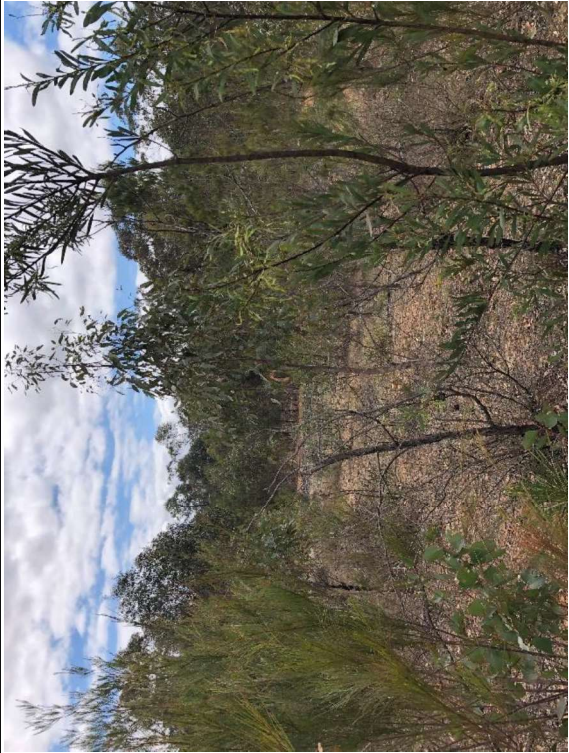
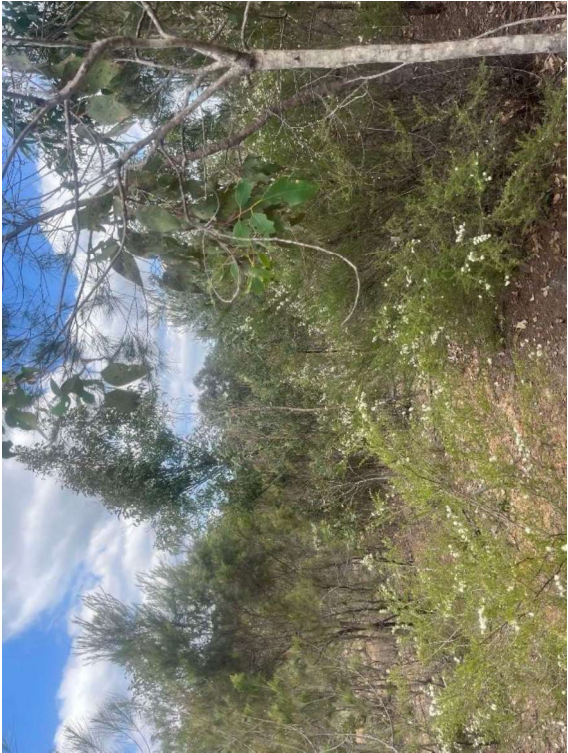
Figure 14: Stage 12A plot F2 in 2023 and 2024

| REA Permanent Monitoring Site Field Sheet 2024 | | Stage: Stage 12a | | |
|---|---|---|---|---|
| <b>Comments:</b> Several missing tree tags and incorrectly tagged trees. <i>Eucalyptus punctata</i> in very good health. Eleven trees tagged in 2024. | | | | |

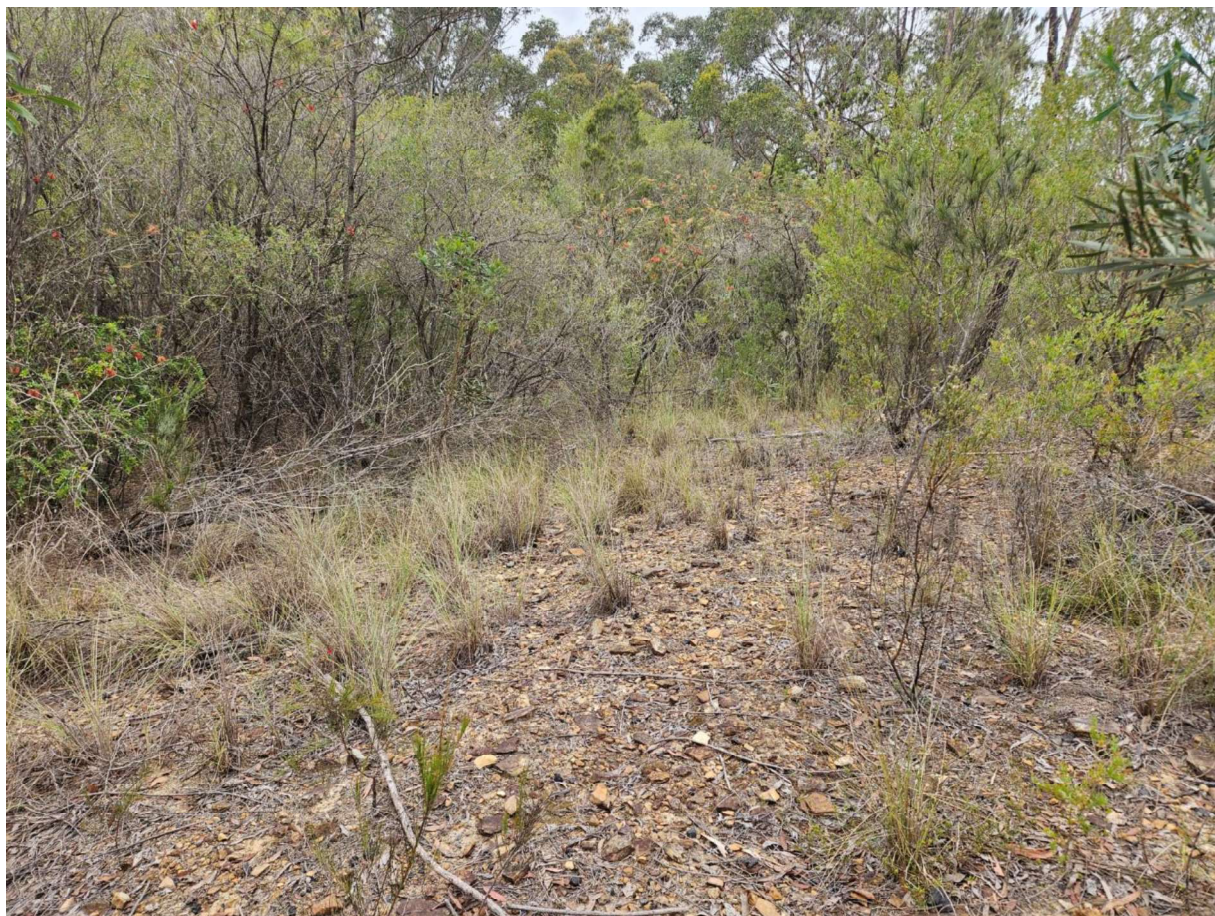
Figure 4: Trial A in Stage 2

A brief visual assessment of native grass and exotic cover was carried out within each trial area during the rehabilitation monitoring in November 2024. Photos of trials A, B, C, E, F and H are provided below.
