GCA Report No.

G25346-1

**Salinity Management Plan at:**

241-245 Pennant Hills Road Carlingford NSW 2118

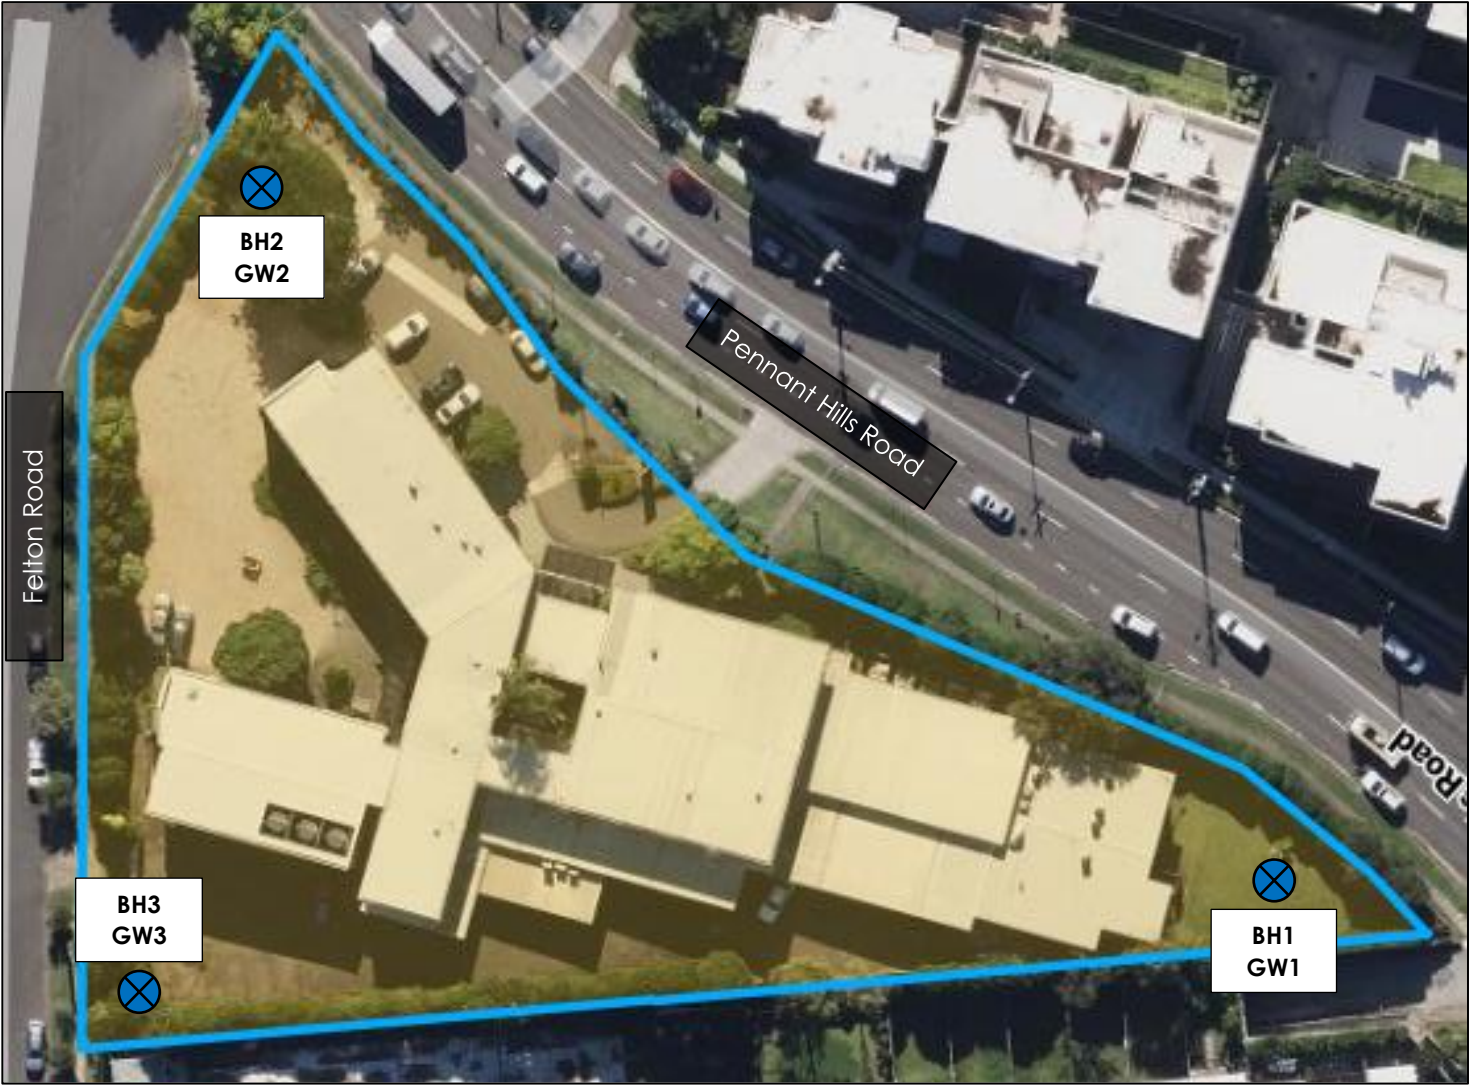
| | Figure 1<br>Site Plan | <b>Salinity Management Plan</b> | Drawn: GN/GA | |

Approximate Boreholes/Standpipe Piezometer Locations

**Attachment 2** Site Plan (Figure 1)
