**Geotechnical Investigation &  
Preliminary Groundwater  
Assessment Report**

241-245 Pennant Hills Road

Carlingford NSW 2118

G25239-1-Rev A

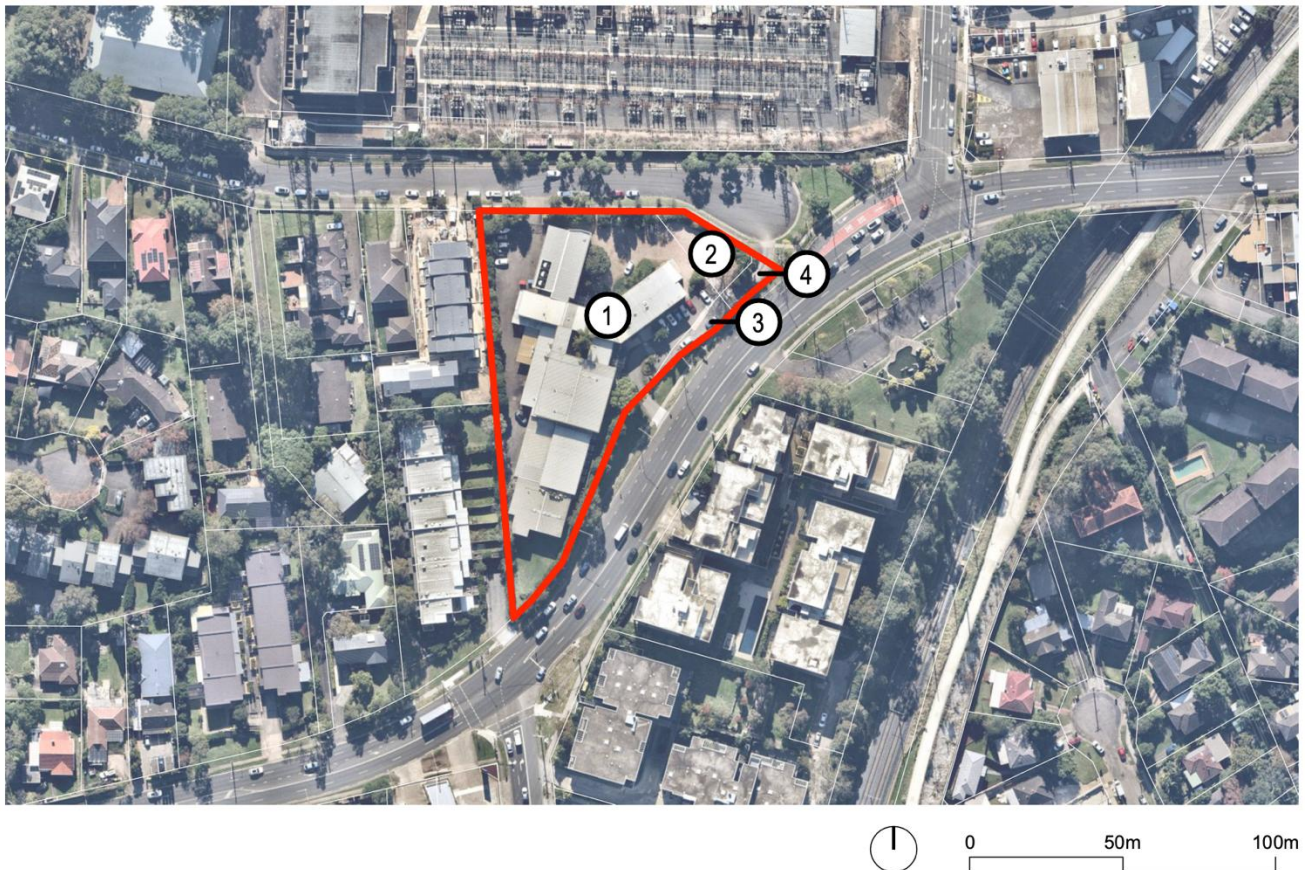
**Figure 3:** Site Aerial Map (Nearmap, edits by Kennedy Associates Architects)

A summary of the site description in Figure 3 is given below, for a total site area of approximately 6,331m<sup>2</sup>:

1. 241-245 Pennant Hills Road, Lot 1 DP805059.
2. 241-245 Pennant Hills Road, Lot 1 DP805059.
3. 241-245 Pennant Hills Road, Lot 1 DP805059.
4. 241-245 Pennant Hills Road, Lot 1 DP805059.

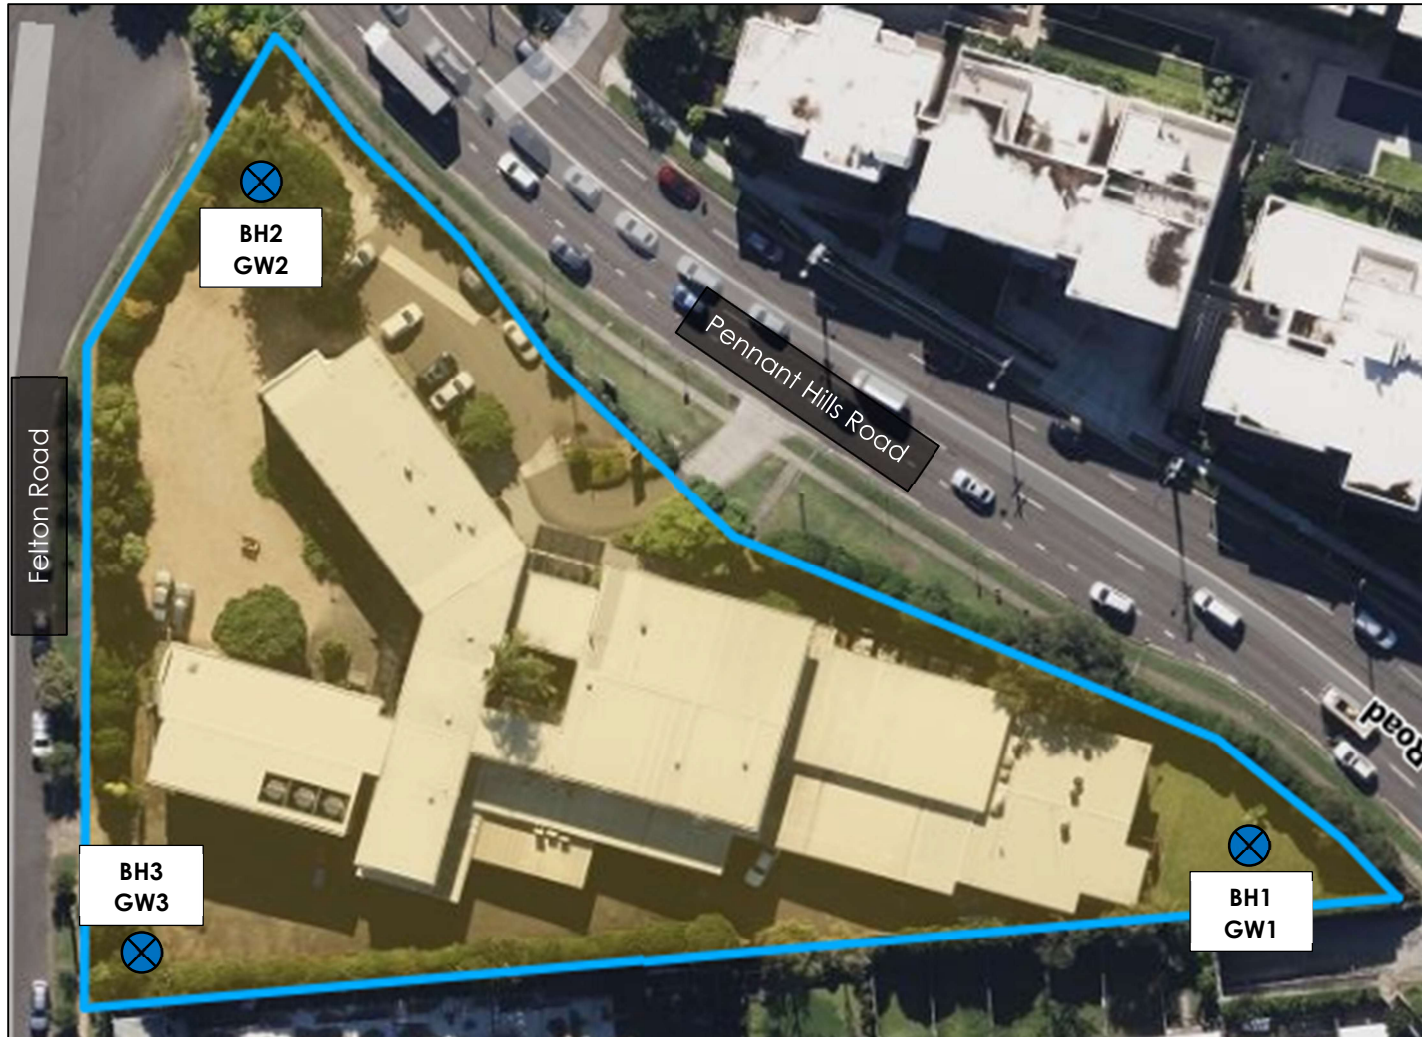
| | Figure 1<br>Site Plan | <b>Geotechnical Investigation &amp; Preliminary Groundwater Assessment</b> | | Drawn: OF/AN | |

Approximate Borehole Locations with Standpipe Piezometer
