**Re: Aboriginal Heritage Due Diligence Report – 2 Flide Street, Caringbah**

This Aboriginal Heritage Due Diligence Report has been prepared by Artefact Heritage and Environment Pty Ltd (Artefact Heritage) on behalf of Homes NSW for a concurrent State Significant Development Application (SSD-84862461) and Planning Proposal for the redevelopment of existing social housing (the Project) at 2 Flide Street, Caringbah (the Study area). The project involves the construction of two residential flat buildings—one rising to part 13 and part 14 storeys, and the other to 8 storeys—comprising a total of 164 social and affordable housing apartments. The development also includes a communal room and a two-level basement car park.

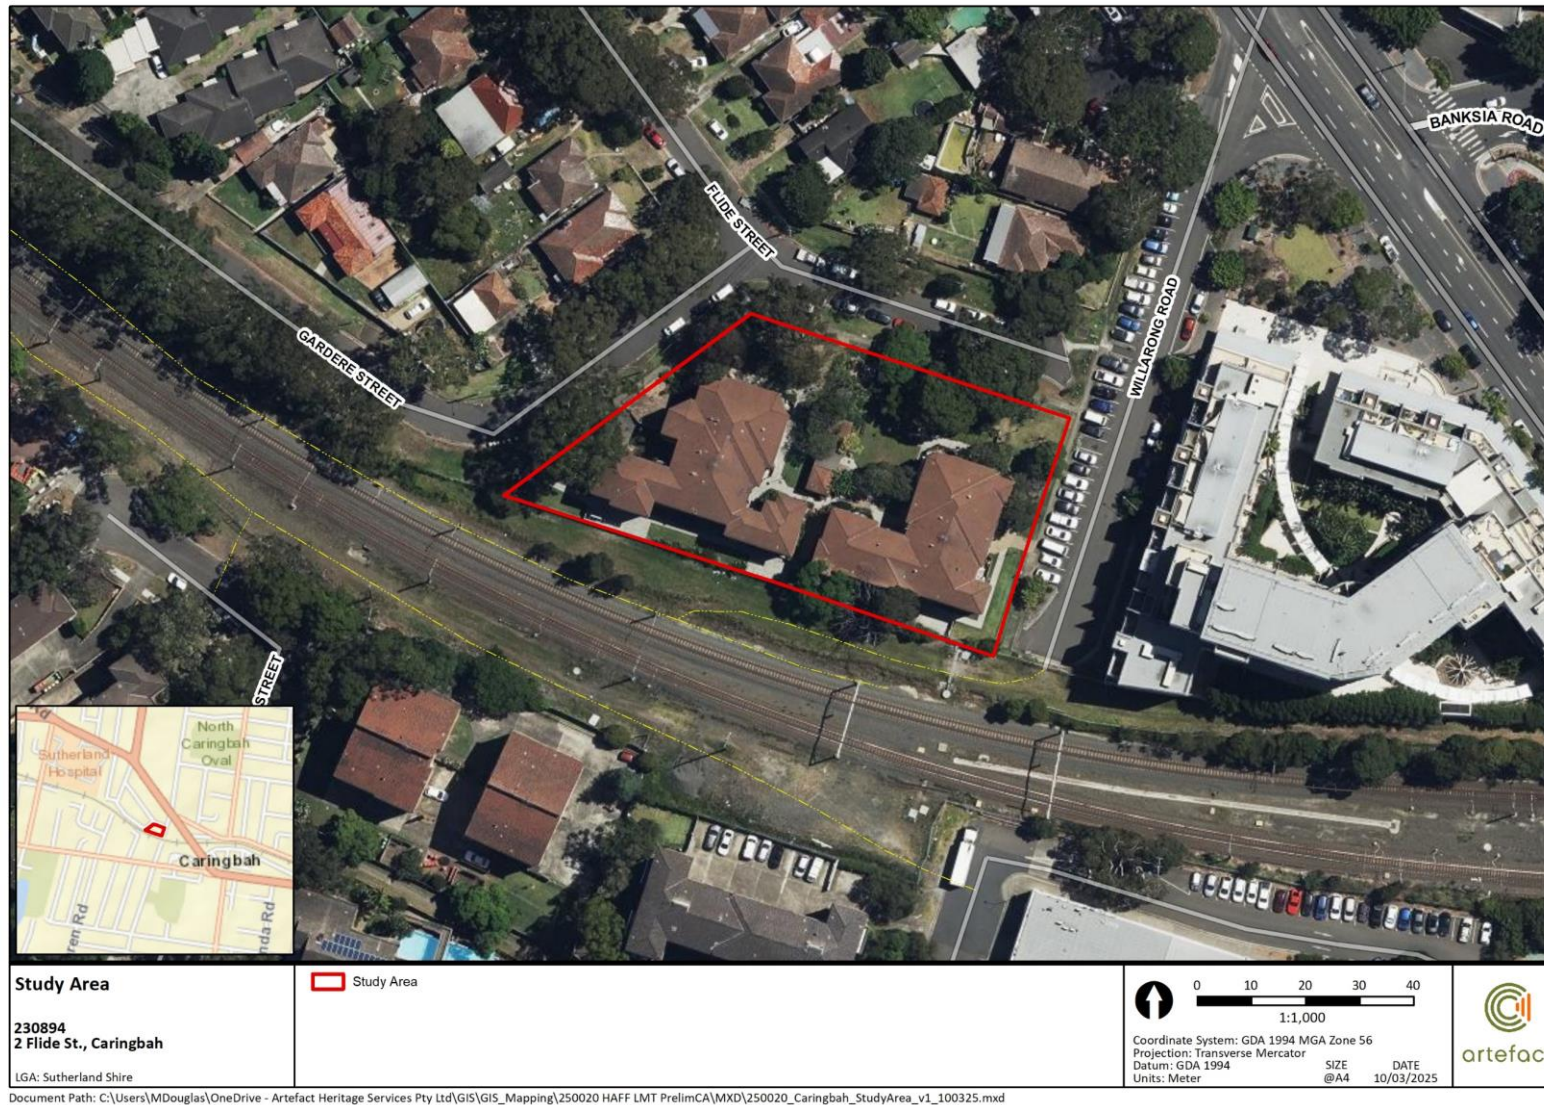
Figure 1: Study Area

The Study area is located within the Sutherland Shire local government area (LGA) and within the boundaries of the La Perouse Local Aboriginal Land Council (LALC). 2 Flide Street, Caringbah (Lots 57, 58, 59, 60 and 80 DP8147) has a total area of approximately 3,596 square metres (sqm) and is bound by Flide Street to the north, Gardere Street to the west, Willawong Road to the east and the rail corridor for the T4 Eastern Suburbs & Illawarra Line to the south. Refer to Figure 1. The site is accessible by public transport, being within 400m of the entrance to Caringbah Station and bust stops on the Kingsway which have frequent services to Sutherland, Miranda and Cronulla.

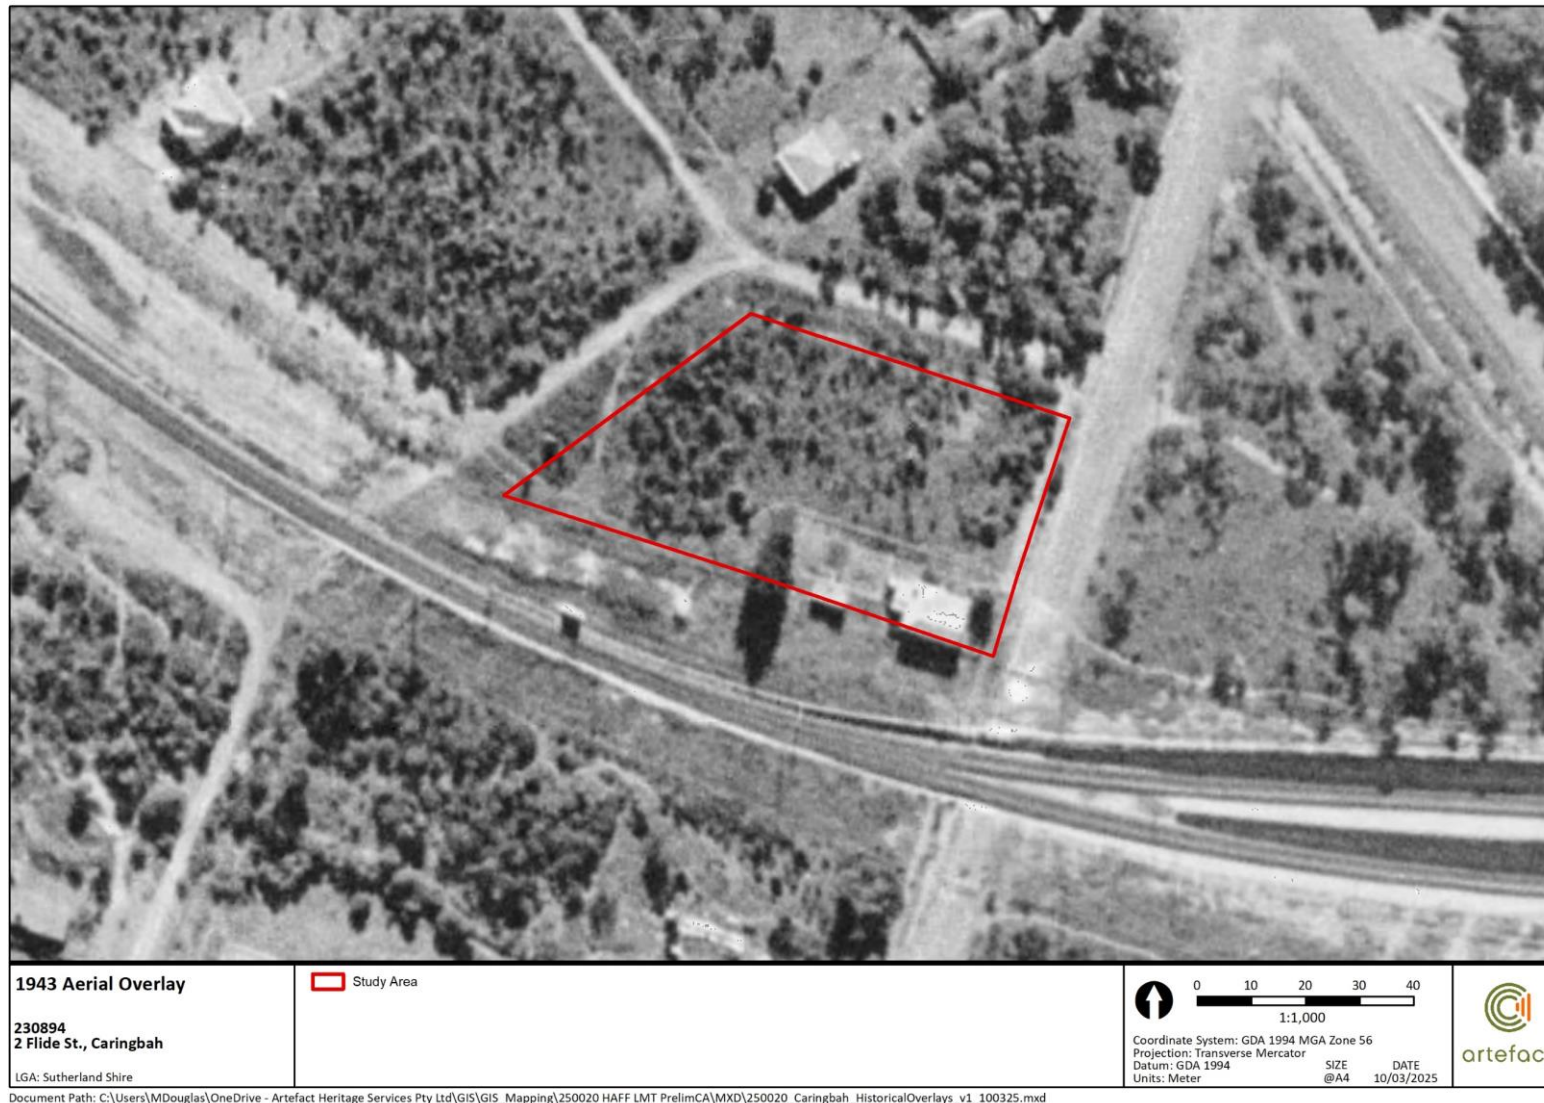
Figure 4: 1943 aerial photograph

Analysis of historic aerial imagery demonstrates that multiple phases of development have occurred within the study area. The study area remains mostly undeveloped by 1943 (Figure 4), except for some structures towards its southeast boundary. However, by 1956 (Figure 5), multiple houses had been constructed across the study area, and it appears that little land remained undisturbed. By 1990 (Figure 6), the structures that are currently extant in the study area had been constructed, with all the former houses being demolished. This cycle of construction, demolition and then redevelopment is likely to have significantly disturbed the study area and limits the potential for Aboriginal objects to be present.

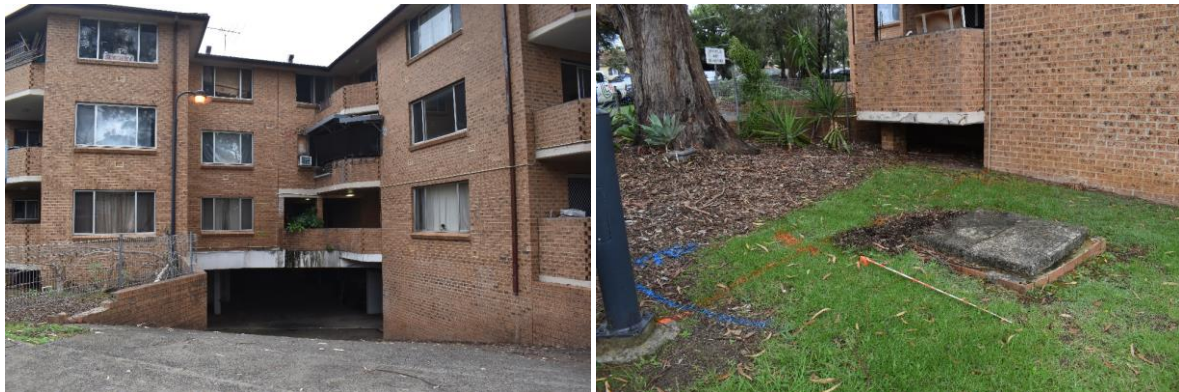
Excavation for an underground carpark under the extent of the property has removed the potential for any natural soils or artefacts to be present (Figure 7). There was nil ground exposure on the northwestern boundary of the terrace buildings where the entrance to the underground carpark is located (Figure 6).

**Figure 7: View east of property entrance with underground parking cut into the landscape. Figure 8: View east to the side of the property entrance and subsurface works indicated**

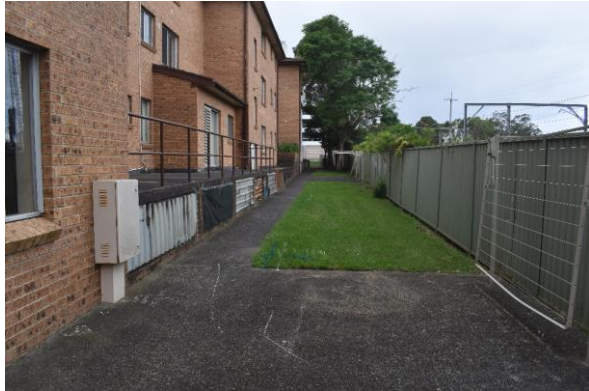
**Figure 9: View of cementing on southeast boundary of the study area**

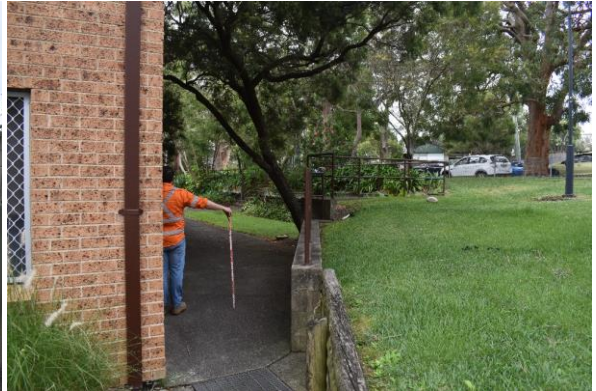
The study area is significantly disturbed and shows evidence of removal of potential artefact bearing residual soils from terracing and cuts into the natural slope for the construction of retaining walls and the extant buildings set into the landscape.

**Figure 10: Terracing of the study area, the garden and landscaping is elevated above the foundation of the extant buildings**

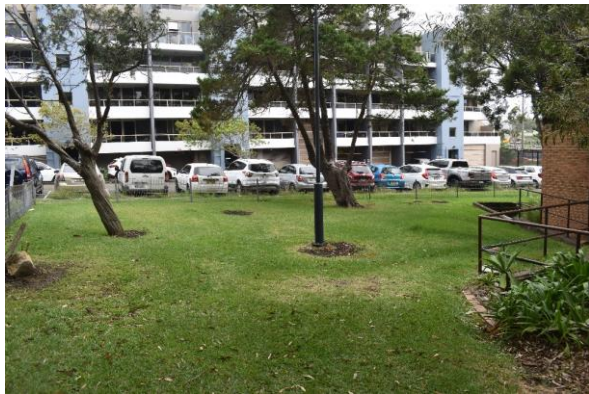
**Figure 11: Introduced landscaping at the northeast of the property.**

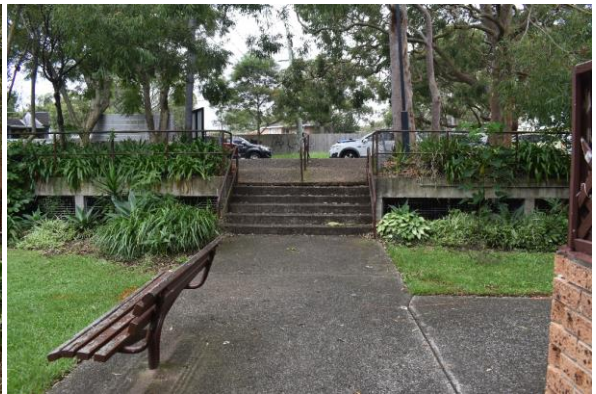
**Figure 12: North access of the property with cement paving and vents to the underground carpark visible.**

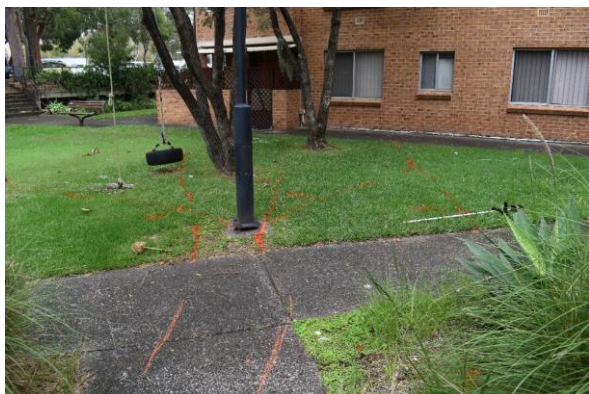
Overall, ground visibility and exposure were very low, being nil in most areas due to concrete paving (Figure 10), grass and vegetation cover in the form of landscaped gardening (Figure 12 and Figure 15). Patches of ground visibility were identified within grassed areas, where imported garden soil was observed (Figure 8). No original vegetation was observed (Figure 11). Across the study area services location markings indicate significant subsurface services that impact the integrity of the soil profiles (Figure 13).

**Figure 13: View of services location markings indicating extensive underground impacts to the study area**

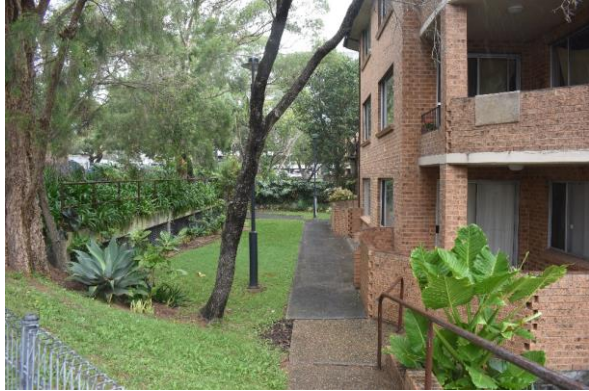
**Figure 15: View of landscaped gardening and landscape terracing**
