**Unexpected Finds (Contamination)  
Protocol**

**Flide Street, Caringbah, Affordable  
Housing**

**2 Flide Street, Caringbah NSW**

**Project 233414.04**

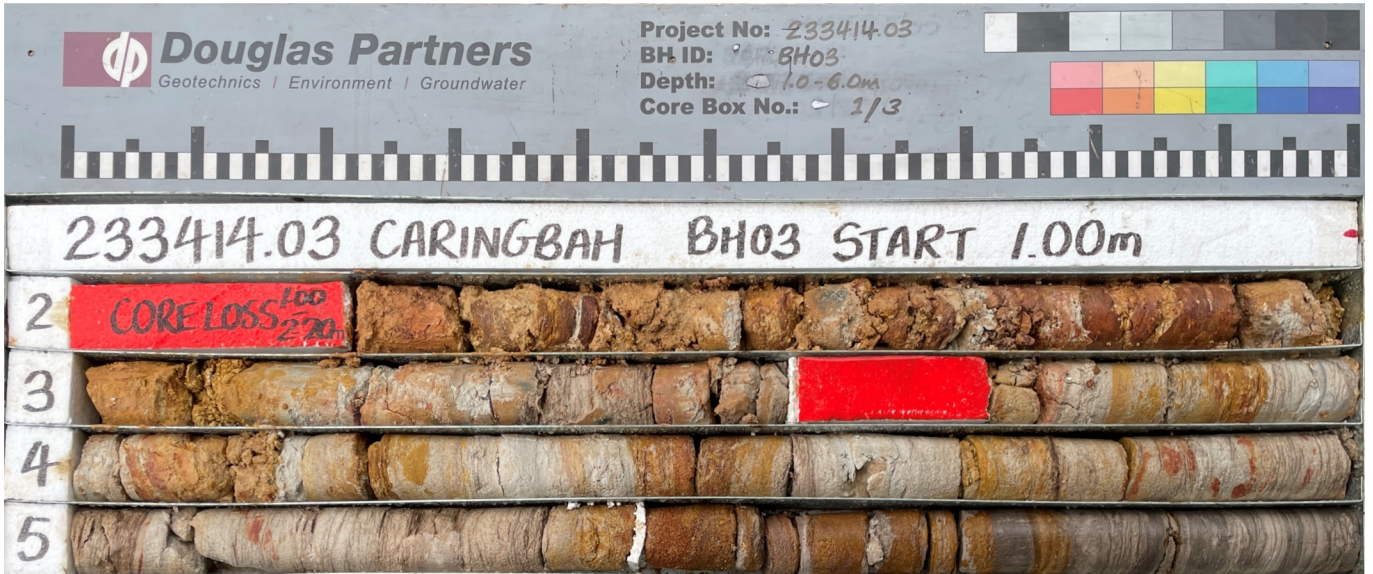
**LOCATION ID:** BH03  
**PROJECT No:** 233414.03  
**DATE:** 30/04/25  
**SHEET:** 1 of 2

1.00-6.00 m depth

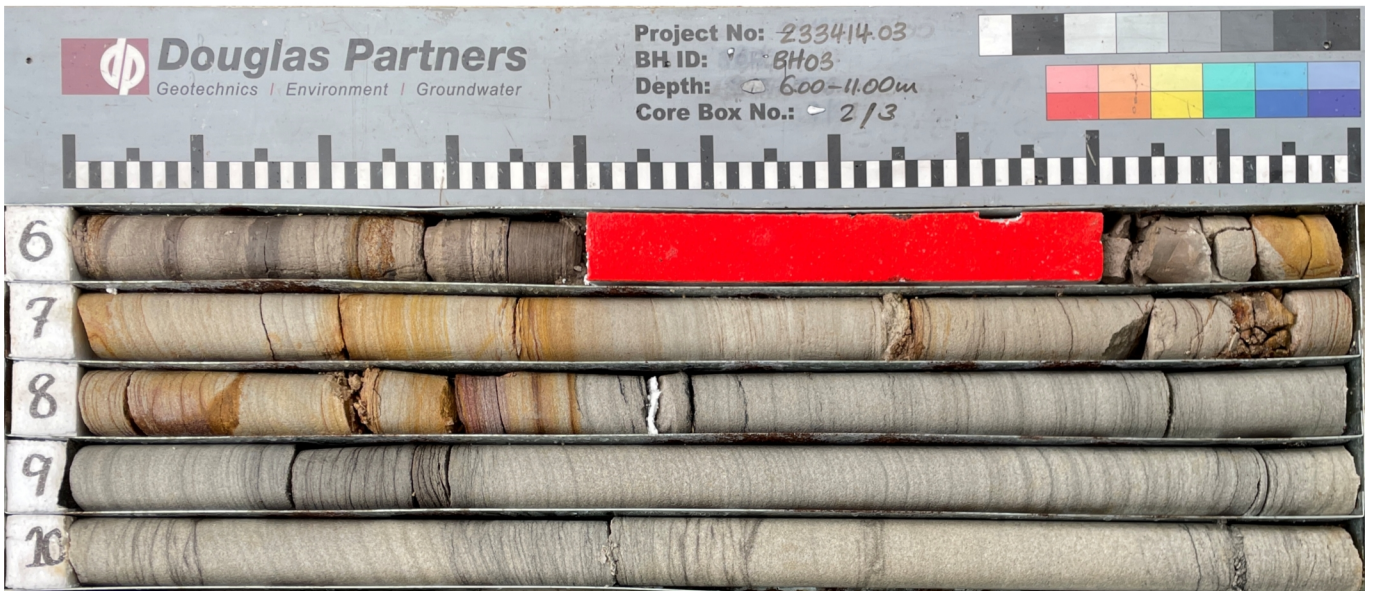
6.00-11.00 m depth

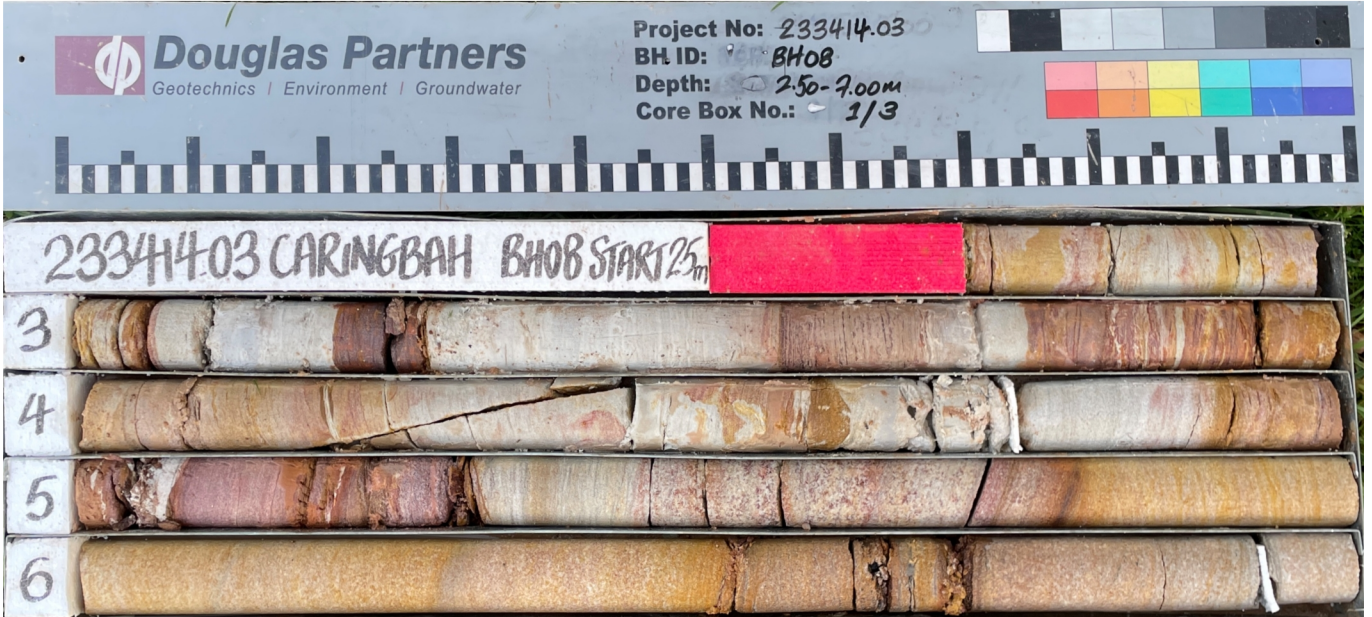
**LOCATION ID:** BH08  
**PROJECT No:** 233414.03  
**DATE:** 01/05/25  
**SHEET:** 1 of 2

2.50-7.00 m depth

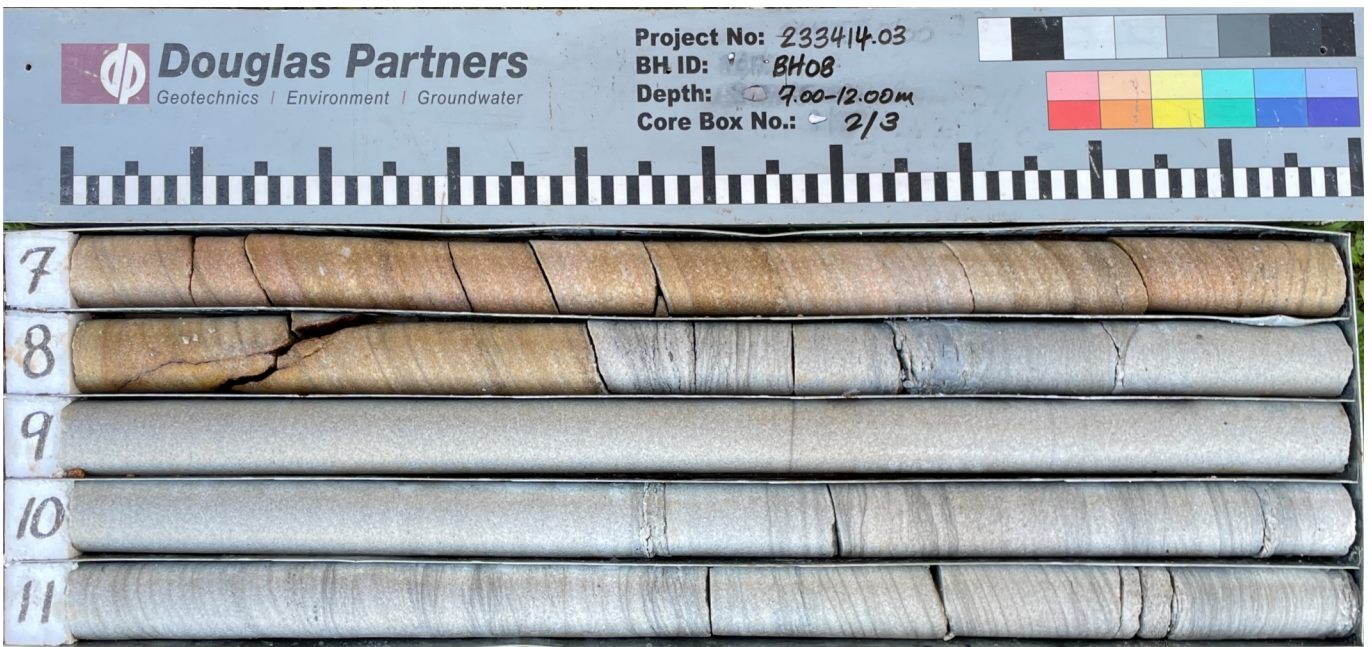
7.00-12.00 m depth

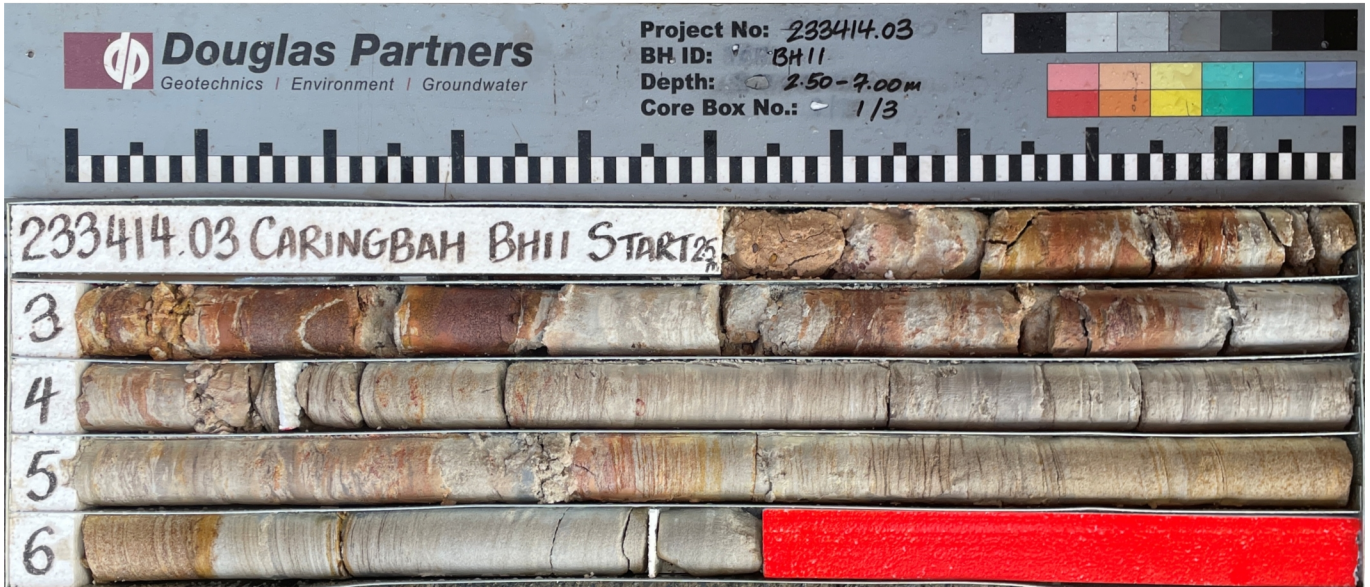
**LOCATION ID:** BH11  
**PROJECT No:** 233414.03  
**DATE:** 02/05/25  
**SHEET:** 1 of 2

2.50-7.00 m depth

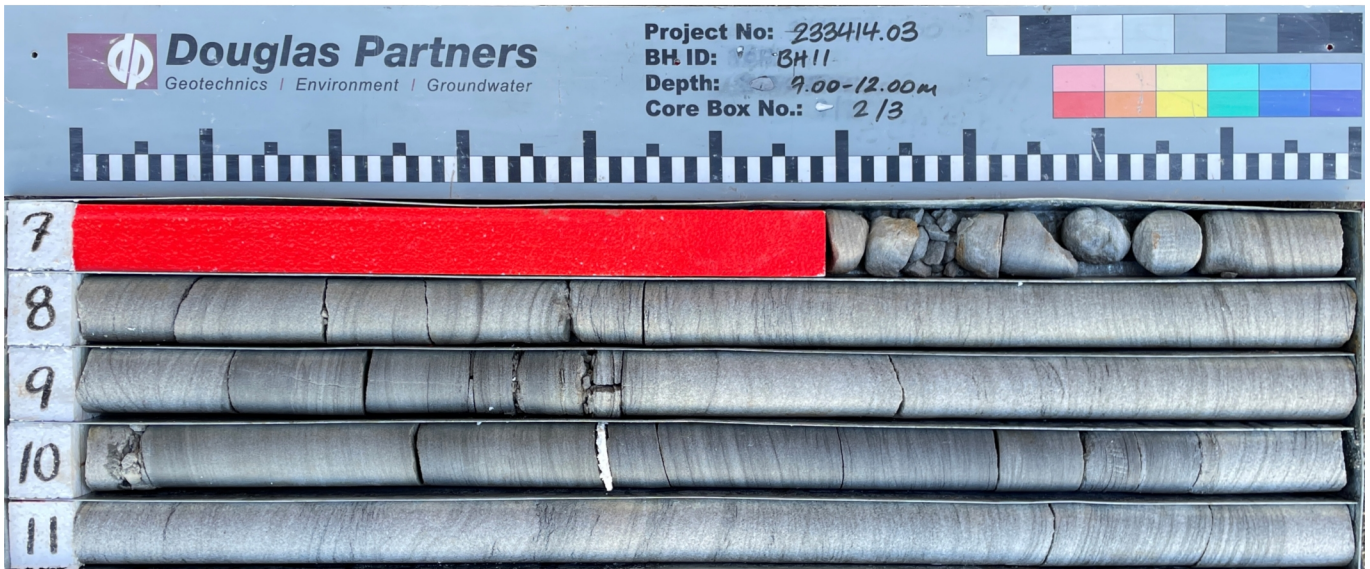
7.00-12.00 m depth

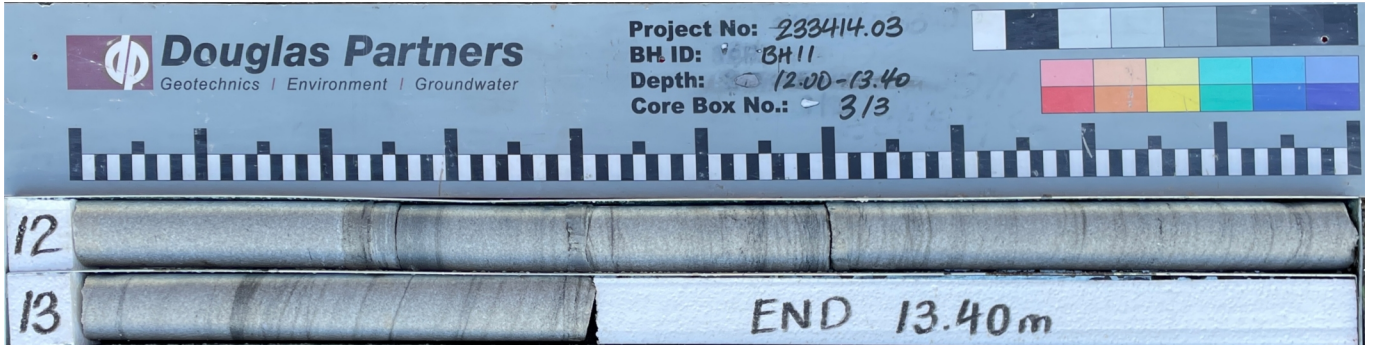
**LOCATION ID:** BH11  
**PROJECT No:** 233414.03  
**DATE:** 02/05/25  
**SHEET:** 2 of 2

12.00-13.40 m depth
