### **Report on Geotechnical Investigation**

**Flide Street, Caringbah, Affordable  
Housing**

**2 Flide Street, Caringbah NSW**

**Project 233414.03**

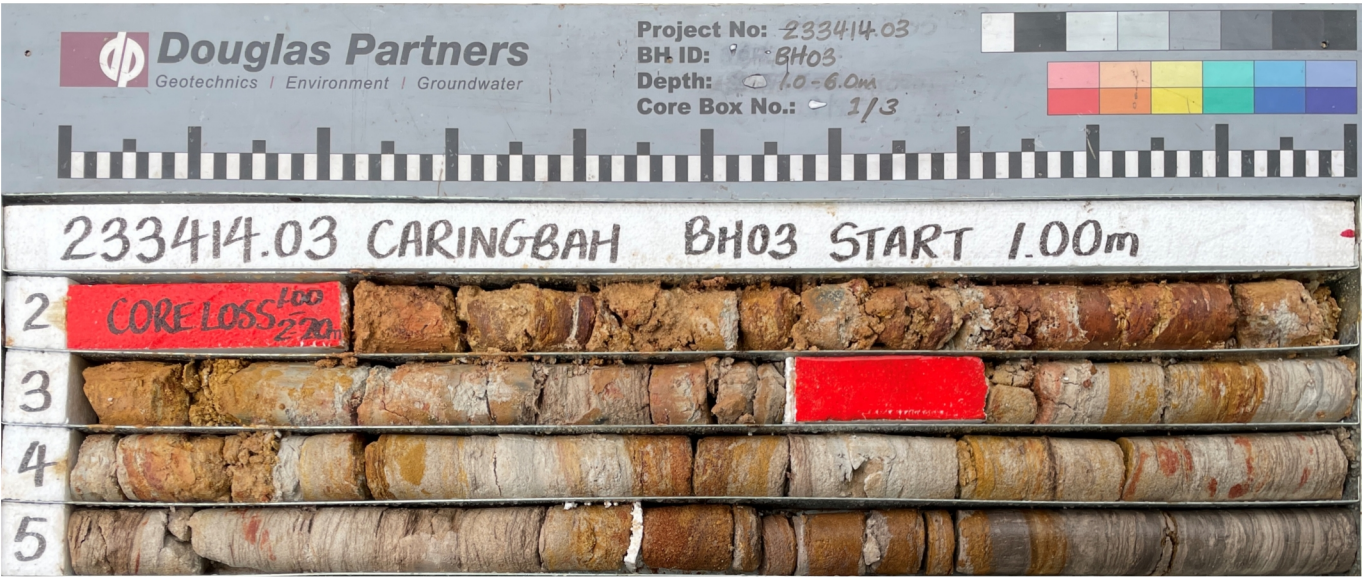
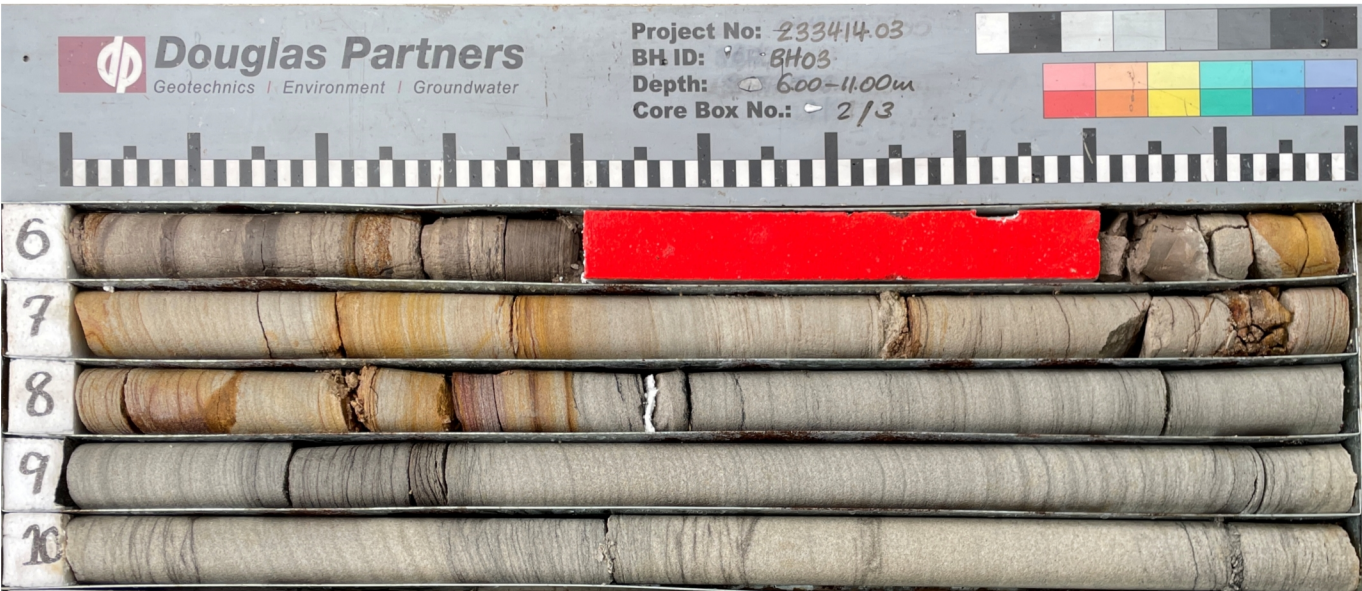
1.00-6.00 m depth

6.00-11.00 m depth

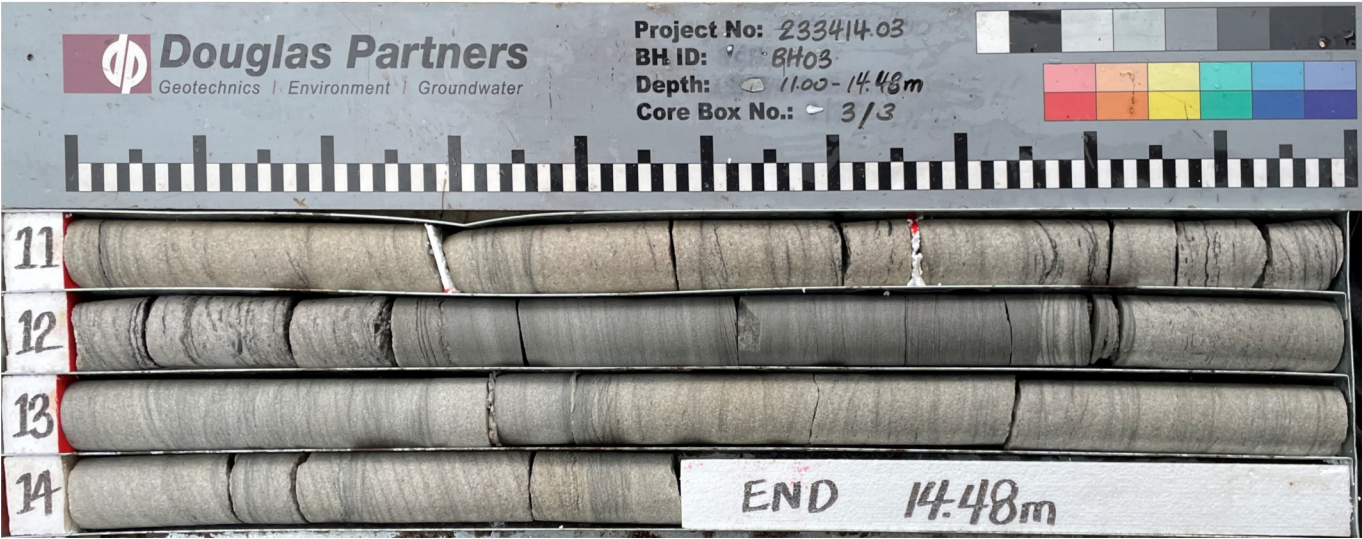
11.00-14.48 m depth

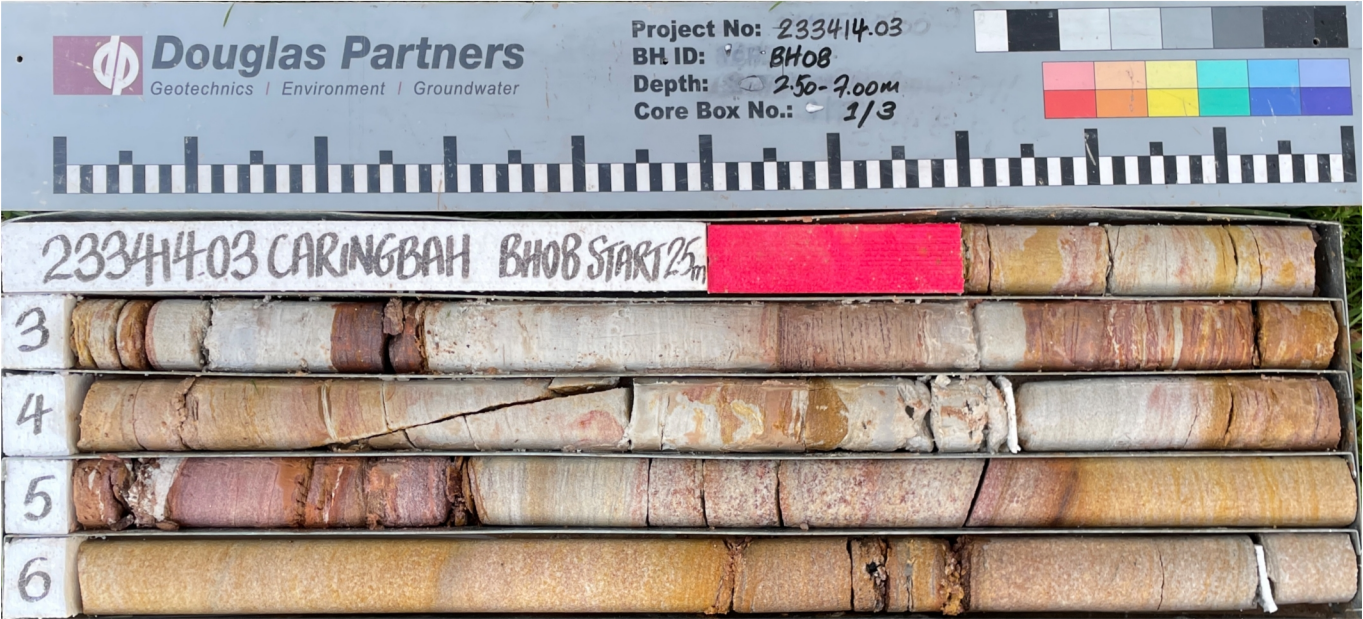
**LOCATION ID:** BH08  
**PROJECT No:** 233414.03  
**DATE:** 01/05/25  
**SHEET:** 1 of 2

2.50-7.00 m depth

7.00-12.00 m depth

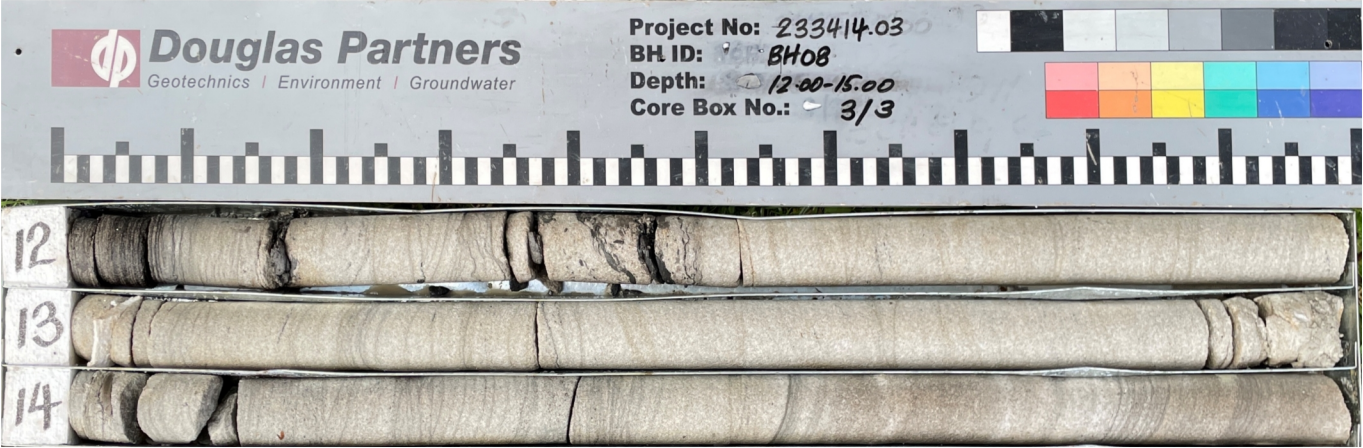
**LOCATION ID:** BH08  
**PROJECT No:** 233414.03  
**DATE:** 01/05/25  
**SHEET:** 2 of 2

12.00-15.00 m depth

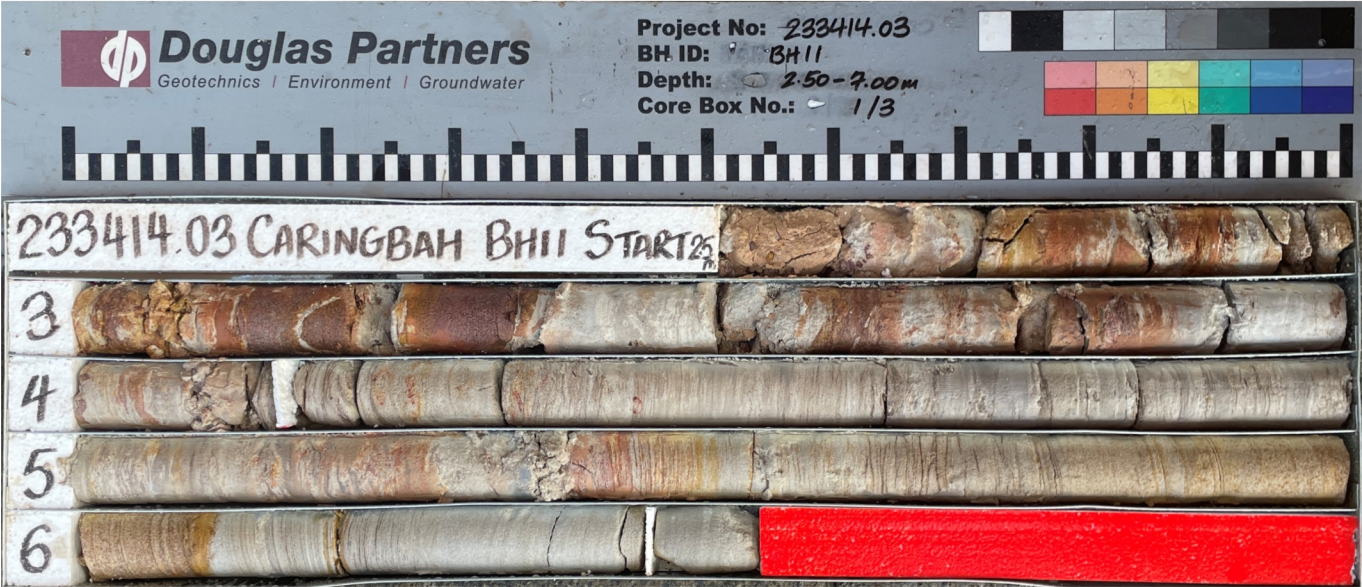
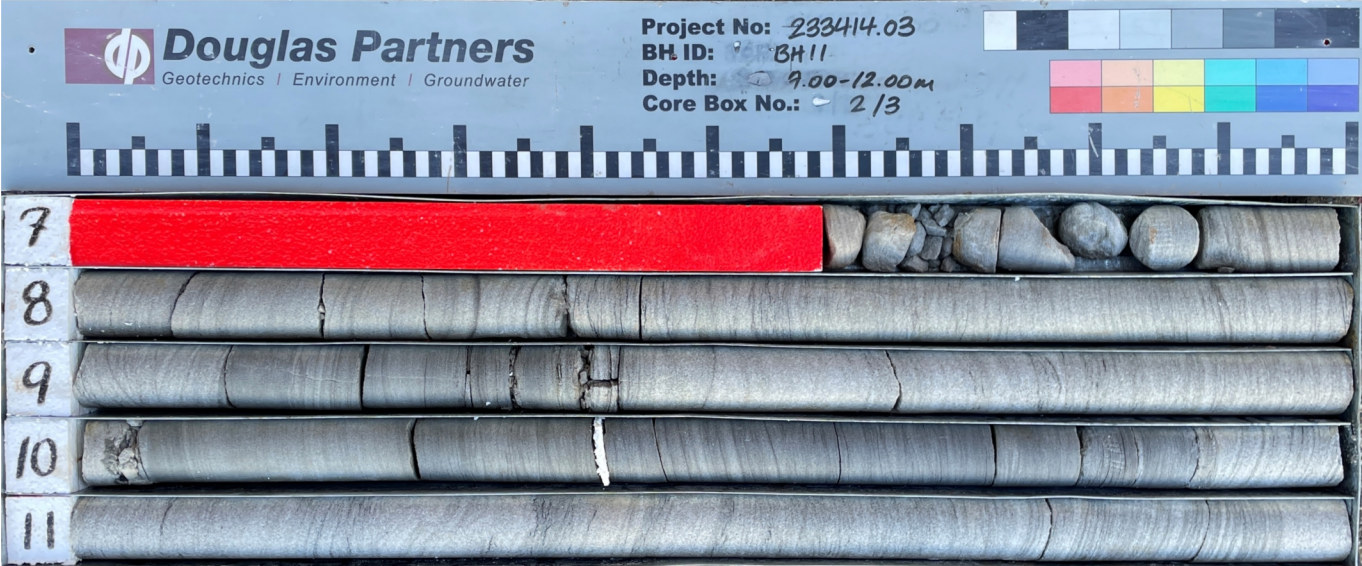
**LOCATION ID:** BH11  
**PROJECT No:** 233414.03  
**DATE:** 02/05/25  
**SHEET:** 1 of 2

2.50-7.00 m depth

7.00-12.00 m depth
