## **Construction Environmental Management Plan**

**Leichhardt Oval Refurbishment**

**68 Mary Street, Lilyfield NSW**

**Project 236743.01**

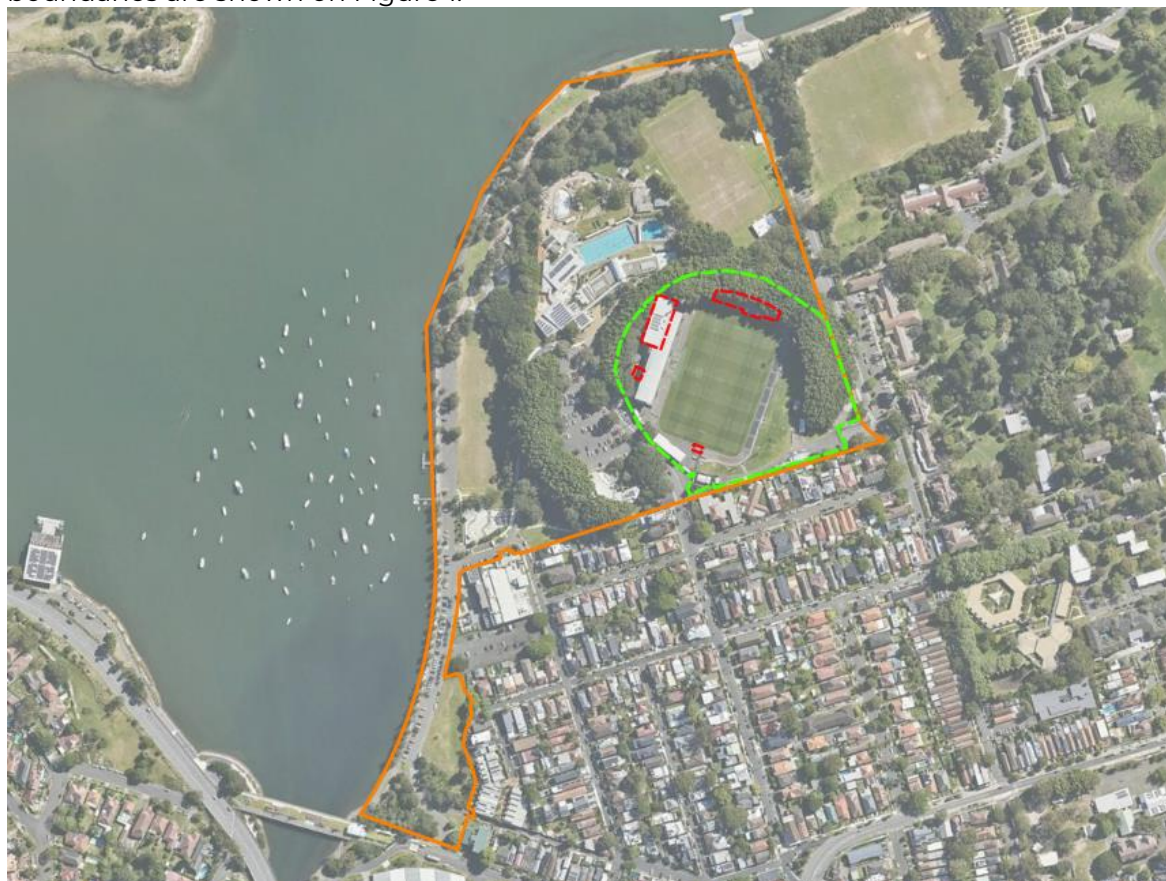
**Figure 1: The subject site boundaries (red dash lines), Leichhardt Oval Refurbishment Project Site boundary (green dash line) and Leichhardt Park boundary (orange line)**

The subject site, the Leichhardt Oval Refurbishment Project Site and Leichhardt Park boundaries are shown on Figure 1.

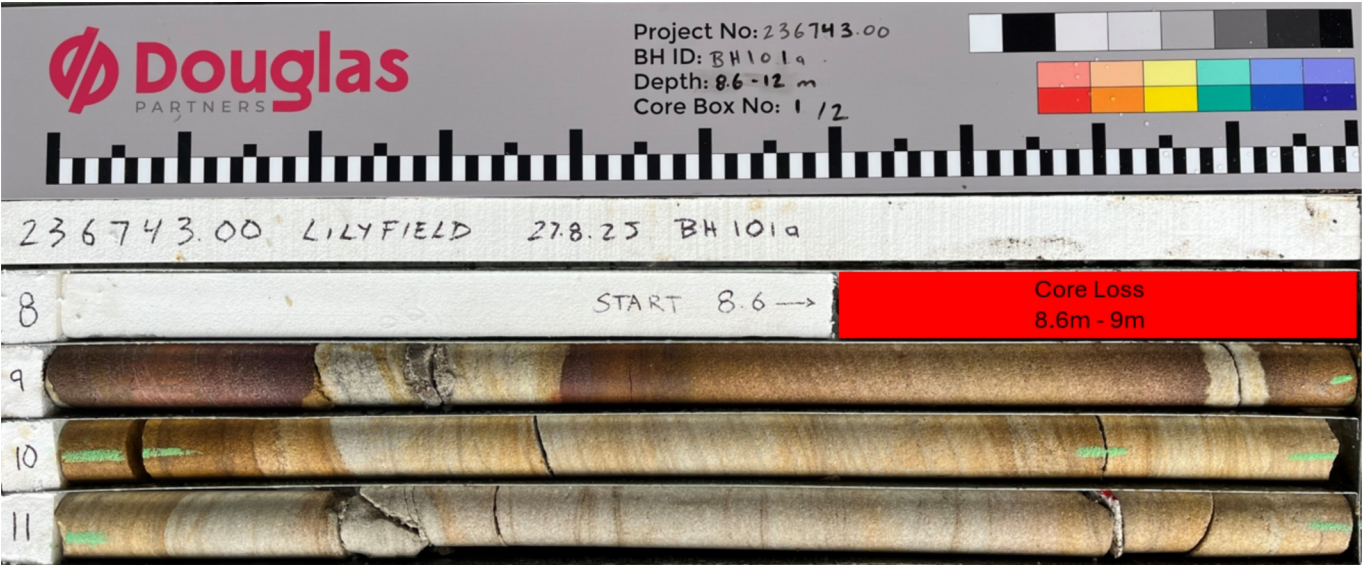
8.60-12.00 m depth

**SURFACE LEVEL:** 23.2 AHD  
**COORDINATE:** E:329320.3, N:6250947.0  
**DATUM/GRID:** MGA2020 Zone 56  
**DIP/AZIMUTH:** 90°/---°

**LOCATION ID:** BH101a  
**PROJECT No:** 236743.00  
**DATE:** 26/08/25  
**SHEET:** 1 of 1

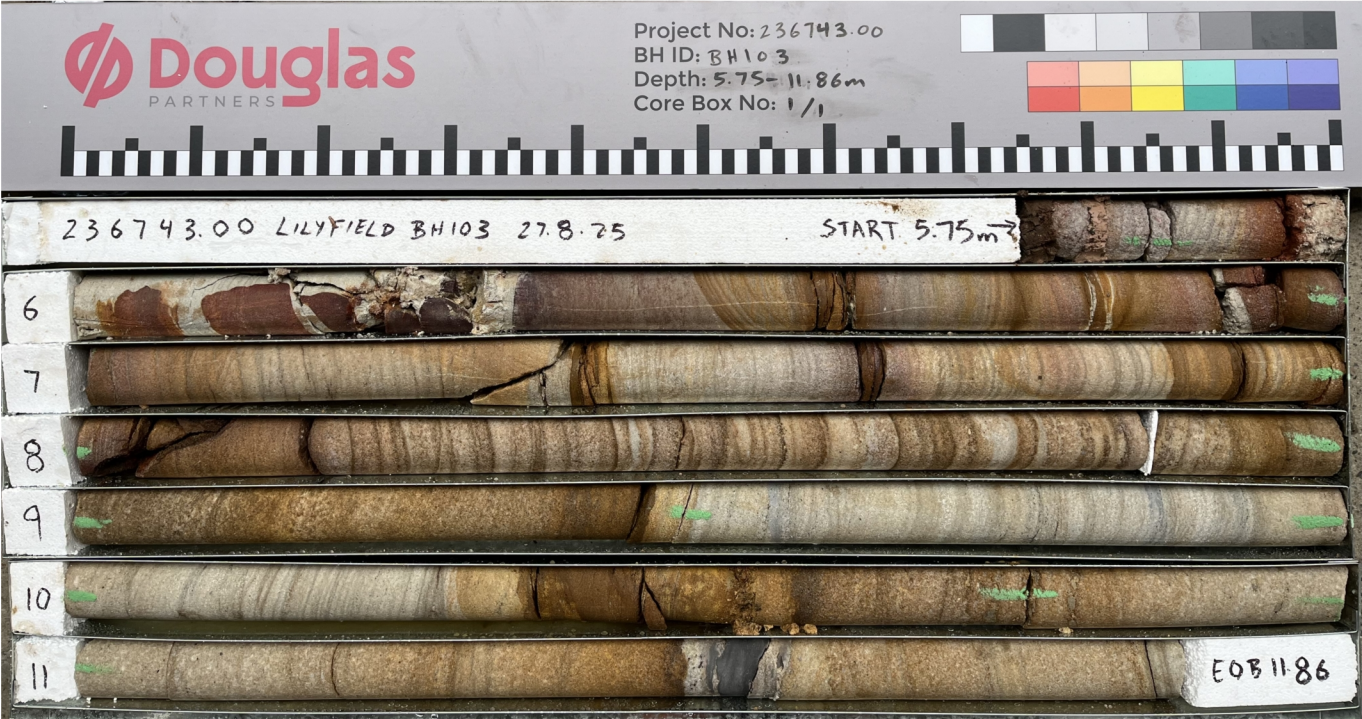
5.75-11.86 m depth

**DATE:** 27/08/25
