Report on  
Geotechnical Investigation

Locomotive Shed Redevelopment  
Locomotive Street, Eveleigh

Prepared for  
Mirvac Projects Pty Ltd

Project 84955.04  
October 2017

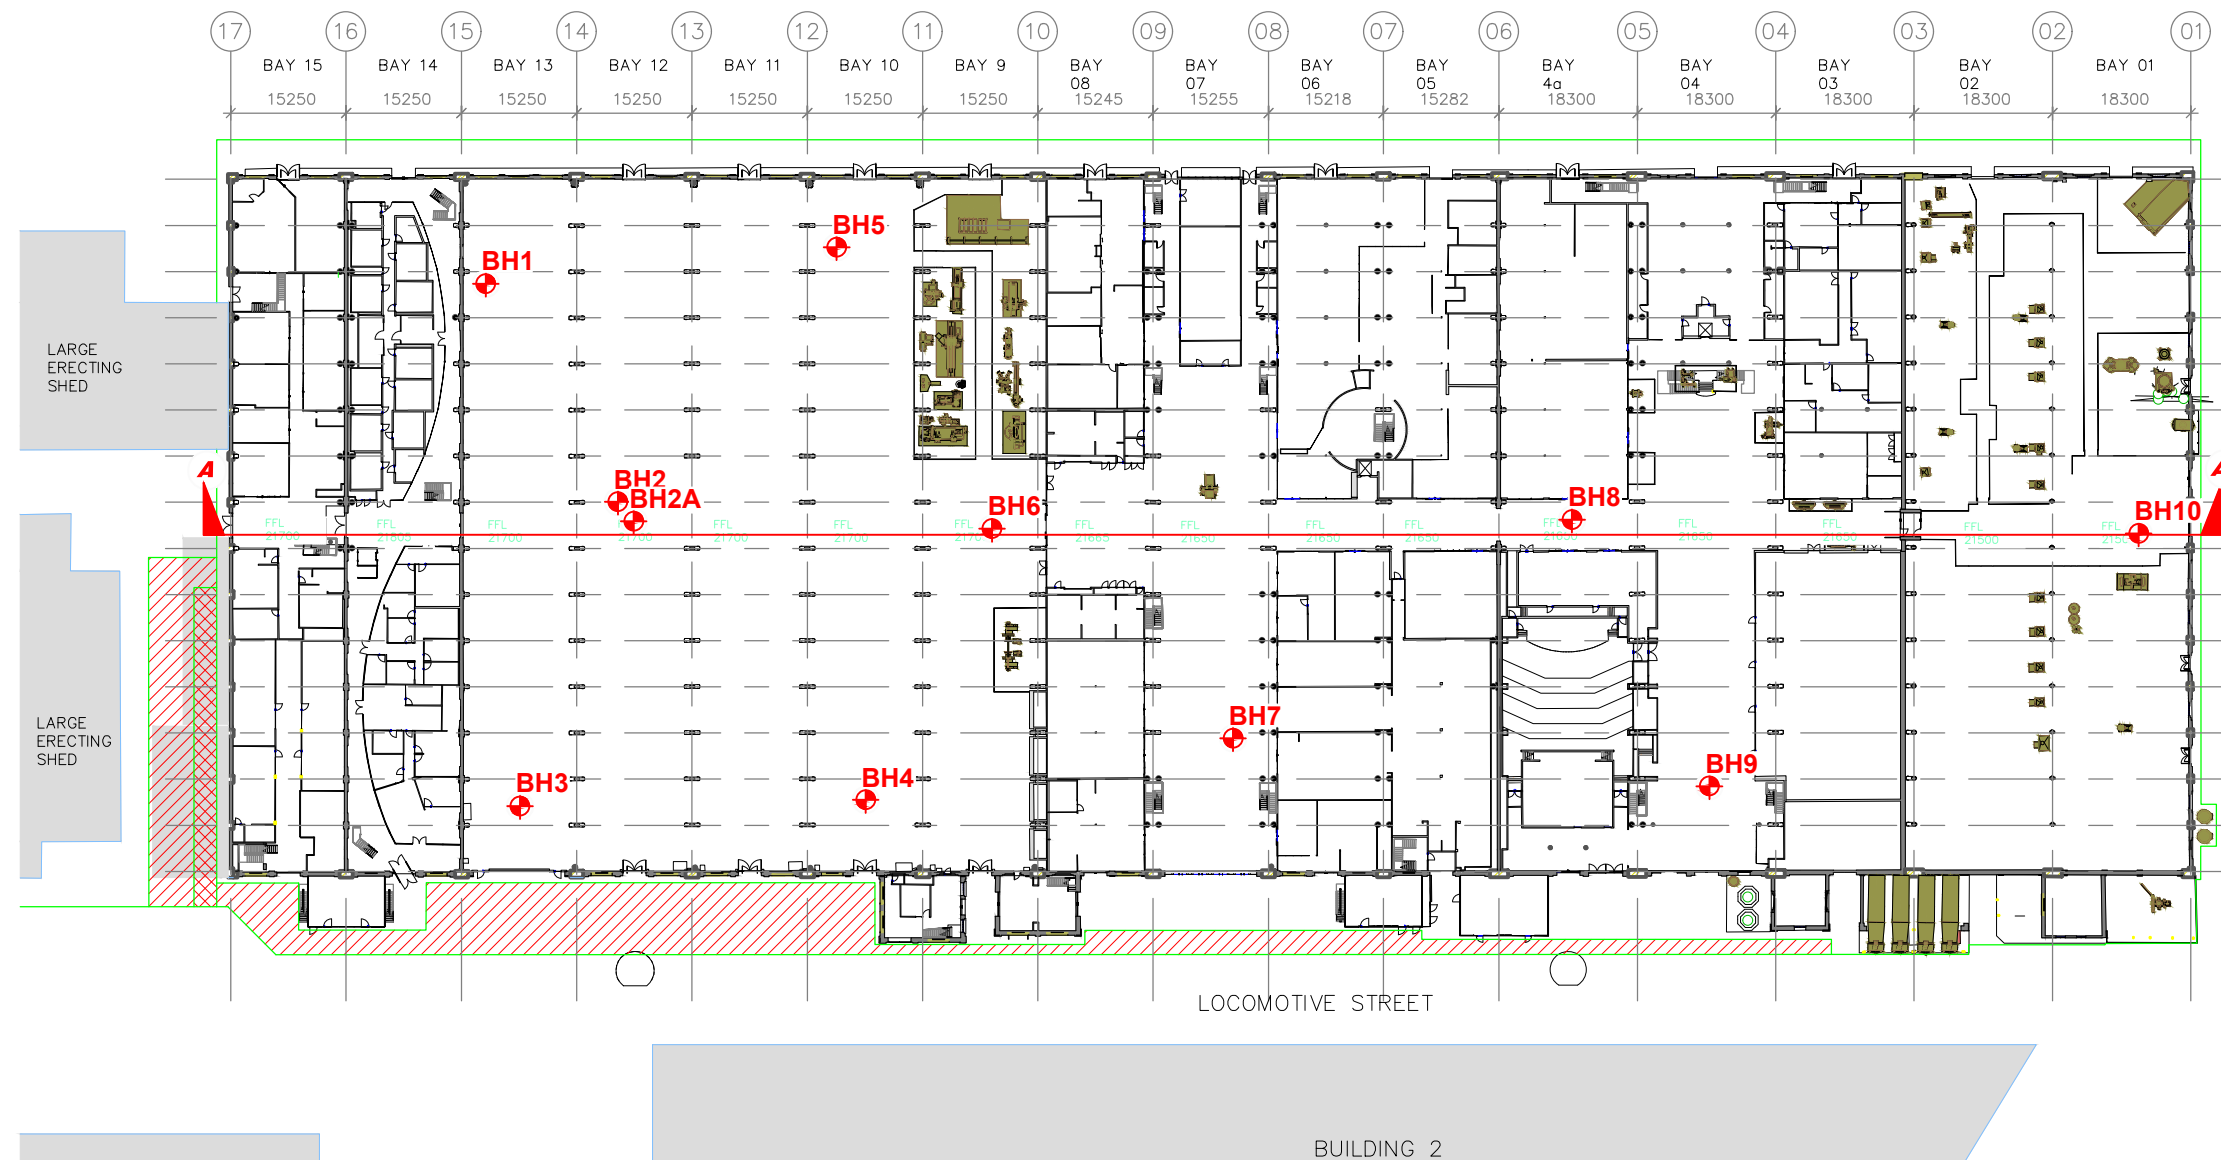
Location of Boreholes

The borehole locations were determined relative to existing features and are shown on Drawing 1 in Appendix B.

- Borehole location
- Geotechnical Cross Section A-A'

The field work comprised drilling of 10 boreholes, identified as BH1 to BH10 from west to east, within the existing building. Borehole BH2 was re-drilled as BH2A at an adjacent location due to the presence of a buried service pipe. All boreholes were drilled with a bobcat mounted drilling rig to depths of between 0.5 m and 10.3 m using solid flight augers and diacore drilling through concrete. Standard penetration tests (SPT) were carried out at regular intervals. The drilling cuttings and SPT samples from the boreholes were logged by a geotechnical engineer.
