**BARANGAROO SOUTH**  
**C1 BUILDING - BASEMENT EXIT INTERSECTION WORKS**

This letter has been prepared in response to a Road Safety Audit (RSA) report prepared for proposed intersection modifications at the basement exit at Hickson Road, Sussex Street and Napoleon Street, Barangaroo.

## Hickson Road, exit from C1 building car park, Barangaroo

### Detailed design road safety audit

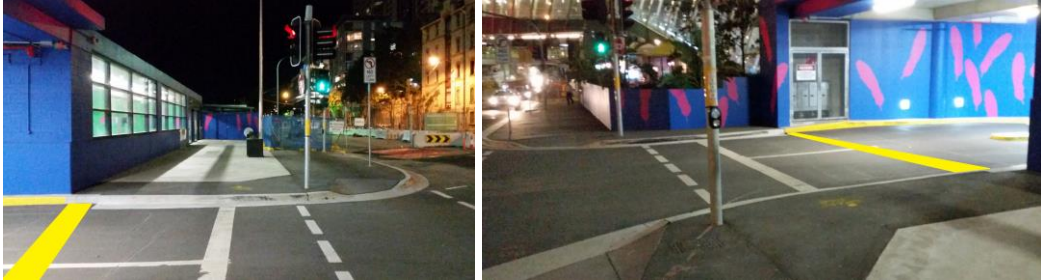
| Ref | Location | Previous road safety audit finding (sourced from report CARD-PROJ-0003-06) | Comment from the current audit team |
|---|---|---|---|
| C-3 | General – Impact of the relocated pedestrian crossing on the operation of the intersection. | <p>The proposed relocation of the pedestrian crossing to the west will also have the following impacts on the operation of the intersection:</p> <ul style="list-style-type: none"> <li>The control area/ conflict zone of the intersection will increase. The control area is generally the area between all of the respective stop lines in each approach. With a larger control area, the clearance times for any vehicles emerging from the basement car park will also increase. This requires more “all red” period for these vehicles clear the intersection before the conflicting traffic streams can be given a green display. This will increase overall intersection delay, possibly leading to additional queuing (due to wasted signal cycle time) and consequential congestion-related crashes (eg. rear-end crashes).</li> <li>Under existing conditions, vehicles egressing from the basement car park and standing at the hold line of the intersection are in the “open air” environment and are more easily seen by other drivers, cyclists and pedestrians using the intersection. Similarly, these drivers would have clearer sight lines to those conflicting traffic streams as well. As such, physical and traffic conditions in the control area of the intersection are predictable for drivers as they progress into the intersection. Under the proposed conditions with the relocation of the pedestrian crossing and stop line, any egressing vehicle would be emerging from a visually concealed area. These drivers would have less awareness of the conditions in the road ahead. Similarly, other road users would have less awareness of any imminent threats posed by these egressing drivers. The movements from each respective traffic stream become less predictable (ie. increased “surprise factor”). Some egressing drivers may respond by “creeping” out into the intersection, or baulking/ hesitating when entering the intersection. These behaviours often lead to cross traffic and rear-end crashes.</li> </ul> <p>The white unbroken stop lines in the two photos below show the existing starting positions of egressing drivers from the basement car park as they enter the intersection. The yellow lines mark the likely starting positions under the proposed scenario.</p> <p><b>Above:</b> Looking north (left-hand image) and south (right-hand image) across the basement car park approach under existing conditions. Note the existing visibility conditions to and from any vehicles at the existing hold line (white unbroken line) compared with the proposed conditions (yellow line). Photos taken on 25/9/2017.</p> | This is still the case as per the detailed design. See the comment to item C-2. |

| Audit Reference | Description | Possible Risk Mitigation Measures<br>(refer to footnotes below) |
|---|---|---|
| C-3 | Impact of relocated pedestrian crossing on the operation of the intersection | A |

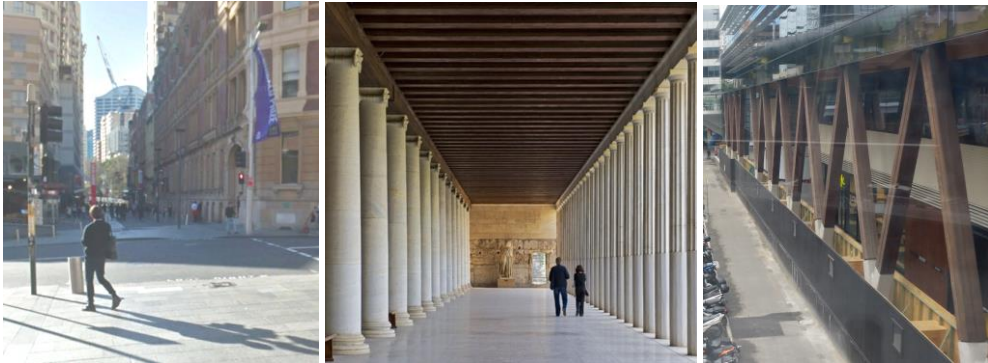
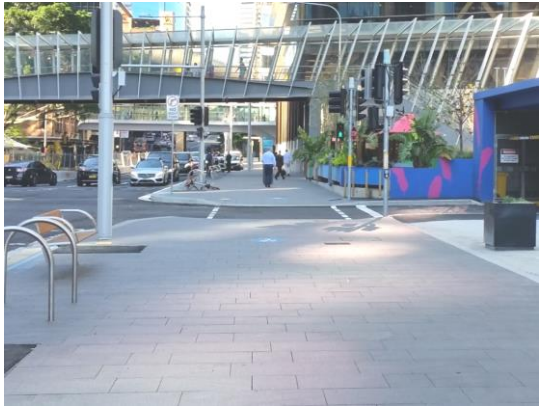
| Ref | Location | Previous road safety audit finding (sourced from report CARD-PROJ-0003-06) | Comment from the current audit team |
|---|---|---|---|
| C-5 | Impact of colonnade on pedestrian “see-through” perceptions. | <p>The relocated crossing will line up with the colonnade walkways on the northern and southern sides of the basement car park ramp. The colonnade and the continuity of structures, décor etc may give a misleading “see through” perception to pedestrians approaching from either side of the crossing. This effect is where the pedestrian from one side of the crossing can see the continuation of the colonnade environment on the other side of the crossing and falsely believes that either (i) there is no crossing in place and the exclusive pedestrian space simply continues north-south, or (ii) that there is a crossing in place but that pedestrians have right-of-way over road vehicles. These false perceptions may increase the risk of vehicle-pedestrian crashes. Some examples of misleading “see-through” effects are provided below.</p> <p><b>Left:</b> An example of a misleading “see-through” effect in Haymarket. The pedestrian mall on this side of the photo appears to continue un-impeded to the shared zone space on the other side of the road. Some pedestrians may lack awareness of the road and its conflicting traffic streams.</p> <p><b>Middle:</b> Colonnade structures have the potential to create misleading “see-through”/ continuation perceptions due to the continuation of columns, ceilings and walkways. <b>Right:</b> The pre-existing colonnade to the south of the subject site.</p> | <p>This would still be the case as proposed under the detailed design. Even without the colonnade in place, there is a strong “see-through” continuation effect as shown below. The footpaths either side of the car park exit are very uniform and pedestrians may fail to acknowledge the presence of a trafficable road midway along this path. With the addition of the colonnade columns and ceiling, the visual continuation effect would be even more prominent.</p> <p><b>Above:</b> Looking southbound along the western footpath of Hickson Road across the C1 building car park exit. Photo taken on 15/3/2018.</p> |

| Audit Reference | Description | Possible Risk Mitigation Measures<br>(refer to footnotes below) |
|---|---|---|
| C-5 | Impact of colonnade on pedestrian "see-through" perceptions | B and C |

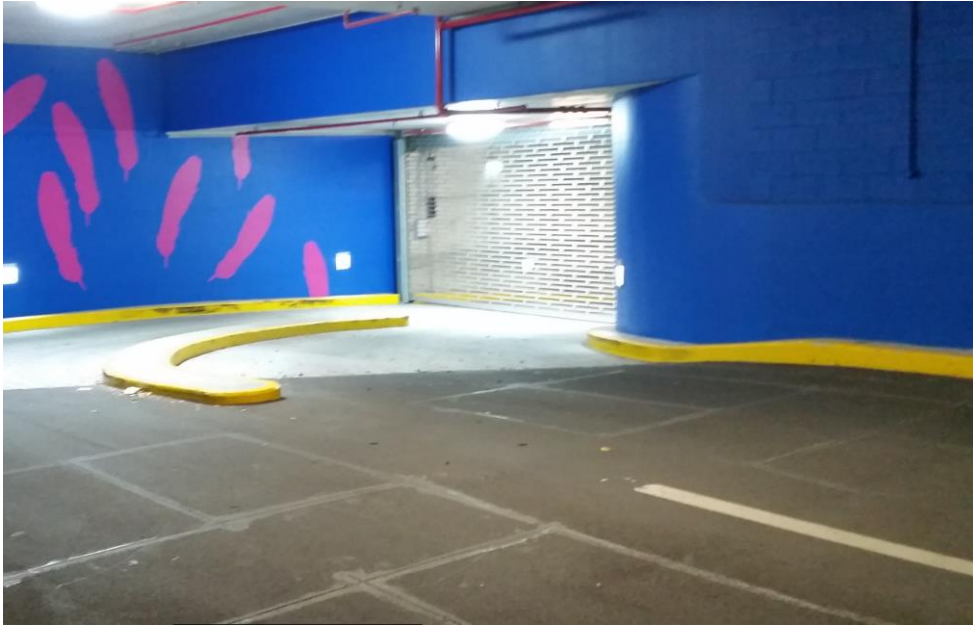
| Ref | Location | Previous road safety audit finding (sourced from report CARD-PROJ-0003-06) | Comment from the current audit team |
|---|---|---|---|
| C-6 | Basement car park ramp in approach to the signalised intersection. | <p>The proposed relocation of the pedestrian crossing would effectively reduce the approach length between the roller door of the car park and the hold line. There would be a lack of storage length available between the hold line and the roller door. As such, any queues from the new hold line would be at greater risk of spilling back to the roller door. The audit team is uncertain whether the roller doors are programmed to detect obstructions to delay the closing of the door under the obstruction has cleared. As such, there is a risk of the roller door closing on top of a queued vehicle, or even queued vehicles rolling back into the roller door before starting up from rest.</p> <p><b>Above:</b> Under existing conditions, there is limited length between the roller door and the hold line in this approach. However, under the proposed conditions, there would be even less approach length and more risk of queues spilling back to the roller door. Photo taken on 25/9/2017.</p> | This would still be the case as per the detailed design. |

| Audit Reference | Description | Possible Risk Mitigation Measures<br>(refer to footnotes below) |
|---|---|---|
| C-6 | Basement car park ramp in approach to signalised intersection | No specific measures required, as the roller door remains open all day while the basement car park is in operation. |

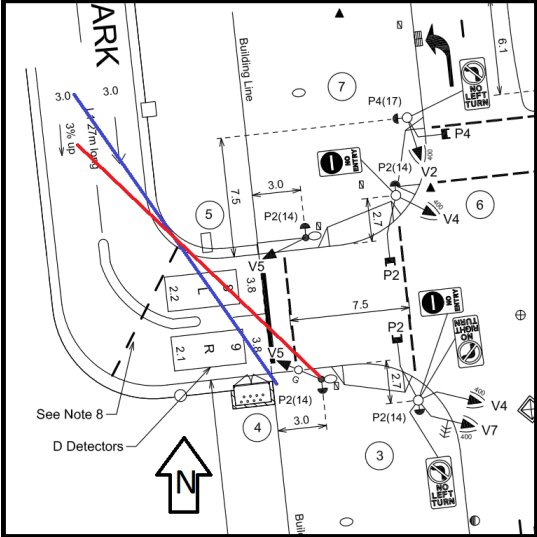
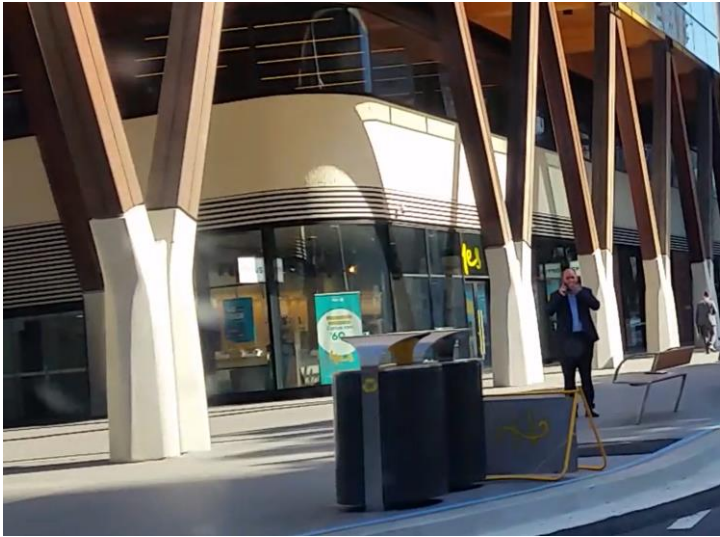
| Ref | Location | Road safety audit finding | Priority |
|---|---|---|---|
| 7 | Primary and dual primary signals in the C1 building car park egress lane. | <p>The TCS design indicates that the primary (post 5) and dual primary (post 4) signals will be the colonnade support pylons themselves. This has a number of concerns as follows:</p> <ul style="list-style-type: none"> <li>The signals will not be in line with the hold line. Typically, primary signals should be placed in line with the hold line or as close to the hold line as practicable. As primary signals, these indicate <i>where</i> the driver is to stop, as well as <i>when</i> to stop.</li> <li>Since the colonnade support columns are further offset from the hold line. This means that there is reduced <i>approach sight distance</i> (ASD) from drivers to the signals. The red line in the left-hand image shows the ASD sight line to the proposed dual primary signal post. By contrast, the blue line shows the improved ASD sight line if the dual primary post was in line with the hold line. The sight constraining feature is the wall on the eastern side of the car park ramp.</li> <li>The colonnade support pylons are “Y” shaped (see right-hand image). It is uncertain whether the actual signals will be mounted to, ie. the central stem of the “Y” or the branched arms. This could affect the position of the signals relative to the approaching traffic.</li> </ul> <div style="display: flex; justify-content: space-around;"> </div> <p><b>Left:</b> The primary and dual primary signals are not aligned with the hold line of the C1 building car park egress. This is unconventional as the primary signals indicate where the driver is to stop as well as when to stop. If aligned with the hold line, there would be improved ASD to the dual primary signals (right-hand side of the approach) as indicated by the blue sight line compared with the red sight line.</p> <p><b>Right:</b> The colonnade support pylons are “Y” shaped and it is not clear whether the signals will be mounted to the central stem or the branched arms of the “Y”.</p> | Low |

| Audit Reference | Description | Possible Risk Mitigation Measures<br>(refer to footnotes below) |
|---|---|---|
| 7 | Primary and dual primary signals in building car park egress lane | H |

- H. Consider various options for the placement of primary and dual primary signal lanterns at the intersection. It is noted the current design plan shows the lanterns on signal posts adjacent to the proposed colonnade columns (not directly on the support pylons as noted on page 15 of the RSA). Alternative options that are worthy of further consideration as part of the detailed design process include:

- a. Placement of signal lanterns directly on the colonnade columns (with or without outreach arms, depending on visibility and clearance requirements for vehicles exiting the basement).

- b. Placement of signal lanterns on outreach arms directly attached to the face of the building.

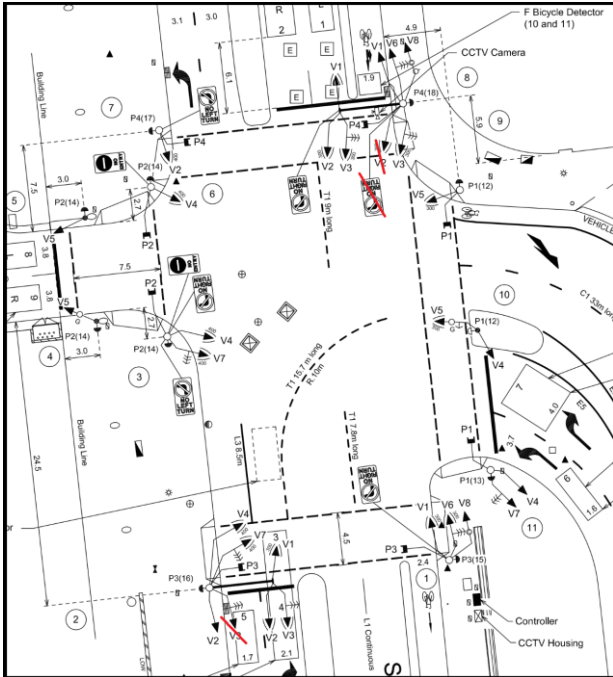
| Ref | Location | Road safety audit finding | Priority |
|---|---|---|---|
| 8 | General – excessive use of signs and signals. | <p>The audit team notes the following signals and signs which are considered excessive and unnecessary:</p> <ul style="list-style-type: none"> <li>▪ The V3 aspects on the vertical portion of mast-arm post 2 are unnecessary. These are right-turn arrow aspects controlling the northbound right-turn from Sussex Street to Napoleon Street. Yet these signals would be on the far left-hand side of the approach. These signals are unnecessary since the V3 signals on the mast arm outreach of the same post would be positioned directly above the northbound right-turn lane.</li> <li>▪ The V2 aspects on the vertical portion of mast-arm post 8 are also unnecessary. These are full circle aspects controlling the northbound <i>through</i> movement, yet these are on the far right-hand side of the departure. The V2 signals on the mast-arm outreach of the same post would be sufficient as secondary signals.</li> <li>▪ The R2-6 NO RIGHT TURN sign on the vertical portion of the mast arm post 8 is unnecessary since it is on the far left-hand side of this approach when the affected traffic stream is on the right-hand side (right-hand lane). There is also an R2-6 NO RIGHT TURN sign on the mast-arm outreach of the same post which is closer to the right-turn lane.</li> </ul> <p><b>Left:</b> The signs and signals marked in red are excessive and unnecessary.</p> | Low |

| Audit Reference | Description | Possible Risk Mitigation Measures<br>(refer to footnotes below) |
|---|---|---|
| 8 | Use of signals and signs | To be considered further during detailed design |

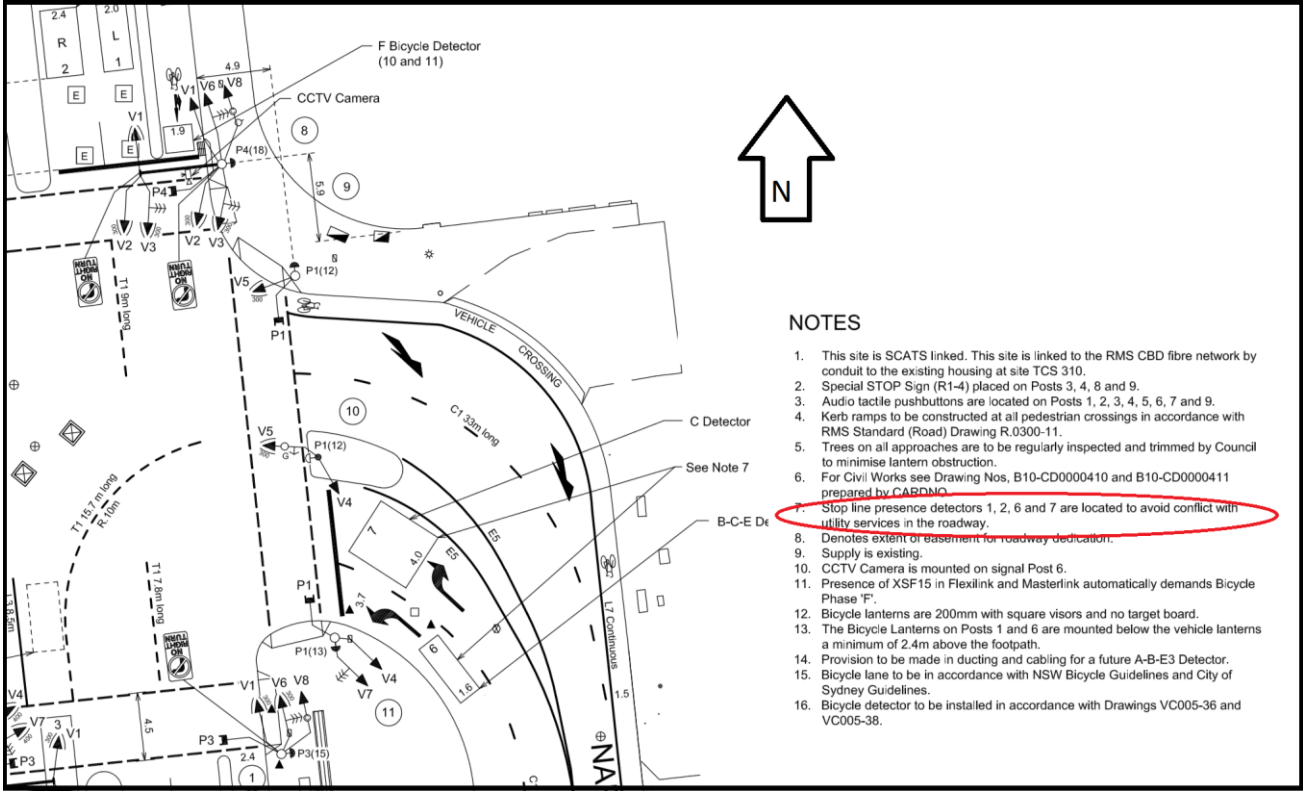
| Ref | Location | Road safety audit finding | Priority |
|---|---|---|---|
| 9 | Pavement loop (presence) detectors 1, 2, 6 and 7. | <p>Note 7 of the TCS plan indicates that these presence detectors have been positioned to avoid conflicts with utility services in the roadway. As shown, loops 1 and 2 are set back from the hold line in the northern approach. Loop 6 is set back in the eastern approach. The audit team is uncertain whether these loops will perform as intended in detecting the presence of the lead vehicle in the queue. This may fail to alert the system of awaiting vehicles and may lead to sub-optimal performance of the signals. This is especially the case when there is only one vehicle in each approach lane and it fails to actuate the loop (because it simply passes over it without stopping).</p> <p><b>NOTES</b></p> <ol style="list-style-type: none"> <li>1. This site is SCATS linked. This site is linked to the RMS CBD fibre network by conduit to the existing housing at site TCS 310.</li> <li>2. Special STOP Sign (R1-4) placed on Posts 3, 4, 8 and 9.</li> <li>3. Audio tactile pushbuttons are located on Posts 1, 2, 3, 4, 5, 6, 7 and 9.</li> <li>4. Kerb ramps to be constructed at all pedestrian crossings in accordance with RMS Standard (Road) Drawing R.0300-11.</li> <li>5. Trees on all approaches are to be regularly inspected and trimmed by Council to minimise lantern obstruction.</li> <li>6. For Civil Works see Drawing Nos, B10-CD0000410 and B10-CD0000411 prepared by CABDMO.</li> <li>7. Stop line presence detectors 1, 2, 6 and 7 are located to avoid conflict with utility services in the roadway.</li> <li>8. Denotes extent of easement for roadway dedication.</li> <li>9. Supply is existing.</li> <li>10. CCTV Camera is mounted on signal Post 6.</li> <li>11. Presence of XSF15 in Flexlink and Masterlink automatically demands Bicycle Phase 'F'.</li> <li>12. Bicycle lanterns are 200mm with square visors and no target board.</li> <li>13. The Bicycle Lanterns on Posts 1 and 6 are mounted below the vehicle lanterns a minimum of 2.4m above the footpath.</li> <li>14. Provision to be made in ducting and cabling for a future A-B-E3 Detector.</li> <li>15. Bicycle lane to be in accordance with NSW Bicycle Guidelines and City of Sydney Guidelines.</li> <li>16. Bicycle detector to be installed in accordance with Drawings VC005-36 and VC005-38.</li> </ol> <p><b>Above:</b> Note 7 of the TCS plan indicates altered placement of detector loops 1, 2, 6 and 7 in the northern and eastern approaches of the intersection.</p> | Low |

| Audit Reference | Description | Possible Risk Mitigation Measures<br>(refer to footnotes below) |
|---|---|---|
| 9 | Pavement loop detectors | To be considered further during detailed design, in light of existing and proposed utility services that may conflict with the location of the loop detectors. |
