# **Vales Point Solar Project**

## **Response to Submissions**

### Vehicle Access, Stage 2 (concept design) Road Safety Audit

## Vales point Power Station, Ruttley's Road, Vales Point

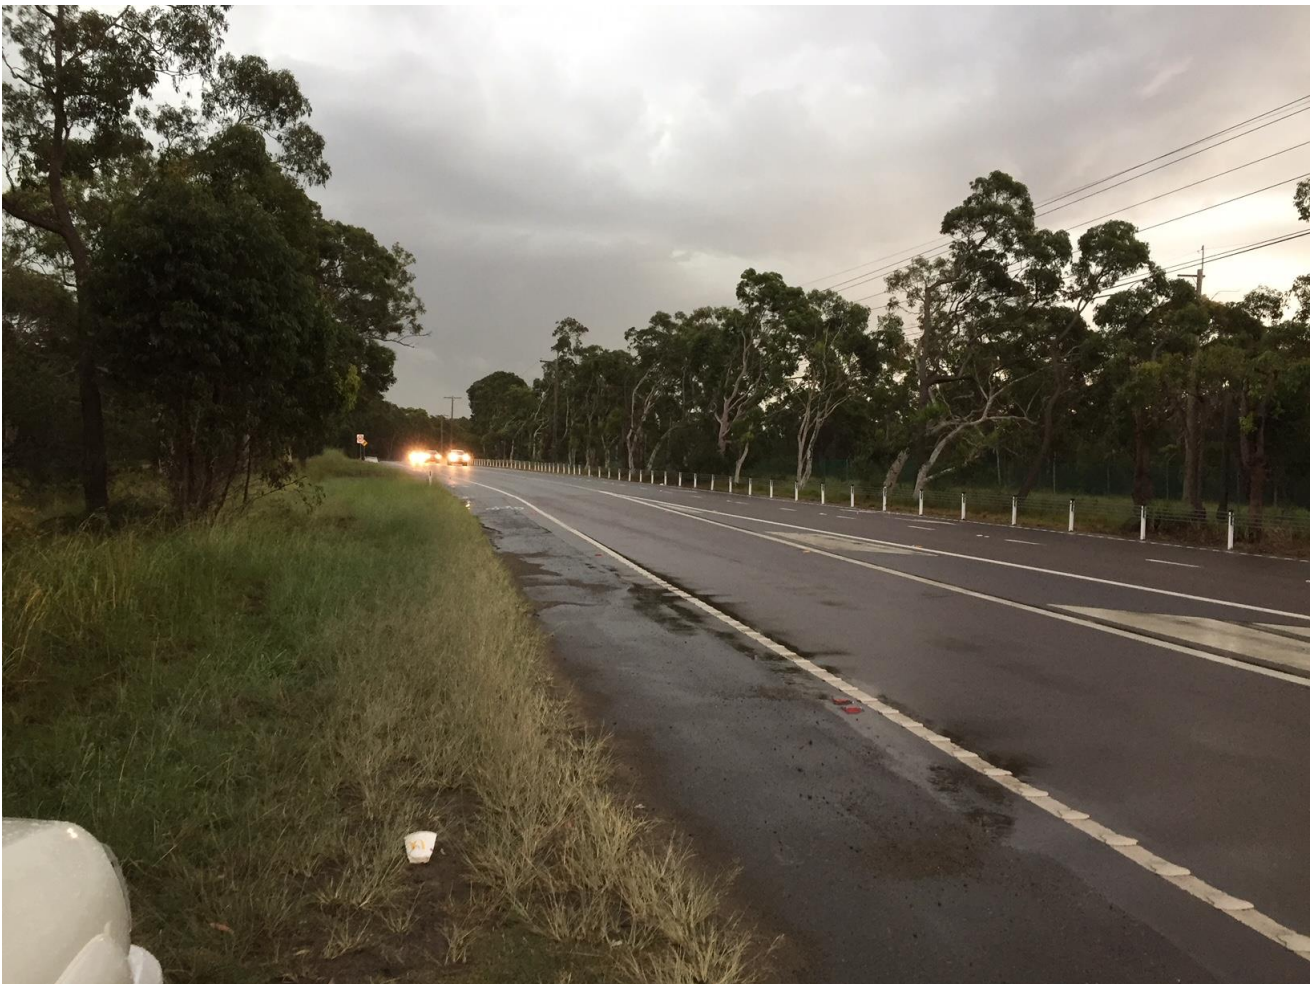
**Figure 2-2: Rutleys Road looking West**

At the time of the audit in the afternoon visibility was good even though light was poor due to an oncoming storm. The road condition was good, with clear pavement markings and retro-reflective devices. No night time audit was undertaken as the site visit was undertaken at dusk on an overcast day. No street lighting is installed in the vicinity of the site. **Figure 1-1, 2-2**

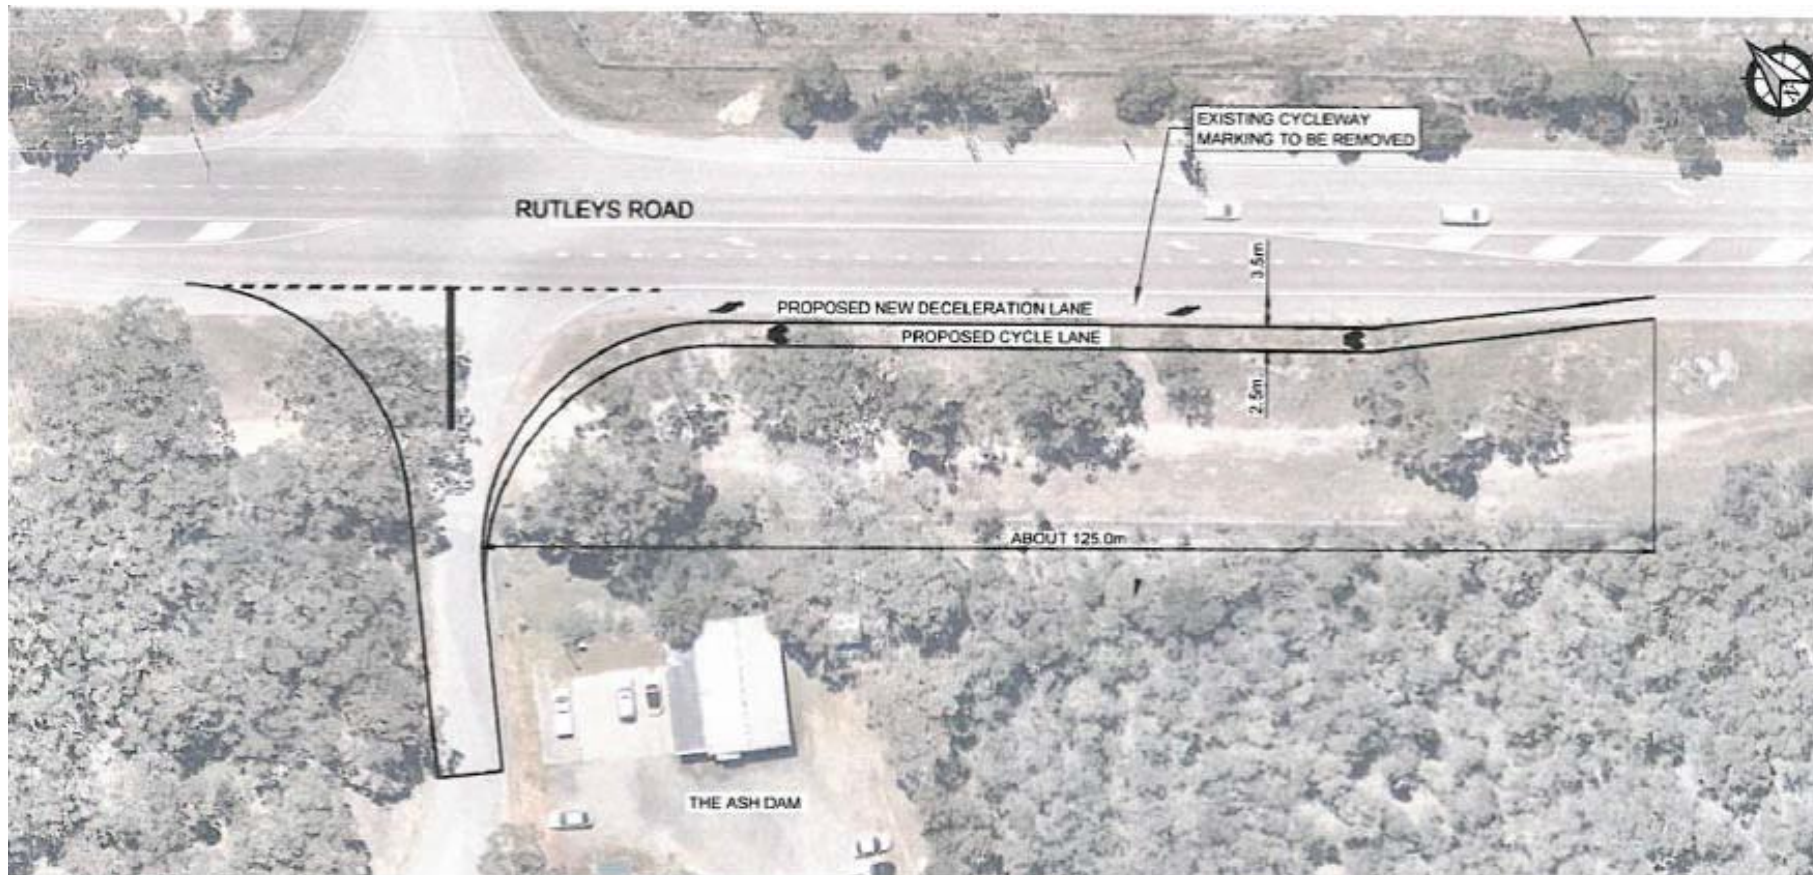
## Appendix A. Concept Design

The proposed changes to the intersection are the addition of a deceleration lane on the approach to the site access on the southern side of the road and the associated relocation of an existing cycle lane. All other pavement marking at the intersection is to remain the same including the protected westbound right turn bay for vehicles accessing the site opposite.
