# Archaeological Methodology Report

Glebe Island Concrete Batch Plan

## Archaeological Methodology Report

### Glebe Island Concrete Batch Plan

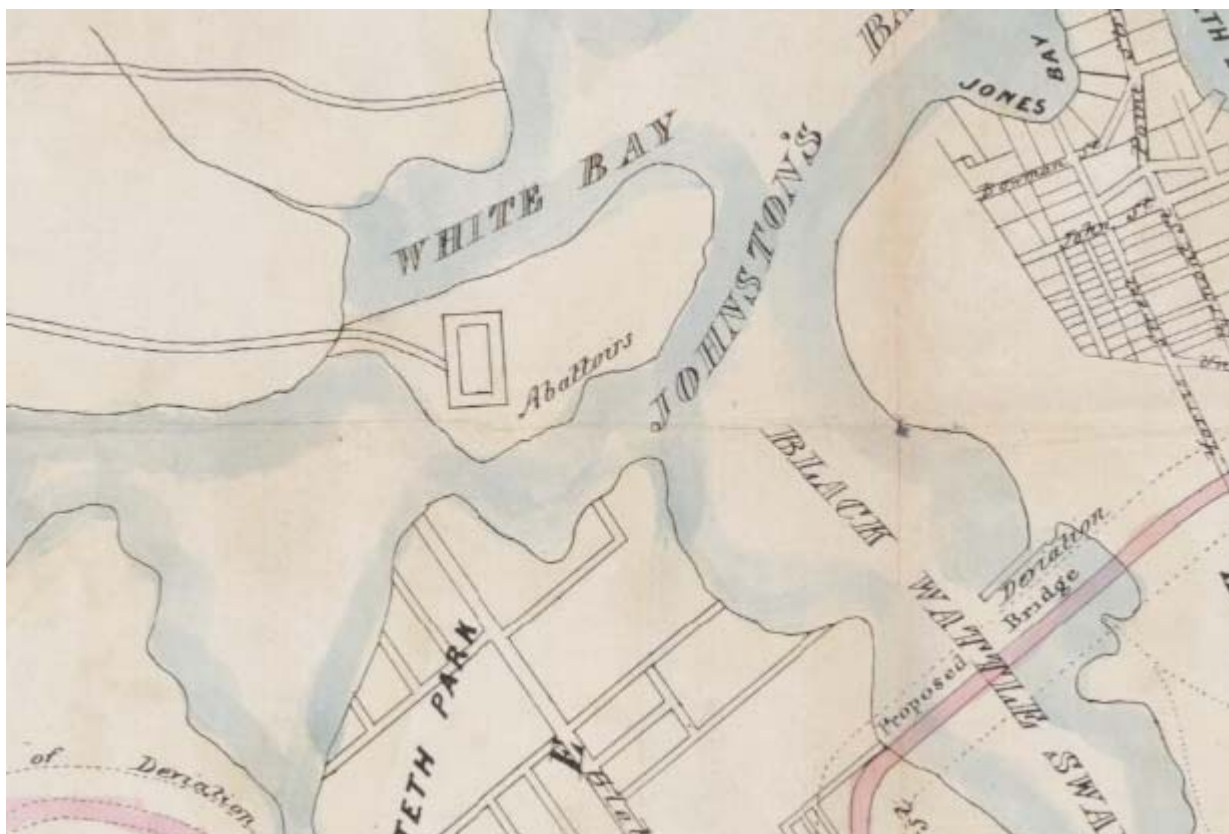
**Figure 6** *“A plan of part of Sydney and its environs: showing the bridges and roads to be constructed by the Pymont Bridge Company” Allan & Wigley Litho 1857. Note: Glebe Island was connected via Abattoir Road only. The punt crossing was not depicted (Source Inner West Council Online Library)*

In 1855, the site was connected to the mainland by means of Abattoir Road, later renamed Banks Road, which crossed the island by means of a cable punt (Figure 6). Later this punt was replaced by a wooden toll bridge (in 1857); this was the first Glebe Island Bridge (Thorpe, 1990) (Figure 7).

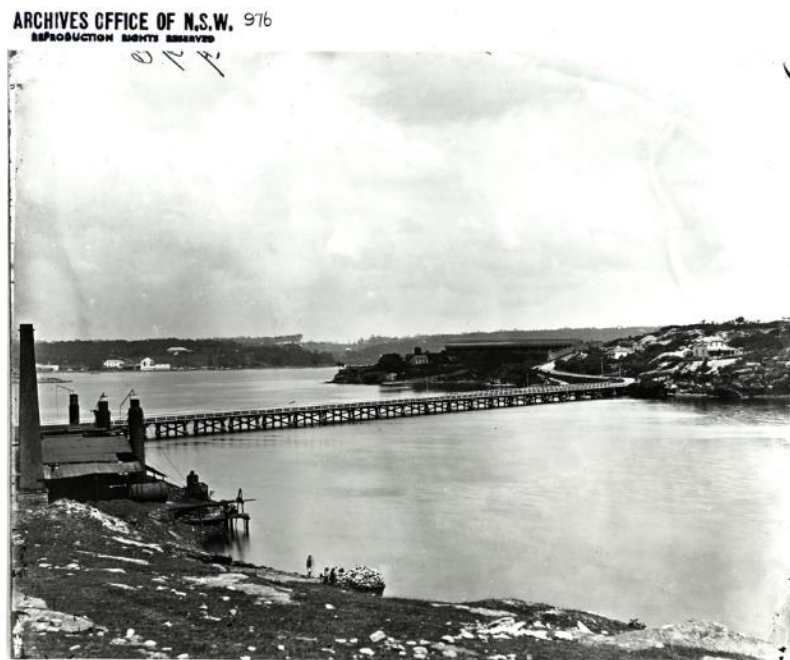
Figure 8 First Glebe Island Bridge. Glebe (NSW) earlier than 1899 (Source: <http://trove.nla.gov.au/version/48145927>)

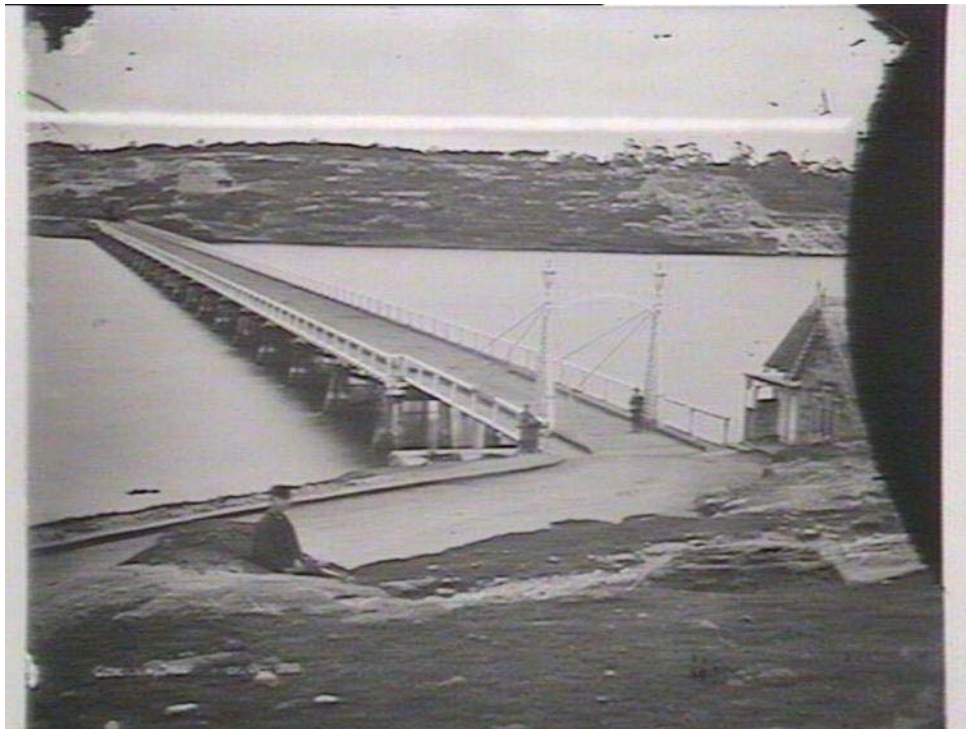
**Figure 9 “Glebe Island Bridge – 10/1870” (source State Library of NSW Digital order no:d1\_05719)**

The first Glebe Island Bridge was a private venture that connected Pymont to Glebe Island at the narrowest point in Johnstons Bay. The bridge was constructed out of Tasmanian Blackbutt timbers, including the piles, and consisted of 24 bents spanning across Johnstons Bay. Each bent consisted of four vertical piles with an additional two raked piles on the outside. Each bent also included a double upper and lower waler (or headstock) with two long cross beams spanning all four piles (Figure 8 and Figure 9). The approach to the bridge on the western side appears to have included an earthen embankment with potential stone abutments.

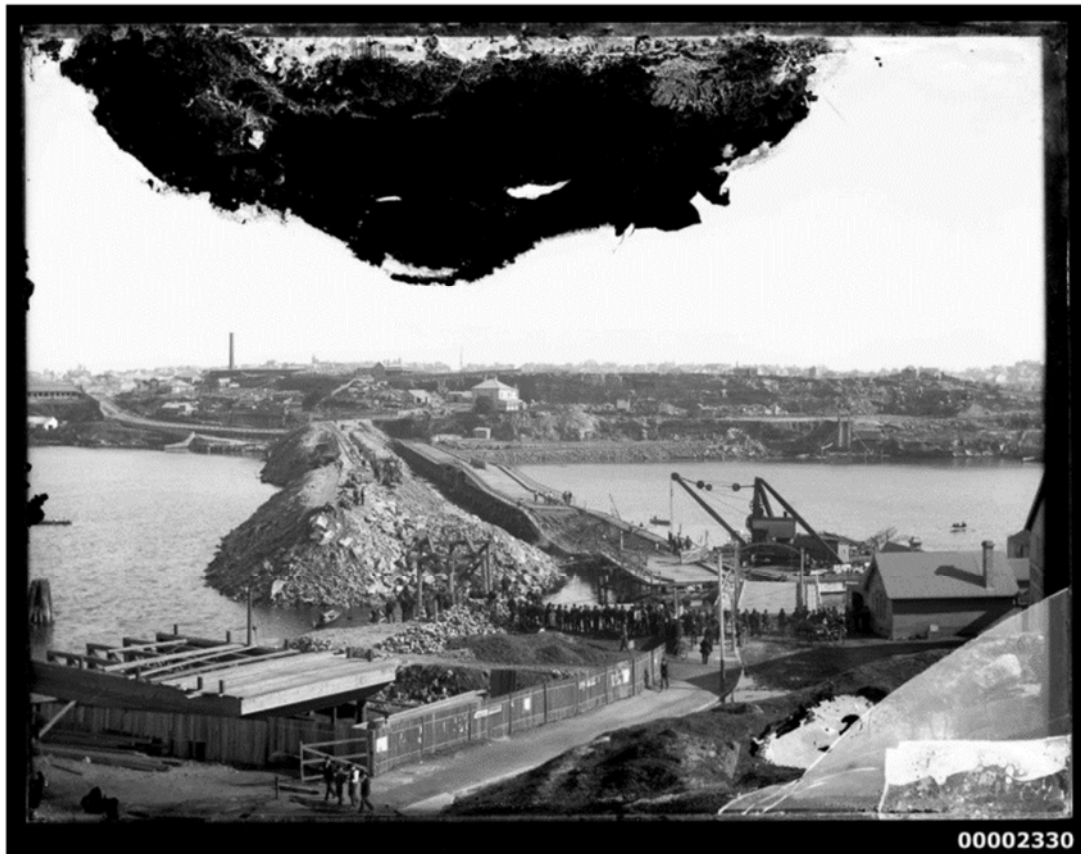
**Figure 10 “Glebe Island Bridge collapse” August 1899 (Source ANMM Collection Gift from Bruce Stannard available online)**

Construction commenced on the Glebe Island Bridge and Pyrmont Bridge at the same time but Glebe Island involved more extensive (and time-consuming) land resumptions (Figure 10). Over 100,000 tons of mud were dredged to establish the causeway and the fill was obtained by cutting down what was left of the hillock of Glebe Island, producing 5.3 hectares (thirteen acres) of flat land for railway yards and 853 metres (2,800 feet) of deep water frontage for wharfage (NSW Heritage Division, 2013).

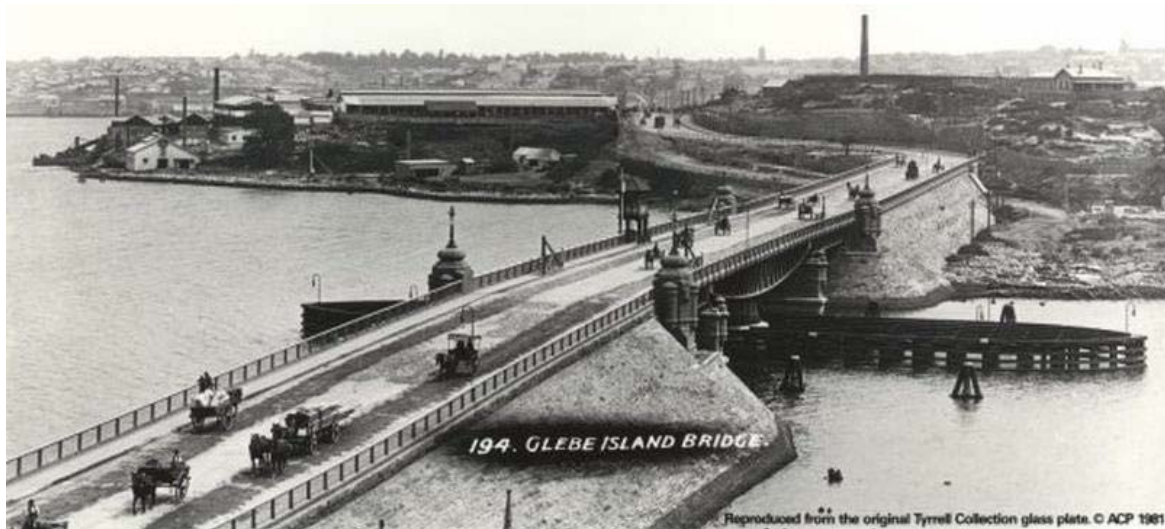
**Figure 11 Glebe Island Bridge c.1910. Note: The pile remains of the first Glebe Island Bridge can be seen cut off near the water level on both sides of the timber fenders associated with the current Glebe Island Bridge (Source Tyrrell Collection held online at the National Library)**

Construction of the trussed swing spans at each site was by simple cantilevering out from the steel pivot ring. Where timber trusses were used for the approaches of the Pyrmont Bridge, the Glebe Island Bridge used two steel deck trusses, then stone-faced embankments to reach each shore. The use of steel trusses for the approach spans had been part of Allan's original design for the Pyrmont Bridge but the Parliamentary Standing Committee on Public Works directed that this material be replaced with timber, presumably as a cost-cutting measure. When Glebe Island Bridge was built, Allan's original specification was reinstated (perhaps owing to the use of built-up embankments and shorter approach spans, providing a more economical outcome) (NSW Heritage Division, 2013) (Figure 11).

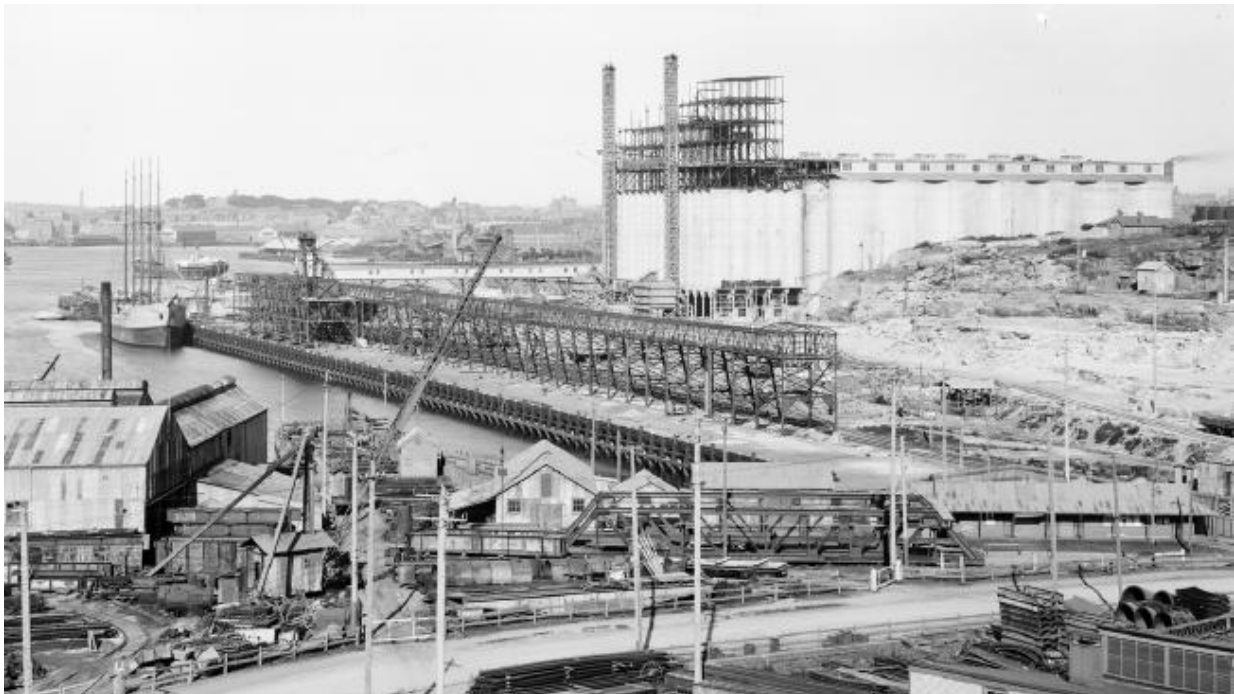
**Figure 12 Glebe Island's wheat silos in a 1920 photo by Arthur Ernest Foster. Picture: State Library of NSW (Series 3 part 2 – file number FL412764)**

The silos designed by J. S. Metcalfe and Co. were shaped as large cylindrical bins capable of holding 6,382,000 bushels. On top of the bins were six steel galleries with conveying equipment to direct the wheat, unloaded from trucks, through a tripper into the bins.

By mid-1921 the first phase of the system was near to completion and was so by the end of that year. The final cost of the terminal at this stage was £1,681,392 (Figure 12).

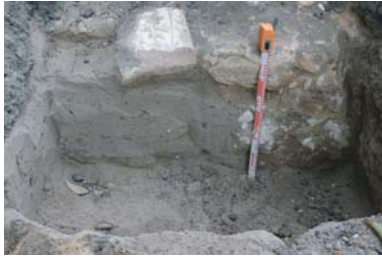
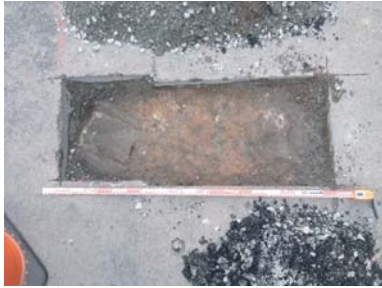
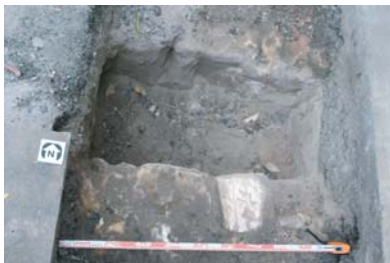
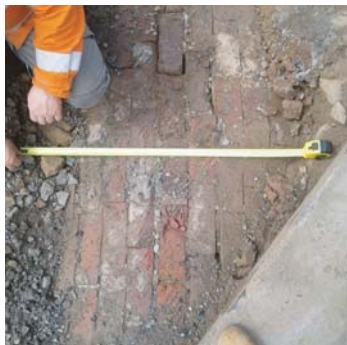
- 1 SCALE IN EVERY PHOTO  
Scale can be
  - Tape Measure
  - Photo Scale.
- 2 PHOTOS FROM DIFFERENT ANGLES  
Flip the object over, or photograph the sandstone from side.
- 3 CLOSE UP OF DETAILS  
Including features, text and marks.  
Detailed photos can be taken in the site office at the end of the day.
- 4 PHOTOS MUST BE IN FOCUS  
Details need to be clear when zooming in.
- 5 OBJECTS CAN BE CLEANED  
Water can be used to gently remove dirt in order to highlight or reveal details.
- 6 OBJECTS MUST BE KEPT SOMEWHERE SAFE  
Objects can be put into zip lock bags or blocks can be stacked somewhere safe.

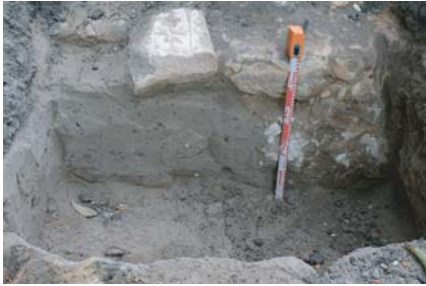
How to photograph sandstone kerbing found in the side of the trench.

Scale should be placed vertical to one side.

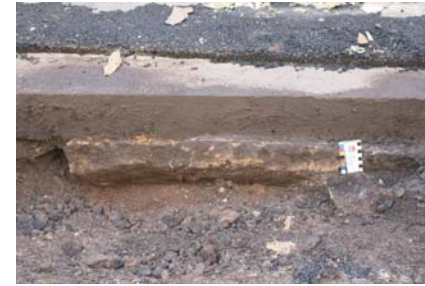
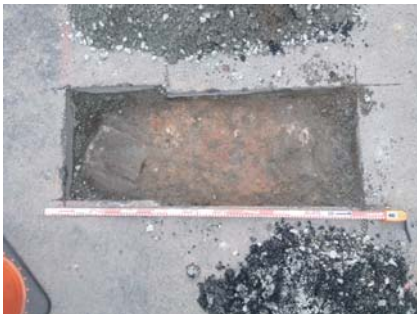
How to photograph sandstone found within a trench.

If the trench is shallow - scale can be placed outside the trench.

If the trench is deep, the scale should be placed within the trench.

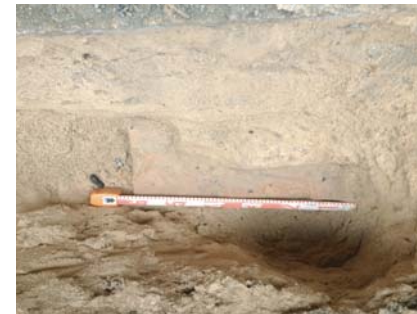
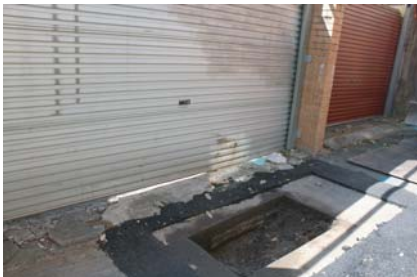
Example of a location photograph that should accompany the Finds Register.

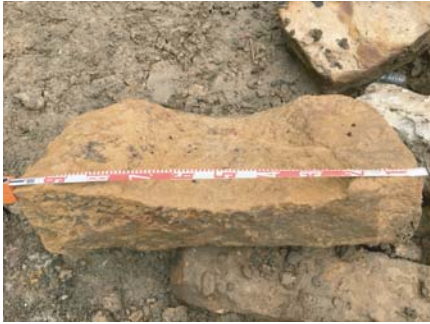
Sandstone cut drains.

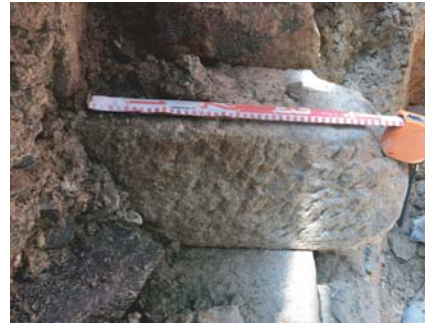
Sandstone kerbing

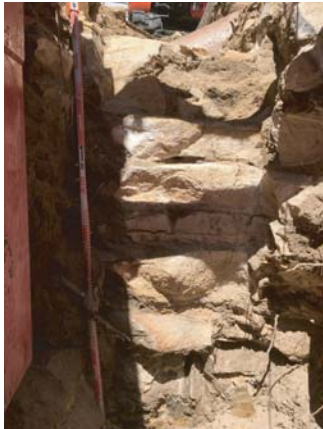
Sandstone fence

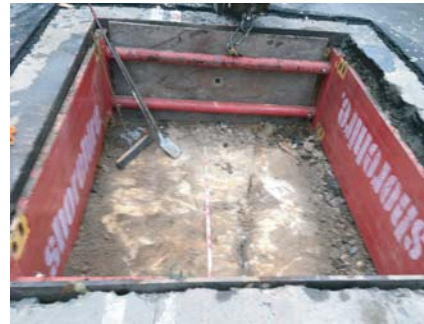
Natural sandstone that has been bench-cut to form a road surface

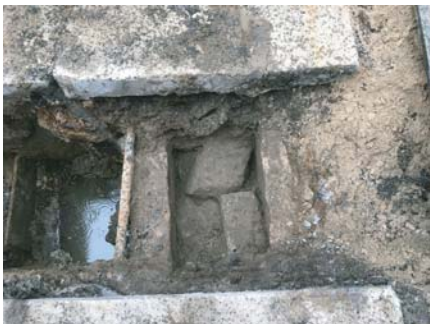
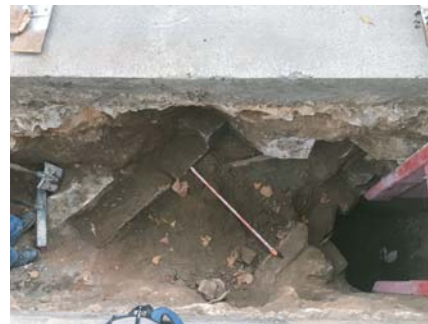
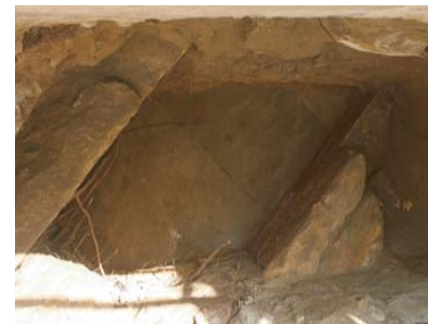
Sandstone drains

When Uncovered → When archaeologically excavated

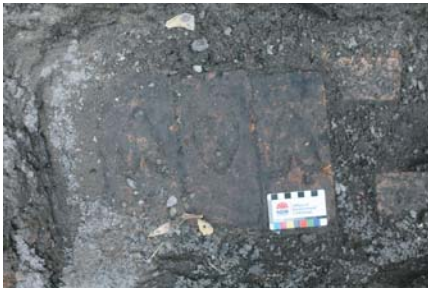
Bricks used to form a drain

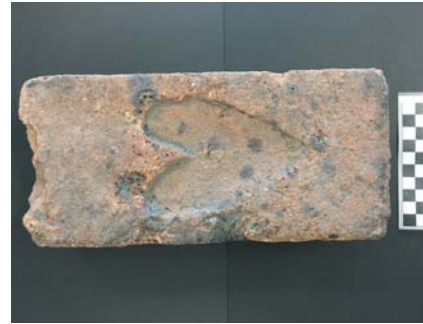
Detailed photograph

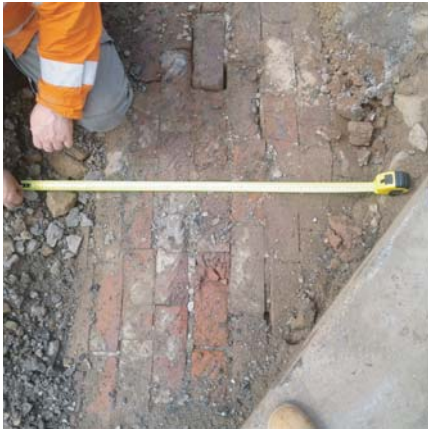
Top of brick barrel drain

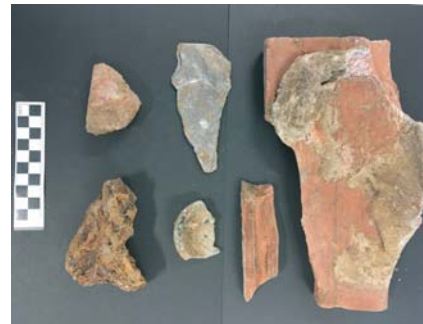
Bricks, slate and other building materials

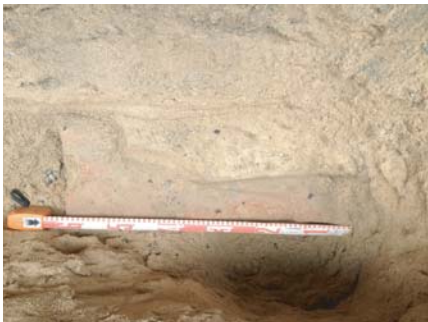
Brick footings below a sandstone wall

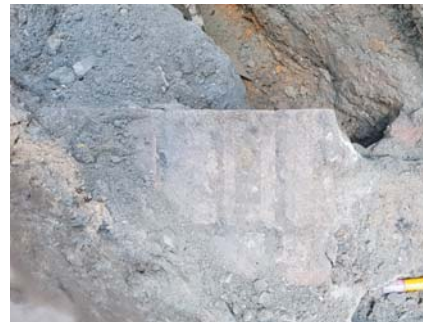
Brick gutter

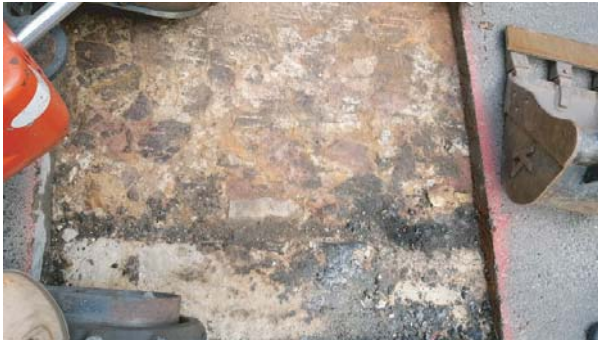
How to take photos of former road surfaces.

Clean back the area so the sandstone or other material can be clearly seen.

Scale should be placed either to the side or at the bottom of the photo and clearly seen.

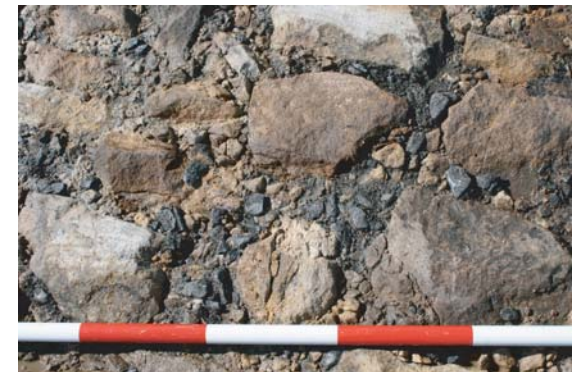
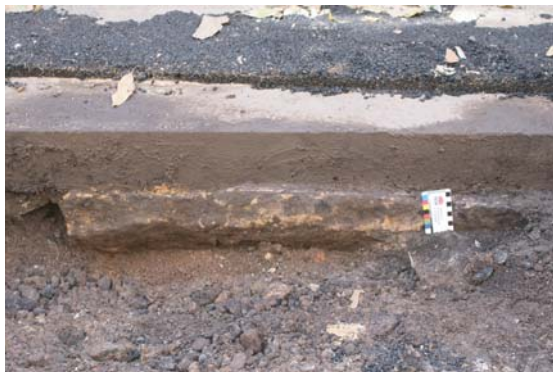
Detailed photographs of the former road surfaces should be taken.

Clean back the area so the sandstone or other material can be clearly seen.

Scale should be placed either to the side or at the bottom of the photo and clearly seen.

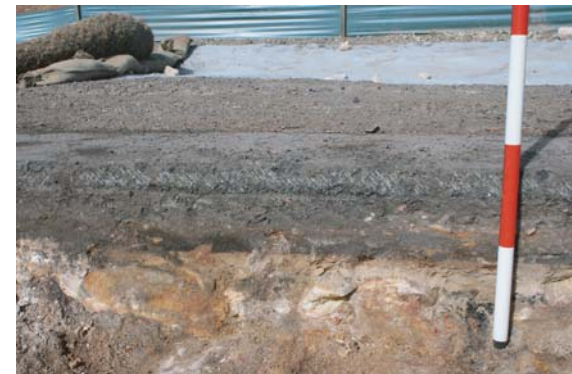
Road surfaces or other items that are found in the side of the trench should be photographed.

Scale should be placed to the side of the item being photographed but clearly seen.

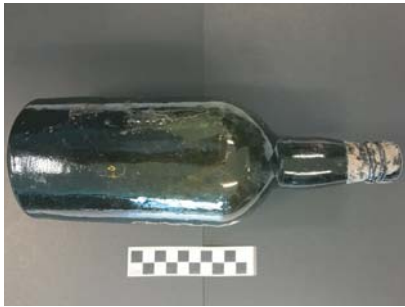
How to photograph a whole bottle.  
Scale kept straight, either below or to one side of the bottle.

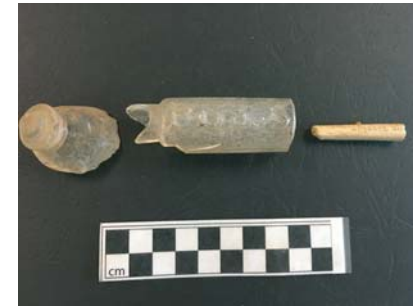
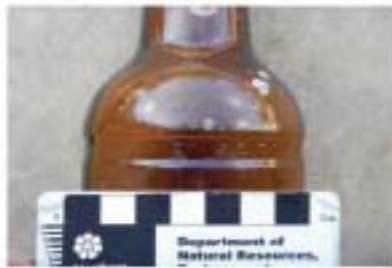
How to photograph detail present on a glass bottle.

Scale kept straight and close to the detail being photographed.

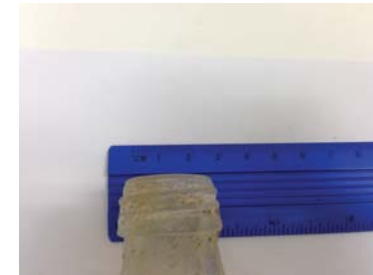
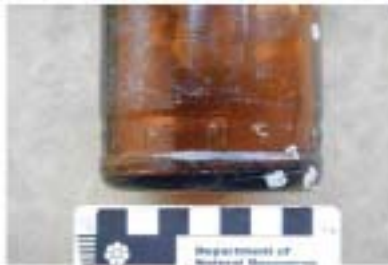
How to photograph detail around the base of a glass bottle.

Scale is in line and kept straight.

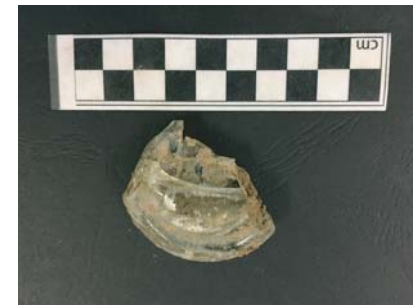
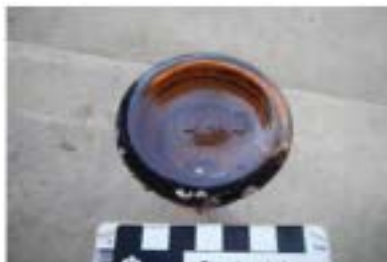
How to photograph the detail on the base of a bottle.

The photo can be taken on an angle to help see the outline of embossing.

Scale is level with the section of the bottle to be photographed and kept straight.

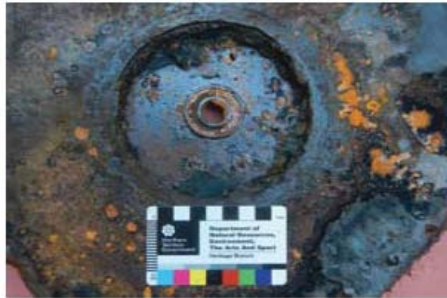
Examples of how to take detailed photographs of metal items.

Photographs of the whole item should be taken before taking detailed photographs.

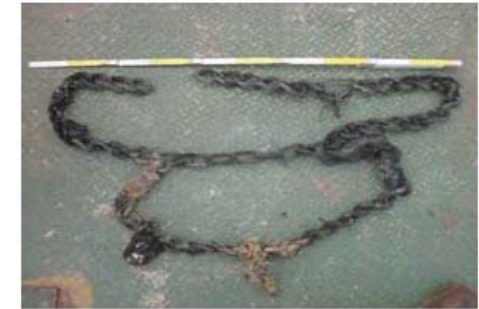
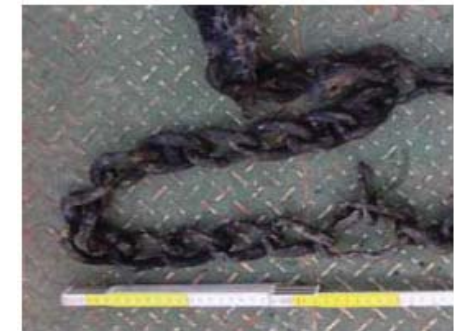
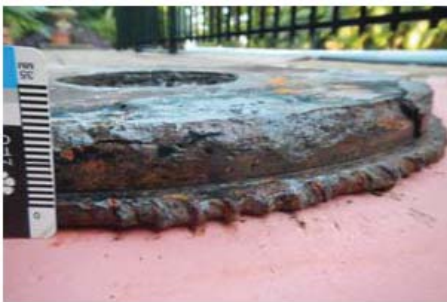
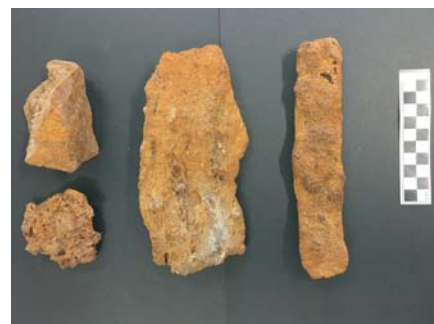
Scale should be present in every photograph and located close to the detail being shot.

Different angles of the same detail should be taken.

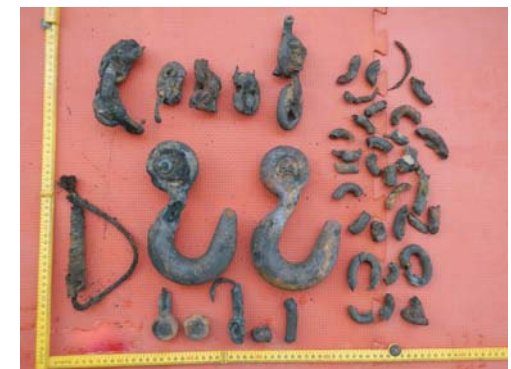
Multiple small objects can be photographed in one shot. Items should be spaced so each can be clearly seen.

The scale needs to be visible so accurate measurements can be taken from the photos.

Detailed photos should still be taken if objects have writing or other stamped features on them.

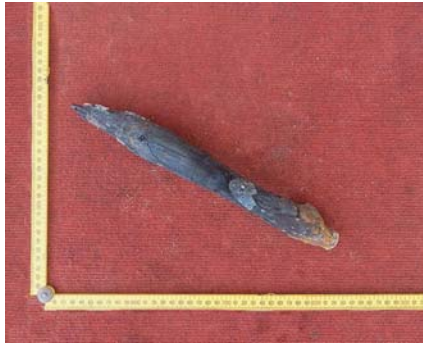
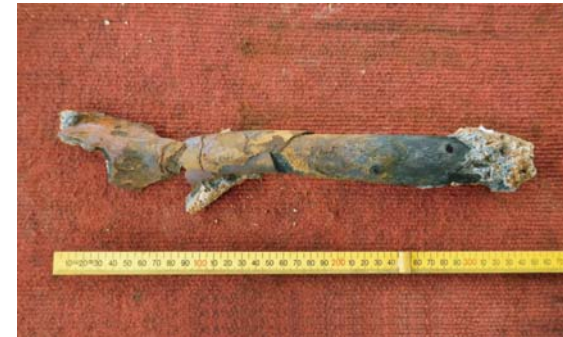
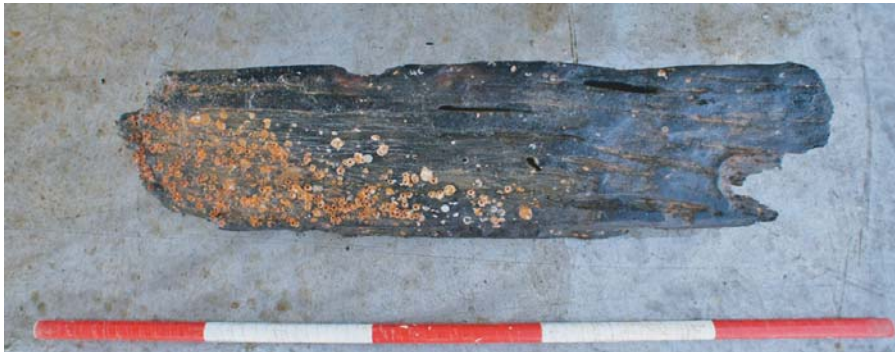
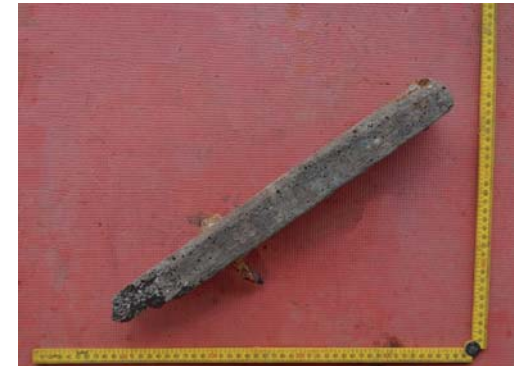
## EXAMPLE OF TIMBER ITEMS

Examples of how to photograph unknown timber items.

Scale in every photograph.

The background of each photograph should be kept as clean as possible to see the item clearly.
