## **Geotechnical Investigation Report 1 & 1A Edward Street & 25-27 Rosedale Avenue, Gordon NSW**

**Prepared for: CPDM Pty Ltd**

**Reference: P3585**

**Date: 13 August 2025**

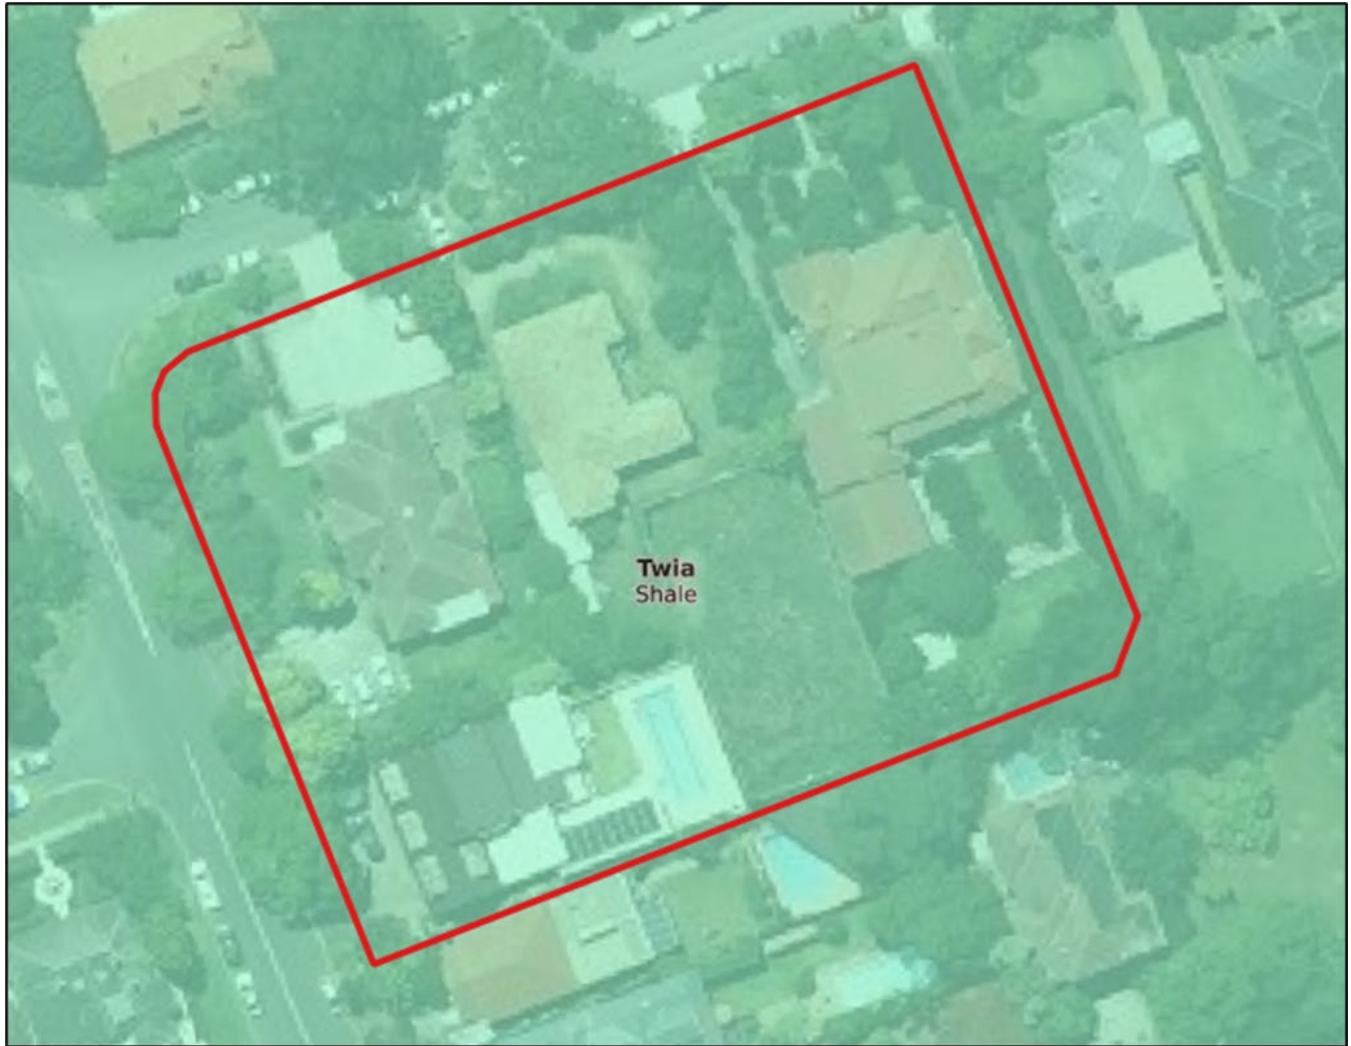
**Figure 1 Regional Geology**

- Geological mapping for the subject site and surrounding area (based on digital geology data from the New South Wales Seamless Geology dataset, version 2.1). The position of the subject site is outlined in red.
- Dark green = Ashfield Shale (Twia), Wianamatta group member (Rwa), approximate site boundary shown in red.

Information on regional sub-surface conditions, referenced from the Department of Mineral Resources Geological Map Sydney 1:100,000 (Geological Series Sheet 9130) indicate that the site is located on the boundary of (Rwa) Ashfield Shale of the Wianamatta Group, which is typically comprised of black to dark-grey shale and laminate, and (Rh) Hawkesbury Sandstone, which is typically comprised of medium to coarse-grained quartz sandstone, with very minor shale and laminite lenses.

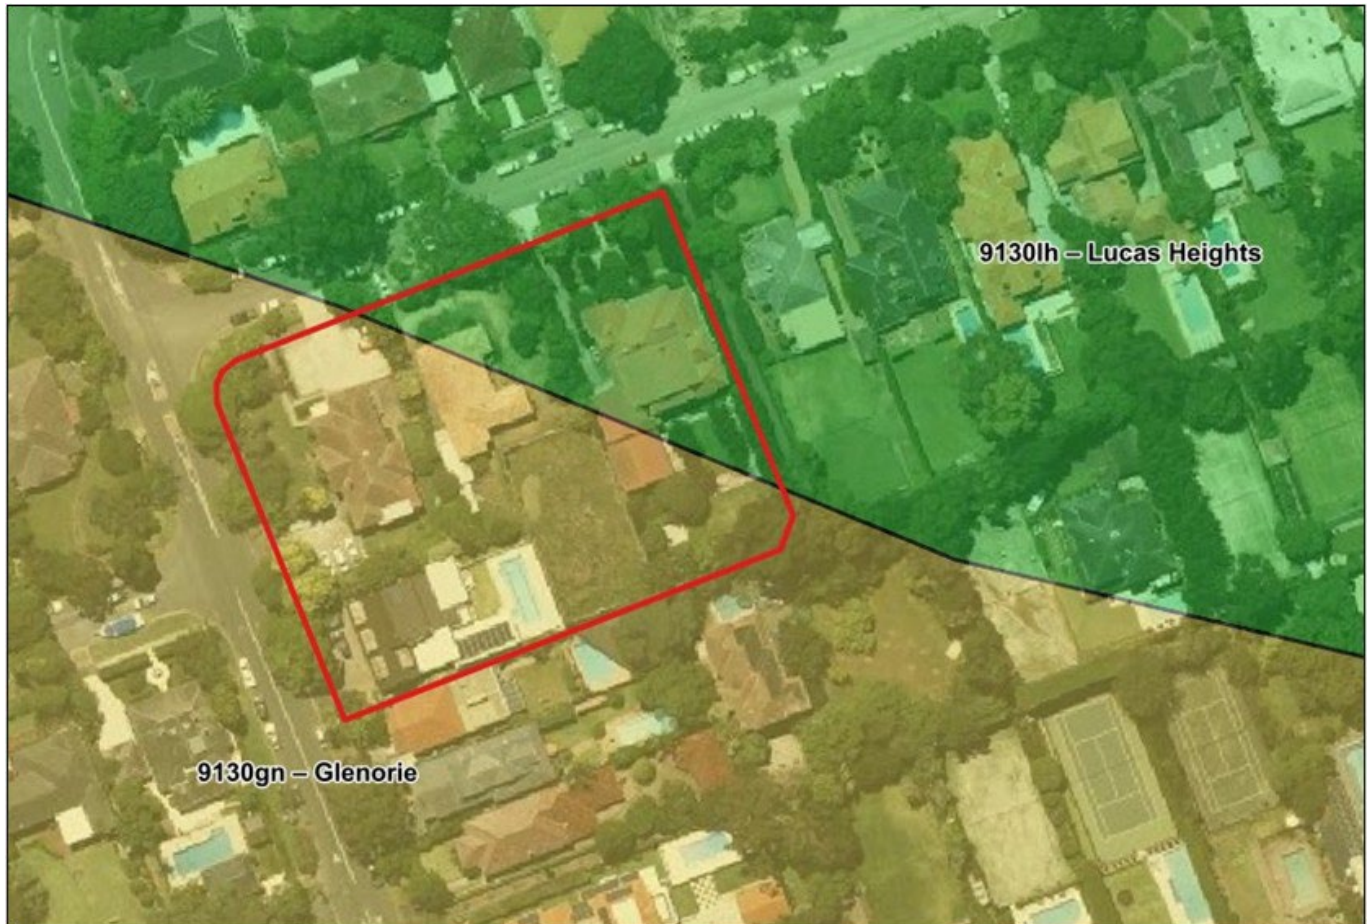
**Figure 2 Soil Landscapes**

- Landscape mapping for the subject site and surrounding area based on digital data supplied by the NSW Department of Environment and Climate Change, 2008. The position of the subject site is shown with a red polygon.

Reference to the Soil Conservation Service of NSW, Sydney 1:100,000, Soil Landscape Series Sheet 9130 (Bannerman & Hazelton, 1990, 4th Edition) indicates that the site is predominantly underlain by the Glenorie soil landscape (9130gn), with the Lucas Heights soil landscape (9130lh) mapped along the northern boundary of the site, forming part of an erosional landform setting. The landscape generally consists of gently undulating to rolling low hills developed on Wianamatta Group shales, with slopes typically ranging from 5% to 20% (see **Figure 2**).

The Glenorie soil landscape is characterised by broad, gently undulating to rolling landforms developed on residual soils derived from Hawkesbury Sandstone with shale interbeds. Soils are typically shallow to moderately deep (<1.0 to 1.5 m), consisting of yellow and brown sandy loams to light clays, often containing gravel or fragments of weathered rock. Drainage is generally moderate, with corresponding permeability, and erosion risk increases on steeper slopes. Rock outcrops may occur locally. Upper slopes and ridgelines are commonly underlain by red and brown podzolic soils, which are moderately reactive and may include highly plastic, impermeable clay layers at lower slopes or drainage lines, contributing to a high erosion hazard in these positions.

The Lucas Heights soil landscape also occurs over Hawkesbury Sandstone and is distinguished by shallow sandy loams to clayey sands overlying highly weathered sandstone. These soils are typically well-drained, non-reactive to slightly reactive, and moderately to highly permeable. Topography is generally more dissected and rugged, with benches, steep slopes, and frequent sandstone outcrops. The skeletal soil profile and low natural fertility impose moderate constraints on urban development, particularly where excavation depth or landscaping is required.

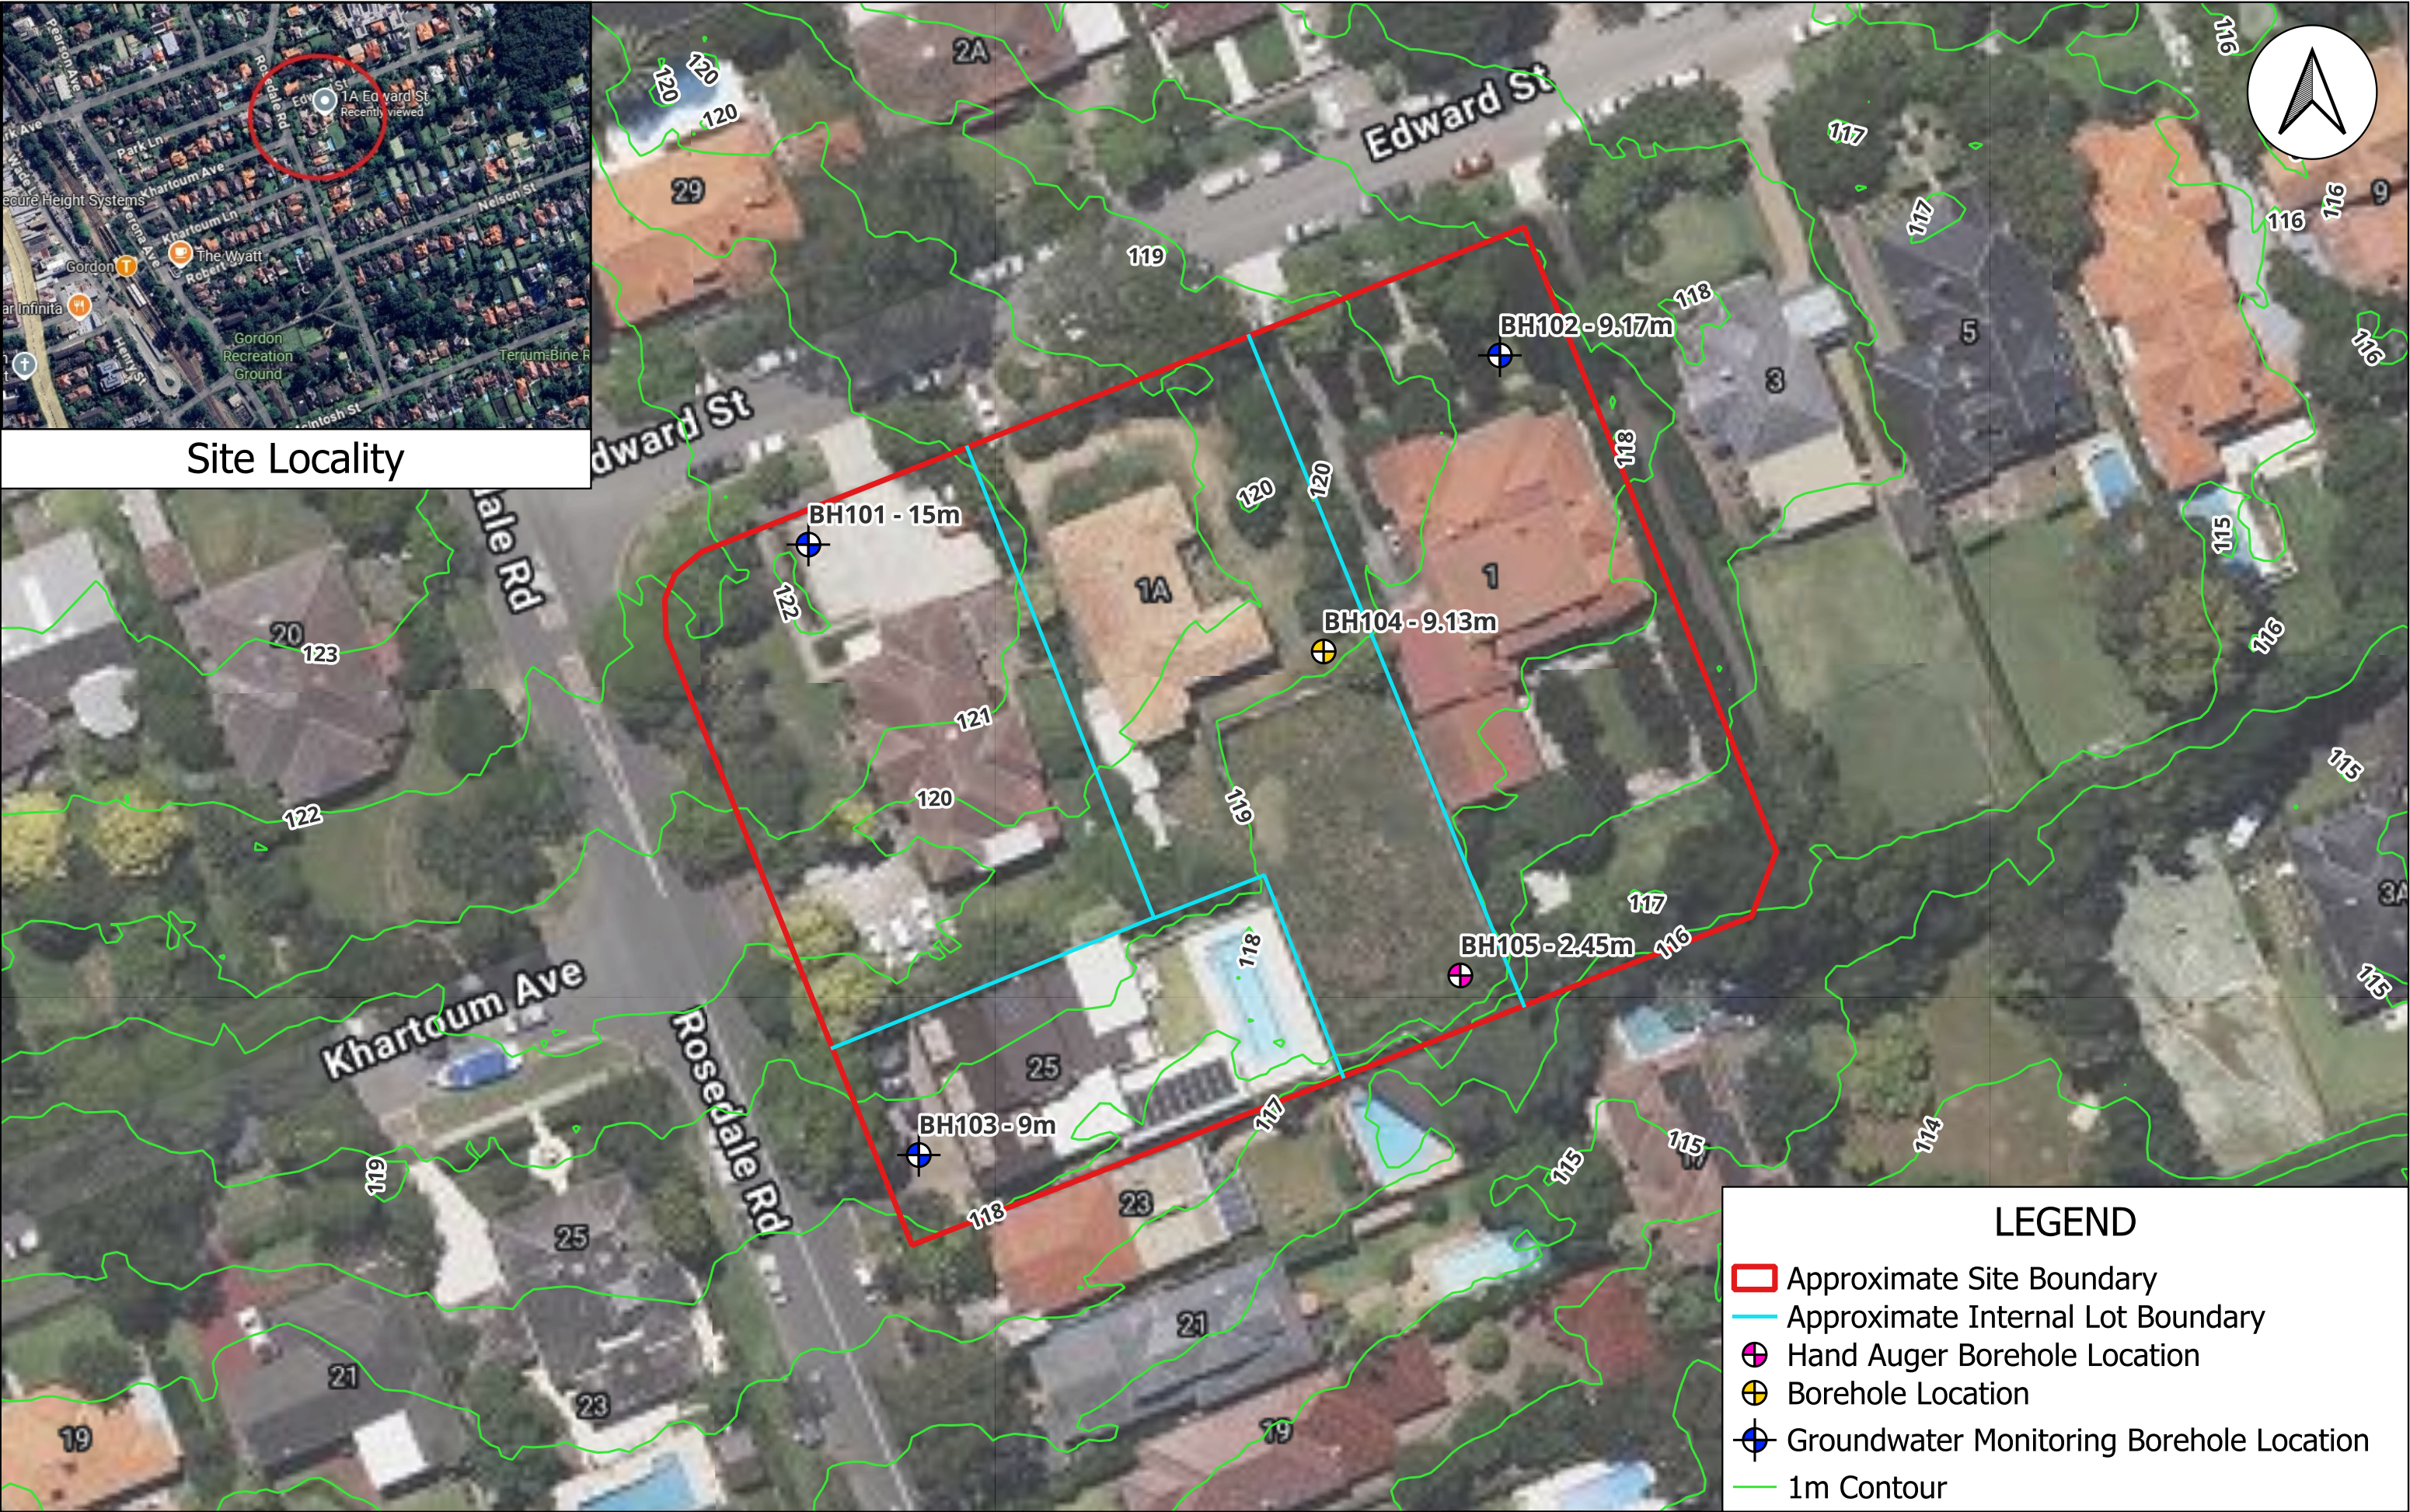
- Approximate Site Boundary
- Approximate Internal Lot Boundary
- Hand Auger Borehole Location
- Borehole Location
- Groundwater Monitoring Borehole Location
- 1m Contour

Topographically, the site located at Gordon, NSW comprises four adjoining residential lots bordered by Edward Street and Rosedale Avenue (refer to **Drawing 1**). The site is bounded to the north by Edward Street, to the west by Rosedale Road, and to the east and south by residential properties. Access to the site is provided via three access points along Edward Street, each serving separate properties, and two access points along Rosedale Road, each serving a separate property. The site contains existing dwellings, landscaped gardens, a swimming pool, and areas of dense vegetation. The site demonstrates a gentle slope in topography, generally falling from west to east, with ground elevations ranging from approximately RL 122.00 AHD at the western corner to approximately RL 117.00 AHD at the eastern corner, representing an elevation change of approximately 5 m across the site.

of 2.5m. BH101 through BH104 were extended using NMLC coring techniques to depths ranging from 9.0 to 15.0 mBGL. Rock core was boxed and photographed and point load tests were undertaken on selected core samples to assess rock strength. Borehole locations are shown on **Drawing 1**, and the borehole logs are attached to this report;
