Our Ref: PSM4240-004L REV2

**RE: TAFE NSW - WESTERN SYDNEY CONSTRUCTION HUB GEOTECHNICAL INVESTIGATION**

## **1 Introduction**

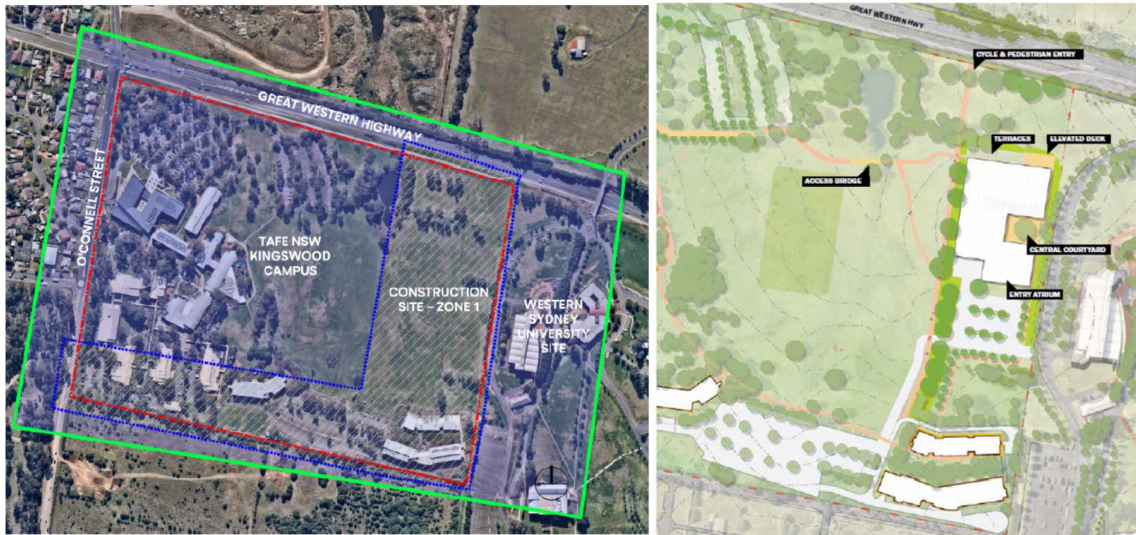
**Inset 1:** : Site location and the site investigation zone bound by the blue dashed zone (left) and the proposed building footprint (right)

The purpose of this report is to present the results of the geotechnical investigation undertaken by Pells Sullivan Meynink (PSM) for the proposed development. Figure 1 presents the locality plan of the site. The whole site area is 23 hectare shown by the red boundary in Inset 1, however, the geotechnical investigation area in this letter is the 'Construction Site – Zone 1', bound by the blue boundary shown in Inset 1 (9.5-hectare L-shaped site). It is noted that the north-western corner does not need to be addressed as there is no scope of works in this location as per Section 3.2 of the Request for quotation (RFQ).

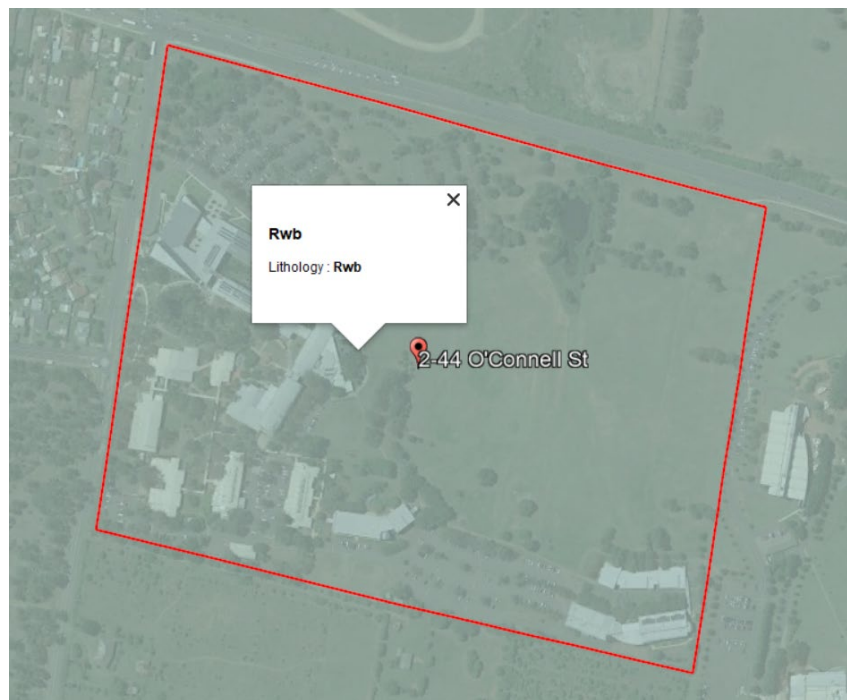
**Inset 2: Geological map of the site**

The 1:100,000 Penrith Geological map (1991) indicates the site is underlain by:

- The Wianamatta Group formation (Bringelly Shale - *Rwb*) Shale, carbonaceous claystone, claystone, laminite, fine to medium-grained lithic sandstone, rare coal, and tuff.

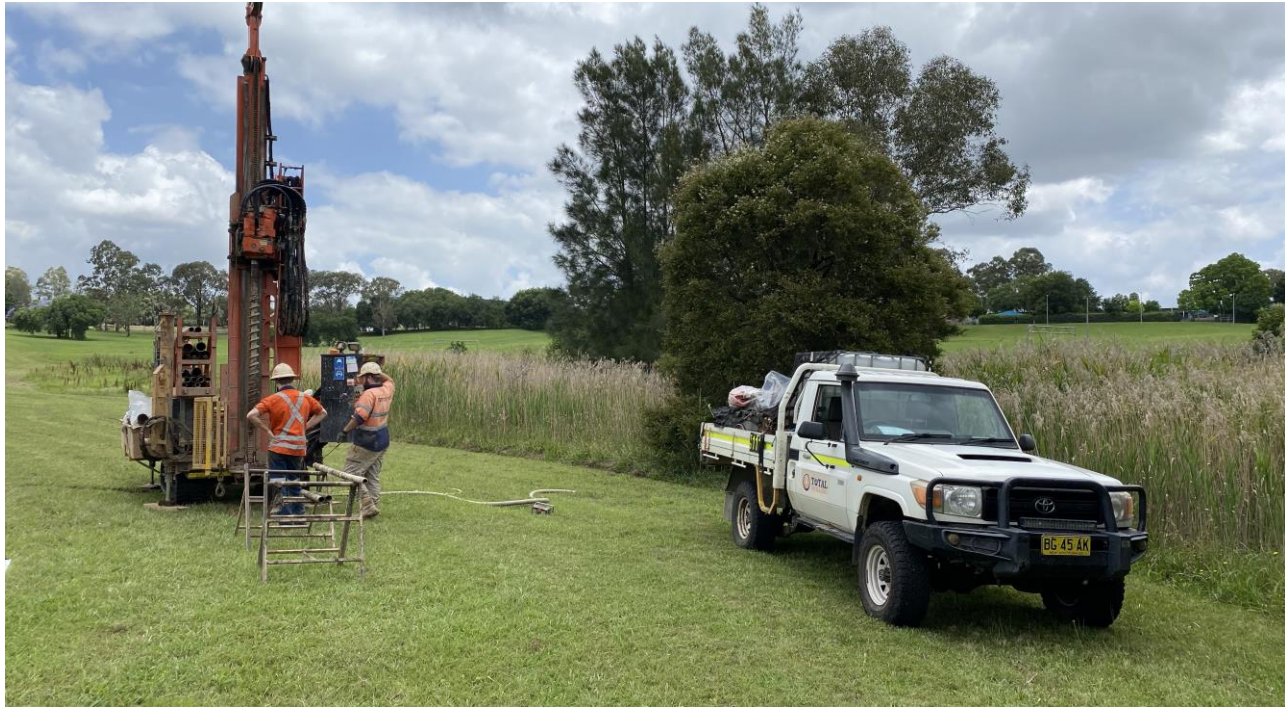
Photo 1 - Drill rig setup at BH05 next to pond, facing south-west (18/11/2020)

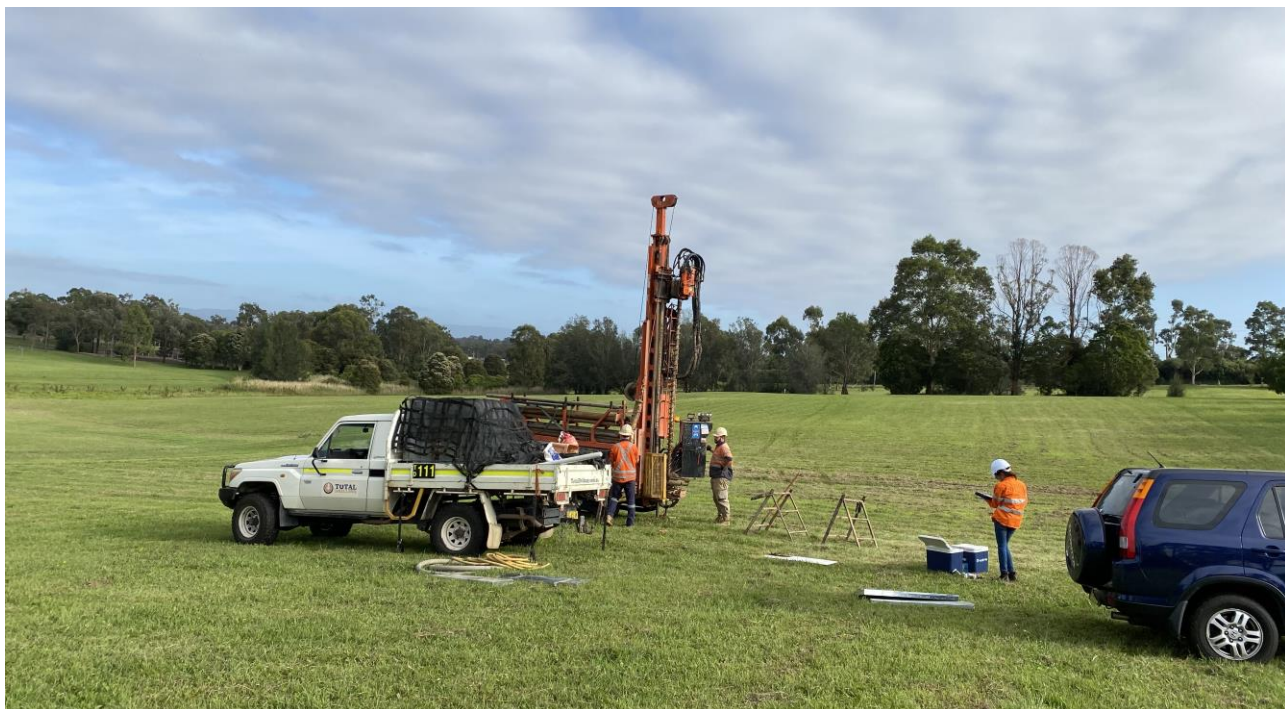
Photo 2 - Drill rig setup and site conditions at BH02 facing north (19/11/2020)

A standpipe piezometer was installed in borehole BH02 upon the completion of the drilling.

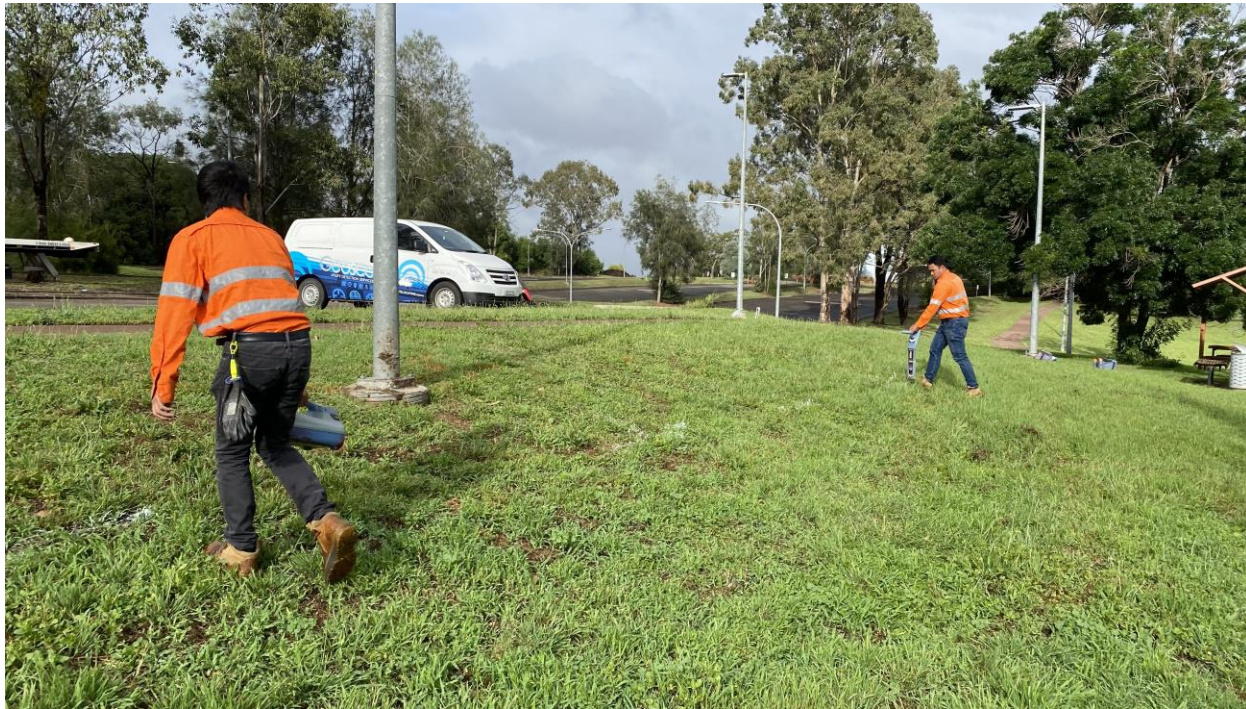
Photo 3 - Service locator at BH018 facing south-west (18/11/2020)

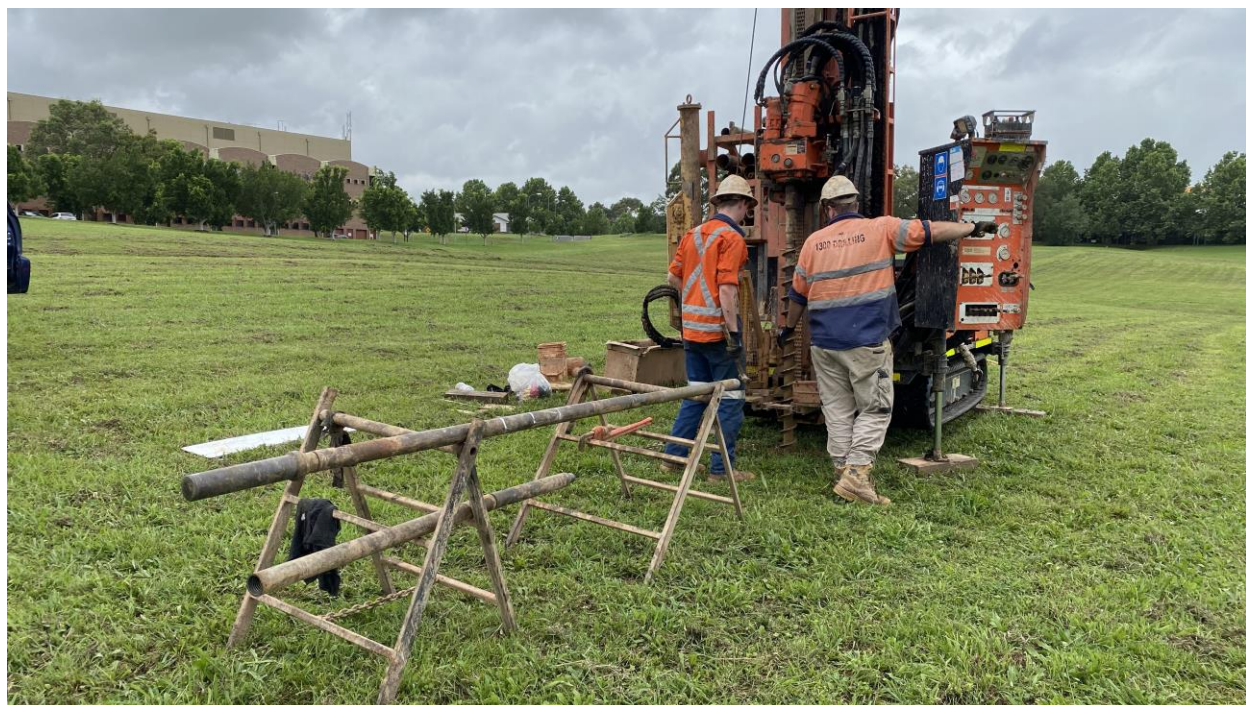
Photo 4 - Drillrig setup at BH01 facing south-east (18/11/2020)

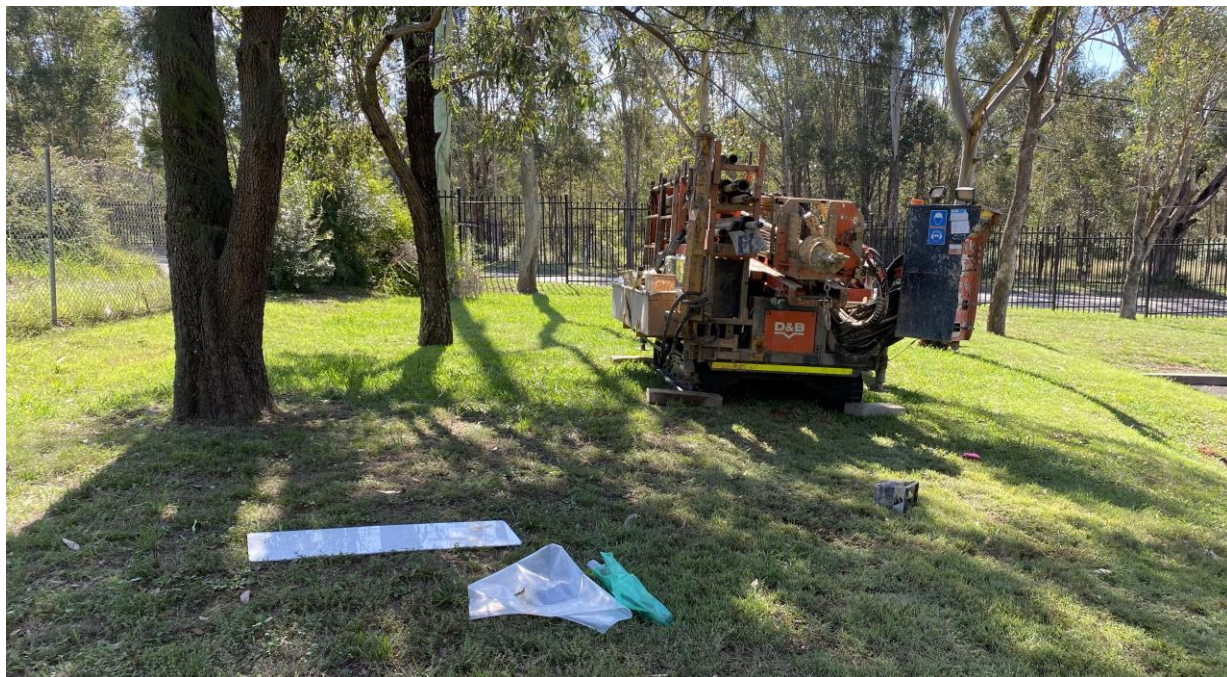
Photo 5 - Drill rig setup at CH02 facing north-east (19/11/2020)

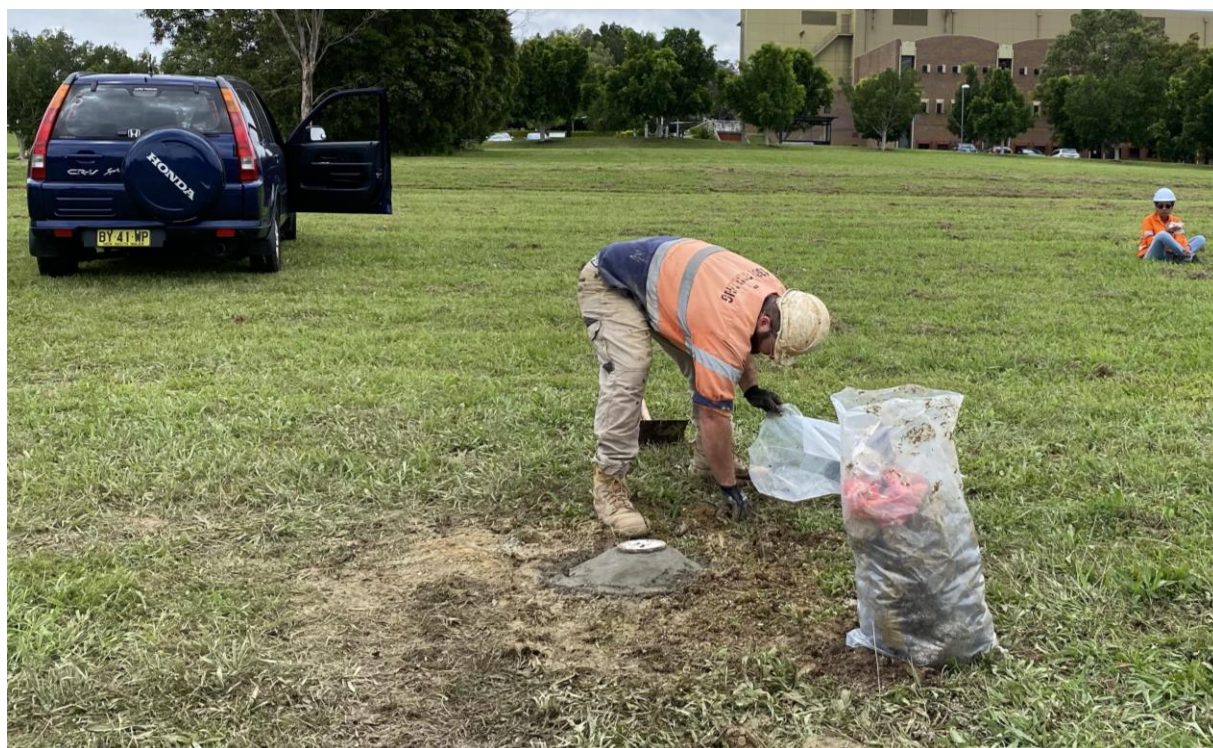
Photo 6 - Standpipe piezometer at BH01 facing east (18/11/2020)
