Salinity Assessment and Management Plan

TAFE NSW Construction Centre of Excellence
2-44 O'Connell Street, Kingswood, NSW

5 February 2021

59831/135362 (Rev A)

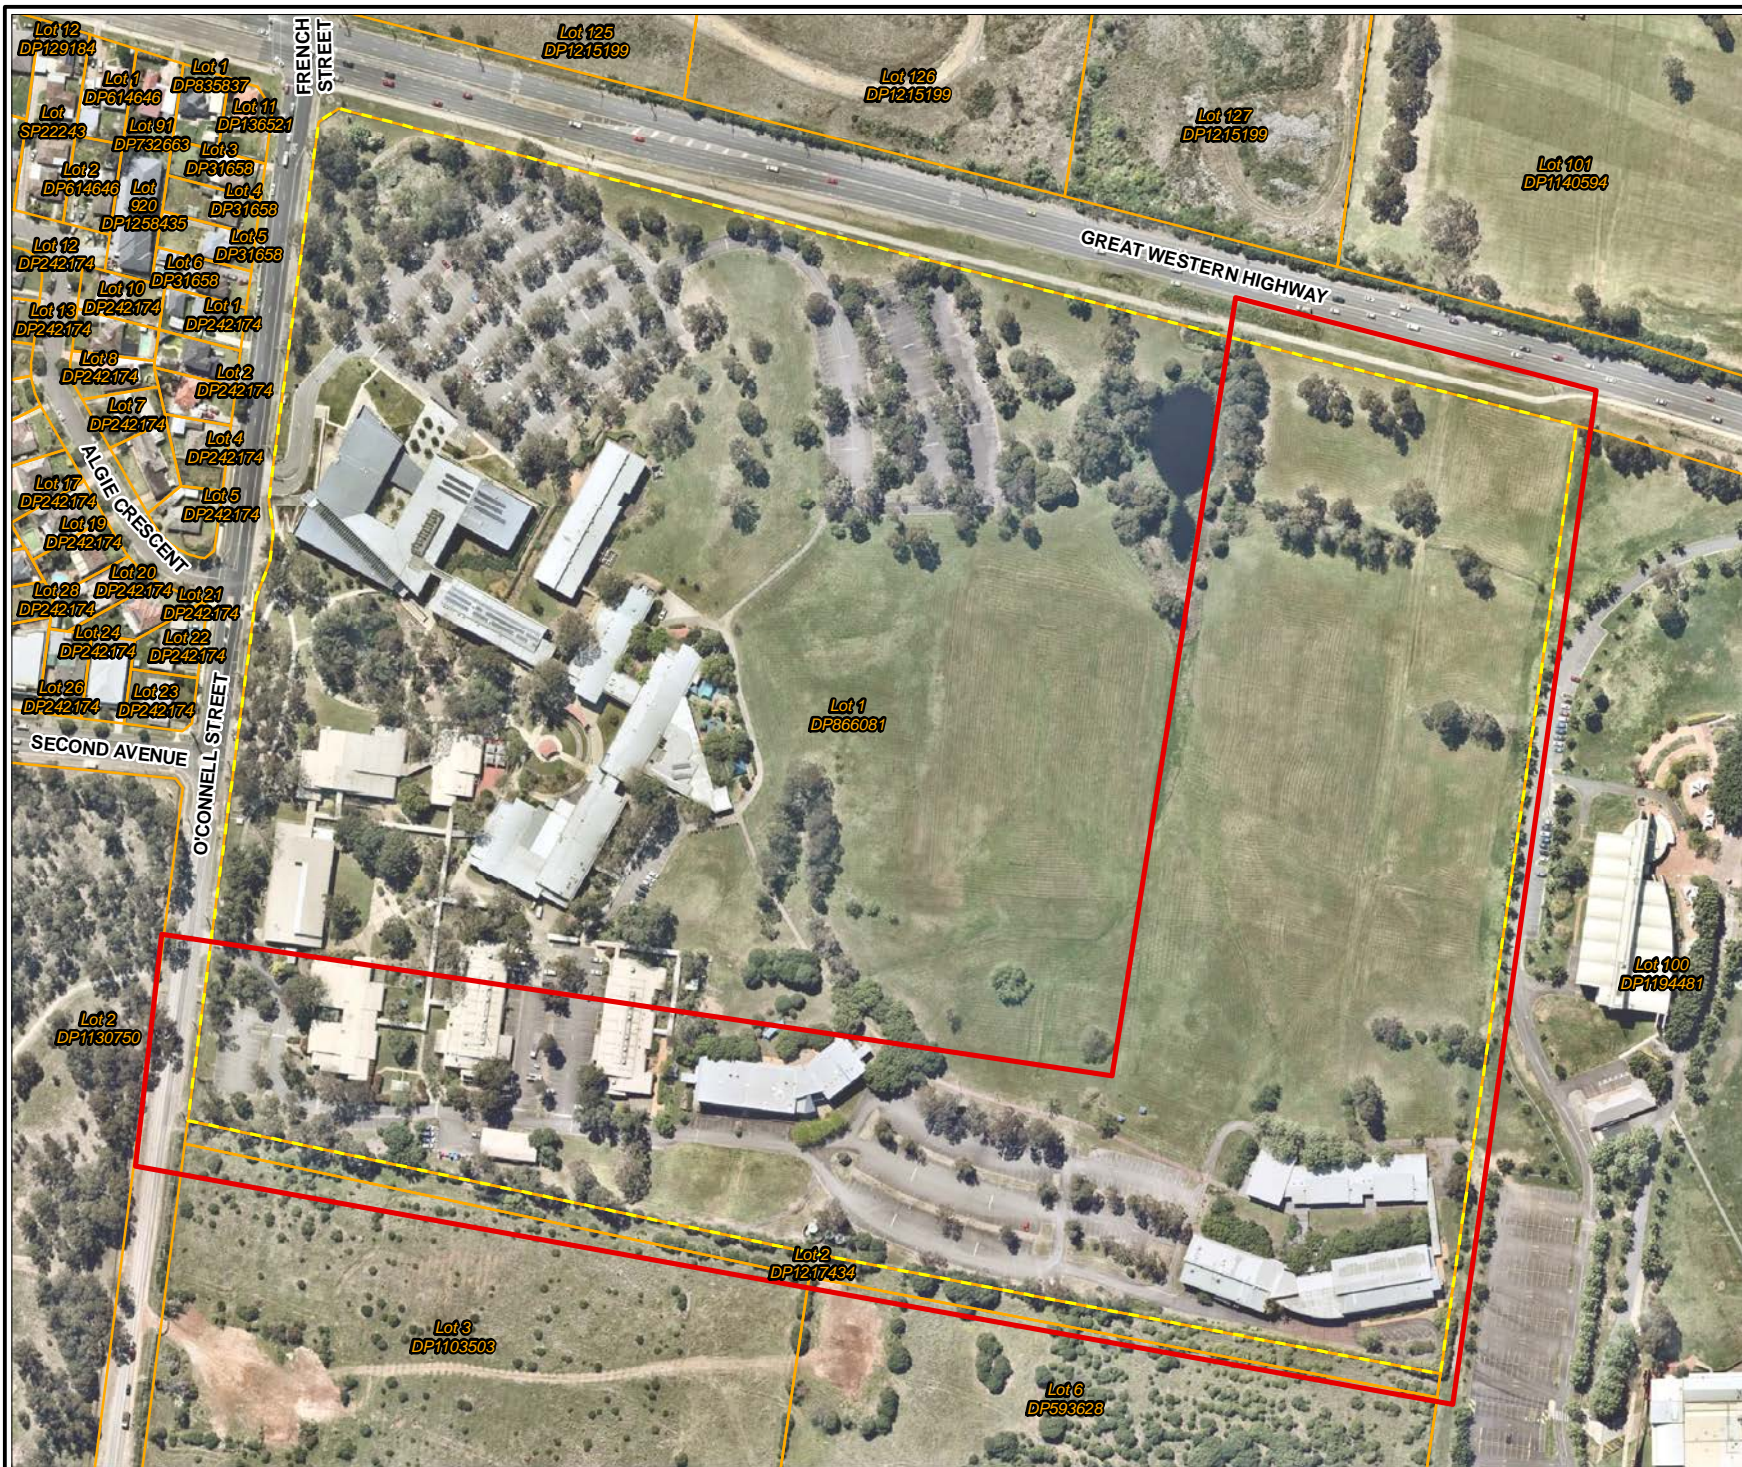
FIGURE 2

SITE LAYOUT

Seven buildings were present on site, of which Buildings B, C, E, N, T and P were used for educational purposes, whilst Building D was used by campus administration/security for office and storage purposes. The building identifiers are shown on the proposed development plans provided in **Appendix A**. Five distinct asphalt paved carpark areas were located on site in the eastern section west of Building B, between Buildings C and E, west of Building D, south of Building N and west of Buildings P and T. The pavement was observed to be in good condition with minor cracking observed.

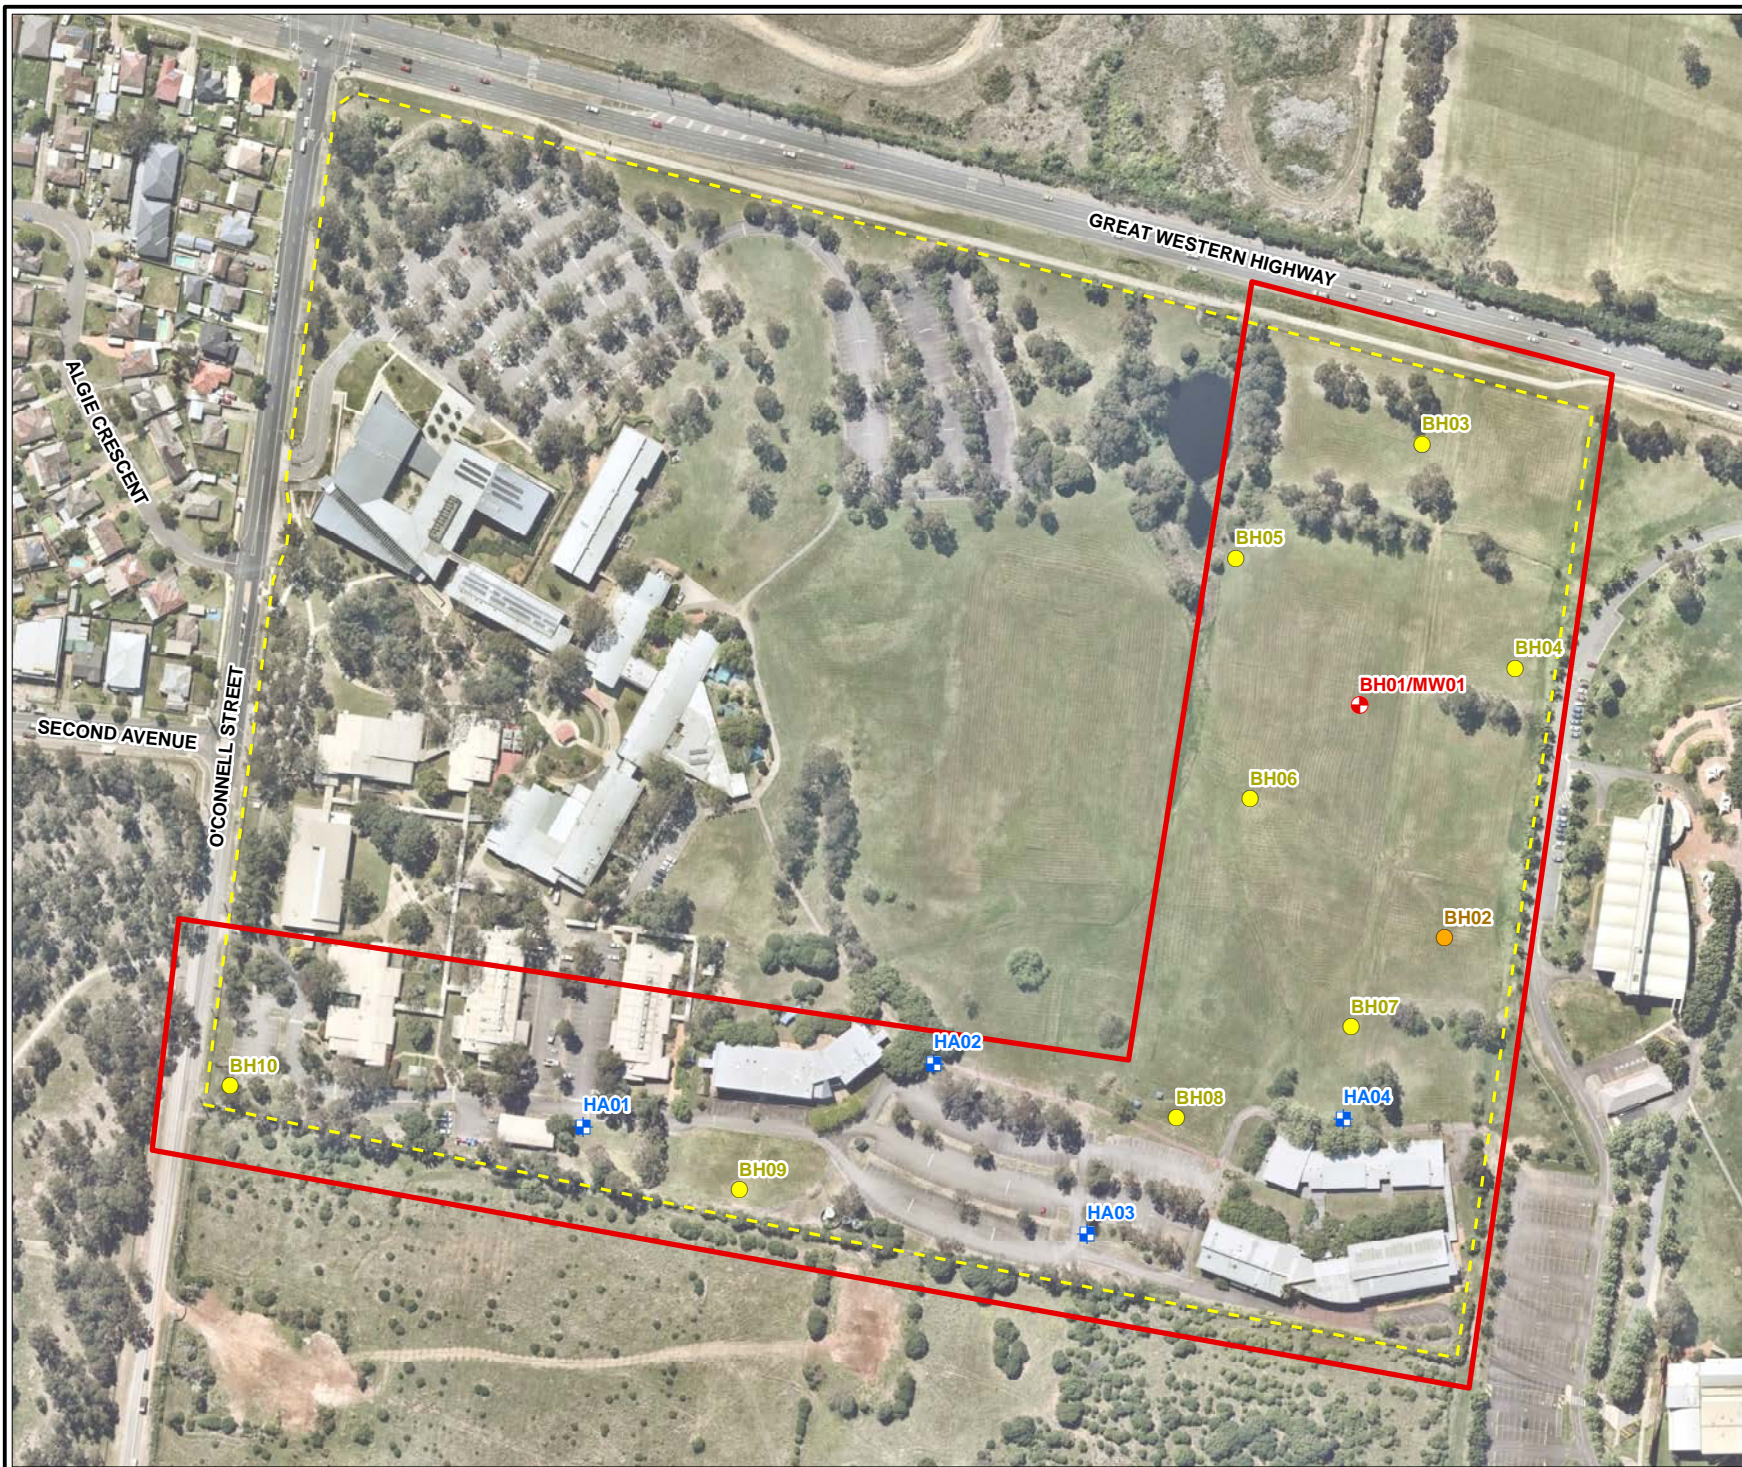
FIGURE 3

- Legend:**
- Approximate Site Boundary
 - TAFE Kingswood Boundary
- Sampling Locations**
- JBS&G Hand Auger
 - PSM Boreholes (Auger)
 - PSM Boreholes (Cored)
 - ⊕ PSM Boreholes (Cored)/ Monitoring Well

SAMPLING LOCATIONS

A total of 14 boreholes were advanced during the combined contamination and geotechnical investigations completed to support the SSDA as documented separately. Sample locations are provided on **Figure 3**. The investigation locations encountered soil and lithology conditions broadly representative of the anticipated conditions based on the regional setting. Soil observations on borelogs are presented in **Appendix B**, a summary of observations of lithology and soil are summarised following.
