Environmental Site Assessment

Waitara Public School  
48-58 Myra Street  
Wahroonga, NSW

31 August 2017  
53033/110766 (Rev A)  
JBS&G

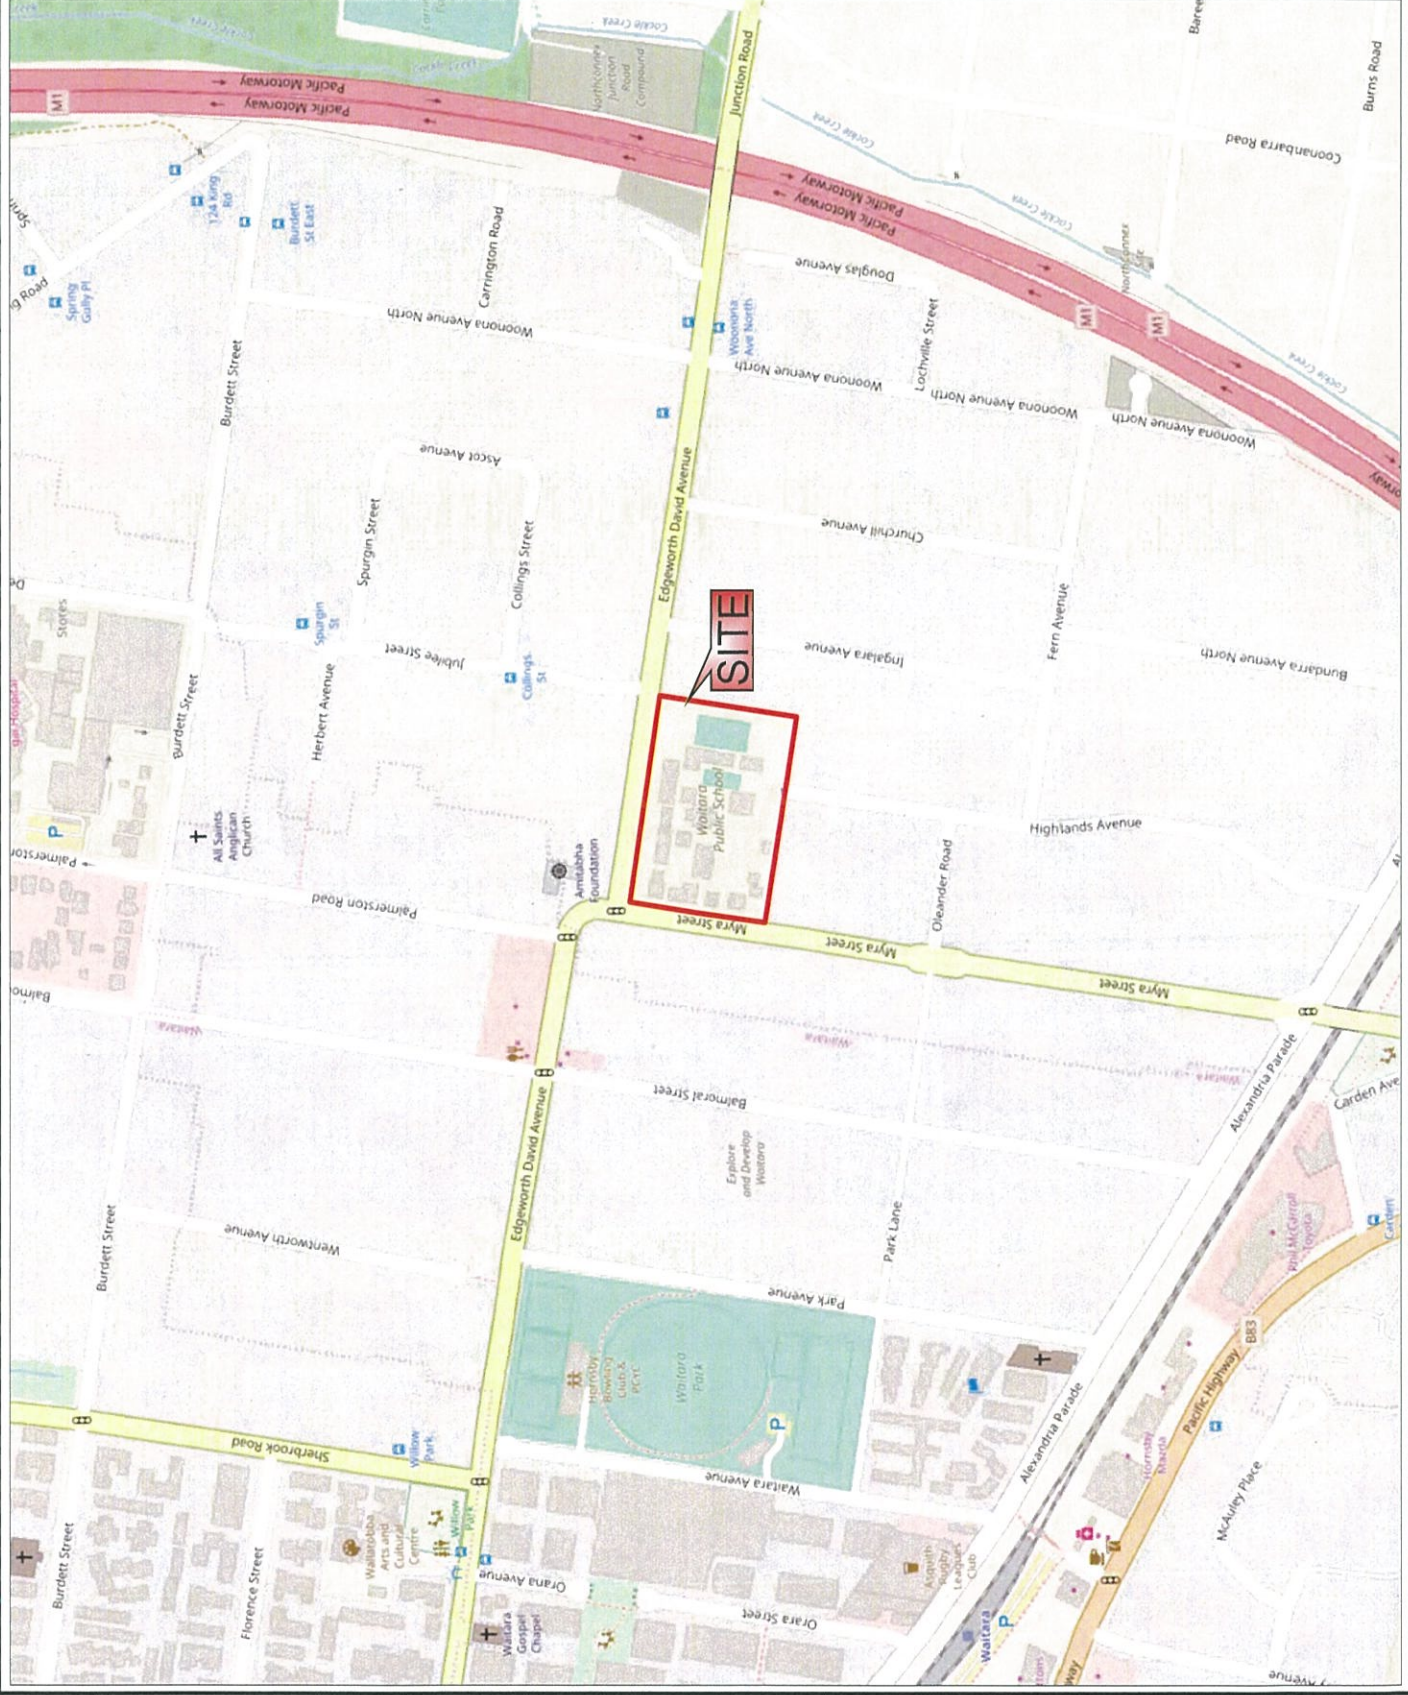
**FIGURE 1**

**SITE LOCATION**

The location of the site shown on **Figure 1**. The layout of the site and approximate site boundary are shown on **Figure 2**. The site details are summarised in **Table 2.1**.

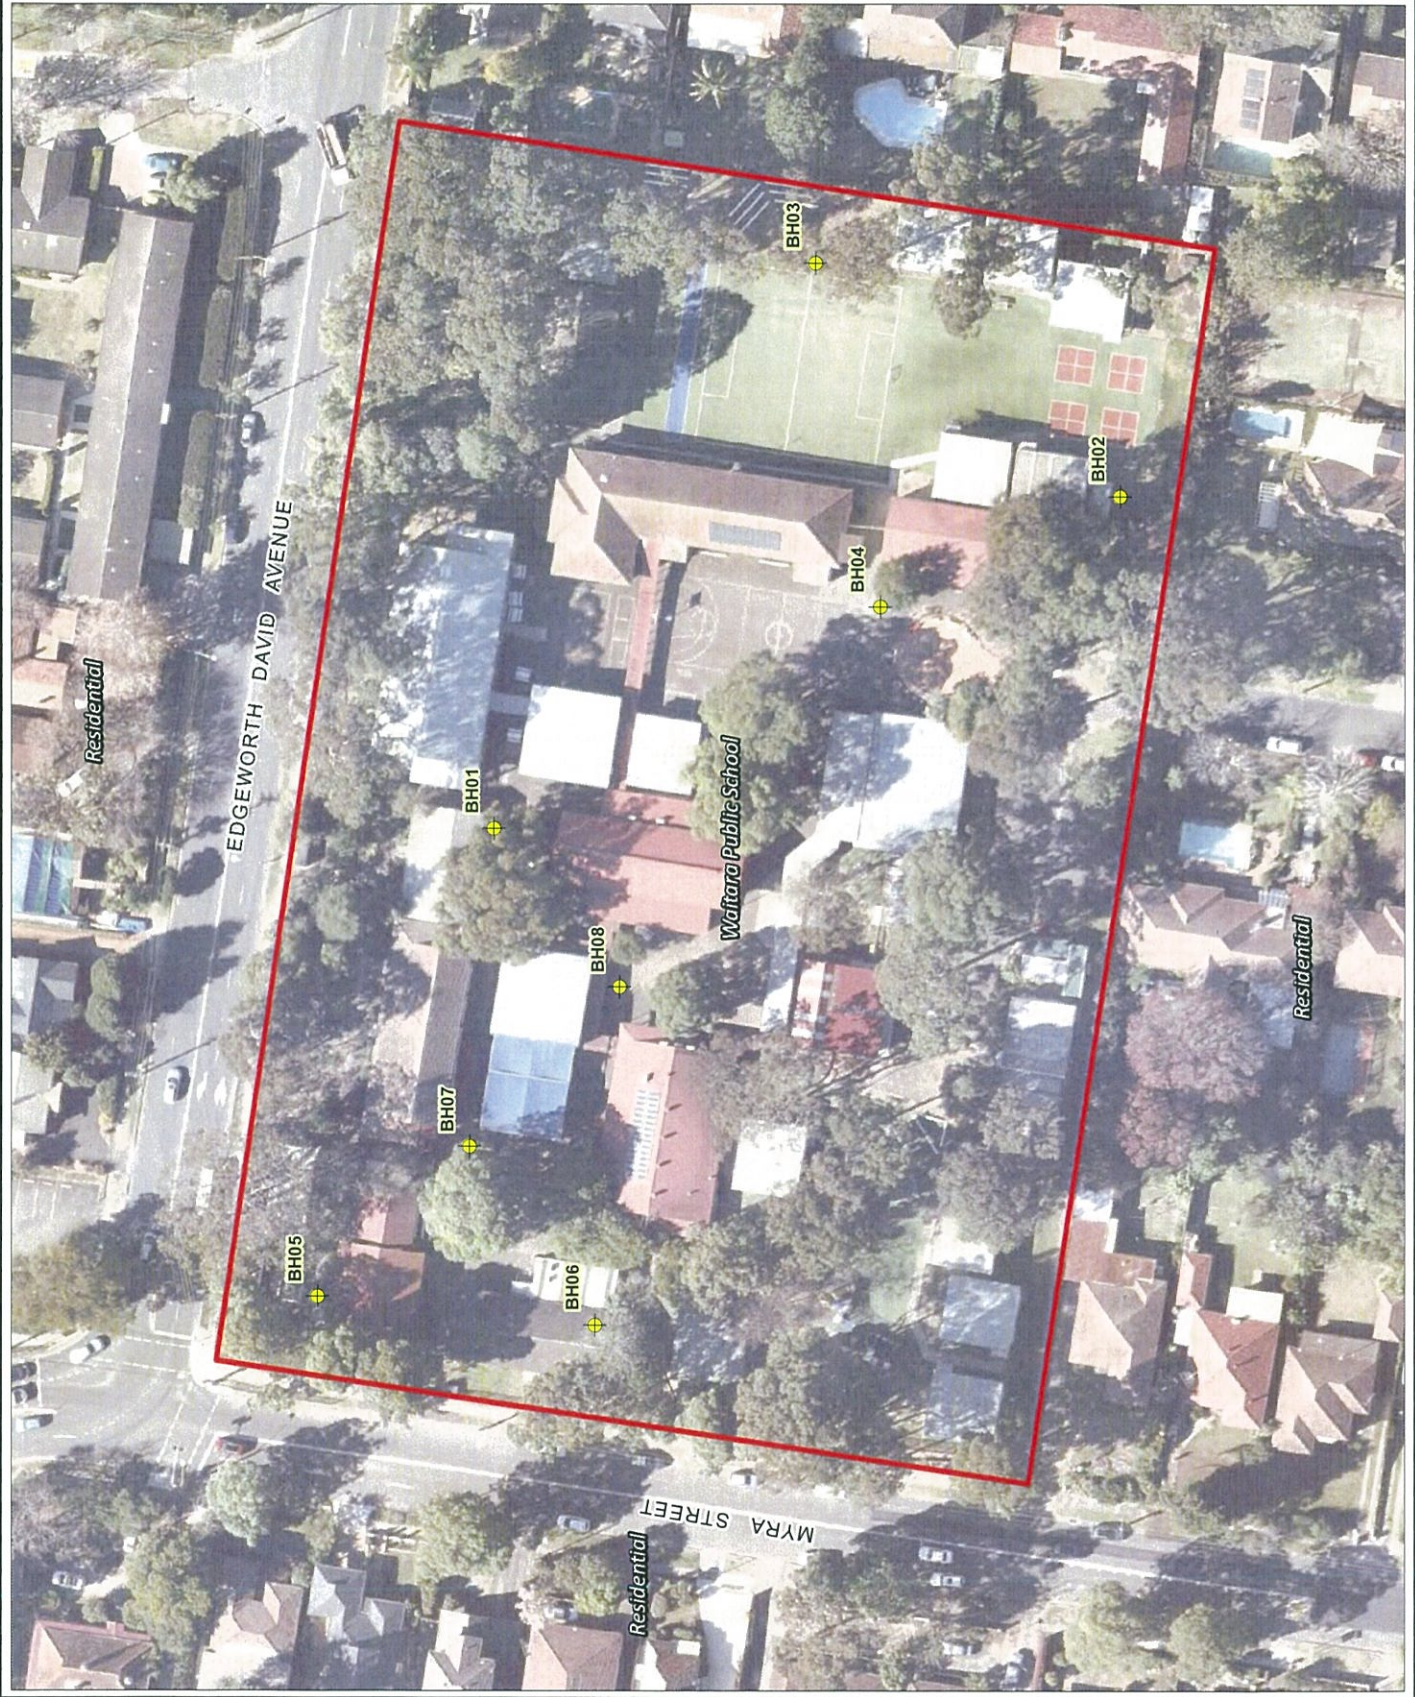
FIGURE 2

For a site of approximately 20,000 m<sup>2</sup> EPA (1995)<sup>8</sup> recommends a stratified approach to sampling. However, based on the requirement to co-locate contamination samples within geo-technical boreholes and the scope of works provided, a total of eight (8) sample locations were undertaken. The borehole locations were generally within the vicinity of the geotechnical investigation locations provided by the client. No locations were drilled on Lot 11 DP17375. The soil sample locations are presented on **Figure 3**.

SITE LAYOUT

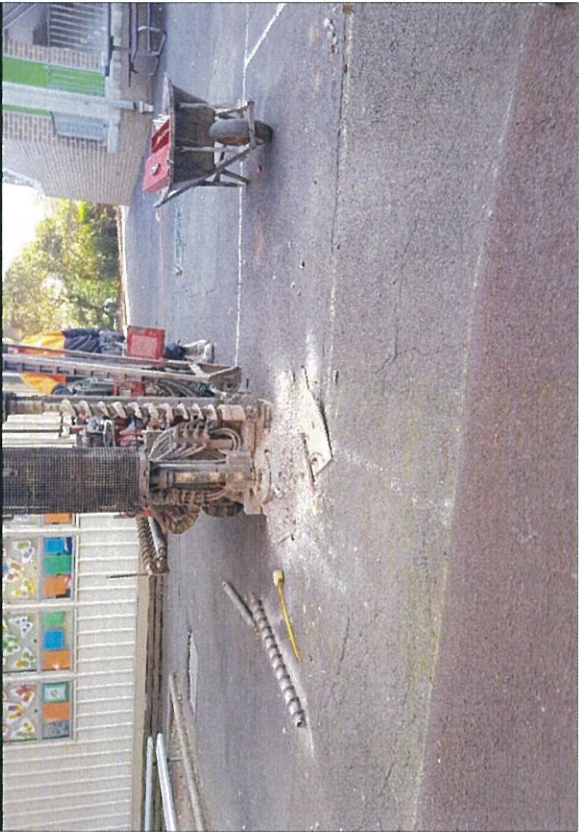
PHOTOGRAPH 1: LOCATION OF BH01 IN THE CENTRAL NORTHERN PORTION OF THE SITE, FACING NORTH. PICTURED IS AN EXAMPLE OF TYPICAL ASPHALT SEALED SURFACES

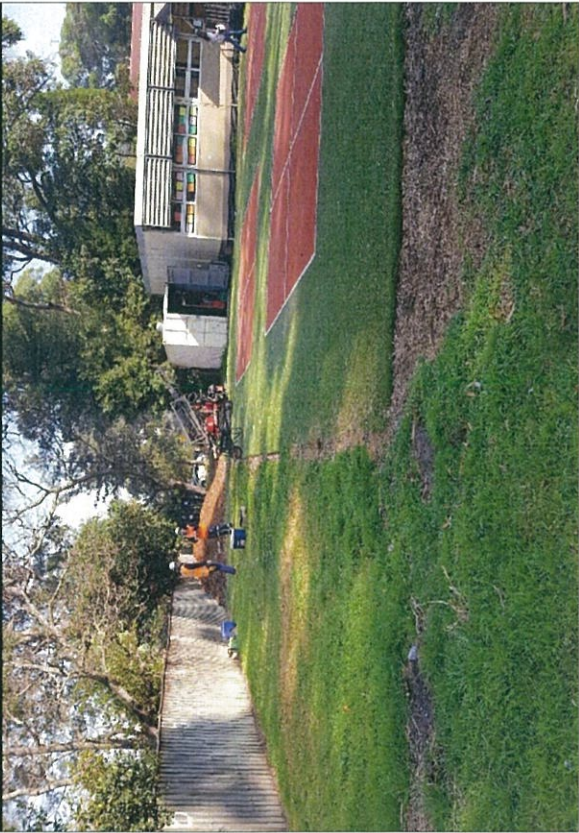
PHOTOGRAPH 2: LOCATION OF BH02 IN THE SOUTH EASTERN CORNER OF THE SITE, FACING WEST. PICTURED IS AN EXAMPLE OF GRASSED AND ARTIFICIAL TURF SURFACES

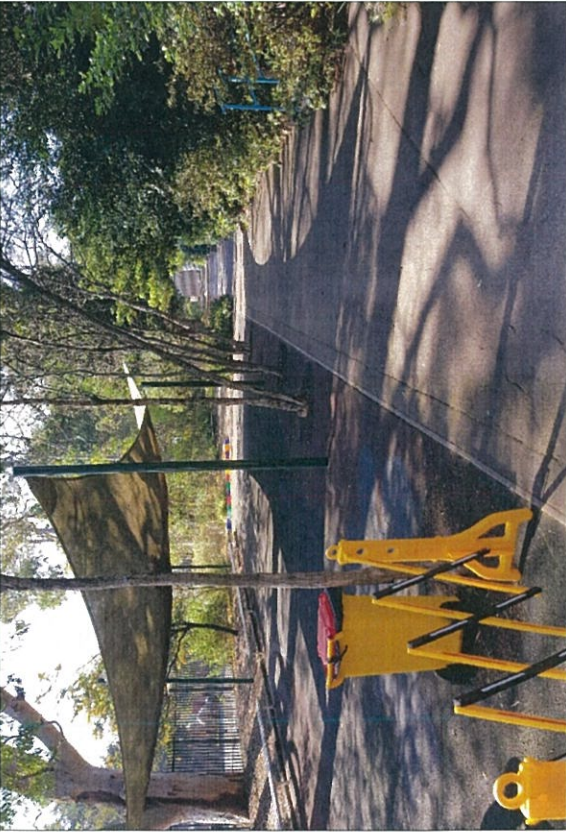
PHOTOGRAPH 3: LOCATION OF BH05 IN THE NORTH WESTERN CORNER OF THE SITE, FACING EAST. PICTURED IS AN EXAMPLE OF CONCRETE AND RUBBER SEALED SURFACES

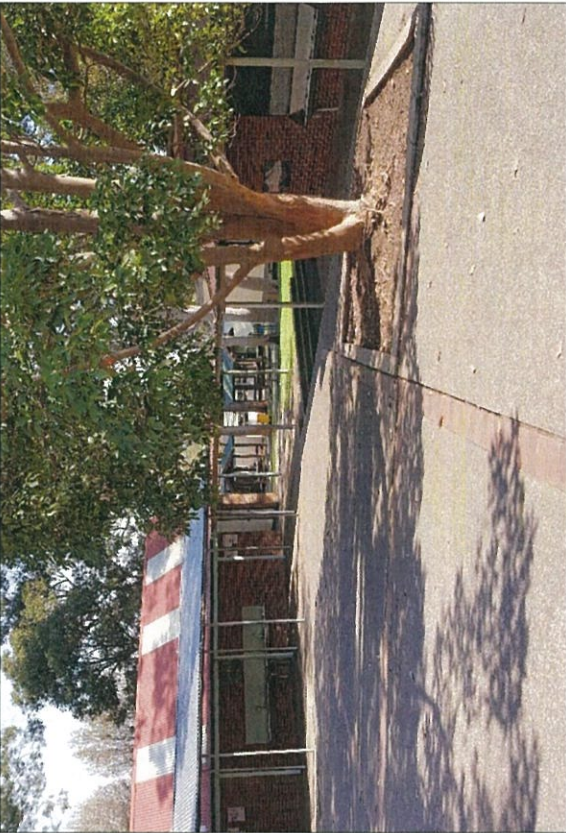
PHOTOGRAPH 4: LOCATION OF BH08 IN THE CENTRAL WESTERN PORTION OF THE SITE, FACING SOUTH WEST. PICTURED IS AN EXAMPLE OF SEALED CONCRETE AND EXPOSED SOIL SURFACES

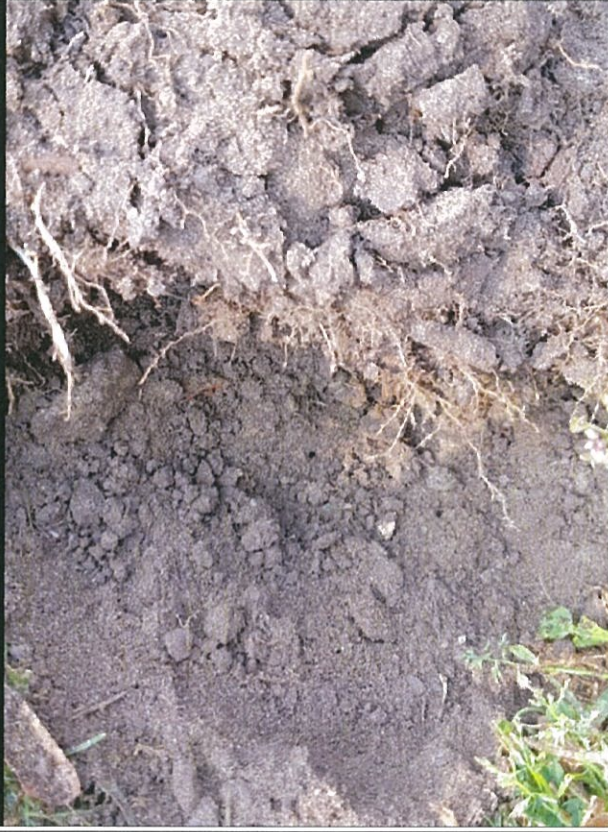
Fill material was encountered at all sample locations and generally comprised brown silty clay or sandy silty clay, heterogeneous, damp, soft to very soft with some trace gravel, organic material, glass and plastic inclusions. Fill material was observed at depths ranging from 0.05 m bgs to 0.25 m bgs.

PHOTOGRAPH 5: TYPICAL FILL MATERIAL ENCOUNTERED AT THE SITE DURING INTRUSIVE SAMPLING

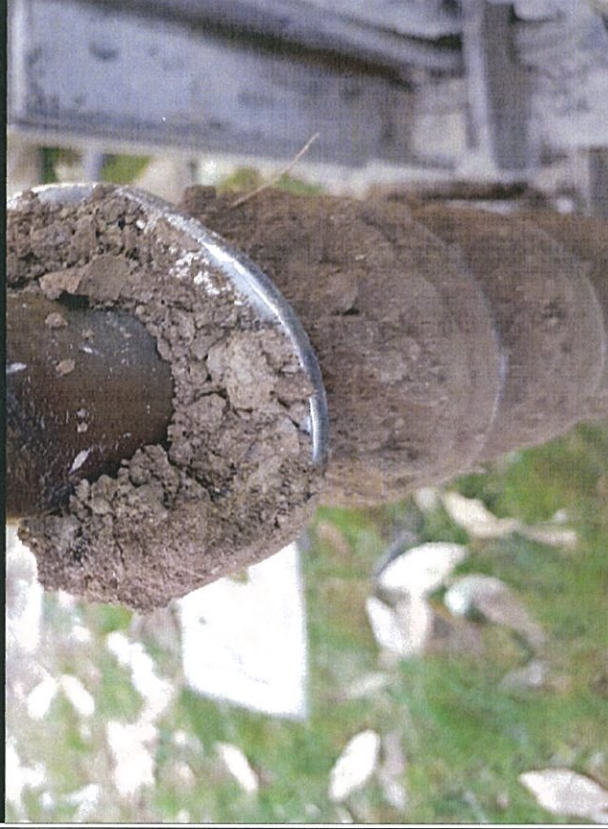
PHOTOGRAPH 6: TYPICAL FILL MATERIAL ENCOUNTERED AT THE SITE DURING INTRUSIVE SAMPLING

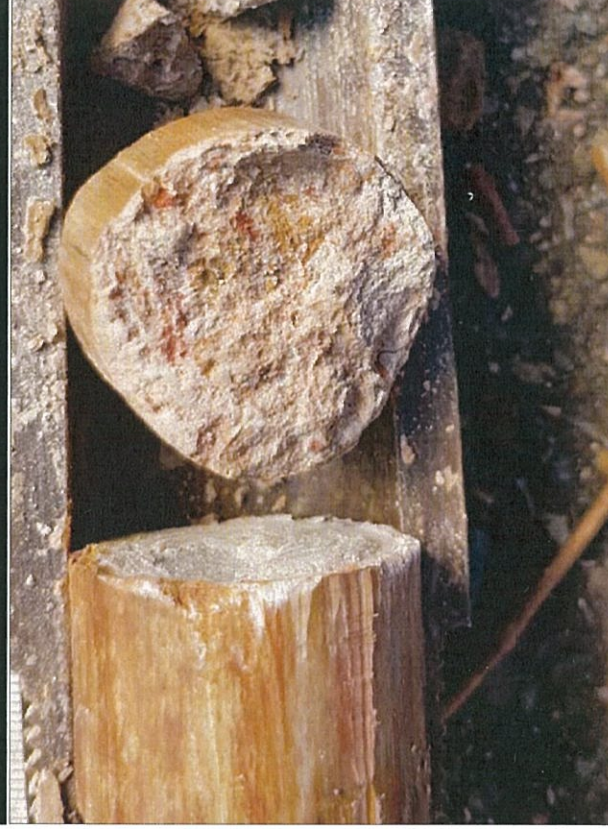
Natural soils underlying the fill material generally comprised orange brown silty clay overlying grey silty clay containing red mottles, high plasticity, homogeneous, damp and stiff, underlain by dark grey weathered shale. Natural clays were encountered at all locations. No groundwater seepage was observed during augering.

PHOTOGRAPH 8: TYPICAL NATURAL MATERIAL ENCOUNTERED DURING INTRUSIVE SAMPLING

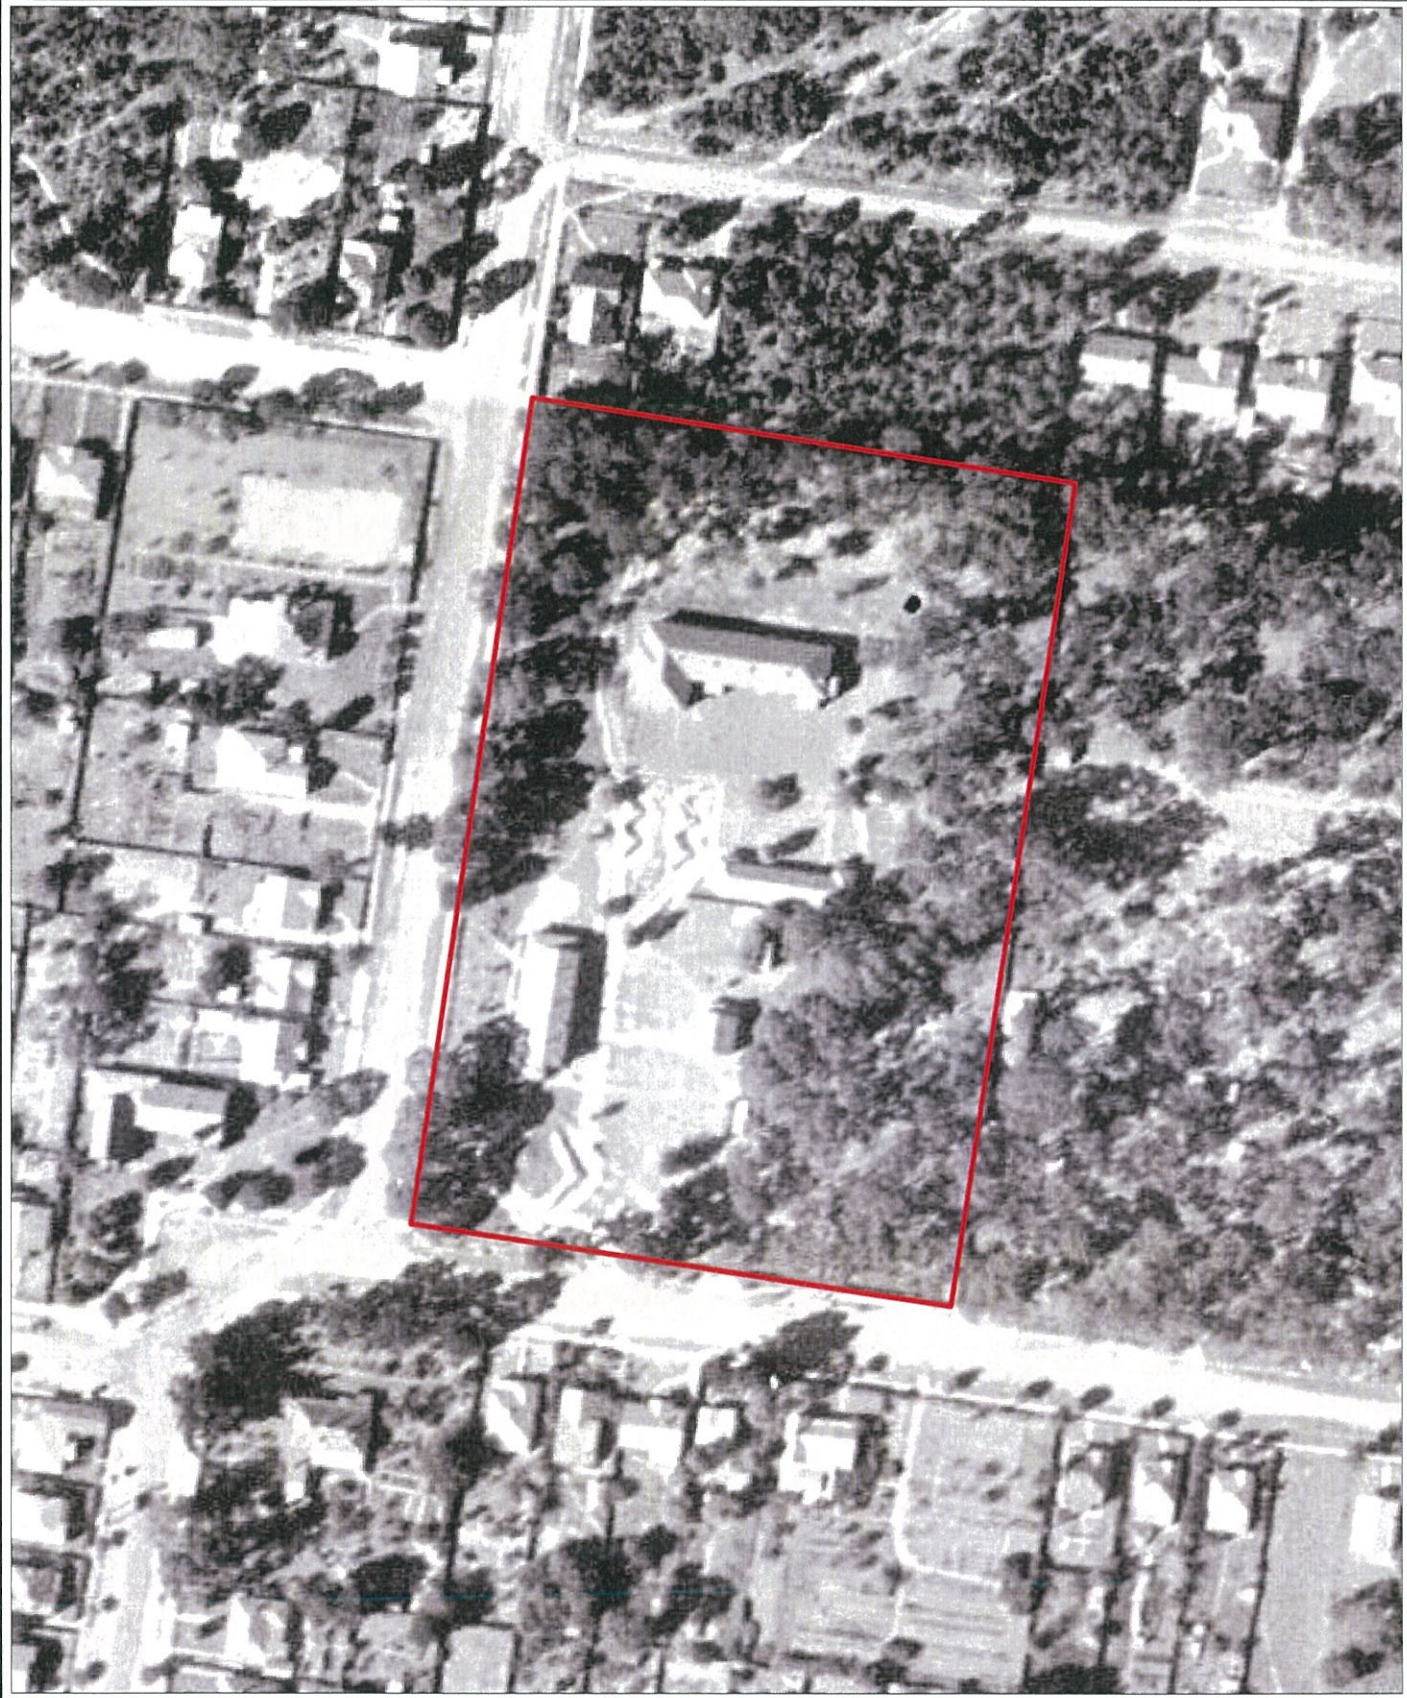
FIGURE 1943

**1943** – The site appeared to be used for education/school purposes. The site contained three large buildings in the northern, central and eastern portions of the site. Smaller buildings (possibly sheds or small classrooms) were in the central portion of the site. What appear to be zig-zag-shaped trenches were visible in the northern portions of the site. Vegetation could be observed in the southern portion of the site and along the site boundaries. Edgeworth David Avenue and Myra Street had been constructed to the north and west of the site respectively. The surrounding land appeared to be used for residential purposes with the property to the south consisting of bushland.

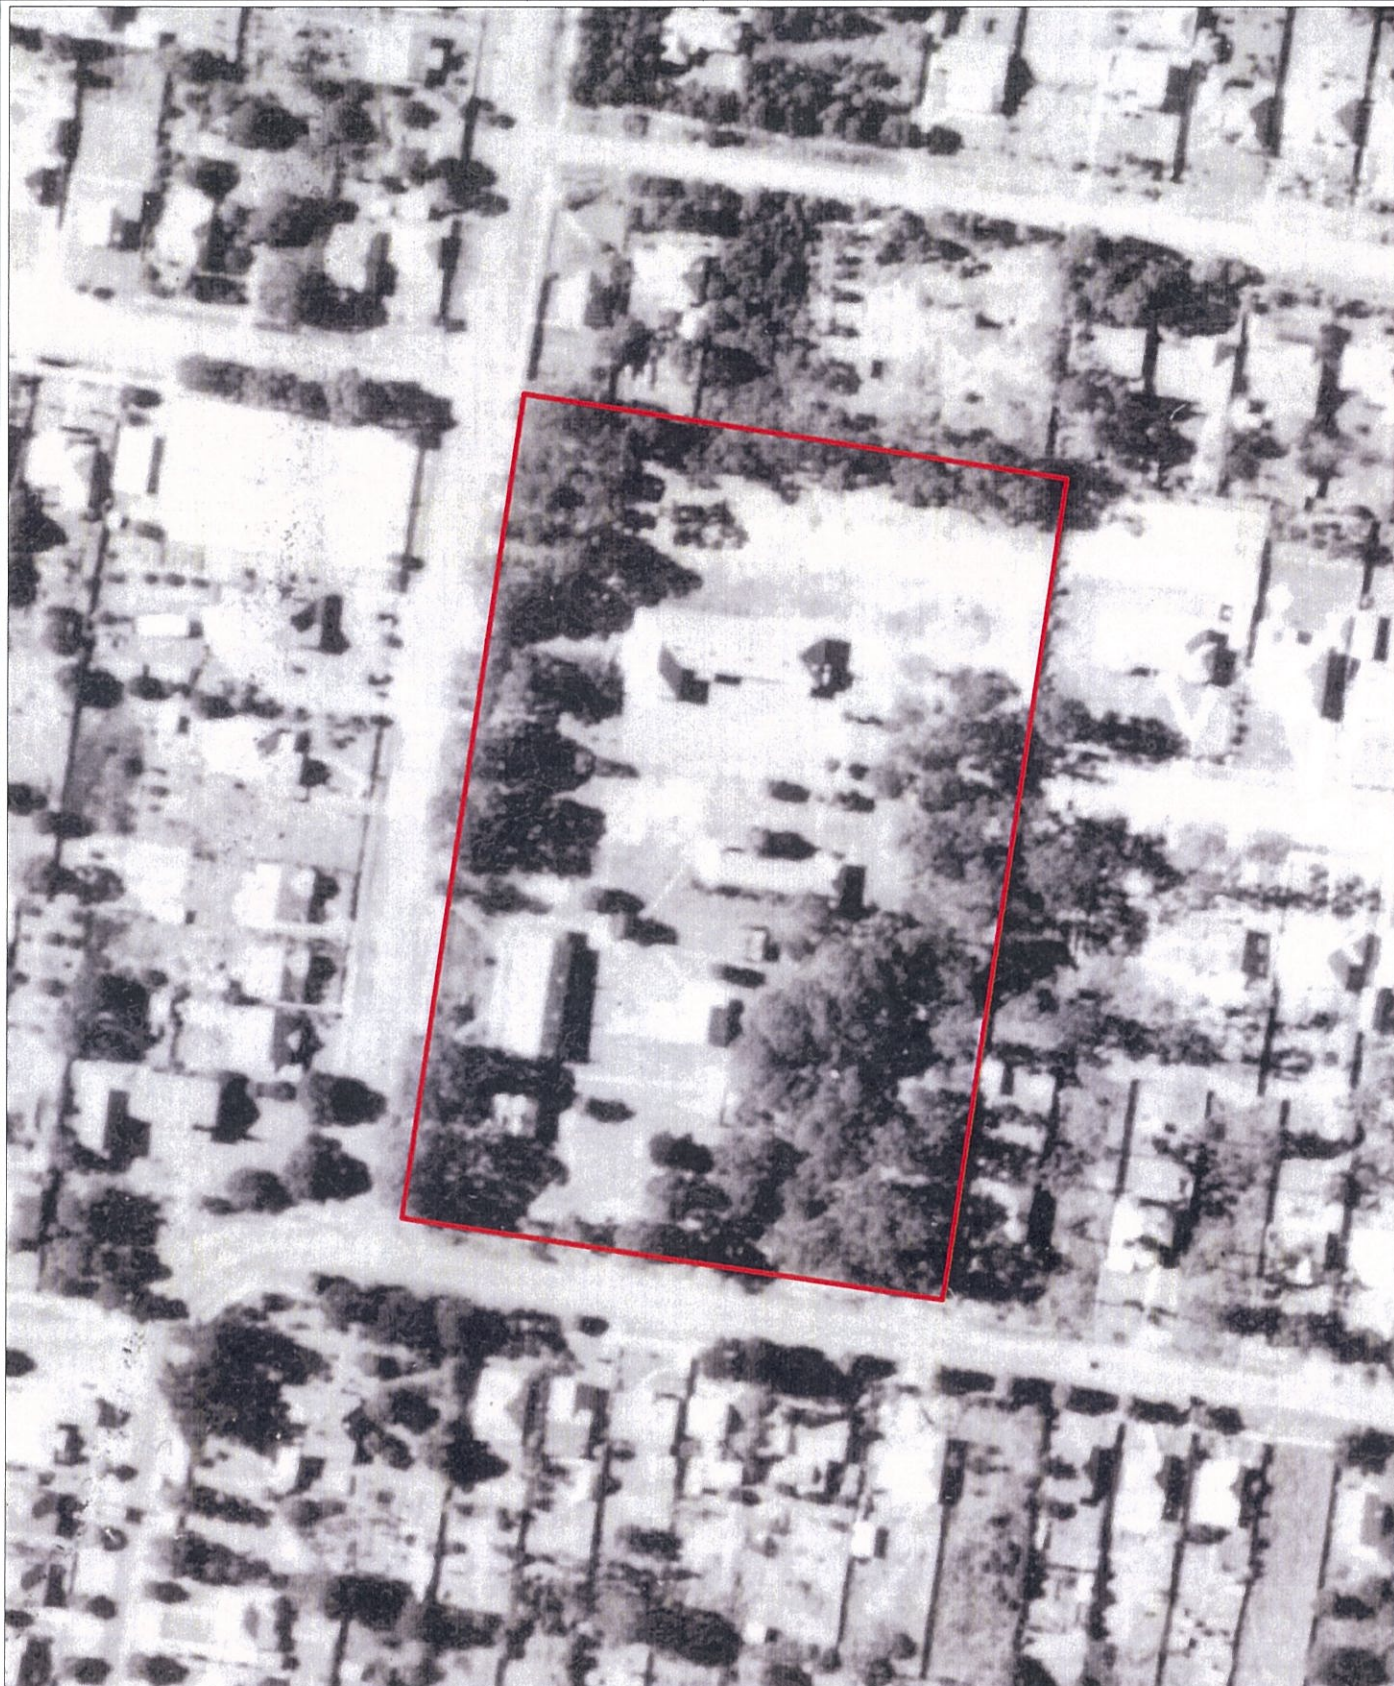
**FIGURE 1951**

**HISTORICAL AERIAL  
PHOTOGRAPH 1951**

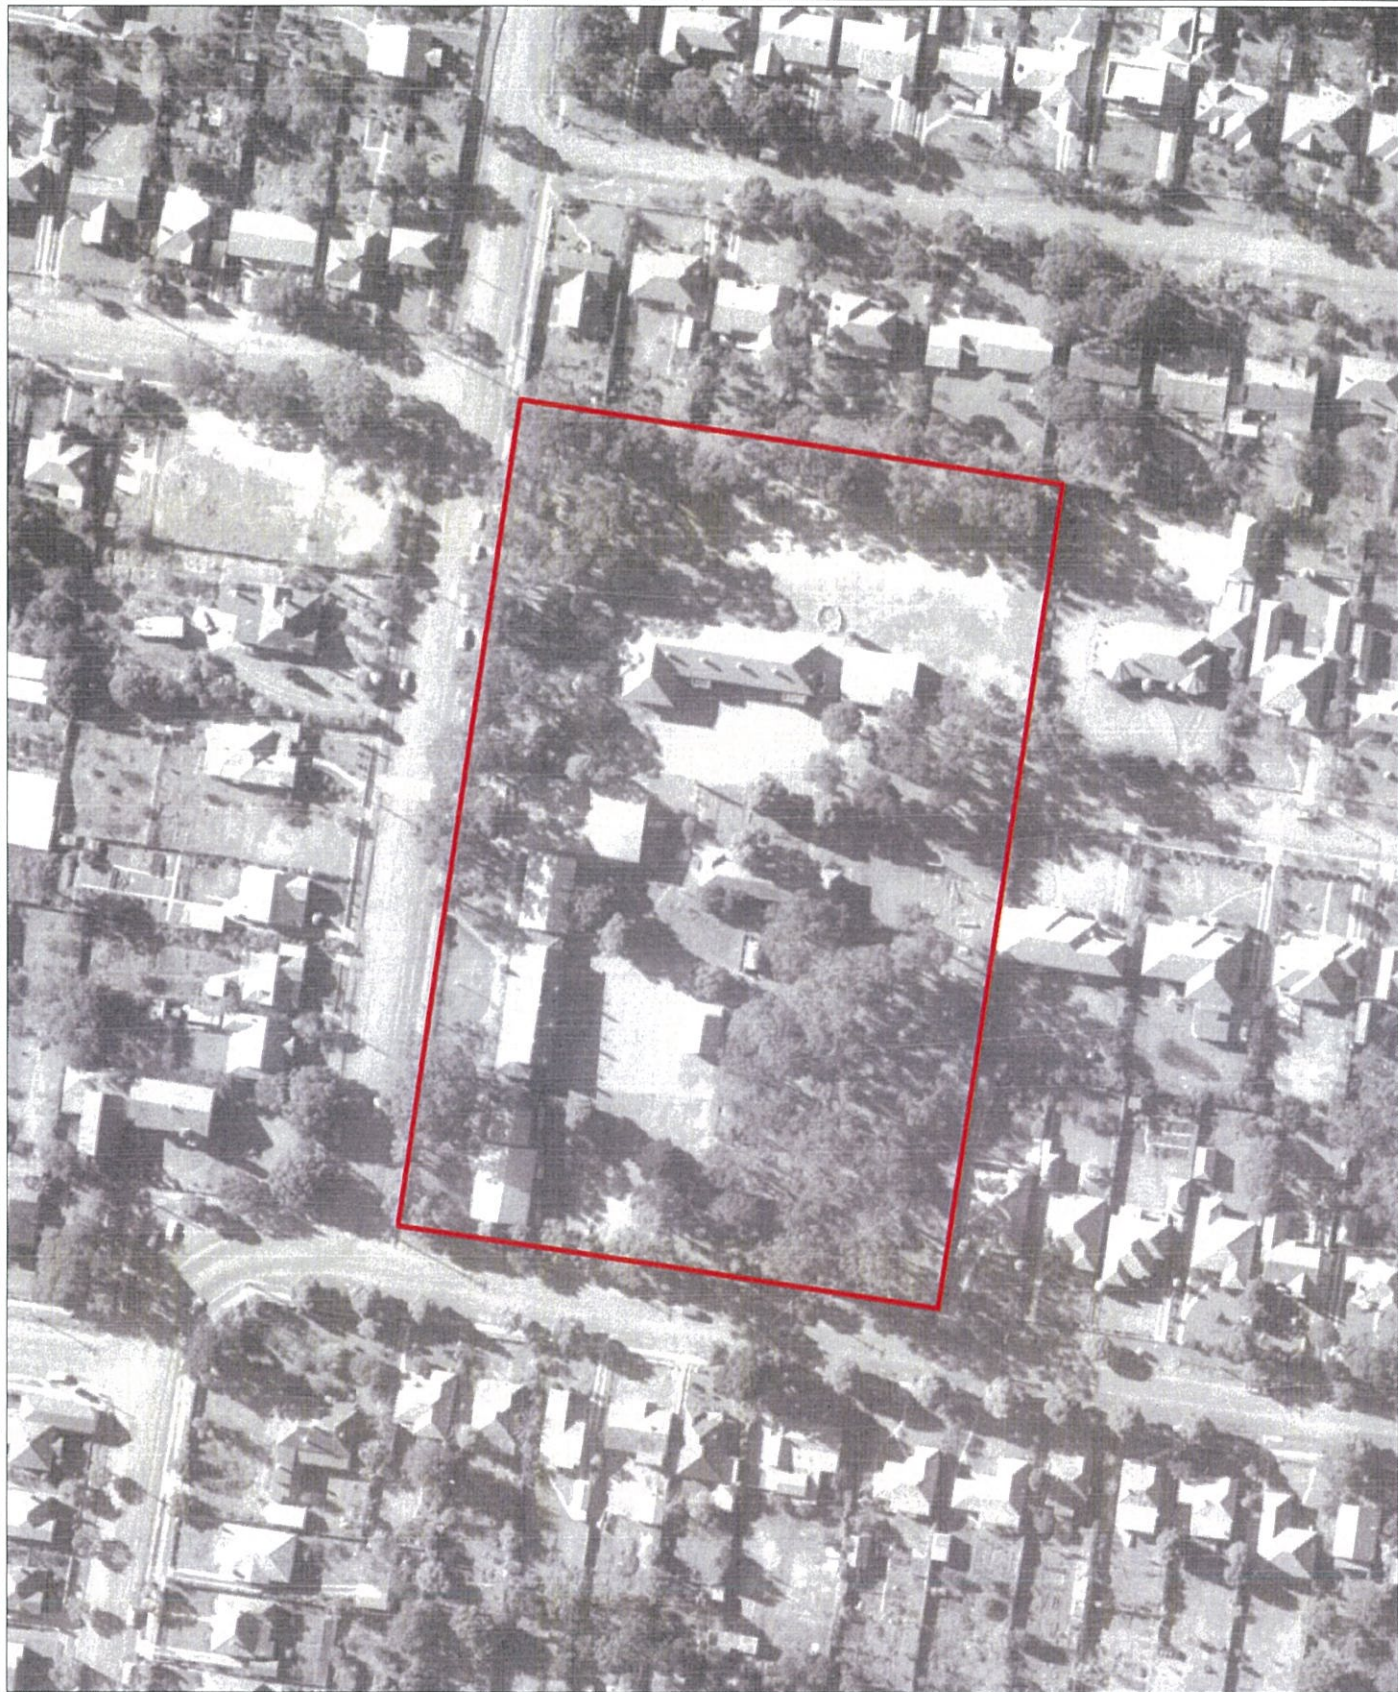
FIGURE 1961

**1961** – Additional buildings (likely classrooms) had been constructed in the north western, northern and south eastern portions of the site. No other significant changes were observed to site. The surrounding land remained for residential use with the bushland to the south completely cleared and residential dwellings constructed.

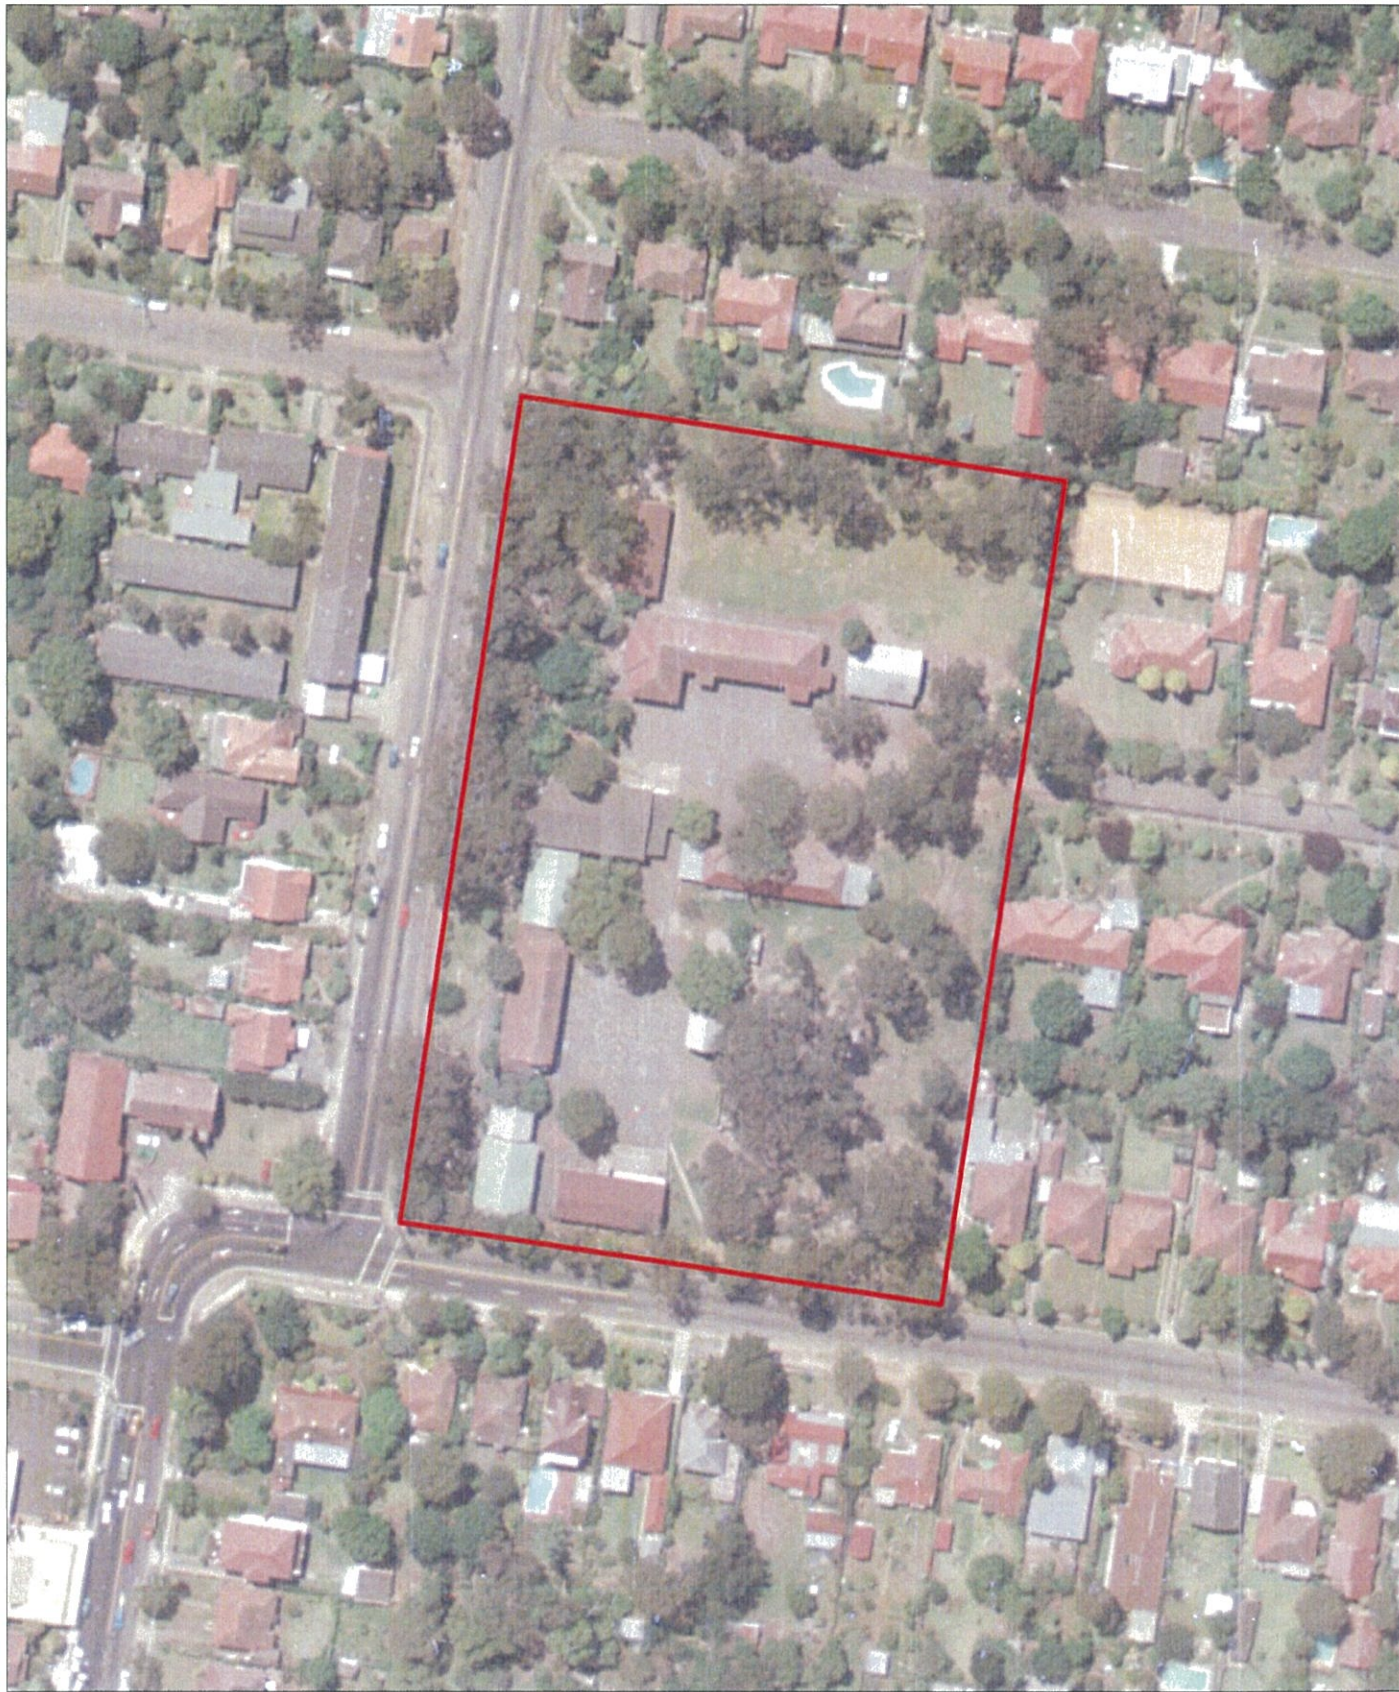
FIGURE 1982

**1982** – The site appeared generally unchanged from the previous 1970 aerial photograph. The site is sealed with asphalt in the north western and central portions of the site. Due to the quality of the previous aerial photographs, it is unknown if these areas were previously sealed. No changed to the surrounding land use was observed.

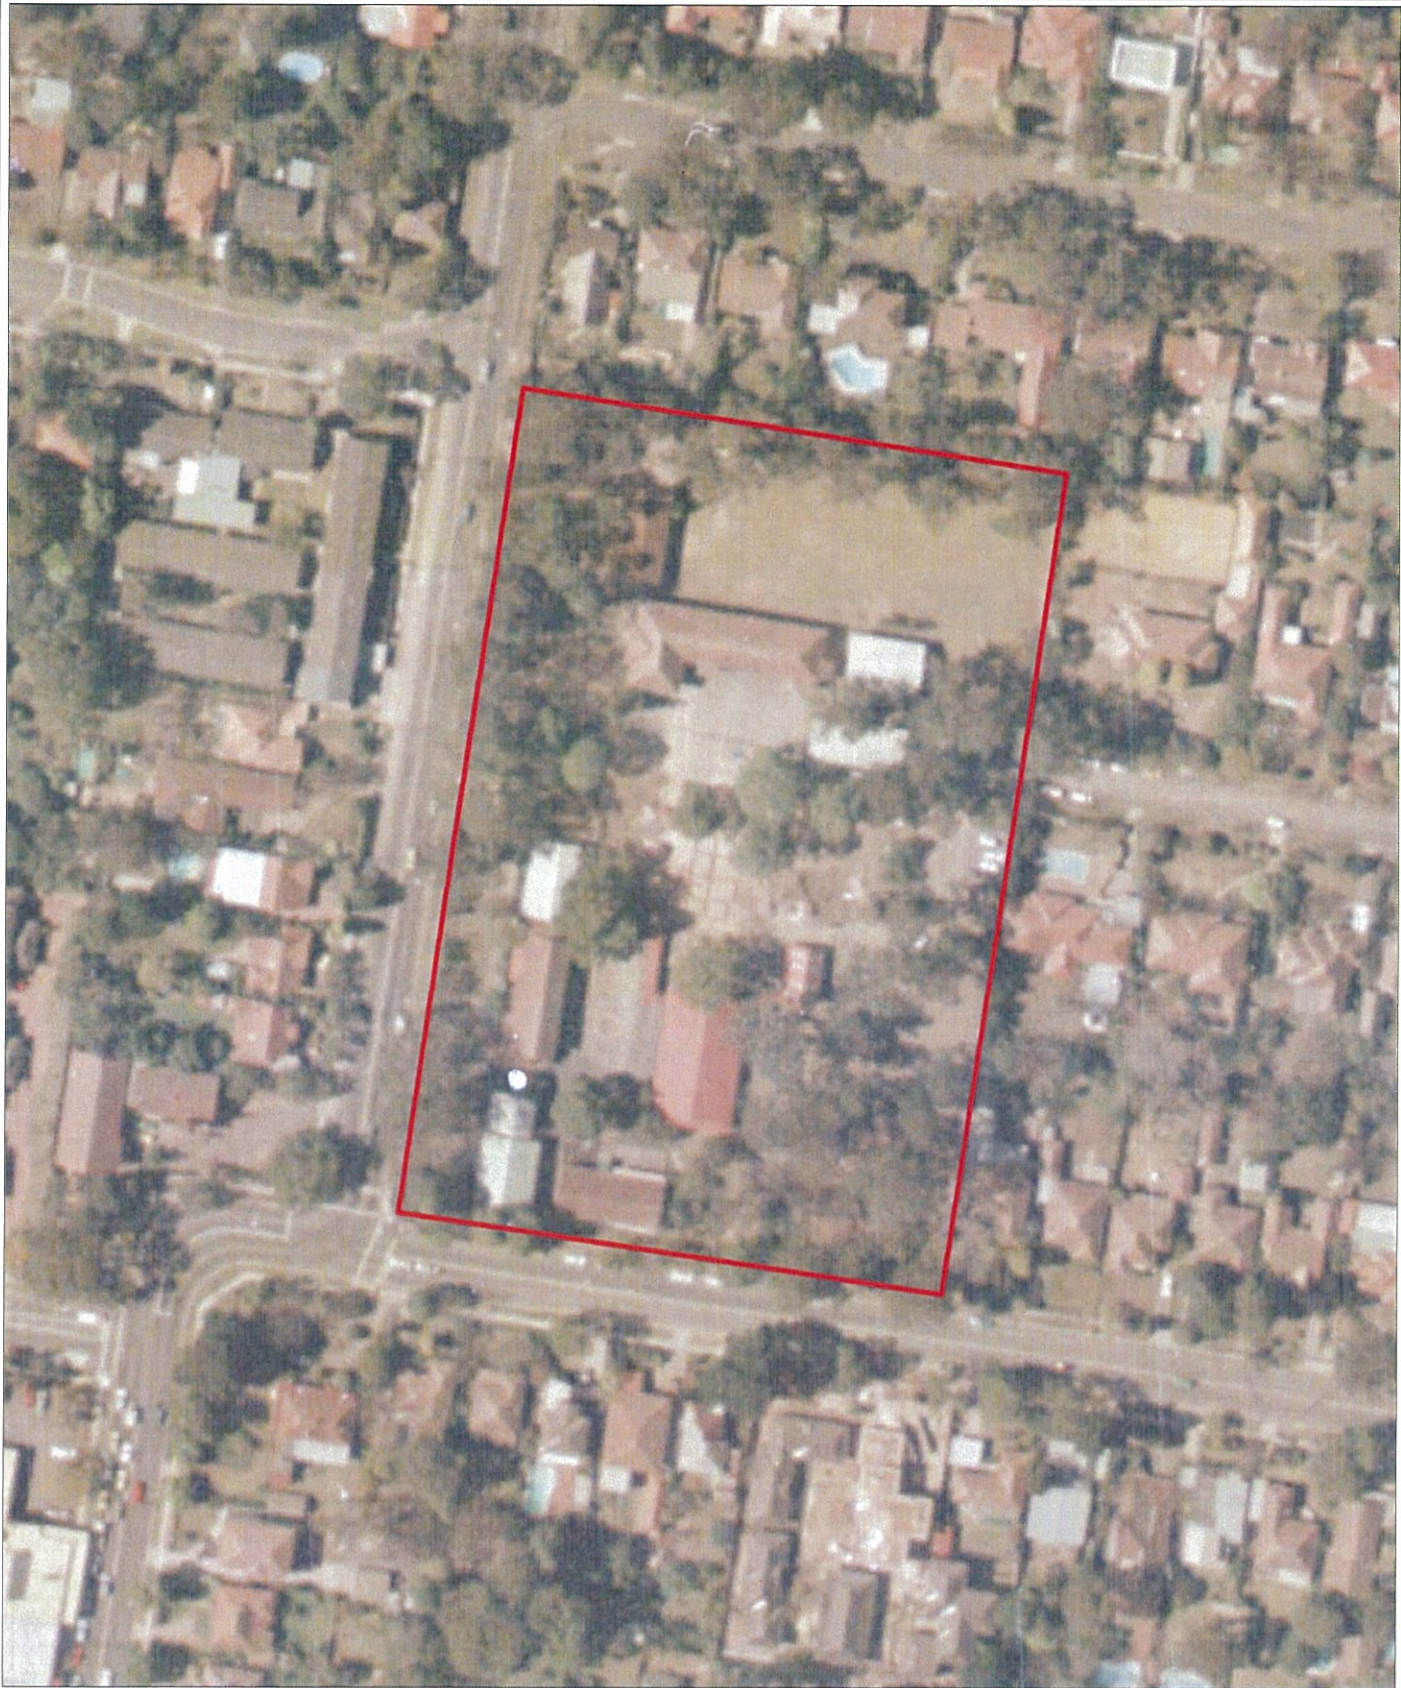
**FIGURE 1991**

**1991** – Three of the classroom buildings in the central portion of the site had been demolished and the area remained sealed. An additional large building (classroom) had been constructed in the western portion of the site. No other changes to the site were noted. The surrounding land use remained unchanged from the previous 1982 aerial photograph.
