Environmental Site Assessment

Waitara Public School  
48-58 Myra Street  
Wahroonga, NSW

31 August 2017  
53033/110766 (Rev A)  
JBS&G

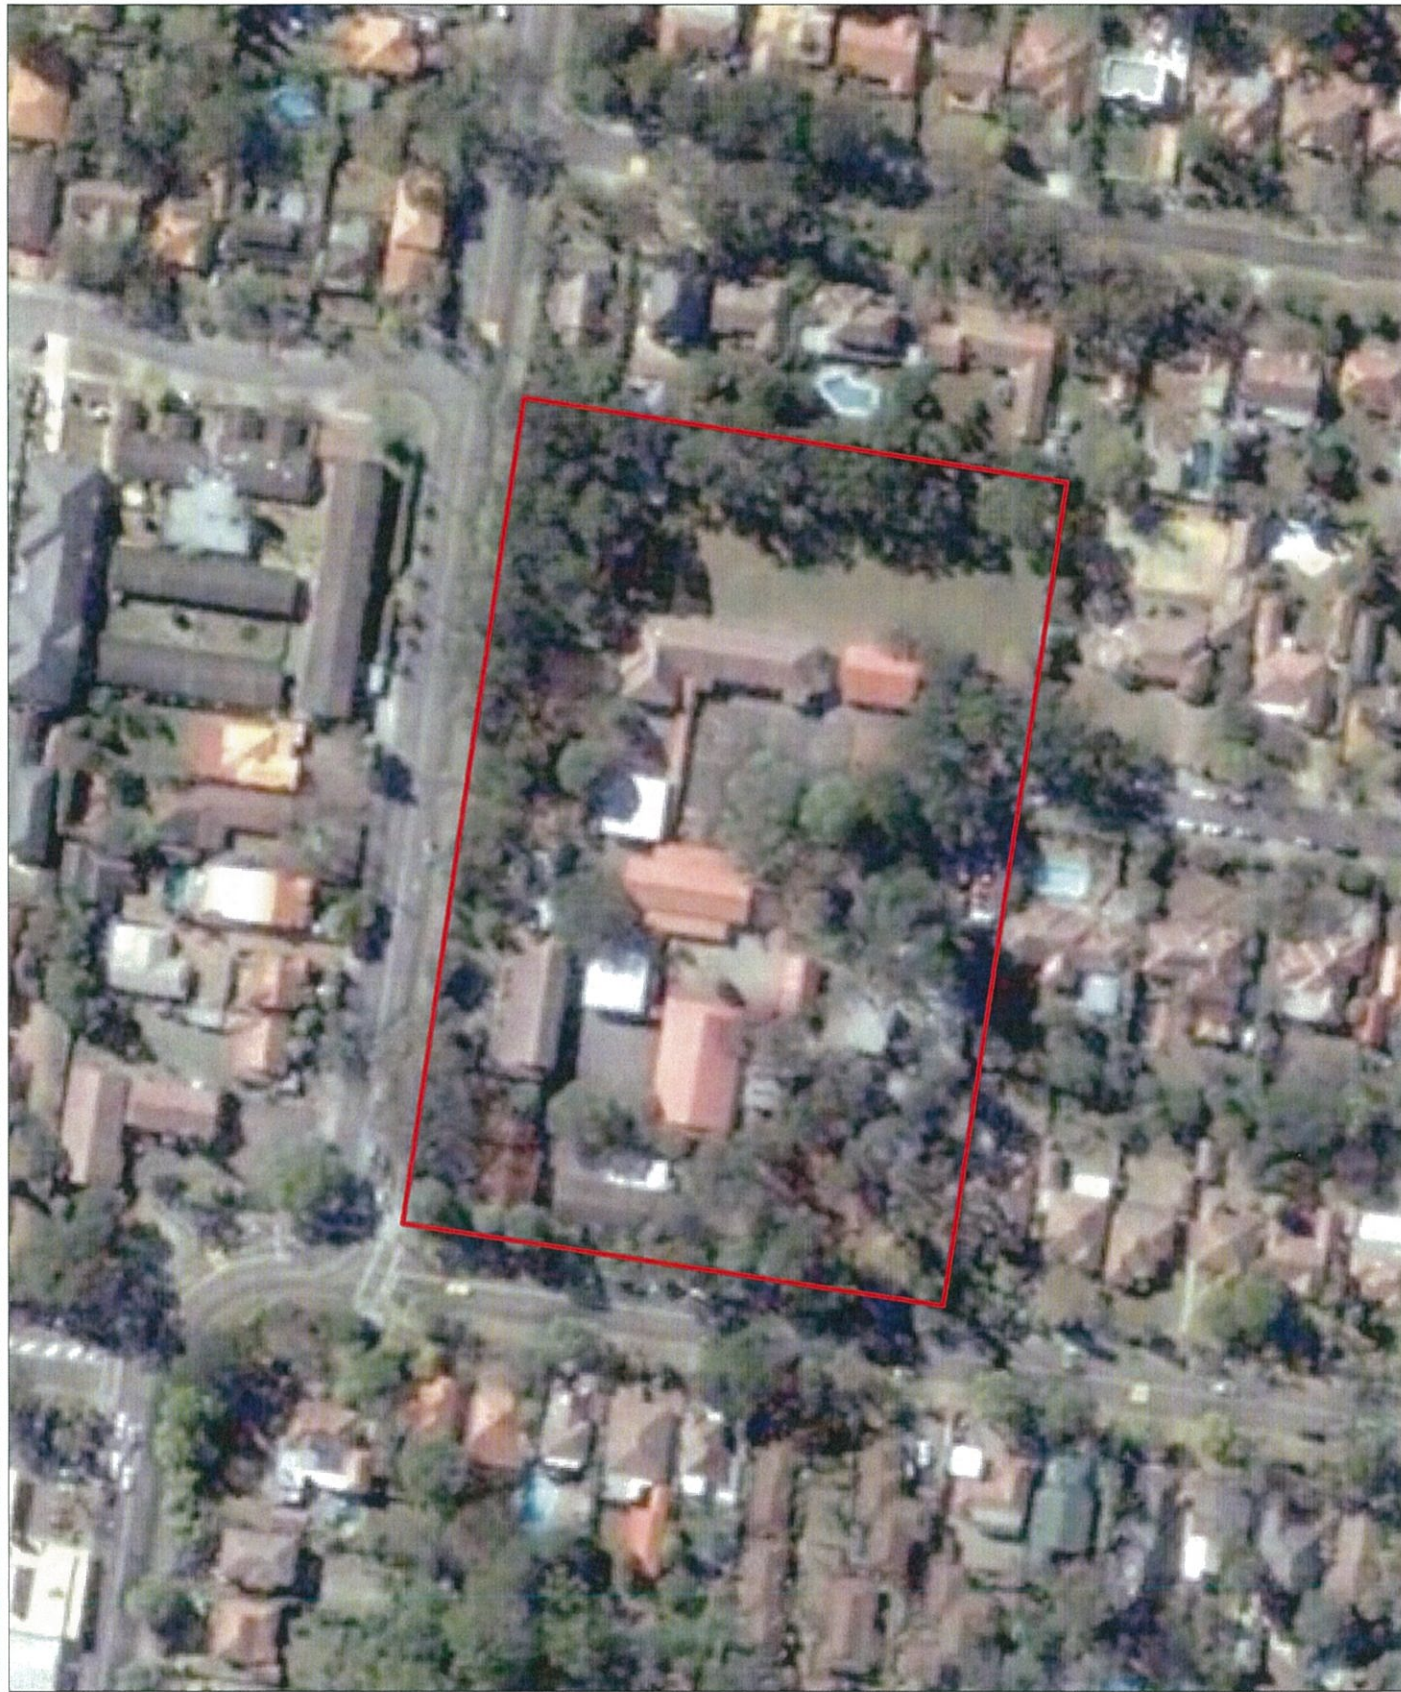
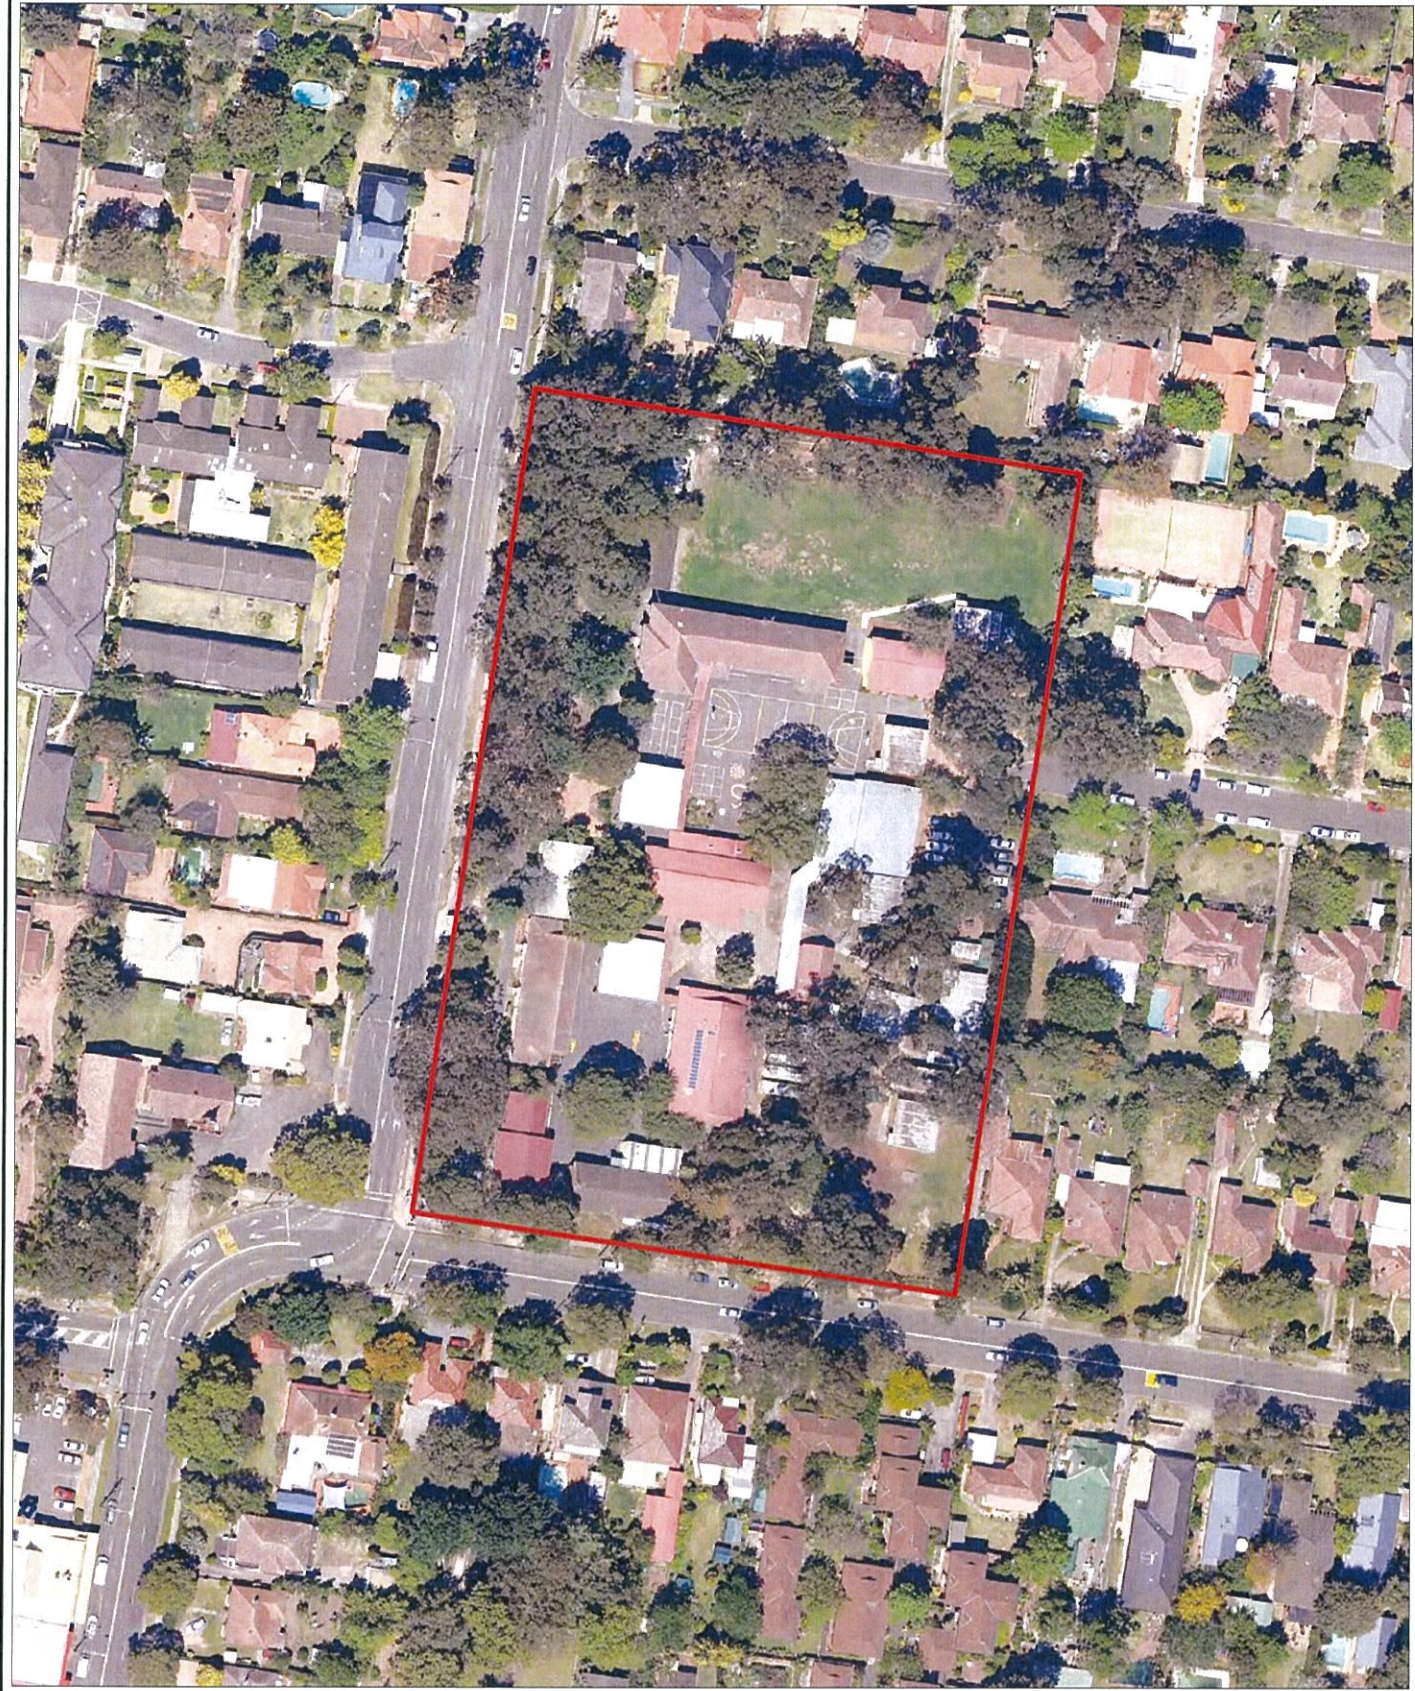
**FIGURE 2003**

**2003** – Three additional interconnected buildings (classrooms) and a structure that appeared to be a demountable building had been constructed in the central portion of the site approximately where the three former buildings existed. No other changes from the previous 1991 aerial photograph were observed. No changed were observed to the surrounding land.

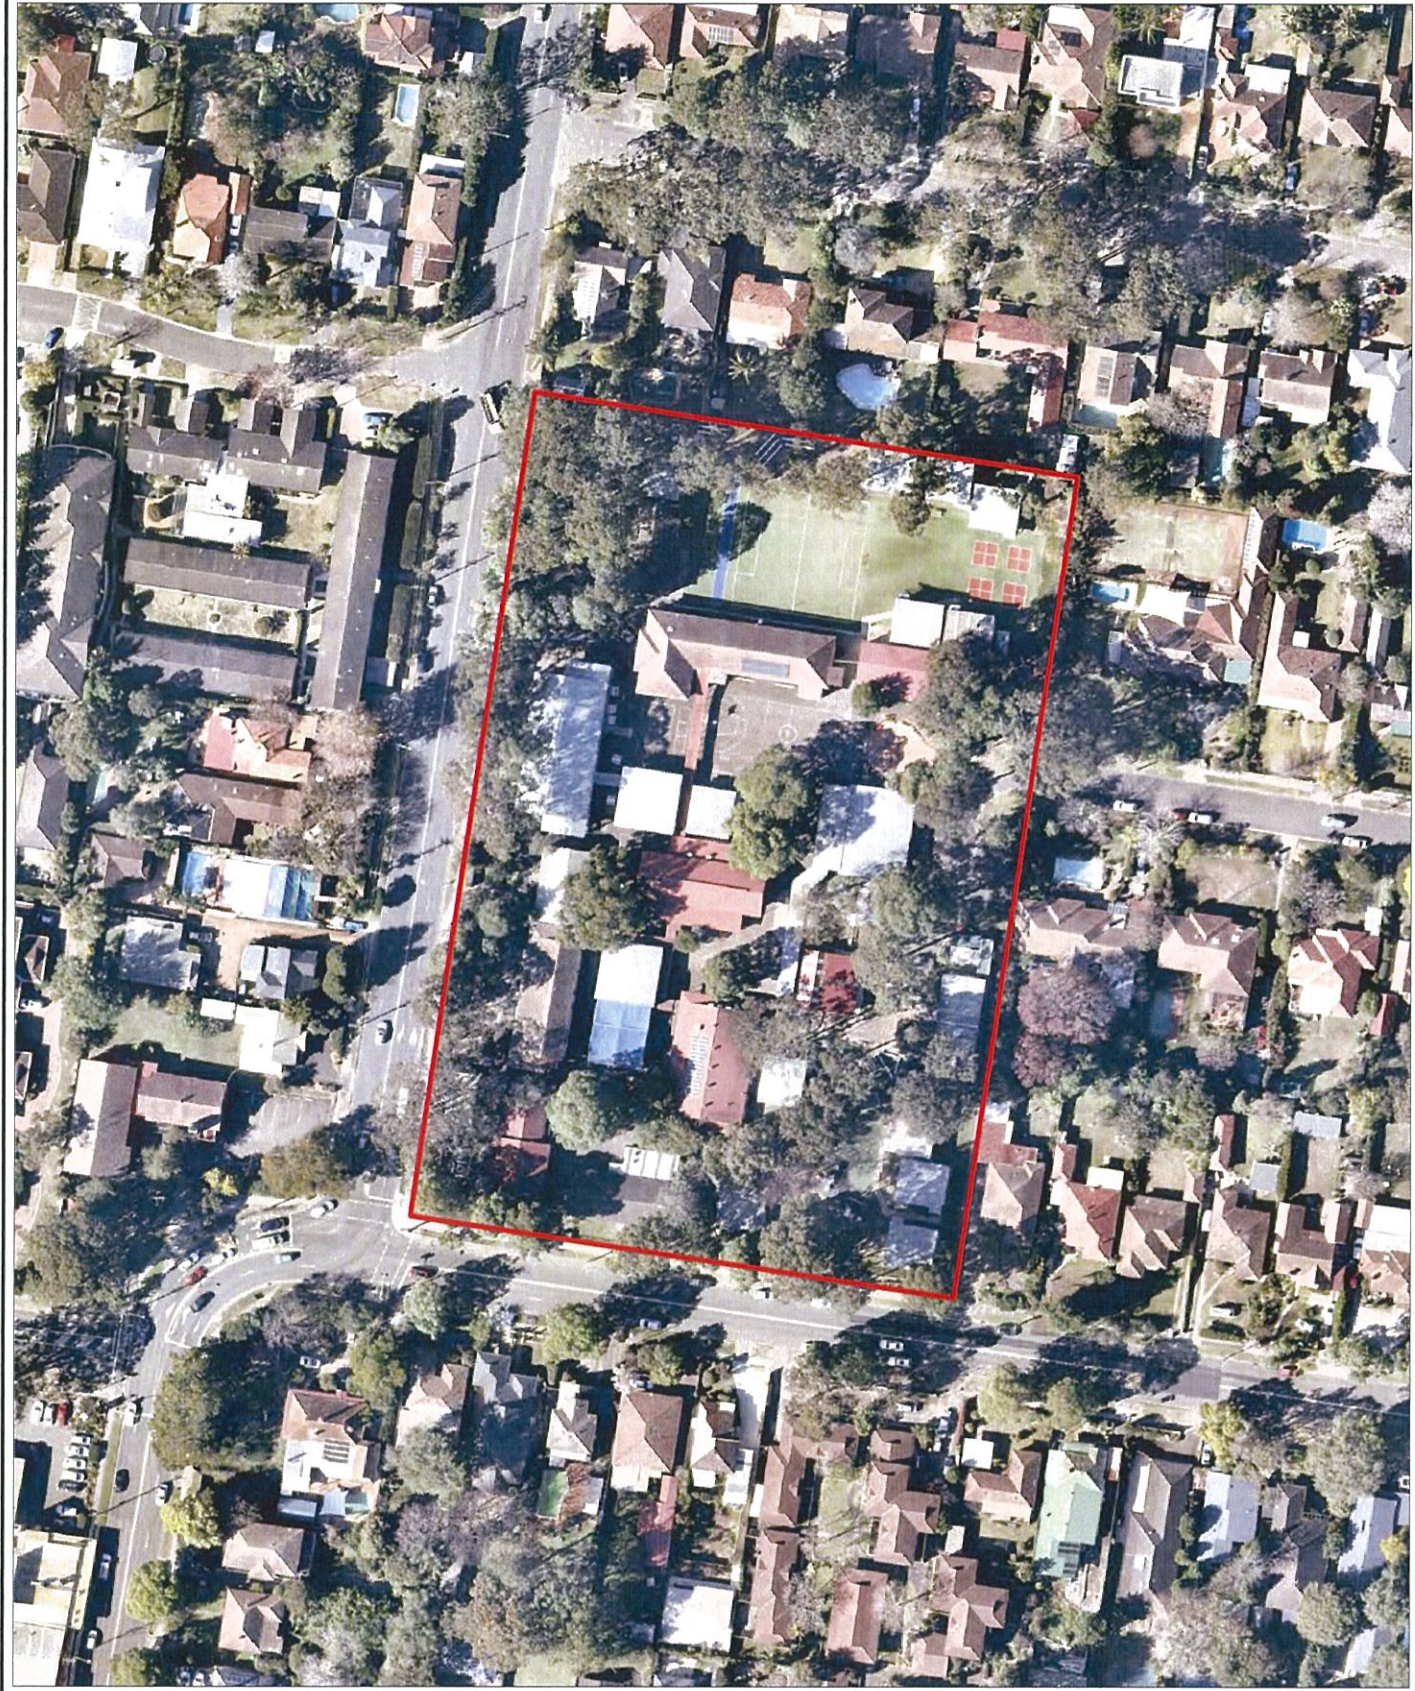
**FIGURE 2009**

**2009** – No significant changes were observed at the site or surrounding land from the previous 2003 aerial photograph.
