**RE: WAITARA PUBLIC SCHOOL  
GEOTECHNICAL AND ENVIRONMENTAL INVESTIGATION**

**WAITARA PUBLIC SCHOOL  
MYRA STREET, WAITARA  
GEOTECHNICAL AND ENVIRONMENTAL INVESTIGATION**

**PSM3331-007R     SEPTEMBER 2017**

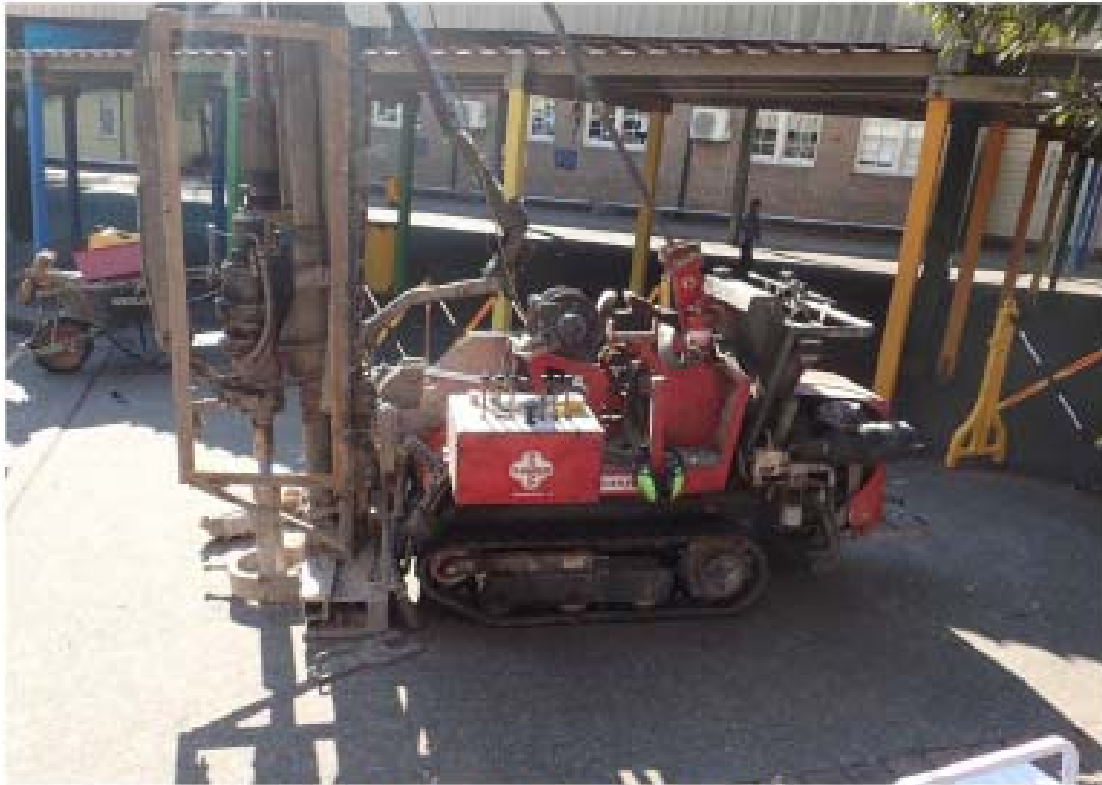
Photo 1 - 1.2 Tonne Tracked Drill Rig

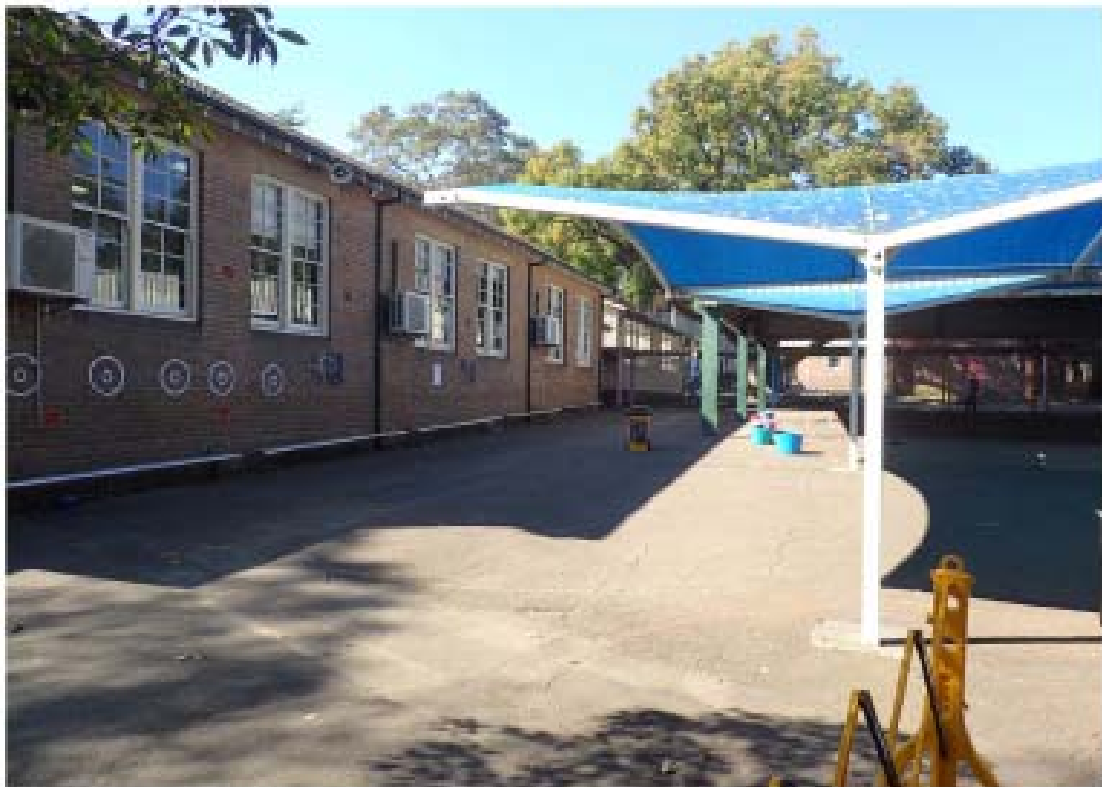
Photo 2 - General Site Conditions (On existing pathway)

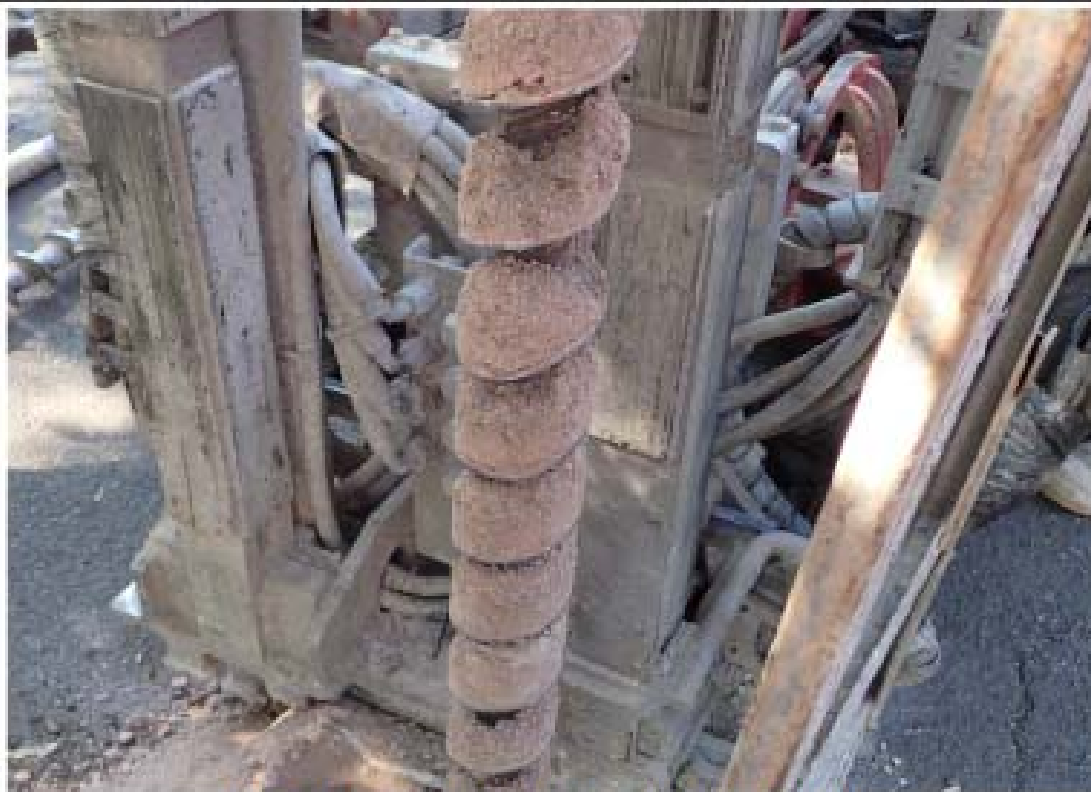
Photo 3 - Typical material encountered at BH07 (CLAY)

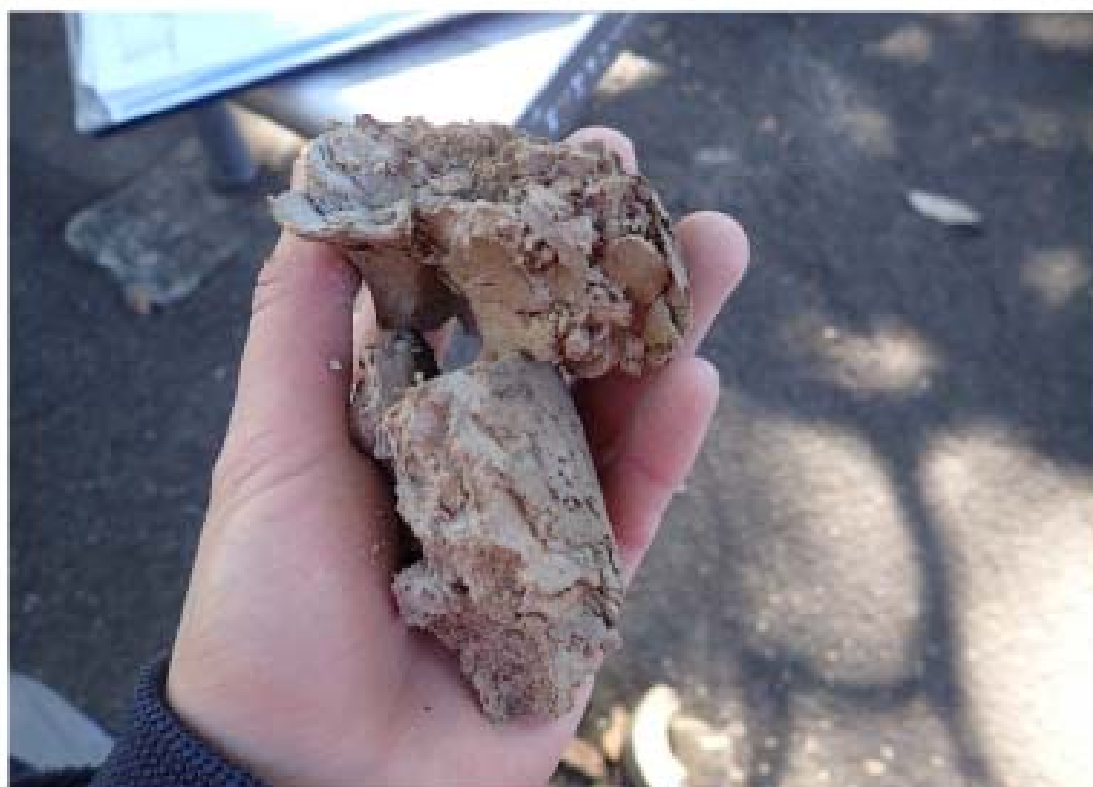
Photo 4 - Typical CLAY material encountered

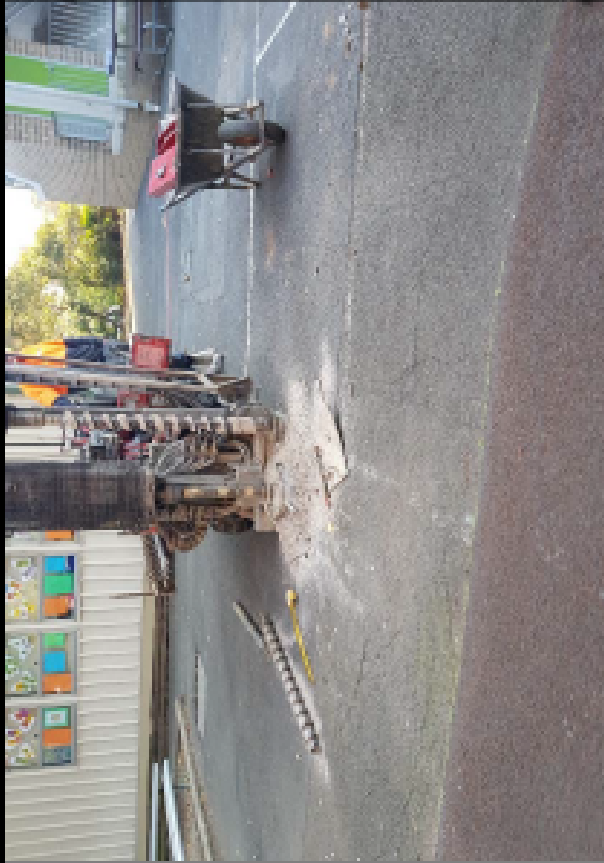
PHOTOGRAPH 1: LOCATION OF BH01 IN THE CENTRAL NORTHERN PORTION OF THE SITE, FACING NORTH. PICTURED IS AN EXAMPLE OF TYPICAL ASPHALT SEALED SURFACES

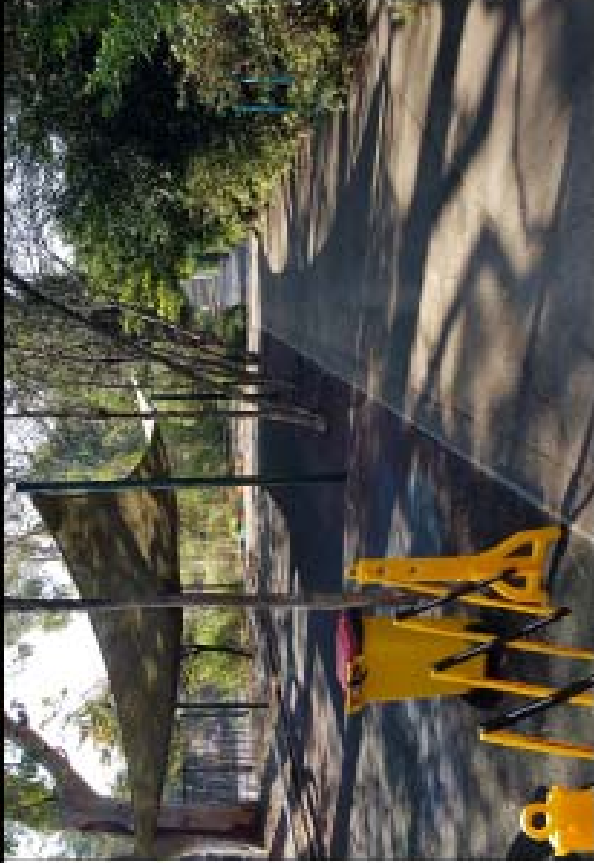
PHOTOGRAPH 3: LOCATION OF BH05 IN THE NORTH WESTERN CORNER OF THE SITE, FACING EAST. PICTURED IS AN EXAMPLE OF CONCRETE AND RUBBER SEALED SURFACES

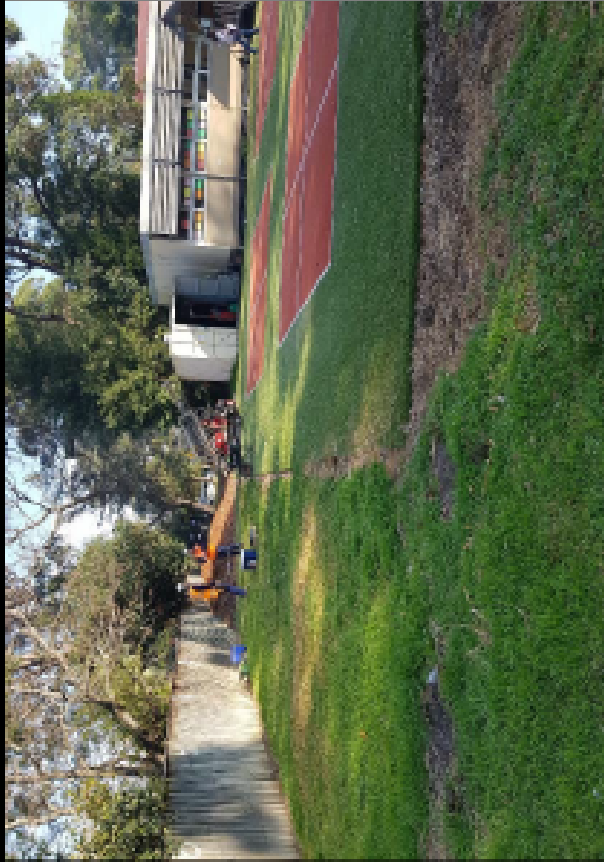
PHOTOGRAPH 2: LOCATION OF BH02 IN THE SOUTH EASTERN CORNER OF THE SITE, FACING WEST. PICTURED IS AN EXAMPLE OF GRASSED AND ARTIFICIAL TURF SURFACES

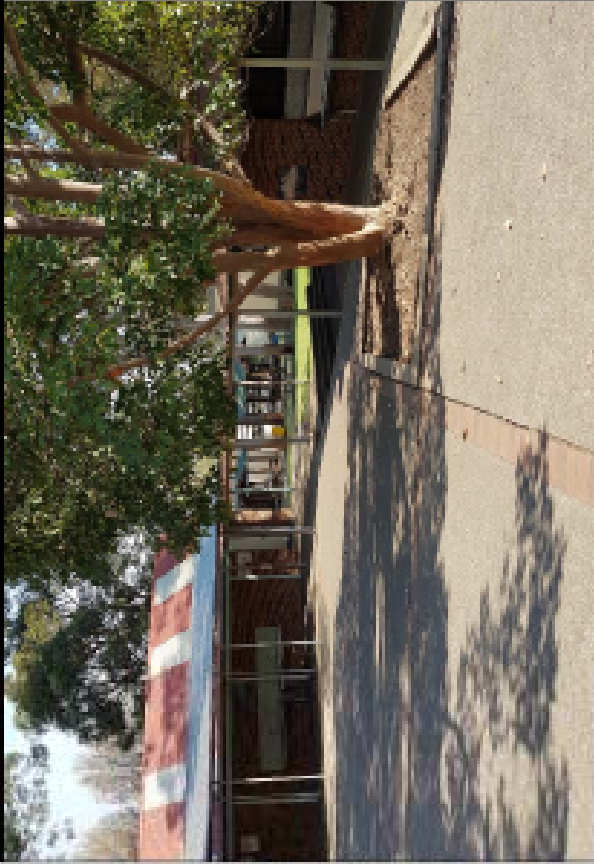
PHOTOGRAPH 4: LOCATION OF BH08 IN THE CENTRAL WESTERN PORTION OF THE SITE, FACING SOUTH WEST. PICTURED IS AN EXAMPLE OF SEALED CONCRETE AND EXPOSED SOIL SURFACES

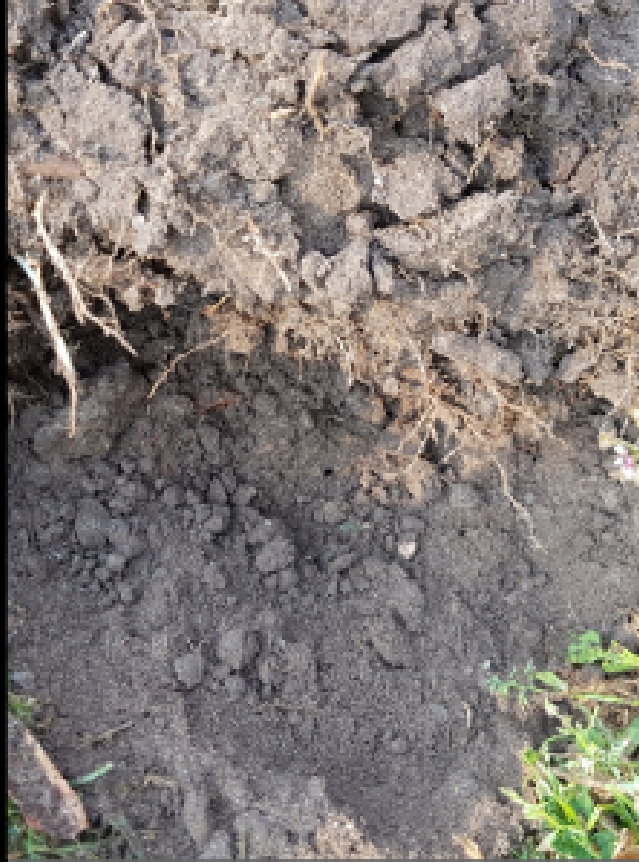
PHOTOGRAPH 6: TYPICAL FILL MATERIAL ENCOUNTERED AT THE SITE DURING INTRUSIVE SAMPLING

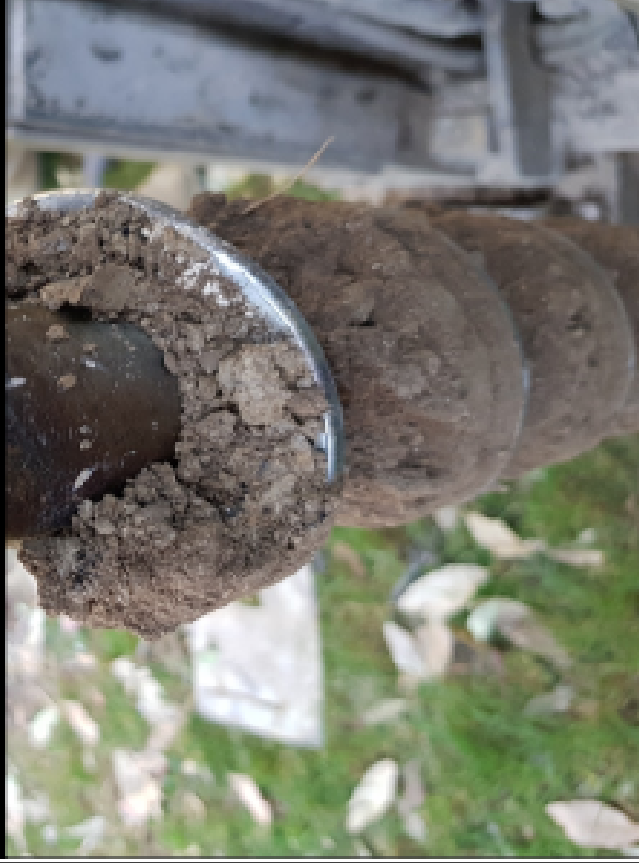
PHOTOGRAPH 6: TYPICAL FILL MATERIAL ENCOUNTERED AT THE SITE DURING INTRUSIVE SAMPLING

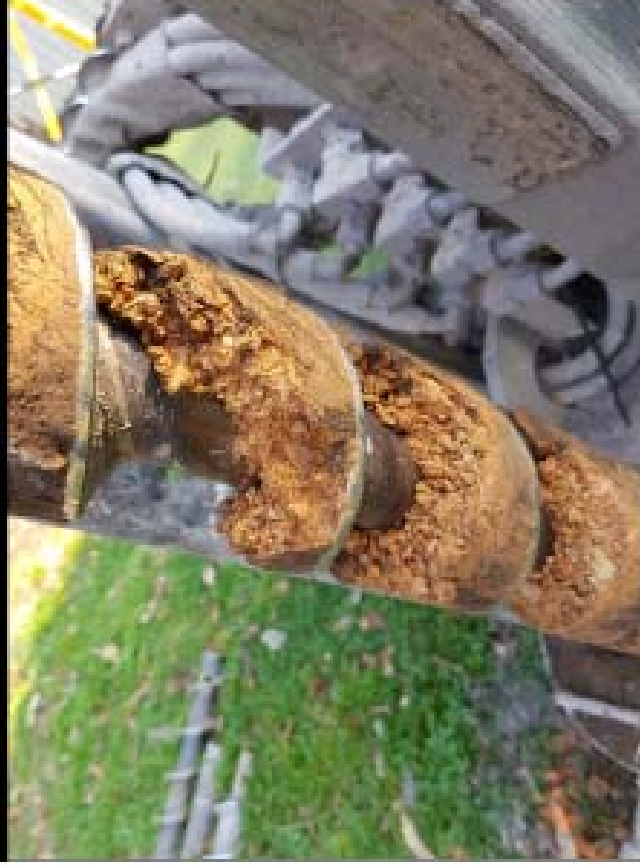
PHOTOGRAPH 7: TYPICAL NATURAL MATERIAL ENCOUNTERED DURING INTRUSIVE SAMPLING

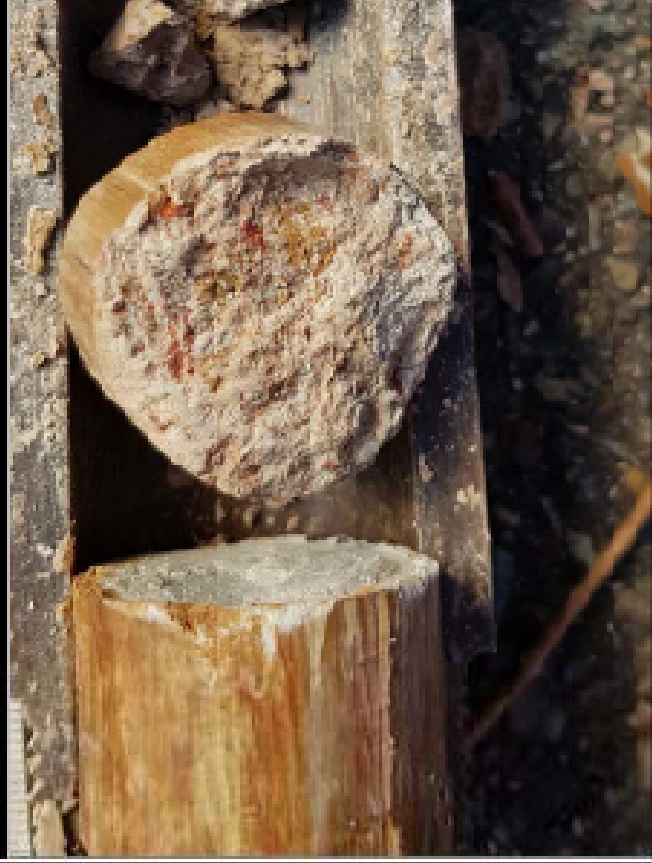
PHOTOGRAPH 8: TYPICAL NATURAL MATERIAL ENCOUNTERED DURING INTRUSIVE SAMPLING

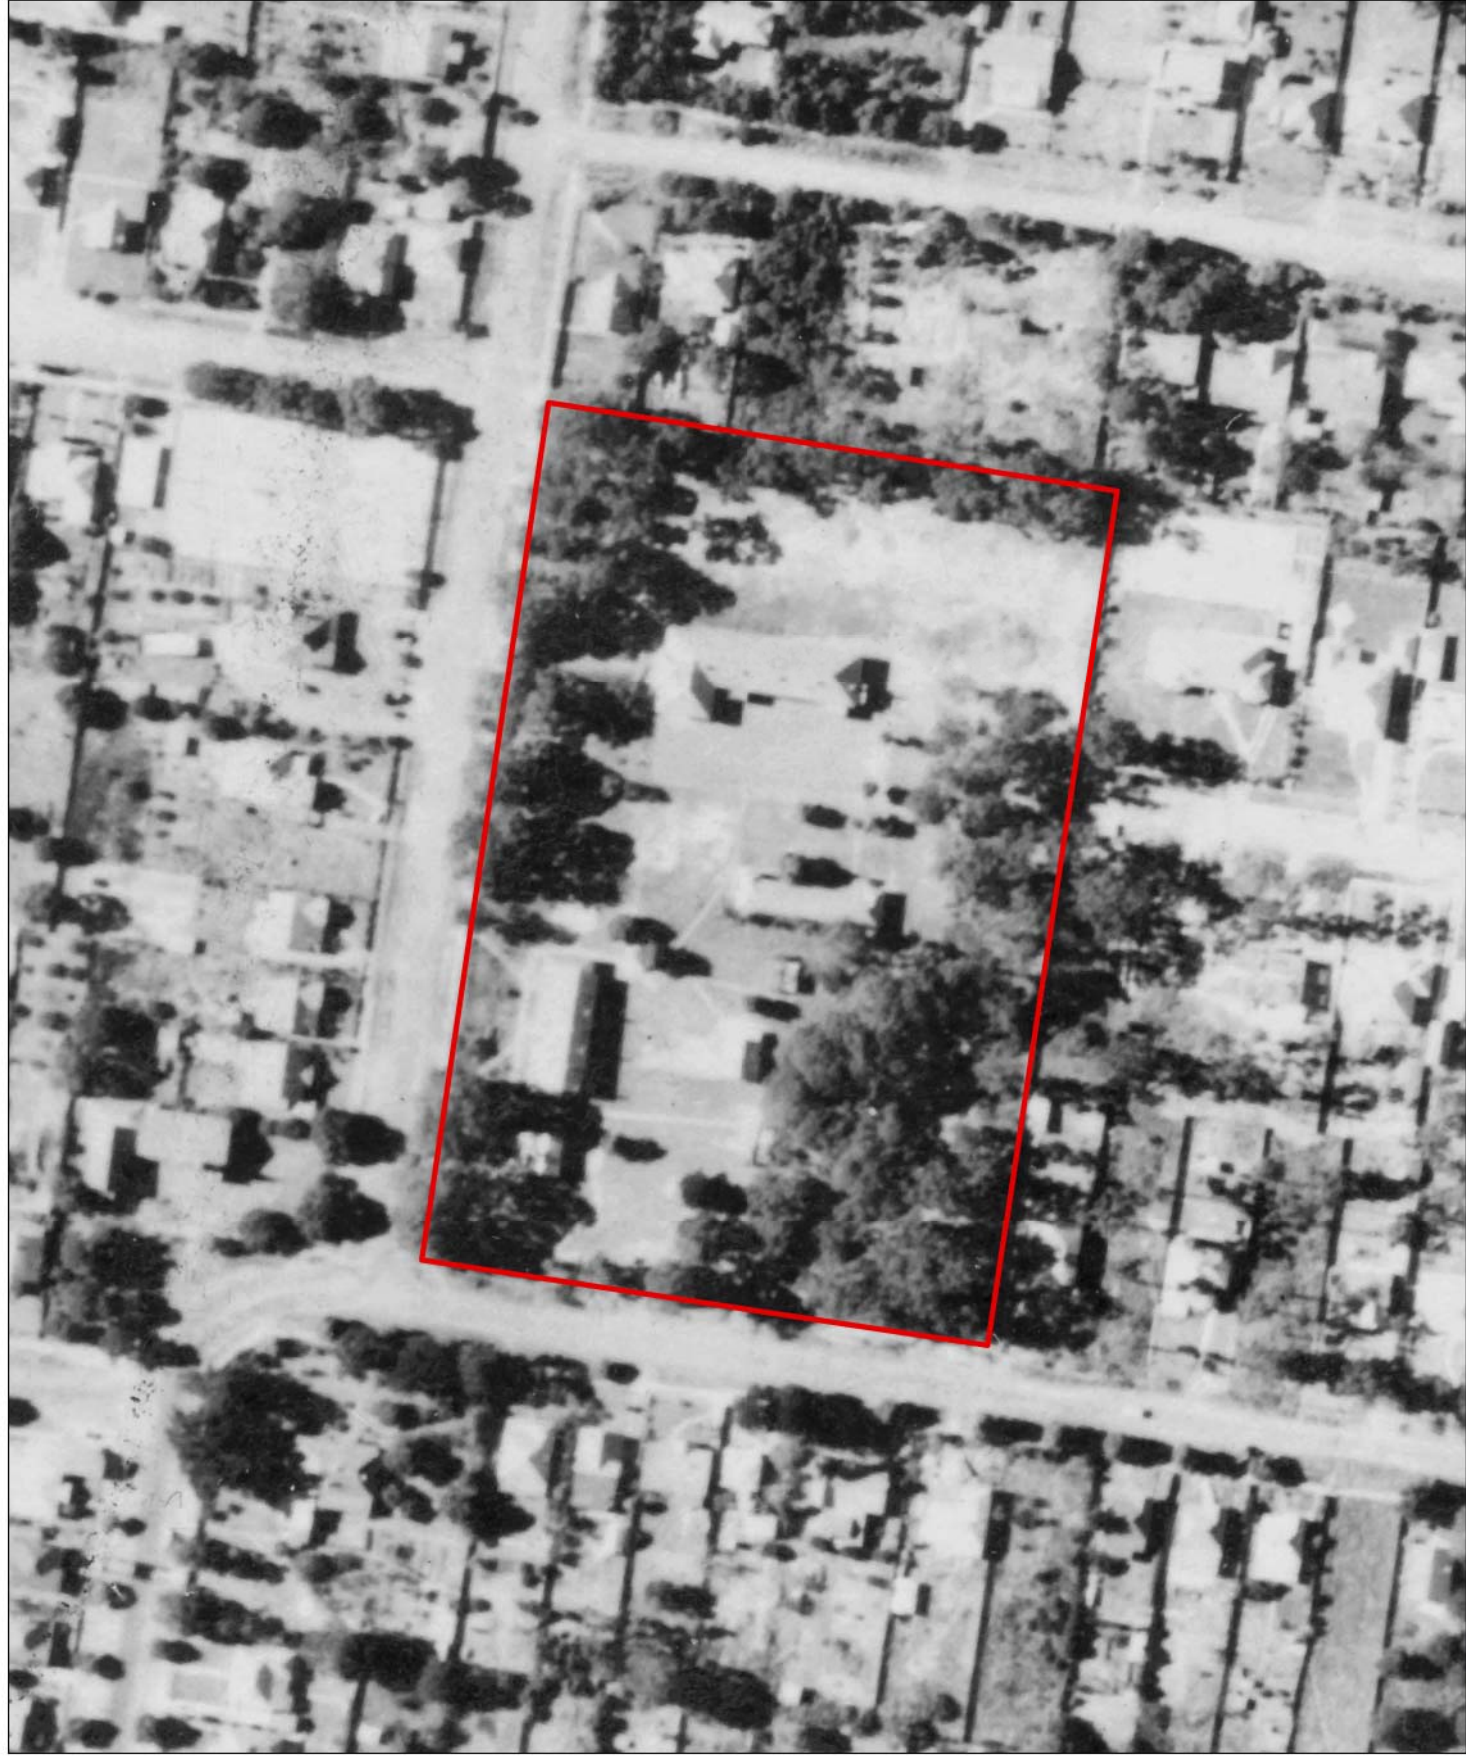
FIGURE 1951

HISTORICAL AERIAL  
PHOTOGRAPH 1951

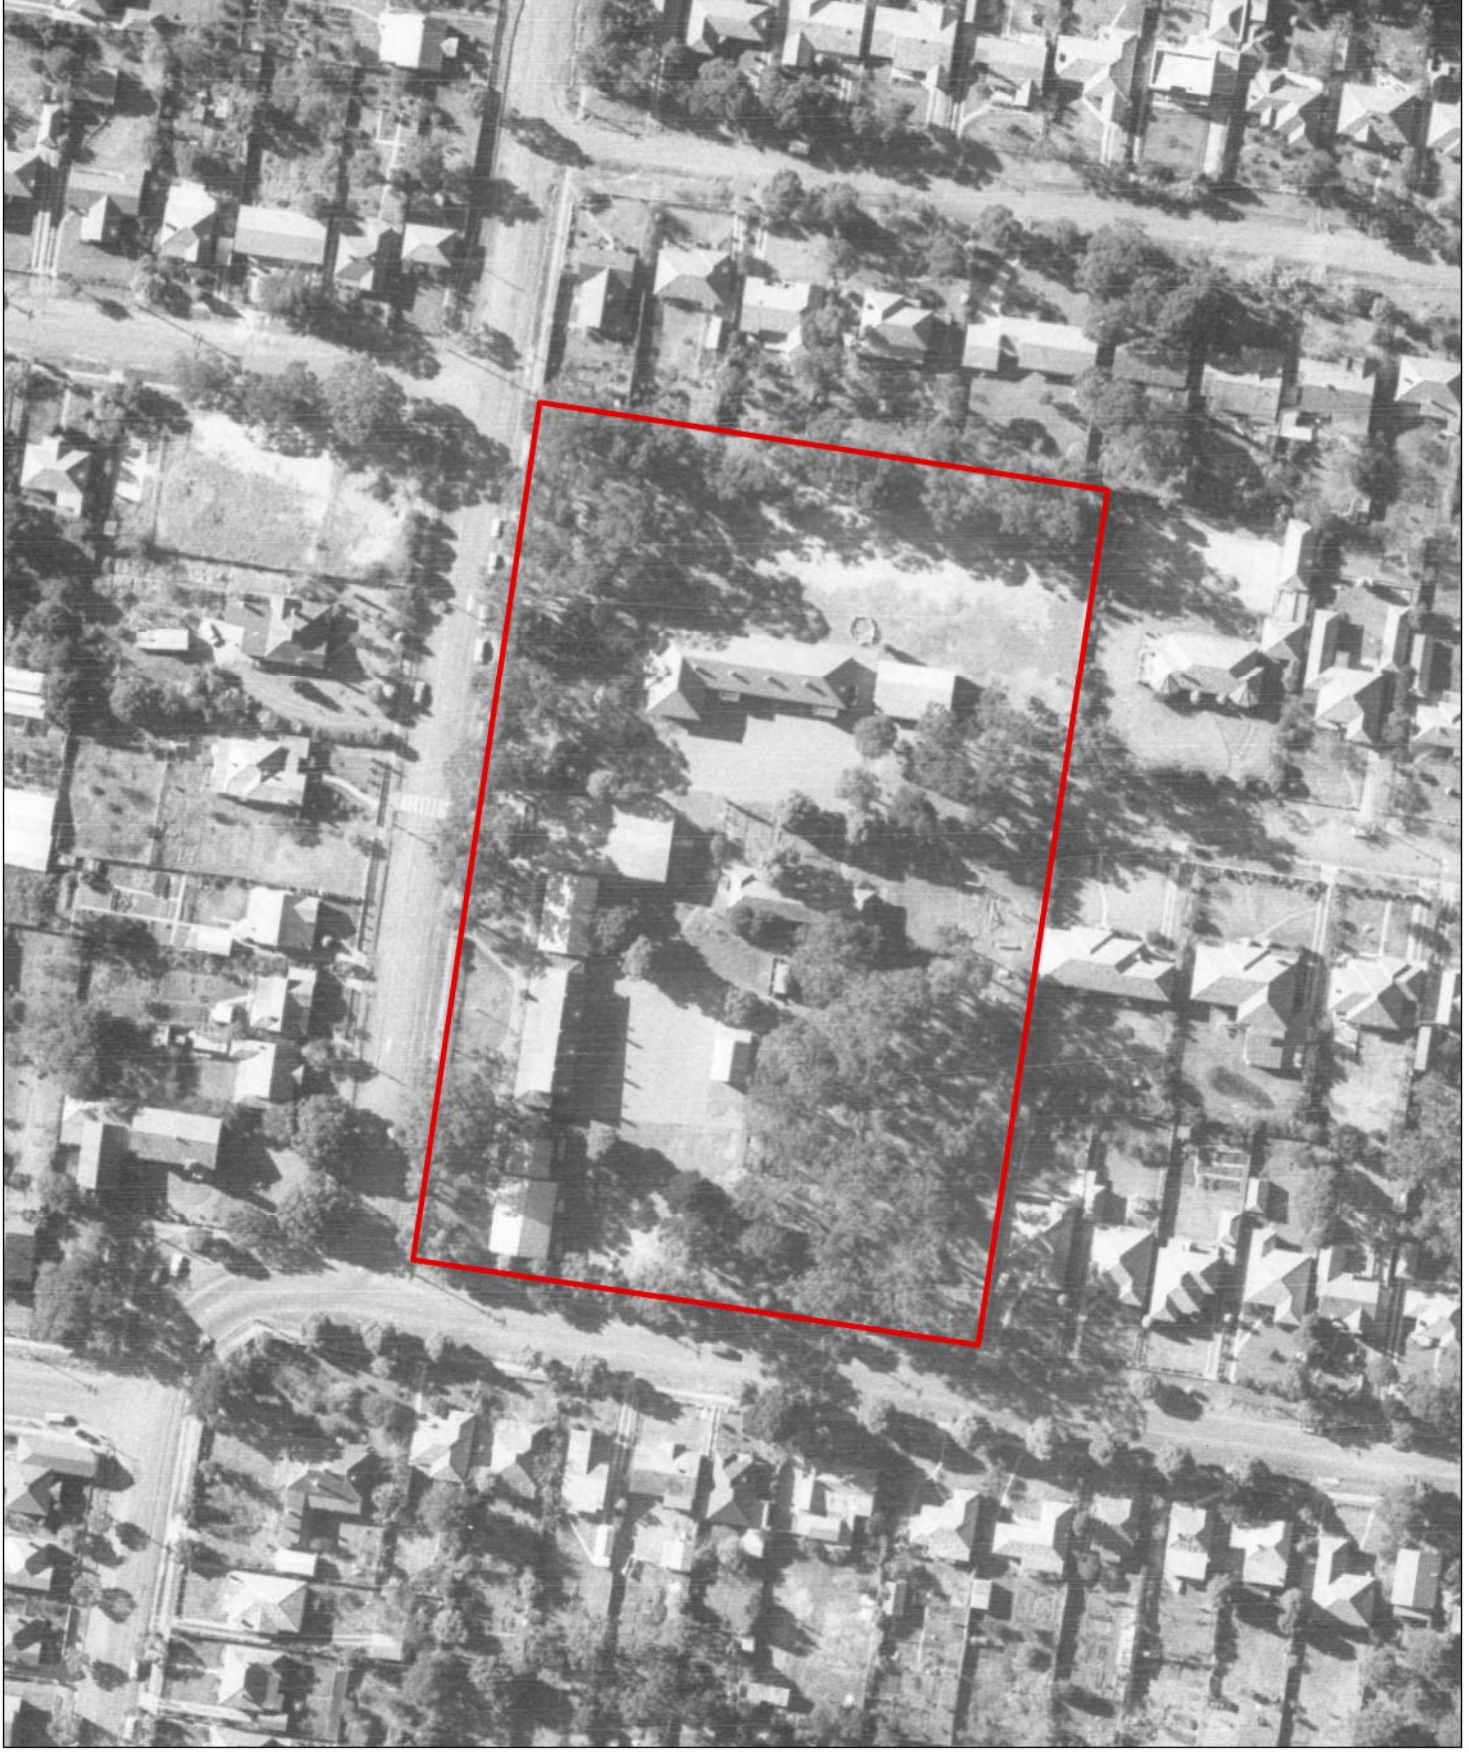
FIGURE 1961

**1961** – Additional buildings (likely classrooms) had been constructed in the north western, northern and south eastern portions of the site. No other significant changes were observed to site. The surrounding land remained for residential use with the bushland to the south completely cleared and residential dwellings constructed.

HISTORICAL AERIAL  
PHOTOGRAPH 1961

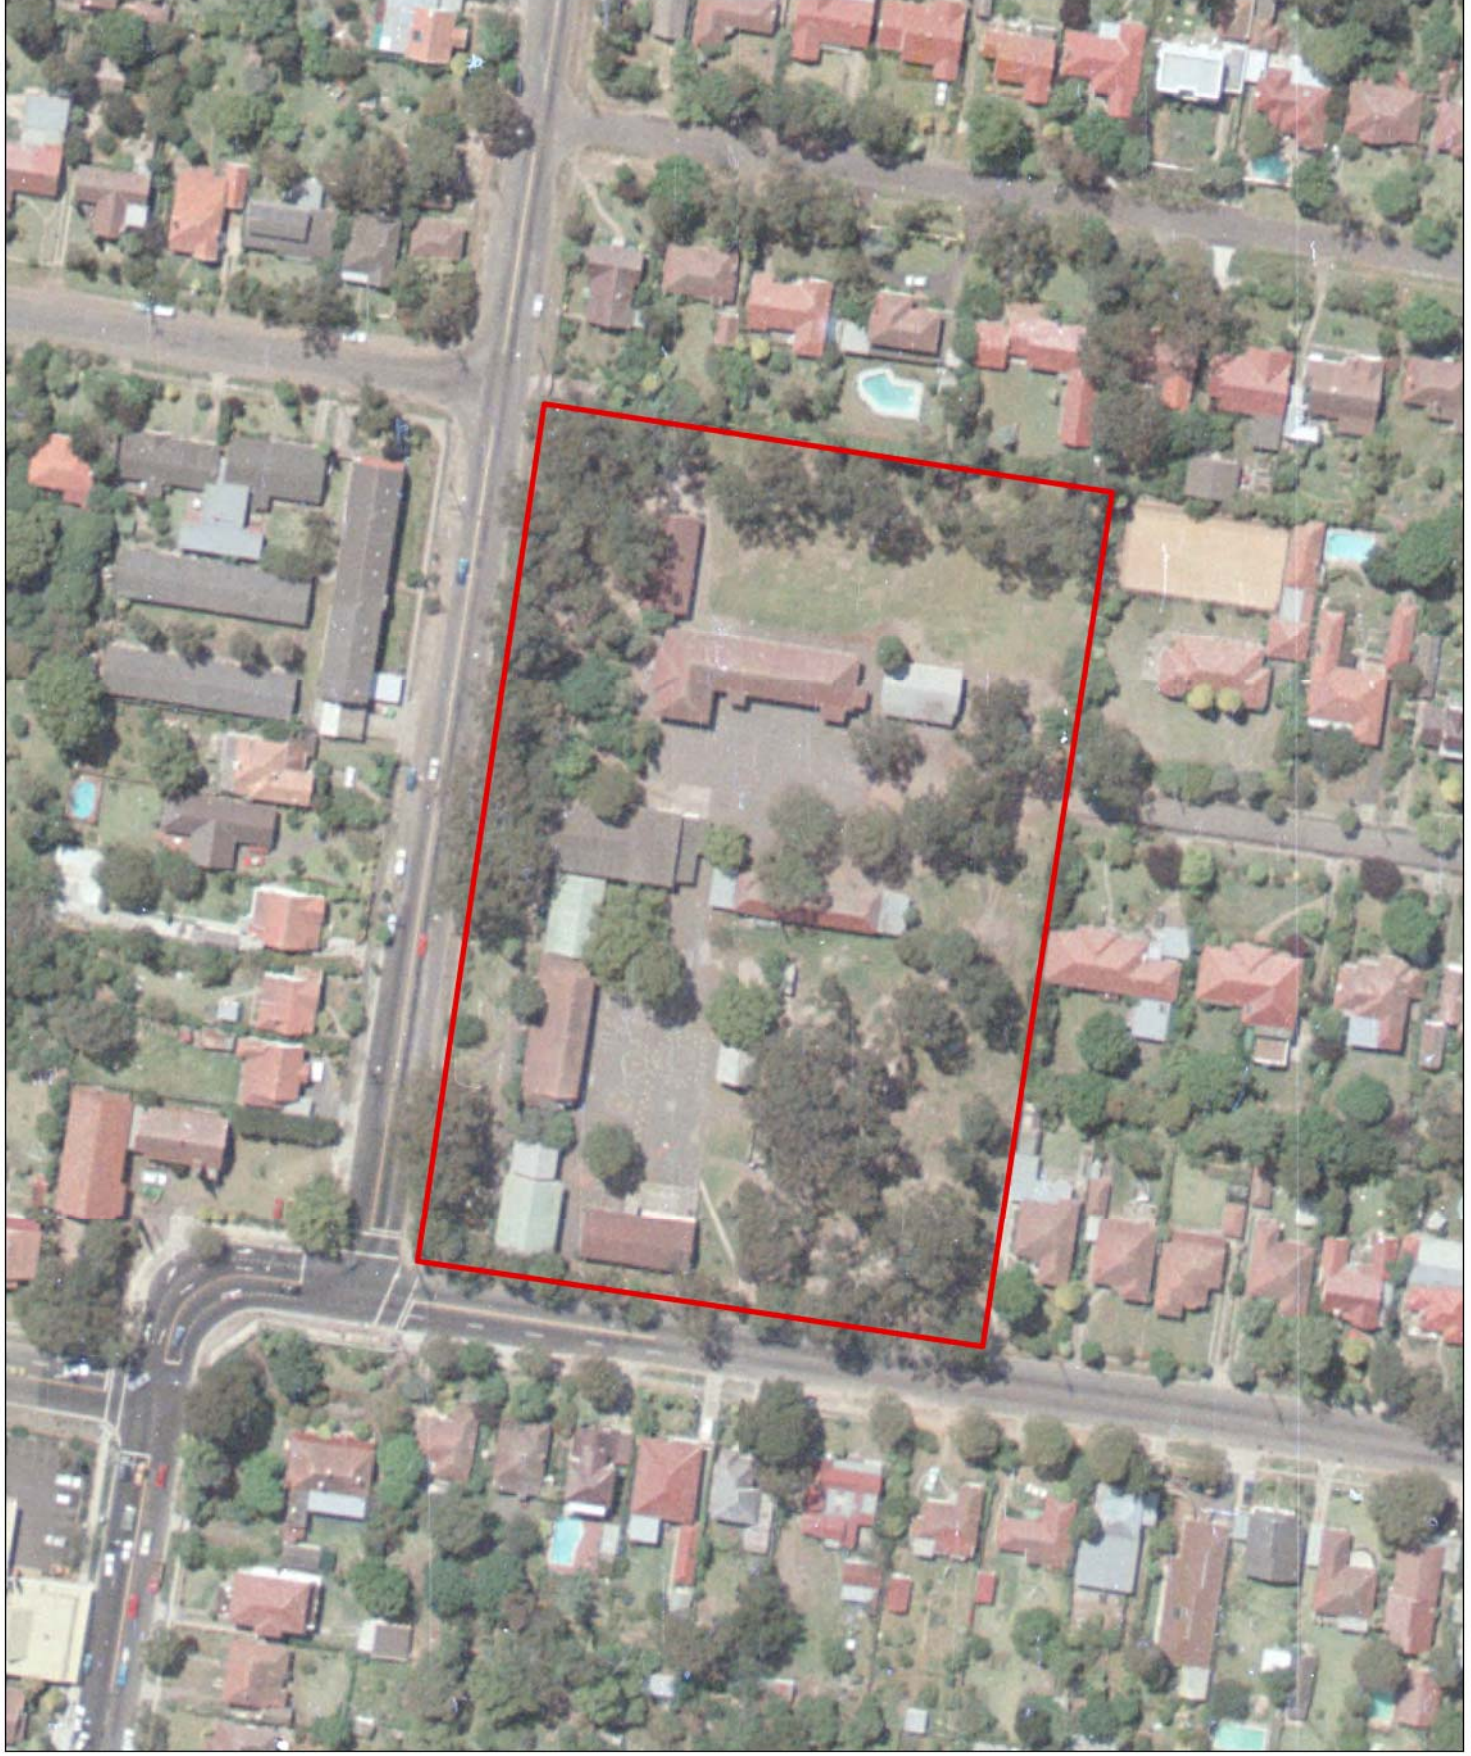
FIGURE 1982

**1982** – The site appeared generally unchanged from the previous 1970 aerial photograph. The site is sealed with asphalt in the north western and central portions of the site. Due to the quality of the previous aerial photographs, it is unknown if these areas were previously sealed. No changed to the surrounding land use was observed.

HISTORICAL AERIAL  
PHOTOGRAPH 1982

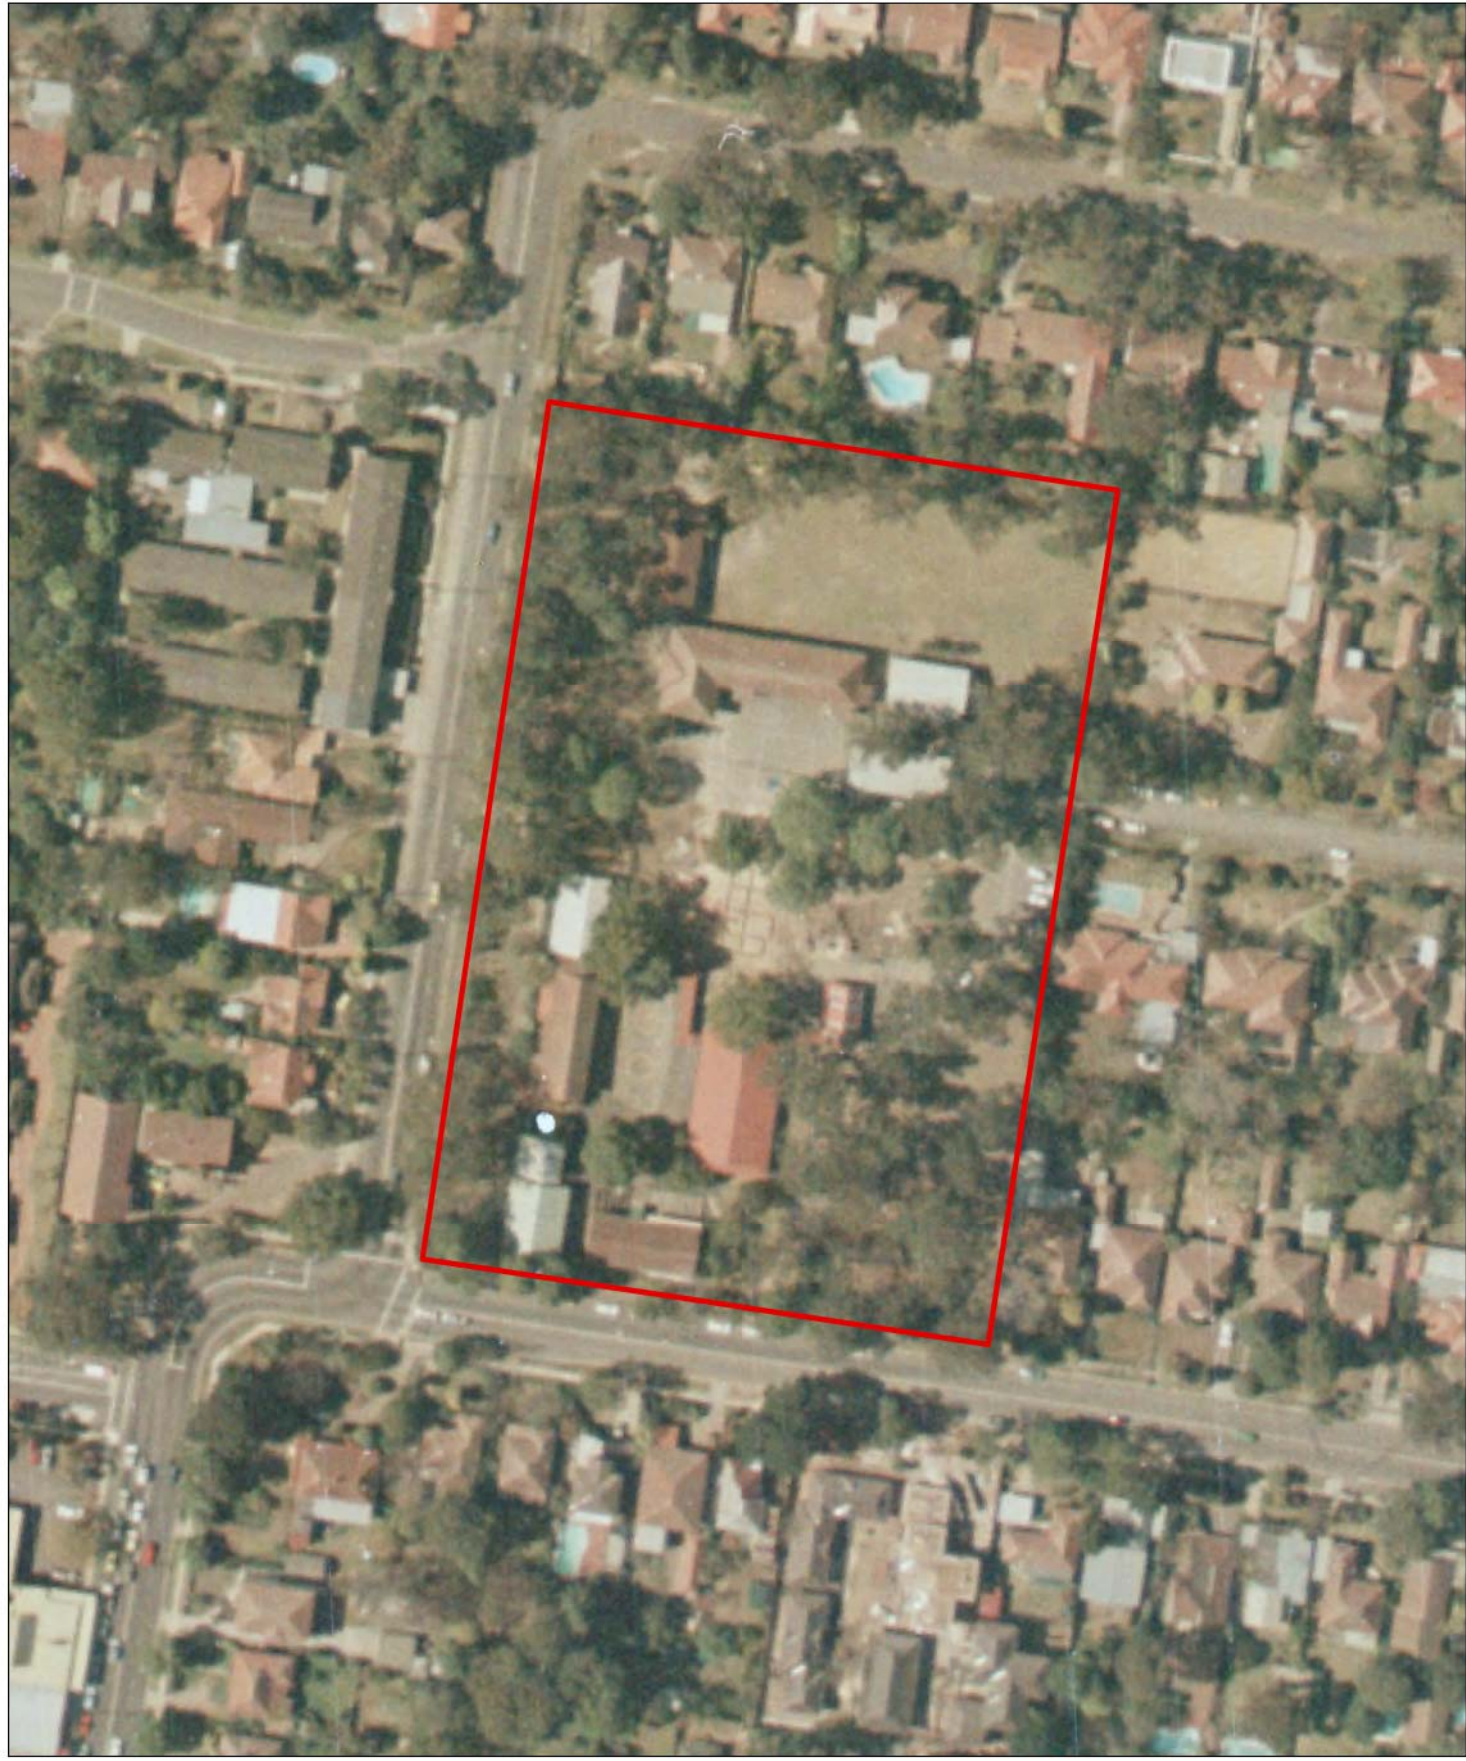
FIGURE 1991

**1991** – Three of the classroom buildings in the central portion of the site had been demolished and the area remained sealed. An additional large building (classroom) had been constructed in the western portion of the site. No other changes to the site were noted. The surrounding land use remained unchanged from the previous 1982 aerial photograph.

HISTORICAL AERIAL  
PHOTOGRAPH 1991

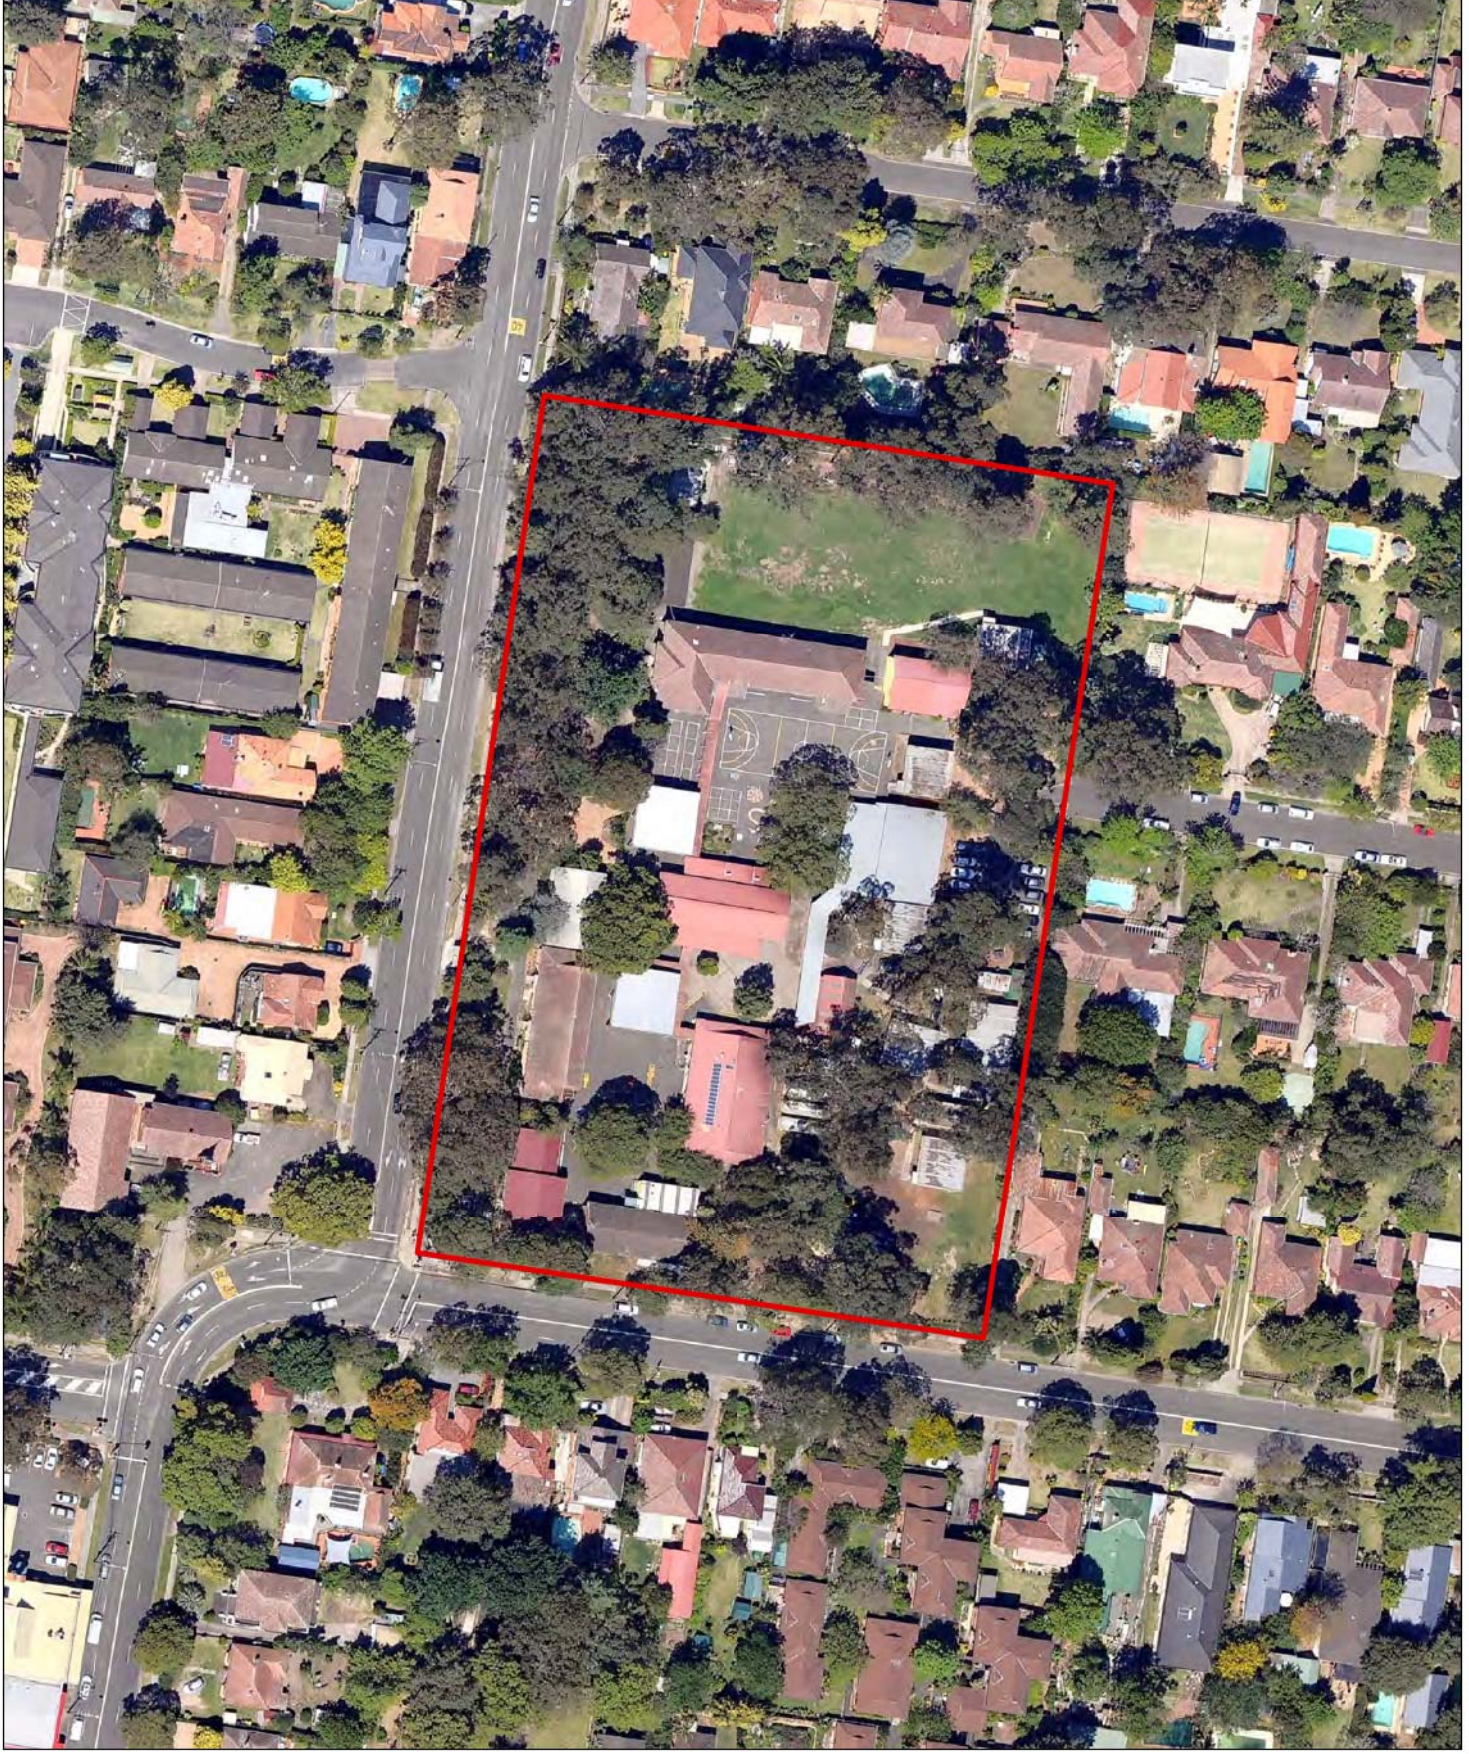
FIGURE 2009

**2009** – No significant changes were observed at the site or surrounding land from the previous 2003 aerial photograph.

HISTORICAL AERIAL  
PHOTOGRAPH 2009
