# STATEMENT OF HERITAGE IMPACT

**Proposed development at  
WAITARA PUBLIC SCHOOL,  
68 Edgeworth David Avenue  
WAHROONGA**

Job No. 2823  
December 2017

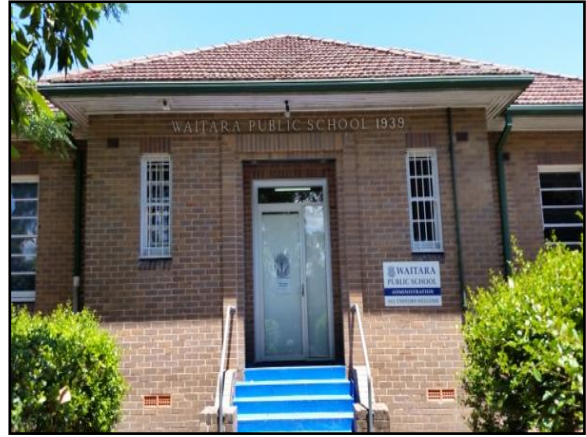
**Figure 18.** View to the northern elevation of Building A, facing south. (Source: Heritage 21, 17.01.17)

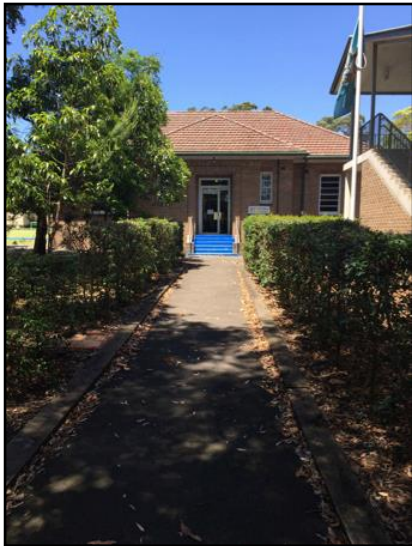
**Figure 19.** View from the northern boundary to the northern elevation of Building A, facing south. (Source: Heritage 21, 17.01.17)

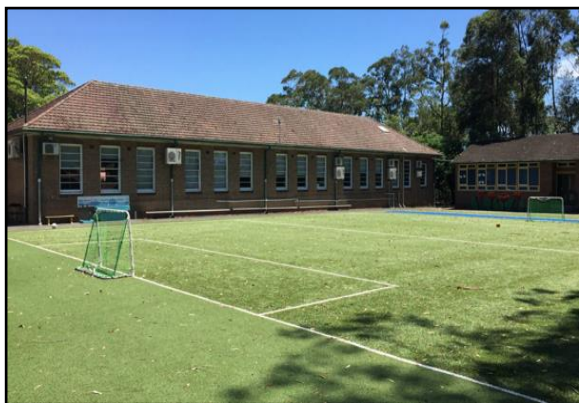
**Figure 20.** View to the eastern elevation of Building A, facing north-west. (Source: Heritage 21, 17.01.17)

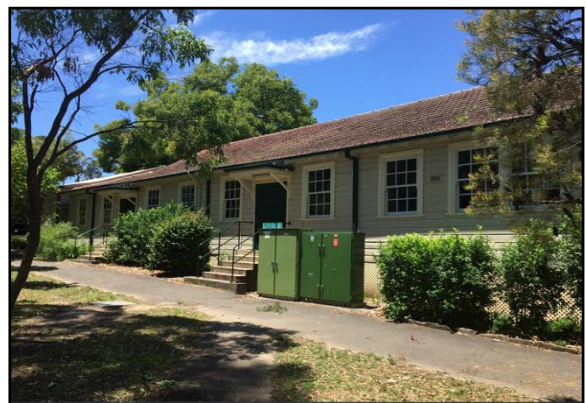
**Figure 21.** View to the northern elevation of Building J, facing north-east. (Source: Heritage 21, 17.01.17)

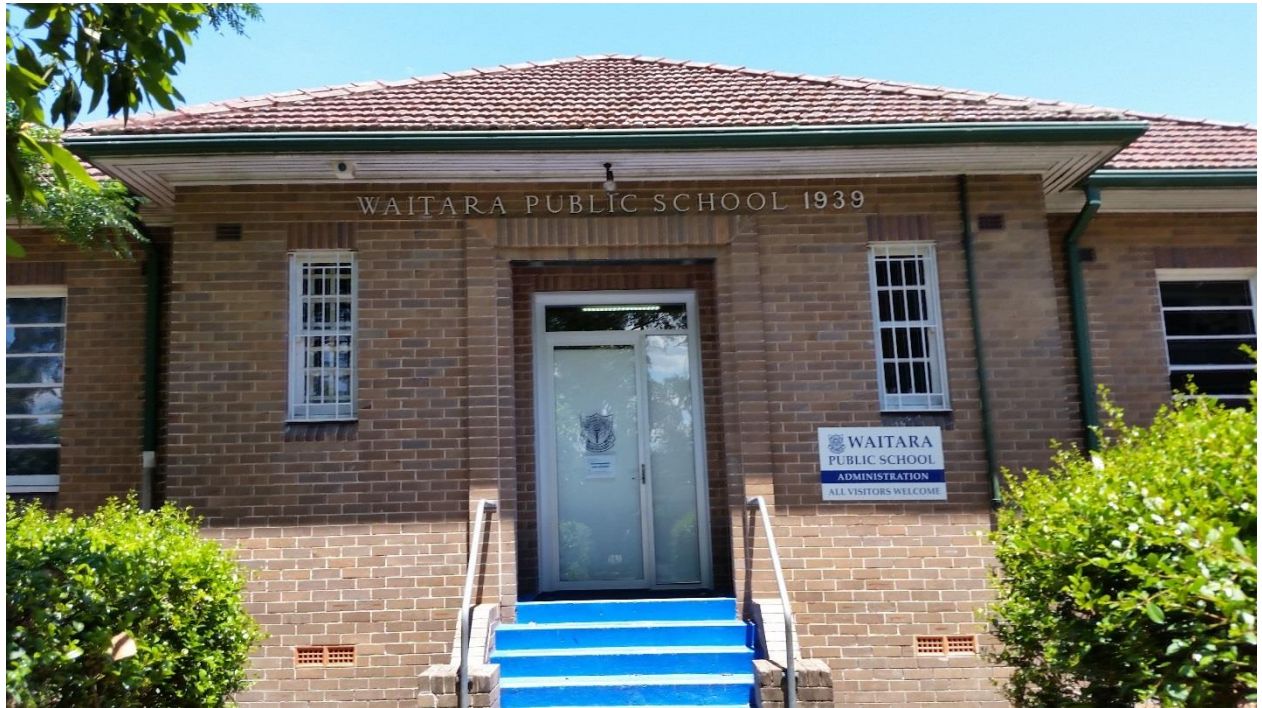
| Image caption | North elevation, previous primary schoolhouse (Building A), constructed in 1939 | | | | |

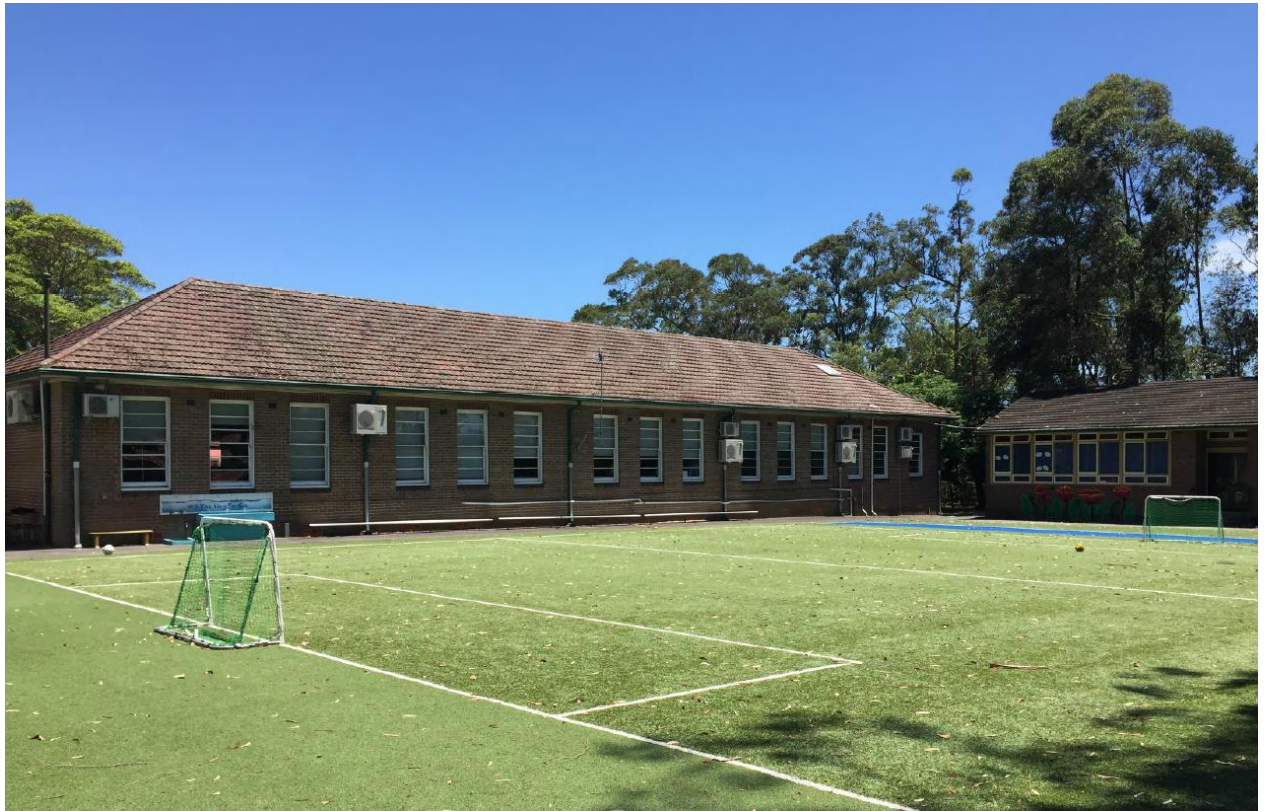
| <b>Image caption</b> | East elevation, primary schoolhouse (Building A), constructed in 1939 | | | | |

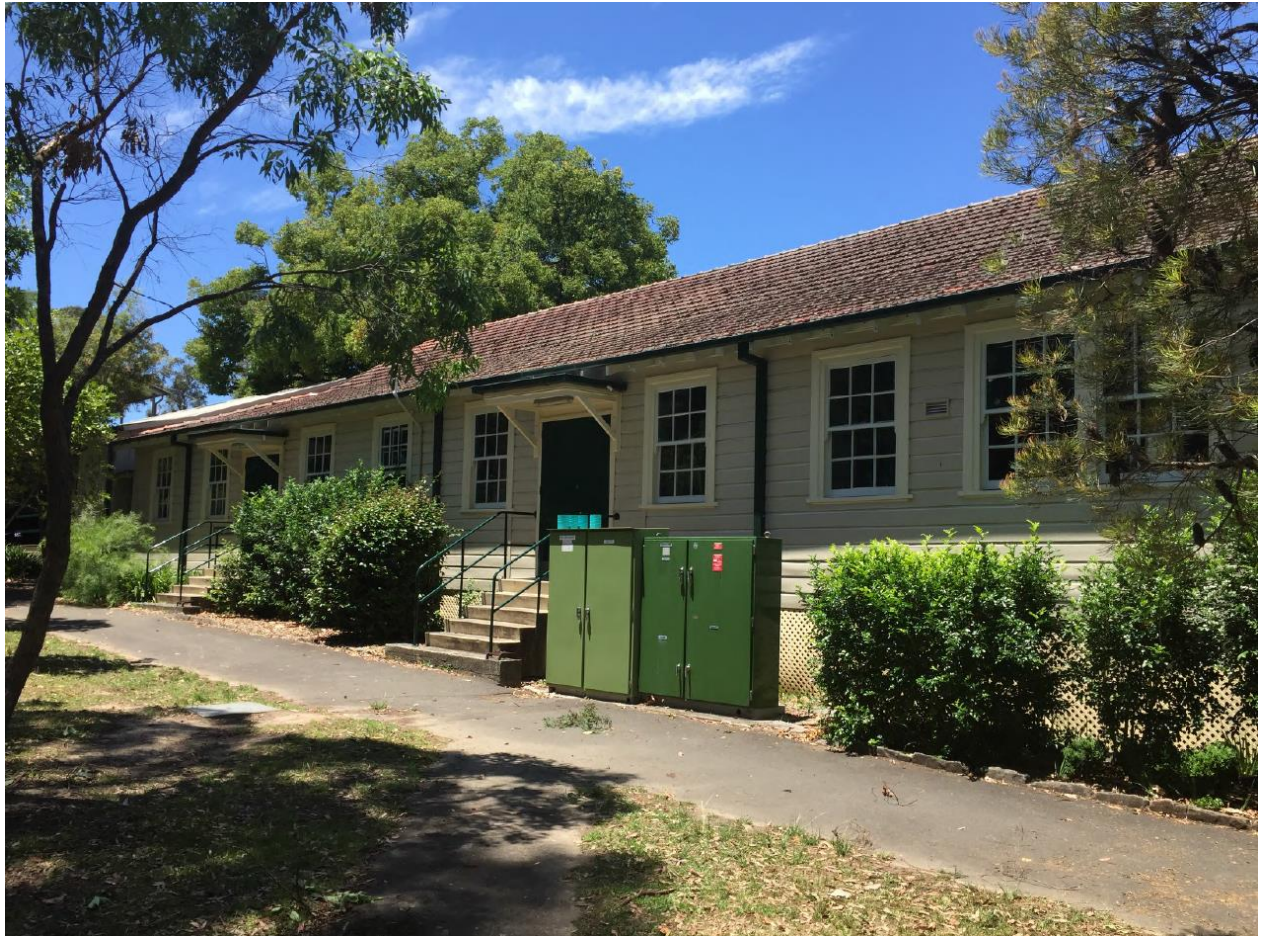
| <b>Image caption</b> | Northern elevation of previous infants' schoolhouse (Building J), constructed in 1927 | | | | |
