**Report on Groundwater Inflow
Assessment**

Proposed Residential Building

601 Pacific Highway, St Leonards NSW

Project 86230.01

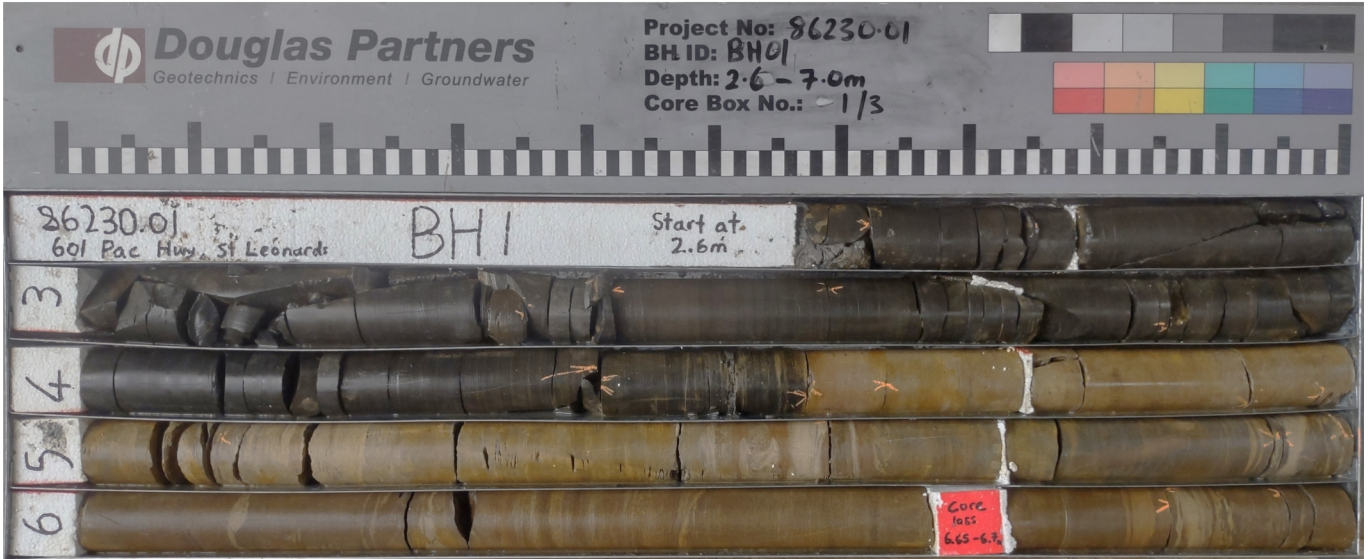
LOCATION ID: BH01
PROJECT No: 86230.01
DATE: 25/03/25
SHEET: 1 of 2

- Concrete slab at all borehole locations, measured to be between 130 mm and 180 mm thick. At BH01, the concrete slab comprised two slabs of 90 mm and 130 mm, with bedding sand separating the two. Reinforcement of 8 mm diameter was noted within the concrete slabs.

- Typically sandy clay and clayey sand with various proportions of igneous gravel within the shallow depths of the boreholes, with variable thickness in a range of 0.4 m to 2.4 m. The fill layer was observed to reduce in thickness in boreholes which were located in the deeper basement levels, with the thickest layer observed in BH01, and the thinnest in BH06.

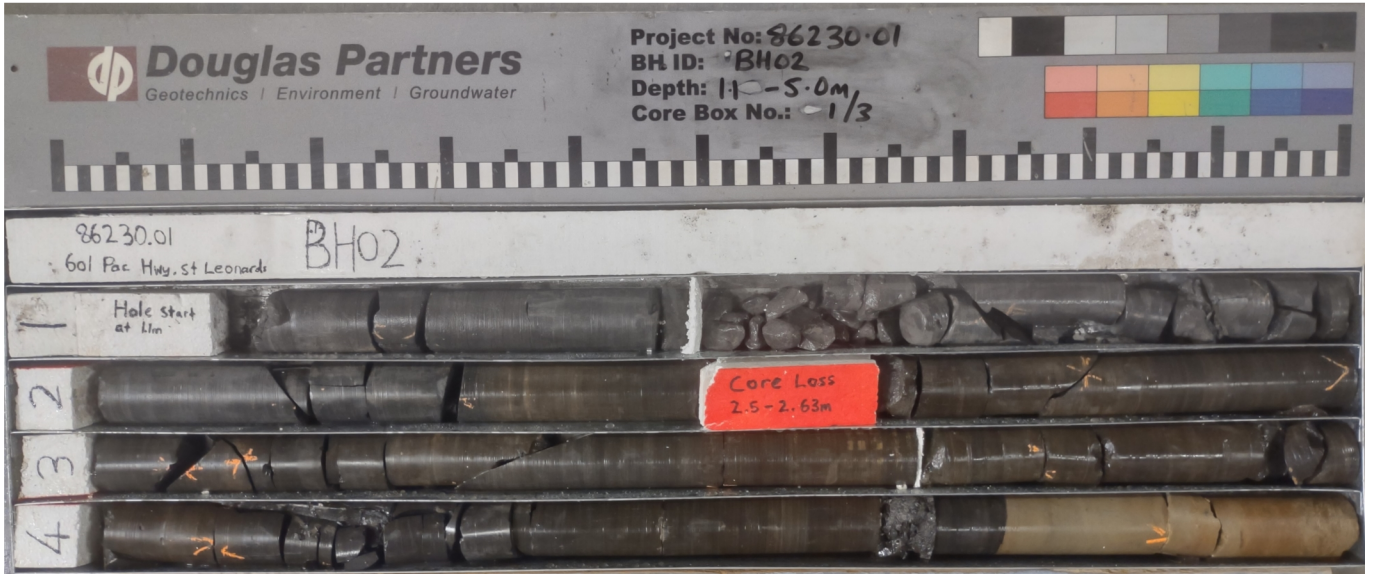
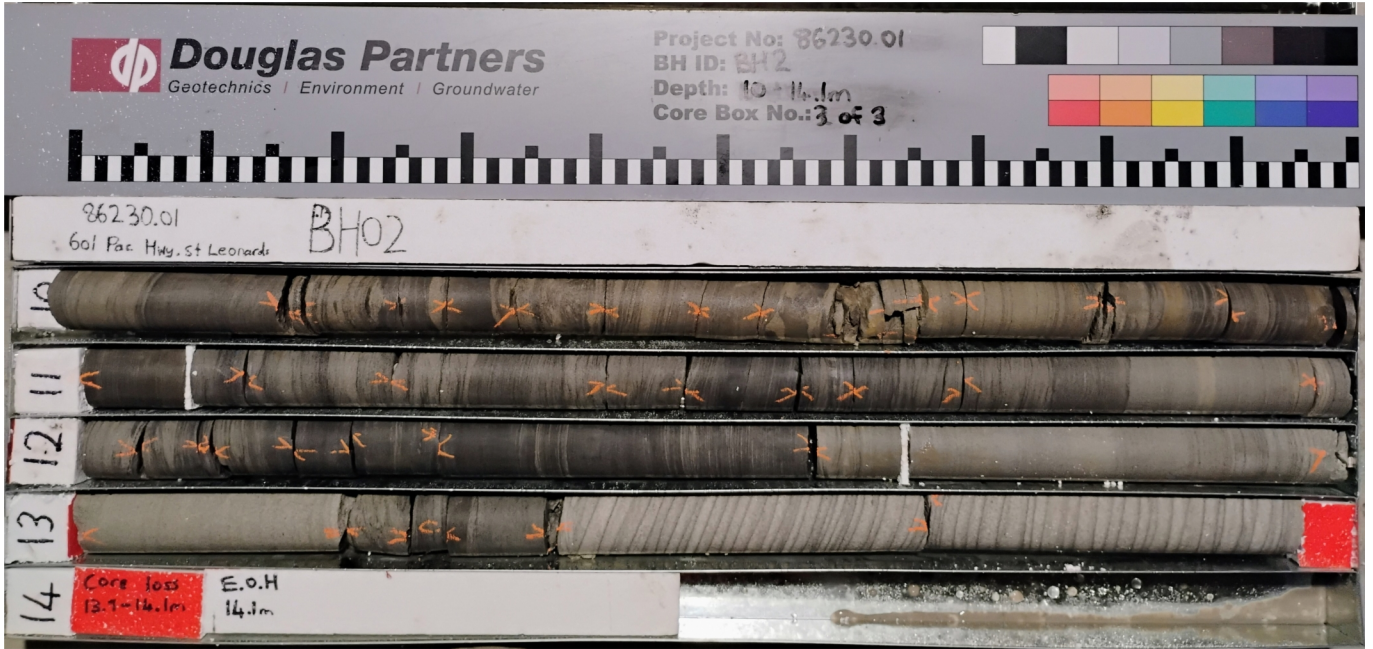
LOCATION ID: BH02
PROJECT No: 86230.01
DATE: 28/03/25
SHEET: 1 of 2

slightly fractured. Frequent joints dipping 30° to 70° were observed within the shale bedrock. Sub-horizontal crushed zones with clay infill were also noted within BH02 between 3.9 m and 4.7 m depth. Very low strength bands accompanied with crushed zones and joints dipping 35° to 60° were noted in BH05 between 2.7 m and 5.3 m depth in BH05.

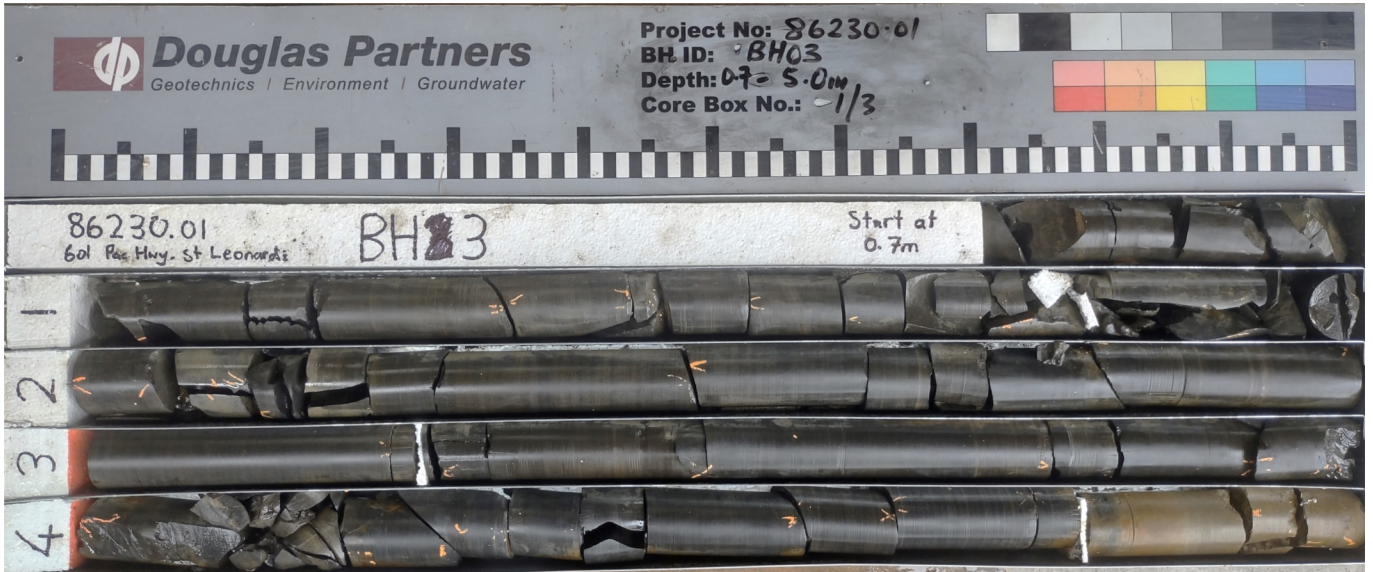
LOCATION ID: BH03
PROJECT No: 86230.01
DATE: 01/04/25
SHEET: 1 of 2

- Typically medium and medium to high strength, fresh to slightly weathered, pale grey and grey fine to medium grained sandstone and laminite (Mittagong Formation), and pale grey medium to coarse grained sandstone (Hawkesbury Sandstone) to depths of about 10.4 m and 17.0 m. Zones of very low and low strength rock were noted within the laminite bedrock at BH01 at depths of 5.0 m, 7.5 m, and 8.5 m. The rock was typically slightly fractured to unbroken. Sub-vertical joints dipping 70° to 90° were observed within BH03 between 7.2 m and 9.5 m depth.

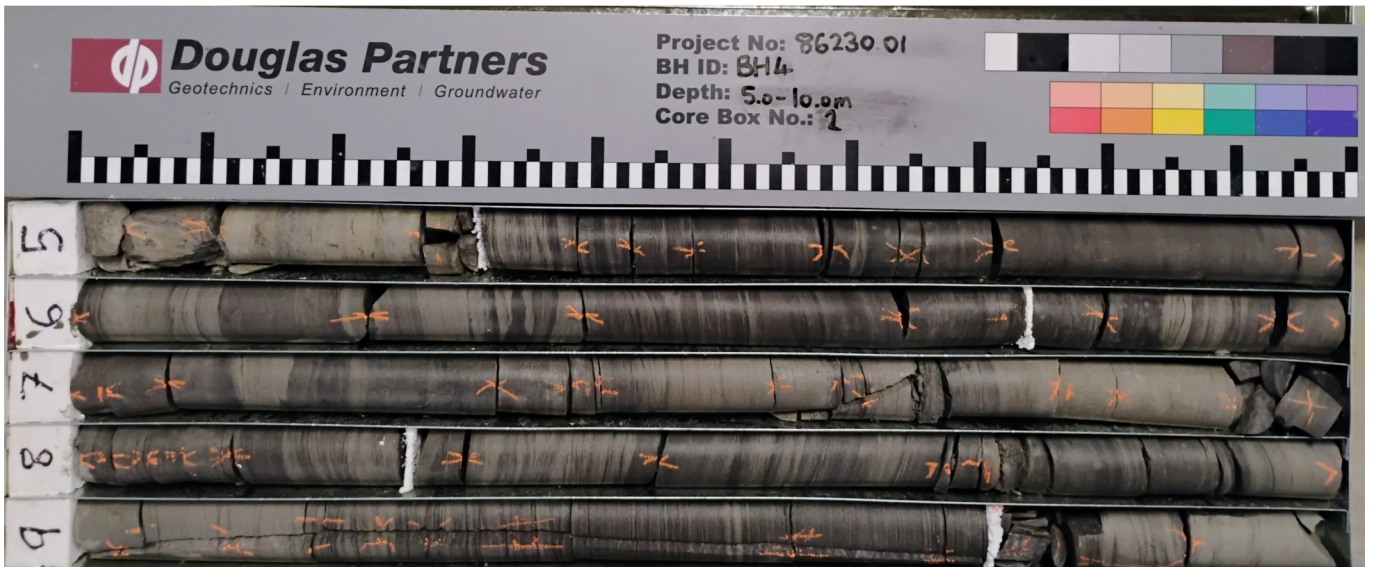
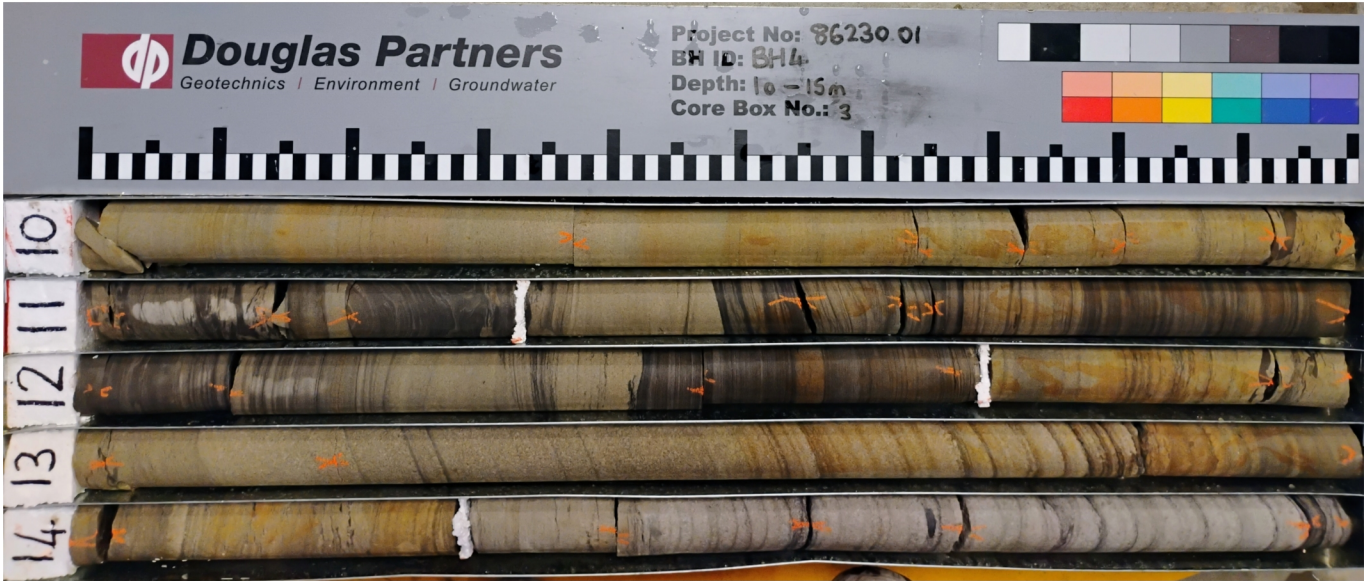
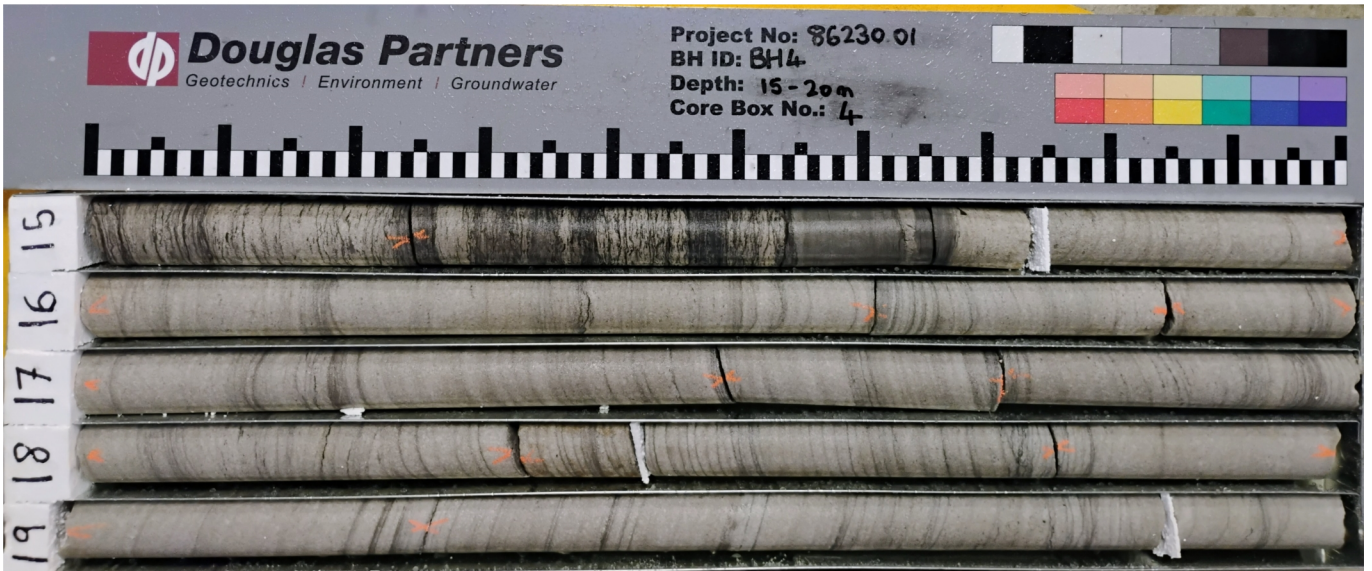
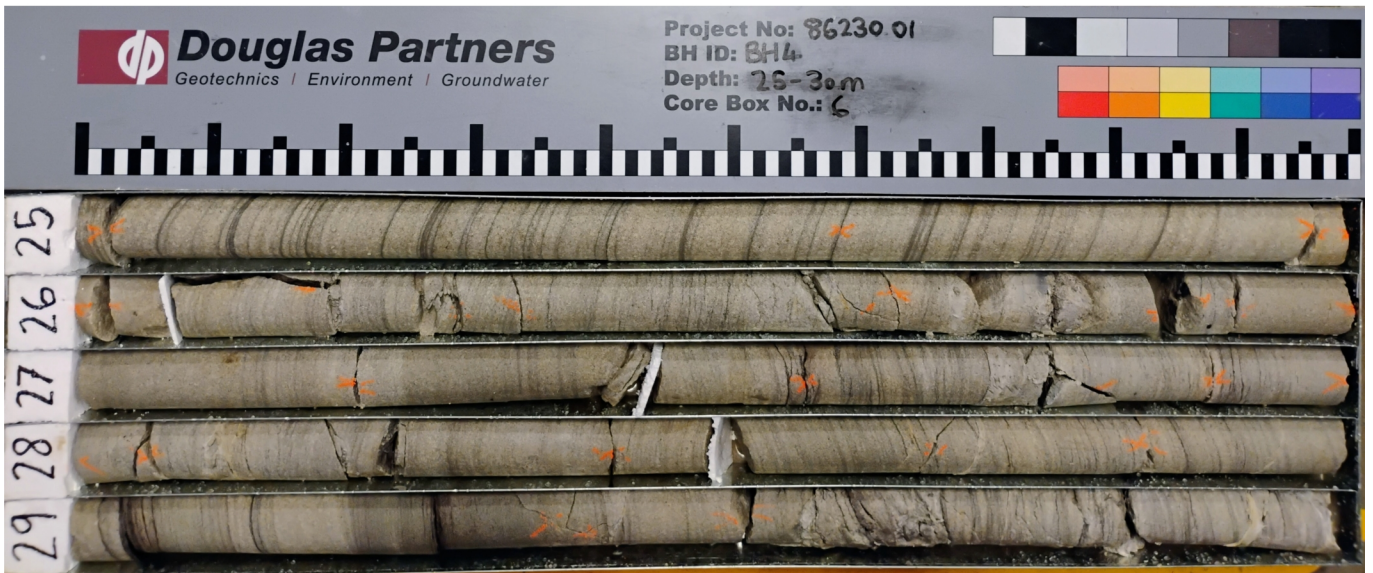
LOCATION ID: BH04
PROJECT No: 86230.01
DATE: 03/04/25 - 07/04/25
SHEET: 1 of 4

- Medium to high strength and high strength, fresh, pale grey to grey, fine to medium grained sandstone and laminite (Mittagong Formation), grading to fresh, high strength, medium to coarse grained sandstone (Hawkesbury Sandstone) to the termination depth of boreholes. A very high strength band was noted within BH01 between 14.3 m and 14.8 m depth. The high strength rock was typically unbroken. A low to medium strength, fractured zone was noted in BH04 between 26.2 m and 30.5 m depth.

- The low to medium strength rock and crushed zones with joints dipping 15° to 25°, observed in BH04 between 26.2 m and 30.5 m depth, were accompanied with significant loss of drilling fluid, indicating a possible presence of a thrust fault.

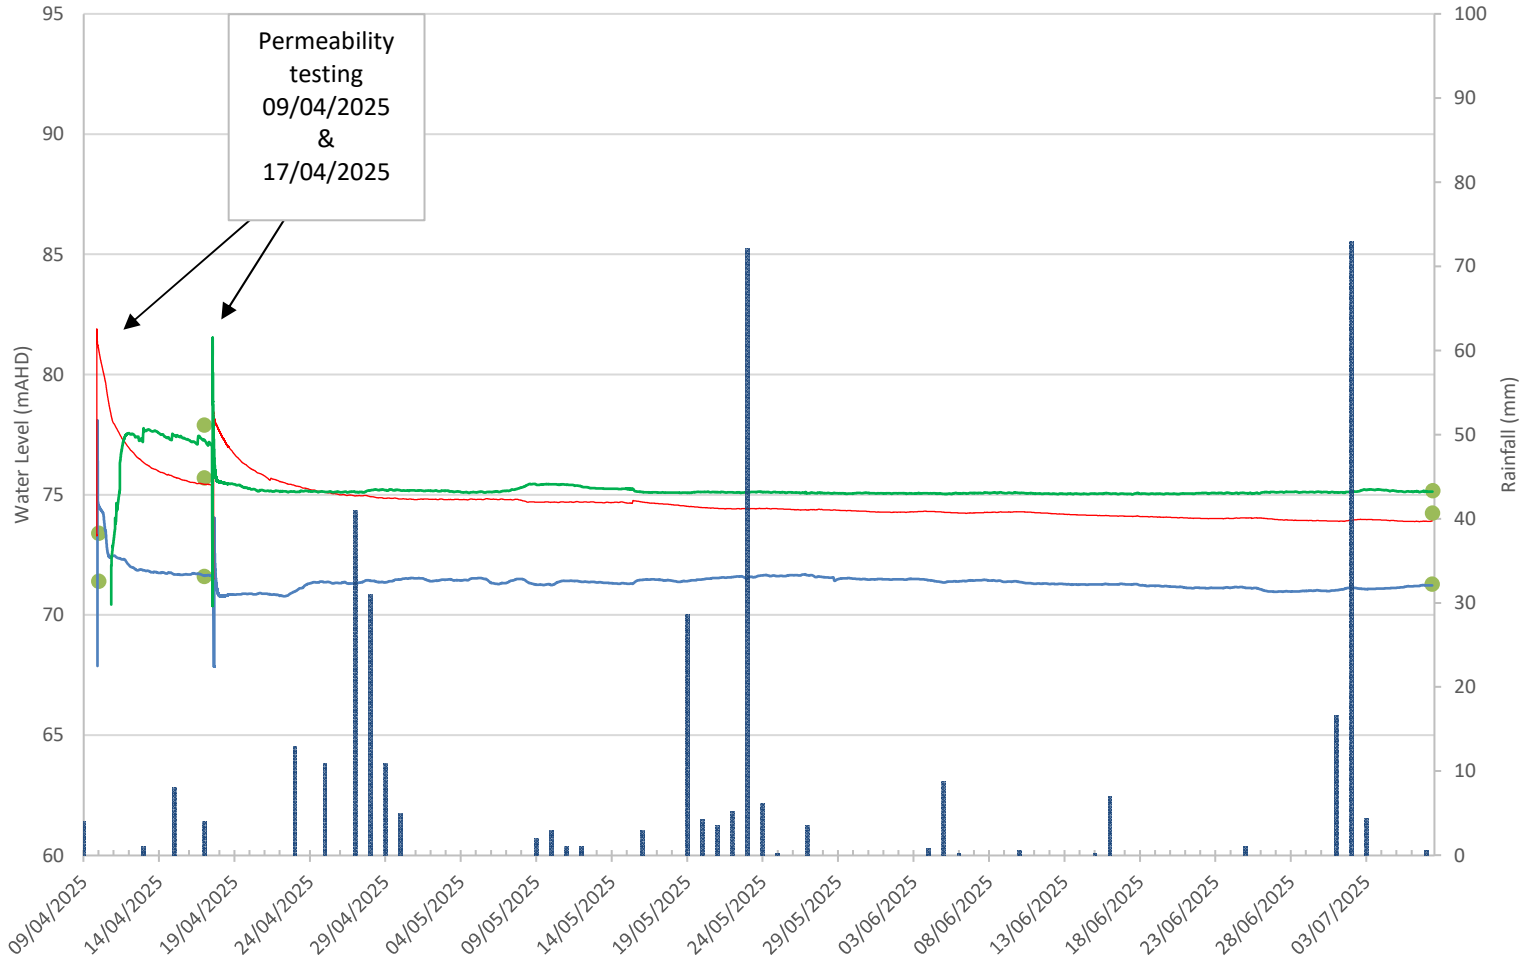
Groundwater Level Monitoring Summary

Permeability testing
09/04/2025
&
17/04/2025

Note: Reading Interval = 1 hour
