Report on Geotechnical Investigation

Proposed Residential Building

601 Pacific Highway, St Leonards NSW

Project 86230.01

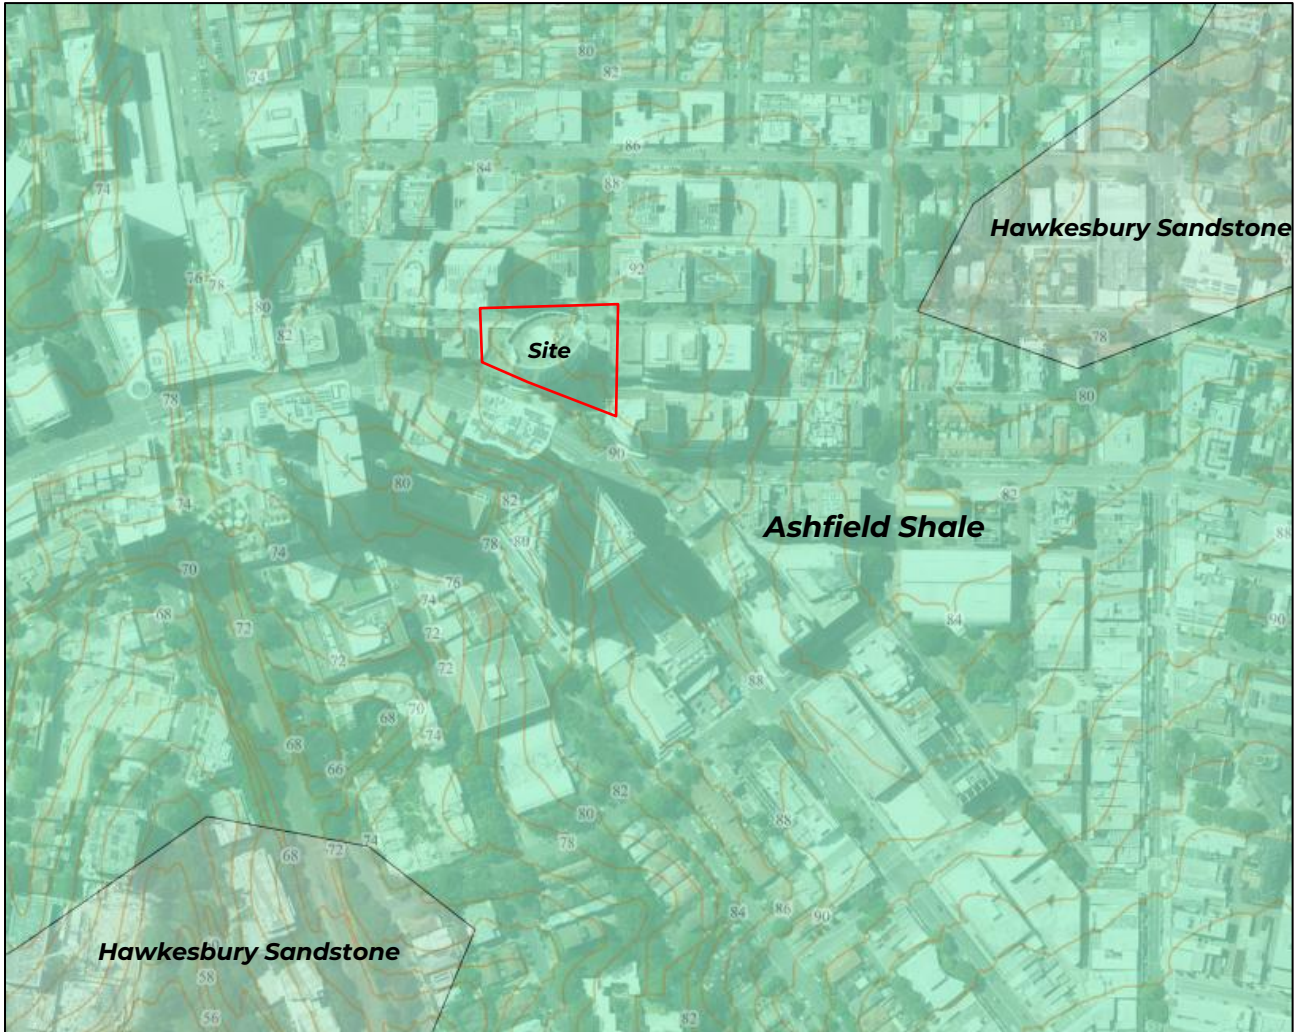
Figure 2 - Geological Map Extract

Reference to the Sydney 1:100 000 Seamless Geology Sheet indicates that the site is underlain by the Ashfield Shale of the Wianamatta Group, described as black to dark-grey shale and laminite. Below the Ashfield Shale is the Hawkesbury Sandstone which typically comprises medium to coarse grained quartz sandstone with some shale and laminite bands or lenses. The Mittagong Formation is a transitional unit often found between the Ashfield Shale and Hawkesbury Sandstone and typically includes laminite and fine-grained sandstone of variable strength, ranging in thickness from about 2 m to 10 m.

The Hawkesbury Sandstone normally has near-horizontal bedding partings spaced from less than 1 m to well over 3 m in places.

An extract from the geological map overlain by 2 m (AHD) contours is shown in Figure 2.

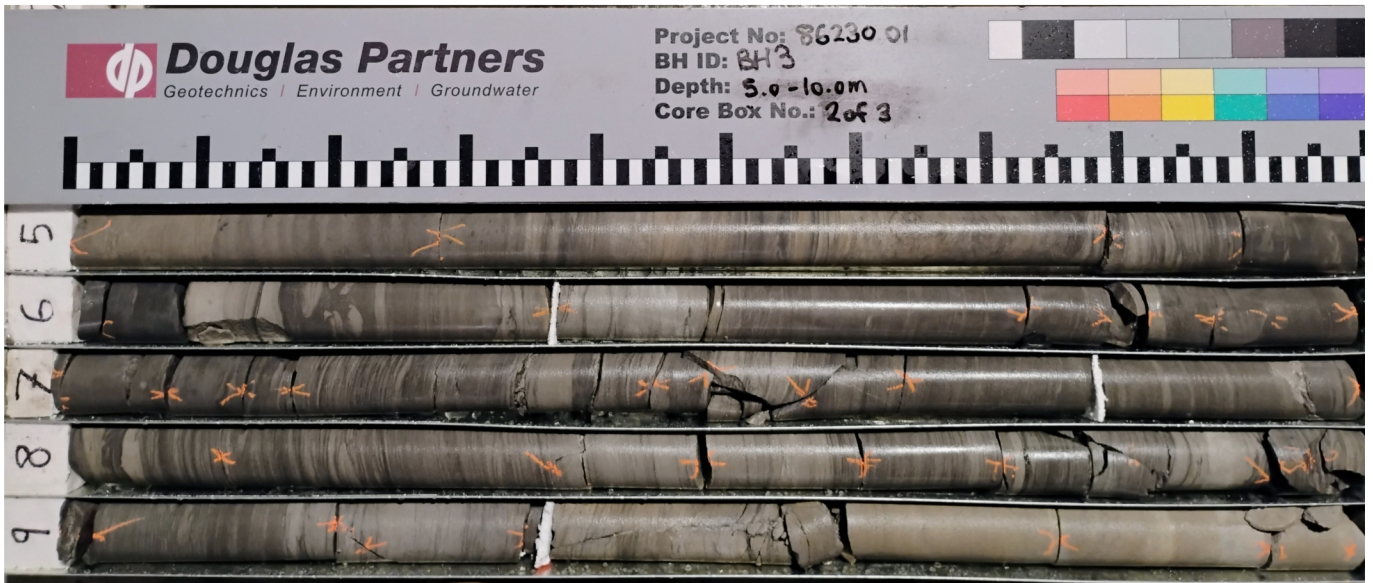
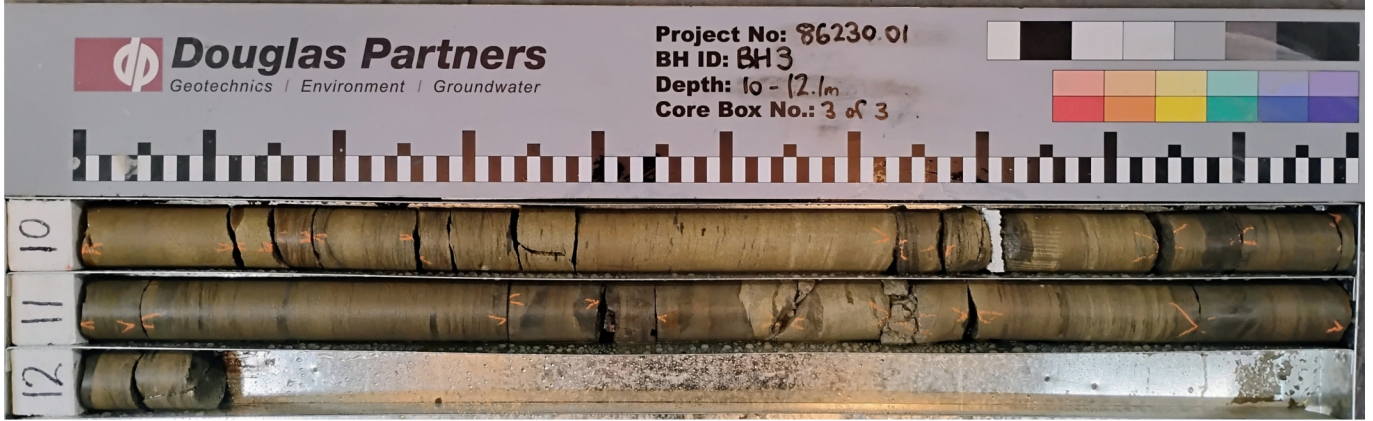
LOCATION ID: BH03
PROJECT No: 86230.01
DATE: 01/04/25
SHEET: 1 of 2

unbroken. Sub-vertical joints dipping 70° to 90° were observed within BH03 between 7.2 m and 9.5 m depth.

The detailed subsurface conditions encountered are presented in the borehole logs in Appendix C along with notes defining descriptive terms and classification methods. Photographs of the recovered rock cores are also included.

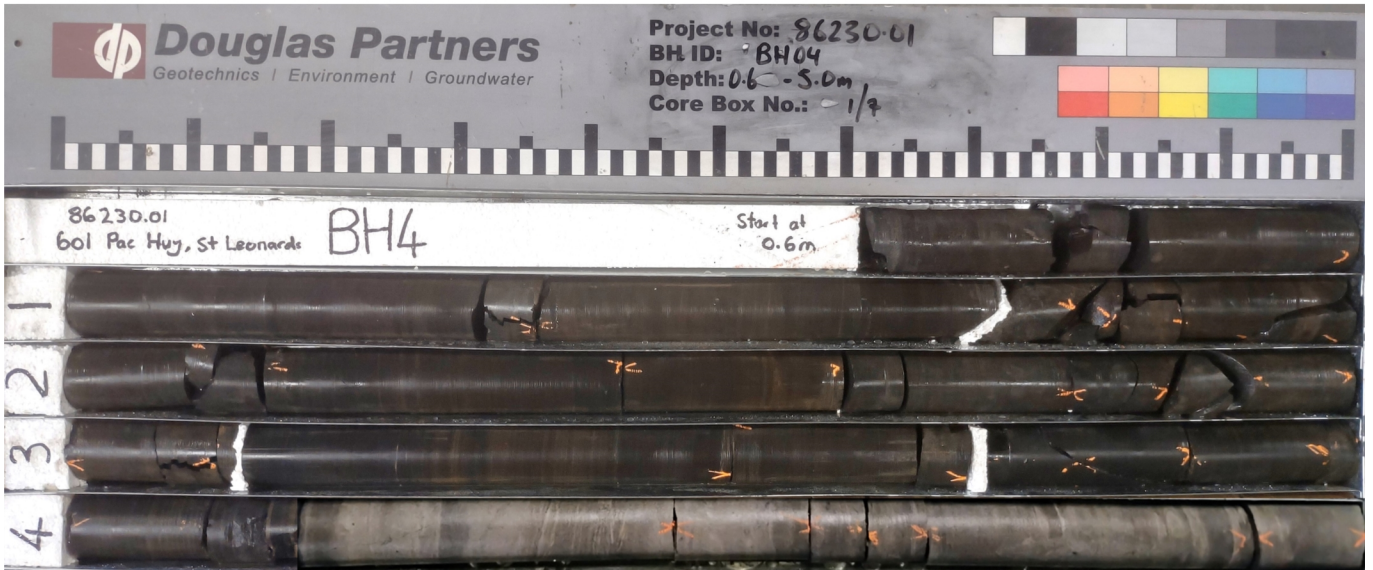
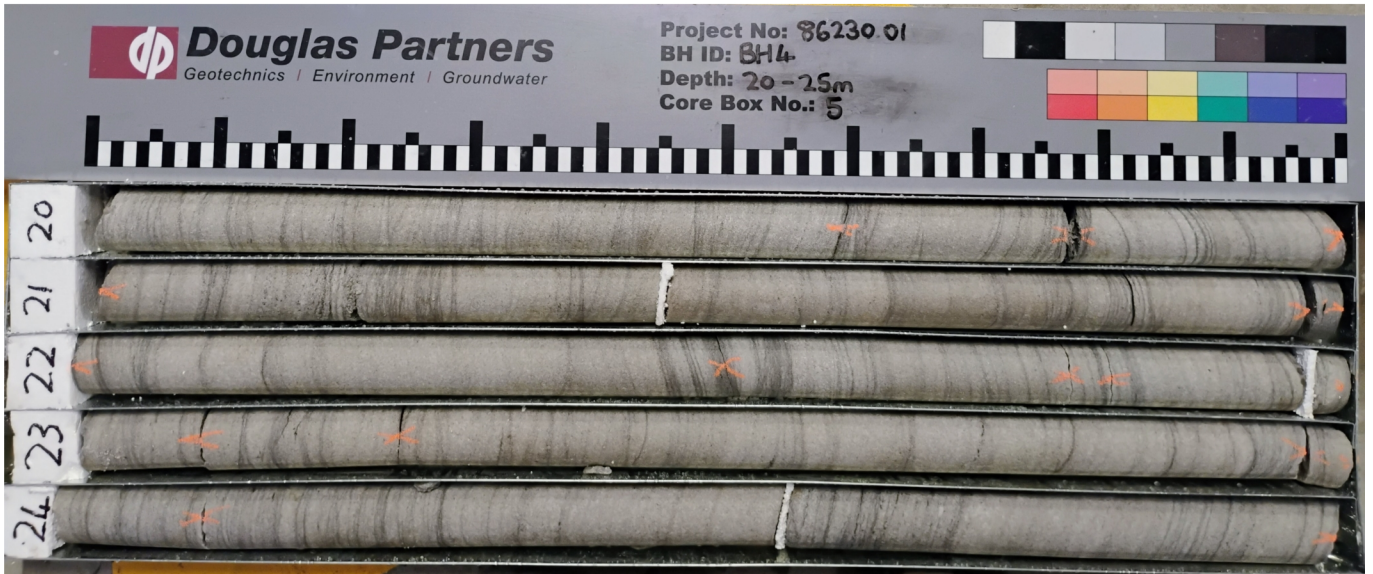
LOCATION ID: BH04
PROJECT No: 86230.01
DATE: 03/04/25 - 07/04/25
SHEET: 1 of 4

- The low to medium strength rock and crushed zones with joints dipping 15° to 25°, observed in BH04 between 26.2 m and 30.5 m depth, were accompanied with significant loss of drilling fluid, indicating a possible presence of a thrust fault.

- Medium to high strength and high strength, fresh, pale grey to grey, fine to medium grained sandstone and laminite (Mittagong Formation), grading to fresh, high strength, medium to coarse grained sandstone (Hawkesbury Sandstone) to the termination depth of boreholes. A very high strength band was noted within BH01 between 14.3 m and 14.8 m depth. The high strength rock was typically unbroken. A low to medium strength, fractured zone was noted in BH04 between 26.2 m and 30.5 m depth.

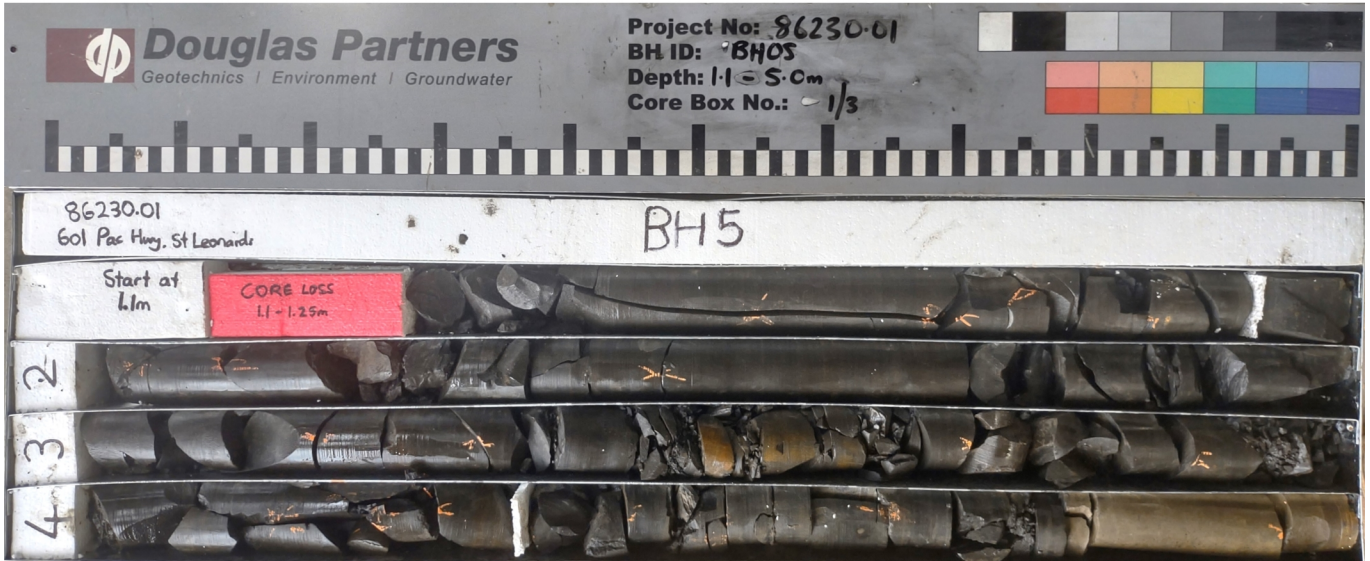
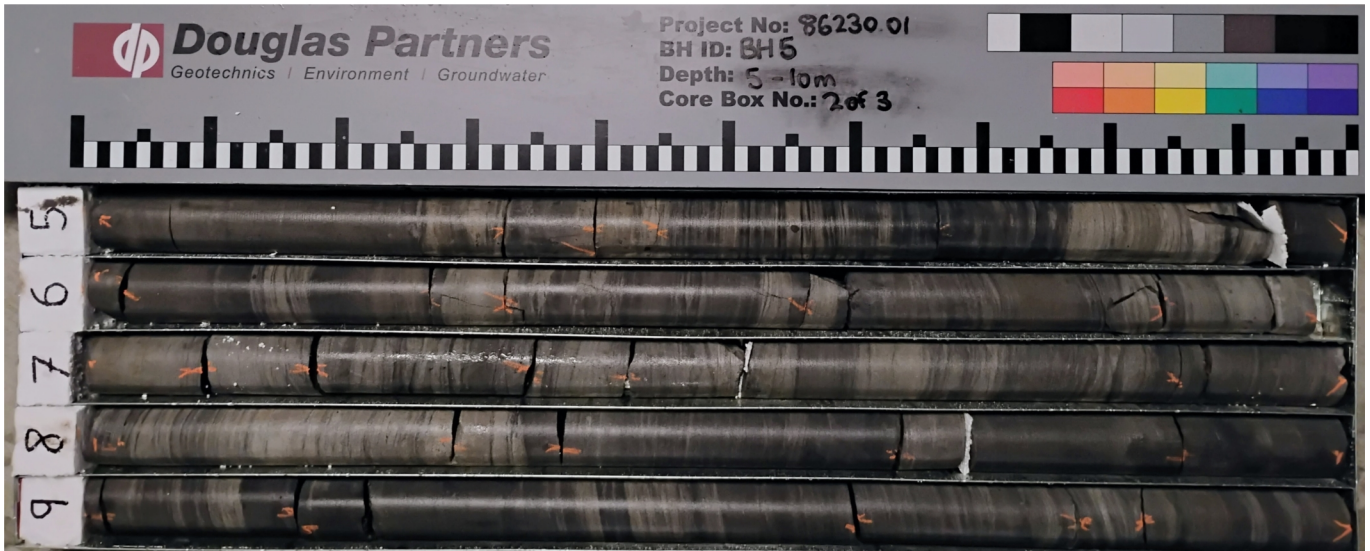
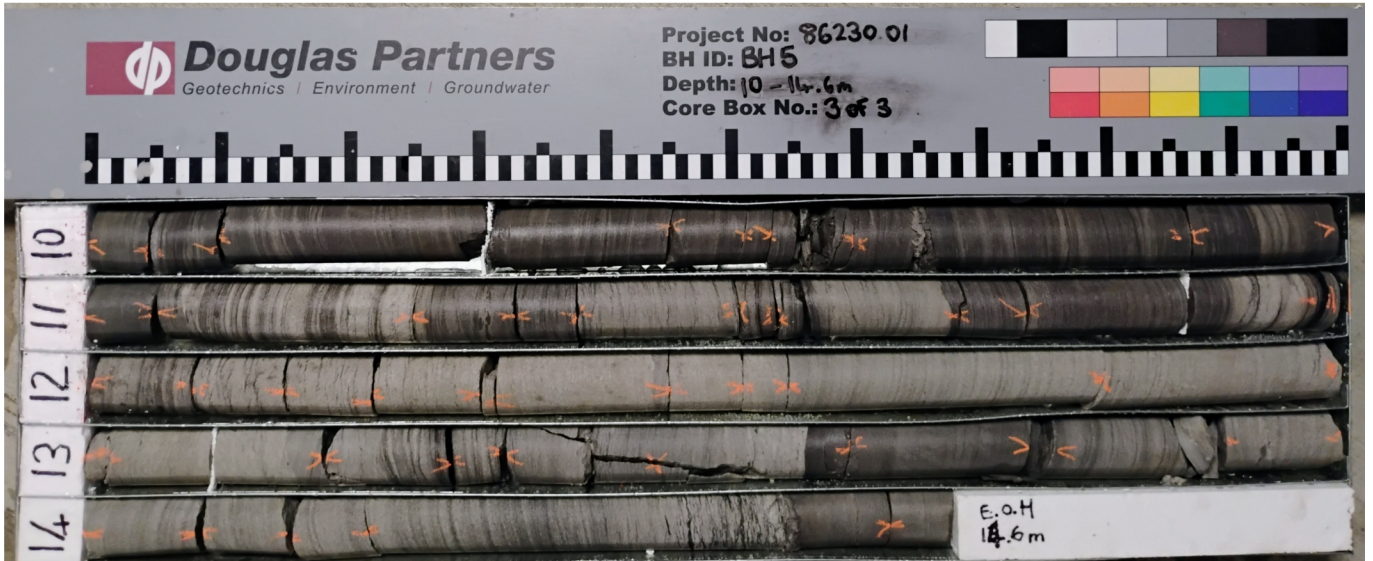
LOCATION ID: BH05
PROJECT No: 86230.01
DATE: 08/04/25
SHEET: 1 of 2

- Generally low to medium strength, fresh, dark grey shale (Ashfield Shale) encountered in all boreholes below the fill to depths between 4.1 m and 4.8 m. The shale was typically slightly fractured. Frequent joints dipping 30° to 70° were observed within the shale bedrock. Sub-horizontal crushed zones with clay infill were also noted within BH02 between 3.9 m and 4.7 m depth. Very low strength bands accompanied with crushed zones and joints dipping 35° to 60° were noted in BH05 between 2.7 m and 5.3 m depth in BH05.

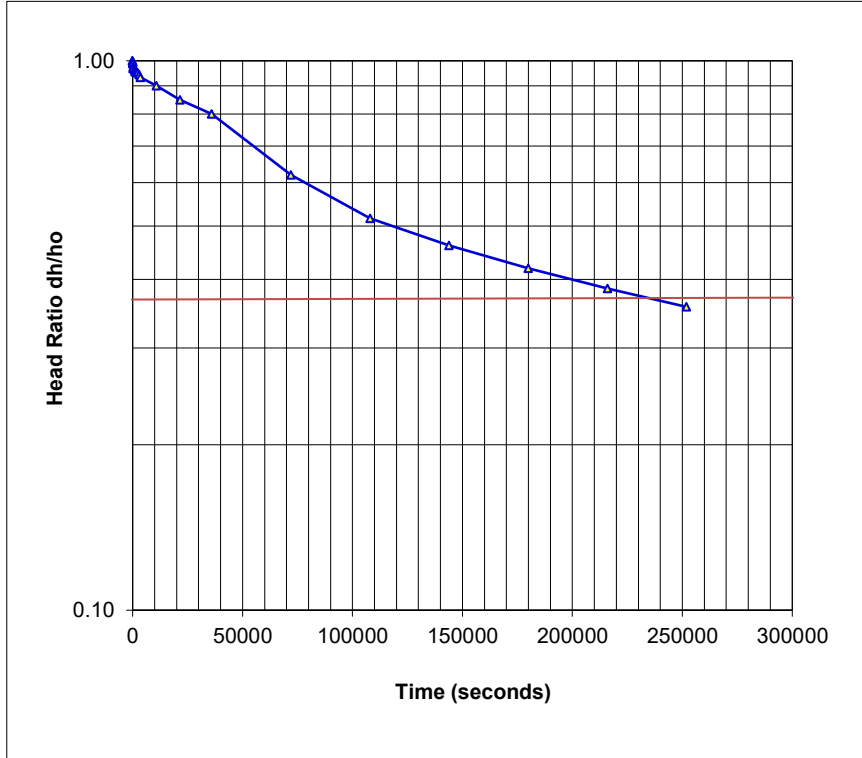
To = 4000 mins
240000 secs

Theory: Falling Head Permeability calculated using equation by Hvorslev
 $k = [r^2 \ln(Le/R)] / 2Le To$ where r = radius of casing
 R = radius of well screen
 Le = length of well screen
 To = time taken to rise or fall to 37% of initial change

Hydraulic Conductivity	k =	4.3E-09	m/sec
	=	0.0004	m/day

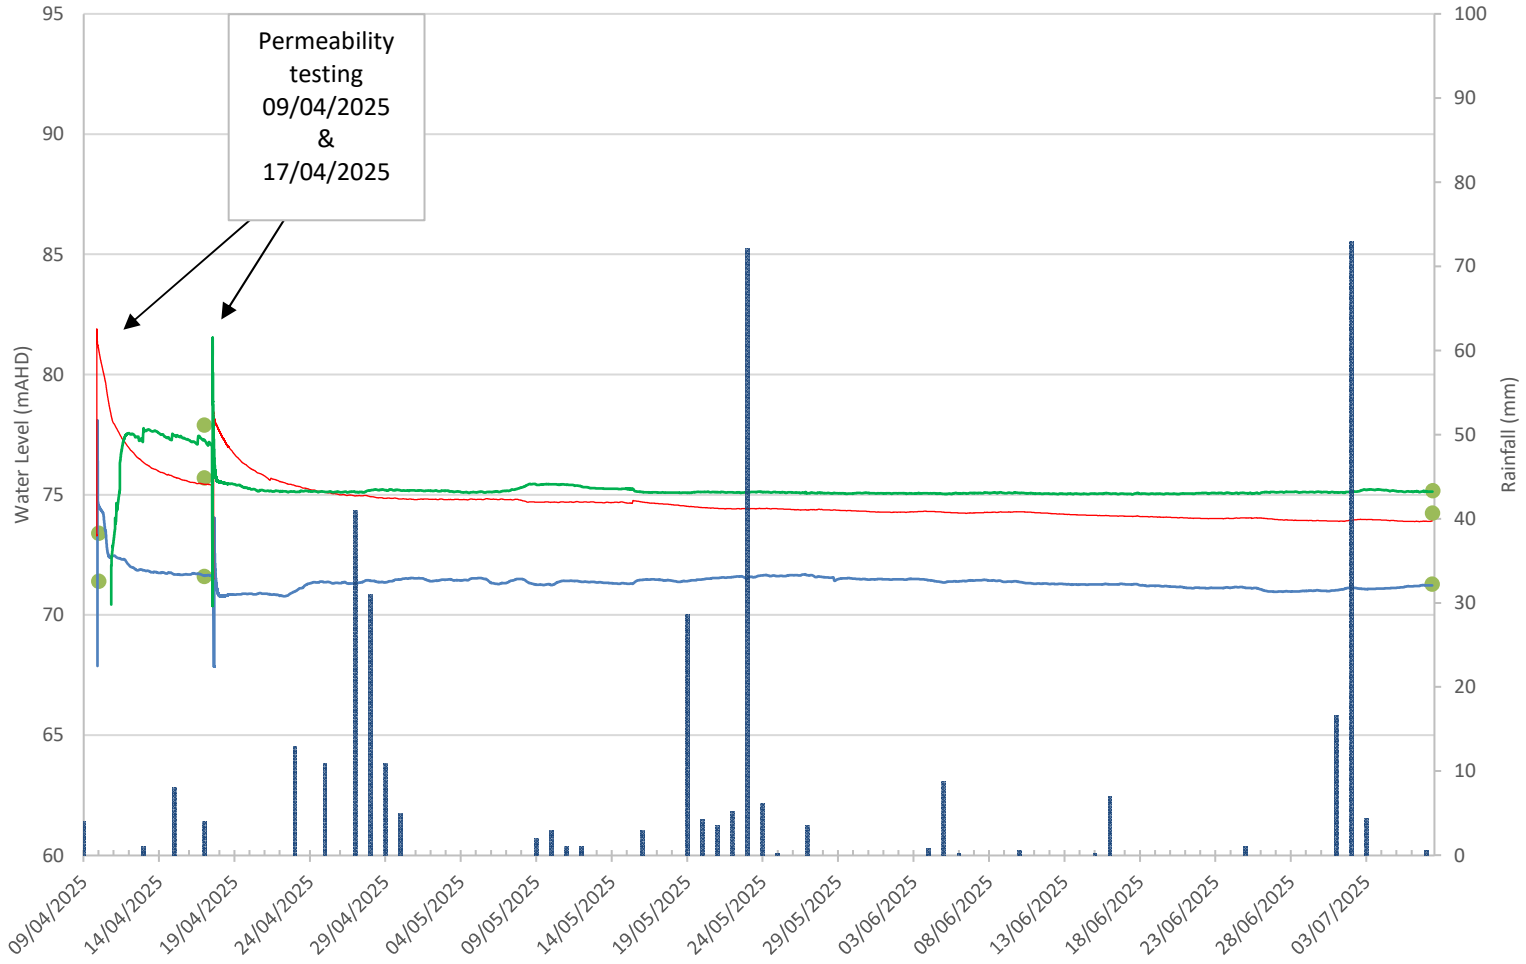
Groundwater Level Monitoring Summary

Permeability testing
09/04/2025
&
17/04/2025

Note: Reading Interval = 1 hour

Groundwater was measured at variable depths of between 3.4 m and 11.1 m (RL 71.3 m to RL 77.9 m). The variable water levels may be attributed to nearby drained basements and / or the Sydney Metro rail tunnels and suggest it may also be associated with perched seepage and not the permanent/regional groundwater table. It should be noted that the groundwater levels are affected by climatic conditions, rock mass permeability and available defects and will vary with time.

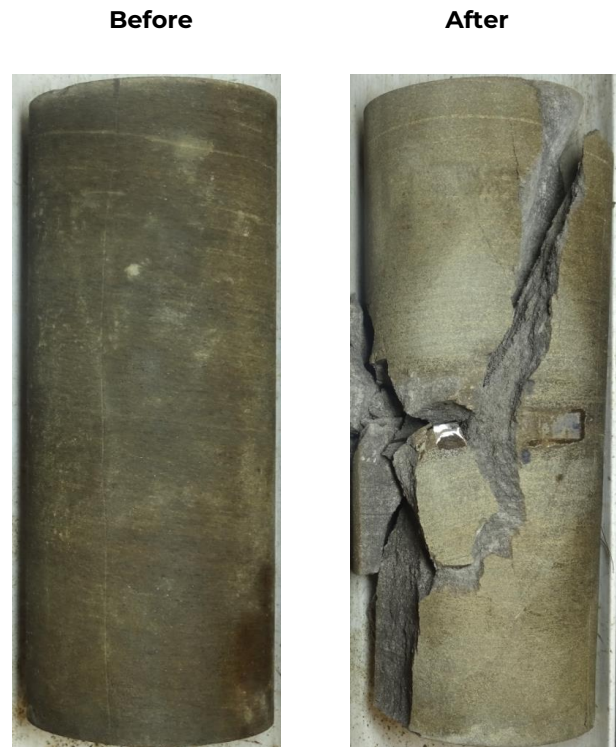
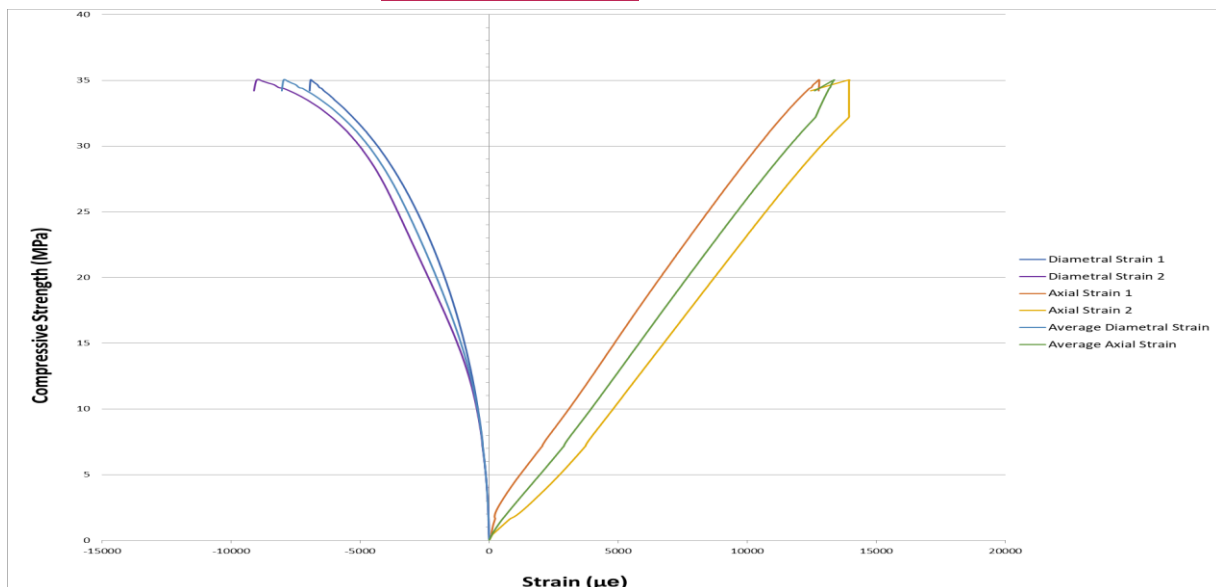
Lab Sample Number	NC-12937A	
Sample Location	BH01	
Depth (m)	7.07 - 7.29	
Rock Description	Interlaminated Siltstone & Sandstone	
Storage History	Wrapped in Plastic	
Conditioning	Tested as Received	
Compression Machine	Automax Multitest	
Measurement	Electric Strain Gauges	
Specimen Diameter / Height (mm)	51.7	145
Height to Diameter Ratio	2.8 : 1	
Moisture Content (%)	2.3	
Wet Mass / Unit Volume (t/m ³)	2.59	
Dry Mass / Unit Volume (t/m ³)	2.53	
Test Duration (sec)	438	
Rate of Displacement (kN/sec)	0.17	
Failure Mode	Tensile	
Uniaxial Compressive Strength (MPa)	35.0	
SECANT MODULUS (50% load)		
Young's modulus (GPa)	2.6	
Poisson's ratio	0.23	
TANGENT MODULUS (25 - 55% load)		
Young's modulus (GPa)	2.7	
Poisson's ratio	0.39

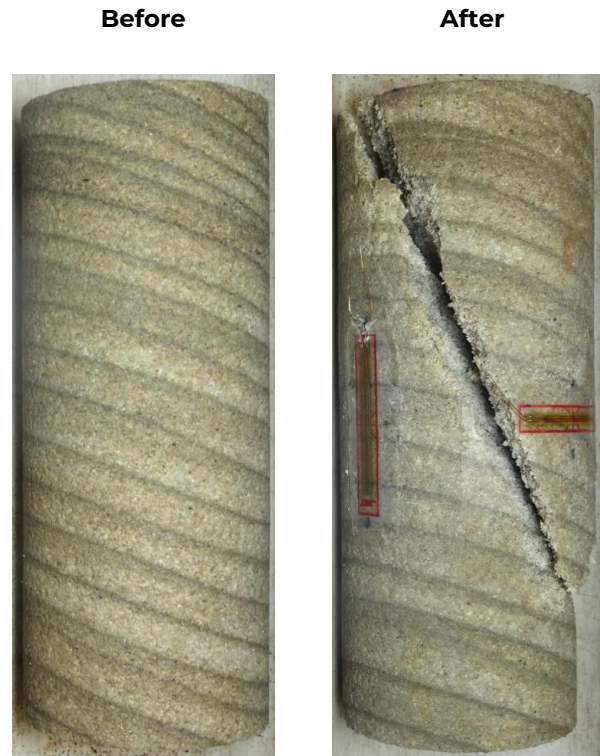
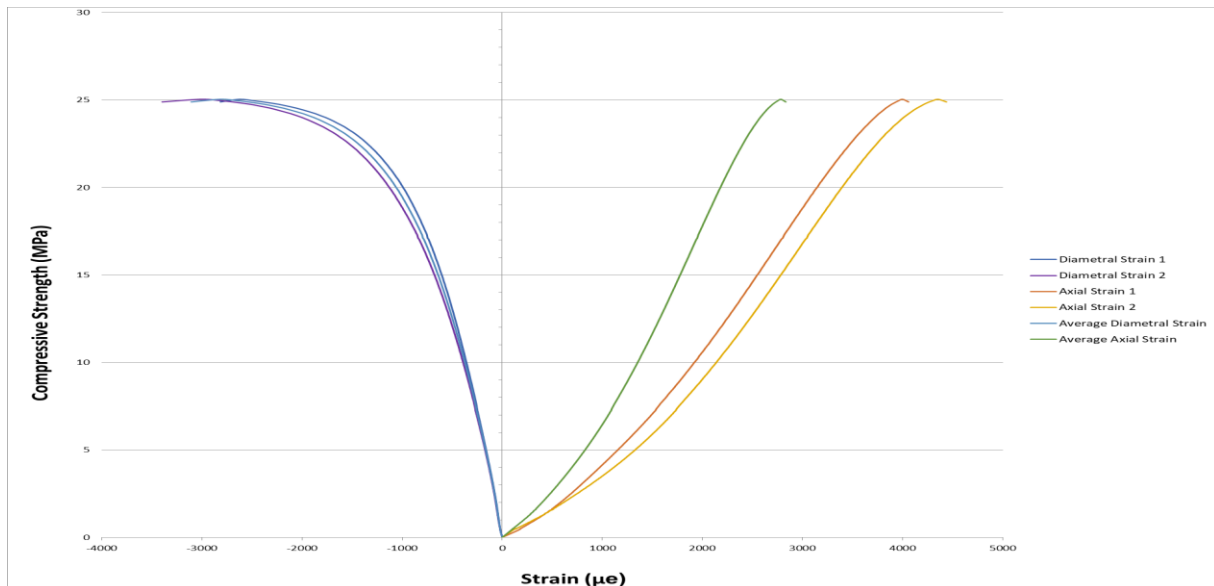
Lab Sample Number	NC-12937B	
Sample Location	BH02	
Depth (m)	13.43 - 13.67	
Rock Description	Sandstone	
Storage History	Wrapped in Plastic	
Conditioning	Tested as Received	
Compression Machine	Automax Multitest	
Measurement	Electric Strain Gauges	
Specimen Diameter / Height (mm)	51.4	143
Height to Diameter Ratio	2.8 : 1	
Moisture Content (%)	6.0	
Wet Mass / Unit Volume (t/m ³)	2.40	
Dry Mass / Unit Volume (t/m ³)	2.27	
Test Duration (sec)	469	
Rate of Displacement (kN/sec)	0.11	
Failure Mode	Shear	
Uniaxial Compressive Strength (MPa)	25.0	
SECANT MODULUS (50% load)		
Young's modulus (GPa)	5.3	
Poisson's ratio	0.21	
TANGENT MODULUS (35 - 65% load)		
Young's modulus (GPa)	7.8	
Poisson's ratio	0.42

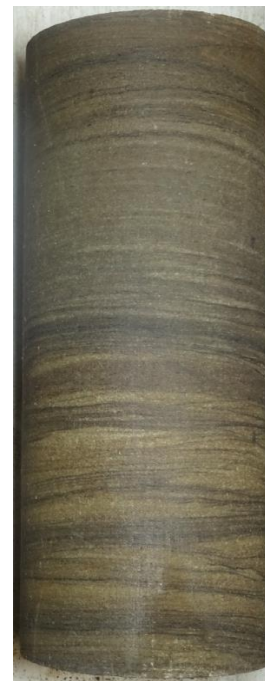
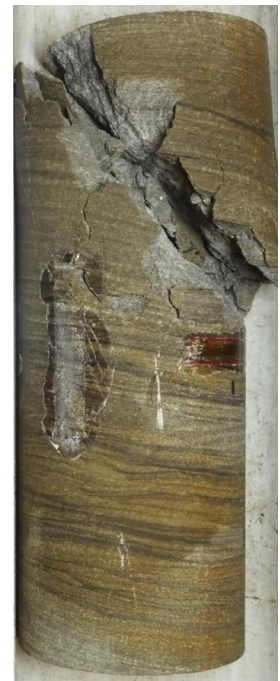
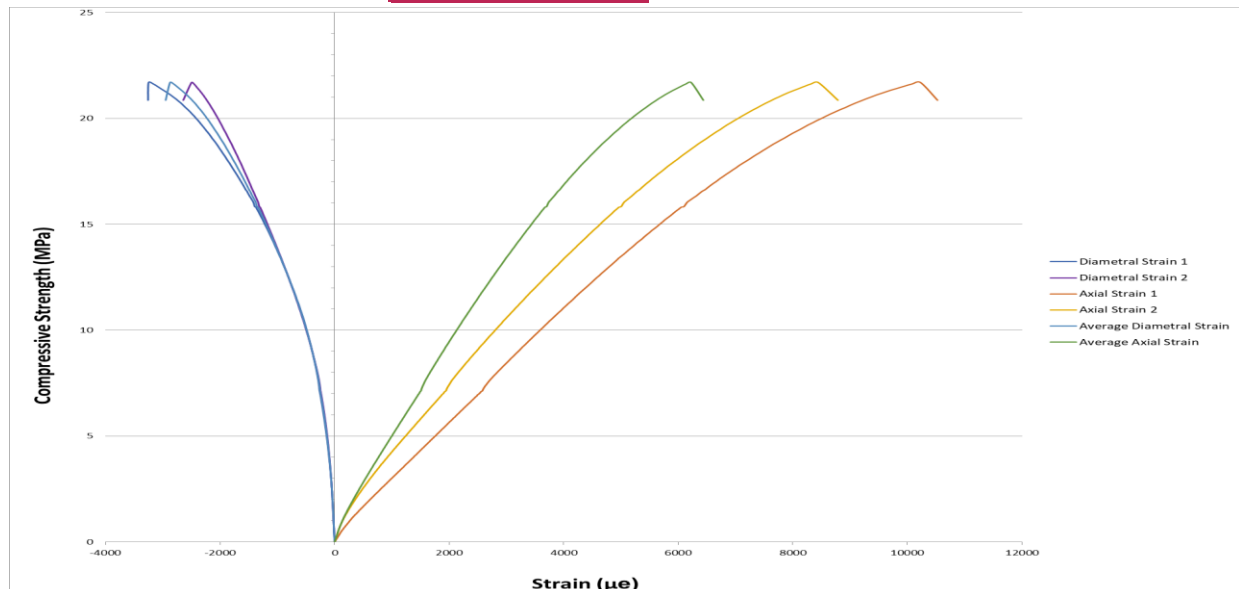
Lab Sample Number	NC-12937C
Sample Location	BH03
Depth (m)	8.12 - 8.36
Rock Description	Interlaminated Siltstone & Sandstone
Storage History	Wrapped in Plastic
Conditioning	Tested as Received
Compression Machine	Automax Multitest
Measurement	Electric Strain Gauges
Specimen Diameter / Height (mm)	51.7 145
Height to Diameter Ratio	2.8 : 1
Moisture Content (%)	2.6
Wet Mass / Unit Volume (t/m ³)	2.58
Dry Mass / Unit Volume (t/m ³)	2.52
Test Duration (sec)	437
Rate of Displacement (kN/sec)	0.10
Failure Mode	Shear
Uniaxial Compressive Strength (MPa)	21.7
SECANT MODULUS (50% load)	
Young's modulus (GPa)	3.1
Poisson's ratio	0.17
TANGENT MODULUS (35 - 65% load)	
Young's modulus (GPa)	2.7
Poisson's ratio	0.32

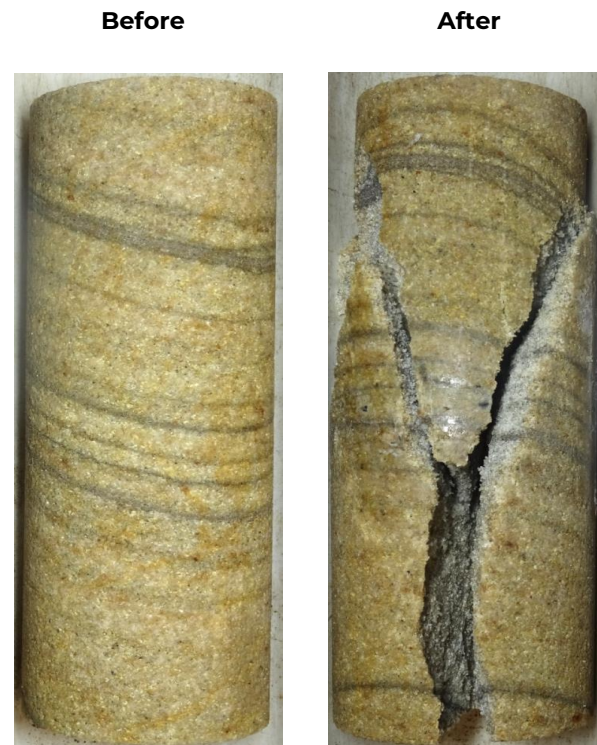
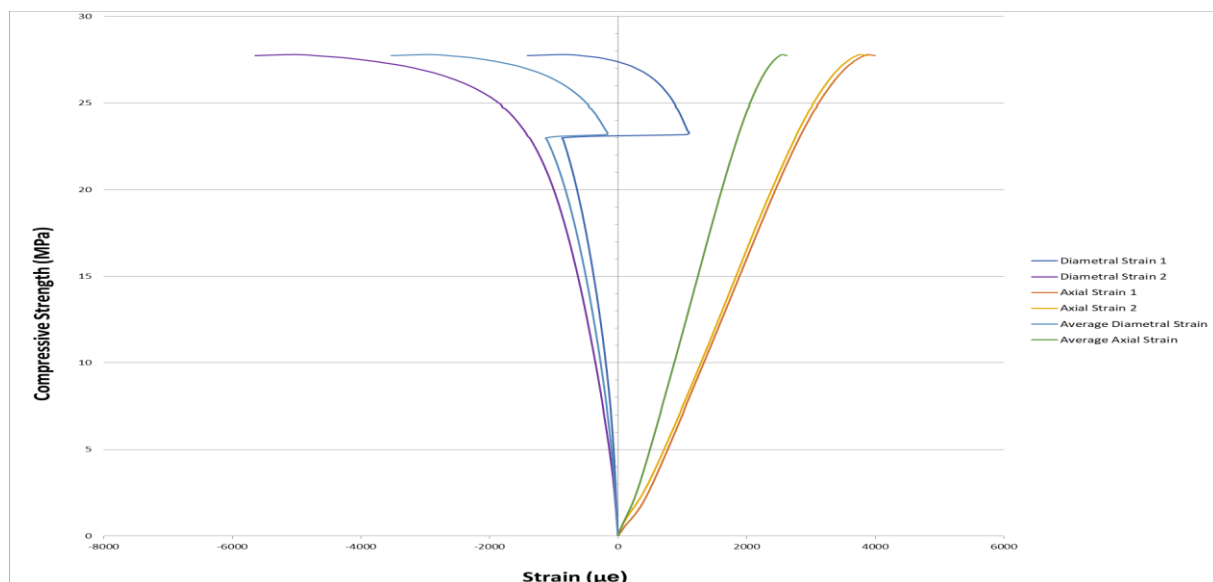
Lab Sample Number	NC-12937D	
Sample Location	BH04	
Depth (m)	25.03 - 25.36	
Rock Description	Sandstone	
Storage History	Wrapped in Plastic	
Conditioning	Tested as Received	
Compression Machine	Automax Multitest	
Measurement	Electric Strain Gauges	
Specimen Diameter / Height (mm)	51.8	145
Height to Diameter Ratio	2.8 : 1	
Moisture Content (%)	5.0	
Wet Mass / Unit Volume (t/m ³)	2.44	
Dry Mass / Unit Volume (t/m ³)	2.32	
Test Duration (sec)	501	
Rate of Displacement (kN/sec)	0.12	
Failure Mode	Tensile	
Uniaxial Compressive Strength (MPa)	27.8	
SECANT MODULUS (50% load)		
Young's modulus (GPa)	8.0	
Poisson's ratio	0.26	
TANGENT MODULUS (25 - 55% load)		
Young's modulus (GPa)	9.0	
Poisson's ratio	0.39

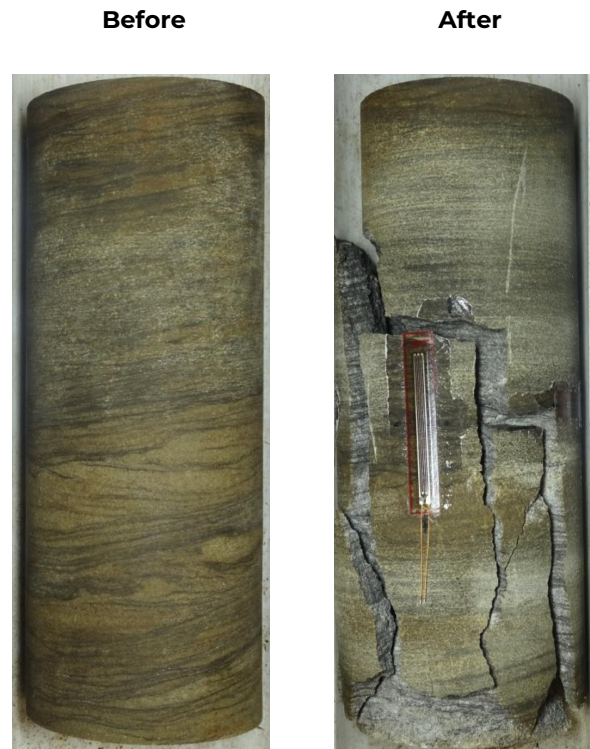
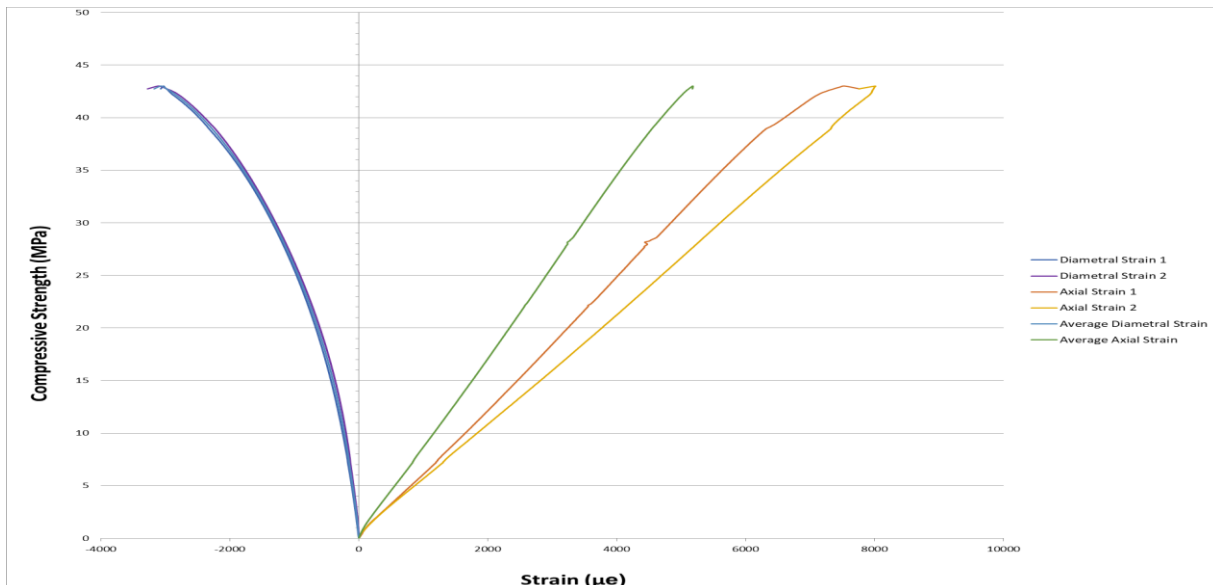
Lab Sample Number	NC-12937E
Sample Location	BH05
Depth (m)	7.61 - 7.87
Rock Description	Interlaminated Siltstone & Sandstone
Storage History	Wrapped in Plastic
Conditioning	Tested as Received
Compression Machine	Automax Multitest
Measurement	Electric Strain Gauges
Specimen Diameter / Height (mm)	51.6 144
Height to Diameter Ratio	2.8 : 1
Moisture Content (%)	1.7
Wet Mass / Unit Volume (t/m ³)	2.55
Dry Mass / Unit Volume (t/m ³)	2.51
Test Duration (sec)	658
Rate of Displacement (kN/sec)	0.14
Failure Mode	Mixed
Uniaxial Compressive Strength (MPa)	43.0
SECANT MODULUS (50% load)	
Young's modulus (GPa)	5.7
Poisson's ratio	0.19
TANGENT MODULUS (35 - 65% load)	
Young's modulus (GPa)	5.9
Poisson's ratio	0.34

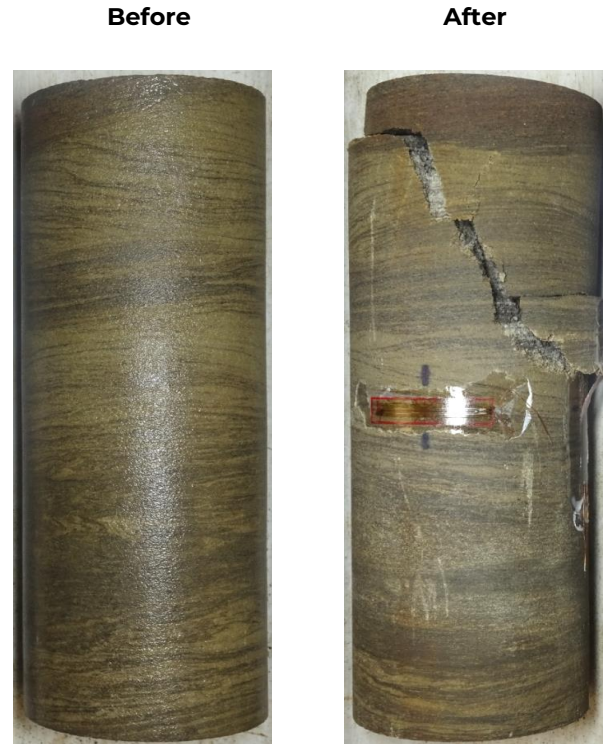
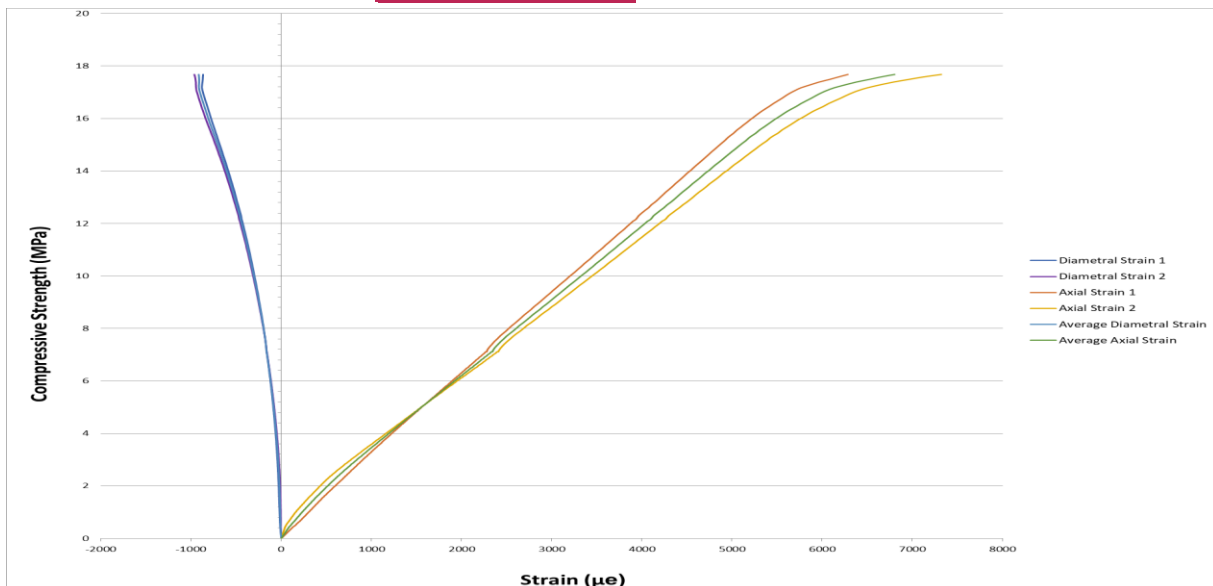
Lab Sample Number	NC-12937F	
Sample Location	BH06	
Depth (m)	6.41 6.64	
Rock Description	Interlaminated Siltstone & Sandstone	
Storage History	Wrapped in Plastic	
Conditioning	Tested as Received	
Compression Machine	Automax Multitest	
Measurement	Electric Strain Gauges	
Specimen Diameter / Height (mm)	51.8	144
Height to Diameter Ratio	2.8 : 1	
Moisture Content (%)	4.8	
Wet Mass / Unit Volume (t/m ³)	2.47	
Dry Mass / Unit Volume (t/m ³)	2.35	
Test Duration (sec)	396	
Rate of Displacement (kN/sec)	0.09	
Failure Mode	Shear	
Uniaxial Compressive Strength (MPa)	17.7	
SECANT MODULUS (50% load)		
Young's modulus (GPa)	3.0	
Poisson's ratio	0.10	
TANGENT MODULUS (35 - 65% load)		
Young's modulus (GPa)	2.9	
Poisson's ratio	0.15
