## University of Wollongong

### Contamination Assessment

Social Sciences & Law Humanities and Arts  
Building

27 September 2017

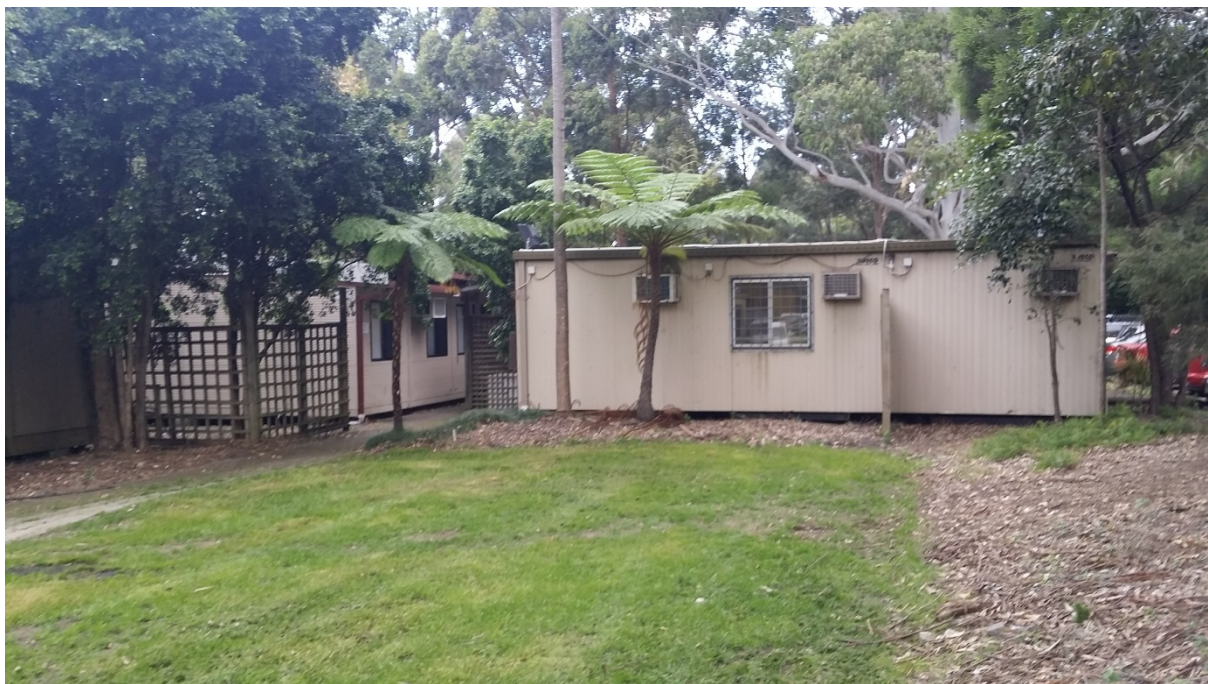
The site is accessible off the university ring road. Nine buildings were observed in the area, some with multiple classrooms (classrooms numbered 45 to 56) (See Photos 1 to 3 for examples). No observations were made inside the structures, but all appeared to be classroom style single storey buildings. One small structure appeared to be a toilet and was located between classrooms 51 and 52. The buildings appeared to be a mix of steel clad and fibre cement type construction as per below:

Photo 1 – Example of classroom (Classroom 50) as viewed from the north

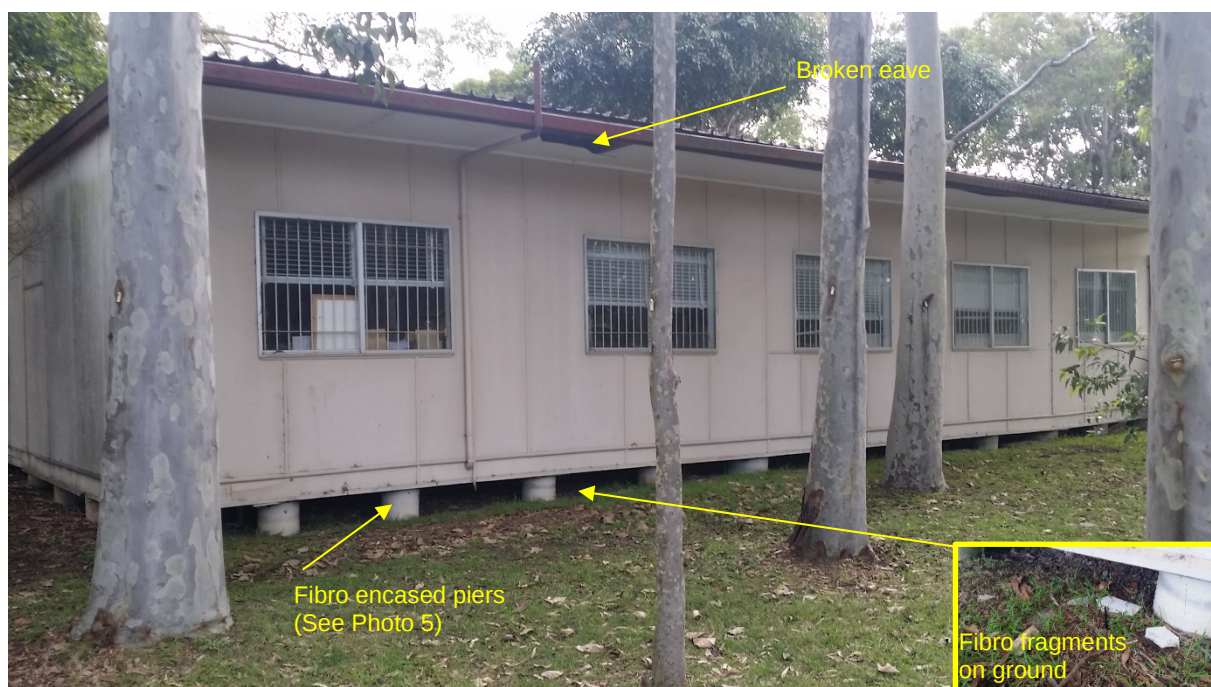
The south eastern part of Classroom 54 was noted to have a broken eave and a few fibro fragments were evident on the ground surface (See Photo 2). A central area ringed by classrooms 45-47 and 51-54 had pavers and some raised garden beds (See photo 4). Remaining areas (excluding carparks) were generally unpaved and either with grass, leaf litter and trees.

Photo 2 – Classroom 54 facing north west

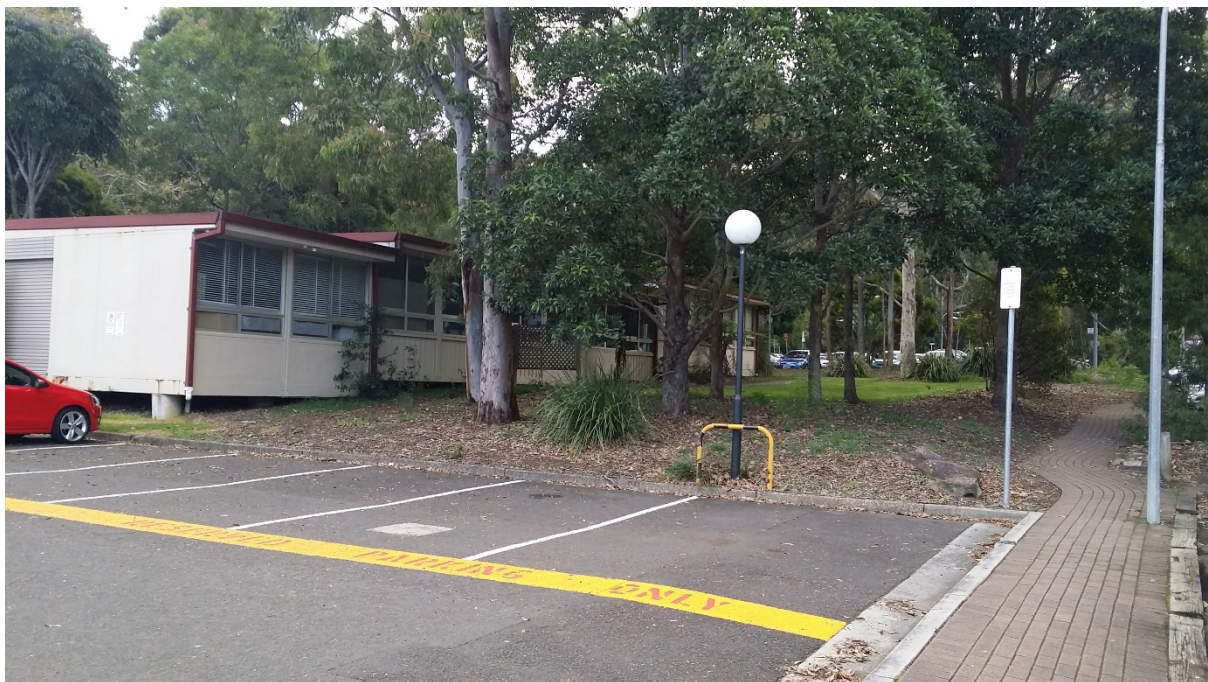
Photo 3 – Site facing south west (Showing classrooms 45-47 and north east car park)

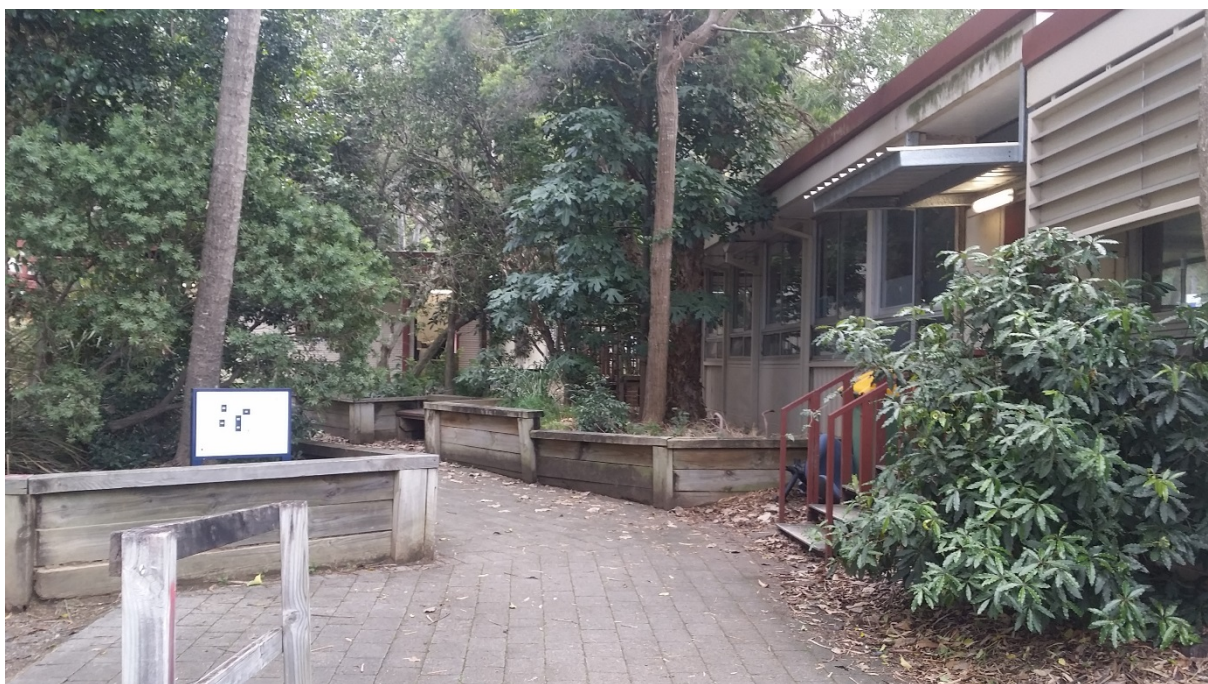
Photo 4 – Central paved area surrounded with classrooms and raised garden beds – facing west

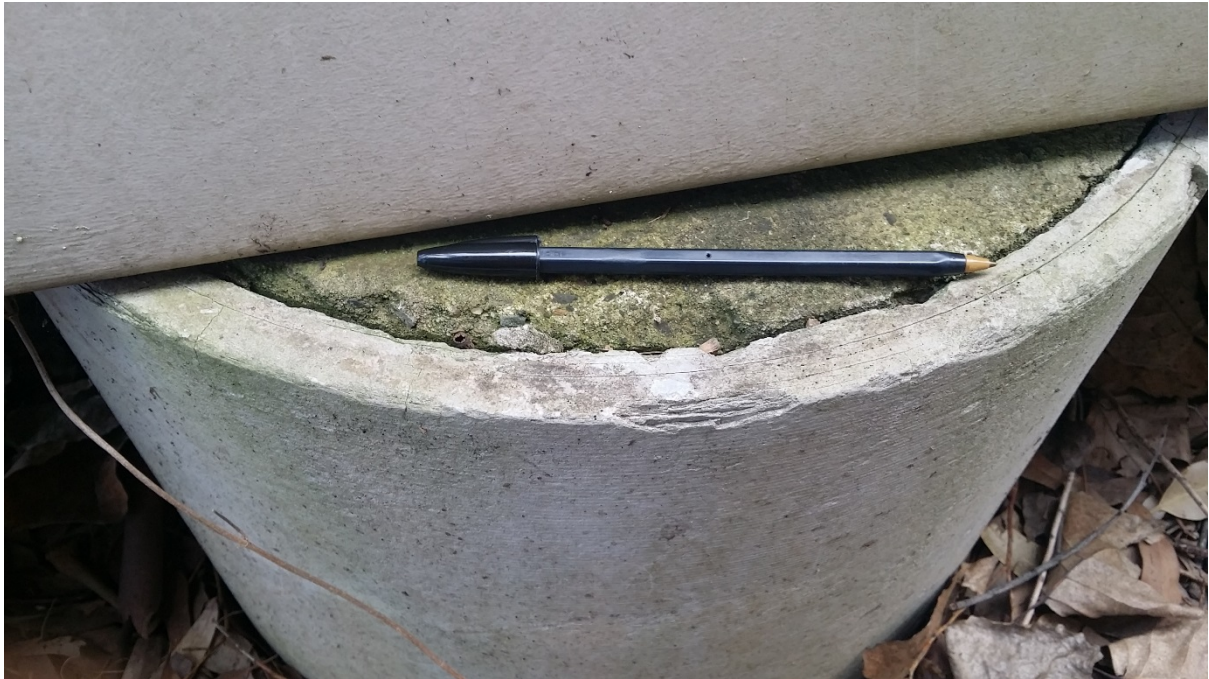
The fibro portions were painted. Most structures were slightly raised off the ground on piers. Some piers were observed to have a fibro type casing (See Photo 5).

Photo 5 – Example of fibro encased concrete pier (at Classroom 54)
