## **Geotechnical Investigation Report 23-31 Dover Road, Rose Bay NSW**

**Prepared for: DOVER STREET (ROSE BAY) DEVELOPMENTS Pty Ltd**

**Reference: P3496\_02 Rev1**

**Date: 17 September 2025**

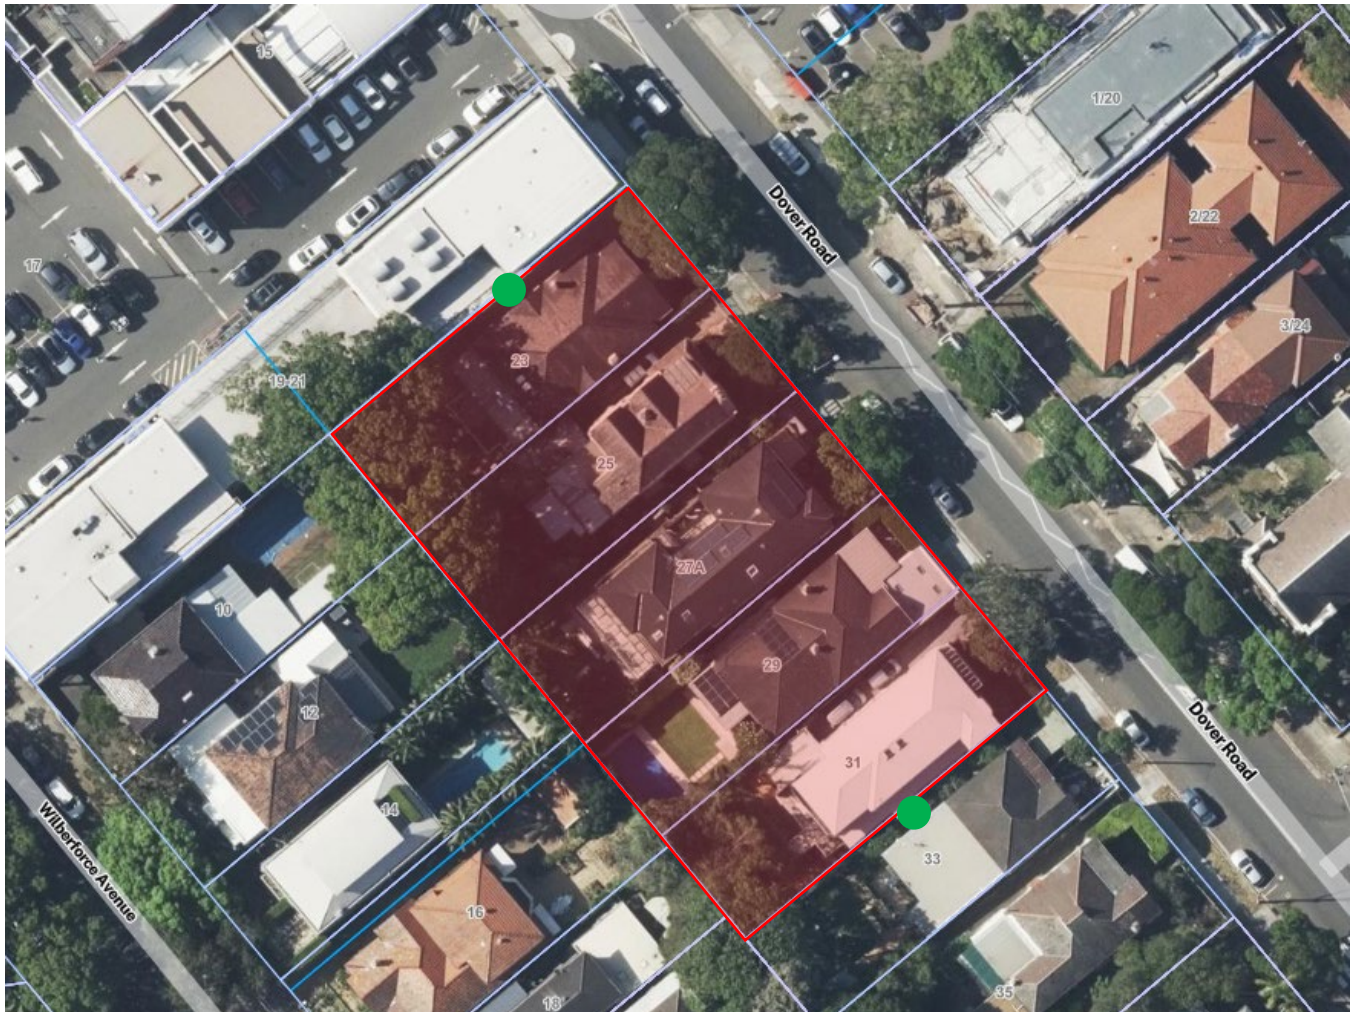
**Figure 1:** Location of vibration monitoring points

vibration receptor in consultation with the project superintendent and geotechnical engineer. Locations of the vibration monitors are shown on **Figure 1** below.

- Vibration Monitor Location

Where vibration intensive works such as driving of sheet piles or vibratory compaction are proposed contractors should make an assessment of the potential impact of their works on the basis of the borehole logs, core photographs and point load data. Monitoring of construction induced vibration must be undertaken at the commencement of such activities at the nearest

Trials must take place at the commencement of works to ensure that the contractor's proposed methodology can be achieved within the nominated vibration thresholds. It is recommended that vibration monitors are placed prior to the early works contractor mobilising to site by a registered acoustic consultant. On the basis of trials at the commencement of works a construction methodology may be proposed to limit peak particle velocities (ppv) to acceptable levels. In the absence of ppv guidelines from affected asset owners, Morrow Geotechnics recommends the following limits be placed on vibrations:
