## Executive Summary

699 – Dover Road HAA  
23 – 31 Dover Road, Rose Bay, NSW  
Figure 1 - The site and locality

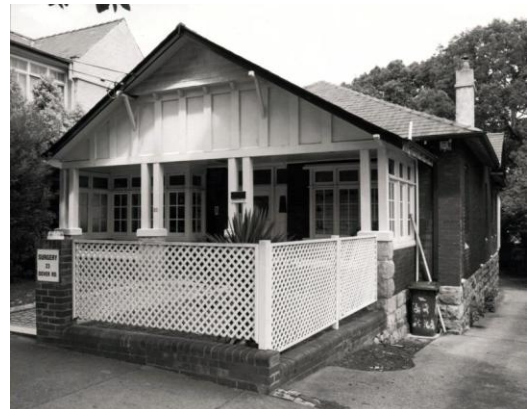
Plate 16 Number 23 Dover Road, 1990s.<sup>29</sup>

The house at 23 Dover Road would be typical of the scale and form that would make up the character of street at the start of the twentieth century (Plate 15 and 16).

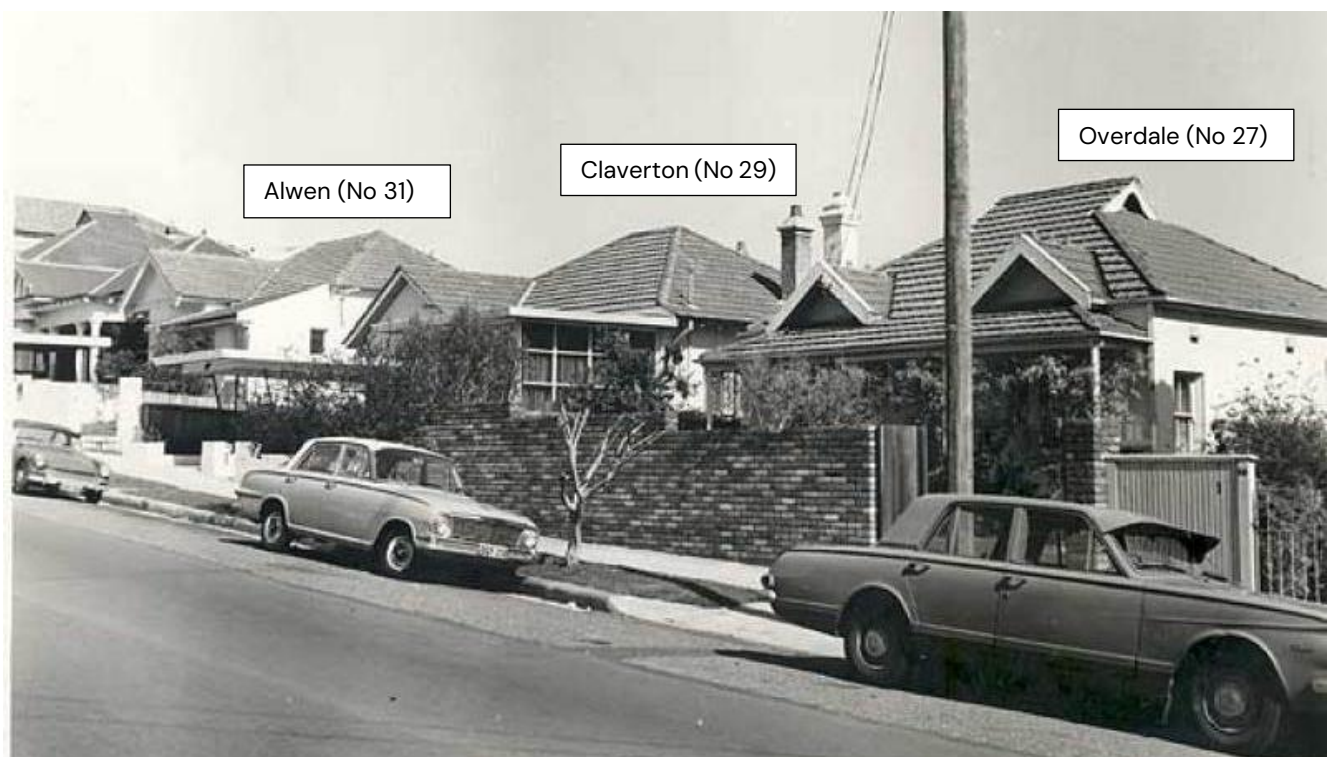
Plate 22 Dover Road showing numbers 27 to 31, c. 1970.<sup>40</sup>

Lot 13 was originally bought by the Maxwell family in 1909 and a single story Federation bungalow built at 29 Dover Road by 1910. The residence was called 'Claverton' and was constructed with sandstone foundations (Plate 22).

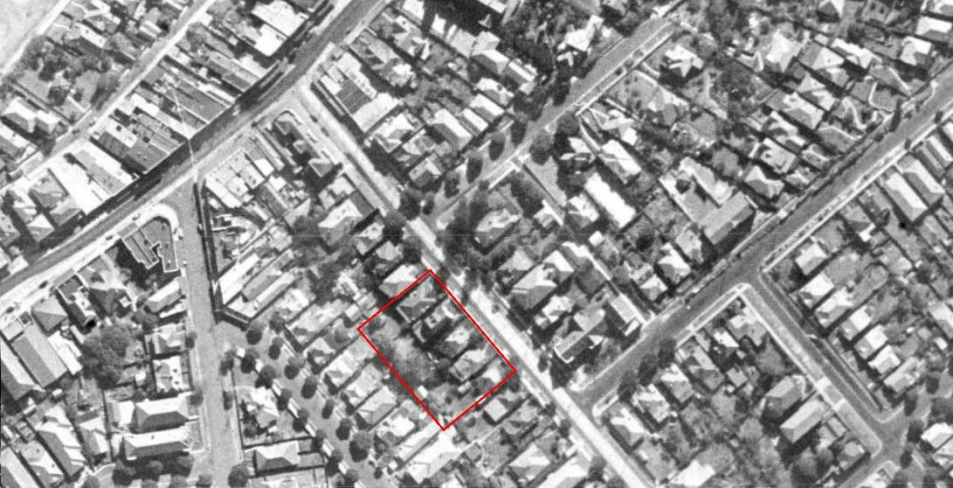
| Aerial photograph (site outlined in red) | Description |
|---|---|
| | <p><b>1943</b></p> <ul style="list-style-type: none"> <li>• The site contains five detached buildings, consistent with existing land titles.</li> <li>• Each property is separated by narrow side setbacks, and all buildings are oriented towards Dover Road.</li> <li>• Visible vegetation, including mature trees and rear gardens, suggests established domestic use and landscaping.</li> <li>• Surrounding streets are fully laid out and lined with street trees.</li> <li>• Residential density across the surrounding blocks is consistent, with a mix of similarly scaled houses on uniform lot sizes.</li> <li>• No major infrastructure work or commercial development is visible in the site or immediate surroundings.</li> <li>• Southwest of the site, properties fronting Newcastle Street and Wilberforce Avenue, appear as elongated structures —possibly warehouses shopping centres, or garages indicating backlot usage of these rear parcels.</li> <li>• Dover Road appears sealed and in use, connecting to New South Head Road (north) and the grid of neighbouring residential streets.</li> <li>• The built environment surrounding the site suggests that the broader Rose Bay area had transitioned to a fully urbanised residential suburb by the early 1940s.</li> </ul> |

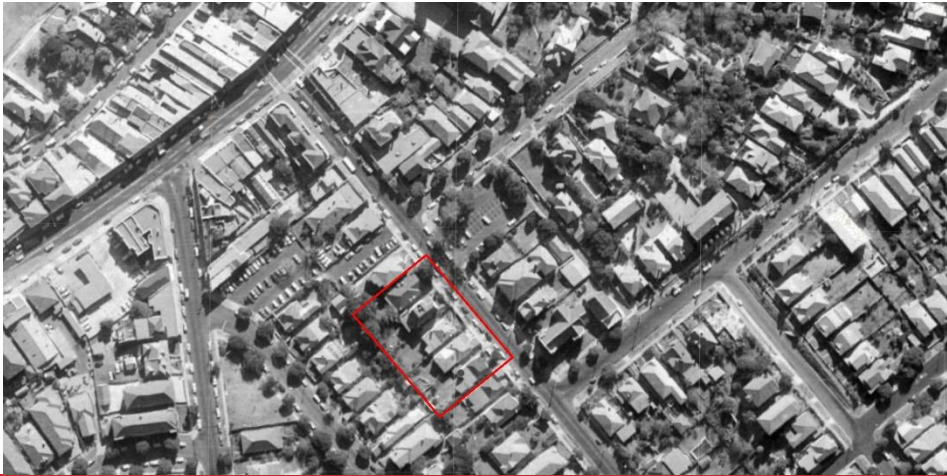
1970

- The five dwellings in the site remain in place, with 31 Dover Road now showing a possible side extension connected to the main structure.
- Rear yards are visibly cleared or simplified, suggesting landscaping changes or reduced vegetation cover.
- Main changes in the vicinity of the project since 1943 is that to the north-west Federation residences have been demolished and the land remodelled for use as a car park
- Street and surrounding urban layout remain consistent with previous aerials, showing continued residential use.

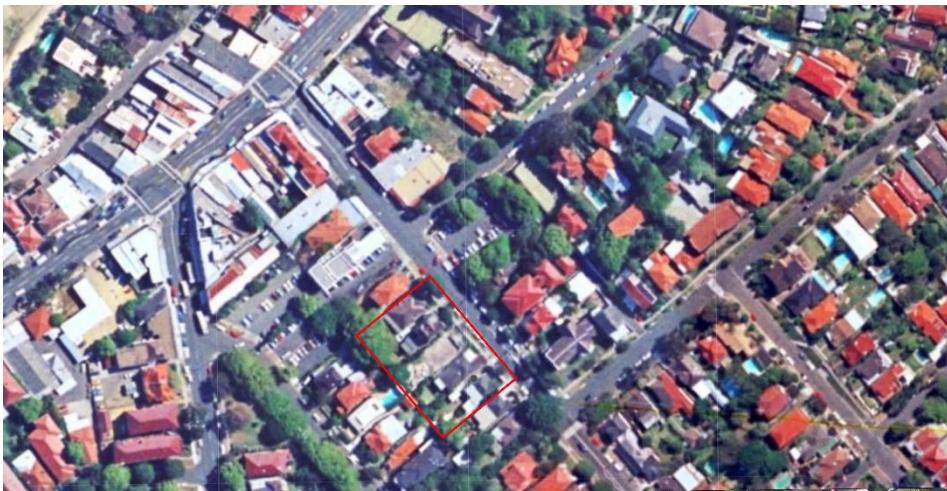
1994

- 27 Dover Road within the site has been completely demolished, with a cleared lot visible in its place.
- Rear extension added to 25 Dover Road, now occupying more of the backyard space than in earlier imagery.
- Another building fronting Wilberforce Avenue (southwest of the car park) has been demolished, and the car park extended further east into that footprint.
- Surrounding development appears consistent with previous imagery.

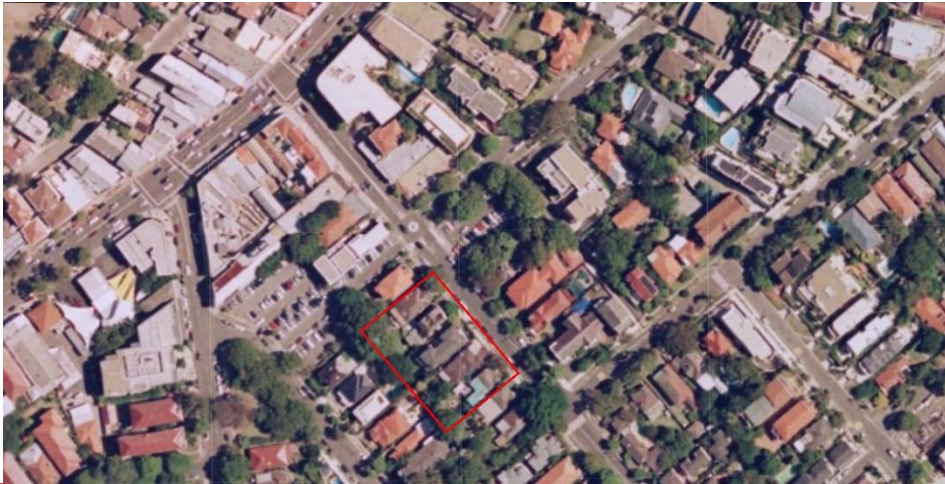
2005

- 27 Dover Road has been rebuilt, now occupying a larger footprint than the previous structure, with the new dwelling covering most of the lot.
- Roofing alterations are visible at 23 and possibly 29 Dover Road, suggesting re-roofing or roof restoration works. No other material changes are observed to the remaining properties within the site.
- Outside the site, the surrounding urban fabric and car park layout appear unchanged from the 1994 aerial.

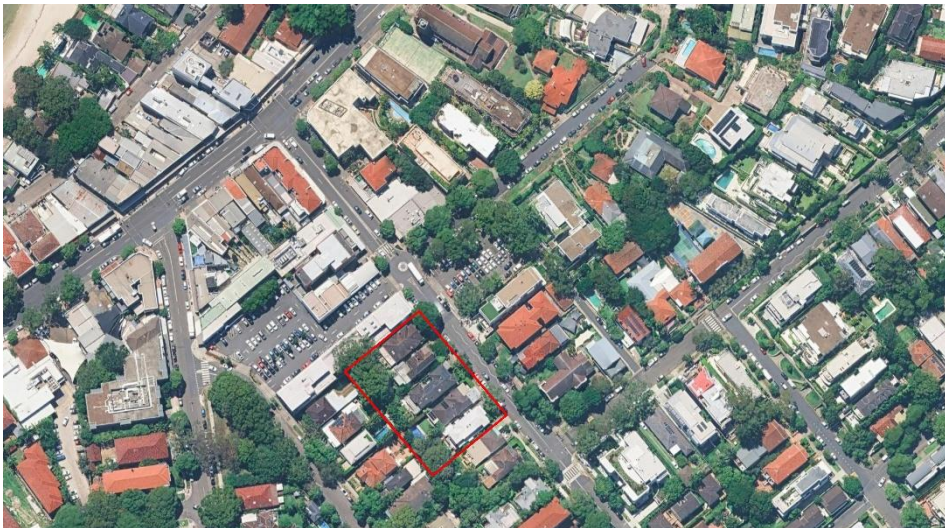
2025

- A new swimming pool has been constructed in the backyard of 29 Dover Road along with landscaping and paved surfaces, indicating recent upgrades.
- 31 Dover Road: The dwelling has been demolished and rebuilt or extensively renovated—a new white, rectilinear structure now occupies the easternmost portion of the lot.
- Surrounding context: Several properties within the broader area appear to have undergone redevelopment or extensive renovation, including:
  - Newly constructed or rebuilt structures along the retail/commercial strip to the north.
  - One or more lots in the broader setting that appear vacant or under construction.

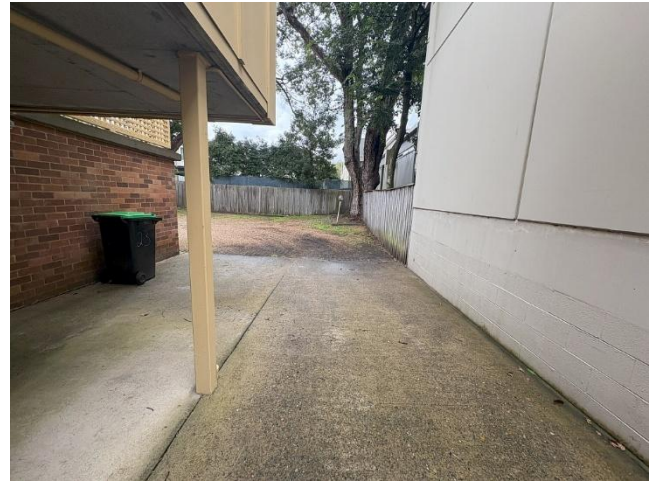
*Plate 27. View south-west showing western side driveway looking towards the backyard. Concrete surface transitions to stabilised gravel area at rear.*

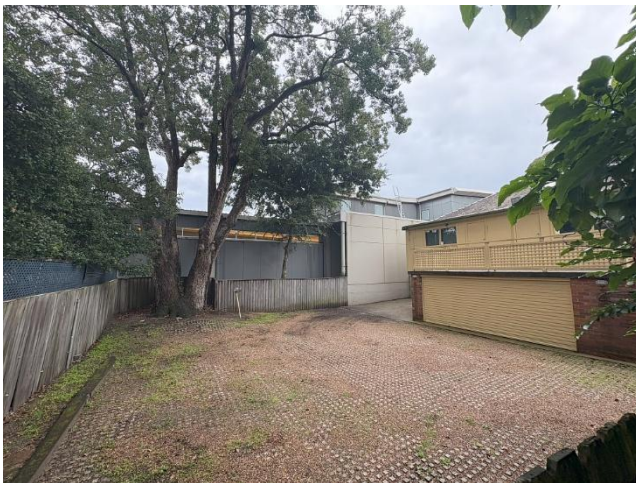
A mature tree in the southwest corner exhibits minor ground heave from root activity, creating a small, localised elevation (Plate 28). There were minor exposures of compacted gravel and fill visible within the grid matrix and at fence lines. No natural soil horizons were observed or surface archaeological relics. The lot slopes gently from the north-east (street frontage) to the south-west (rear fence), reflecting the local broader cross-fall drainage pattern of the site (Plate 29).

*Plate 28. View north-west showing gravel-infilled cellular grid surface, tree root uplift, and partial exposure of disturbed ground in rear yard.*

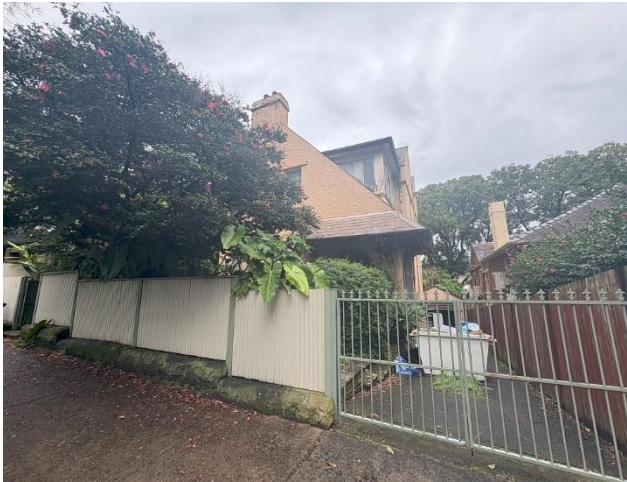
*Plate 30. View south-west showing the front facade.*

25 Dover Road is a modified Federation Arts and Crafts dwelling, constructed in 1913 by T. George and Son, well known builders in the local area. The property consists of a rendered masonry exterior, visible sandstone base, and weatherboard panelling to the rear. The property is fenced with a combination of timber and metal panels (Plate 30). The front setback is landscaped with garden beds edged in sandstone and brick, a concrete pathway, and ornamental plantings. The front yard includes vegetation and paved surfaces (Plate 31).

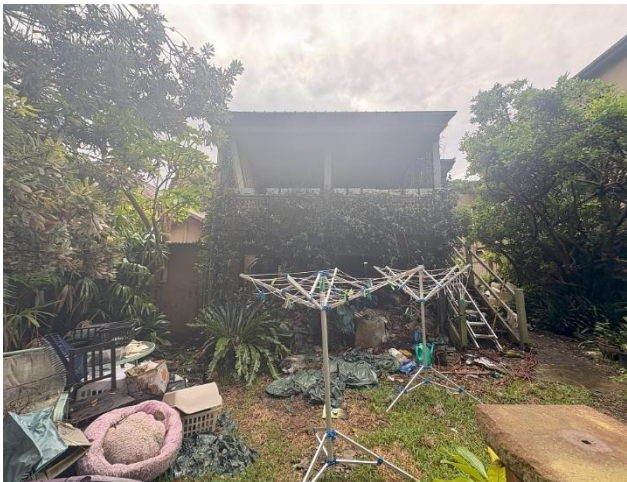
*Plate 32. Rear yard and elevated deck*

The backyard comprises a grassed open area approximately 8.2 m in length, bounded by dense ornamental vegetation and modern structural elements (Plate 32). The eastern portion of the yard is surfaced with large-format sandstone pavers measuring ~5 cm thick. The western boundary is occupied by a bitumen driveway with a central grass strip, leading to a rear garage (Plate 33). The backyard is level, while the overall lot slopes gently from north-east (street frontage) to south-west (rear), consistent with the local hind-dune topography.

Surface modification across the property includes paved garden beds, landscaping, and a timber-framed deck/bungalow structure added during renovations (pers. Comms D. MacNaught in 2025) The space beneath the deck is heavily disturbed and used for storage (Plate 32).

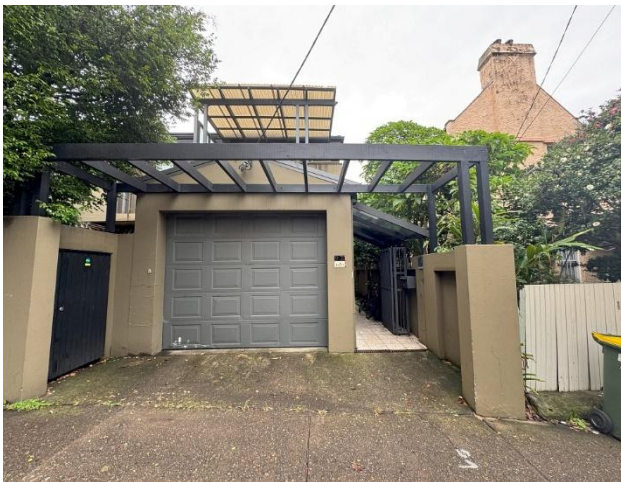
*Plate 34. View south-west. Front view of 27A-B Dover Road, showing garage entry and rendered boundary walls.*

27 Dover Road originally contained a Federation period dwelling that was demolished in 1994 and replaced by the existing dwelling. contains modern three-storey residential building with a rendered masonry exterior and integrated garage fronting the street (Plate 34). The property features a substantial

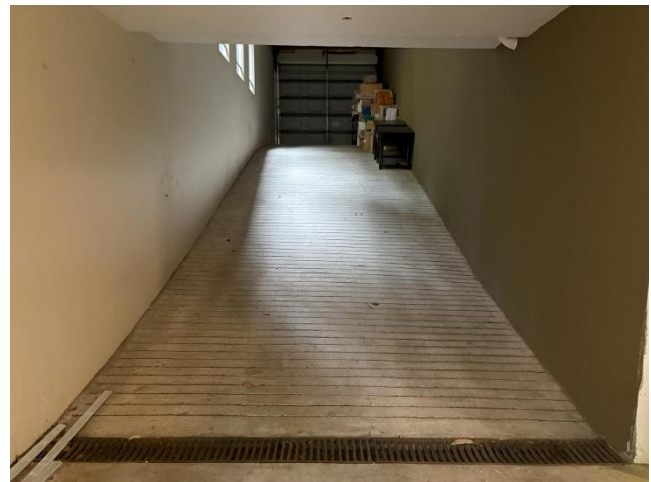
*Plate 35. View north-east. Underground garage beneath house showing sloped driveway and subfloor storage/parking area*

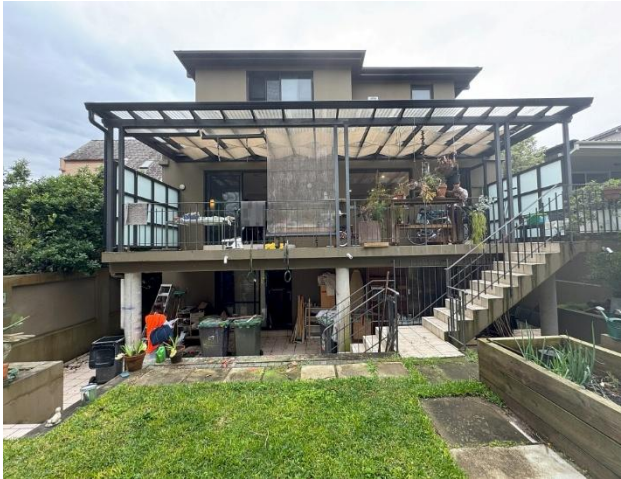
The backyard is levelled at the building footprint, with the rear garden set at a higher elevation, consistent with a cut-in design. The rear facade includes foundational concrete pylons supporting the upper storeys, evidencing deep excavation and structural reinforcement. A storm drain (Plate 39) and multiple service access points were observed across both paved and garden areas.

*Plate 36. View north-east. Rear façade of dwelling and backyard, showing concrete retaining wall, raised garden, and foundational pylons.*

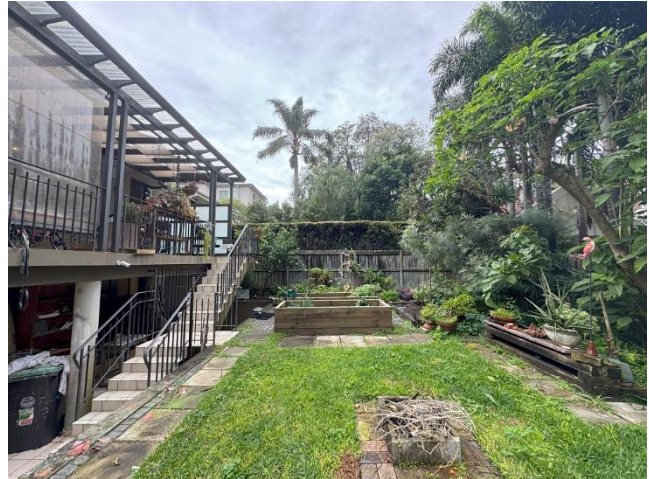
*Plate 37. View south-east across backyard showing elevated rear garden, terraced retaining walls, and foundational pylons.*

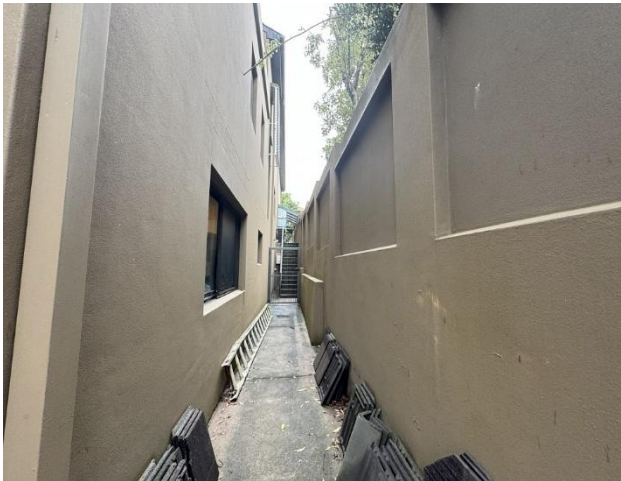
*Plate 38. View north-east. Eastern side passage showing concrete surface with stairs ascending to front of property.*

The western boundary features a narrow paved side alleyway leading from the front of the property to the rear courtyard. The eastern boundary is similarly developed, with a concrete-paved side passage including integrated drainage and access stairs leading down to the backyard (Plate 38). The combination of stepped levels, cut-and-fill surfaces, and engineered retaining elements indicates substantial landform modification across the site.

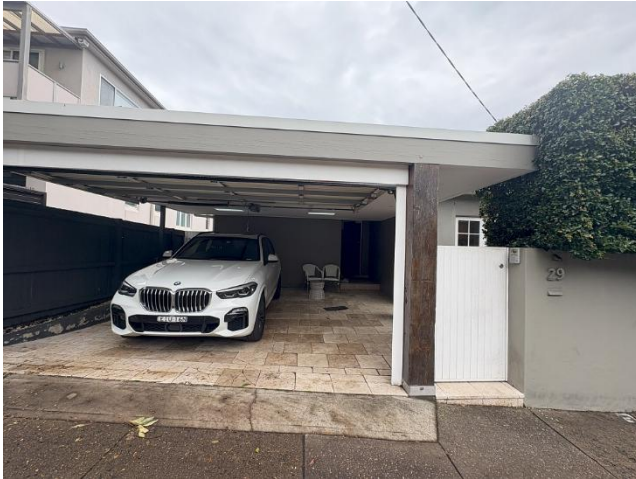
*Plate 40. View south-west. Front facade of 29Dover Road, showing driveway and pedestrian entryway.*

29 Dover Road contains a Federation period dwelling that has been substantially altered. Constructed with a sandstone and brick base, with rendered-brick walls, and a flat roof. The front end of the property contains a concrete paved driveway and courtyard, enclosed by a high rendered-brick fence (Plate 40).

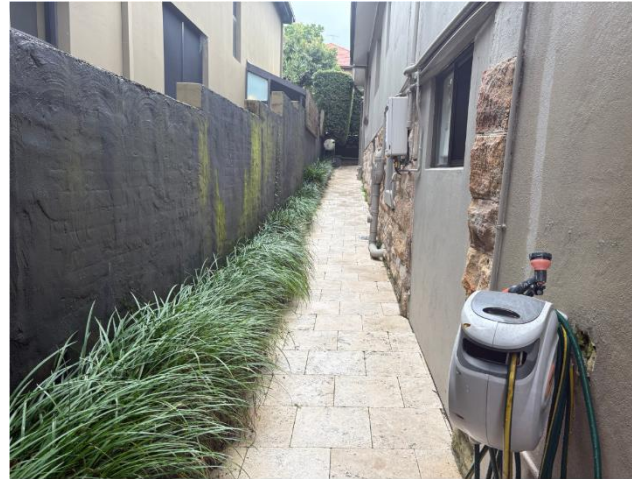
*Plate 41. View north-east along the sloped pathway highlighting gradient from rear yard to front facade.*

The western side of the property contains a concrete-paved path and bordering garden bed, with various dwelling services embedded in house exterior (Plate 41). The backyard consists of open lawn, bordered by tall hedging and garden beds, with concrete pavers leading to the in-ground pool (Plate 42). No ground exposures are visible in the backyard. The western perimeter garden beds are situated at ground level; the eastern perimeter garden beds are raised and constructed of stone pavers, containing a variety of vegetation and small trees.

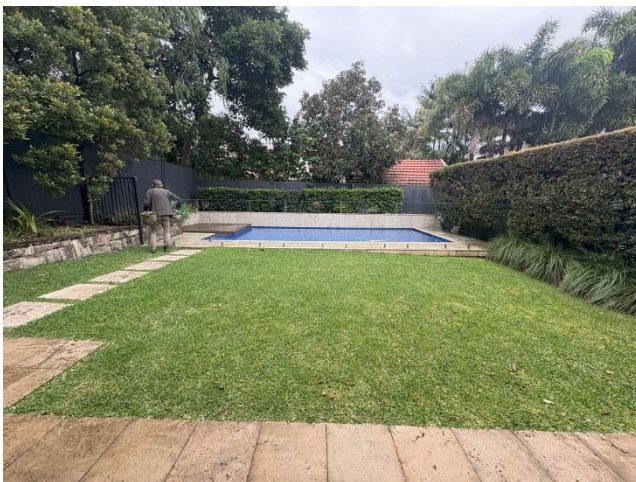
*Plate 42. View south-west showing lawn, in-ground pool, pool fence and paved pathway.*

Extensively levelling has occurred to place the pool on a uniform plane with the lawn (Plate 42). The pool services are located at the rear west side, against the back perimeter fence, on potentially the original ground level.

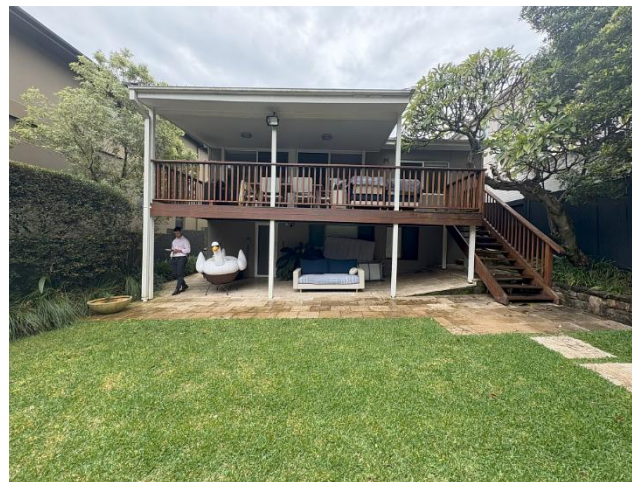
*Plate 43. View north-east showing rear facade of house, lawn, paved area, and garden beds flanking the perimeter*

The lot slopes gently from the north-east (street frontage) to the south-west (rear fence), aligning with the local hind-dune topography and cross-fall drainage pattern. The slope is visible at the concrete-paved area directly under the rear of the house, beneath the deck, with concrete ramp and wooden staircase (Plate 43).

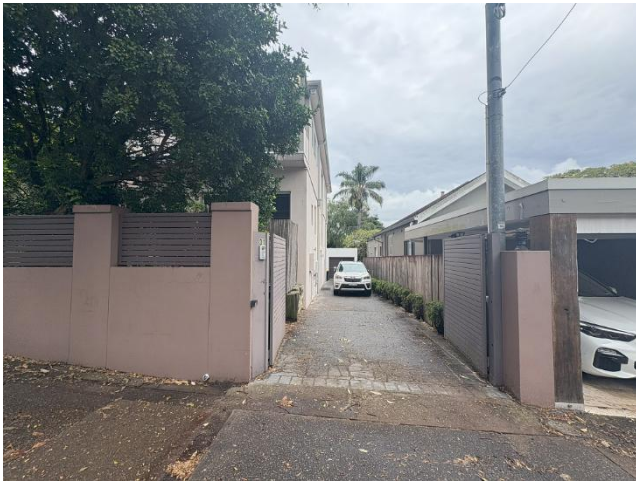
*Plate 44. View south-west. Front facade of 31 Dover Road, showing dwelling and driveway.*

31 Dover Road consists of a highly modified Federation period dwelling, constructed of rendered brick and a pitched tiled roof. The front yard is fenced in by a rendered brick and wooden walls (Plate 44). The western side of the property contains a paved driveway extending to a garage, followed by a narrow access-way to the backyard (Plate 45).

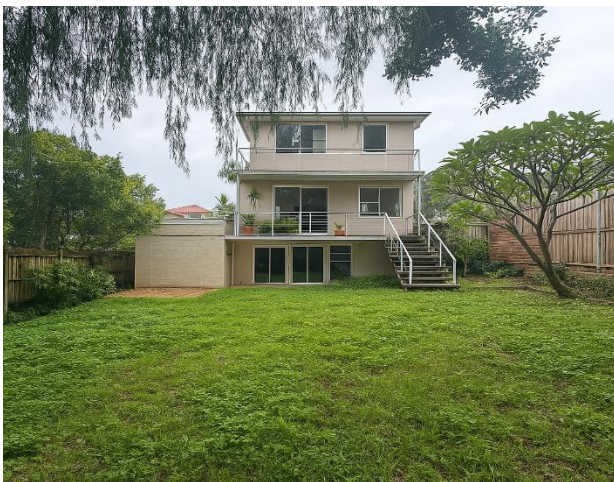
*Plate 46. View north-east showing rear facade of house.*

The backyard consists of a lawn, bordered by vegetation and trees (Plate 46). The eastern side of the yard contains a temporary shed and sections of brick paved areas. The lot slopes gently from the north-east (street frontage) to the southwest (rear fence), aligning with the local hind-dune topography and cross-fall drainage pattern. However, landscape levelling of the backyard is evident in the depreciating angle of the rear perimeter fence (Plate 46–Plate 47).

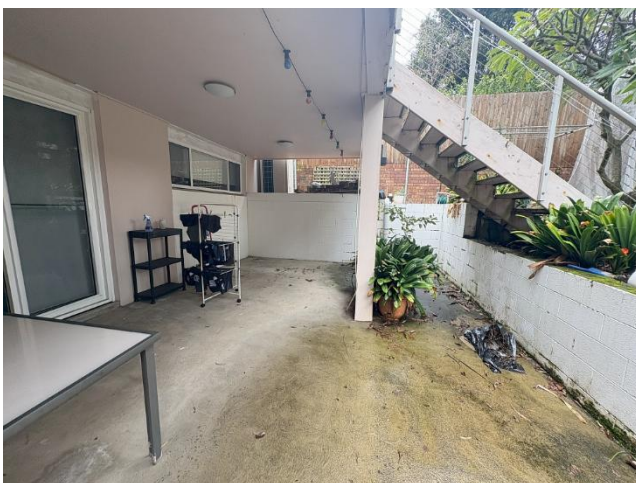
*Plate 48. View south-east showing basement level concreted area and retaining walls.*

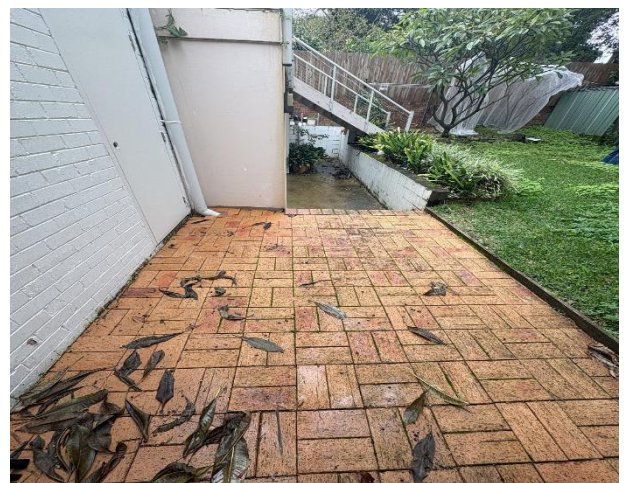
*Plate 49. View south-east showing brick-paved, terrace garden and lower level.*

At the rear of the house is a basement level constructed of concrete and brick retaining walls, a clear indication of disturbance to natural subsurface layers (Plate 48–Plate 49).

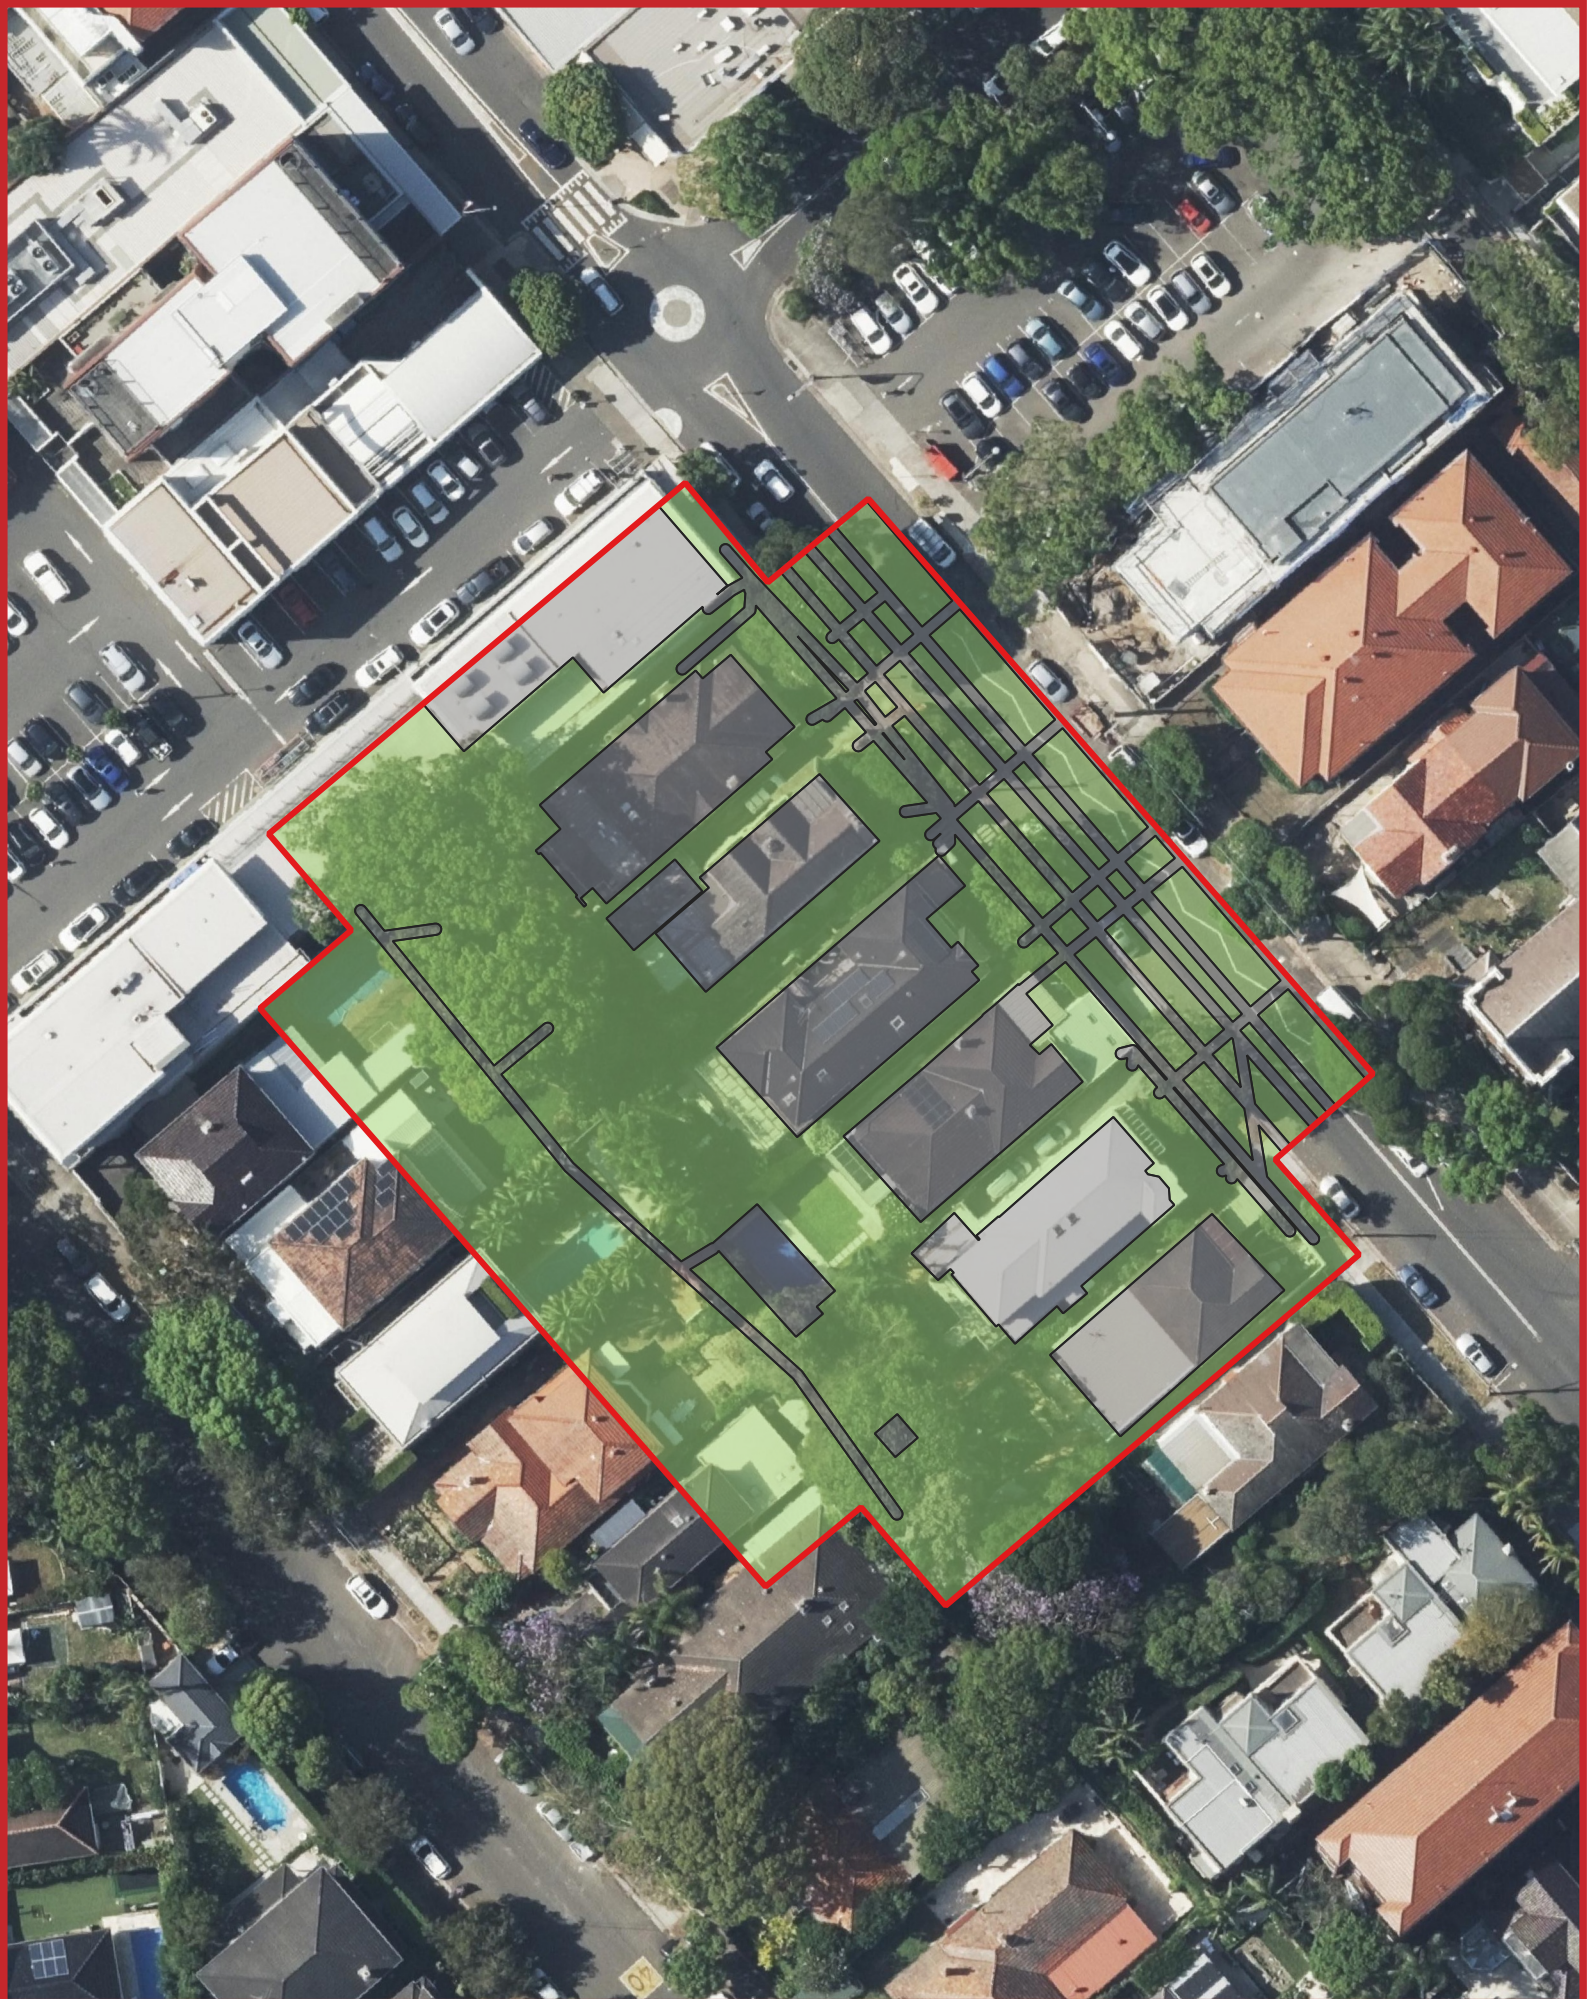
699 – Dover Road HAA  
 23 – 31 Dover Road, Rose Bay, NSW  
 Figure 3. Archaeological Sensitivity Map of the Project Area
