## **Aboriginal Cultural Heritage: Contractor Briefing Document**

Hurlstone Agricultural High School (Hawkesbury)  
2 College Road, Richmond NSW

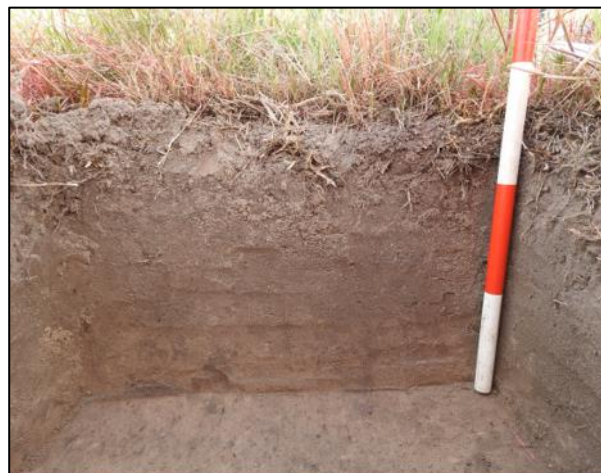
CRR17  
ATT 34  
Zone Three  
Transect 8  
N Section  
12/12/17

The A horizon is found to be absent in majority of the pits. However, a deposited topsoil was present overlaying the A2 horizon which came down onto the B horizon. Minor disturbances were evident however the majority of the soil profile observed was found to be intact but extremely sterile.

The study area is a floodplain/ flats. The soils observed through testing are consistent with the Berkshire Park soil landscape (bp) in which on flats and small drainage lines, 50cm of sandy clay loam A2 horizon (bp2) can be found overlaying <50cm B horizon made up of sandy clay with iron nodules (bp3).

- bp2 (A2 horizon) reddish brown – yellowish brown sandy to fine sandy clay loam with a porous sandy fabric, however can be hardsetting.no inclusions.
- bp3 (B horizon) brown sandy (slightly silty) clay with porous sandy fabric. It has a weak structure and may contain mottles, usually orange in colour, ironstone nodules are common.

The soil profile within the development footprint is deemed disturbed as observed through test excavations conducted by AMAC on site.
