Report on
Detailed Asbestos Delineation Investigation

Hurlstone Agricultural High School (Hawkesbury)
Londonderry Road, Richmond

Prepared for
NSW Department of Education

Project 85644.06
August 2018

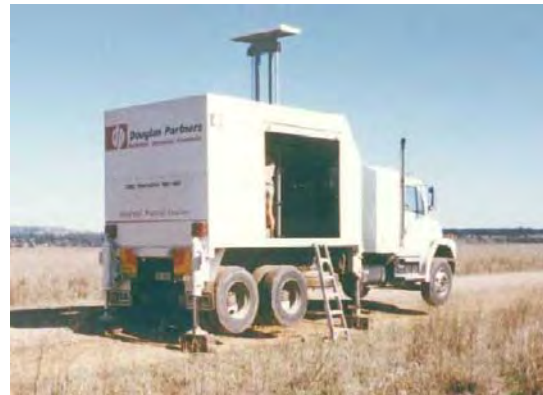
Figure 2: Purpose built CPT rig

The cone is thrust into the ground at a steady rate of about 20 mm/sec, usually using the hydraulic rams of a purpose built CPT rig, or a drilling rig. The testing is carried out in accordance with the Australian Standard AS1289 Test 6.5.1.
