# Arboricultural Impact Assessment Report

Hurlstone Agricultural High  
School  
(Hawkesbury Campus)  
Londonderry Road  
Richmond NSW

Date Prepared: 11 April 2018

Ref: 18/04/11/WSU

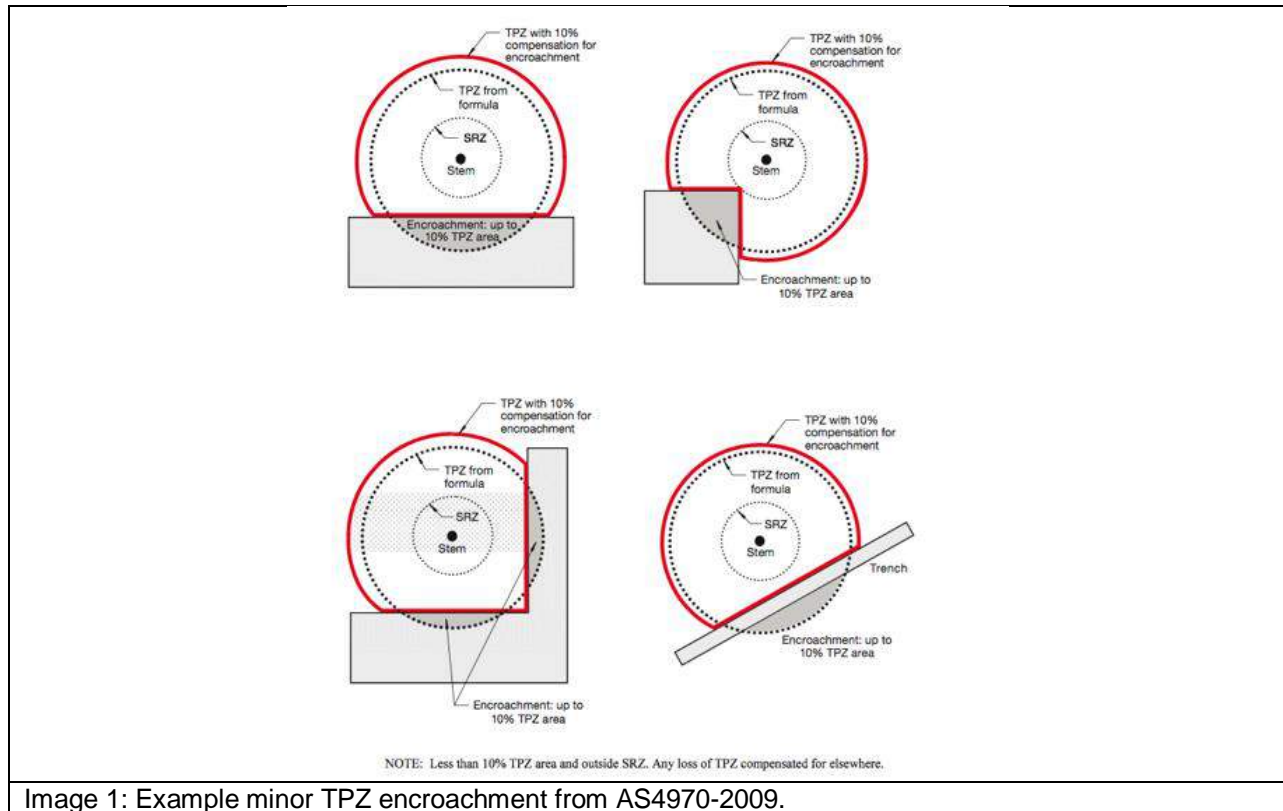
Image 1: Example minor TPZ encroachment from AS4970-2009.

- 7.3 Minor encroachment into TPZ:** Sometimes encroachment into the TPZ is unavoidable. Encroachment includes but is not limited to activities such as excavation, compacted fill and machine trenching. Minor encroachment of up to 10% of the overall TPZ area is normally considered acceptable, providing there is space adjacent to the TPZ for the tree to compensate and the tree is displaying adequate vigour/health to tolerate changes to its growing environment.

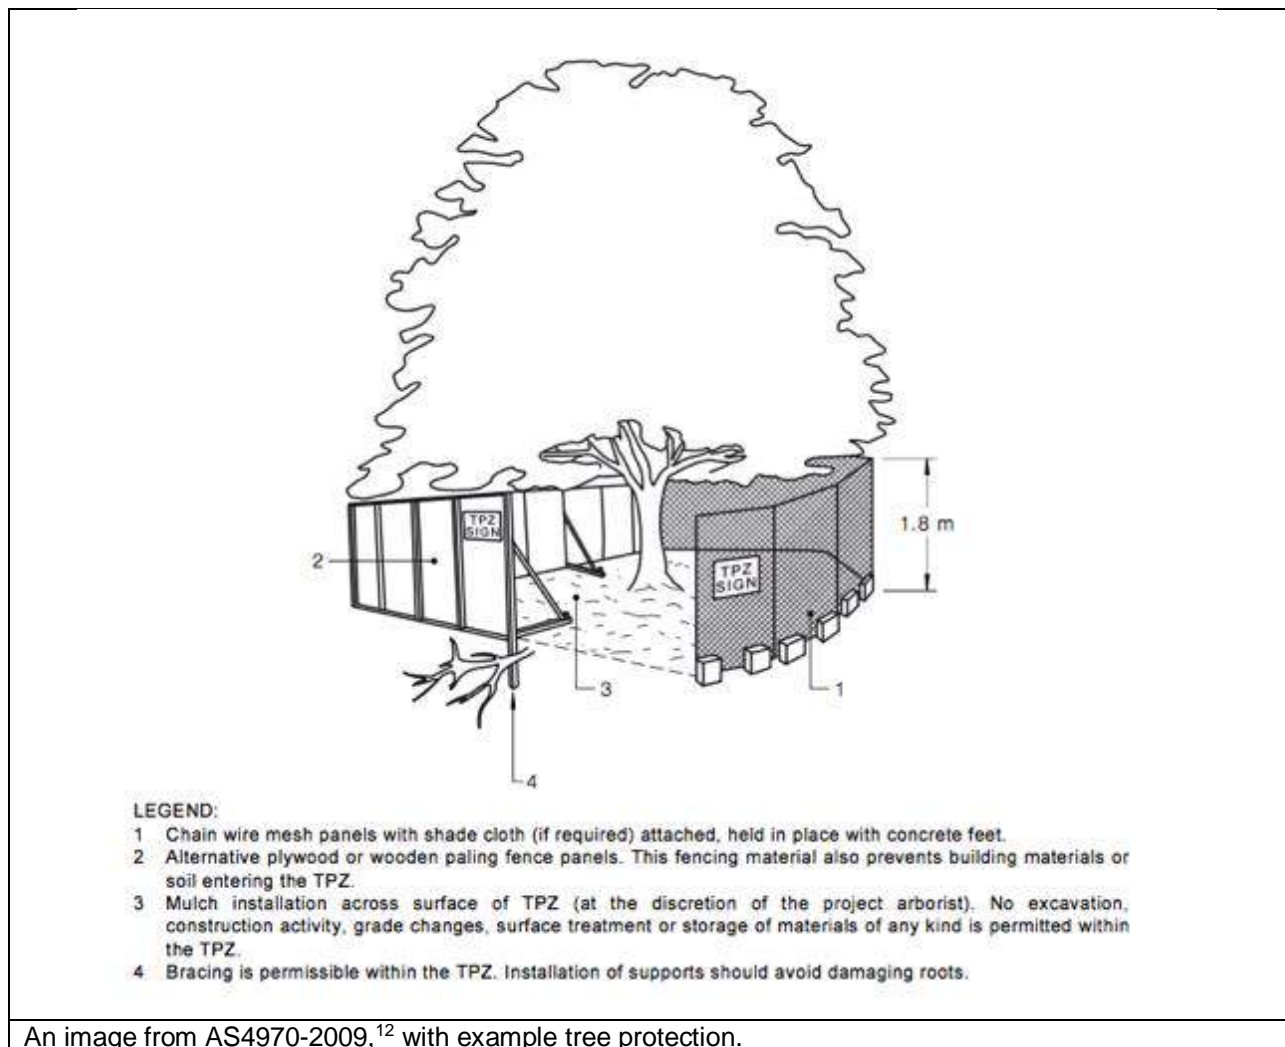
An image from AS4970-2009,<sup>12</sup> with example tree protection.

- The name, address, and telephone number of the developer/builder and project Arborist
- 12.6.3 Trunk and Branch Protection:** The trunk must be protected by wrapped hessian or similar material to limit damage. Timber planks (50mm x 100mm or similar) should then be placed around tree trunk. The timber planks should be spaced at 100mm intervals, and must be fixed against the trunk with tie wire, or strapping and connections finished or covered to protect pedestrians from injury. The hessian and timber planks must not be fixed to the tree in any instance. The trunk and branch protection shall be installed prior to any work commencing on site and shall be maintained in good condition for the entire development period.

**Vehicle Use:** A layer coarse crushed aggregate to a depth of 100mm overlaid onto geo textile fabric. Any vehicles used to distribute the crushed rock must work from outside the TPZ of trees to be retained, or within the footprint of the ground protection to avoid soil compaction.

**Pedestrian Use Only:** Ground protection must consist of good quality composted wood chip/leaf mulch to a depth of between 150-300mm, laid on top of geo textile fabric. Next, support such rumble boards/scaffold boards or track mats to spread the weight and avoid load points. All ground protection located in the TPZ of trees to be retained must be installed/distributed manually. Ground protection is to be specified by the project Arborist as required.

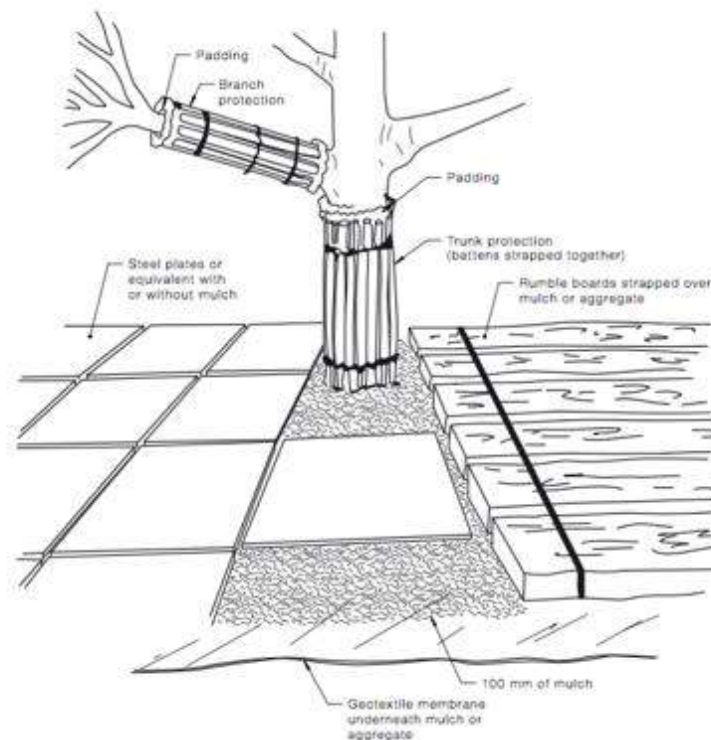
- 1 For trunk and branch protection use boards and padding that will prevent damage to bark. Boards are to be strapped to trees, not nailed or screwed.
- 2 Rumble boards should be of a suitable thickness to prevent soil compaction and root damage.

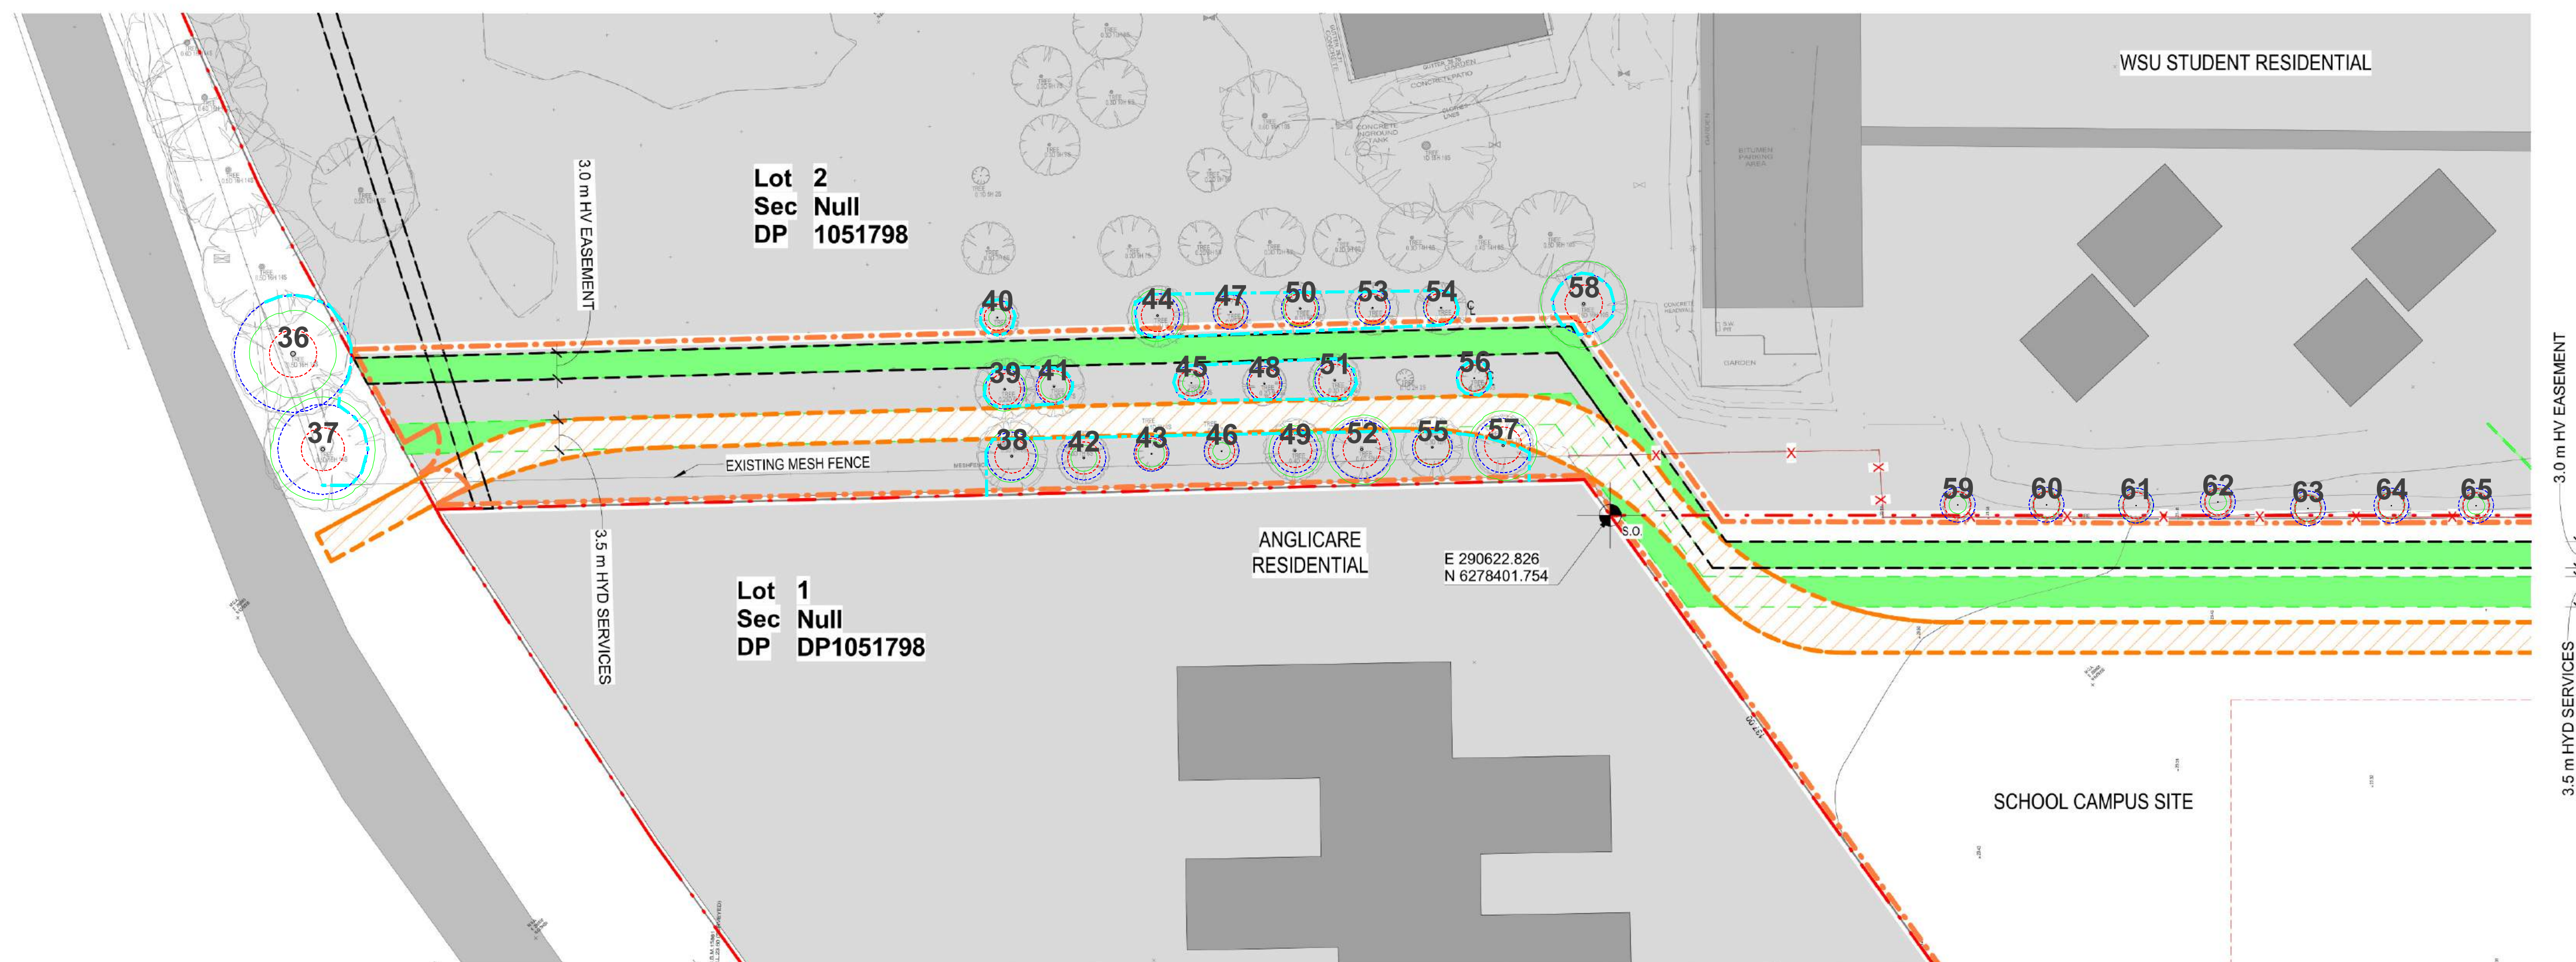
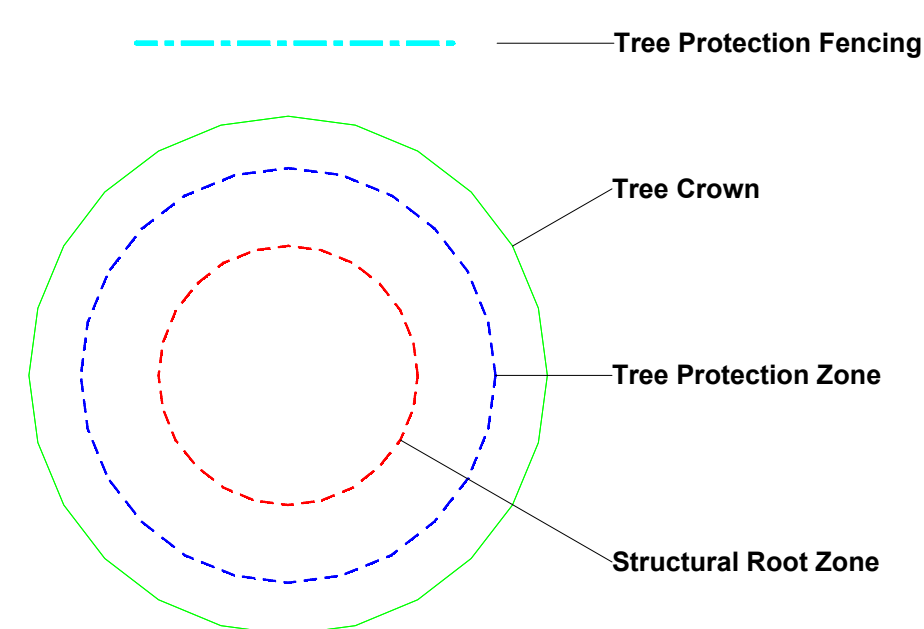
01 SERVICE PATH SET OUT - PART 1

- BULK EARTHWORKS SUB-BASE PLATFORM FOR BUILDINGS - REFER CIVIL ENGINEER'S DOCUMENTS
  - SERVICE TRENCHING - REFER COMBINED SERVICES DOCUMENTS (INCLUDES EXISTING WSU RECYCLED WATER LINE)

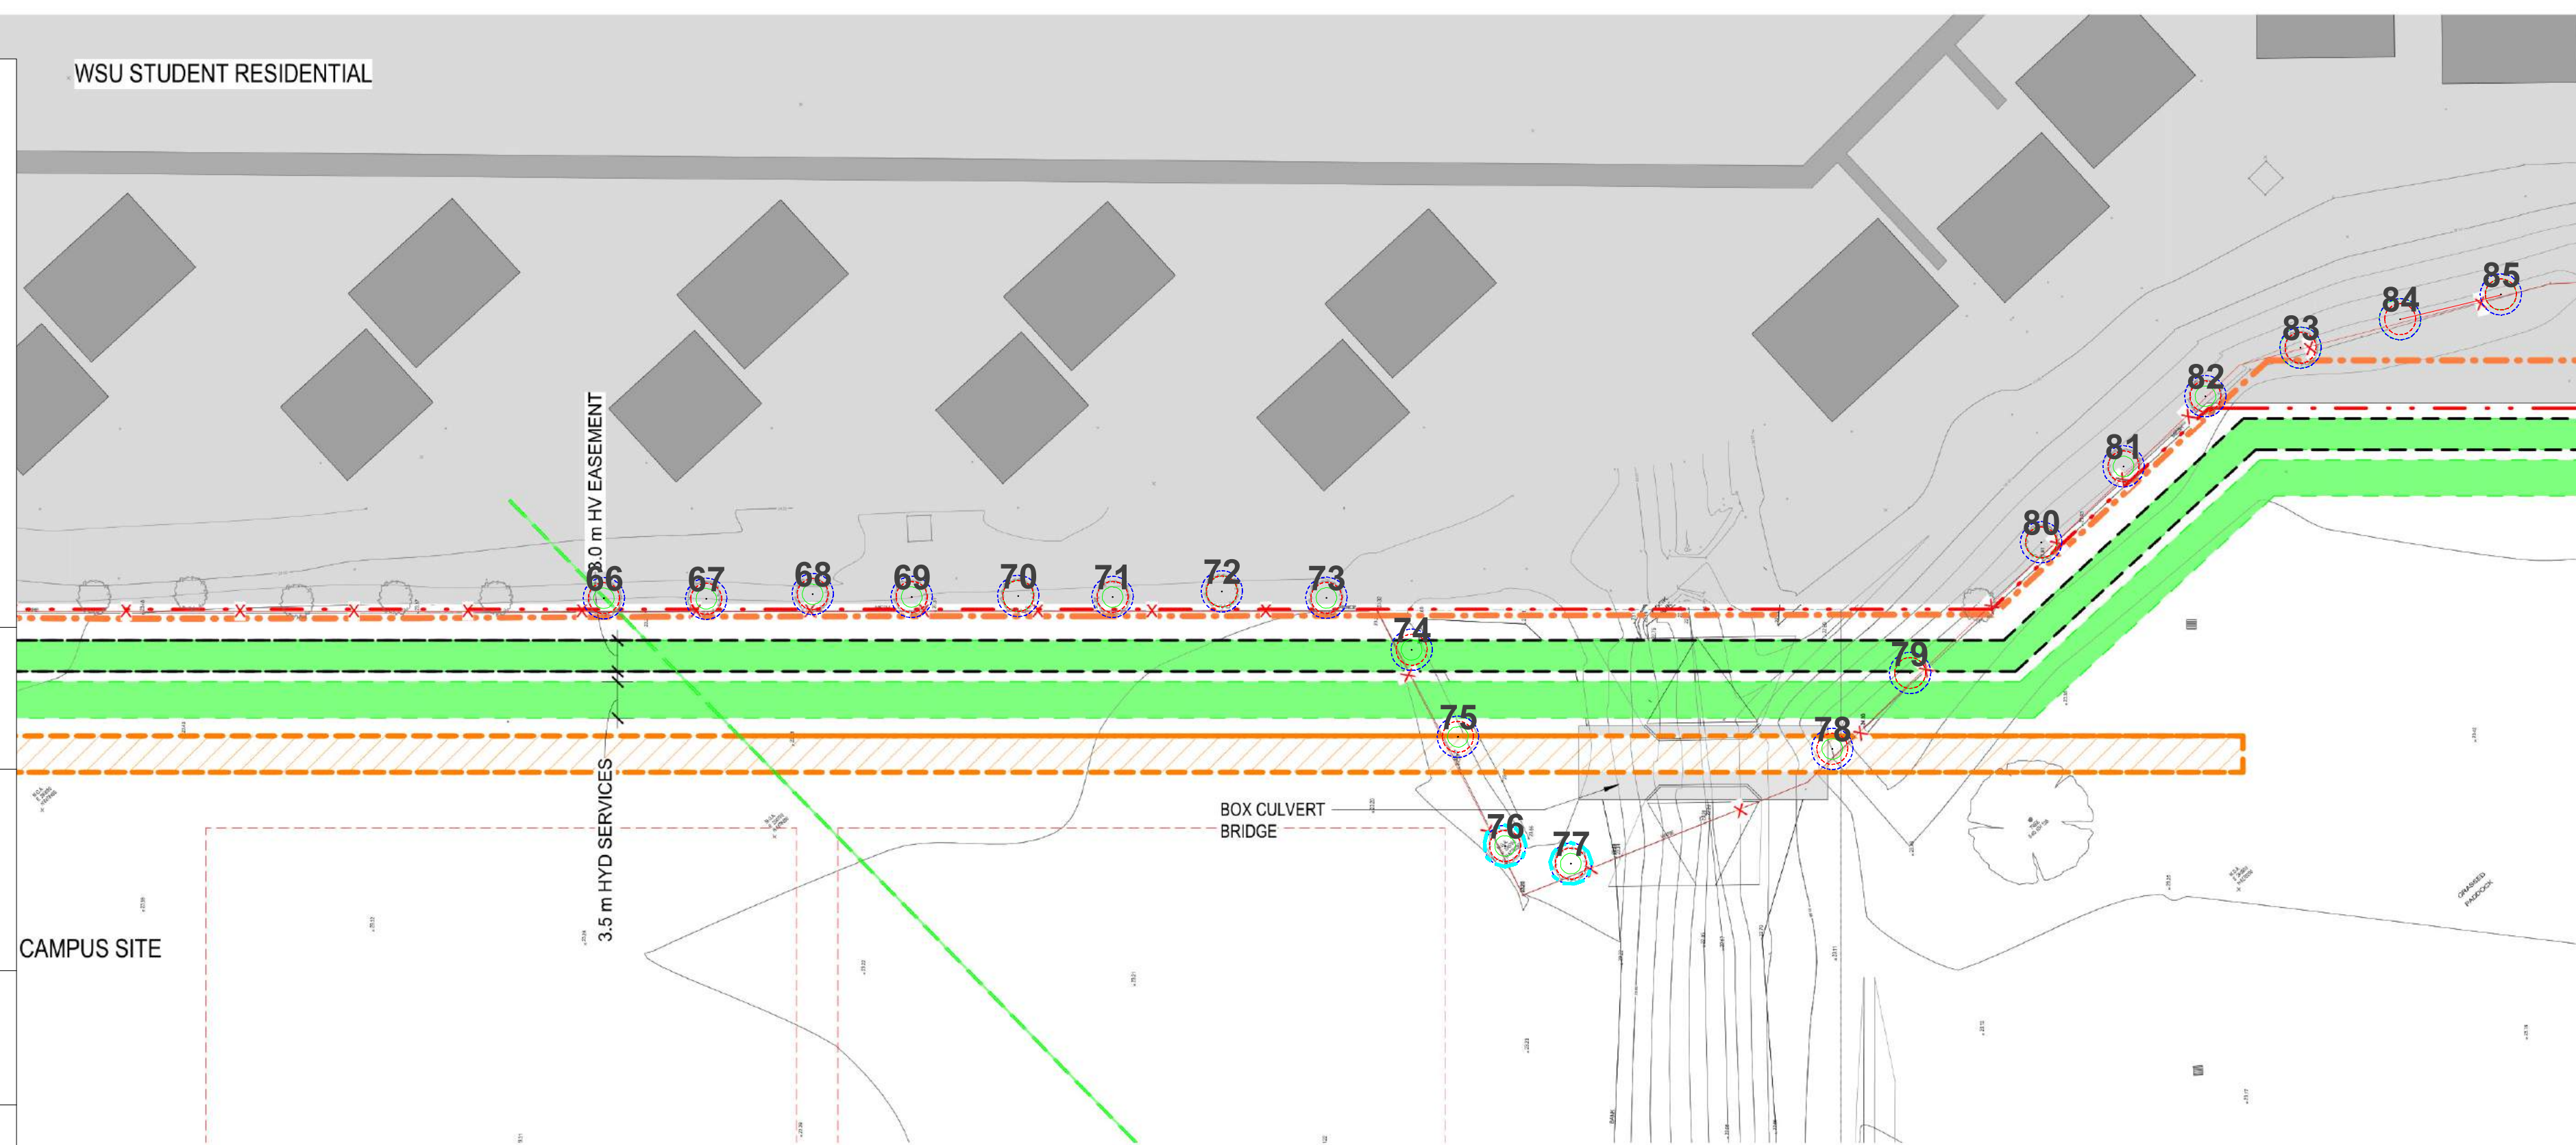
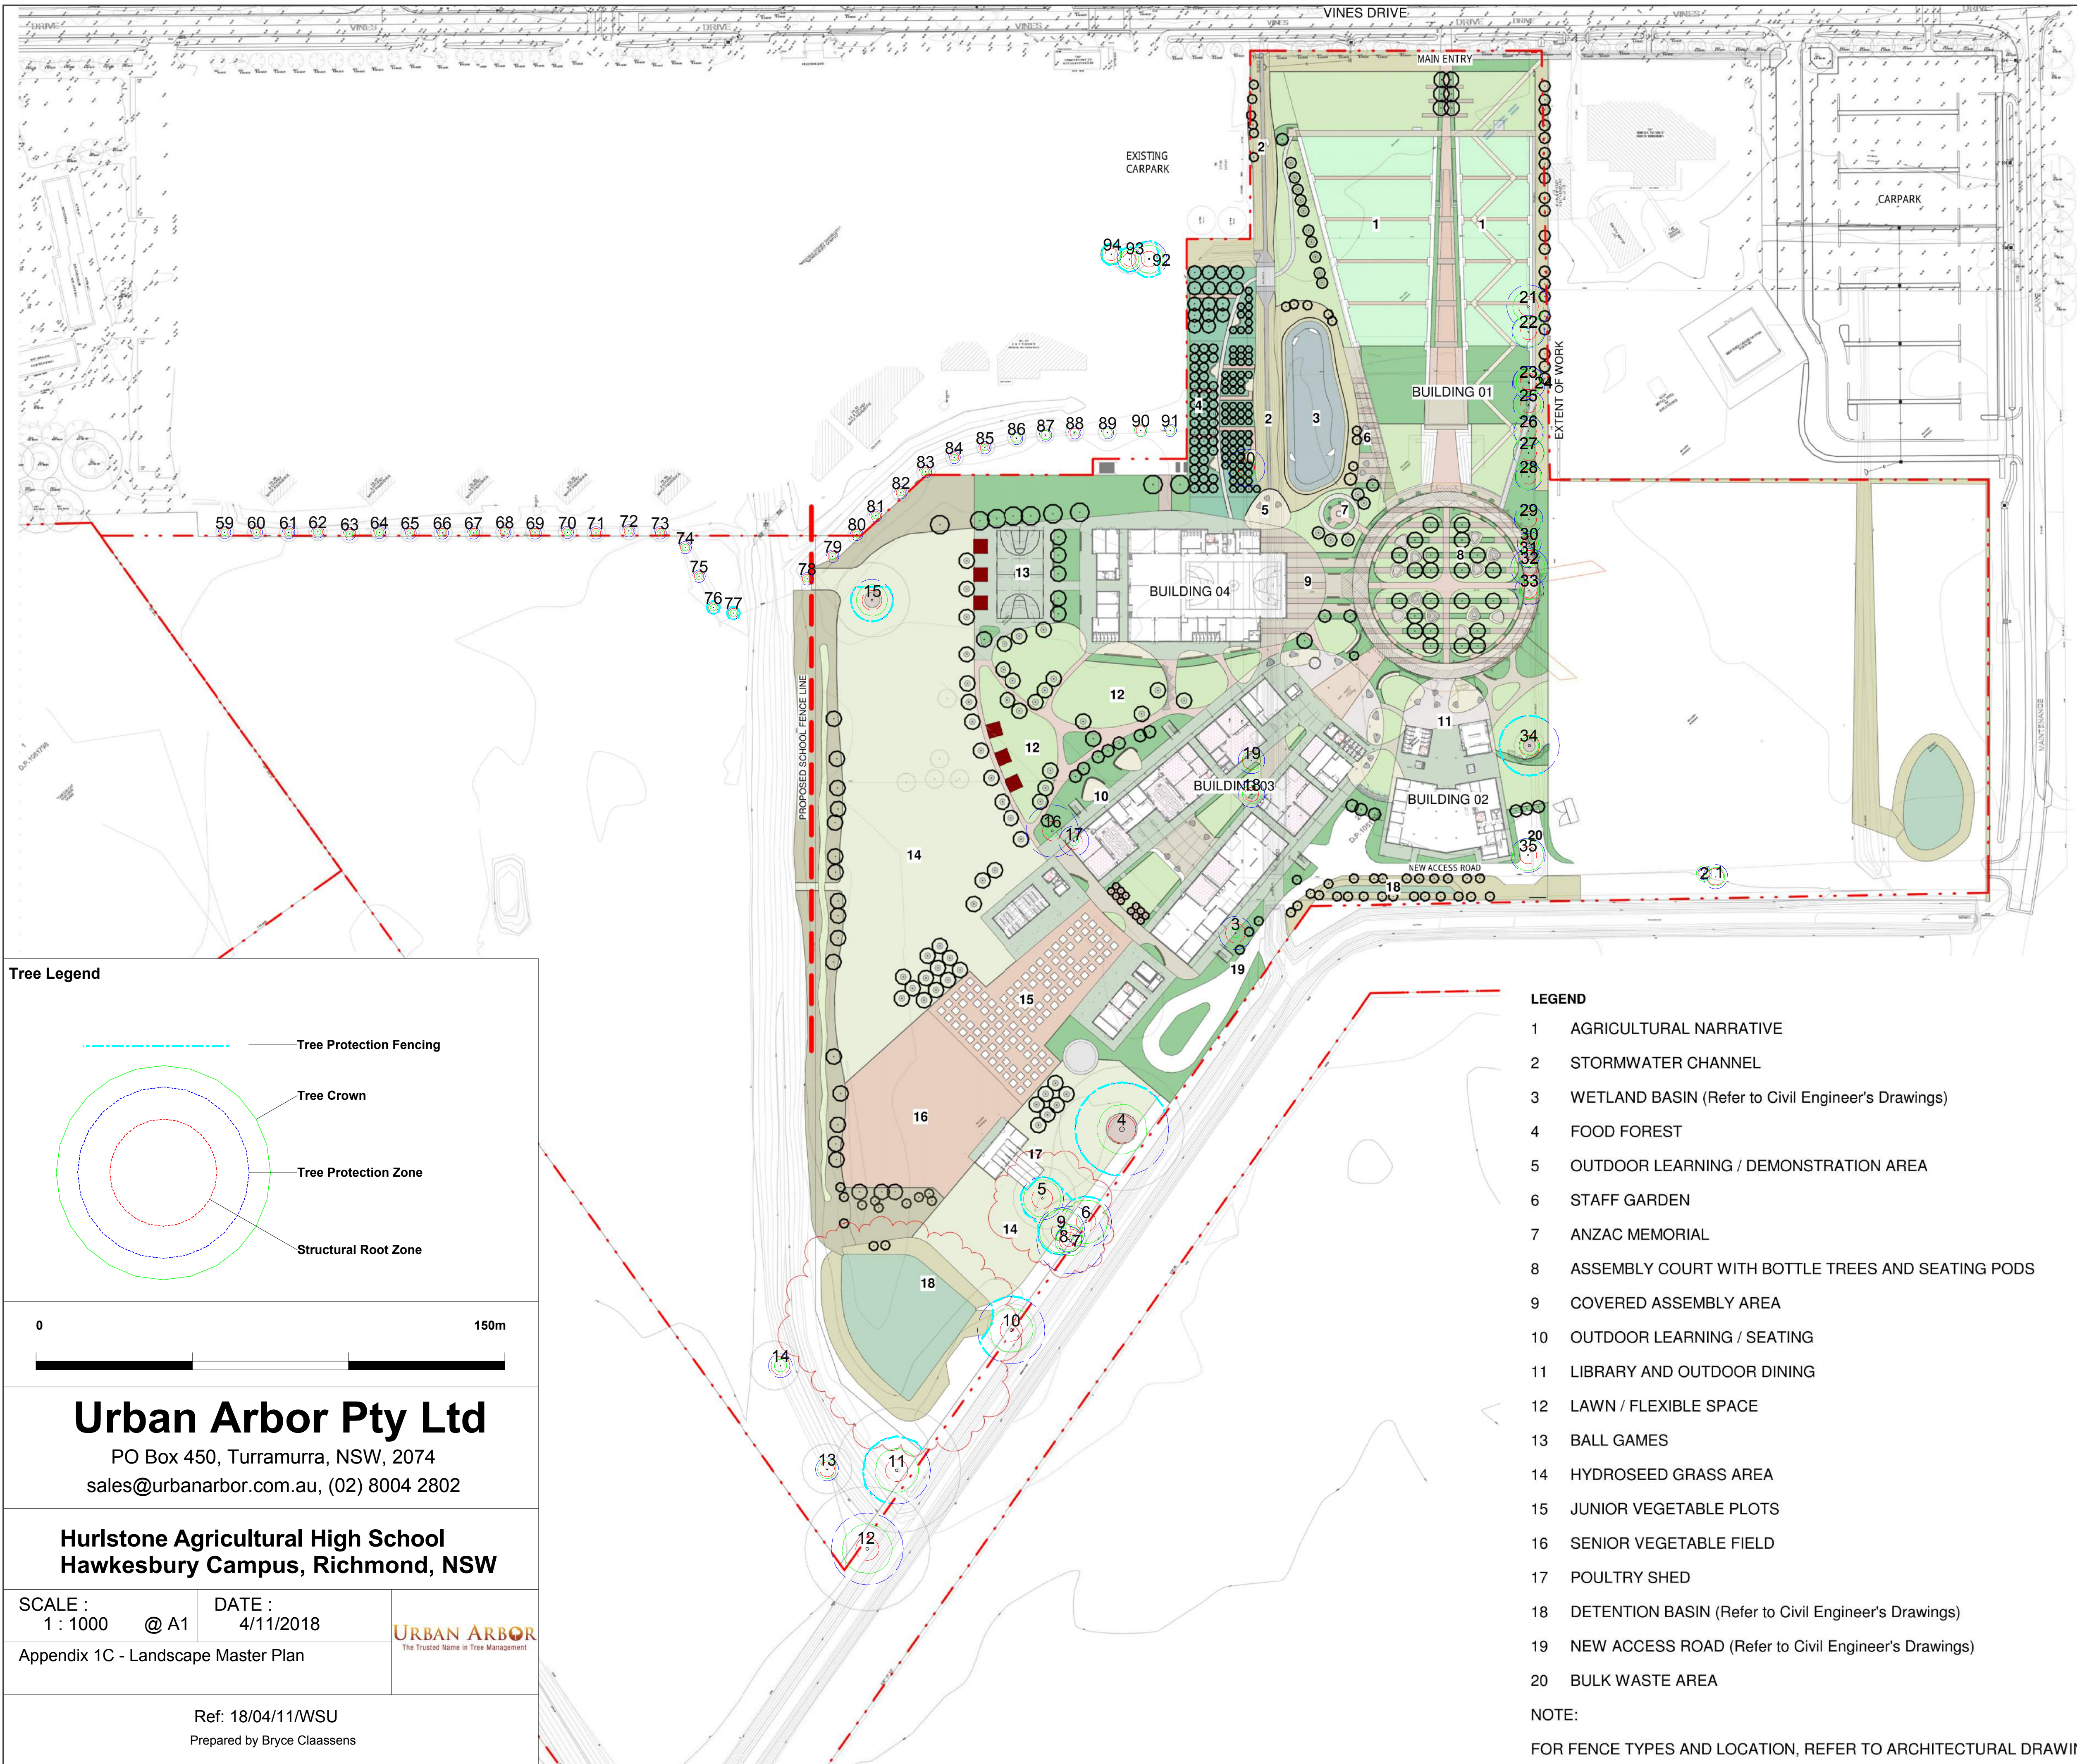
Appendix 1B - Early Works Plan  
Service Path Set Out

Tree Protection Fencing

- 12.5 Site Specific Tree Protection Recommendations:** The table below provides recommendations for each tree, including site specific tree protection requirements. All trees to be retained must be protected in accordance with general requirements of AS4970-2009 for the duration of the development, details of which are discussed in further details in this section of the report.

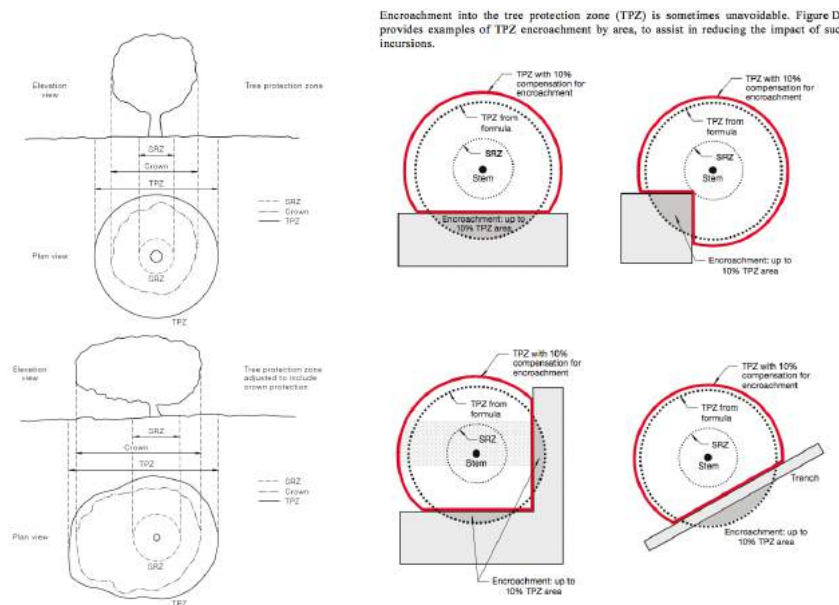
**Minor encroachment into TPZ:** Sometimes encroachment into the TPZ is unavoidable. Encroachment includes but is not limited to activities such as excavation, compacted fill and machine trenching. Minor encroachment of up to 10% of the overall TPZ area is normally considered acceptable, providing there is space adjacent to the TPZ for the tree to compensate and the tree is displaying adequate vigour/health to tolerate changes to its growing environment.

**Major encroachment into TPZ:** Where encroachment of more than 10% of the overall TPZ area is proposed the project Arborist must investigate and demonstrate that the tree will remain in a viable condition. In some cases, tree sensitive construction methods such as pier and beam footings, suspended slabs, or cantilevered sections, can be utilised to allow additional encroachment into the TPZ by bridging over roots and minimising root disturbance. Major encroachment is only possible if it can be undertaken without severing significant size roots, or if it can be demonstrated that significant roots will not be impacted.
