## Aboriginal Due Diligence

5 Blue Street, North Sydney

May 2026

Curio Projects, 2026, *Aboriginal Due Diligence: 5 Blue Street, North Sydney*. Prepared for Lighthouse Project Group.

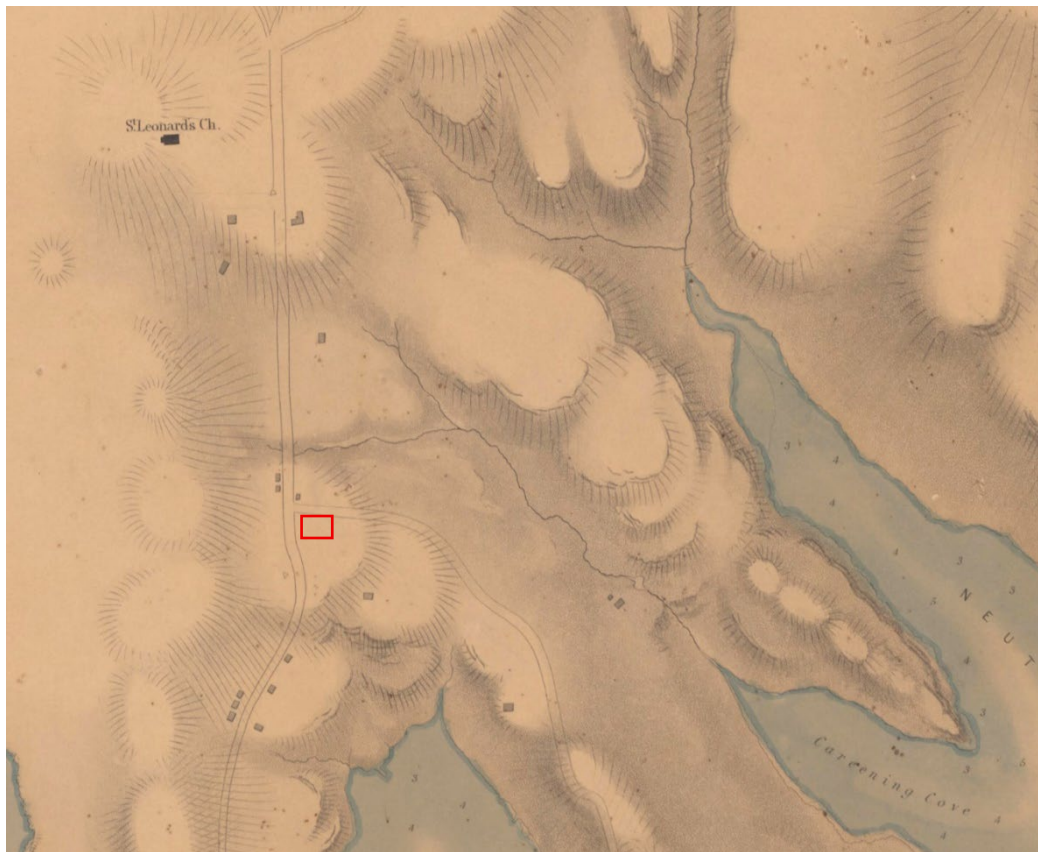
Figure 3.2: 1853 Trigonometrical survey of Port Jackson, with approximate location of study area highlighted in red. Note that only Miller (NS) and Blue Street (EW) are present in this survey, possibly indicating that the other streets were not present or were still largely dirt tracks when this part of Sydney was surveyed.

established east to west, and Miller and Walker Streets running north to south.<sup>8</sup> This area had at least 106 dwellings by 1846, and by 1859 the growing commercial and retail centre ran from Miller Street down to Milsons Point.<sup>9</sup> The area was overall noted to be fairly undeveloped and only had a small number of cottages and larger villas scattered around the smaller hills. The study area appears to have been an undeveloped slope adjoining the early form of Miller Street during this period, with some small residences located to the north and south. The site's south-eastern corner is also located close to the head of Rainbow Creek, likely running down from the ridge to the north-west, as seen in Figure 3.2 below.

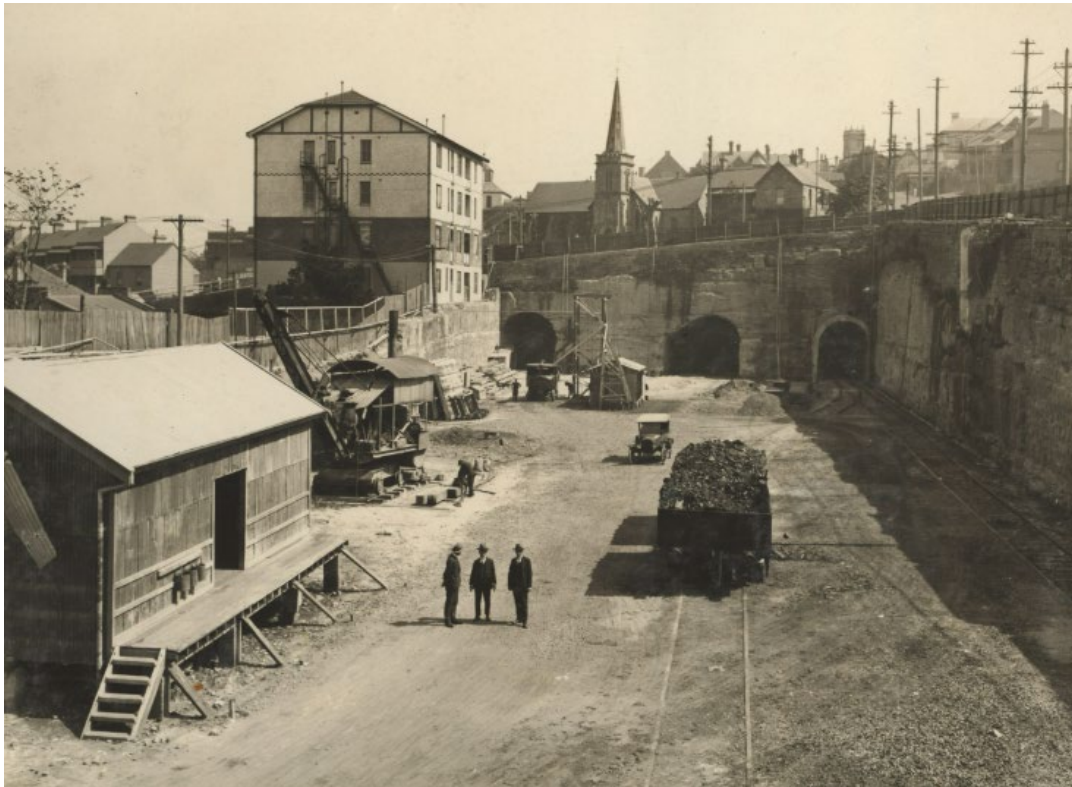
Figure 3.4: Construction of North Sydney Station 1925 – directly beneath the current study area, looking west  
Source: NSW State Archives NRS-12685-1-[4/8722]-4/8722-10

North Sydney Station was constructed within a substantial rock cutting, with the platforms located below street level and an overhead concourse built above them to provide pedestrian access from the surrounding road network. Spoil excavated from the North Sydney Station site was reportedly reused to form the ramp up to the main bridge level, with concrete retaining walls constructed along nearby streets including Broughton Street, Alfred Street, Bradfield Highway and Pacific Highway.<sup>13</sup>

The station was designed with four platforms, corresponding to the four railway tracks originally intended to cross the Sydney Harbour Bridge as part of John Bradfield's broader transport scheme for the harbour crossing and northern railway approaches. At the Waverton end of the station, four tunnels were cut into the rock to carry the rail alignment westward. In addition to these operational tunnels, approximately 260m of unused tunnel stubs were also excavated for proposed future railway lines to Newport and Northbridge. These were reportedly included during the original construction phase because Bradfield considered that later excavation for these proposed lines would be difficult and disruptive once the North Shore Line was operational.<sup>14</sup>

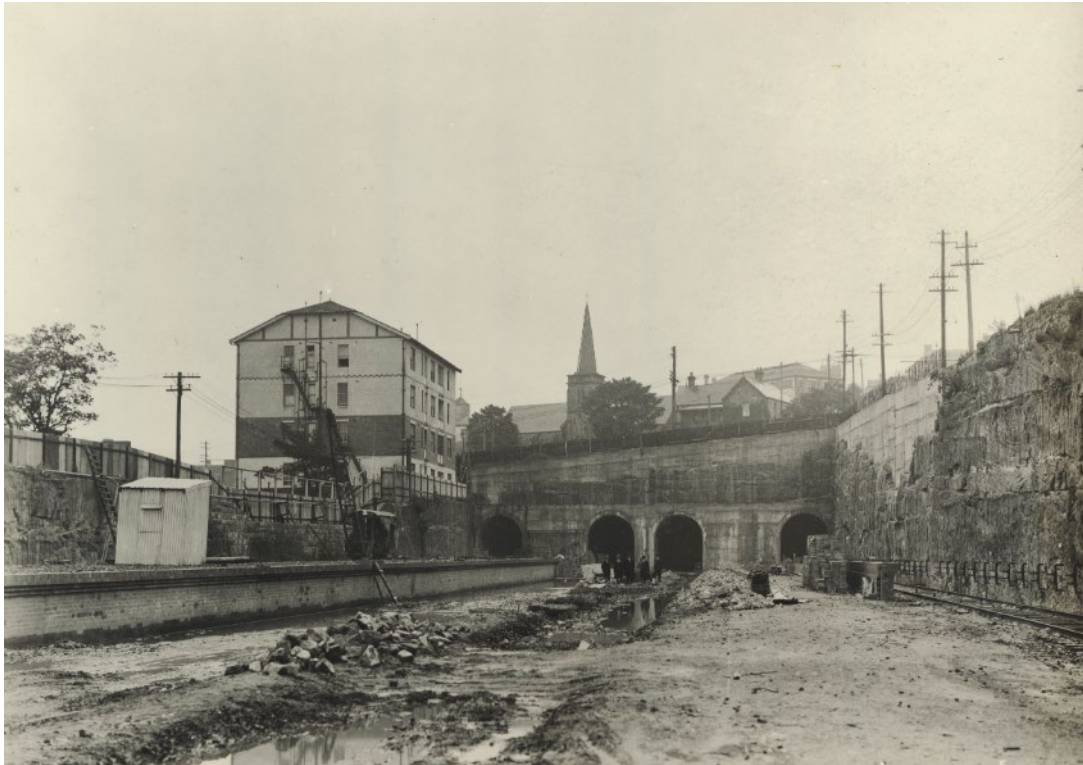
Figure 3.5: Construction of North Sydney Station 1931 – directly beneath the current study area, looking west  
Source: NSW State Archives NRS-12685-1-[4/8723]-4/8723-9

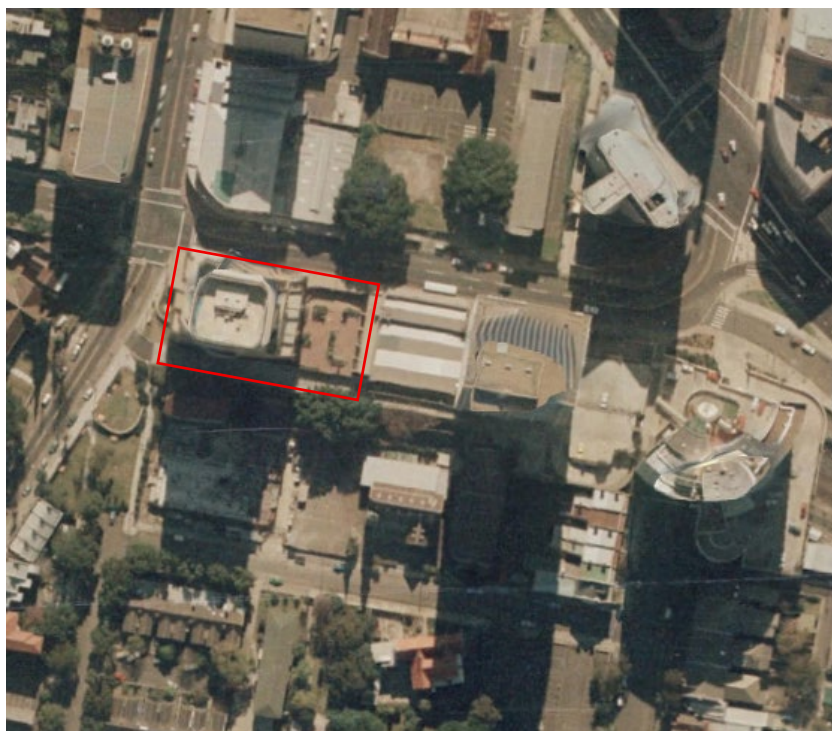
Figure 3.7: 1986 aerial  
Source: NSW Historical Imagery Viewer

The Zurich Building at 5 Blue Street represents the later major phase of over-station commercial development. Completed/opened in 1984 as Zurich Insurance House, the building enclosed the remaining open portions of North Sydney Station and established the site's long-term use as a major commercial office building above the railway.
